2. The object of these tests was to determine the suitability of the Model DV direction finder for use in naval aircraft.

MODEL DV RADIO DIRECTION FINDER

SUBJECT: Aircraft Radio - Model DV Radio Direction
Finding Equipment - Report on Tests of.

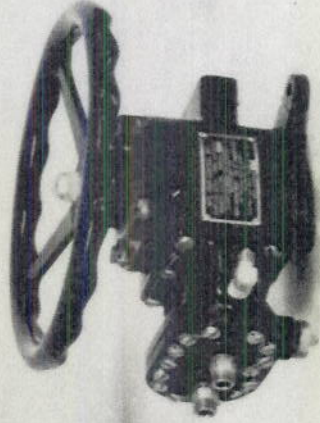
Model DV Direction Finder Equipment.
Hydraulic Control Units.

(b) The incorporation of flexible couplings in the hydraulic system allows a more flexible operation and minimizes breakage and leakage due to vibration.

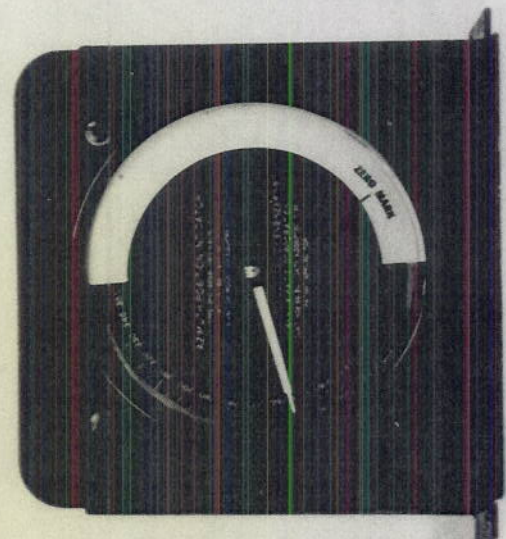
Model DV Direction Finder Units.
Azimuth Indicators.

11. At temperatures from -20 to -32° C. the azimuth control unit developed a back lash of 3° . This does not affect the synchronizing or accuracy of the azimuth indicators and is purely a loss in movement of the mechanical control.
