NRL Report No. M-1506

Report  
on  
Installation of Naval Research Laboratory Lamination  
Detector at Philadelphia Navy Yard.

NAVAL RESEARCH LABORATORY  
ANACOSTIA STATION  
WASHINGTON, D.C.

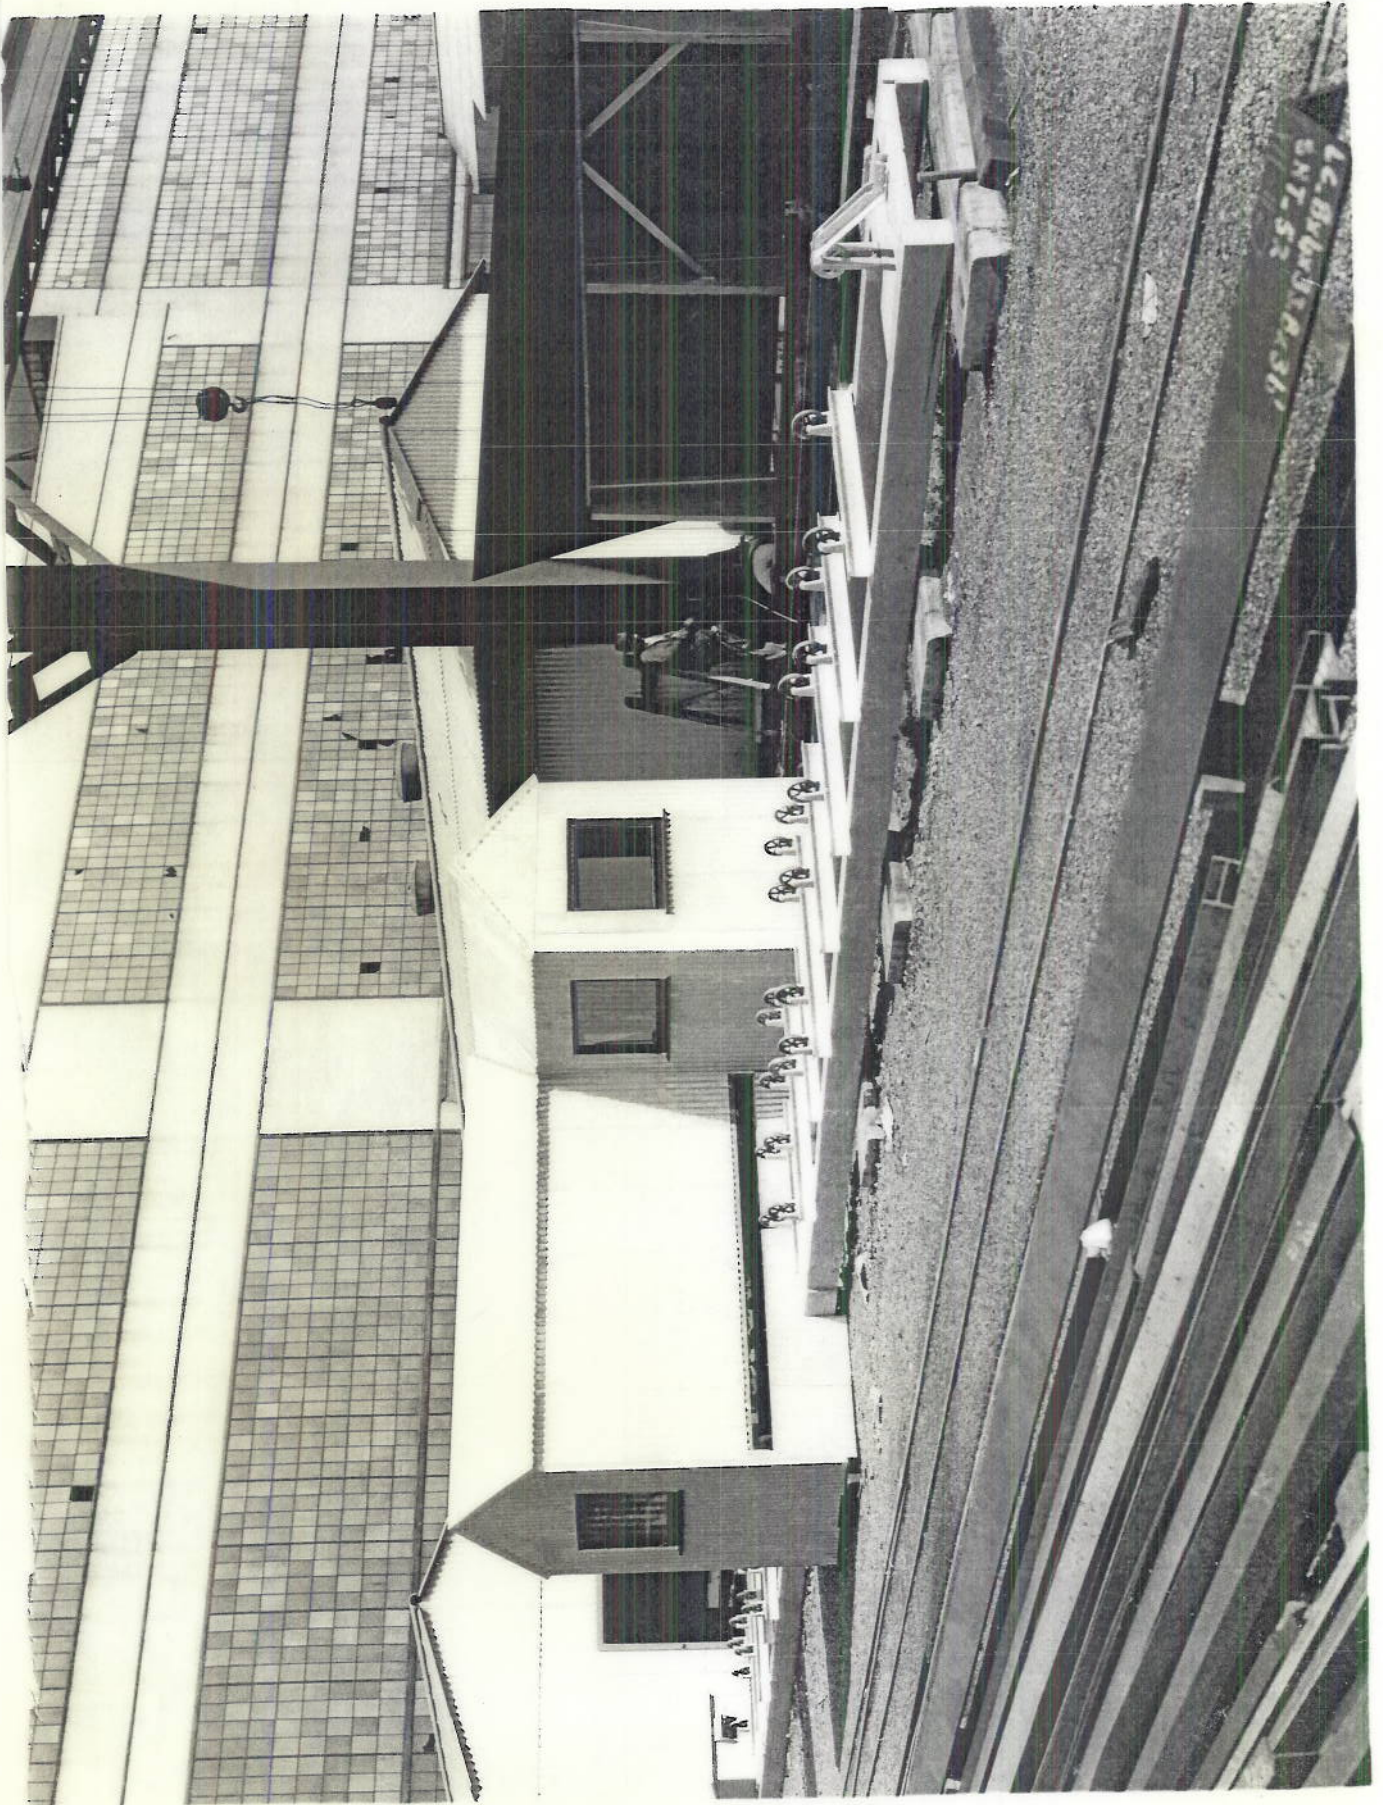
9. The equipment used for the tests is shown in Figures 1, 2, 3, 13, 14, 15 and 16. Figure 1 is a view of the building and roller bed foundation, both of which were especially constructed for the tests. Figure 2 is a close-up view showing a plate in position for test. Figure 3 is an interior view showing equipment shipped up from the Naval Research Laboratory. Figure 13 is a shop view of the exciting coil and assembly of pick-up units. Figure 14 is a close-up view of a single pick-up unit. Figure 15 is a view of the recorder. Figure 16 is a view of the illuminated screen of the cathode-ray oscillograph, with an indication of defect by pick-up unit number 6.

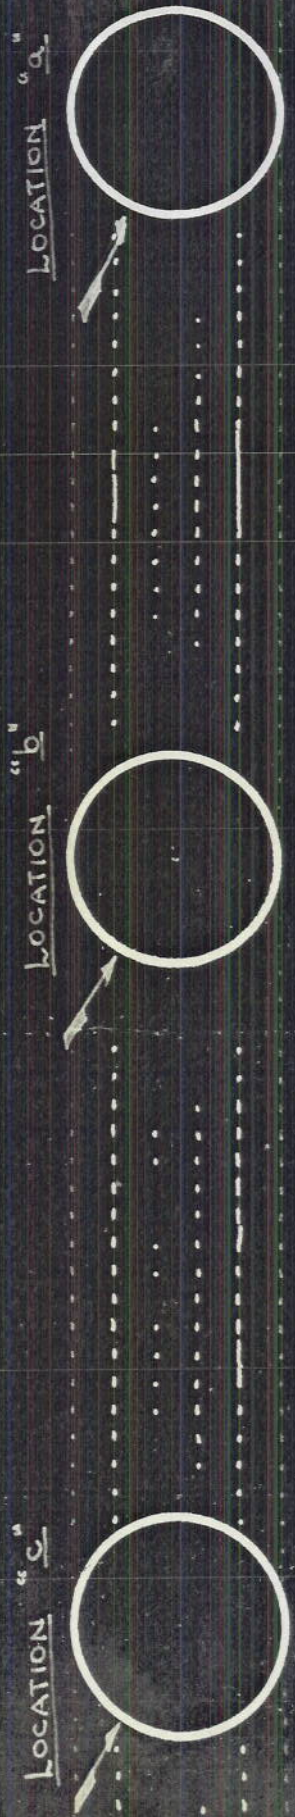
FIGURE 7  
EXAMPLE OF NEGATIVE CORRELATION BETWEEN TOP AND BOTTOM INDICATIONS: ABSENCE OF MARKING AT LOCATIONS 'a', 'b', AND 'c' OPPOSITE 'a', 'b', AND 'c' OF FIGURE 6.

27. Indication of lamination for examination of one side of a plate must correlate positively with indication from the other side of the plate if either indication is to be significant as indicating presence of a lamination. Figures 6 and 7 show a case of decided negative correlation between lamination detector indications from top and bottom of a plate. The fact that examples of decided negative correlation not only do occur, but are fairly often observed is proof that the lamination detector is not yet entirely outside a laboratory stage of development. As mentioned earlier in this report, pick-up units mounted both above and below a plate would serve to eliminate

indications which signify a detection only of negative correlation effects. Incidentally, not all examples of negative correlation are at regularly spaced regions as in Figures 6 and 7. The more common form of such example is where the indication occurs singly, and at random, in the plate.

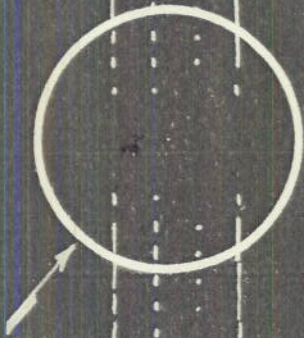
LOCATION OF PIT, PICK-UP NO. 4.

EXACT SIZE OF PIT

GREATEST DEPTH OF PIT: 3/32 INCH.

NOTE: THE INDICATION FOR PICK-UP NO. 4 HAS BEEN "TURNED UP" THE BETTER TO SHOW ABSENCE OF MARKING AT LOCATION OF THE PIT. THE PIT IS ON TOP SURFACE OF THE PLATE, DIRECTLY IN LINE WITH PICK-UP NO. 4.

FIGURE 8  
EXAMPLE OF EFFECT OF DEEP PIT: INDICATION IS OPPOSITE TO EFFECT OF LAMINATION.

PLATE NUMBER 45: 300" x 72" x 15# LBA.

30. Figure 8 is included to show that the effect of a pit is opposite to effect of a lamination. The indication is one of rise in voltage (blank space on the record) instead of a fall in voltage (marked space on the record). The observation is what one should expect. The increase in voltage due to a pit is simply evidence that because of the discontinuity of surface condition, more magnetic flux is forced out into the air, to be detected by the pick-up coil. The detection of surface imperfections by the Magnaflux method depends upon this same principle of there being a concentration of magnetic flux wherever the normally smooth surface of a magnetized body is broken by a crack.
