Design, Construction, and Testing of the PFAS Effluent Treatment System (PETS), a Mobile Ion Exchange–Based System for the Treatment of Per-, Poly- Fluorinated Alkyl Substances (PFAS) Contaminated Water

March 2022

Final Report

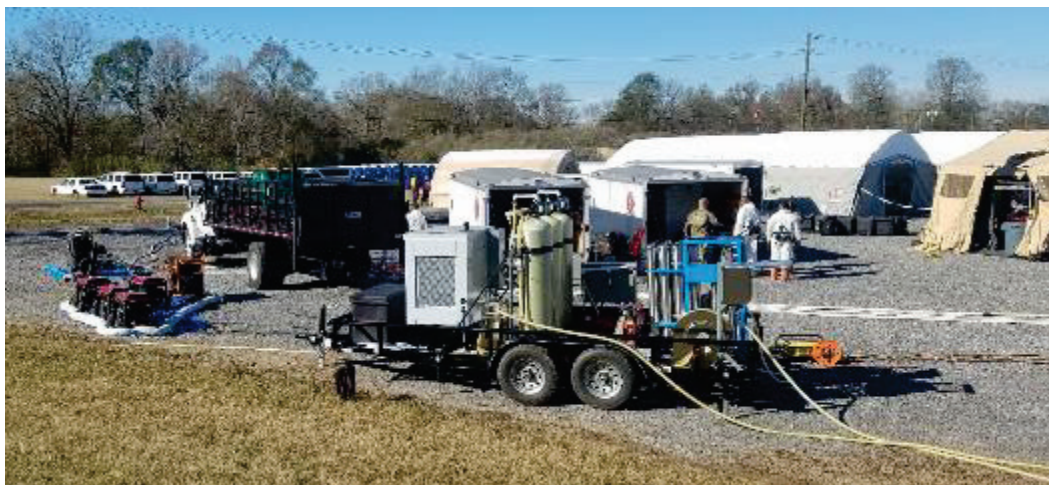
Figure 2. The Decontamination Effluent Treatment System (DETS).

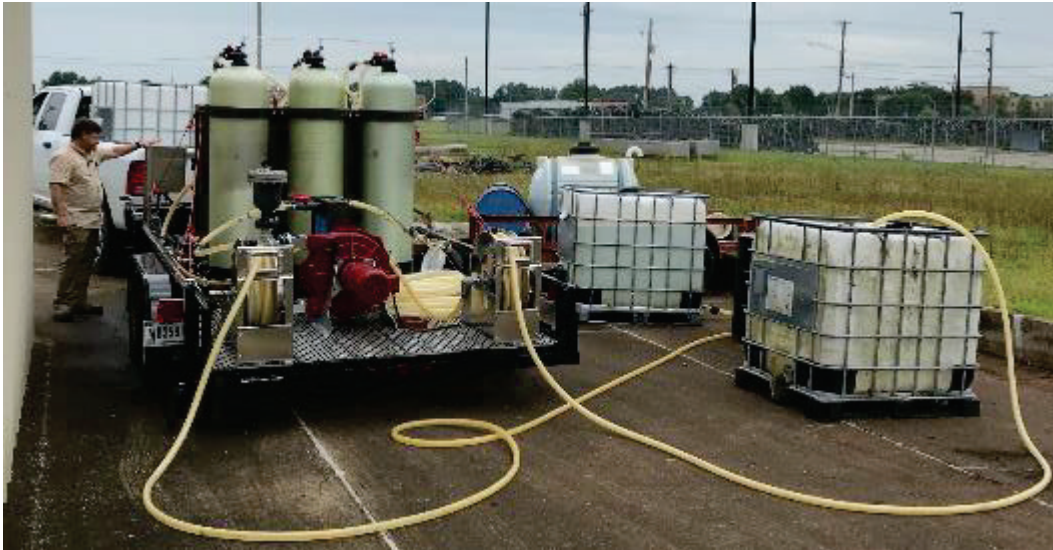
Figure 3. PFAS Effluent Treatment System (PETS).

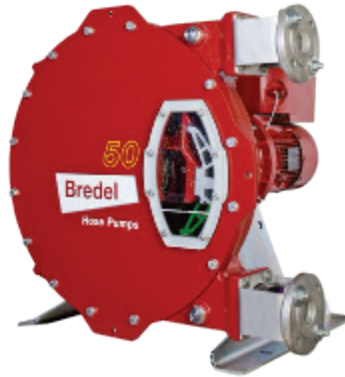
Figure 8. Bredel 40 Hose pump used in the PETS.

The pump uses 240V, three-phase power and requires a variable frequency drive (VFD) to control pump speed. At the recommendation from the pump vendor, we chose a 3 hp VFD from ABB (model #ACS255-03U-10A5-2+BO63+F278) to control the pump.

We also selected a pulse dampener so as to reduce the pulsations from the hose pump and to reduce stress on the system. Again, at the recommendation of the vendor, we chose a Sentry bladder type pulse dampener from Blacoh Fluid Control (model #C911W-F). The pump was bolted to the decking material.

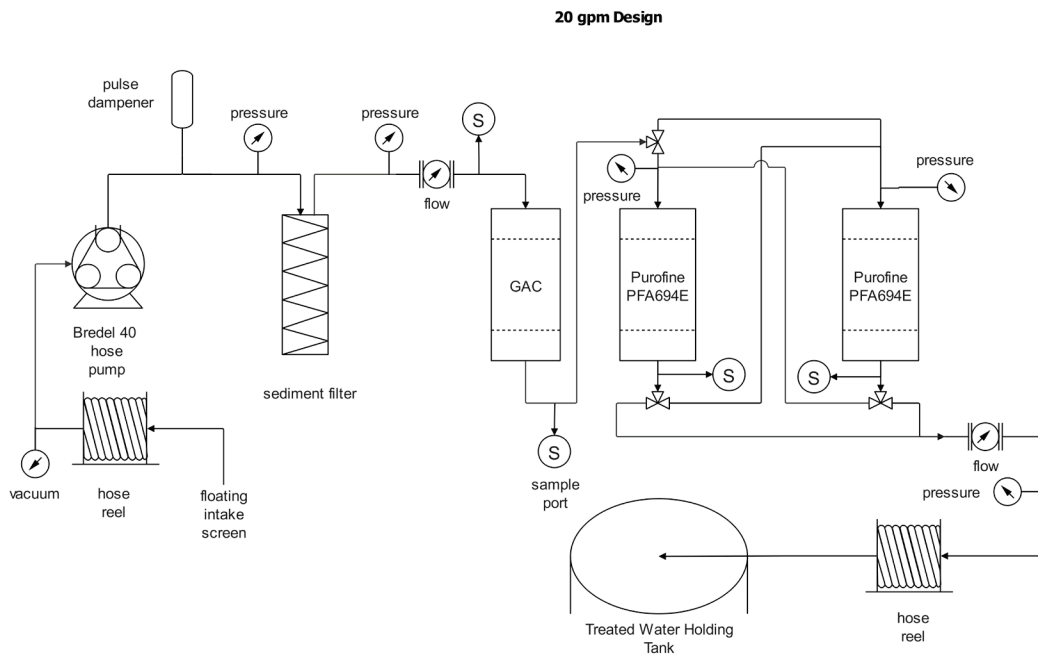
Figure 9. Basic process flow diagram of the PETS.

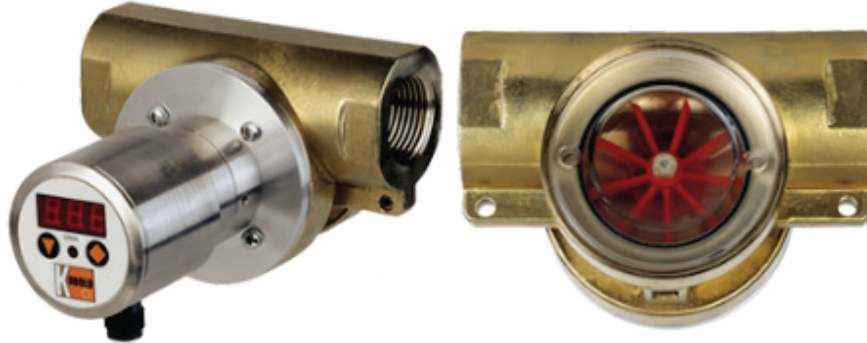
Figure 10. Kobold Model DRG-1155N6C34P Flowmeter used in the PETS.

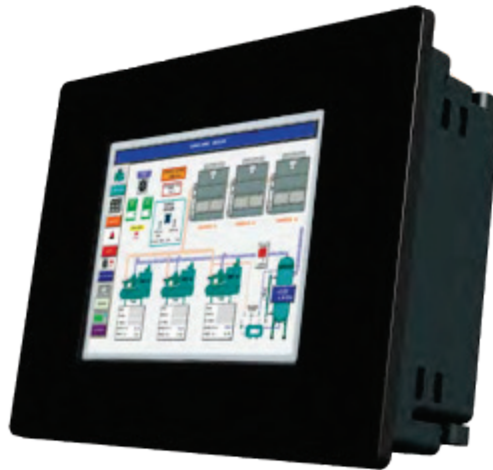
Figure 11. Human machine interface–programmable logic controller (HMI-PLC) unit used on the PETS.

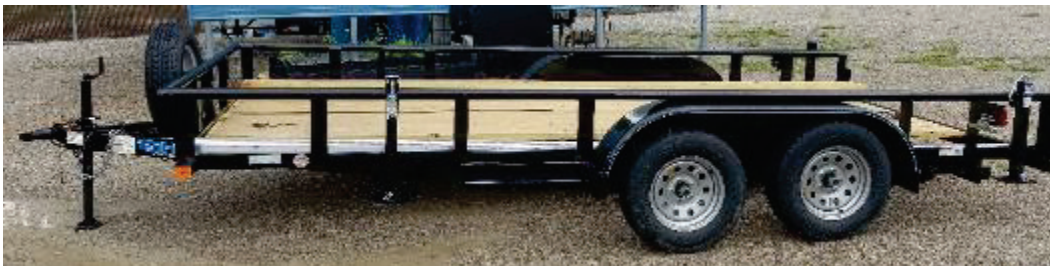
Figure 12. Trailer (Top Hat Model THMP8316) used for the PETS.

After purchase, we replaced the 2 × 6 lumber decking material with aluminum planks purchased from Direct Metals (www.directmetals.com). The planks had dimensions of 1.5 × 6 × 191 in (3.81 × 15.2 × 485.1 cm) and were punched with rectangular holes (figure 13). The replacement of decking material provided a very strong, rigid, and well-drained surface to which equipment could be mounted, and the material will not rot or suffer from corrosion when exposed to the environment for long durations.

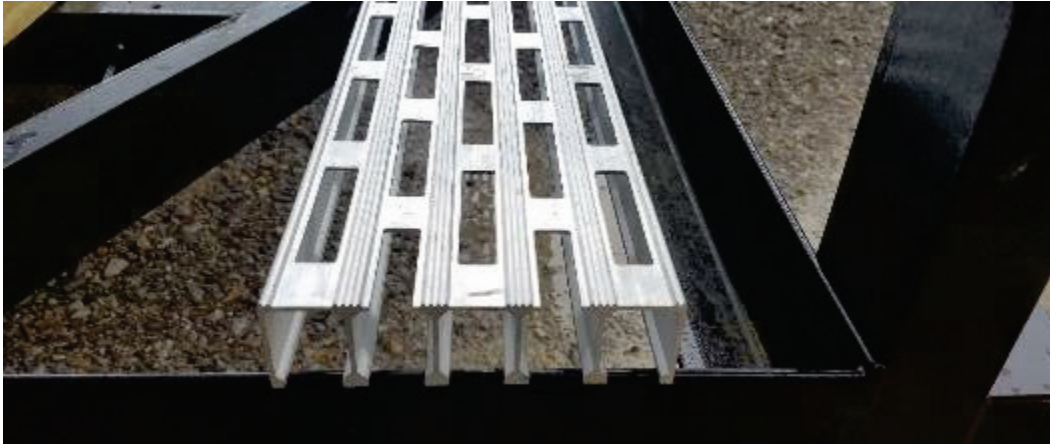
Figure 13. Aluminum planks installed on the PETS trailer.

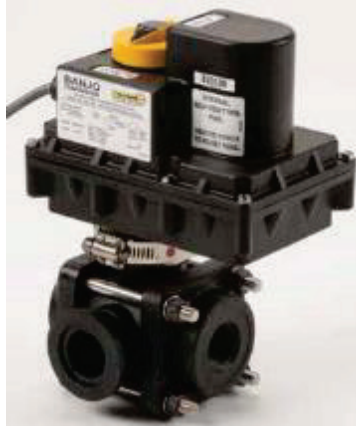
Figure 14. Banjo EV100SL Actuated three-way valve used in the PETS system.

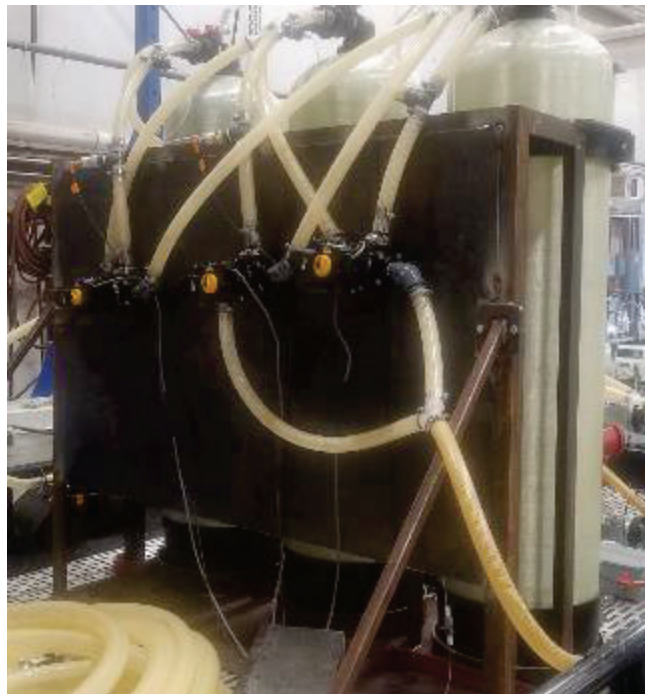
Figure 15. Media tank support frame.

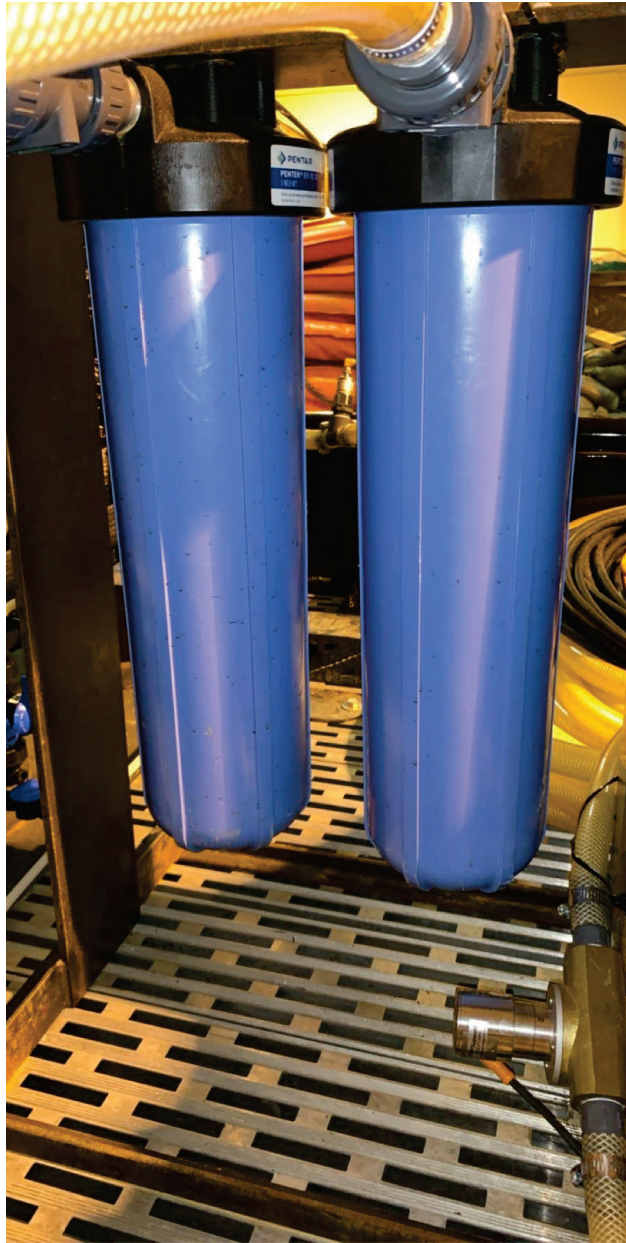
Figure 16. Sediment filters and support frame.

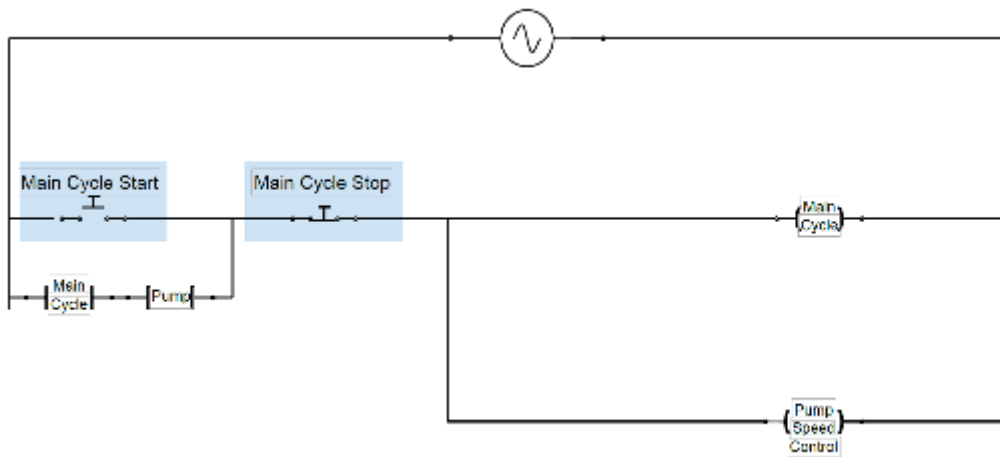
Figure 22. Main cycle logic.

Automatic pump speed control is enabled when the main cycle is running and consists of a PID loop that attempts to maintain a user-selected flow rate. PID values include a proportional gain of 110, an integral time of 50, and a derivative time of 0. In response to the very large pressure fluctuations generated by the hose pump, the PLC maintains a 40 s rolling average for all gage inputs. This average is used within the pump speed control loop to prevent hunting behavior. The rolling average is also used on all gage displays to make them more readable.

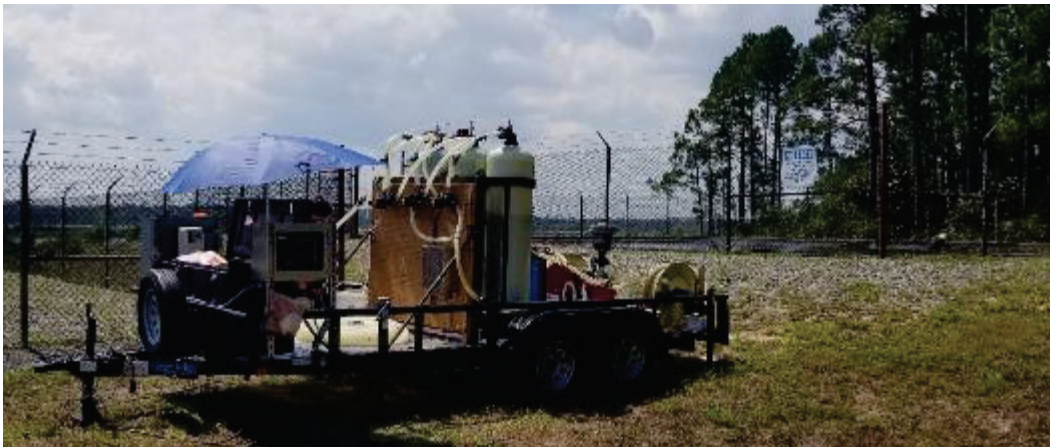
For this initial field test, two items had not been completed in the construction of the PETS. Owing to delays in the acquisition and delivery of the generator unit, the generator was not yet mounted on the trailer. The PETS was operated with line power provided at the fire training area for the duration of this demonstration. Additionally, the Masonite pegboard on which the three-way valves were mounted had not been replaced with a steel plate. The PETS as tested is shown in figure 29.

Figure 29. The PETS during demonstration 1 at Hurlburt Field.

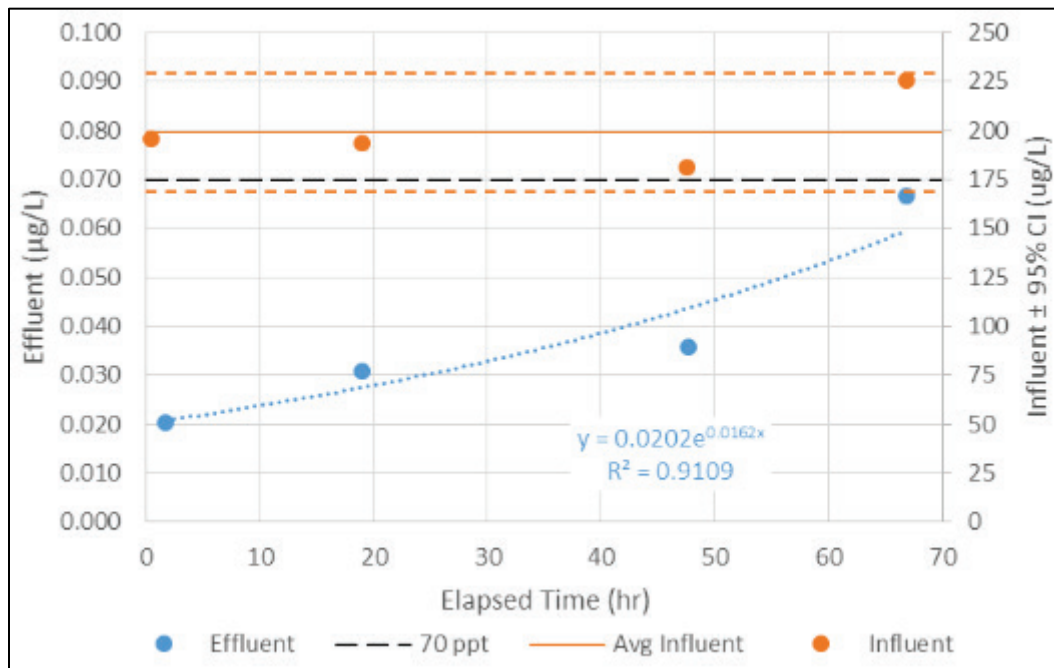
Figure 33. Total PFAS results—Hurlburt Field, demonstration 1. Brown dashed lines are 95% confidence limits and blue dashed line is best fit trend.

PFOS and total PFAS concentrations in the effluent were below the goal of 70 ng/L for all samples. Effluent PFAS concentrations did increase steadily and exhibited exponential growth, as is typically seen during the

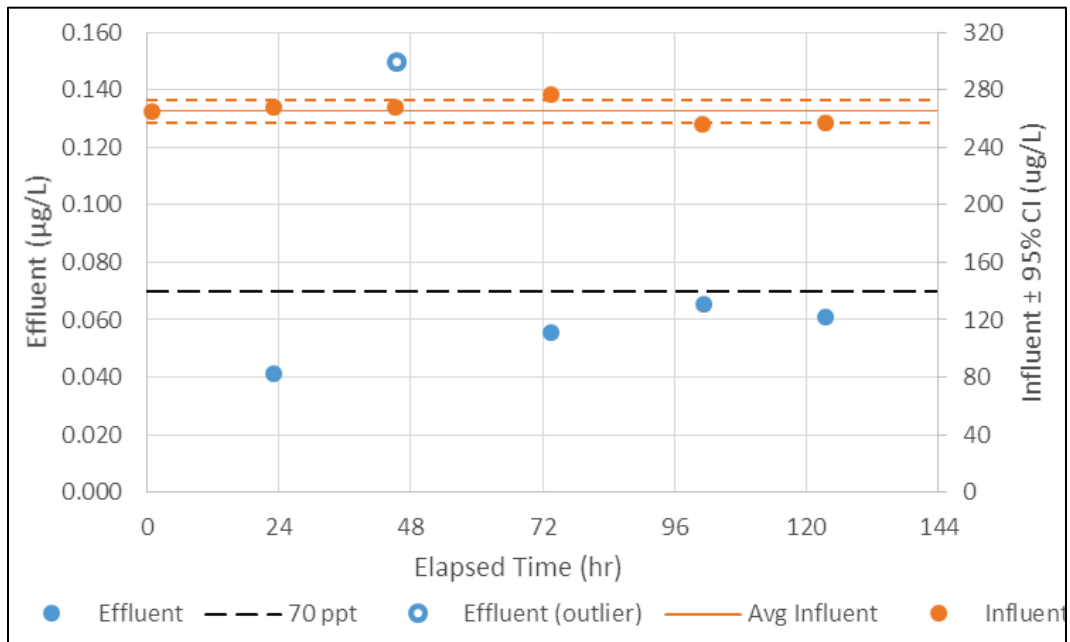
Figure 37. Total PFAS concentrations—Hurlburt Field, demonstration 2. Brown dashed lines are 95% confidence limits.

PFOS and total PFAS concentrations in the effluent were below the goal of 70 ng/L for four of the five samples (the exception being the one collected on 1 August 2019, which was 140 and 150 ng/L for PFOS and total PFAS, respectively). The sample on 1 August was collected after the system was restarted following an intake of air into the system. The high PFAS levels were therefore likely a result of short-circuiting due to entrained air in the media. PFAS concentrations returned to below the 70 ng/L goal again by the following day, but PFAS concentrations did continue to increase and were approaching the 70 ng/L treatment goal by the end of the demonstration.

Samples of the effluent were collected each day from the sample point located just after the last media tank on the PETS, each associated by sample identification numbers E1 through E6. The results are presented in table 11. The only PFAS compound measured above 3 µg/L in the effluent was PFOS. A plot of PFOS and total PFAS concentrations in the influent and effluent are presented graphically in figure 36 and figure 37.

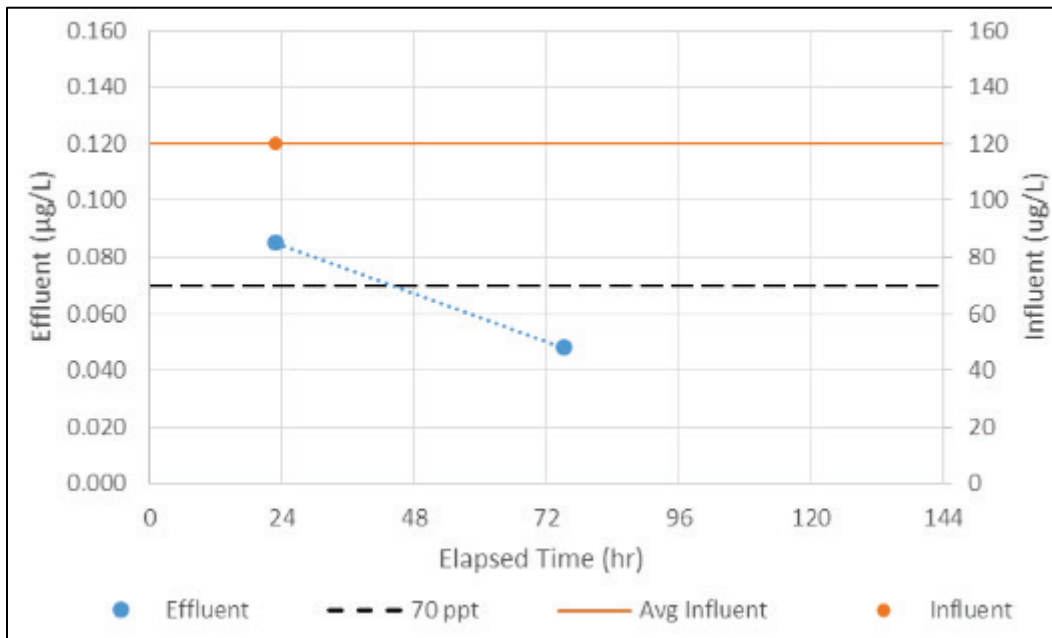
Figure 41. PFOS concentrations—Hurlburt Field, demonstration 3.
Blue dashed line is best fit trend.

The initial effluent sample collected after approximately one day of operation exceeded our goal of 70 ng/L, and the second sample collected after approximately three days of operation was below our treatment goal. An obvious reason for the high result of the first sample could not be determined. A sediment filter replacement was conducted about 10 min before the sample was collected. It is possible that some air was entrained in the media and caused short-circuiting of the media.

Samples of the effluent were collected each day from the sample point located just after the last media tank on the PETS, and the results are presented in table 13. The only PFAS compound measured above 3 µg/L in the effluent was PFOS. A plot of PFOS and total PFAS concentrations in the influent and effluent are presented graphically in figure 41 and figure 42.

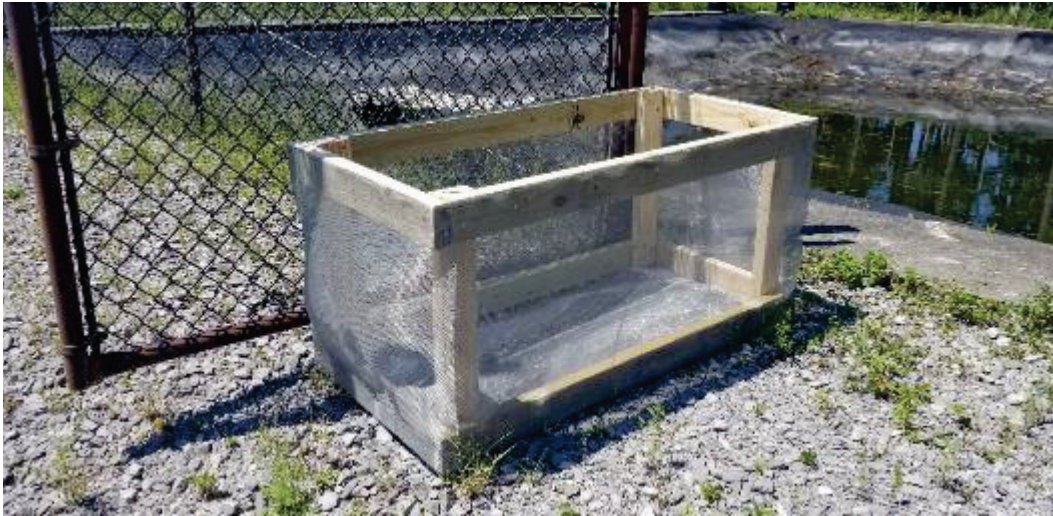
Figure 43. Screened box for sediment filtering.

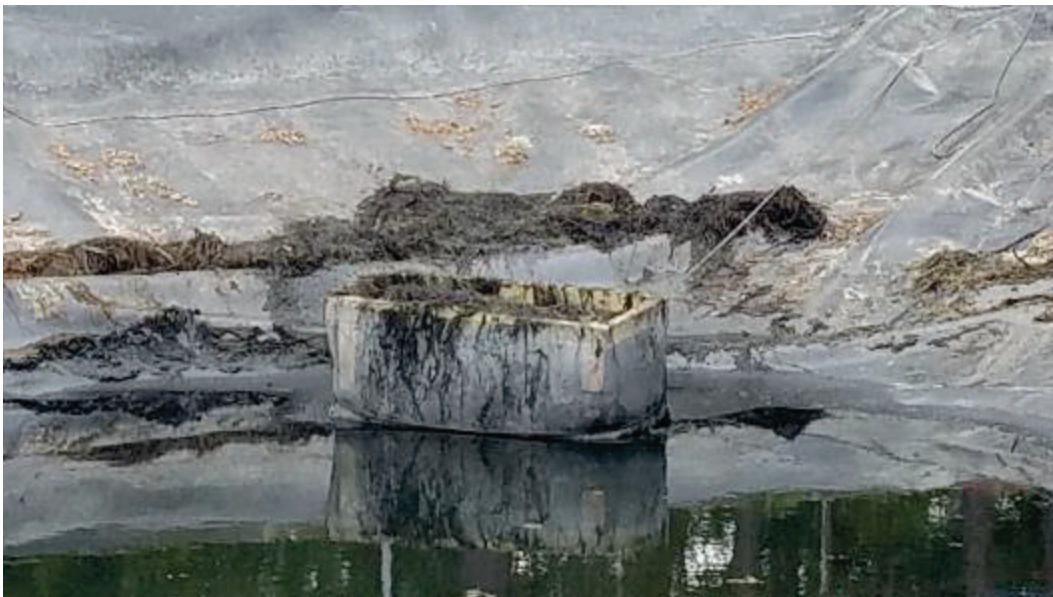
Figure 44. Filled sediment filtering box at end of demonstration 3.

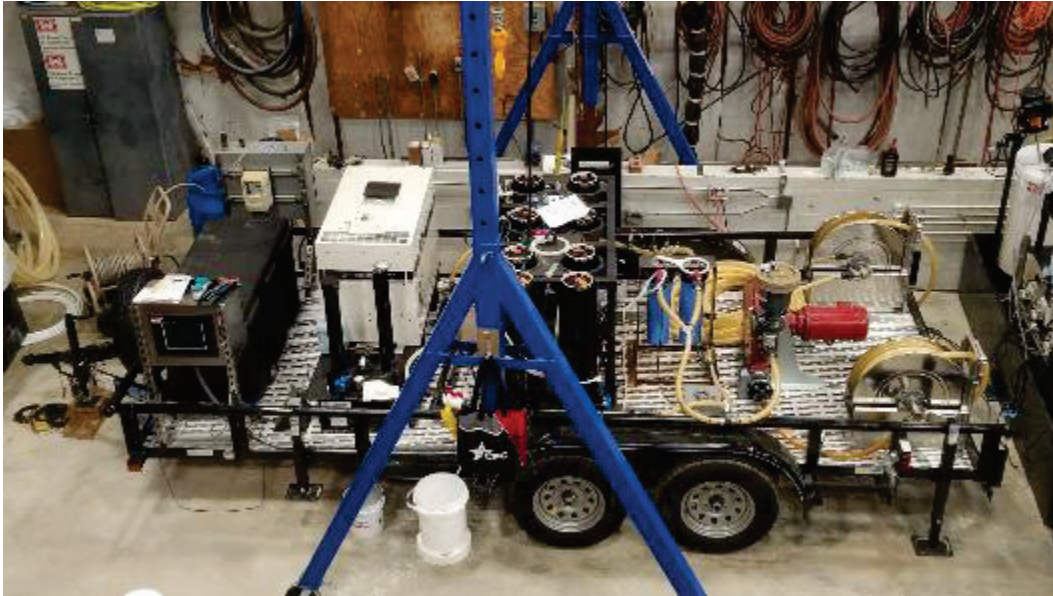
Figure 50. PETS small-tank development.
