NRL Report No. B-1823

Report of Test

Indicator Motors, Type "N"

Henschel Corporation  
Amesbury, Massachusetts

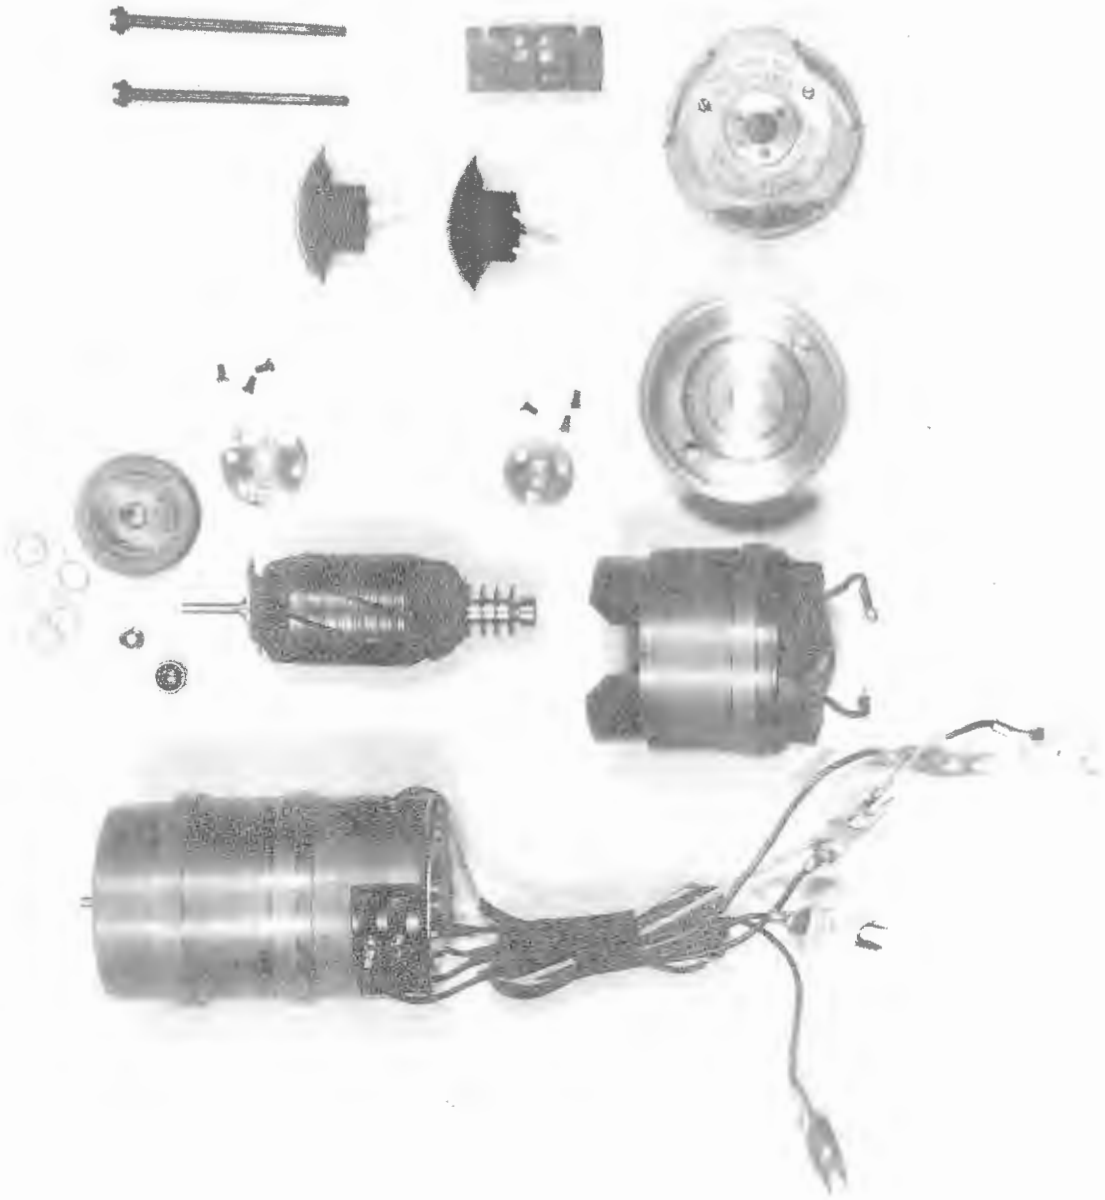
PLATE I

6. The motors submitted are of the bipolar stationary field type. The stator windings are connected directly to the external terminals  $S_1$  and  $S_2$  by insulated stranded wire. The rotor consists of three independent coils connected in Y and symmetrically disposed about the rotor axis. The rotor windings connect to the external terminals  $R_1$ ,  $R_2$ , and  $R_3$  through silver collector rings and brushes. All terminals for external connections are on insulating blocks.

7. The rotors are mounted in non-separable ball bearings which rest in the end bells and against end plates. Brass shims are inserted between the forward bearing and the end plate to limit end play. Through bolting is used to secure the end bells to the frame. Further details of design and construction are shown by photograph, Plate 1.

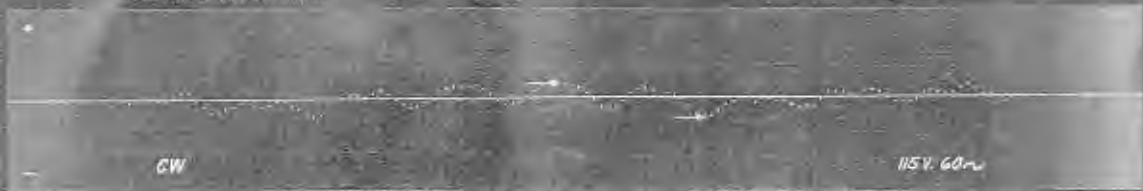
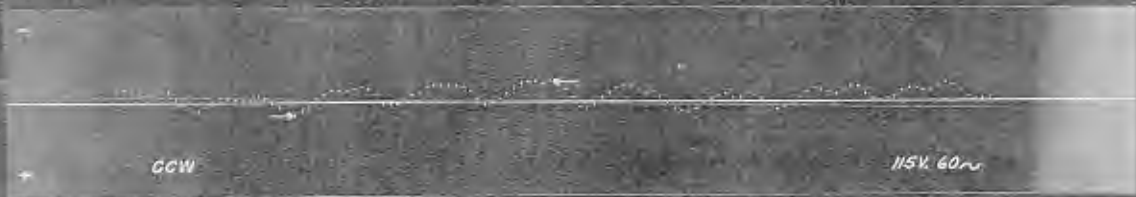
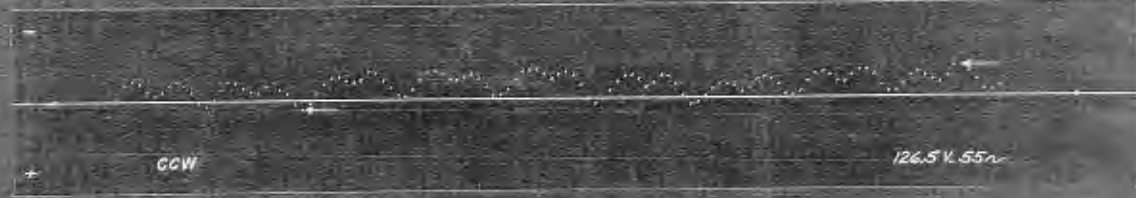
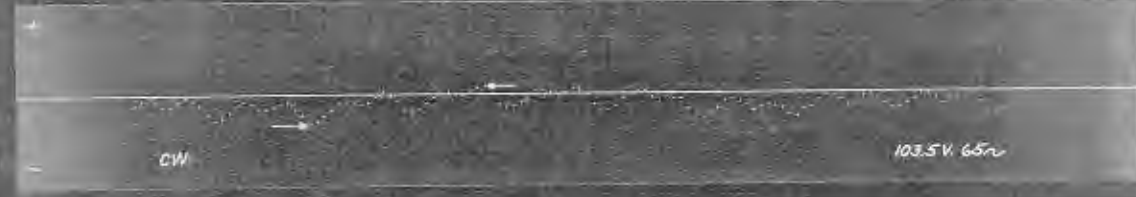
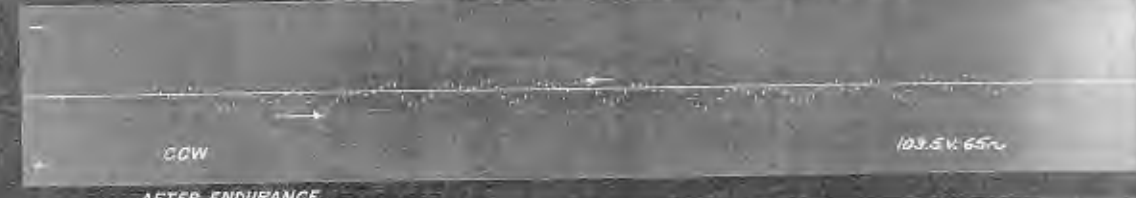
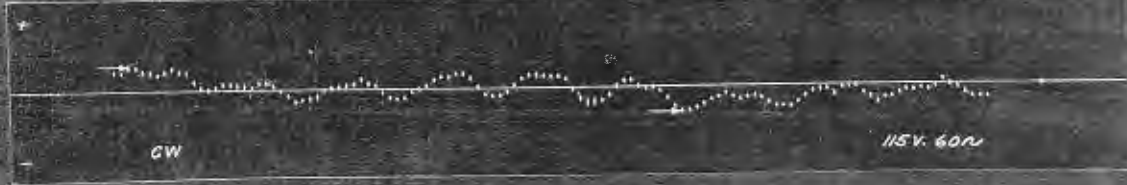
RESULTS OF ACCURACY TESTS (STATIC METHOD)  
MOTOR NO. 1  
NOTE: ARROWS INDICATE MAXIMUM ERRORS

- (5). Motor No. 1 failed after 24 hours on endurance. Its erratic performance at this point in the test is shown in Plates 2 and 10. This failure was traced to poor brush contacts and excessive end play in the rotor shaft. The end play, coupled with intermittent open circuit at the brushes, was sufficient to cause the damper to disengage from time to time. Because of this performance, which would seriously impair the operation of the remainder of the system on endurance and eventually destroy the faulty motor, motor No. 1 was eliminated from the endurance test.

- (5.) Motor No. 1 failed after 24 hours on endurance. Its erratic performance at this point in the test is shown by traces Plates 2 and 10. This failure was traced to poor brush contacts and excessive end play in the rotor shaft. The end play, coupled with intermittent open circuit at the brushes, was sufficient to cause the damper to disengage from time to time. Because of this performance, which would seriously impair the operation of the remainder of the system on endurance and eventually destroy the faulty motor, motor No. 1 was eliminated from the endurance test.

\*Not used on endurance because of erratic behavior as explained under "Conclusions b-5" and shown in Plates 2 and 10.

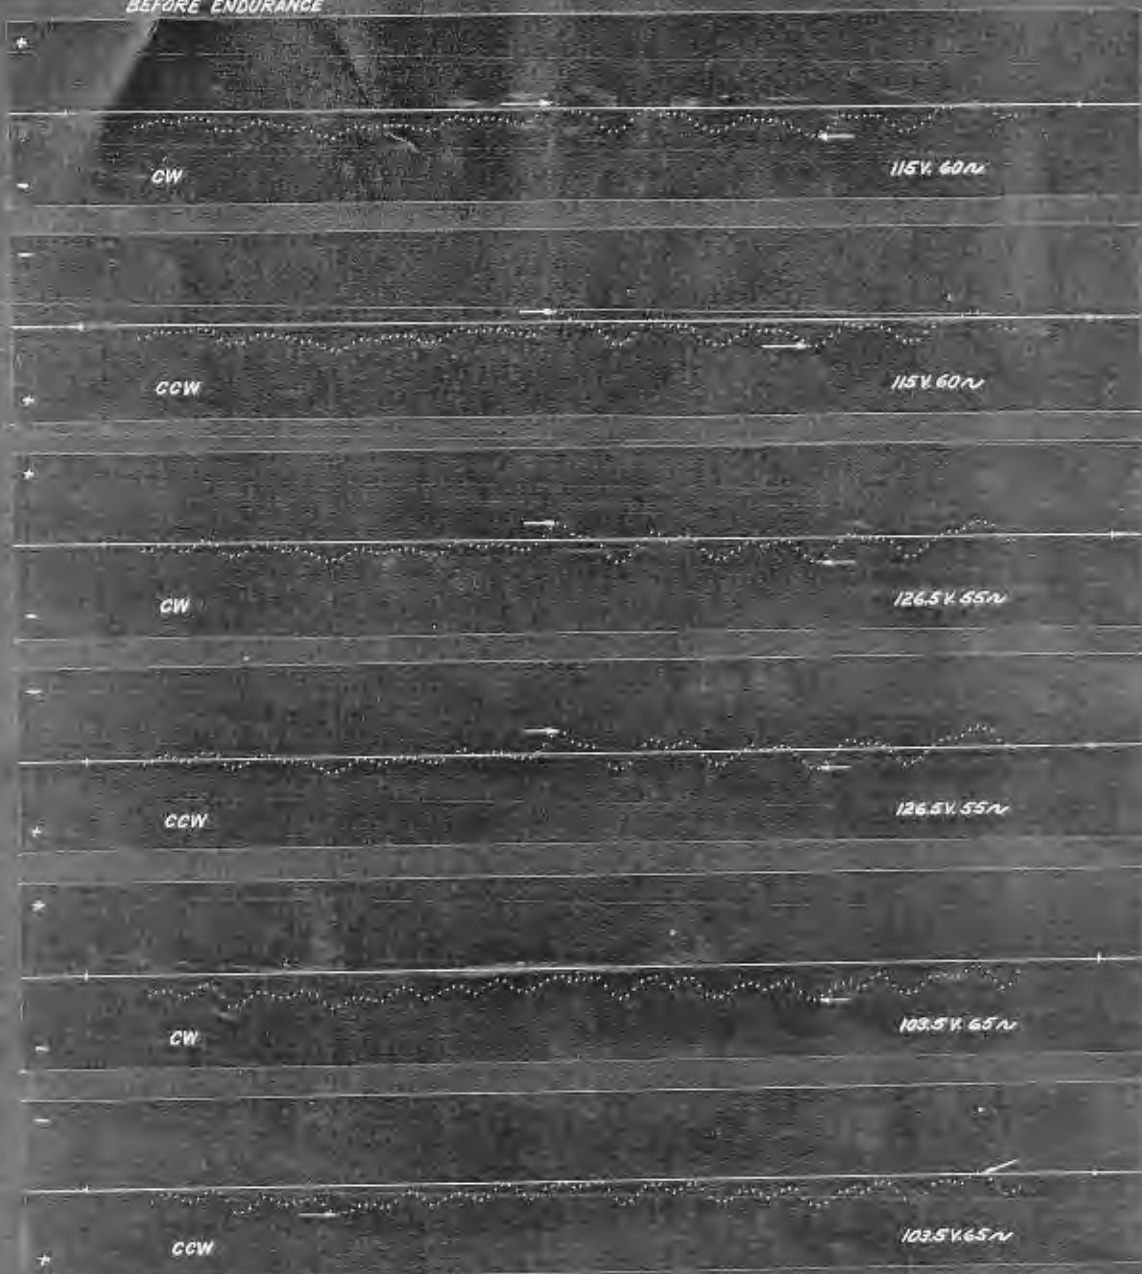
MOTOR NO. 2

RESULTS OF ACCURACY TESTS (STATIC METHOD)

NOTE: ARROWS INDICATE MAXIMUM ERRORS

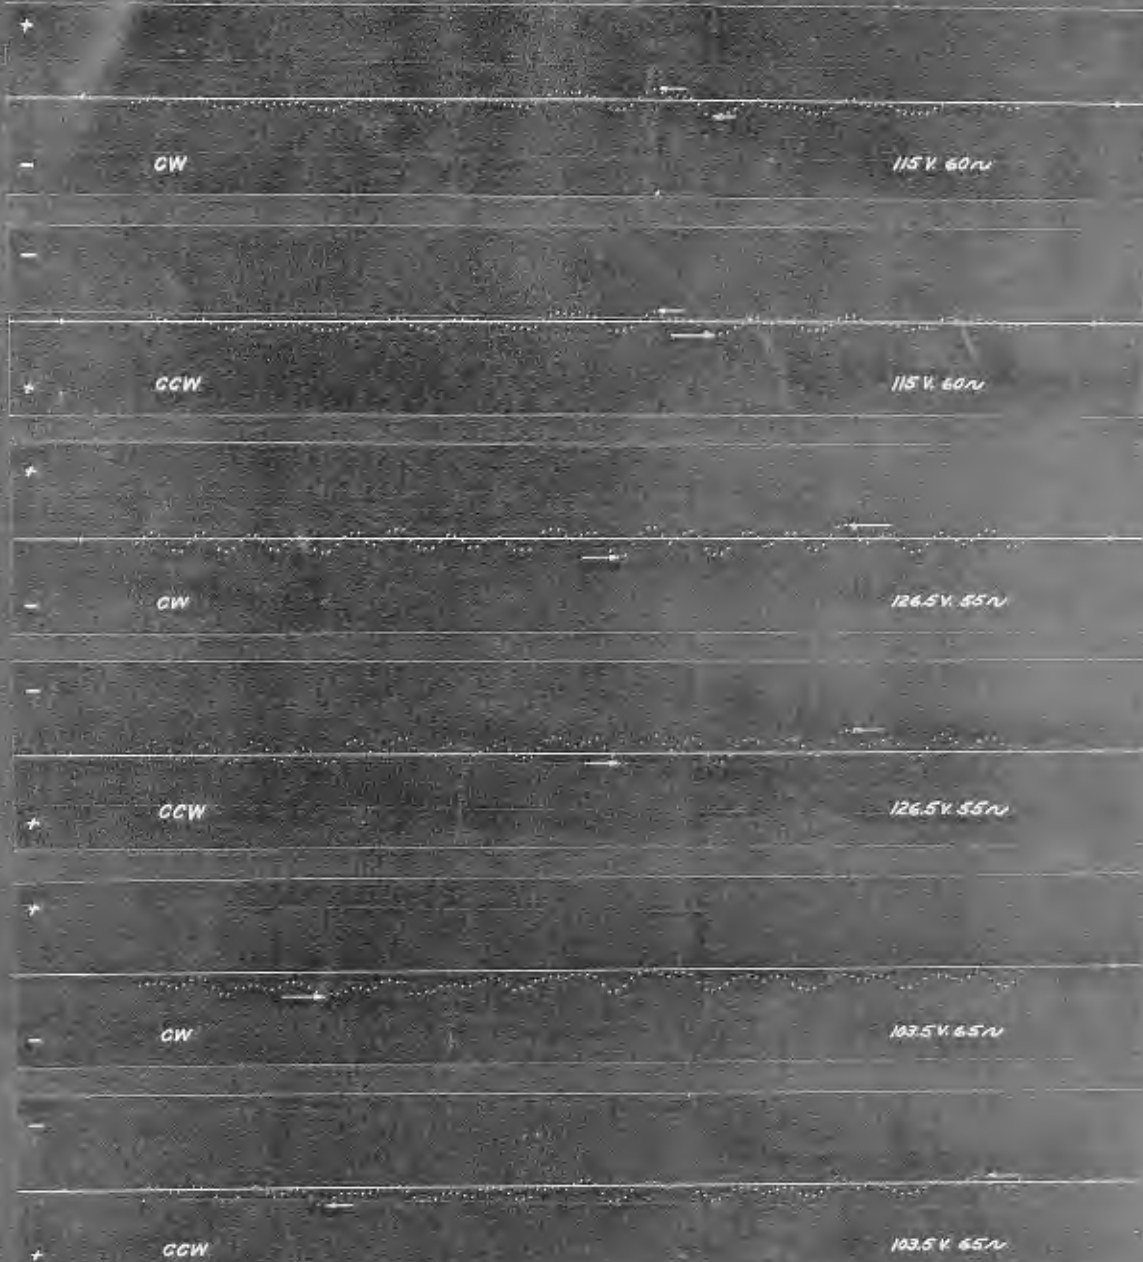
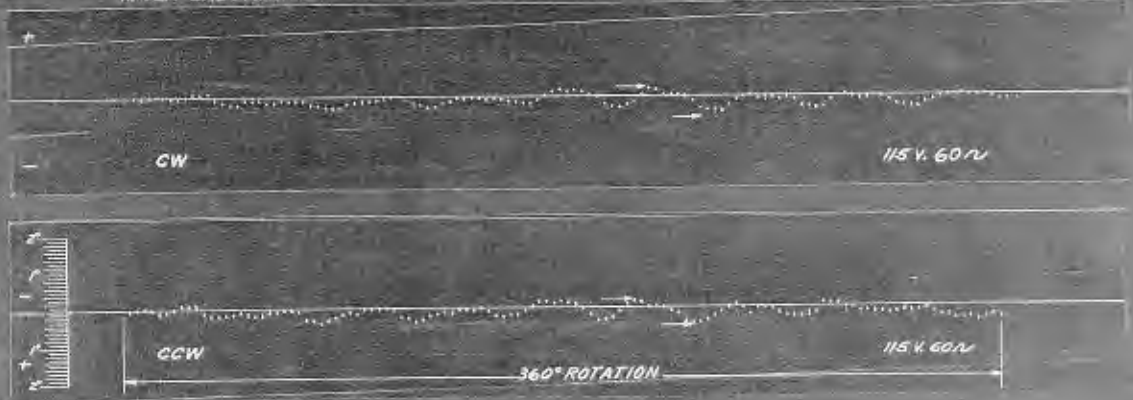
MOTOR NO. 3

RESULTS OF ACCURACY TESTS (STATIC METHOD)

NOTE: ARROWS INDICATE MAXIMUM ERRORS

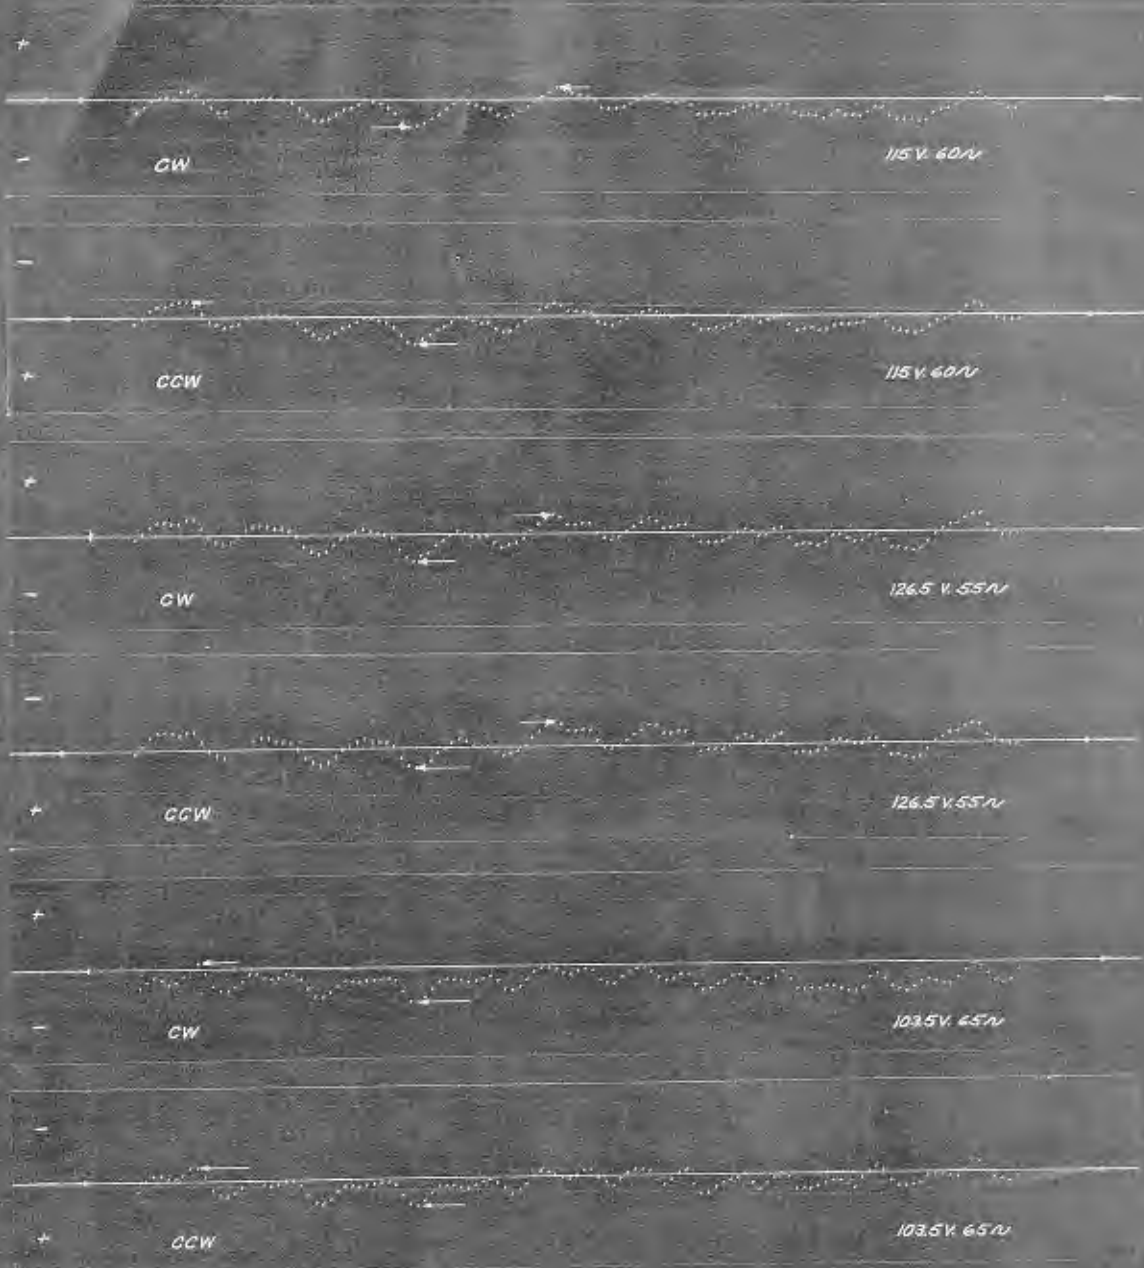
MOTOR NO. 4

RESULTS OF ACCURACY TESTS (STATIC METHOD)

NOTE: ARROWS INDICATE MAXIMUM ERRORS

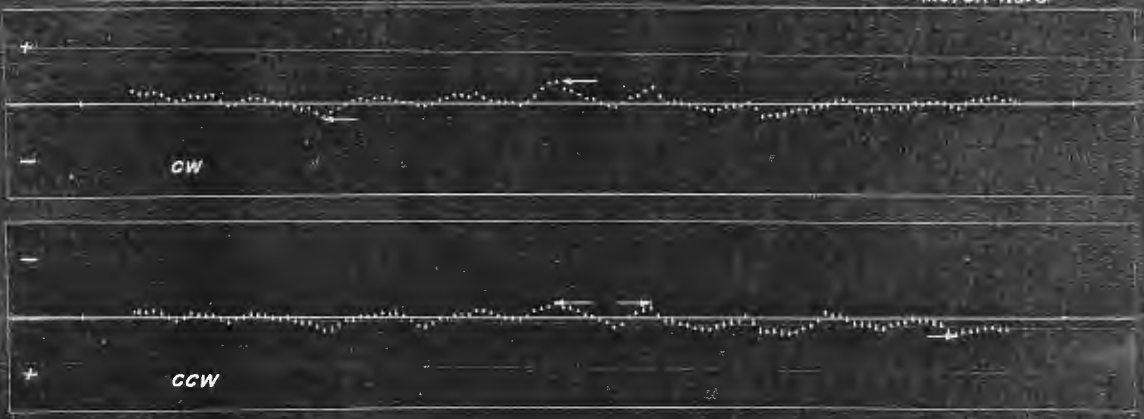
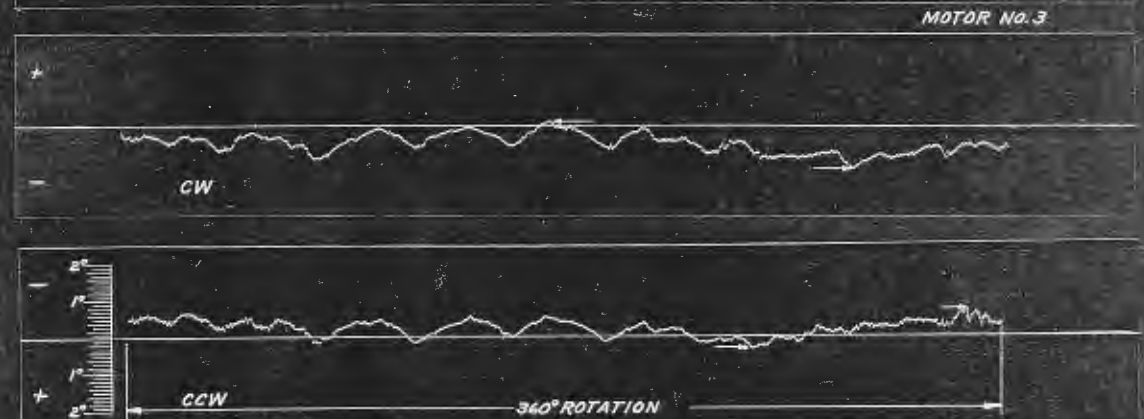
RESULTS OF ACCURACY TESTS  
 STATIC AND DYNAMIC METHODS  
 AFTER ENDURANCE, SHOCK AND VIBRATION  
 115 V. 60 CY

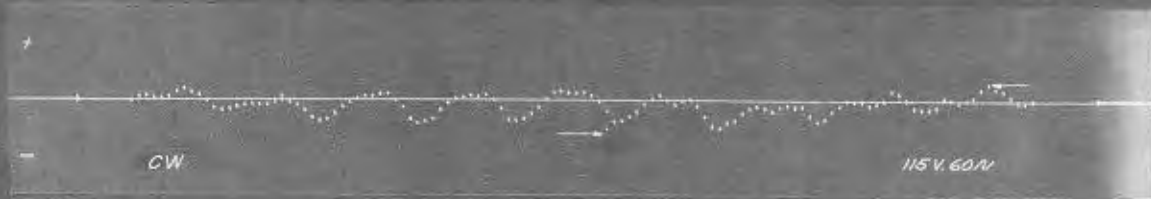
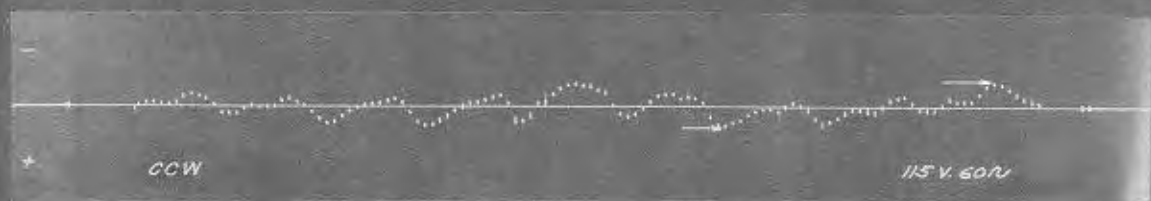
RESULTS OF ACCURACY TESTS (STATIC AND DYNAMIC METHODS)  
 MOTOR NO. 1  
 AFTER ENDURANCE AND ADJUSTMENT

\*See Plate 12.
