ARL-TR-9451 • APR 2022

# X-Ray Computed Tomography Evaluation of Electron Beam Additively Manufactured Titanium Components

| <b>14. ABSTRACT</b><br>Two electron beam additively manufactured (EBAM) titanium specimens provided by the US Army Combat Capabilities Development Command Ground Vehicle Systems Center at the Tank-Automotive and Armaments Command, Detroit Arsenal, were inspected and evaluated using X-ray computed tomography (XCT). XCT scanning parameters and overall protocols used to achieve acceptable scan image results are discussed. XCT image results, including 2-D internal slices at select locations and 3-D sectioned visualizations, are also shown and discussed. The physical nature of the types of features found in these specimens are also described and discussed. | | | | | |

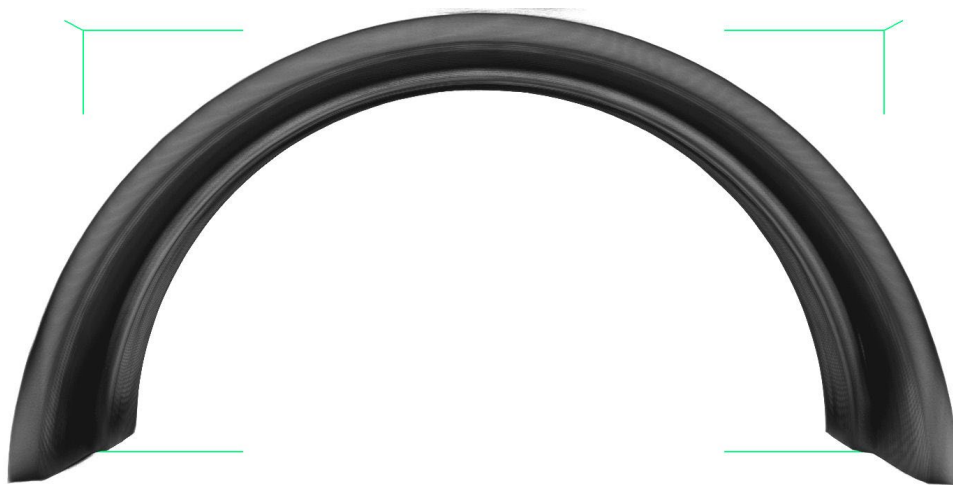
**Fig. 8** Outside 3-D solid image of the half-ring specimen, in which some of the dark air artifact is apparent in the middle area of the half ring from one end to the other

Results from the first scan of the specimen are not discussed due to their relative lack of quality, except to say that highly attenuating path lengths through arc sections of the specimen produced very compromising air artifacts in the reconstructed image data that made it difficult, if not impossible, to interpret both interior and exterior features of the specimen. The second scan of the specimen did produce better image results, although there was still some level of the black air artifact in the images. Figure 8 shows an outside view of the half ring, in which some of the dark air artifact is apparent in the middle area of the half ring from one end to the other, along with a little more at the bottoms of the ends. Figures 9–11 show three sets of 3-D solid sectioned visualizations and their corresponding 2-D planar views. The 2-D view of Fig. 9 (middle image) appears to show a few relatively short gap-like features along the lower curved edge of the specimen. The bottom image of Fig. 9 is a close-up view of the middle image showing a smaller section in the middle and to the left. The relatively thin gaps in the lower side of the half ring, which are about 2–3 mm wide, are evident and highlighted by the

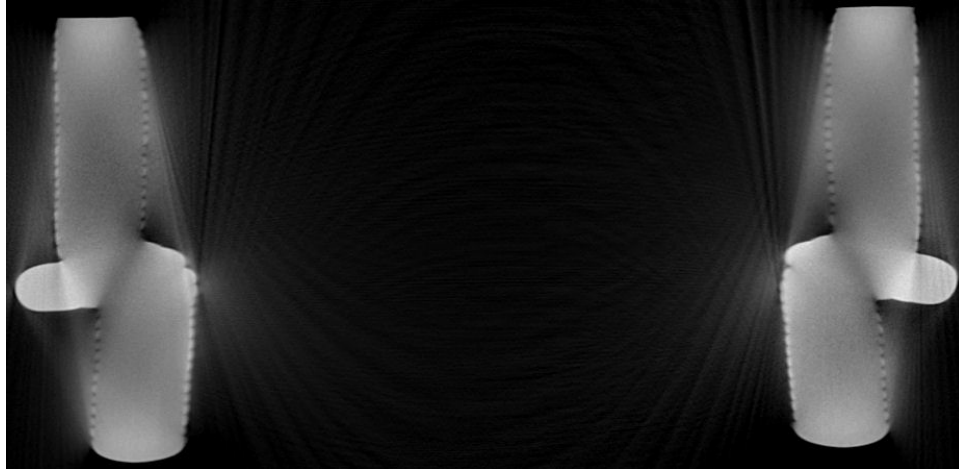
**Fig. 13 (a–d) A series of 2-D planar images that section the half ring at various locations in the radial or side-to-side direction**

**Fig. 13 (a–d) A series of 2-D planar images that section the half ring at various locations in the radial or side-to-side direction (continued)**
