Tar-Pamlico and Neuse River Basins, North Carolina, Geomorphic Summary Report

Kathleen E. Harris and Christopher P. Haring

June 2022

Final report

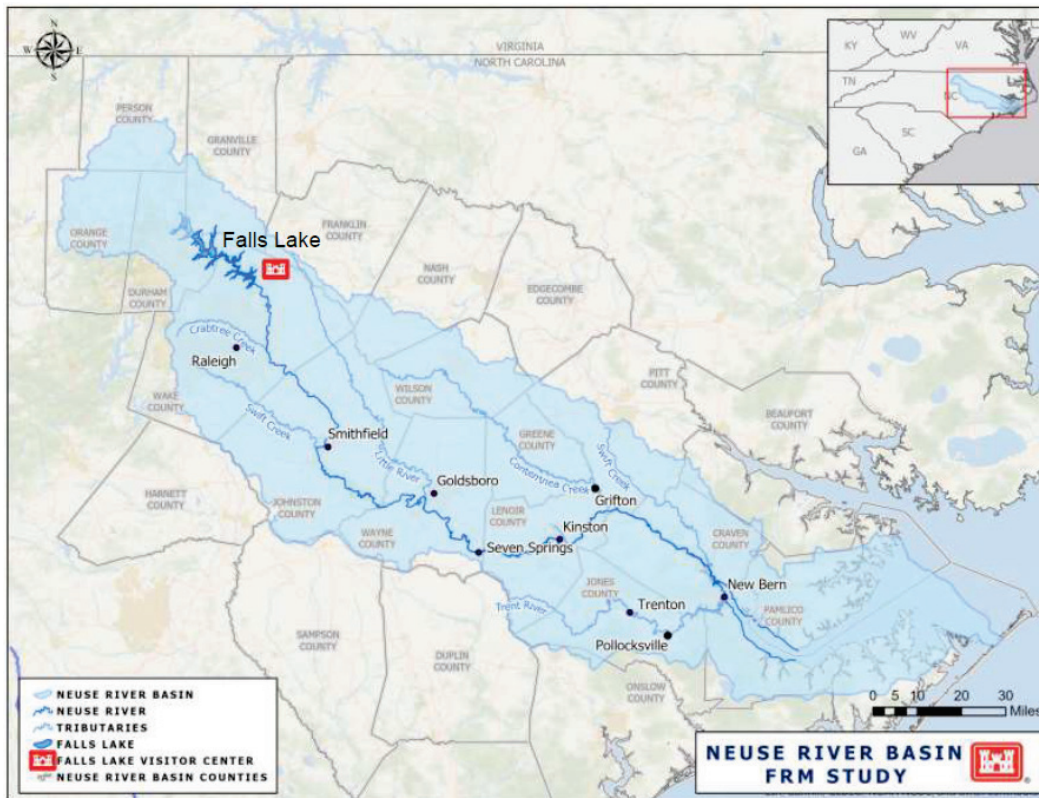
Figure 5. Neuse River Basin (source: USACE Wilmington District [SAW]).

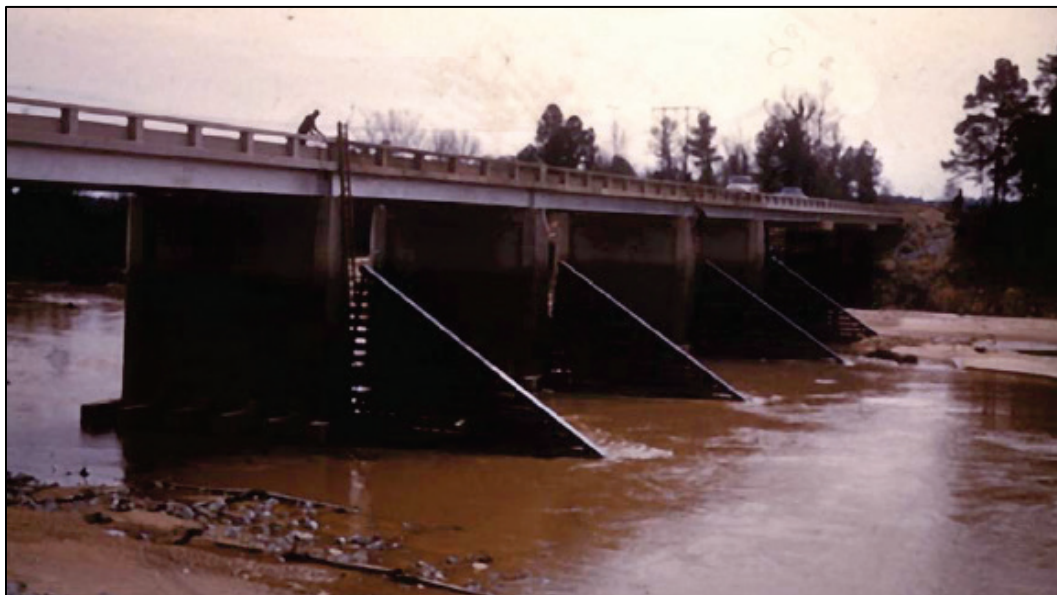
Figure 7. Debris fin deflectors diverting debris from bridge piers (Bradley et al. 2005).

Research regarding management of LWD has largely been focused on structures for diverting LWD away from critical infrastructure (e.g., bridge piers, culvert, hydropower intakes) or for collecting debris for easier removal. Numerous structures have been employed such as foils, fins (Figure 7), or debris sweepers (Figure 8) to encourage the passage of debris around bridge piers rather than the accumulation (Lagasse et al. 2010; Bradley et al. 2005). Additionally, steel or timber racks are used to stop debris from reaching bridge piers (Figure 9) (Bradley et al. 2005; Schmocker and Hager 2013) and trash racks and other proprietary rack structures are used to stop debris from entering hydropower or storm water intakes (Figure 10) (Tyler 2011; Bradley et al. 2005). Structures such as piles (Figure 11) and debris dams (Figure 12) retain LWD in more optimal locations (Wallerstein and Thorne 1997; Bradley 2005) and gate structures capture LWD at the banks for more convenient removal (Figure 13) (Panici and Kripakaran 2021). Many of these options come with the added expense of periodic removal of debris from the structures themselves whether designed to accumulate LWD or not.

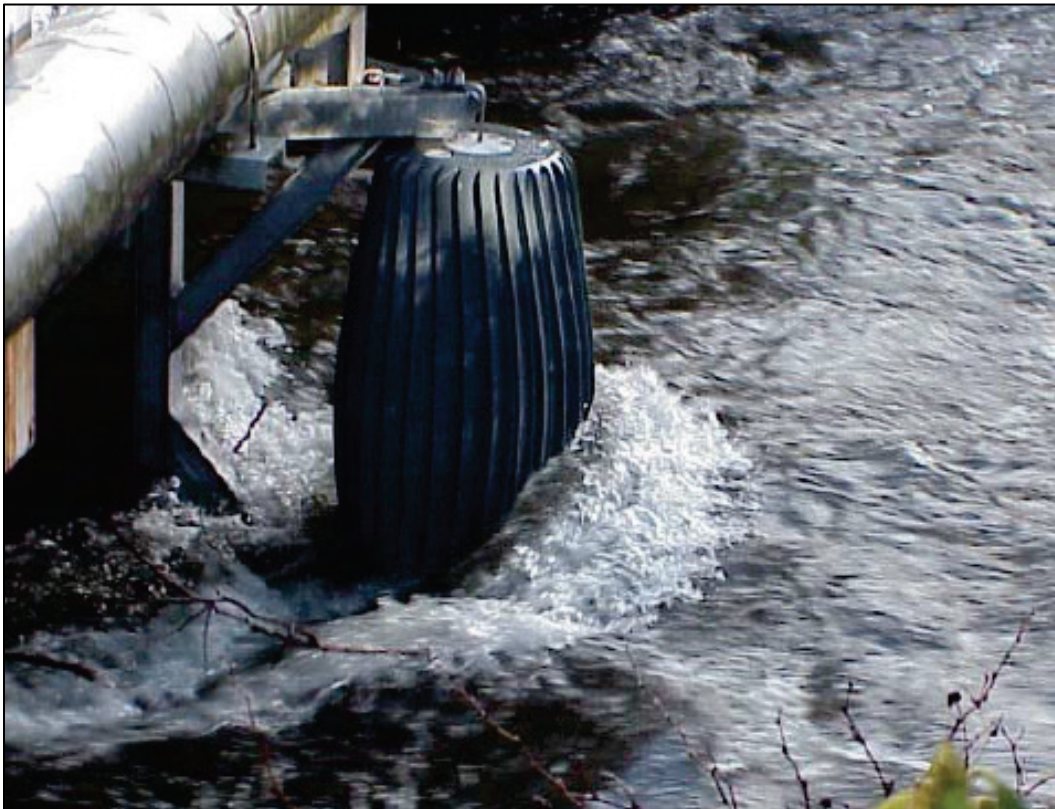
Figure 8. Debris sweeper installed on the Cedar Creek in Washington, USA (Bradley et al. 2005).

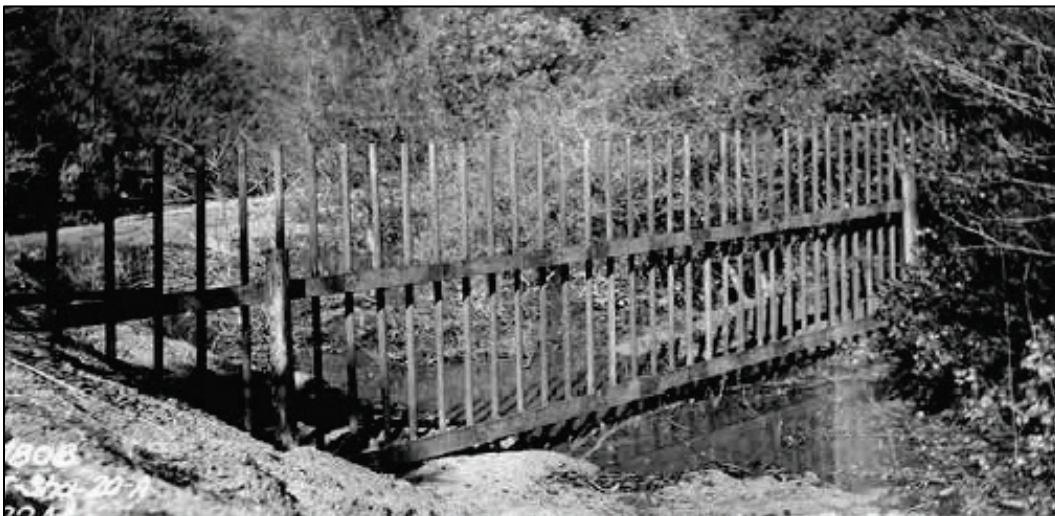
Figure 9. Post and rail debris rack (Bradley et al. 2005).

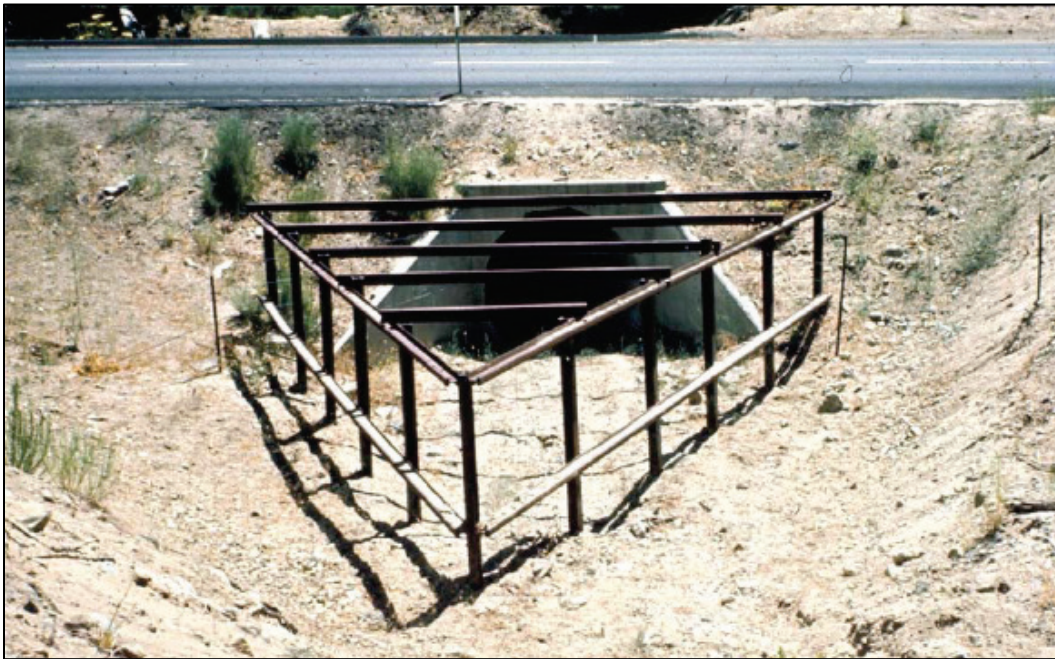
Figure 10. Debris deflector protecting a culvert from debris accumulation (Bradley et al. 2005).

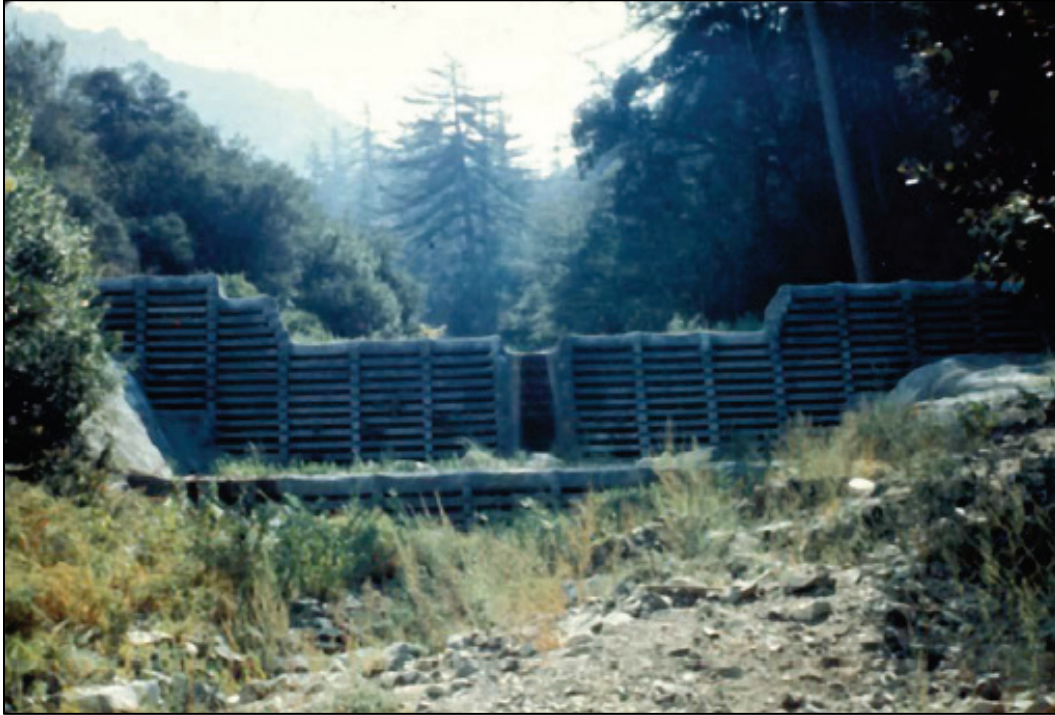
Figure 12. Debris dam made of timber (Bradley et al. 2005).

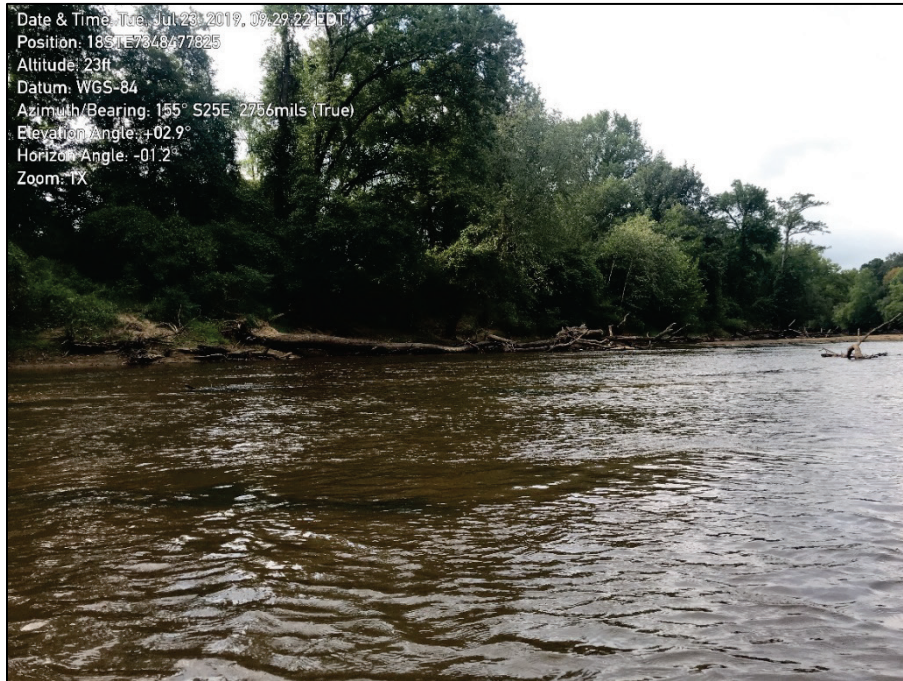
Figure A-1. Fallen tree in the Tar River near Tarboro, NC.

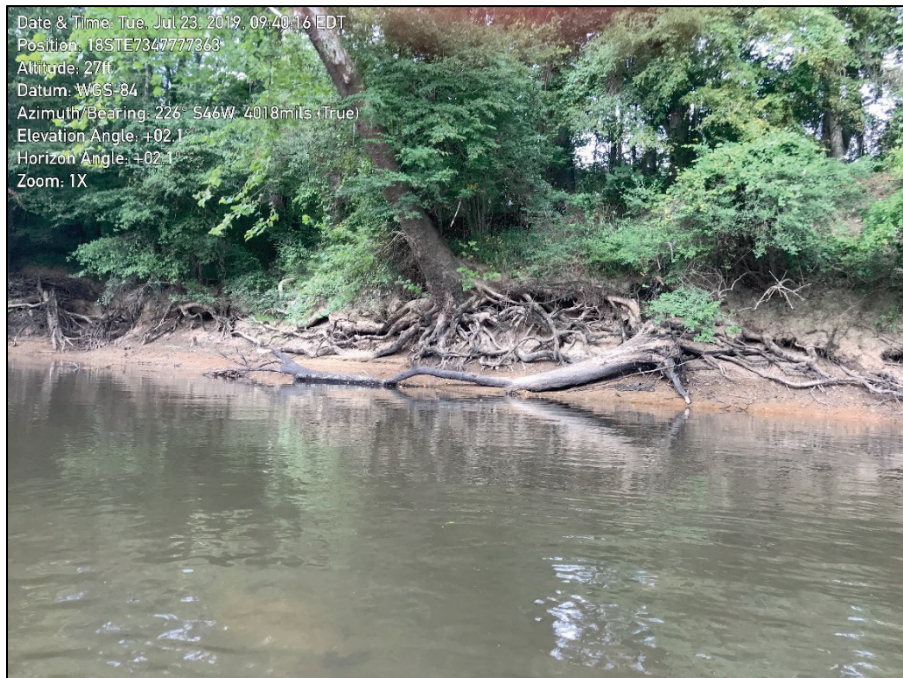
Figure A-2. A tree at risk of falling into the river as erosion occurs at its roots, seen in the Tar River near Tarboro, NC.

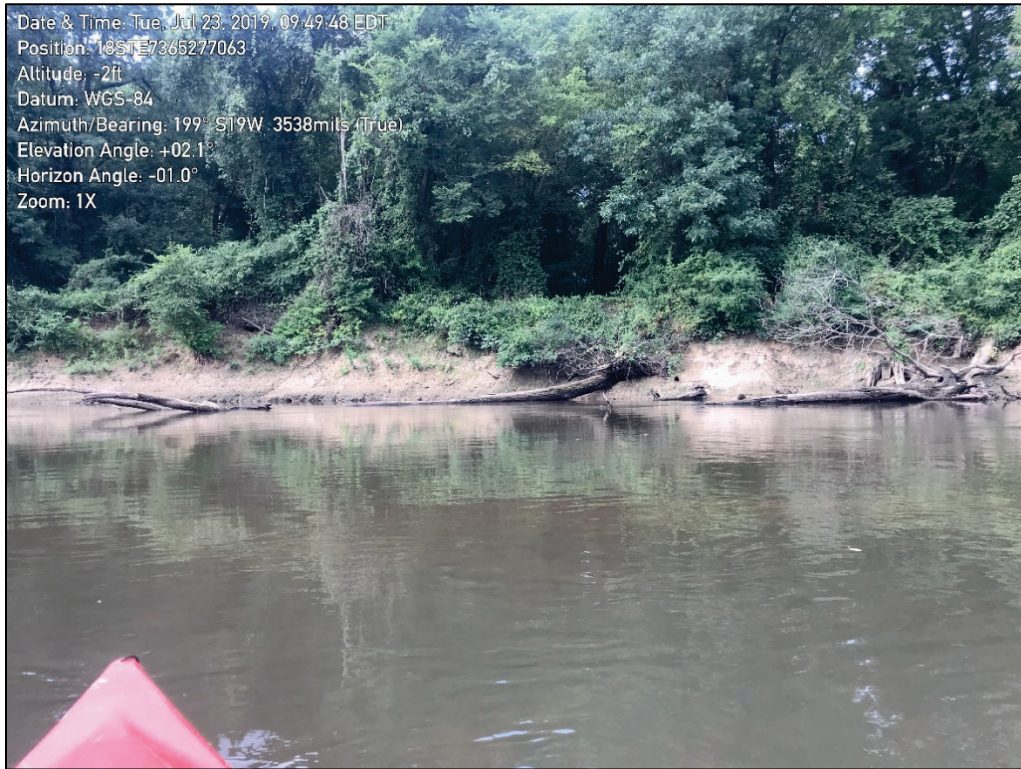
Figure A-3. Smaller amounts of LWD along banks in the Tar River near Tarboro, NC.

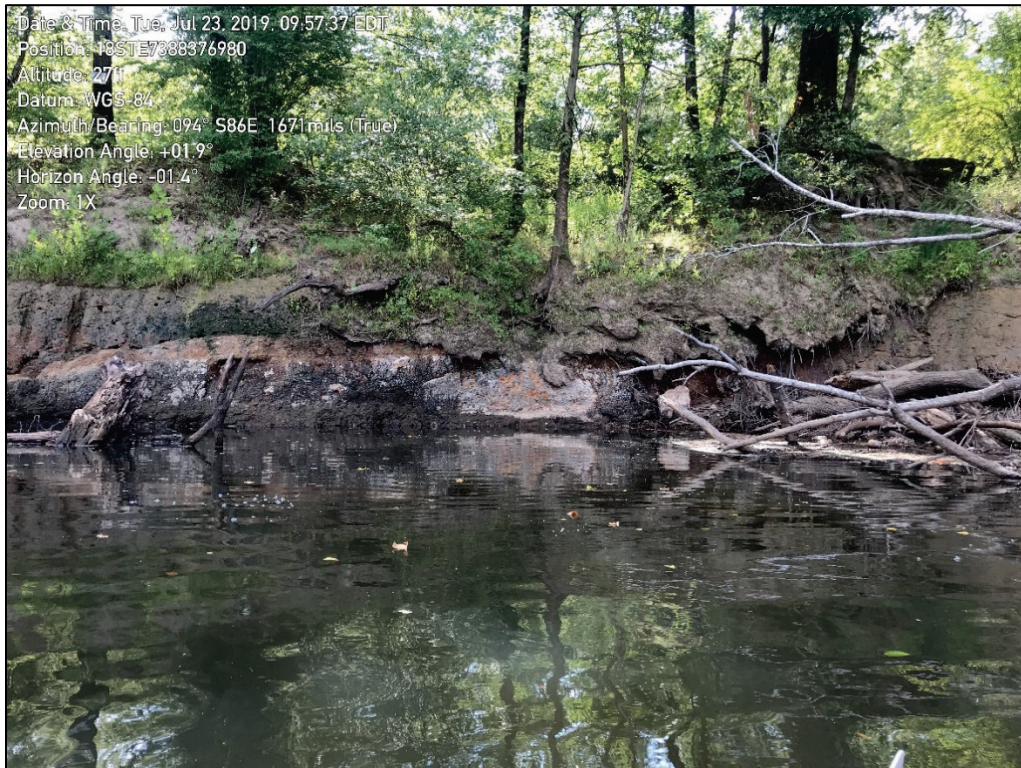
Figure A-4. Bank caving and LWD in the Tar River near Tarboro, NC.

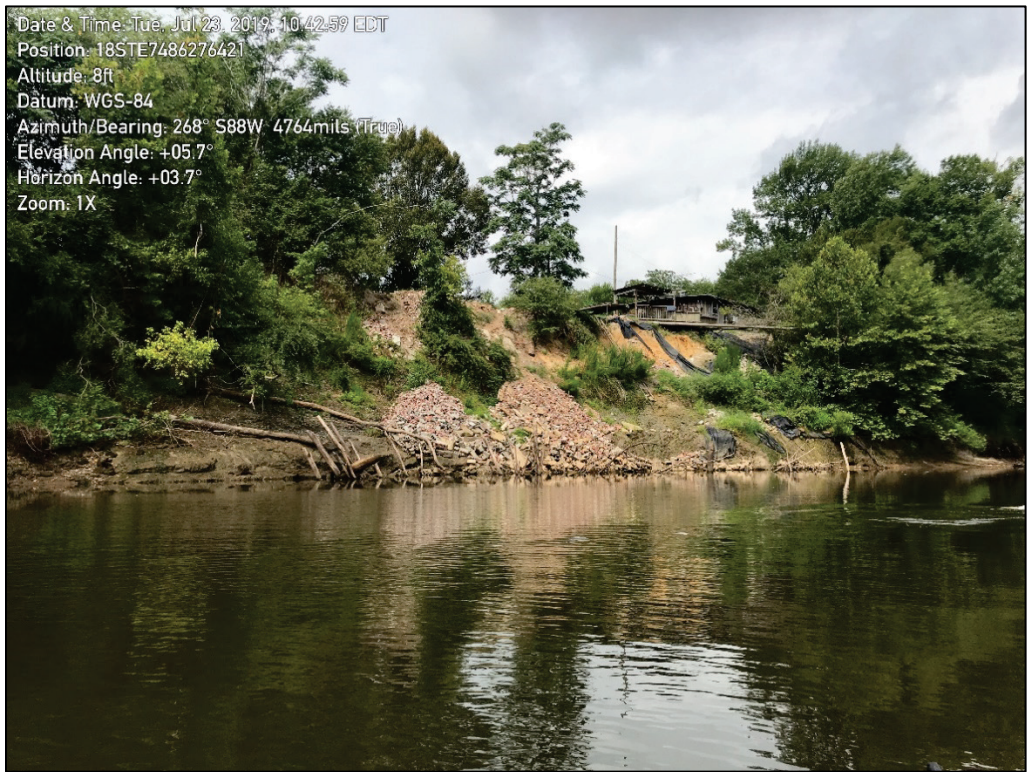
Figure A-8. Possible past stabilization efforts on the Tar River near Tarboro, NC.

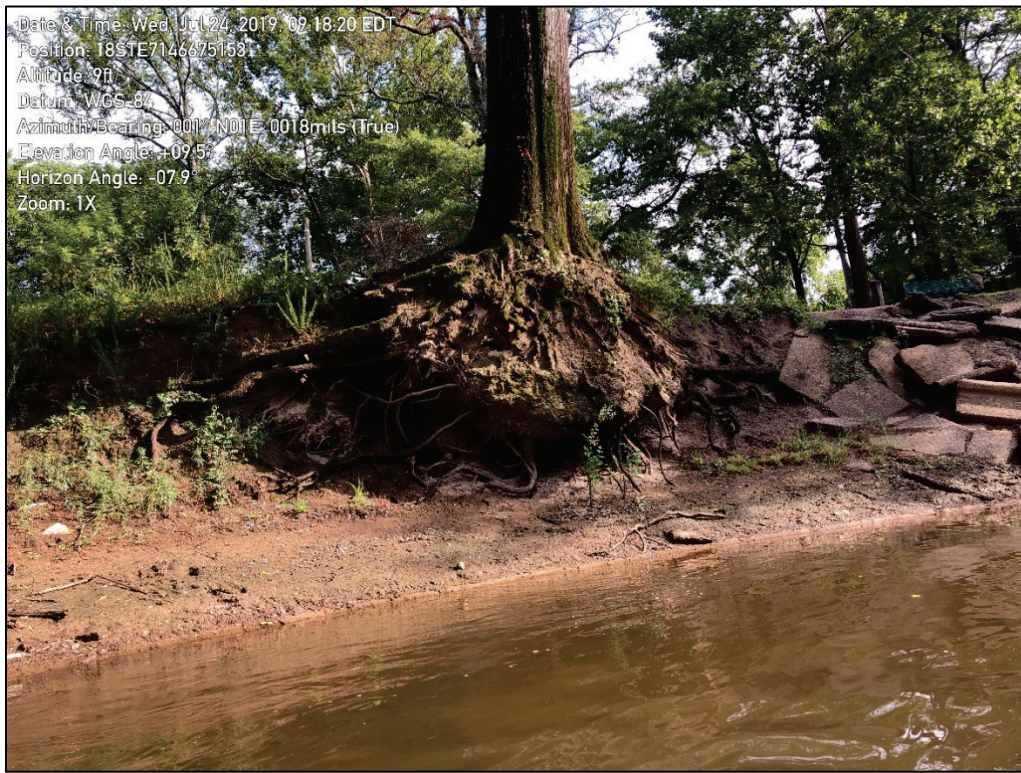
Figure A-9. A tree at risk of falling into the river as the soil around the roots erodes, seen on the Tar River near Tarboro, NC.

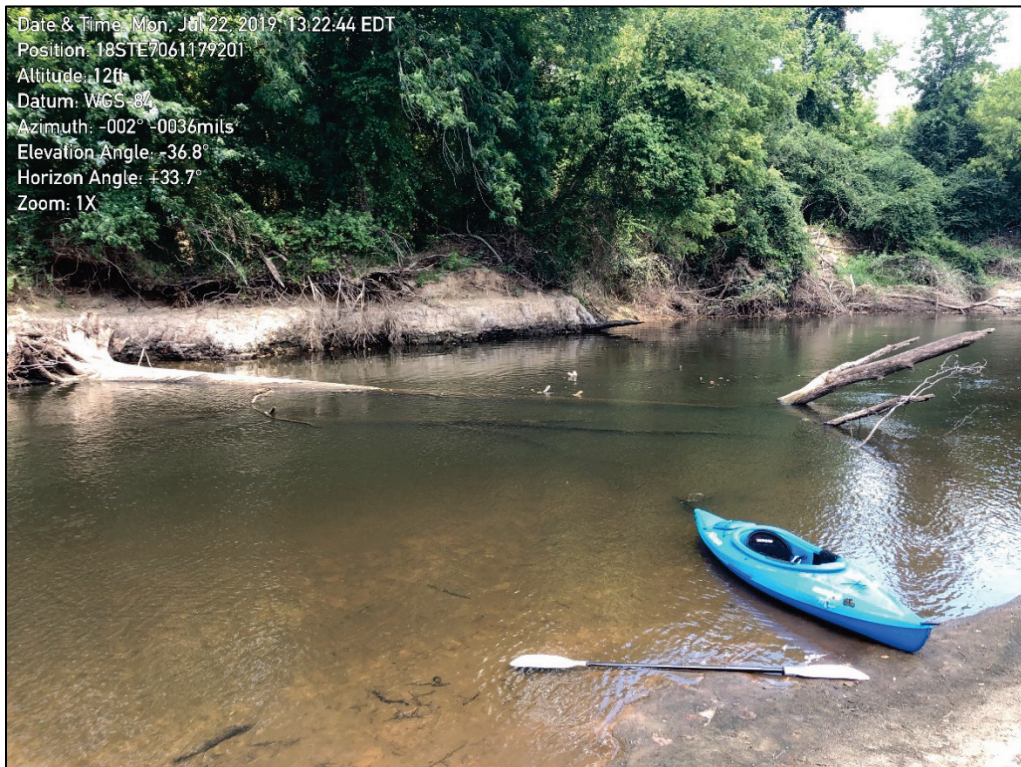
Figure A-10. Submerged LWD on the Tar River near Tarboro, NC.

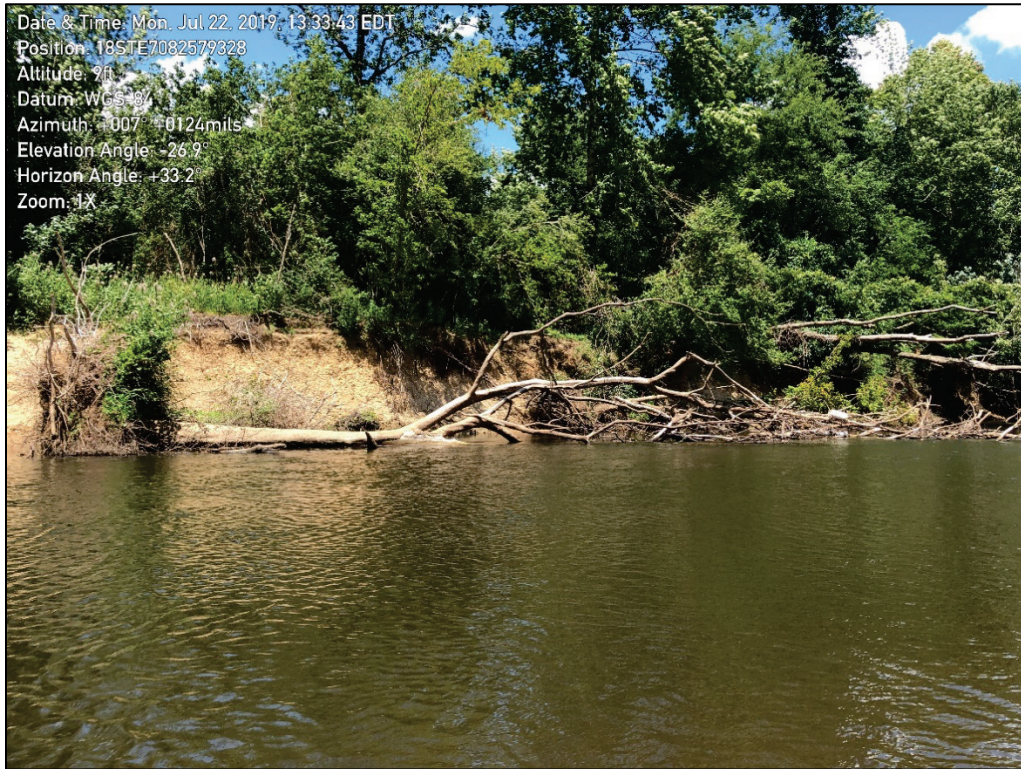
Figure A-11. LWD along the bank of the Tar River near Tarboro, NC.

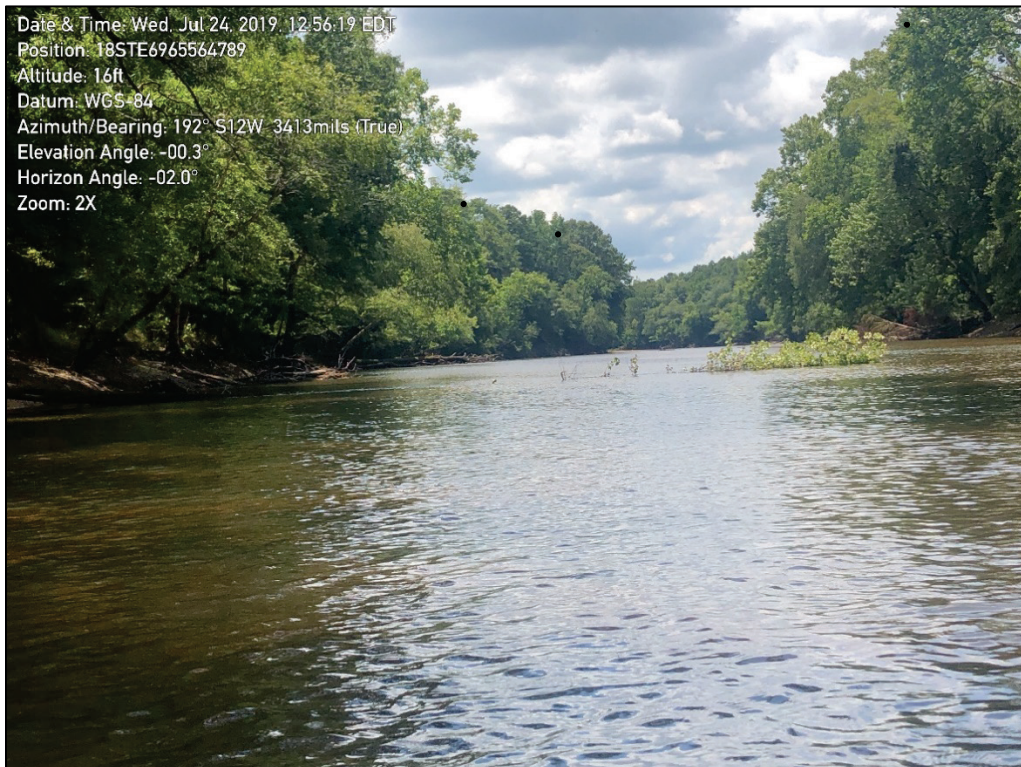
Figure A-12. Tar River near Tarboro, NC will LWD present, but not across the entirety of the channel.
