NRL Report No. B-2083

Report of Test

Horn, Proposed Types H-10 and H-11
(Manufacturer's Type WP-1)

Maslo Marine Manufacturing Company
Reading, Pennsylvania

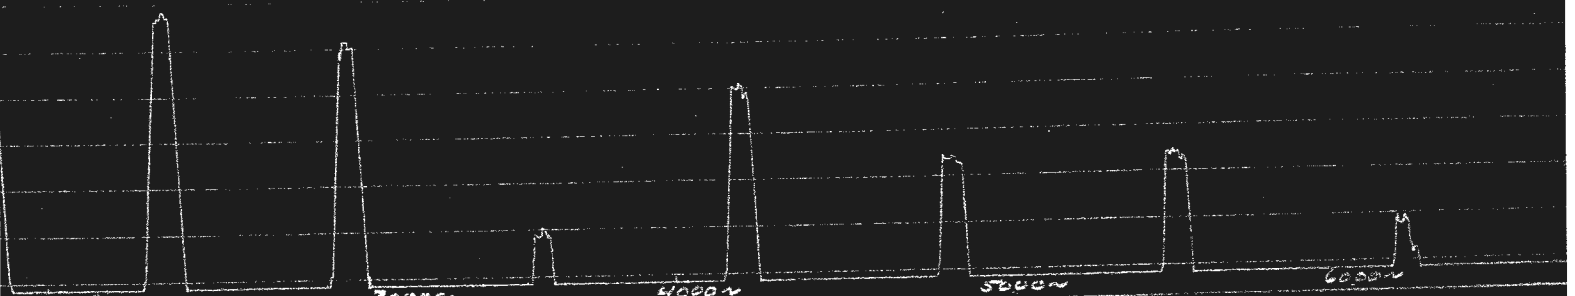
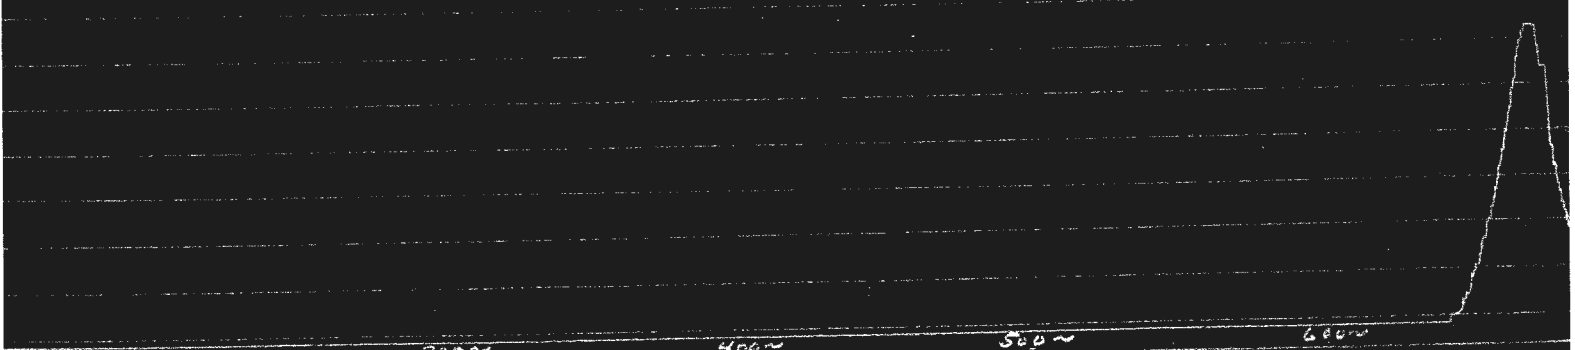
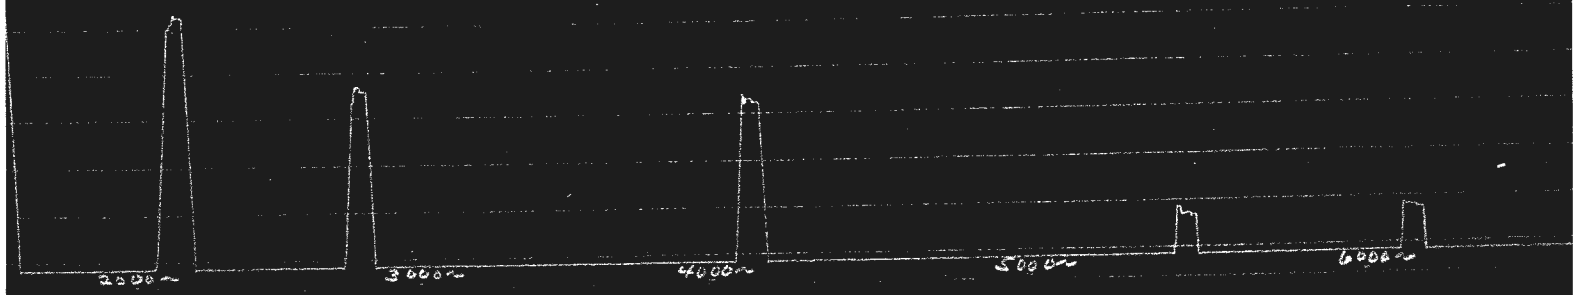
PLATE 1

<u>PLATE</u>
Photostat of the acoustical analyses charts, with microphone at 18 feet in a sound proof room	1
Photostat of the acoustical analyses charts with microphone at 100 feet in open air	2
Photograph of motor operated compressor and horn assembly	3
Photograph of motor operated compressor, disassembled ..	4
Photograph of horn, disassembled	5
Photograph of compressor rotor showing cause of failure.	6

10. The acoustical analyses of the horn were made when the horn was operated from a supply of air controlled by a regulator, at the pressures produced by the compressor (11.1 pounds at 115 v.d.c. and 7.4 pounds at 115 v.a.c.) Plate 1 shows the analyses at 18 feet in a soundproof room and Plate 2 shows the analyses at 100 feet in open air.

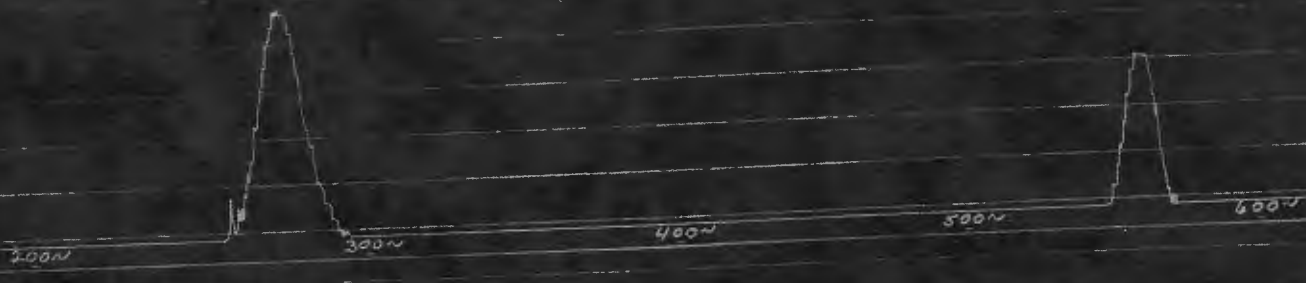
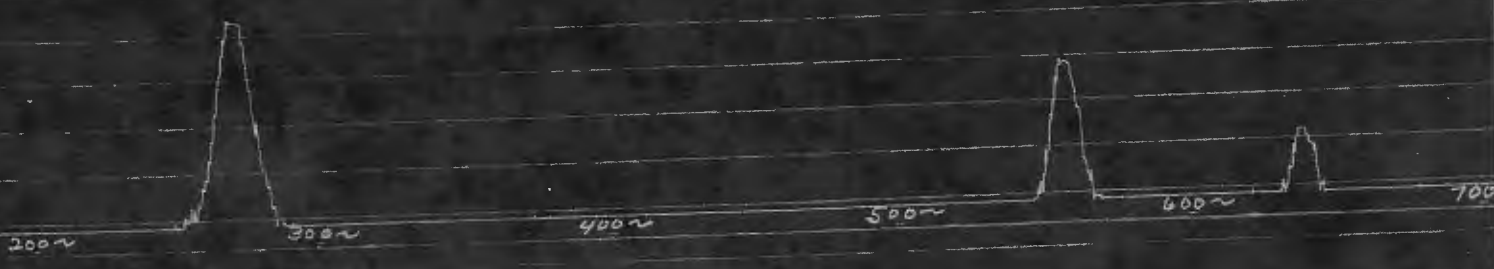
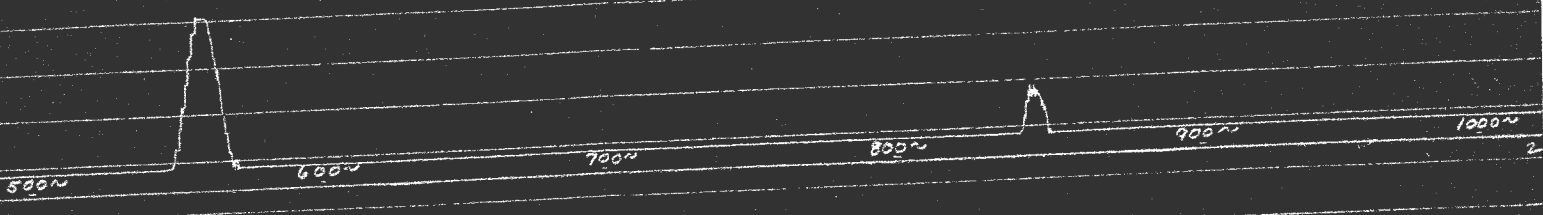
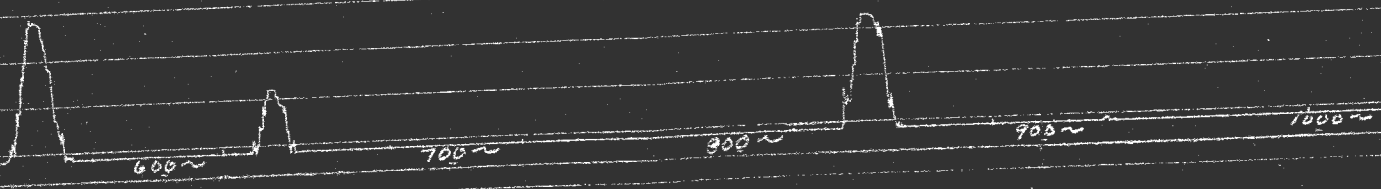
PLATE 2

TYPE H-10 HORN
REPORT NO. B-2083
ANALYSIS AT 100 FEET
IN OPEN AIR

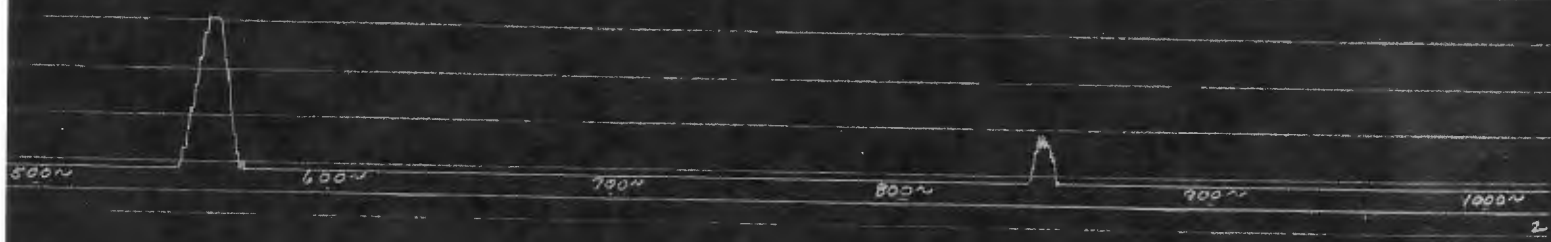
AT 100 FEET

N AIR

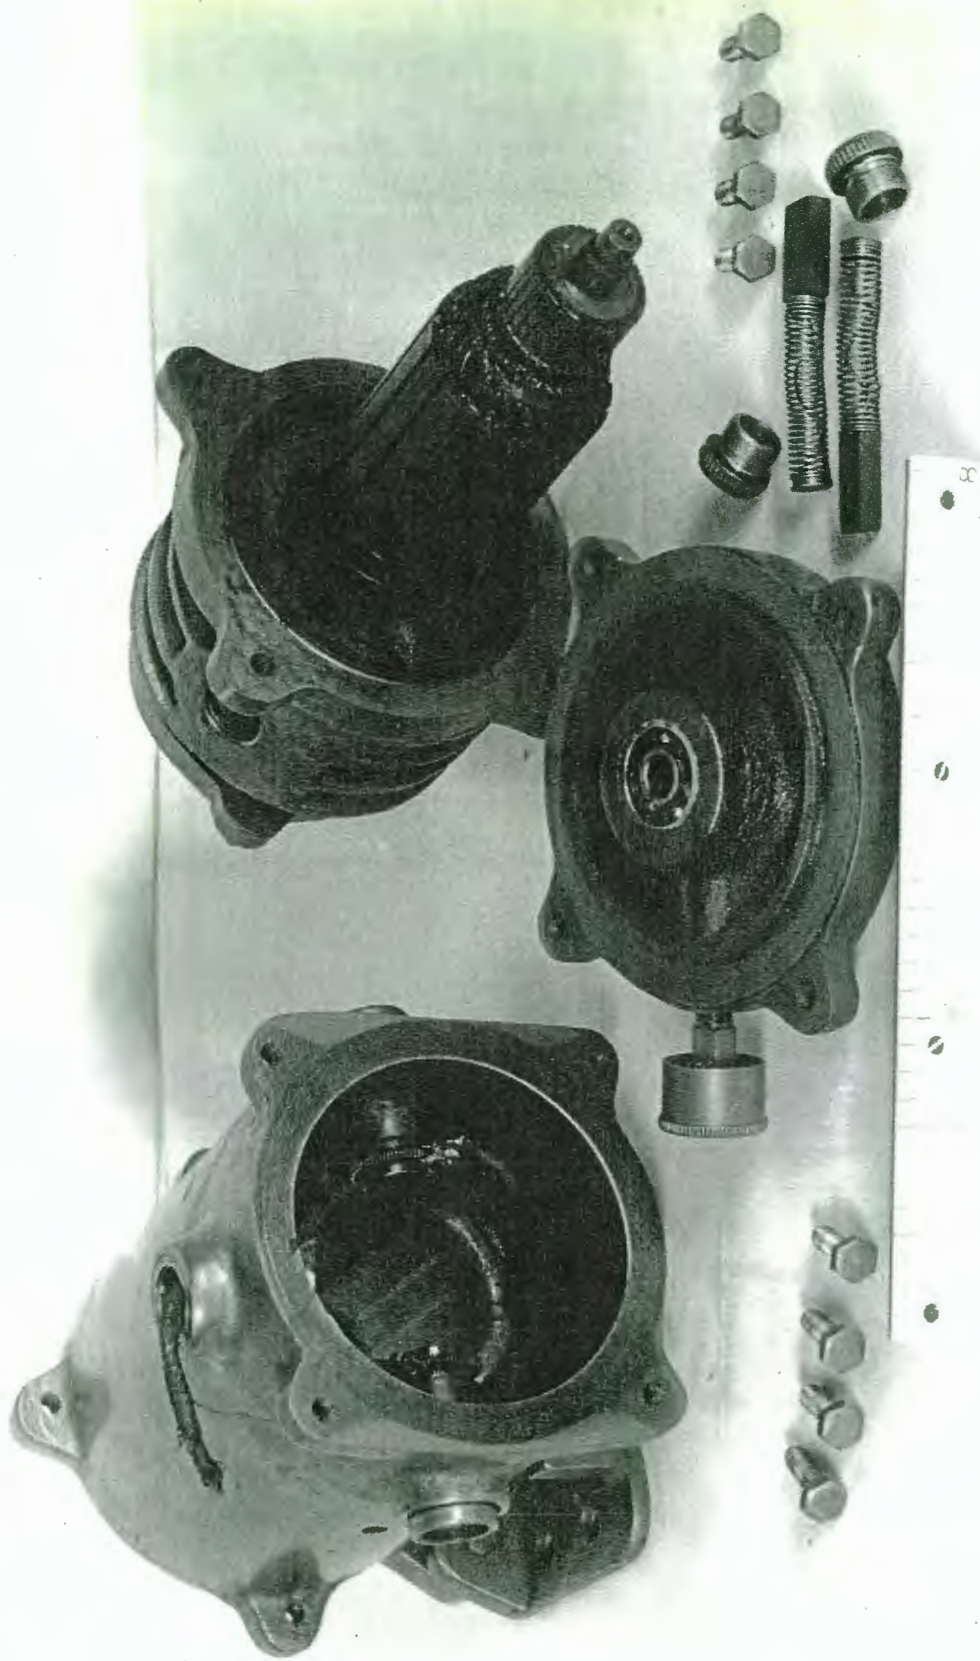
PLATE 4

5. The type WP-1 compressor is of the rotary vane type and is directly connected to the motor. The rotor has three slots, each provided with two phenolic vanes which contact the rotor housing. The air enters the motor housing at the commutator end and is forced out through an opening, tapped 1/2-inch (IPS), in the top of the compressor housing.

6. The motor is of the series type and is equipped with ball bearings. It is enclosed in a cast iron housing attached to a cast base by two 3/8-inch steel cap screws threaded into the base. The compressor housing is secured to the motor housing by four 1/4-inch steel cap screws threaded into lugs on the motor housing.

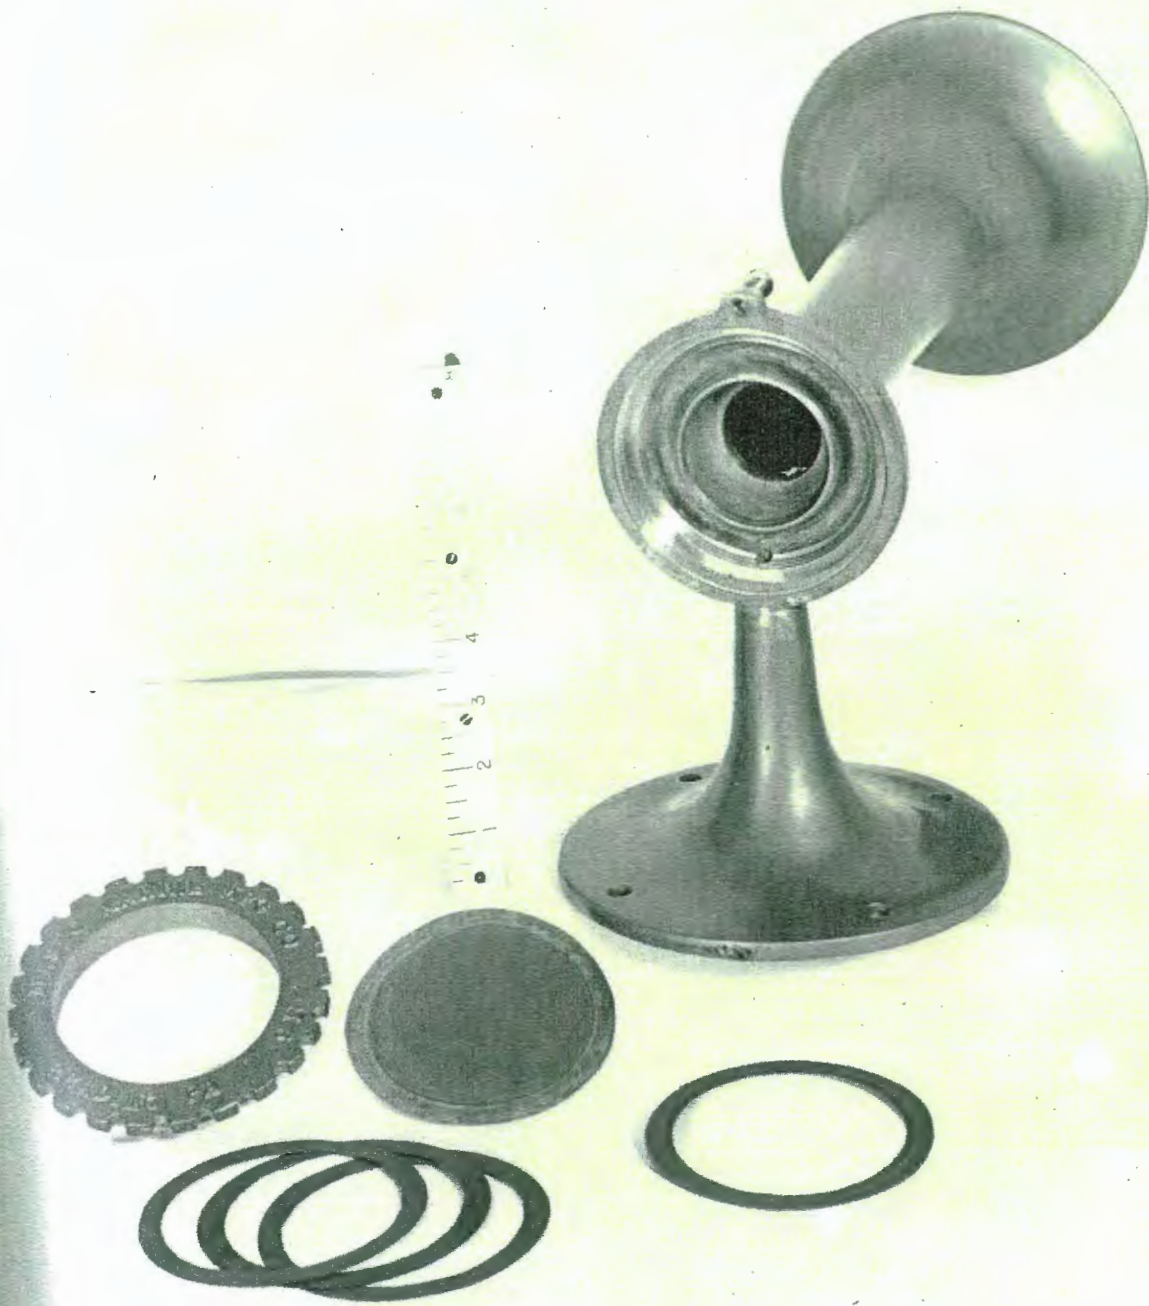
PLATE 5.

7. The type M5 horn is provided with a 4-inch diameter phosphor bronze diaphragm secured between flat fiber gaskets by a ring threaded into the diaphragm housing and locked by a brass machine screw. The projector is sweated into the diaphragm housing. The pedestal, cast integral with the housing, is drilled for four 5/16-inch mounting screws and is provided with an opening in the bottom, threaded 3/8-inch (IPS) for connecting to the compressor. As received, the horn was mounted on the compressor by means of a connecting pipe nipple.

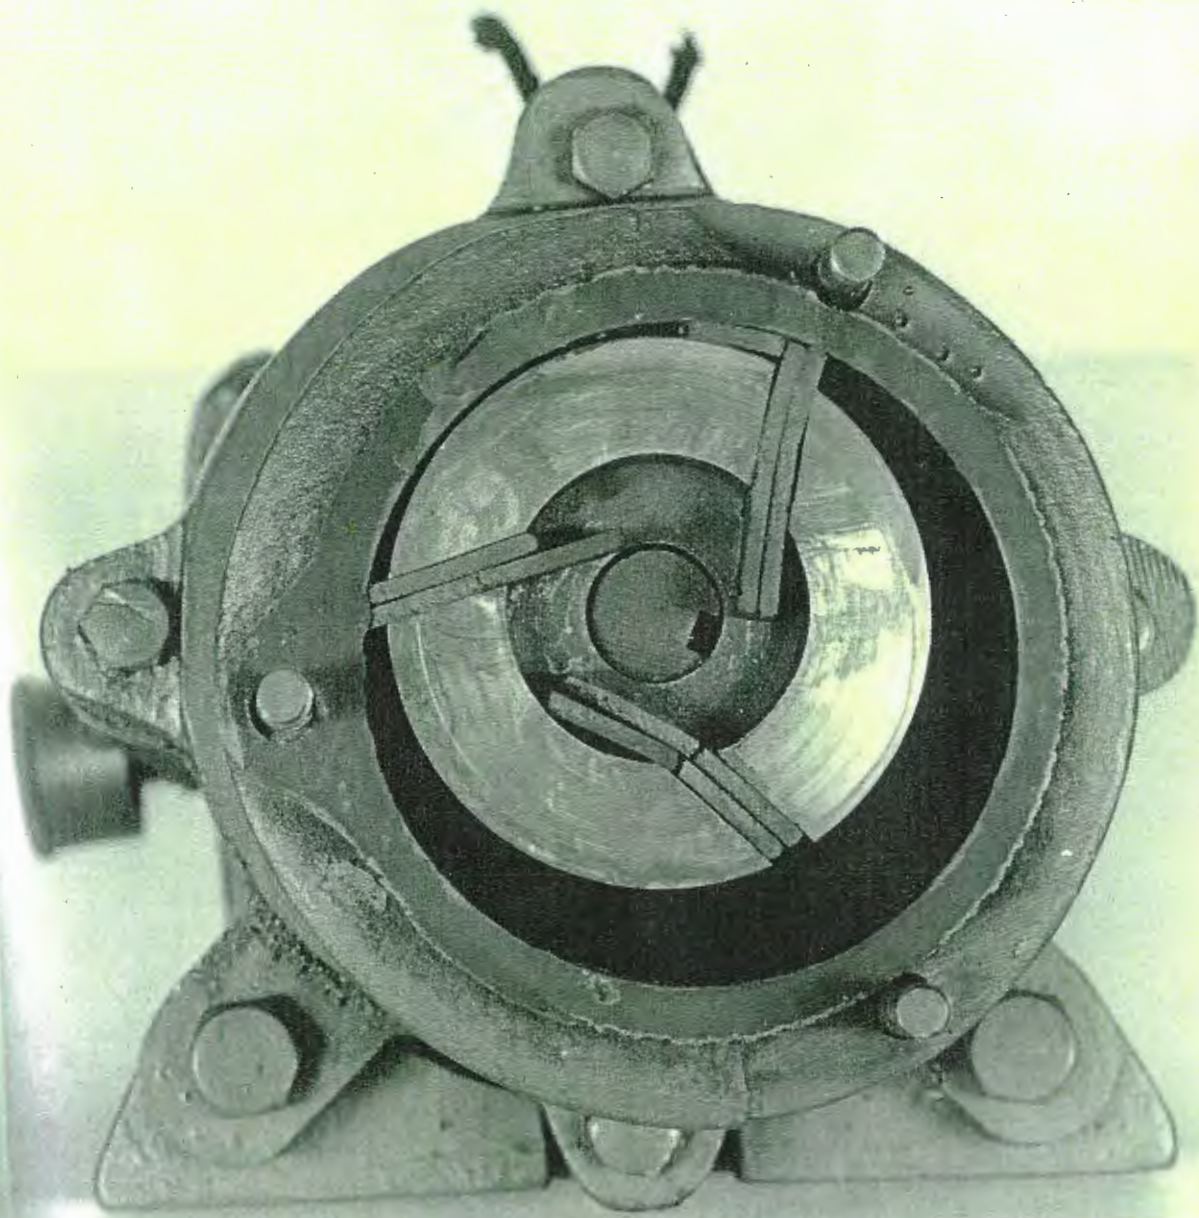
PLATE 6

- (1) Allowable power consumption was exceeded by 2682 watts when operated at 115 volts, d.c., and 1710 watts when operated at 115 volts, 60 cycles.
- (2) Failure after 2-1/4 hours during the endurance test due to broken vanes in the compressor.
- (3) The ventilated motor is not of watertight construction.

11. The sample was subjected to an endurance test at which time there was allowed 1 second to bring the motor up to rated speed and 5 seconds of signalling each minute. Due to the failure of the compressor, no further tests could be conducted.

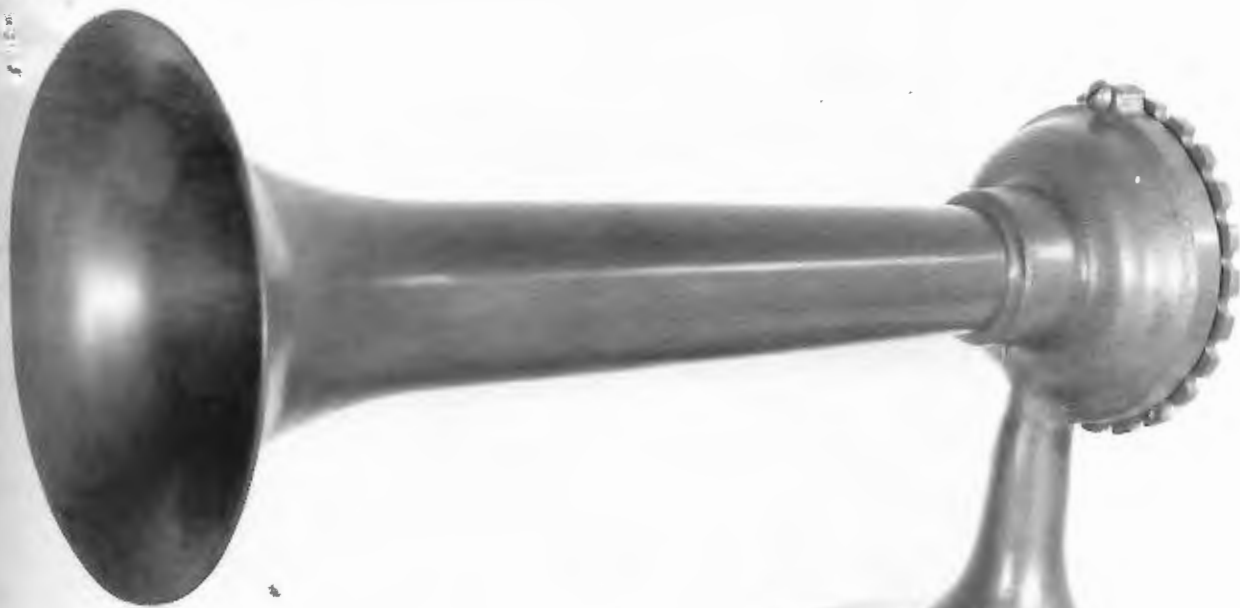
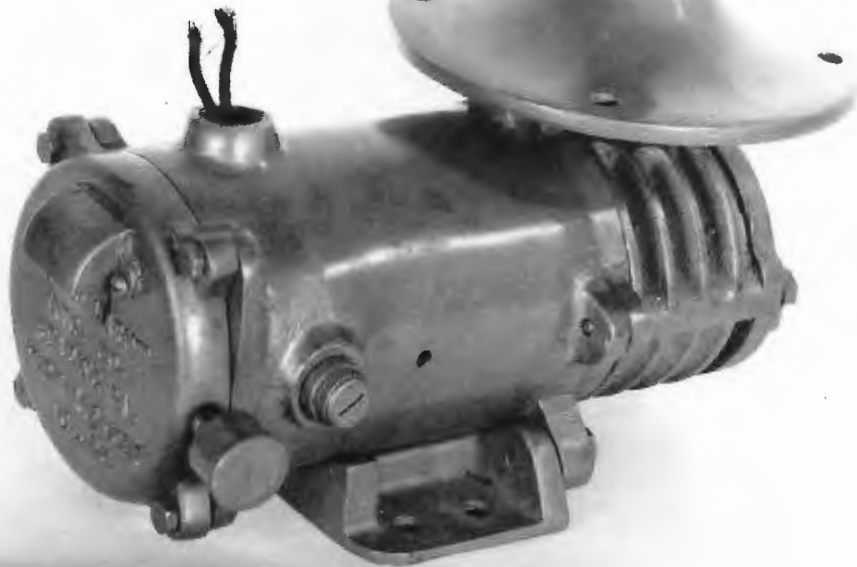
PLATE 3

8. The assembly is finished with gray paint. Further details in the design and construction of the subject horn are shown by photographs, Plates 3 to 6.

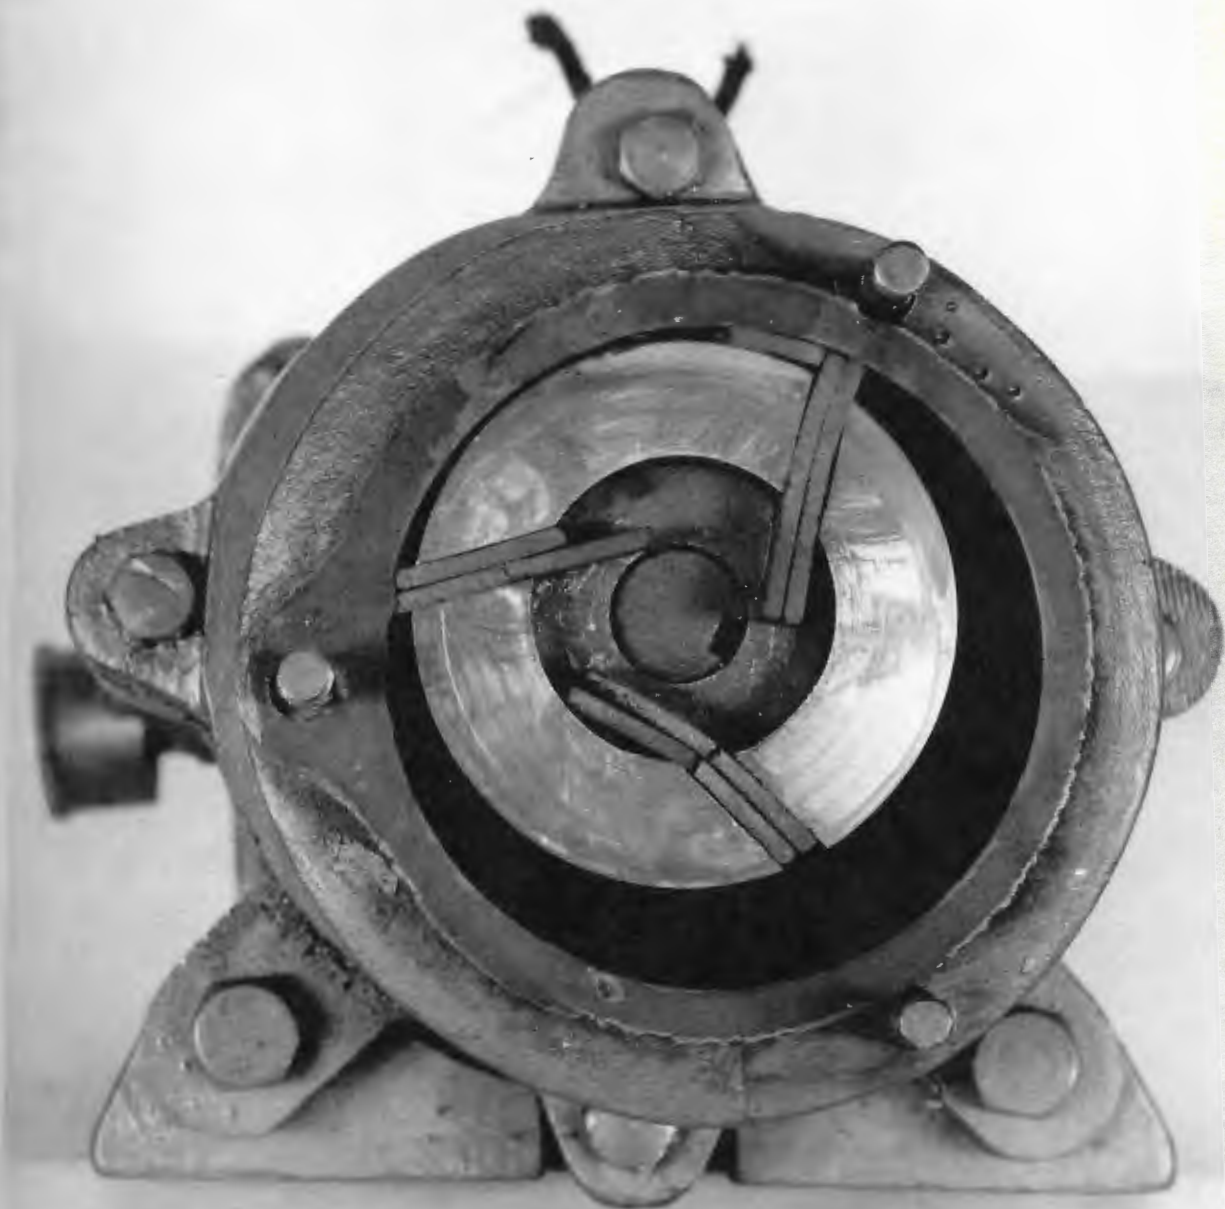
PLATE 6

- (1) Allowable power consumption was exceeded by 2682 watts when operated at 115 volts, d.c., and 1710 watts when operated at 115 volts, 60 cycles.
- (2) Failure after 2-1/4 hours during the endurance test due to broken vanes in the compressor.
- (3) The ventilated motor is not of watertight construction.

(a) That the subject horn be NOT APPROVED for Naval use in its present form. It is to be noted that the sample submitted is a type WP-1 instead of a WP-2 on which the Bureau's authorization for test was based.
