NRL SHOCK-FRACTURE TEST FOR WELDED
JOINTS IN ARMOR

Report No. M-2050

NRL Report No. M-2050

NRL Shock-Fracture Test for Welded Joints in Armor.

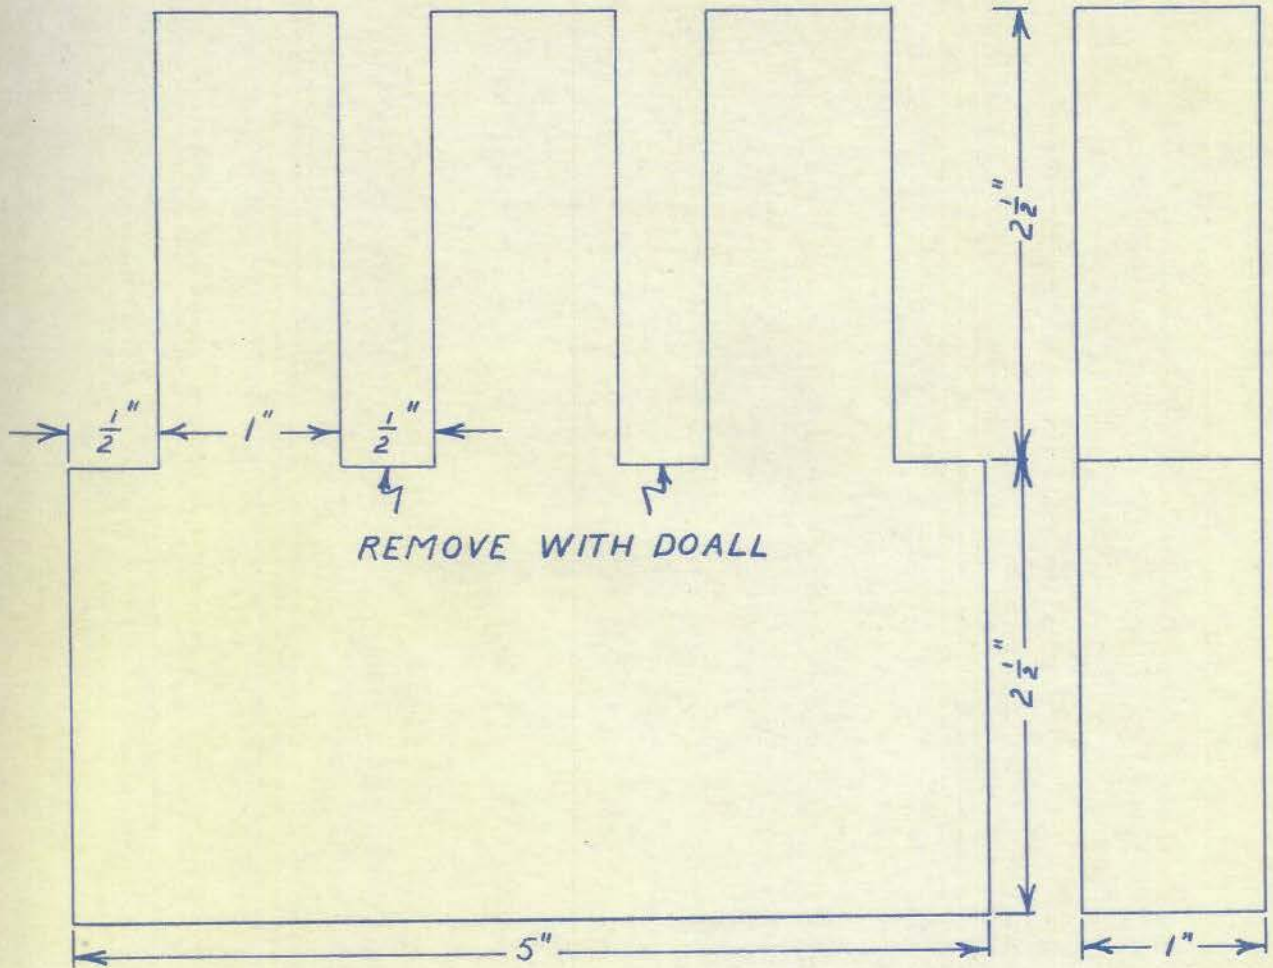
PLATE I

SPECIMEN PREPARED BY POWER HACK SAW

NRL SHOCK FRACTURE TEST SPECIMEN

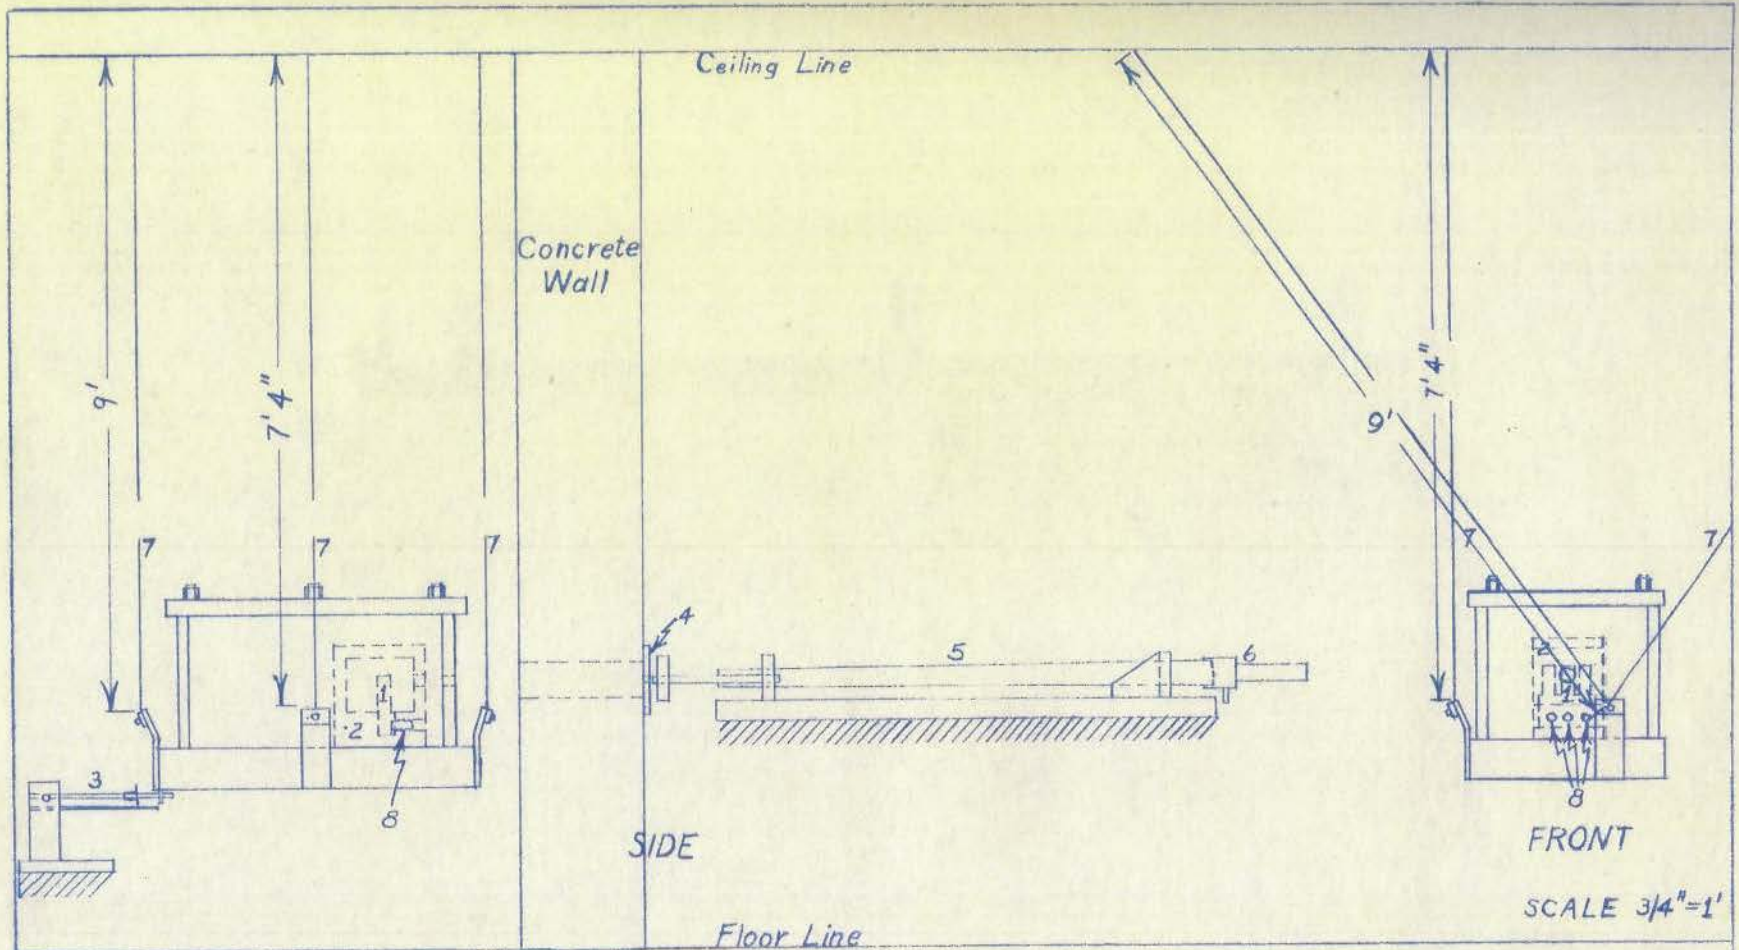
1. Specimen
2. Jig
3. Sliding Indicator and Scale
4. Blast Shield
5. Caliber .50 Browning Machine Gun

6. Air-Operated Firing Mechanism
7. Five Wire Supports
8. 3/4" Allen Screws to Hold Specimen

10. A special jig which was mounted in the pendulum to hold the specimens securely during testing was found necessary (Plates 7, 8 and 9). The weight of the jig (approximately 80 lbs.) was distributed so that the impact of the dart at 1 inch from the end of a finger would not be far from the center of gravity of the jig as positioned in the pendulum assembly.

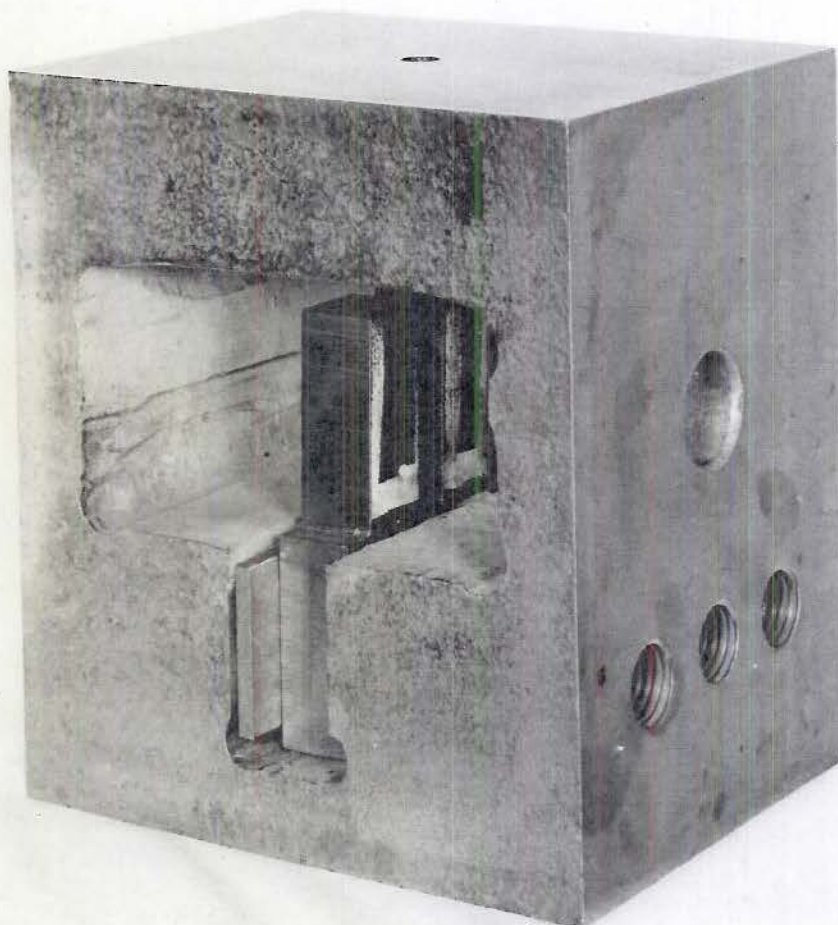
100 POUND JIG USED FOR HOLDING NRL SHOCK FRACTURE SPECIMENS

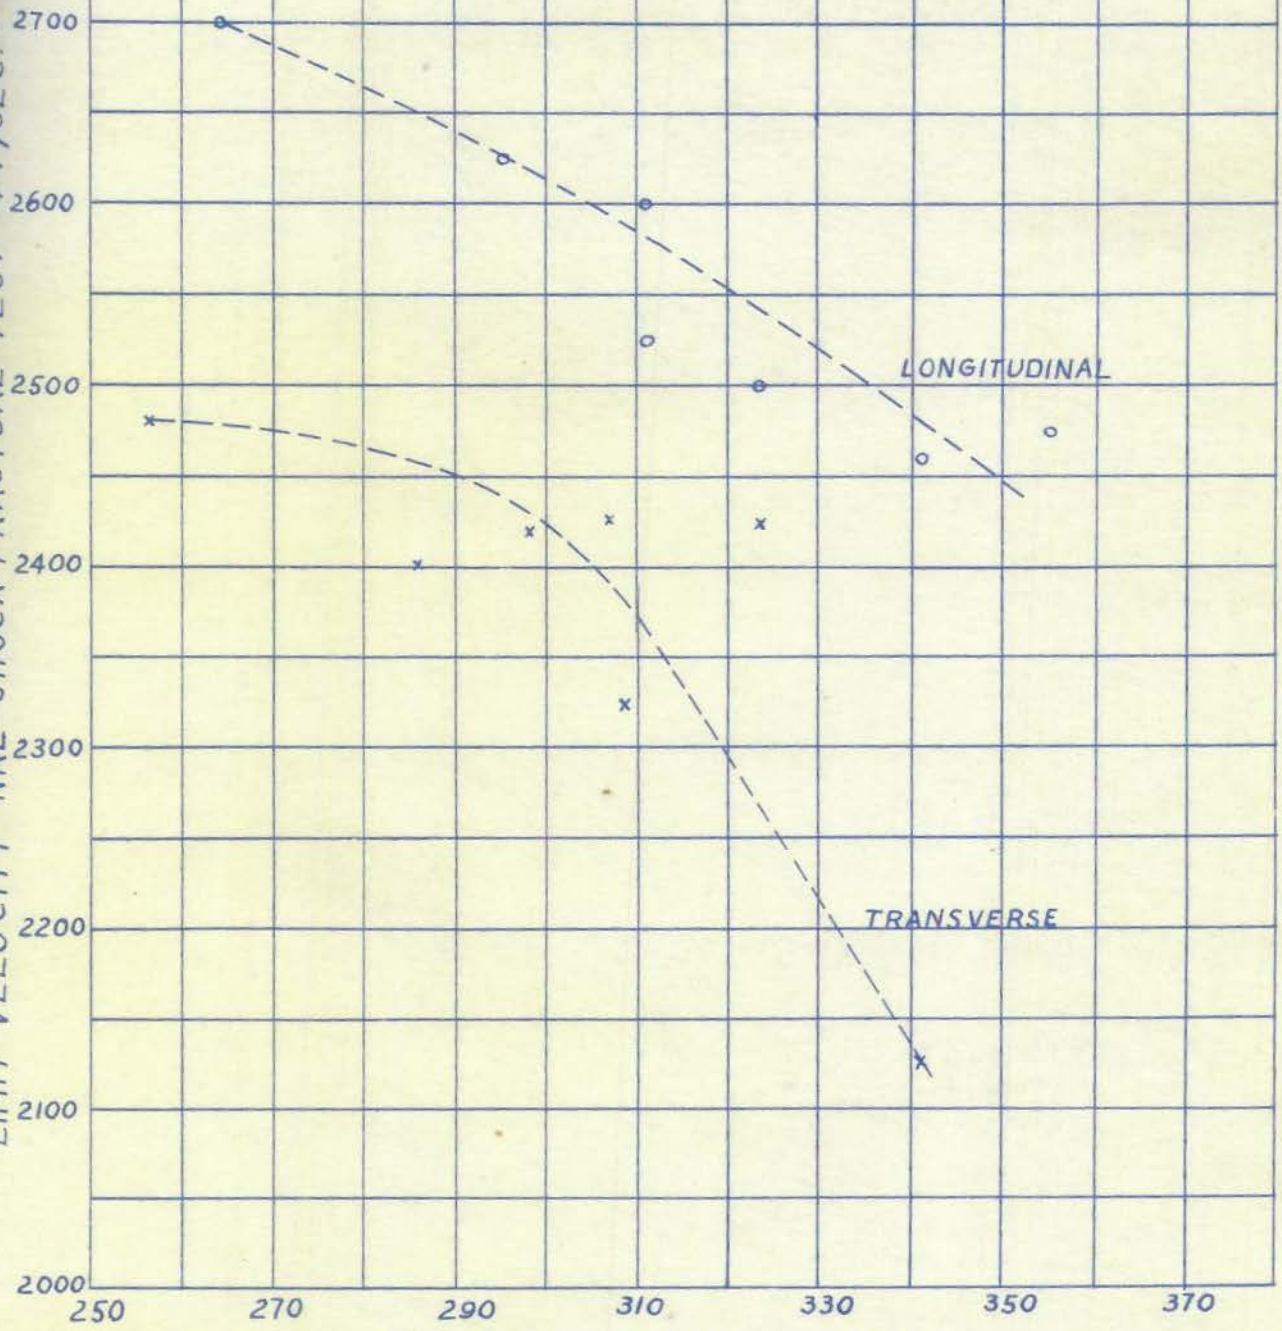
PLATE 24

LIMIT VELOCITY NRL SHOCK FRACTURE TEST - FT/SEC.

BRINELL HARDNESS NUMBER

13. The performance of the test specimens of #206 plate material indicated greater ability to absorb energy in the shock-fracture test when the finger is cut in the principal direction of rolling than in the transverse direction. There is a decrease in the limit velocity and hence a decrease in the energy absorption in the shock-fracture test as the hardness is increased from 260 to 350 Brinell. This relation is contrary to the increase in limit velocity with an increase in hardness obtained for full penetration by A.P. projectiles. A similar shock behavior has been observed for other grades of armor. These data are presented graphically in Plates 24 and 25.

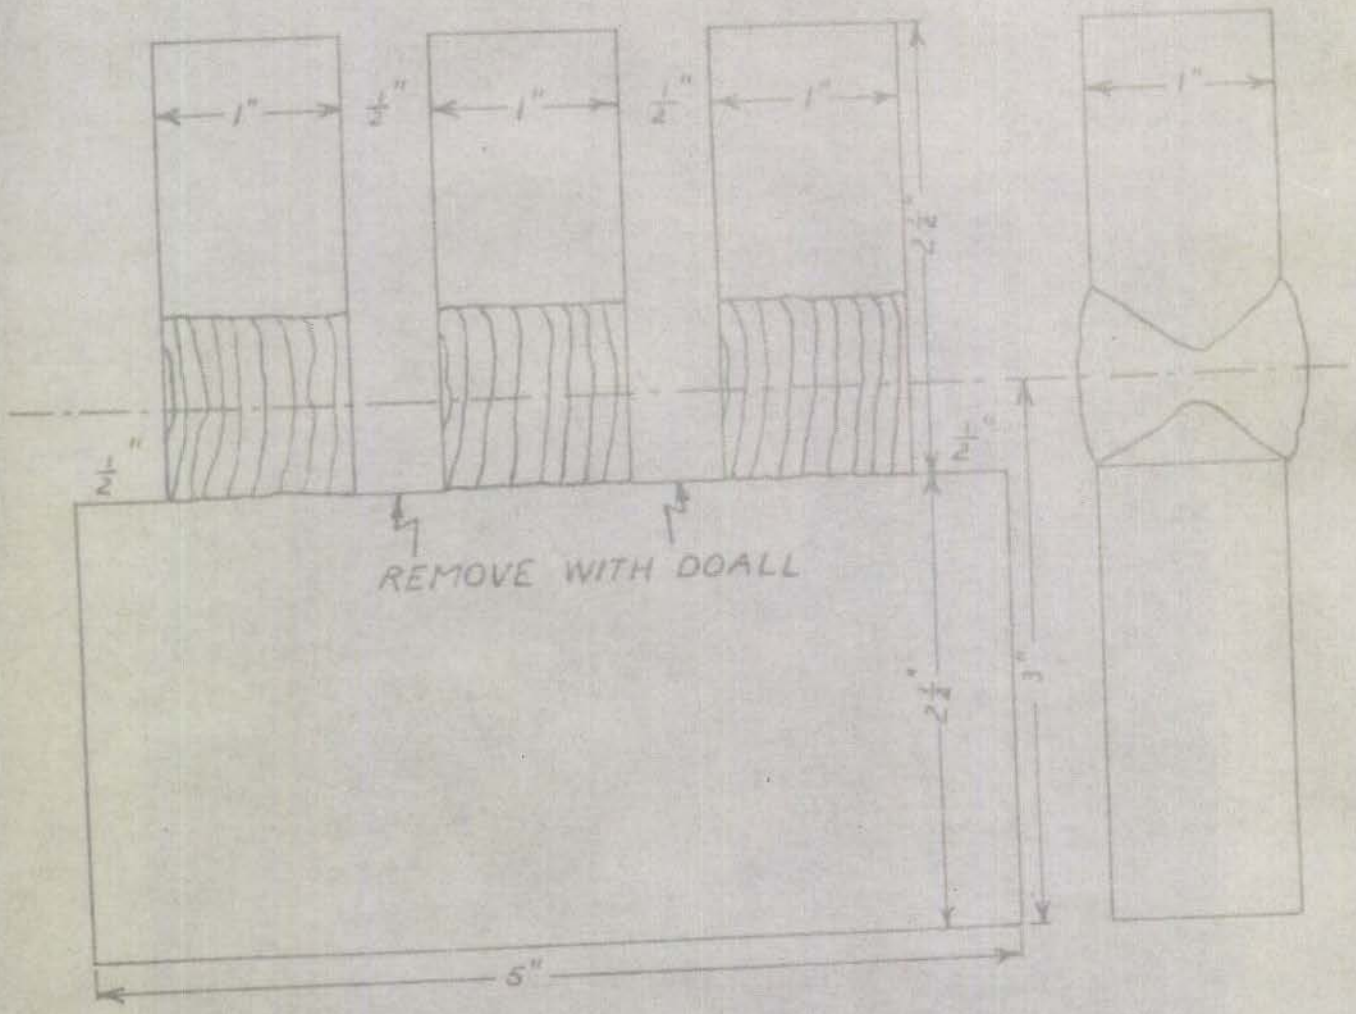
SPECIMEN PREPARED BY POWER HACK SAW

NRL SHOCK FRACTURE TEST SPECIMEN FOR WELD JOINT

14. The performance of the test piece used in the study of unwelded armor indicated that it would be entirely satisfactory for use in testing the quality of a number of welded sections taken from H-plates (in the one-inch thickness) which had previously been tested at the Aberdeen Proving Grounds. Test specimens were prepared from each of these sections in accordance with details given in Plate 26 and tested in the NRL shock fracture test.

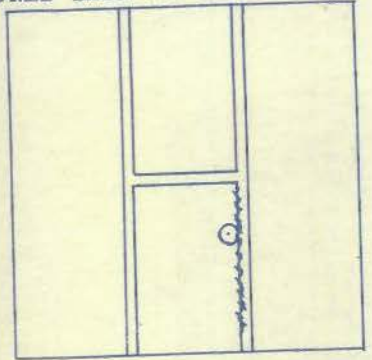
RD. 1 VEL. 776 FT/SEC.
HIT $1\frac{3}{4}$ " LEFT OF RIGHT LEG AND $6\frac{1}{4}$ " BELOW CROSS WELD
CROSS WELD CRACK FROM LEG,
LEFT LEG CRACK WITH CROSS WELD,
 $10\frac{1}{4}$ " RIGHT LEG CRACK WITH ALL BELOW CROSS WELD, $4\frac{3}{4}$ " F.Z.

BACK
CROSS WELD CRACK FROM LEG,
LEFT LEG CRACK WITH CROSS WELD,
 $13\frac{1}{4}$ " RIGHT LEG CRACK WITH ALL BELOW CROSS WELD, ALL F.Z.

15. The performance of the test samples from H-plates which were tested with 75 mm. proof projectiles is given in Table II. Photographs of the H-plate and NRL shock fracture test specimens are given in Plates 27 to 44. The criterion which many experts regard as the most indicative of H-plate performance is the amount of cracking on the back of the plate when subjected to the impact of the 75 mm. slug. These data are presented in Table III and Plate 45.

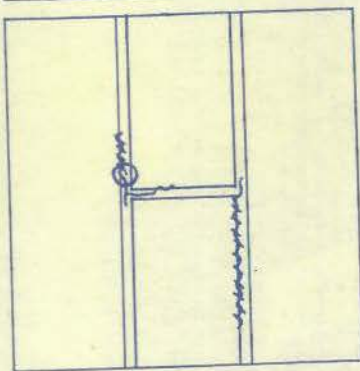
RD. 2 VEL. 763 FT/SEC.
HIT ON OF LEFT LEG AND $2\frac{1}{2}$ " ABOVE CROSS WELD
 4 " CROSS WELD CRACK FROM LEFT LEG, ALL F.Z.
 $5\frac{1}{4}$ " LEFT LEG CRACK WITH ALL ABOVE CROSS WELD, $1\frac{3}{4}$ " F.Z.
 $11\frac{3}{4}$ " RIGHT LEG CRACK WITH ALL BELOW CROSS WELD, $4\frac{3}{4}$ " F.Z.

BACK
 5 " CROSS WELD CRACK FROM LEFT LEG, 2 " H.A.Z.
 9 " LEFT LEG CRACK WITH 8 " ABOVE CROSS WELD, $5\frac{1}{2}$ " F.Z.
 15 " RIGHT LEG CRACK WITH 1 " ABOVE CROSS WELD, $13\frac{1}{2}$ " F.Z.
 $1\frac{1}{4}$ " HORIZONTAL BULGE $1\frac{1}{8}$ " VERTICAL BULGE

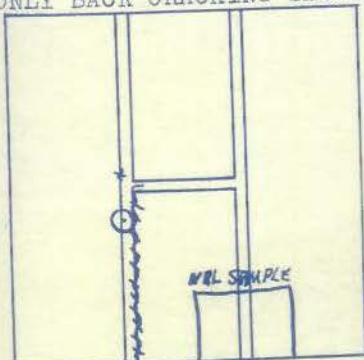
RD. VEL. 735 FT/SEC.
 HIT $\frac{3}{4}$ " LEFT OF LEFT LEG AND $5\frac{1}{2}$ " BELOW CROSS WELD
 CROSS WELD CRACK FROM LEG,
 19" LEFT LEG CRACK WITH ALL BELOW CROSS WELD, ALL F.Z.
 RIGHT LEG CRACK WITH CROSS WELD,

BACK
 1" CROSS WELD CRACK FROM LEFT LEG,
 19" LEFT LEG CRACK WITH 1" ABOVE CROSS WELD, ALL F.Z.
 RIGHT LEG CRACK WITH CROSS WELD,

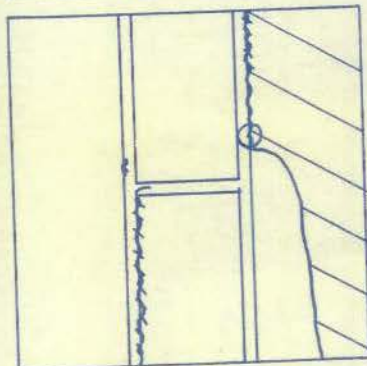
RD. 2 VEL. 777 FT/SEC.
 HIT $\frac{1}{4}$ " RIGHT OF RIGHT LEG AND 7" ABOVE CROSS WELD
 CROSS WELD CRACK FROM LEG,
 18" LEFT LEG CRACK WITH ALL ABOVE CROSS WELD, ALL F.Z.
 12 $\frac{1}{4}$ " RIGHT LEG CRACK WITH ALL ABOVE CROSS WELD, 8 $\frac{1}{2}$ " F.Z.; 3 $\frac{1}{2}$ " H.A.Z.
 2 $\frac{1}{2}$ " PLATE CRACK

BACK
 1" CROSS WELD CRACK FROM LEFT LEG,
 19" LEFT LEG CRACK WITH 1" ABOVE CROSS WELD, ALL F.Z.
 12 $\frac{1}{4}$ " RIGHT LEG CRACK WITH ALL ABOVE CROSS WELD, 6 $\frac{1}{4}$ " F.Z.;
 2 $\frac{1}{2}$ " PLATE CRACK 6" H.A.Z.

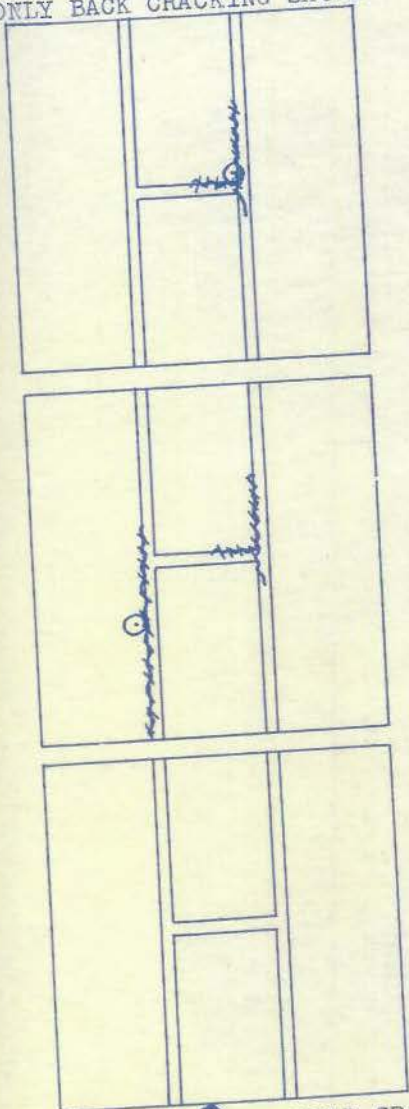
RD. 1 VEL. 760 FT/SEC.
 HIT $\frac{1}{8}$ " LEFT OF RIGHT LEG AND $1\frac{1}{2}$ " ABOVE CROSS WELD
 4" CROSS WELD CRACK FROM RIGHT LEG, ALL F.Z.
 LEFT LEG CRACK WITH CROSS WELD,
 9 $\frac{1}{2}$ " RIGHT LEG CRACK WITH $6\frac{1}{2}$ " ABOVE CROSS WELD, 2" F.Z.
 BACK
 5" CROSS WELD CRACK FROM RIGHT LEG, ALL F.Z.
 LEFT LEG CRACK WITH CROSS WELD,
 11 $\frac{1}{2}$ " RIGHT LEG CRACK WITH 8" ABOVE CROSS WELD, 10 $\frac{1}{4}$ " F.Z.
 1 $\frac{1}{4}$ " HORIZONTAL BULGE 1" VERTICAL BULGE

RD. 2 VEL. 685 FT/SEC.
 HIT $1\frac{1}{8}$ " LEFT OF LEFT LEG AND 6" BELOW CROSS WELD
 4" CROSS WELD CRACK FROM RIGHT LEG, ALL F.Z.
 19 $\frac{3}{4}$ " LEFT LEG CRACK WITH 9" ABOVE CROSS WELD, 17 $\frac{1}{4}$ " F.Z.
 9 $\frac{9}{8}$ " RIGHT LEG CRACK WITH 7" ABOVE CROSS WELD, 2" F.Z.
 BACK
 5 $\frac{1}{2}$ " CROSS WELD CRACK FROM RIGHT LEG, 5" F.Z.
 32" LEFT LEG CRACK WITH 18" BELOW CROSS WELD, 21" F.Z.
 11 $\frac{1}{2}$ " RIGHT LEG CRACK WITH 8" ABOVE CROSS WELD, 10 $\frac{1}{4}$ " F.Z.
 1" HORIZONTAL BULGE $\frac{3}{4}$ " VERTICAL BULGE

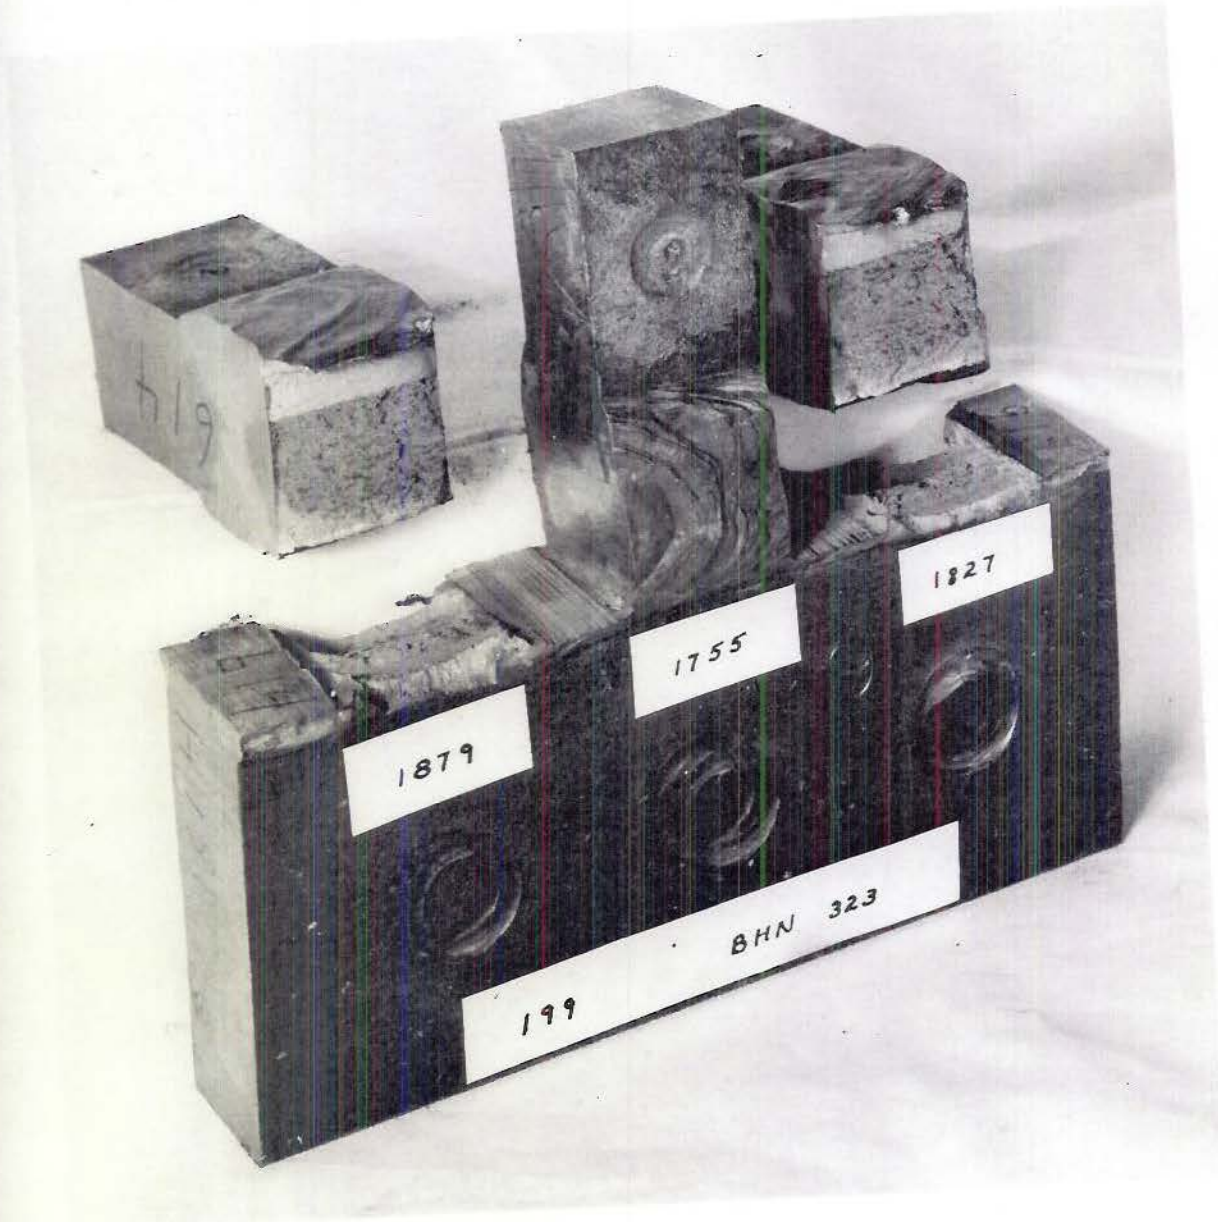
NRL SHOCK FRACTURE SPECIMEN. DOUBLE V WELDS AT BASE OF FINGERS.

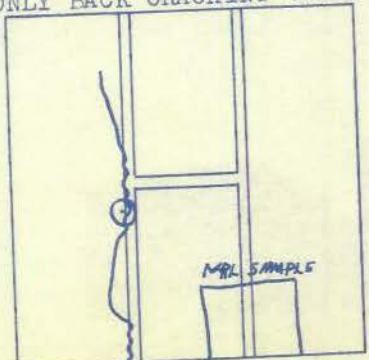
RD. 1 VEL. 779 FT/SEC.
 HIT $\frac{1}{4}$ " LEFT OF LEFT LEG AND $\frac{5}{8}$ " BELOW CROSS WELD
 CROSS WELD CRACK FROM LEG
 $10\frac{1}{2}$ " LEFT LEG CRACK WITH ALL BELOW CROSS WELD, ALL H.A.Z.
 RIGHT LEG CRACK WITH CROSS WELD,
 $6\frac{3}{4}$, $10\frac{1}{4}$ " PLATE CRACKS
 BACK CROSS WELD CRACK FROM LEG
 $11\frac{1}{2}$ " LEFT LEG CRACK WITH ALL BELOW CROSS WELD, ALL H.A.Z.
 RIGHT LEG CRACK WITH CROSS WELD,
 $9\frac{1}{2}$, $8\frac{1}{2}$ " PLATE CRACKS

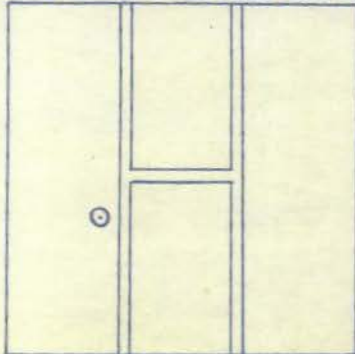
RD. 1 VEL. 768 FT/SEC.
HIT 2 1/4" LEFT OF LEFT LEG AND 5/8" FROM CROSS WELD

CROSS WELD CRACK FROM LEG,
LEFT LEG CRACK WITH CROSS WELD,
RIGHT LEG CRACK WITH CROSS WELD,

CROSS WELD CRACK FROM LEG,
LEFT LEG CRACK WITH CROSS WELD,
RIGHT LEG CRACK WITH CROSS WELD,
7/8" HORIZONTAL BULGE 13/16" VERTICAL BULGE

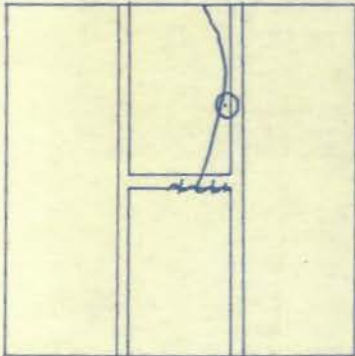
RD. 2 VEL. 785 FT/SEC.
HIT 1 1/4" LEFT OF RIGHT LEG AND 7/8" ABOVE CROSS WELD

7" CROSS WELD CRACK FROM RIGHT LEG, ALL F.Z.
LEFT LEG CRACK WITH CROSS WELD,
RIGHT LEG CRACK WITH CROSS WELD,
13" PLATE CRACK

7 1/2" CROSS WELD CRACK FROM RIGHT LEG, ALL F.Z.
LEFT LEG CRACK WITH CROSS WELD,
RIGHT LEG CRACK WITH CROSS WELD,
18" PLATE CRACK

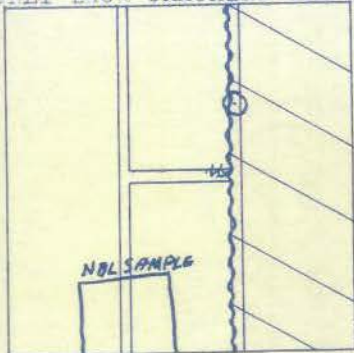
RD. 1 VEL. 746 FT/SEC.
HIT $\frac{1}{4}$ " LEFT OF RIGHT LEG AND $\frac{7}{8}$ " ABOVE CROSS WELD
CROSS WELD CRACK FROM LEG,
LEFT LEG CRACK WITH CROSS WELD,
36" RIGHT LEG CRACK WITH 18" ABOVE CROSS WELD, ALL H.A.Z.

BACK
3" CROSS WELD CRACK FROM RIGHT LEG, ALL F.Z.
LEFT LEG CRACK WITH CROSS WELD,
36" RIGHT LEG CRACK WITH 18" ABOVE CROSS WELD, ALL H.A.Z.
2" SECONDARY CRACK

REMARKS PLATE DOES NOT MEET BALLISTIC REQUIREMENTS A65 497-3

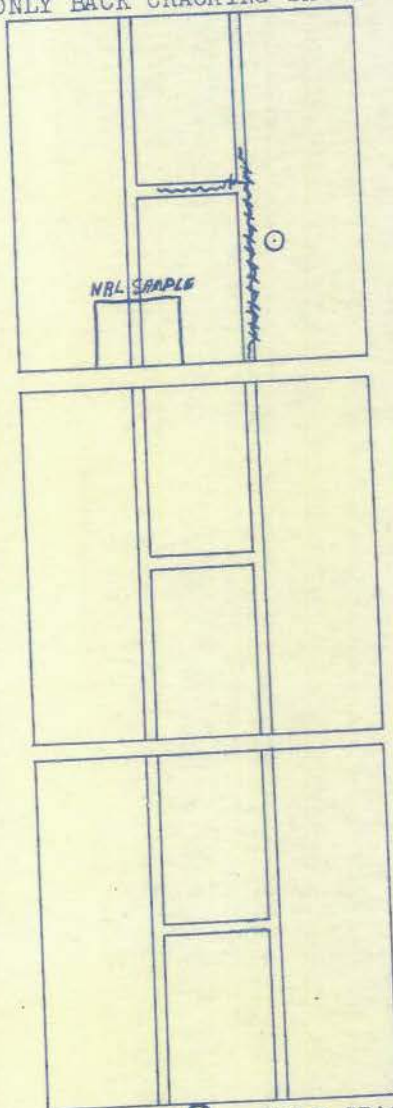
RD. 1 VEL. 755 FT/SEC.
 HIT 2 1/2" RIGHT OF RIGHT LEG AND 5 1/2" BELOW CROSS WELD
 5 1/4" CROSS WELD CRACK FROM LEG, —
 LEFT LEG CRACK WITH CROSS WELD,
 20" RIGHT LEG CRACK WITH 2" ABOVE CROSS WELD, ALL F.Z.

BACK 8 1/2" CROSS WELD CRACK FROM RIGHT LEG, 1 1/4" F.Z.
 LEFT LEG CRACK WITH CROSS WELD,
 22" RIGHT LEG CRACK WITH 4" ABOVE CROSS WELD, 9 1/2" H.A.Z.
 1 1/2" HORIZONTAL BOLGE 3/4" VERTICAL BOLGE 6" F.Z.

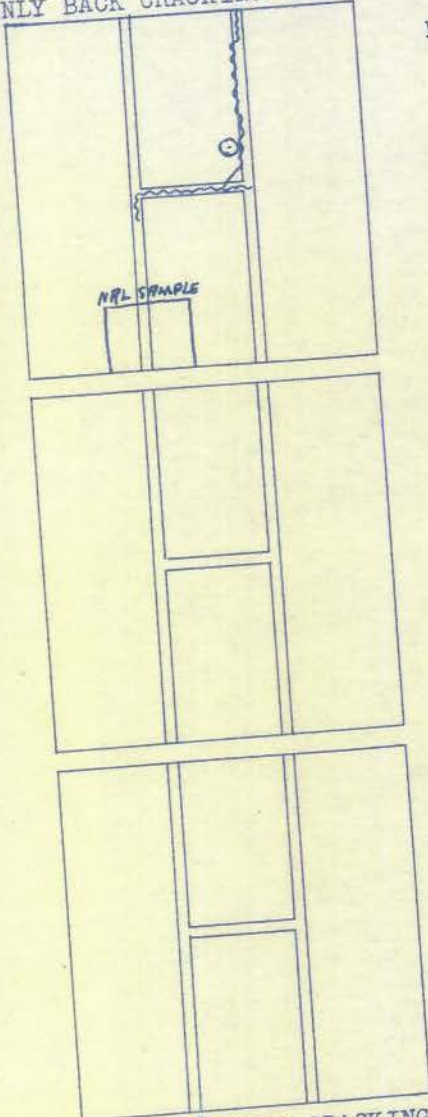
RD. 1 VEL. 762 FT/SEC.
 HIT 1/2" LEFT OF RIGHT LEG AND 5" ABOVE CROSS WELD,
 1 1/4" CROSS WELD CRACK FROM RIGHT LEG,
 1 3/4" LEFT LEG CRACK WITH ALL BELOW CROSS WELD, ALL F.Z.
 1 5/8" RIGHT LEG CRACK WITH ALL ABOVE CROSS WELD, ALL F.Z.
 3/8" PLATE CRACK
 BACK
 12" CROSS WELD CRACK FROM _____ LEG, _____
 3" LEFT LEG CRACK WITH ALL BELOW CROSS WELD, _____
 15" RIGHT LEG CRACK WITH ALL ABOVE CROSS WELD, 11" F.Z.
 3/4" PLATE CRACK

REMARKS PLATE WELDED WITH 1/4", 7/16", 1/2" ELECTRODES

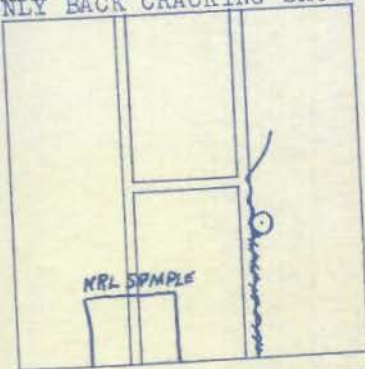
RD. 1 VEL. 762 FT/SEC.
 HIT 1/2" RIGHT OF RIGHT LEG AND 5/8" BELOW CROSS WELD
 CROSS WELD CRACK FROM LEG,
 LEFT LEG CRACK WITH CROSS WELD,
 12" RIGHT LEG CRACK WITH ALL BELOW CROSS WELD, ALL H.A.Z.
 9", 2 1/4" PLATE CRACKS

BACK CROSS WELD CRACK FROM LEG,
 LEFT LEG CRACK WITH CROSS WELD,
 18 1/4" RIGHT LEG CRACK WITH 1/4" ABOVE CROSS WELD, 1 1/2" F.Z., 6 1/2" H.A.Z.
 1" VERTICAL BULGE 6" PLATE CRACK

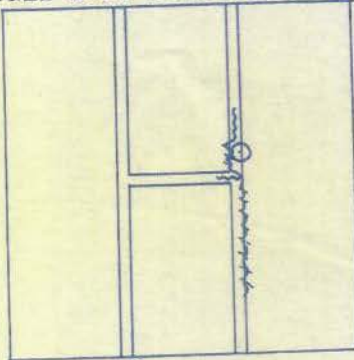
RD. 1 VEL. 775 FT/SEC.
 HIT $\frac{1}{2}$ " RIGHT OF RIGHT LEG AND $\frac{1}{2}$ " CROSS WELD
 $3\frac{1}{2}$ " CROSS WELD CRACK FROM ^{ABOVE} RIGHT LEG,
 LEFT LEG CRACK WITH CROSS WELD, —
 $15\frac{1}{2}$ " RIGHT LEG CRACK WITH $6\frac{1}{2}$ " BELOW CROSS WELD, —

BACK
 $2\frac{1}{4}$ " CROSS WELD CRACK FROM RIGHT LEG, —
 LEFT LEG CRACK WITH CROSS WELD,
 17 " RIGHT LEG CRACK WITH $6\frac{1}{2}$ " BELOW CROSS WELD, $14\frac{1}{2}$ " F.Z.
 $1\frac{1}{2}$ " HORIZONTAL BULGE $1\frac{1}{2}$ " VERTICAL BULGE

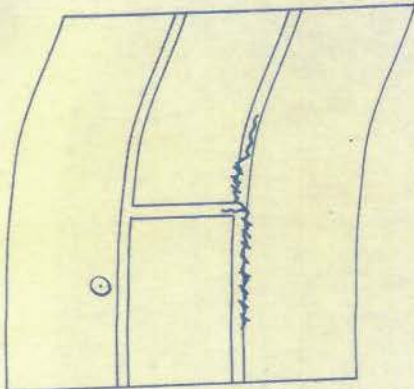
RD. 2 VEL. 684 FT/SEC.
 HIT $2\frac{1}{2}$ " LEFT OF LEFT LEG AND 7" BELOW CROSS WELD

BACK
 $2\frac{1}{4}$ " CROSS WELD CRACK FROM RIGHT LEG, —
 LEFT LEG CRACK WITH CROSS WELD,
 $18\frac{1}{4}$ " RIGHT LEG CRACK WITH $7\frac{1}{2}$ " BELOW CROSS WELD, $14\frac{1}{2}$ " F.Z.
 $13\frac{1}{16}$ " HORIZONTAL BULGE $3\frac{1}{4}$ " VERTICAL BULGE

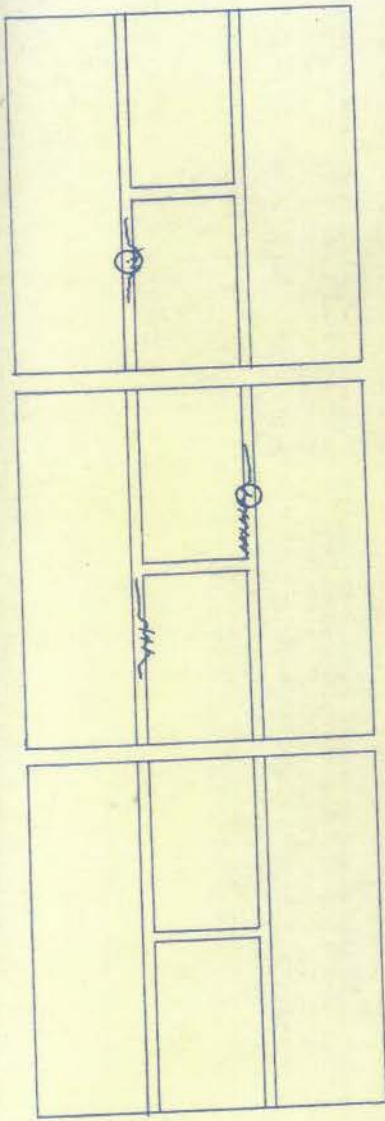
SUBMITTED BY HEIL COMPANY PLATE NO. H-13
 ARMOR MFR JONES AND LAUGHLIN TYPE 1" ROLLED HOMO
 ELECTRODE LINCOLN ARMOR WELD MN MOD 18-8 AUS PURPOSE QUALIFICATION
 PROJECTILE 75 MM T21 PROOF PROJECTILE DATE 10-10-42
 PREHEAT OF PLATE AT TIME OF WELDING 150°F
 TEMPERATURE OF PLATE AT TIME OF TESTING _____

RD. 1 VEL. 802 FT/SEC.
 HIT ON ~~OF~~ LEFT LEG AND 7" CROSS BAR
 BELOW
 8 1/4" CROSS WELD CRACK FROM LEG,) IN
 LEFT LEG CRACK WITH ALL BELOW CROSS WELD,) FUSION
 RIGHT LEG CRACK WITH CROSS WELD,) ZONE

IMPACT 0 BACK CRACKING wavy
 FUSION ZONE CRACKING none
 REMARK VELOCITY OF FIRST IMPACT HIGHER THAN NECESSARY
LOCATION OF NRL SAMPLE UNKNOWN

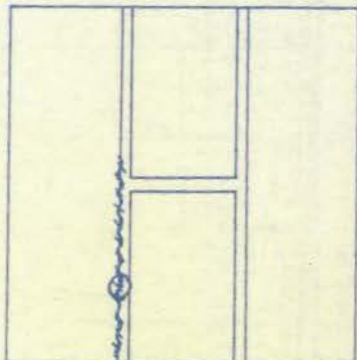
SUBMITTED BY GORDON MANUFACTURING CO PLATE NO. H-1
 ARMOR MFR GREAT LAKES STEEL TYPE 1" ROLLED HOMO
 ELECTRODE CRUCIBLE-ARMORIZE MANN MOD K-2 AWS PURPOSE QUALIFICATION
 PROJECTILE 75MM T21 PROOF PROJECTILE DATE 10-20-42
 PREHEAT OF PLATE AT TIME OF WELDING 120°F
 TEMPERATURE OF PLATE AT TIME OF TESTING _____

RD. 1 VEL. 770 FT/SEC.
 HIT 3/4" LEFT OF LEFT LEG AND 10" BELOW CROSS BAR
 CROSS WELD CRACK FROM _____ LEG, (IN
1/4" LEFT LEG CRACK WITH 1 1/2" ABOVE CROSS WELD, ALL (FUSION
 RIGHT LEG CRACK WITH _____ CROSS WELD, (ZONE
 BACK
 CROSS WELD CRACK FROM _____ LEG, (IN
20" LEFT LEG CRACK WITH 2" ABOVE CROSS WELD, ALL (FUSION
1 7/8" HORIZONTAL BULGE 1 1/2" VERTICAL BULGE CROSS WELD, (ZONE
