NRL REPORT NO. R-2048

Effect of Painting Type 327A and 227A  
Transmitting Tubes For Blackout Purposes

# SEARCH RADAR SECTION

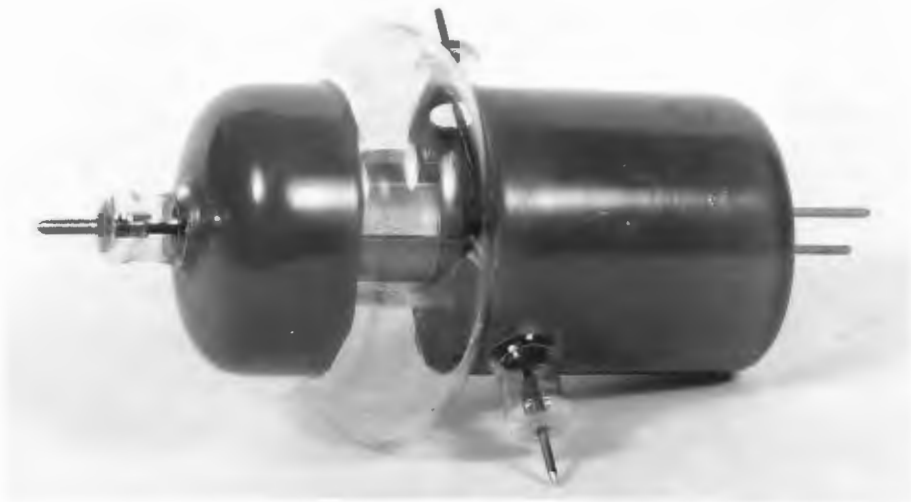
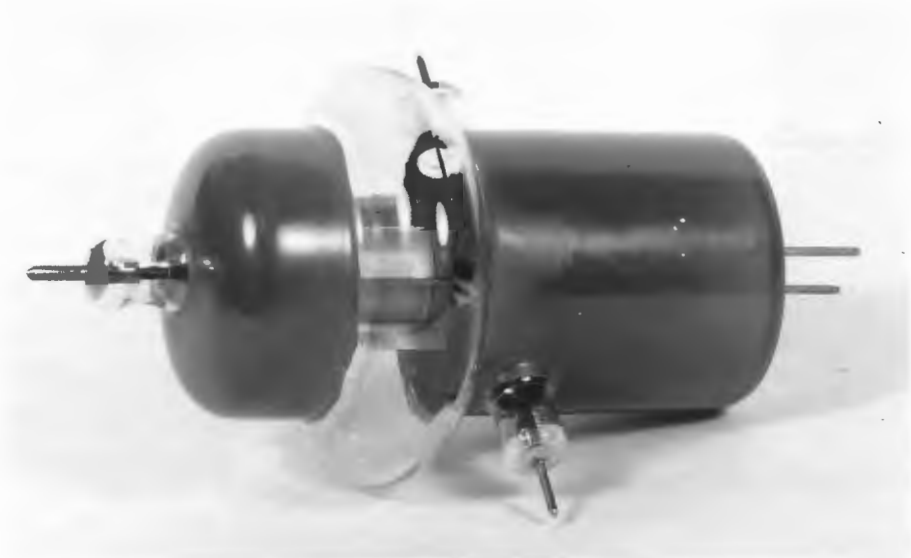
PLATE 2

Plate II Photograph of Sprayed 327A Tubes

7. Tests on Partially Painted Tubes. Two type 327A tubes were then painted by hand, as shown in Plate I, leaving the bulge just opposite the anode, as well as the lead projections, unpainted. Since no light is emitted through the anode, leaving the bulge unpainted permits no light to escape directly from the filament and permits only scattered light to escape. In operation the anodes are only a very dull red and consequently emit only a slight amount of visible light. These tubes gave no trouble from sparkover at anode voltages up to 15 Kv even after several hundred hours in a life-test oscillator. However, the paint tends to flake off as is shown in Plate I, which was made after the tubes had run 150 hours in the oscillator. Two type 327A tubes were then painted, as shown in Plate II, by spraying red Glyptal on the tube and drying them in an oven for two hours at 125° C. Except for a slight darkening, the paint on these tubes was satisfactory after 300 hours use in an oscillator. This shows that spraying the tubes, and drying the paint in an oven, is superior to hand-painting. The 227A tubes were also painted by spraying Glyptal on them as shown in Plate III.

8. Life-Tests on Partially Painted Tubes. The life test data on the partially painted tubes is given in Table I. The average life of the 4 type 327A tubes was 283 hours when operating with an anode voltage of 15 Kv. The average life for the 2 type 227A tubes was 440 hours with an anode voltage of 10 Kv. From previous tests at Naval Research Laboratory the average life of unpainted 327A tubes under similar conditions is about 390 hours and about 480 hours for unpainted 227A tubes. The difference in average life between painted and unpainted tubes is 27% for the 327A and 8% for the 227A. These data, however, are too few to accurately determine the change in average life, but they indicate that partially painting the tubes as shown in Plates II and III should not reduce the life of the tubes by more than 25%.

<u>Tube Serial Number</u>	<u>Total Hours Use</u>	<u>Filament Current (Amp.)</u>	<u>Filament Emission (Amp.)</u>	<u>Grid Emission (ua)</u>	<u>Cut-off Ratio</u>
I2-37107 Type 327A	Glyptal sprayed on and dried in an oven (See Plate II).				
	0	11.0	33	15	21.7
	160	11.27	—	20	20.0
	221	11.40	29	10	19.8
	299	Failed during filament emission test; grid to filament short. Decreasing cut-off ratio indicates some distortion which probably contributed to failure of tube.			
3267T Type 227A	Glyptal sprayed on tube and dried in an oven (see Plate III).				
	0	10.6	32	40	20.0
	293	Failure: Gassy.			
6034W Type 227A	Glyptal sprayed on tube and dried in an oven (see Plate III).				
	0	10.8	33	10	21.4
	293	11.53	24	0	21.9
	546	12.17	—	—	22.0
	587	12.27	20	—	24.2
	587	Failure: Low Filament Emission.

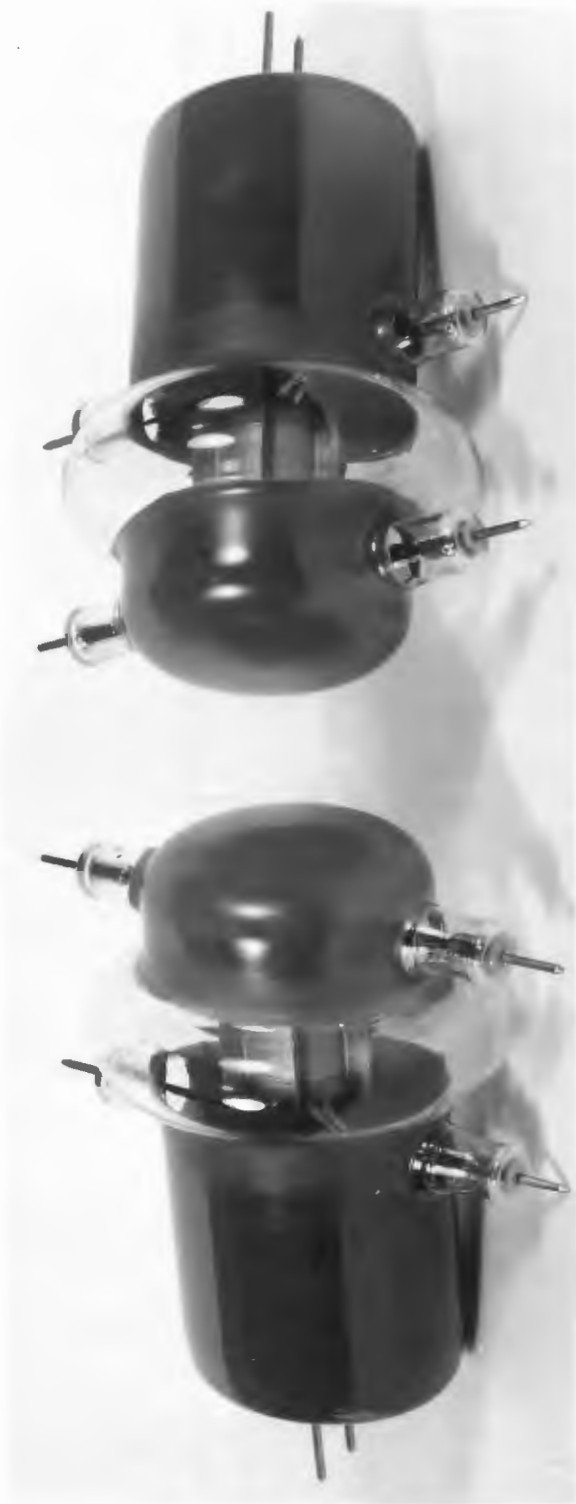
PLATE 3

Plate III Photograph of Sprayed 227A Tubes
