March 15, 1943

Report No. O-2025

Second Partial Report on the Precipitation-Static
Problem

NAVAL RESEARCH LABORATORY
ANACOSTIA, STATION
WASHINGTON, D.C.

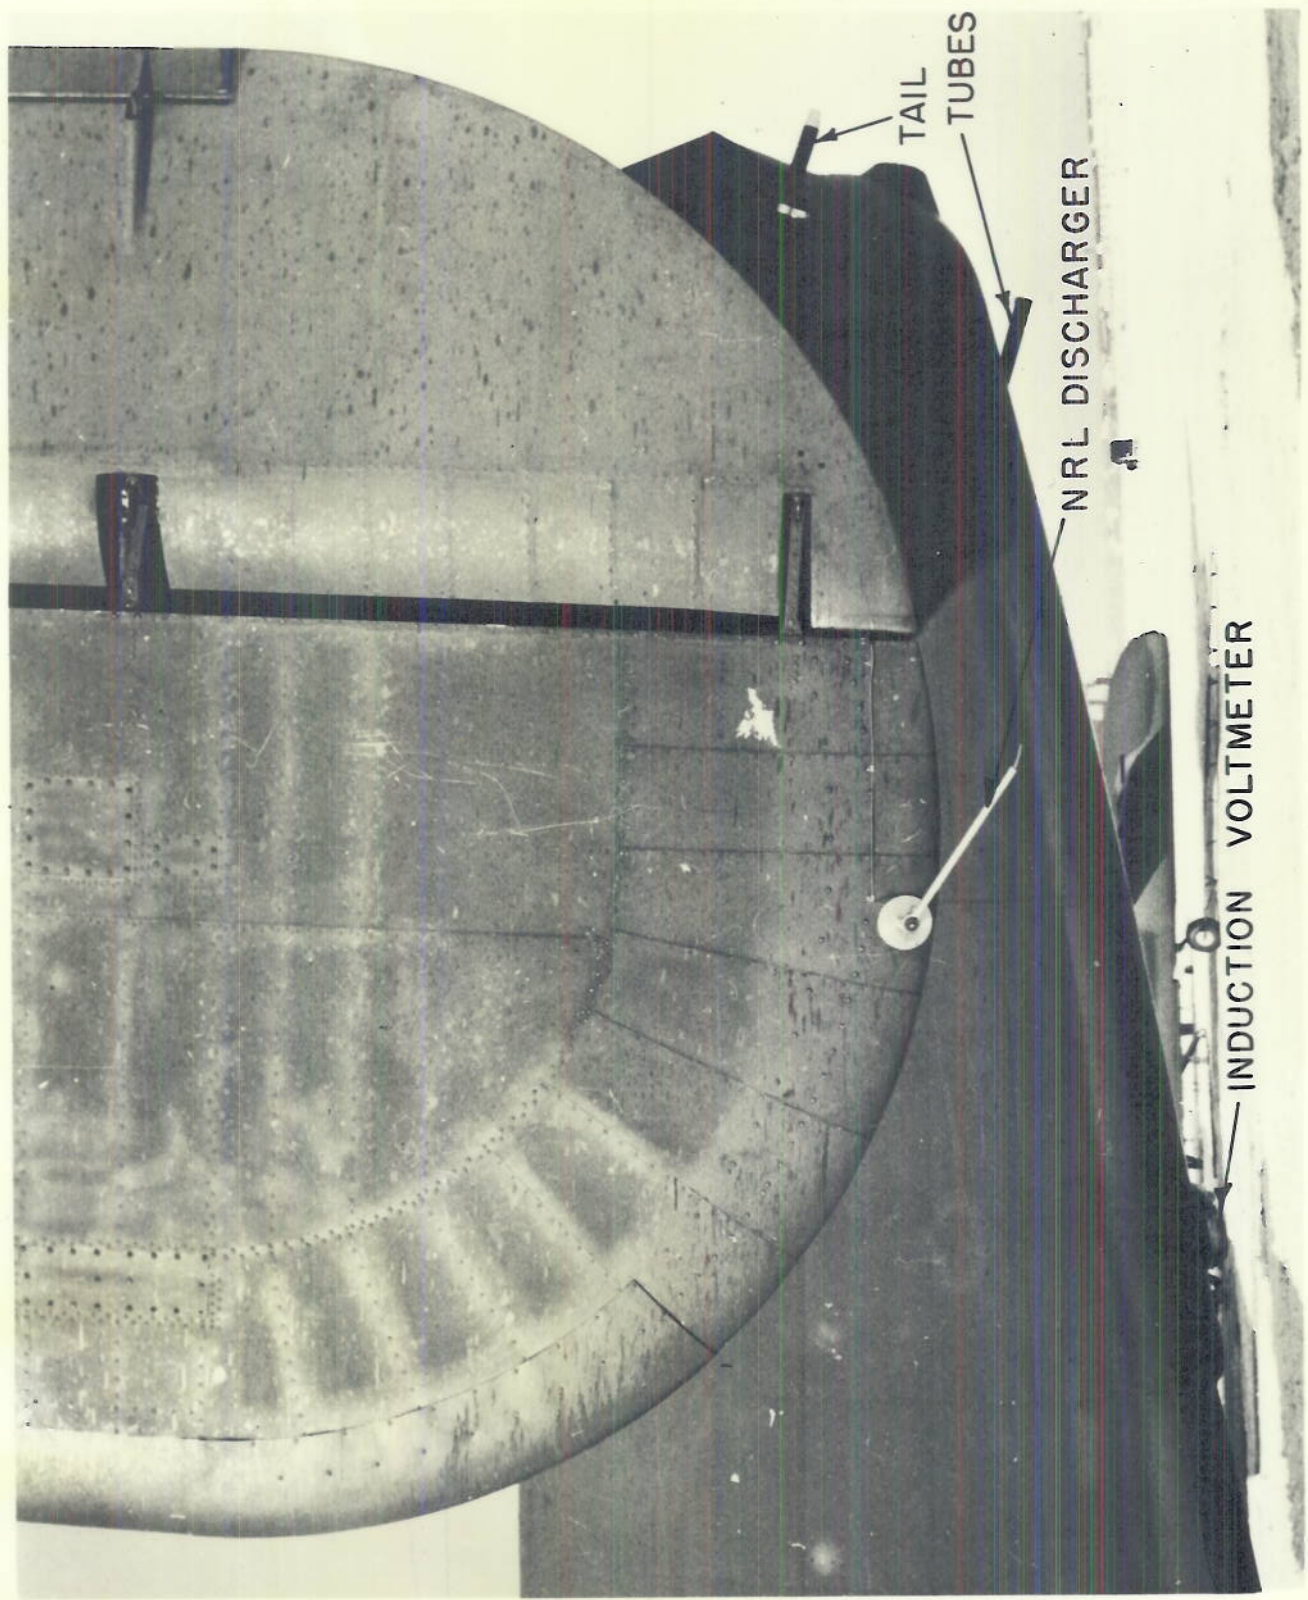
EMPENNAGE OF THE B-24 AIRPLANE

14. The dischargers shown in Plates 3 and 4 were insulated from the plane so that the current discharged could be measured. A much better design for ordinary use is sketched in Plate 12. This drawing discloses dimensions and other details of construction; the simplicity of installation of these dischargers is apparent.

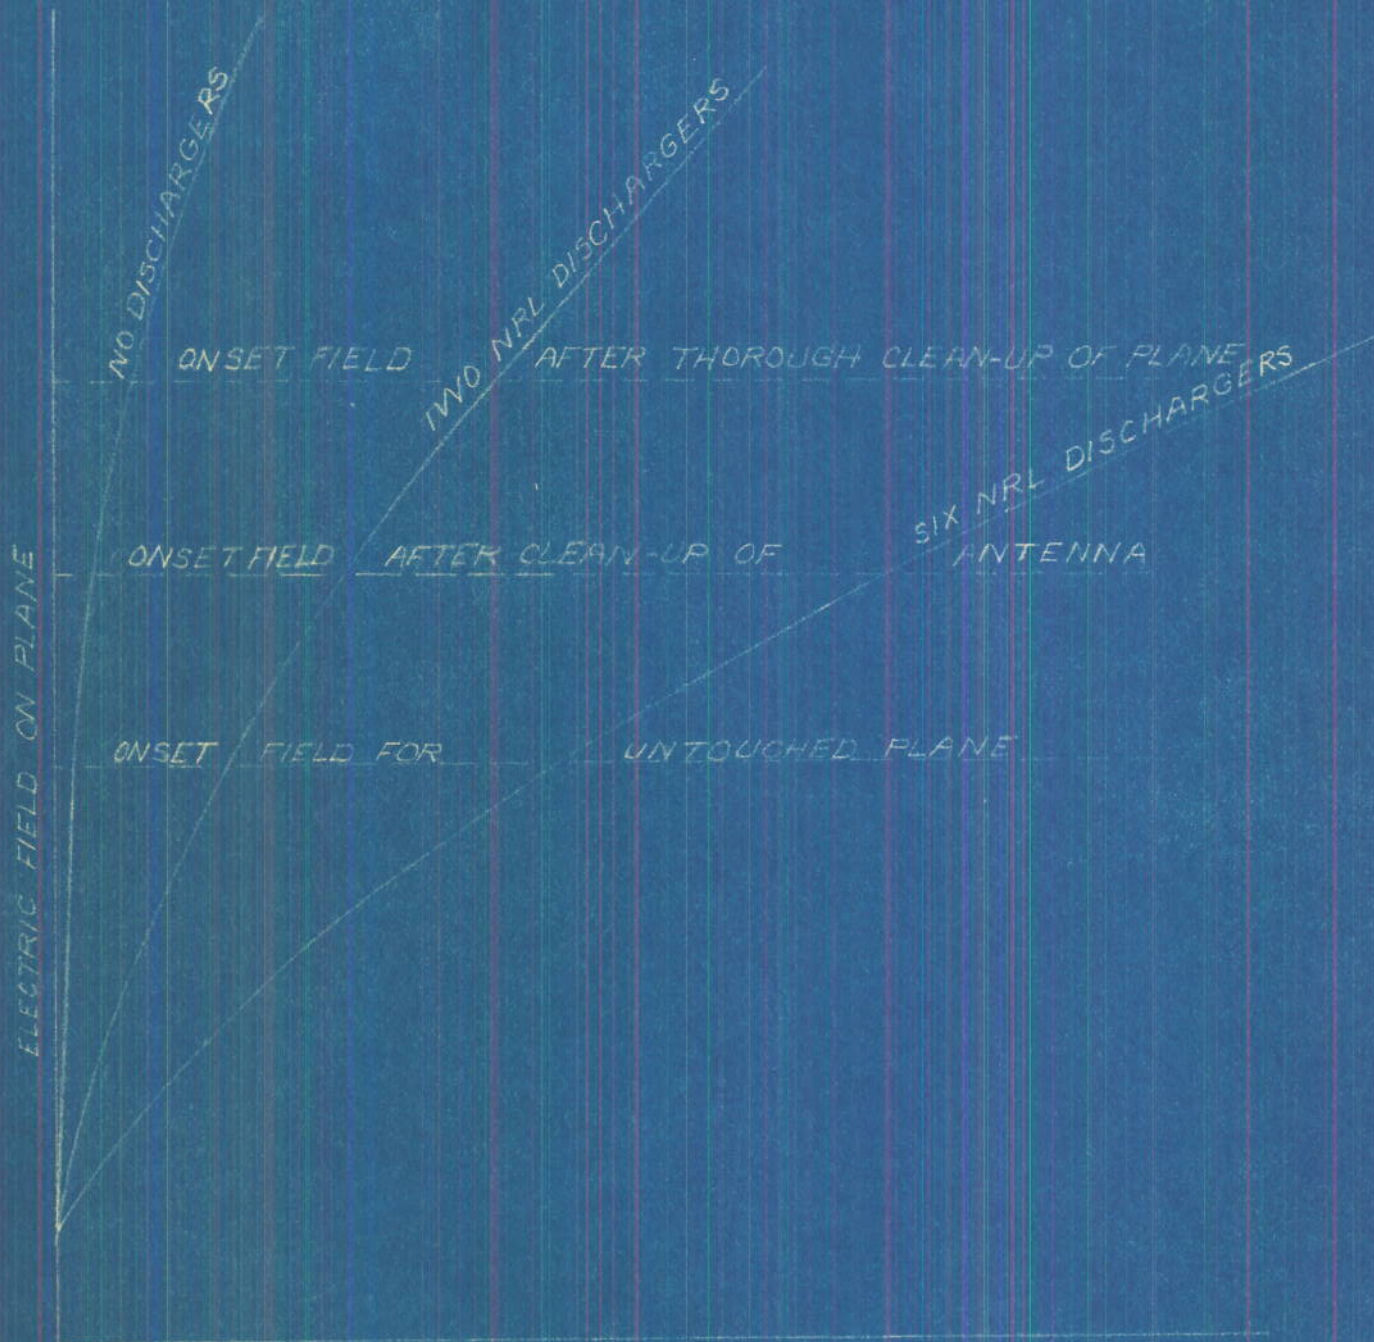
PLANE DISCHARGE CURRENT - INCREASES WITH INTENSITY OF SNOW STORM, SPEED OF PLANE & SIZE OF PLANE

THE RELATIVE EFFECTIVENESS OF THE DIFFERENT METHODS FOR THE REDUCTION OF PRECIPITATION STATIC.

25. It is important to realize that the clean-up of the plane to reduce discharge, although of much value, as is illustrated in Plate 11, is not alone sufficient. This is because the amount of charge collected by the plane in snow or rain is so great that discharge cannot be prevented. Hence, dischargers of a quiet type must also be provided.
