Stability Analysis of Old River Low Sill Structure

Lucas A. Walshire, Joseph B. Dunbar,
and Benjamin R. Breland

September 2022

Under Project 478533, "Old River Low Sill Structure Stability Investigation" (MIPR PA
WI 1L8F7L)

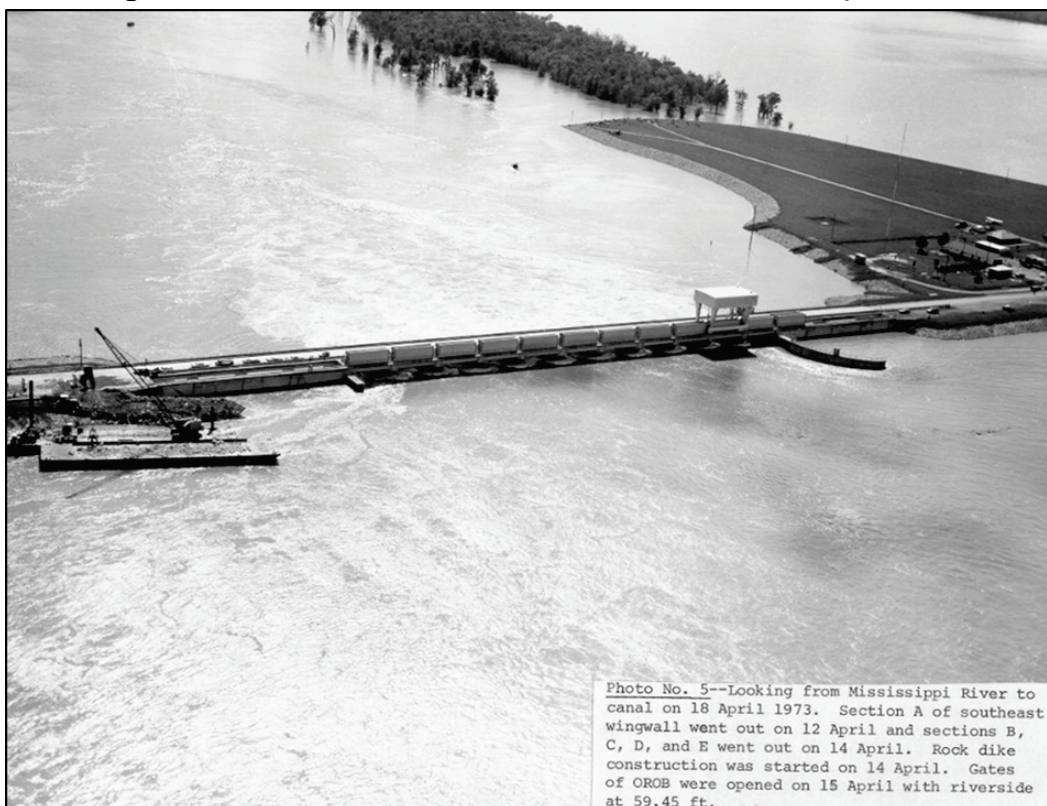
Figure 7. Construction of rock dike on left abutment on 18 April 1973.

Construction of the rock dike was begun 14 April, and the dike was completed 7 May, requiring 98,000 tons of rock (USACE 1975a). Rock placement was performed with the gates open on the ORLSS. The overbank structure was opened on 14 April after the wing wall collapsed

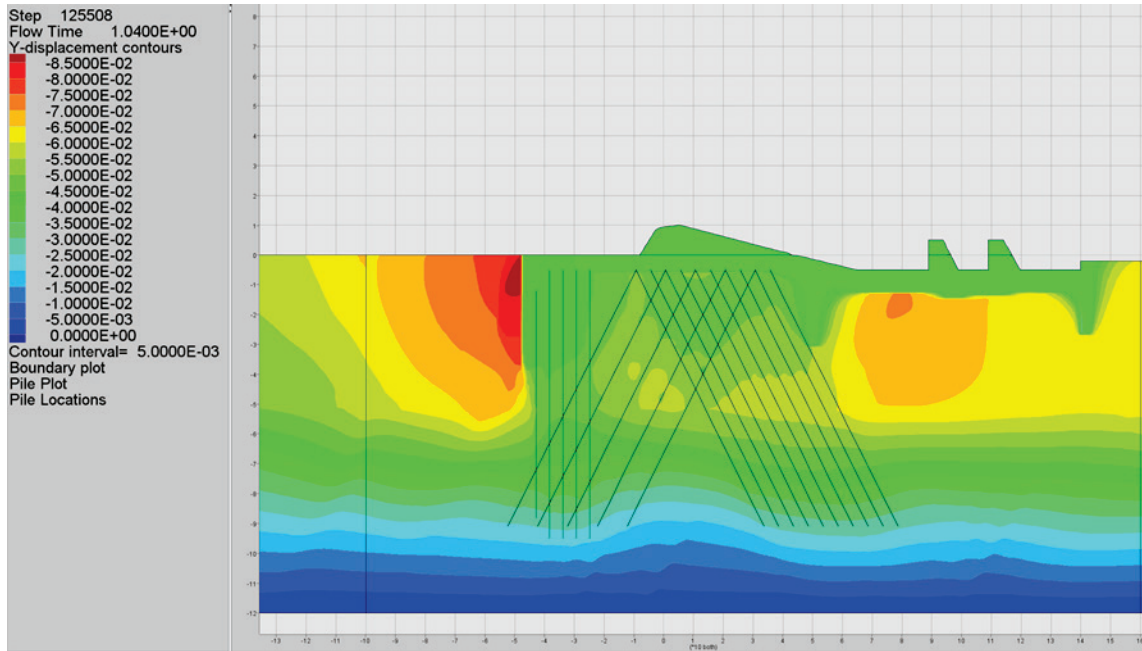
Figure 50. Vertical displacement contours predicted with 2-D deformation model, contours reported in feet (vertical piles located on upstream side).
