Evaluation of 11 Buildings in the Fort McCoy Cantonment

Sunny E. Adams, Madison L. Story, and Adam D. Smith

September 2022

Under Project 493912, "Evaluation of 11 Buildings in the Fort McCoy Cantonment,"
MIPR 0011555028

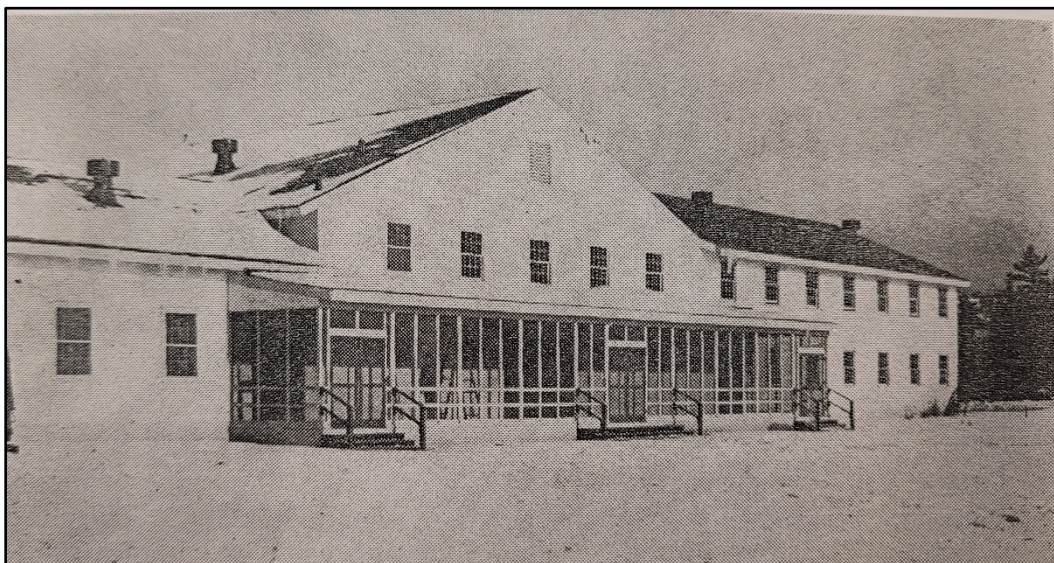
Figure 11. Building 905, Service Club No. 3, after reconstruction, January 1953 (La Crosse Sunday Tribune. Public Domain).

Additionally, in November 1950, Service Club No. 3 at Camp McCoy (Figure 7, Figure 8, and Figure 9), Building 905, caught fire. The fire, whose origin is unknown, damaged most of the building, with only the superstructure, walls, roof of the kitchen and adjacent boiler room, latrines, storage area, and corridor remaining (Figure 10). The footings and concrete piers of the structure also remained. To make use of the remaining features, the club was rebuilt following the 800 series standardized plan, #800-517, that was used for the original building, though it also incorporated the plans for a porch that was added in 1943 (Figure 11, Figure 12, Figure 13, Figure 14, Figure 15, and Figure 16).²⁰ Service Club No. 1 (Building 2000) continued to be available for use during construction.²¹

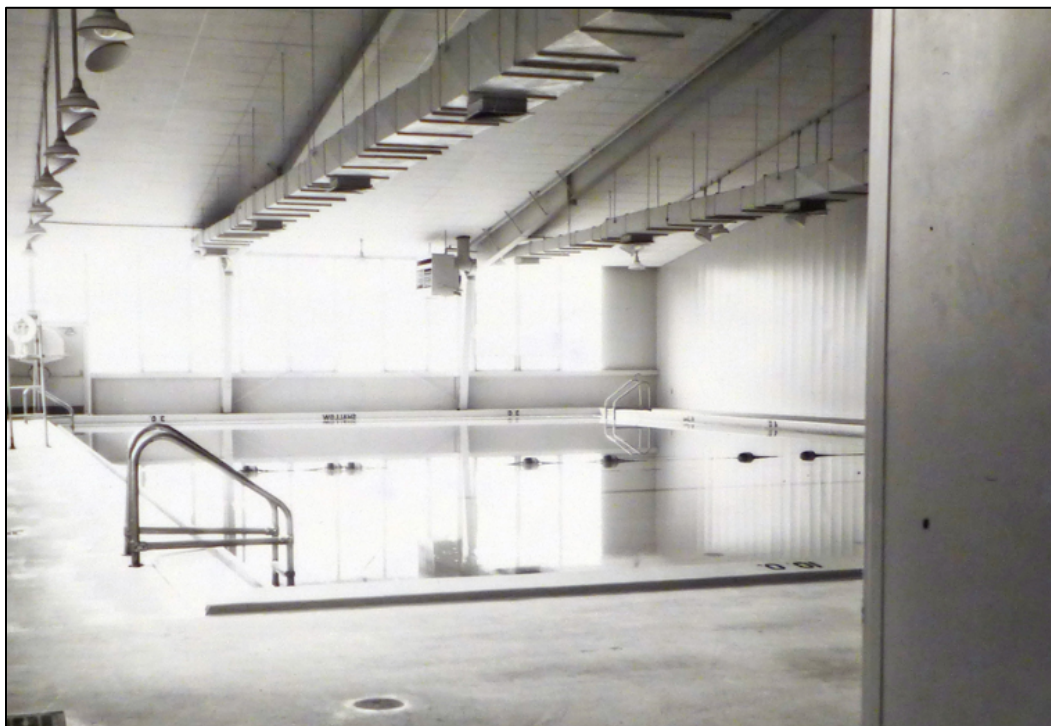
Figure 23. Swimming pool in Building 1122, July 1978 (Photo no. 675942, July 25, 1978, McCoy, CP. WIS. Book #5, Record Group 111-SCA 400, NARA, College Park, MD. Public Domain).

An exception to this was the renovation of 167 buildings for \$2 million as well as the construction of a fieldhouse with a swimming pool (Building 1 1122), warehouse, and gatehouse for \$750,000 (Figure 22, Figure 23, and Figure 24). These were constructed and used by Camp McCoy's Job Corps Training Center, a program at the camp that taught low-income teenage boys vocational, technical, and social skills. The Job Corps Training Center was open from 1966 to 1968, at which point the facilities were transferred to the Army.³⁴

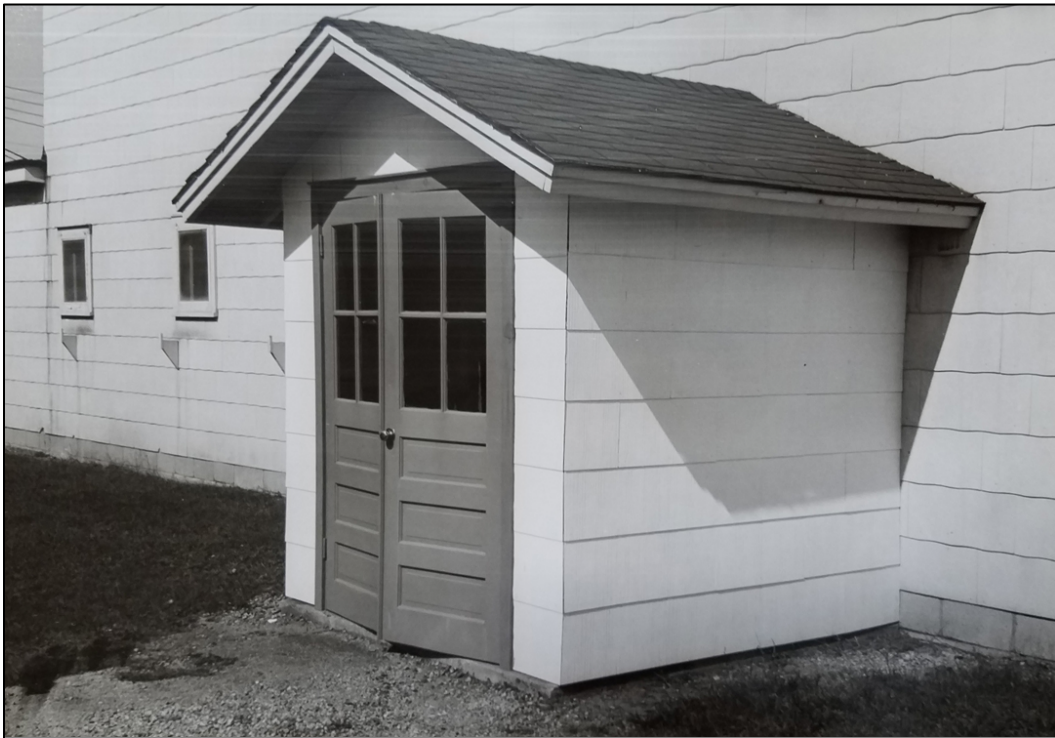
Figure 26. Enclosed side exit to Theater No. 5, Building 2017 (“Post Engineer Project Enclose Side Exits to Theater #5.” Public Domain).

Additionally, in 1968, the Post Engineer Office projects included sidewalk upgrades (Figure 25), changes to Theater No. 5 (Building 2017) (Figure 26), and the construction of a new oil storage building (Building 2191) (Figure 27).³⁵

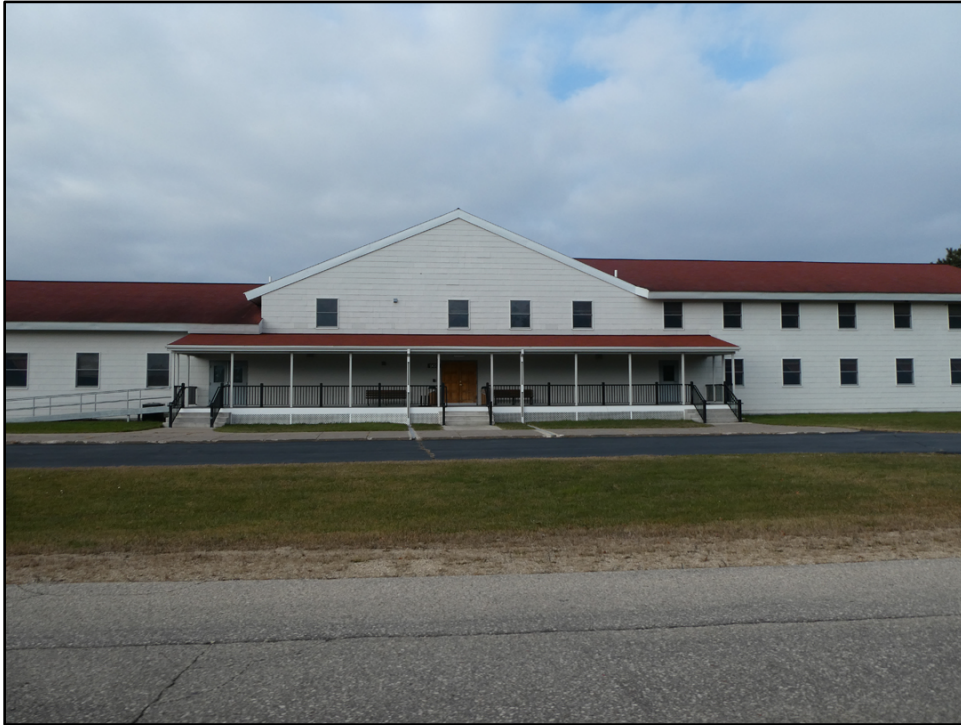
Figure 33. Southeast side of Building 905, Service Club No. 3 (ERDC-CERL 2020).

Building 905 has a T-shaped footprint, concrete pier foundation with wood foundation skirting, wood frame construction clad with cement asbestos siding, a cross-gable roof clad with red asphalt shingles, and metal fascia and soffit (see Figure 33 and Figure 34). The windows are replacement one-over-one double-hung vinyl windows. The doors are replacement doors. The building has an approximate area of 18,140 sq ft.

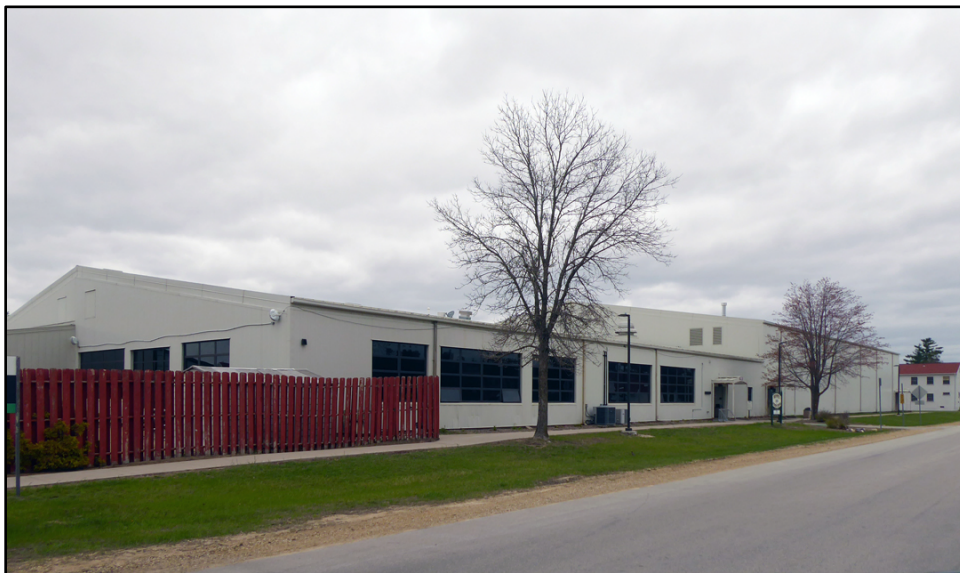
Figure 38. Southeast oblique of Building 1122, Rumpel Fitness Center (ERDC-CERL 2021).

Building 1122, originally the Rumpel Fieldhouse, was constructed in 1967 as a fitness center with an indoor pool, locker rooms, a weight room, and a large gymnasium space for a total of 37,800 sq ft (see Figure 40, Figure 41, and Figure 42). The building was built as a long rectangular structure with a one-story portion on the south end and a high-bay area on the north end. The building had metal cladding with standing metal seam siding. There

were two different gable roofs clad with standing metal seam panels (see Figure 38 and Figure 39).

At an unknown date, the original metal siding and roofing materials were removed, and newer metal materials were added. All the original, large, multipane industrial-style windows were removed and replaced with the current anodized bronze aluminum windows. All the original metal exterior doors have been replaced since the construction of the building. Two large sets of windows and a set of metal and plate glass doors with side-lights and transom were added on the southeast side of the wall, and a solarium addition was added to the southwest side of the wall; all of these changes were most likely completed in 1999. Also at an unknown date, a small sauna room addition was added on the southwest corner of the pool area. There are several original blonde interior doors intact (see Figure 43).

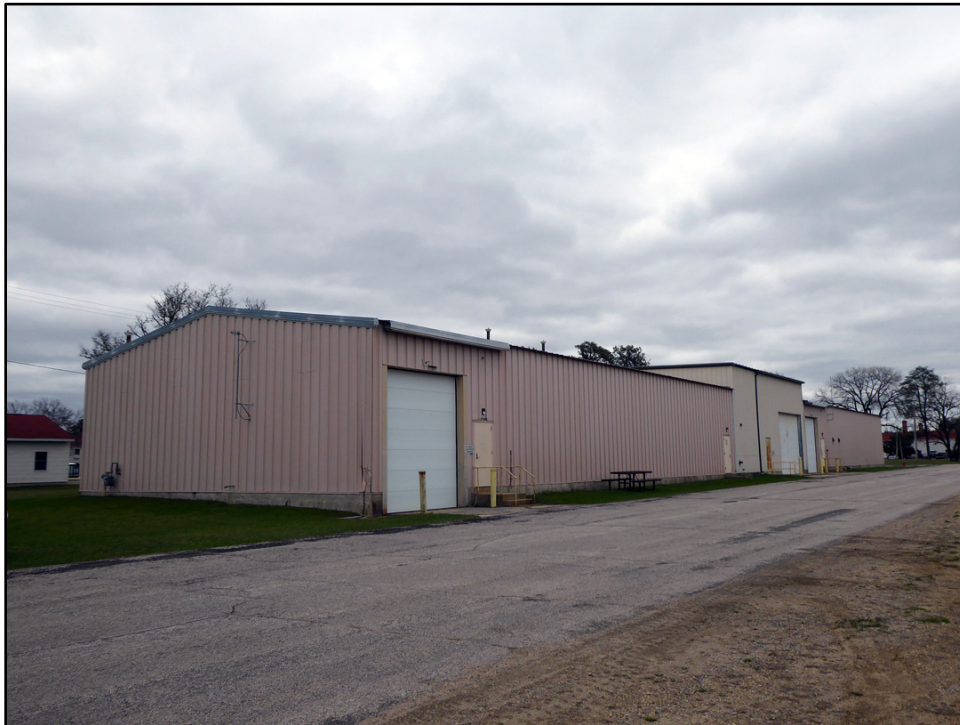
Figure 45. Southwest oblique of Building 1268 (with the original Building 1267 in the foreground, the hyphen addition in the middle, and Building 1268 in the background) (ERDC-CERL 2021).

Building 1268 is a long, rectangular prefabricated metal building (see Figure 45). There are three separate buildings combined to make up Building 1268. The original Building 1268 is located on the east end, a newer metal hyphen addition is in the middle, and the original Building 1267 is on the

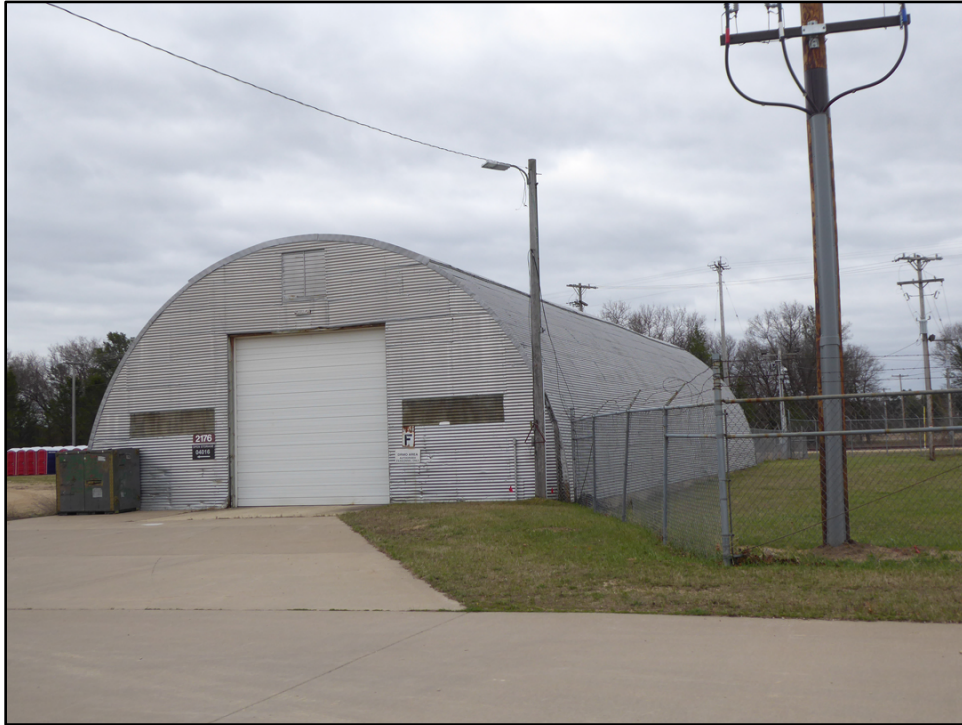
Figure 47. Northwest oblique of Building 2176 (ERDC-CERL 2021).

Building 2176 was constructed in 1968 as a Quonset hut used for storage as a Government surplus property facility. The original construction of the Quonset hut was designed as a lightweight prefabricated structure of corrugated steel members that were bolted together on-site. At an unknown date(s), the original steel-framed windows on the north and south sides of the building were removed and the openings filled with a plexiglass material, and the original door(s) on the north side were removed and replaced with one large metal overhead door (see Figure 47 and Figure 48). The interior of Building 2176 was not accessible to the researchers at the time of the survey.

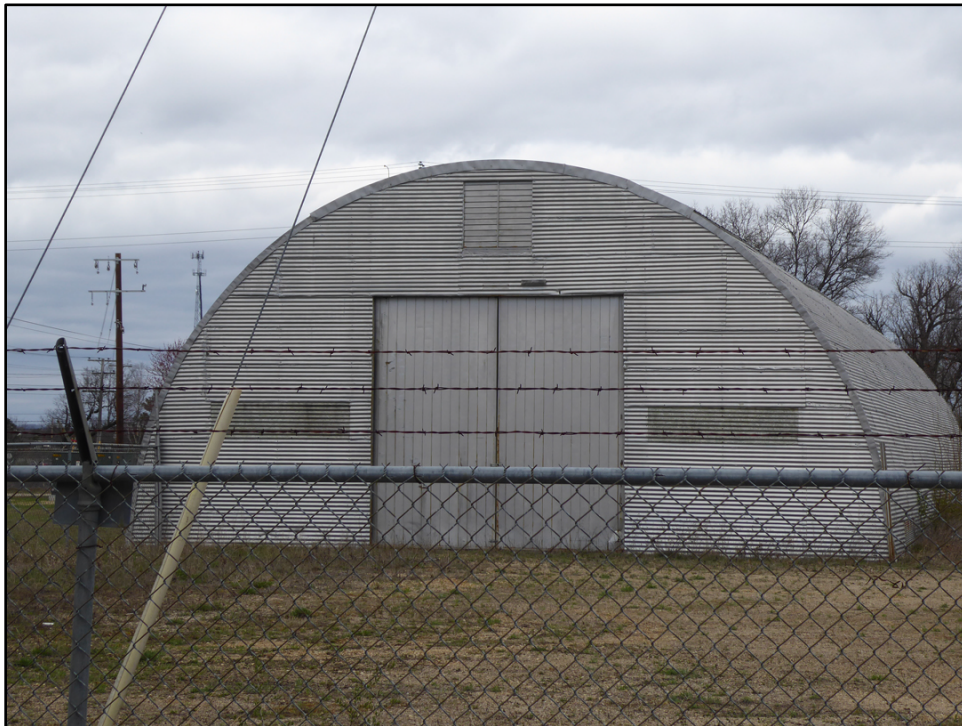
Figure 48. South side of Building 2176 (ERDC-CERL 2021).

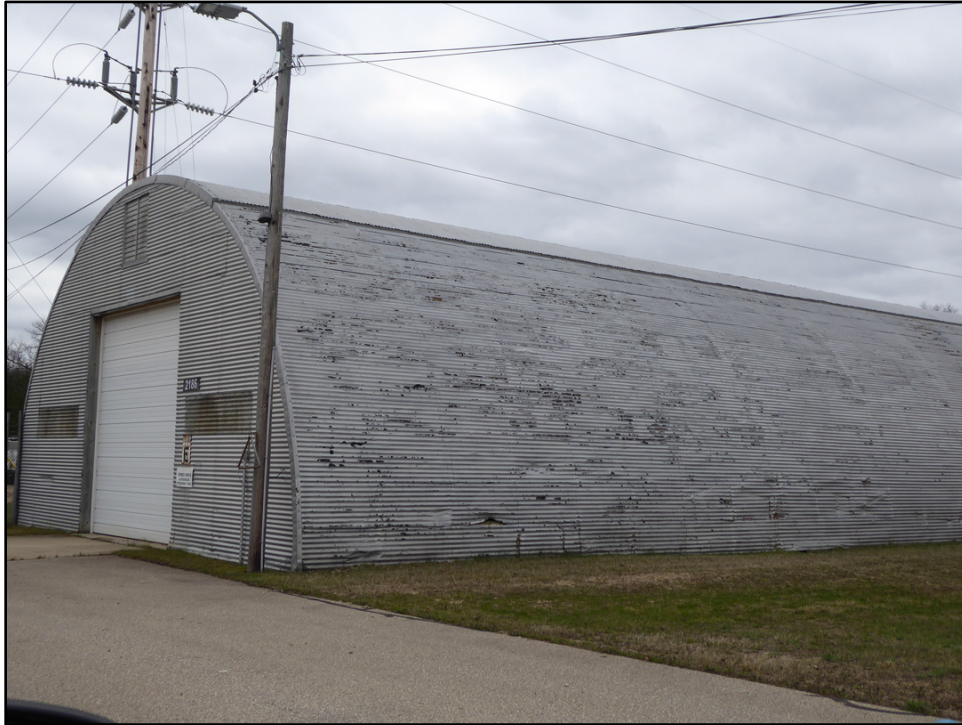
Building 2186 was constructed in 1964 as a Quonset hut used for storage as a Government surplus property facility. The original construction of the Quonset hut was designed as a lightweight prefabricated structure of corrugated steel members that were bolted together on-site. At an unknown date(s), the original steel framed windows on the north and south sides of the building were removed and the openings filled with corrugated metal sheets, and the original door(s) on the north side were removed and replaced with one large metal overhead door (see Figure 50 and Figure 51). The interior of Building 2176 was not accessible to the researchers at the time of the survey.

Figure 50. Northwest oblique of Building 2186 (ERDC-CERL 2021).

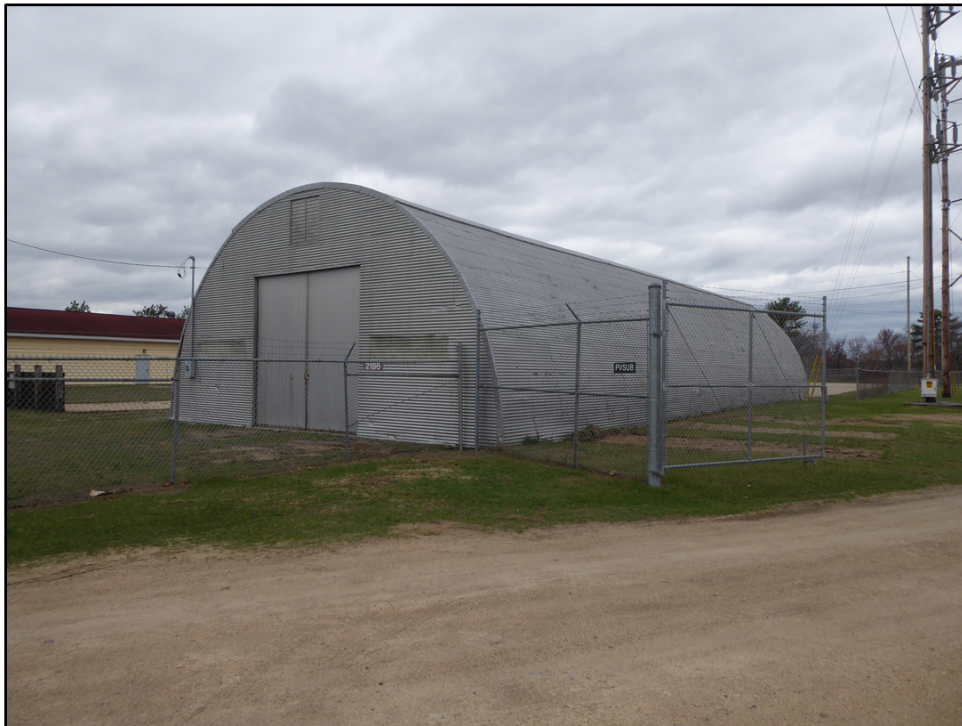
Figure 51. Southeast oblique of Building 2186 (ERDC-CERL 2021).

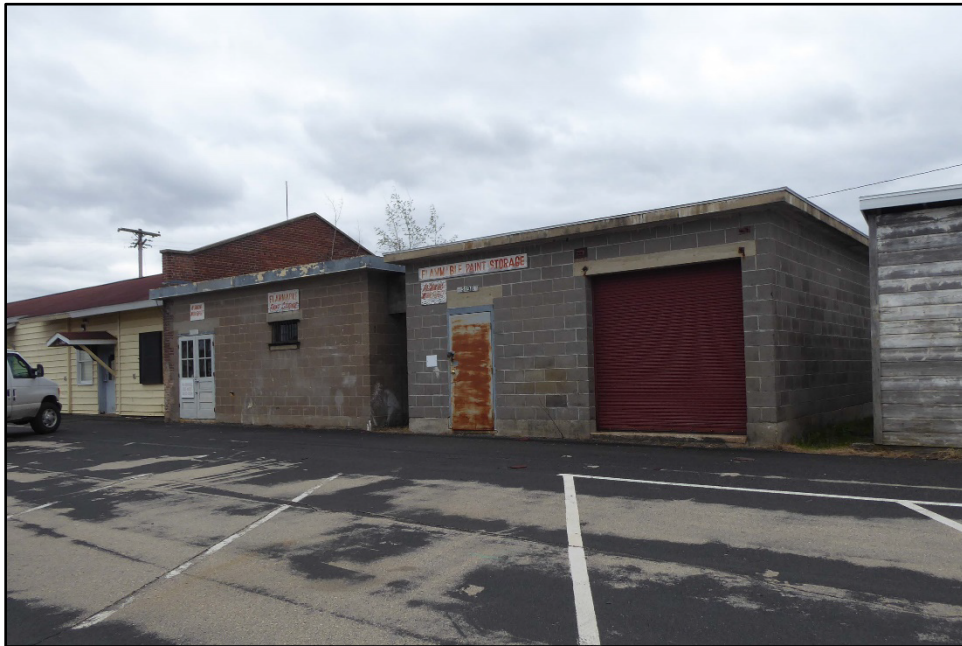
Building 2198 was constructed in 1975 as a simple, utilitarian-style structure using concrete block for the exterior walls and a shallow, shed concrete roof with overhanging eaves (see Figure 53 and Figure 54). The building was used for flammable paint storage in the 2100 block warehouse area. At an unknown date, the original metal door on the north side of the building was removed and replaced with a newer metal roll-up door. It is unclear if there was an original window on the south side or if the metal louvered vent was original. The interior of Building 2198 was not accessible to the researchers at the time of the survey.

Figure 53. Northwest oblique of Building 2198 (*right*) and Building 2199 (*left*) (ERDC-CERL 2021).

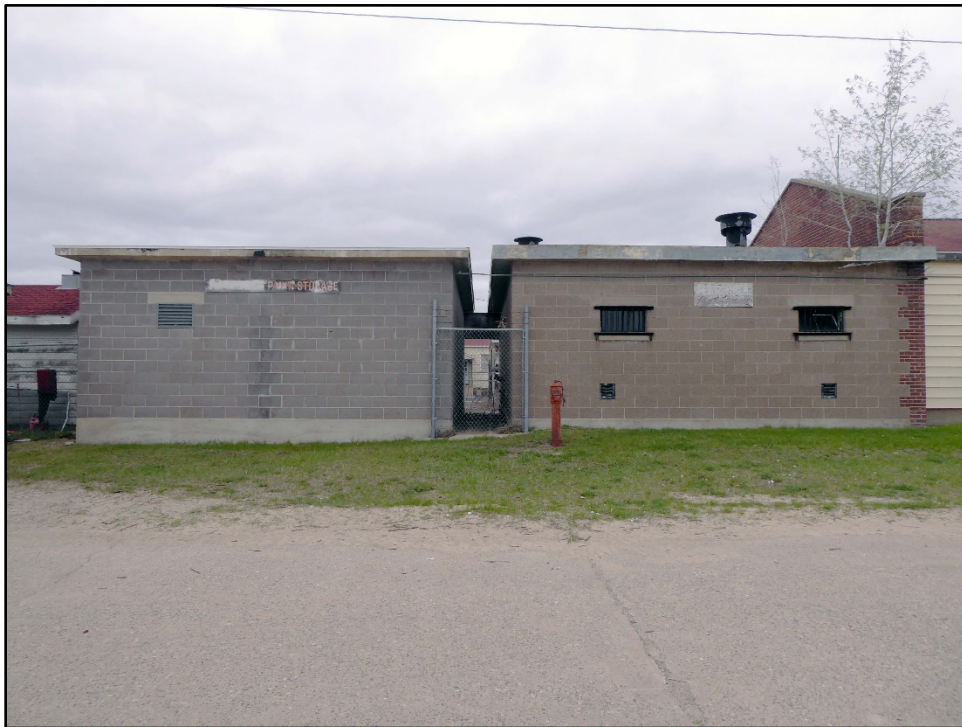
Figure 54. South side of Building 2198 (*left*) and Building 2199 (*right*) (ERDC-CERL 2021).

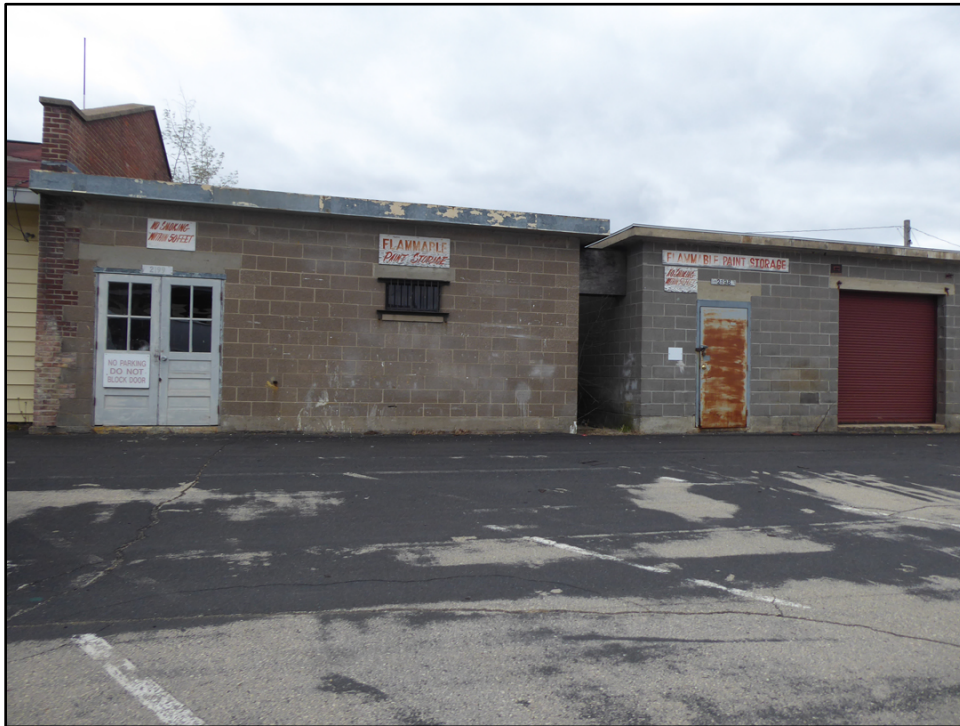
Building 2199 was constructed in 1952 as a simple, utilitarian-style structure using concrete block for the exterior walls and a shallow, shed concrete roof with overhanging eaves (see Figure 56 and Figure 57). The building was used for paint shop building in the 2100 block warehouse area. The building has undergone no exterior modifications. The original construction materials, including the wood glass and panel entry doors, small metal-sash windows, concrete windowsills, concrete lintels, metal fascia, and wood signs, are intact. The interior of Building 2198 was not accessible to the researchers at the time of the survey.

Figure 56. North side of Building 2199 (*left*) and Building 2198 (*right*) (ERDC-CERL 2021).

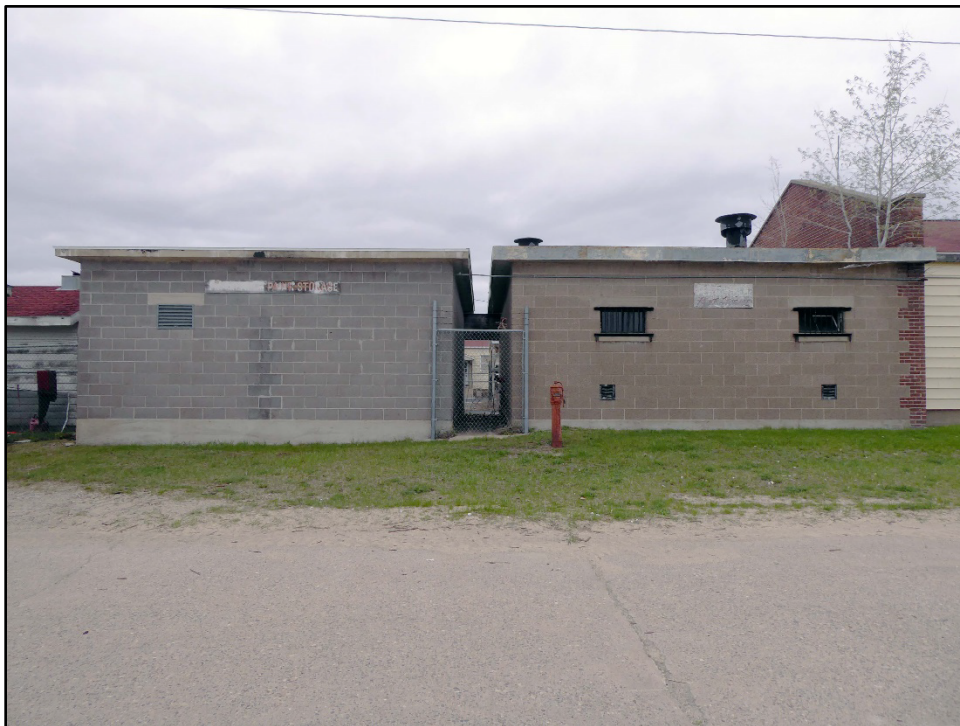
Figure 57. South side of Building 2199 (*right*) and Building 2198 (*left*) (ERDC-CERL 2021).

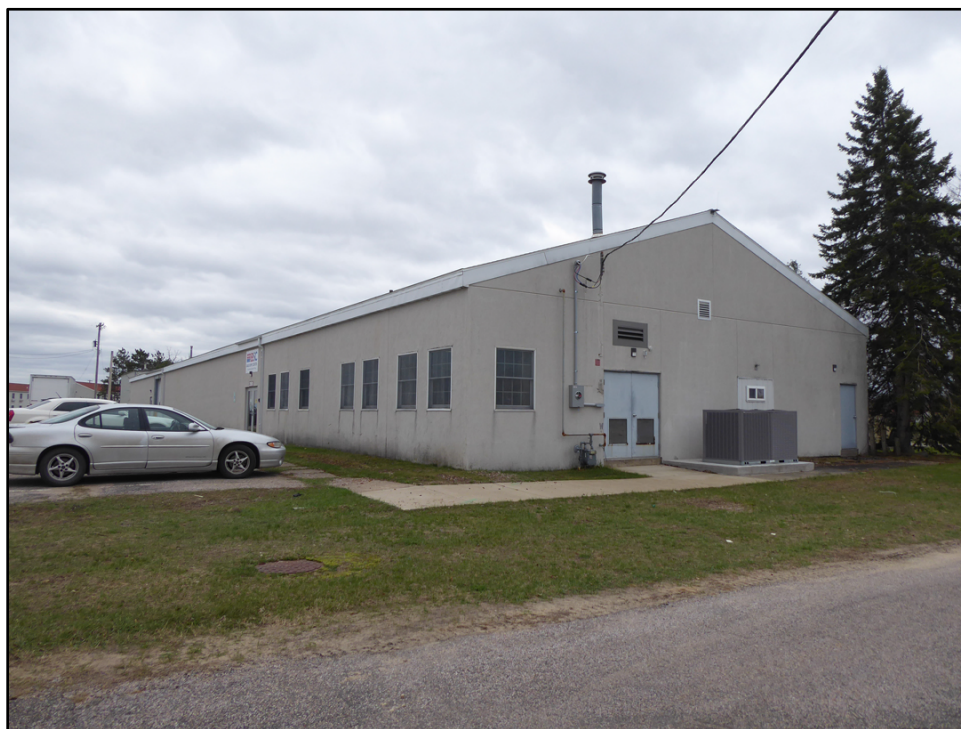
Building 2569 was constructed in 1946 as a general-purpose warehouse. Building 2569 is a one-story structure with a rectangular footprint, a concrete foundation, and a side gable roof clad with red asphalt shingles (see Figure 59 and Figure 60). The exterior walls are clad with stucco-like wall panels. The original windows have all been replaced with vinyl double-hung windows. The fascia has been replaced with newer metal material. The interior of Building 2569 was not accessible to the researchers at the time of the survey.

At an unknown date(s) the original exterior was covered with the current stucco-like wall panels, the original windows were removed and replaced with the current vinyl double-hung windows, and the roof was replaced in-kind with red asphalt shingles (see Figure 59 and Figure 60).

Figure 59. North oblique of Building 2569 (ERDC-CERL 2021).

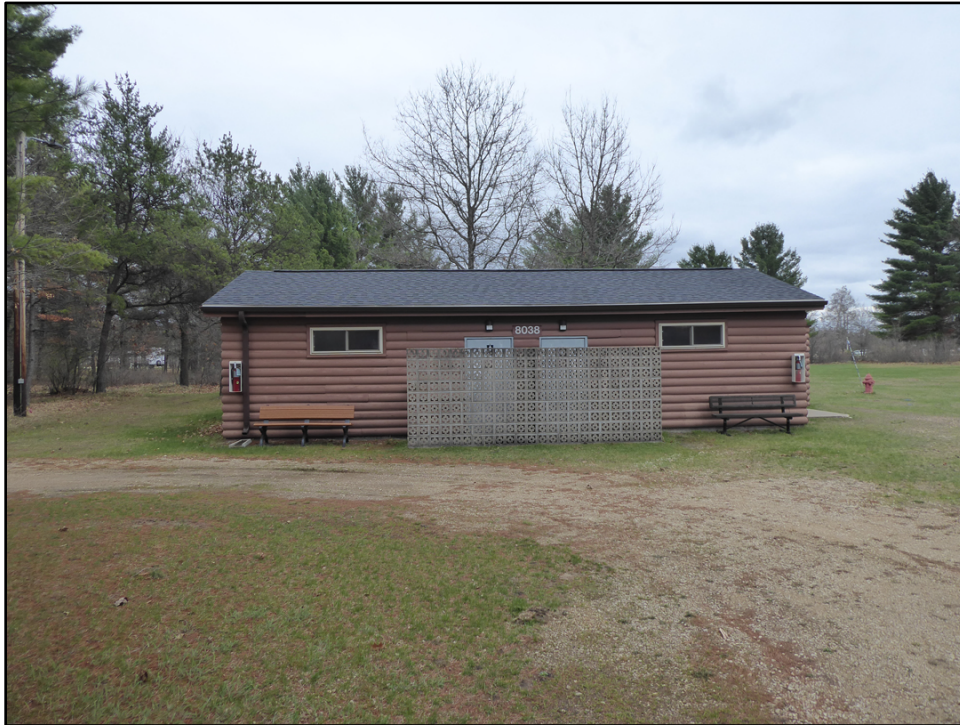
Building 8038 was constructed in 1971 as a latrine and shower facility at the Pineview Campground recreation area. The building was constructed using concrete block for the exterior walls. At an unknown date(s) a log-like cladding material was applied over the original concrete block walls, and all of the windows were replaced with the current vinyl slider windows (see Figure 62 and Figure 63). The only design feature intact is the concrete lattice screen wall that is on the west side of the building. The interior was laid out in two separate spaces, with a latrine and shower area for men and another for women. At an unknown date, all of the materials and fixtures were replaced (see Figure 64).

Figure 62. West side of Building 8038 (ERDC-CERL 2021).

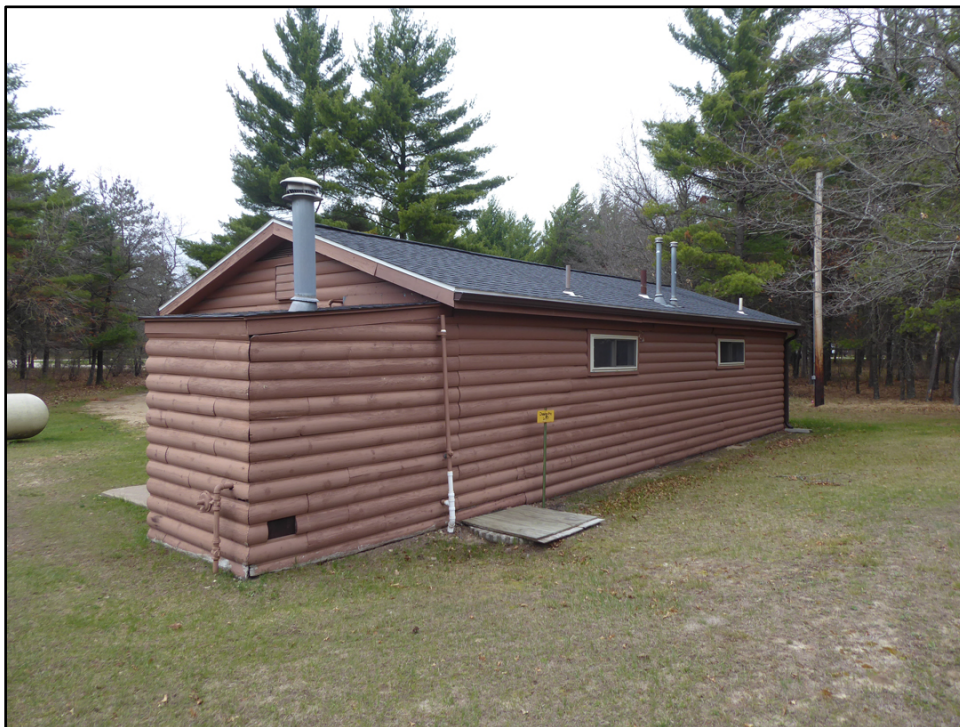
Figure 63. Southeast oblique of Building 8038 (ERDC-CERL 2021).

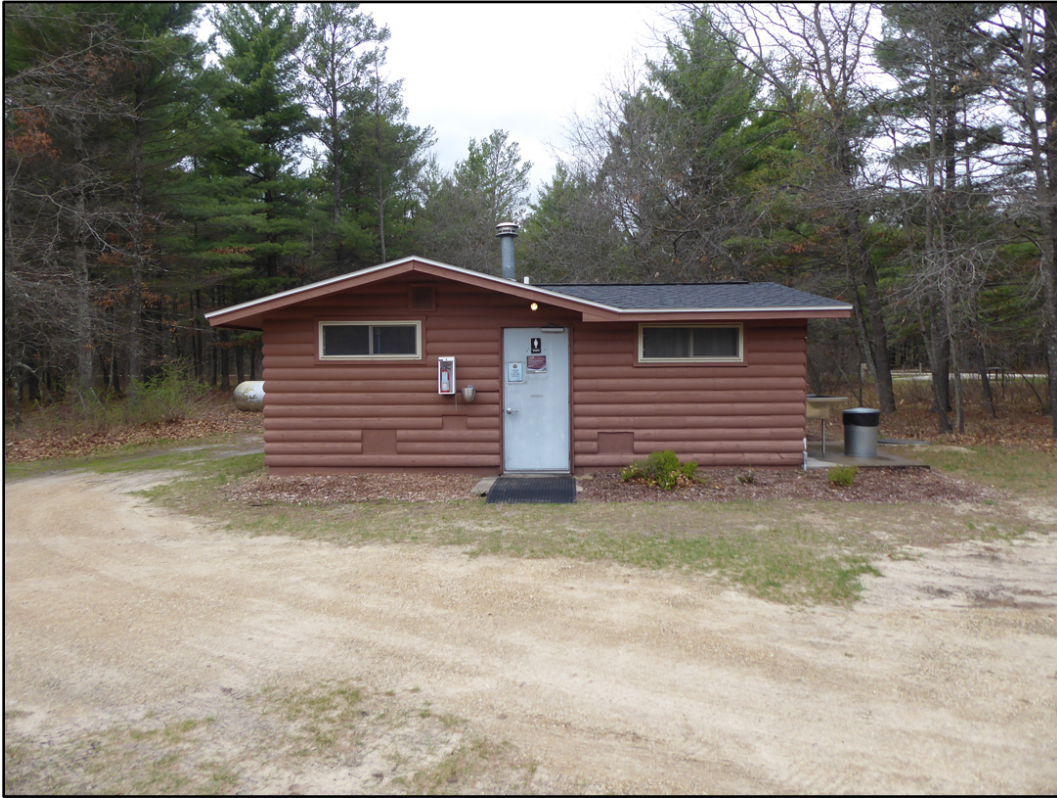
Building 8040 was constructed in 1971 as a latrine and shower facility at the Pineview Campground recreation area. The building was constructed using concrete block for the exterior walls. At an unknown date(s) a log-like cladding material was applied over the original concrete block walls, and all of the windows were replaced with the current vinyl slider windows (see Figure 66 and Figure 67). The interior was laid out in two separate spaces, with a latrine and shower area for men and another for women. At an unknown date, all of the materials and fixtures were replaced (see Figure 68).

Figure 66. Northwest side of Building 8040 (ERDC-CERL 2021).

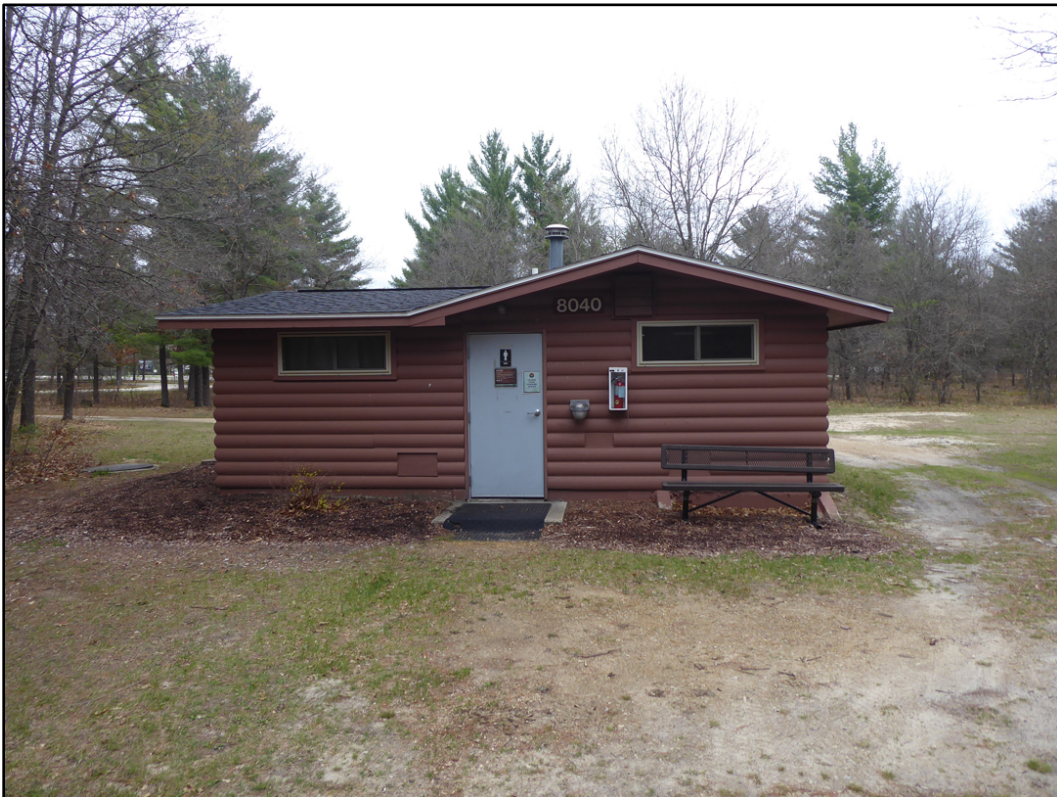
Figure 67. Southwest side of Building 8040 (ERDC-CERL 2021).

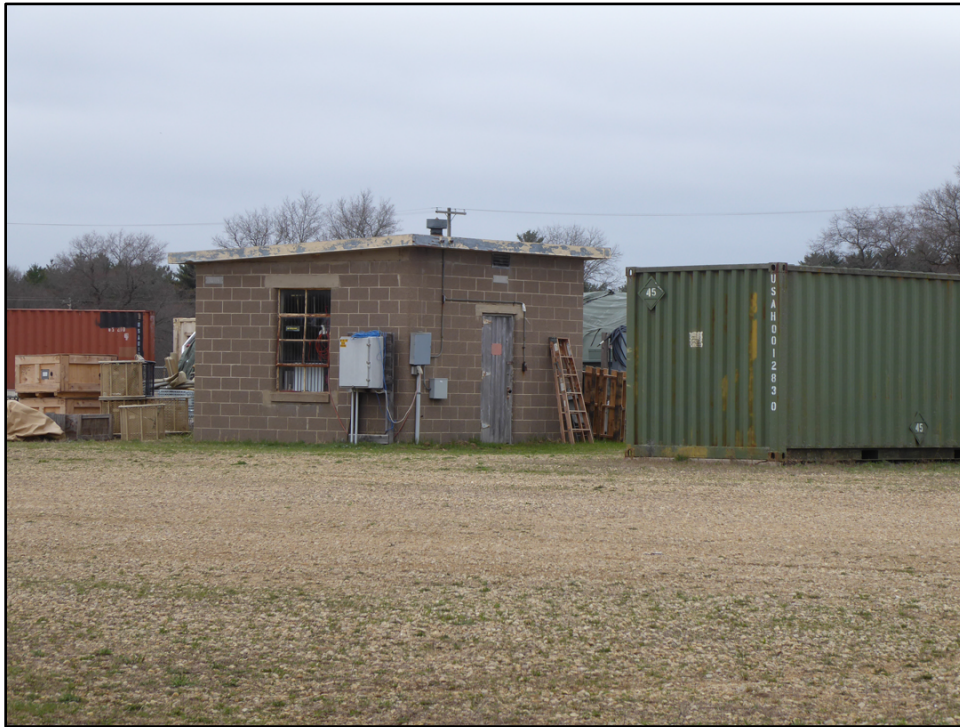
Building 10119 was constructed in 1951 in the former WWII hospital area, block 10, as a small one-story concrete block structure (see Figure 70 and Figure 71). The building has undergone no exterior modifications and is currently being used as an organizational storage building with a category code of 44224.

Figure 70. Southeast oblique of Building 10119 (ERDC-CERL 2021).

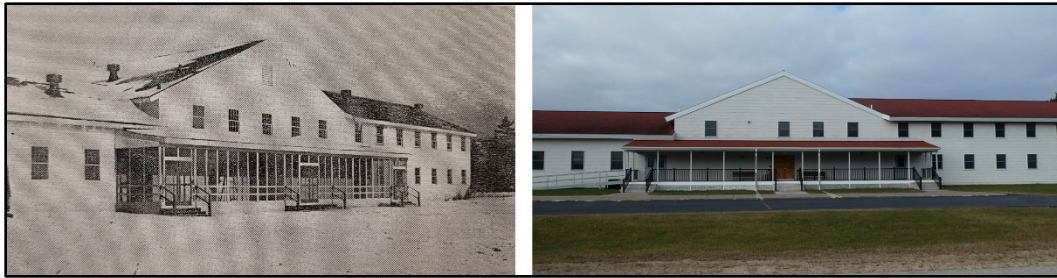
Figure 72. Comparison image of the southeast side of Building 905, Service Club No. 3. *Left image* from 1953 after the reconstruction of the building due to fire damage, and *right image* from 2021 (*Left* is from *La Cross Sunday Tribune*, January 11, 1953, and *right* is from ERDC-CERL. Public Domain).

Building 905 was originally constructed in 1942 as a WWII temporary building being used as a service club. Building 905 is not significant under Criterion A for WWII temporary building construction (1939–1946) since the majority of the building’s structure and detail were lost in a fire in 1950, and the building was reconstructed in 1952 using the original standardized plan for Service Club Type SC-3, drawing #800-517 (see Figure 72, Figure 73, and Figure 74). It is the recommendation of this report that Building 905 is NOT eligible for the National Register of Historic Places (NRHP) at the national level due to the lack of integrity due to changes in

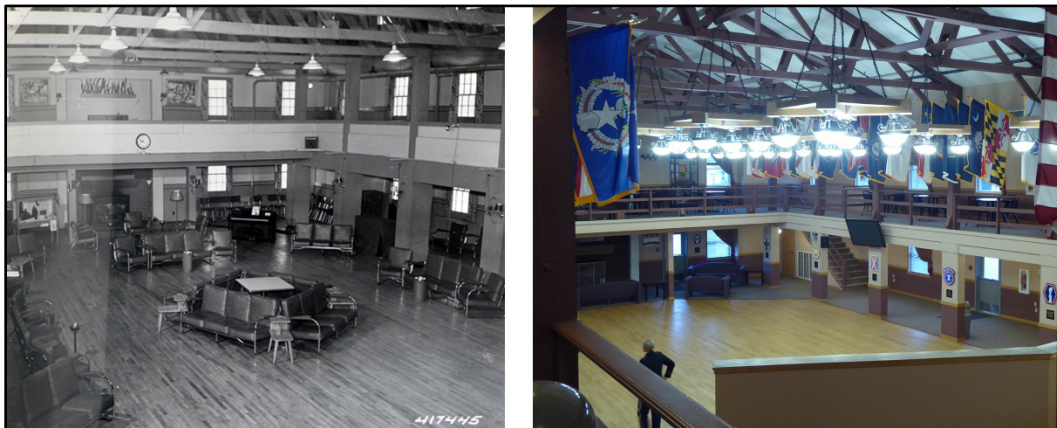
Figure 73. Comparison image of an interior view looking northeast in the dancehall in Building 905, Service Club No. 3. The left image is from 1952 after the reconstruction of the building due to fire damage and the right image is from 2021 (Left image is Photo no. 417445, December 5, 1952, McCoy, CP. WIS. Book #4, RG111-SCA-402, NARA, College Park, MD, and right image is from ERDC-CERL, 2021. Public Domain).

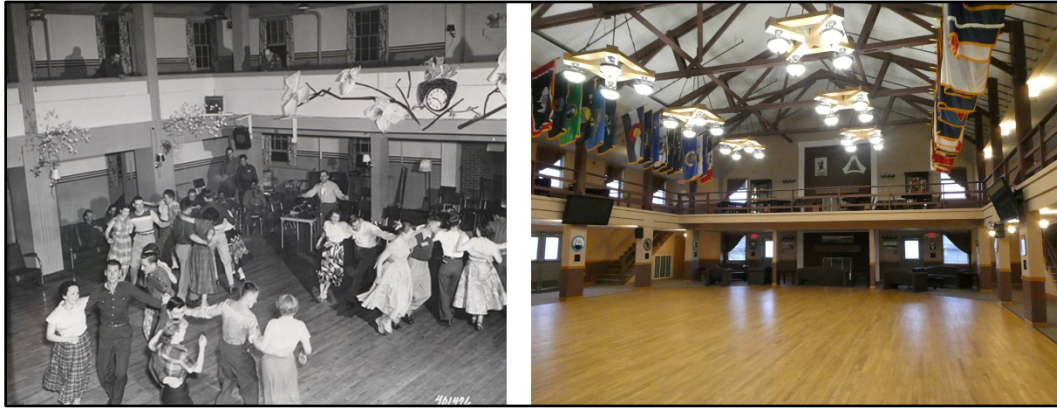
Figure 74. Comparison image of an Interior view looking northwest in the dancehall being used by soldiers dancing in Building 905, Service Club No. 3; *left image* from 1952, and *right image* from 2021 (*Left image* is Photo no. 401476, April 29, 1952, McCoy, CP. WIS. Book #3, Record Group 111-SCA 401, NARA, College Park, MD, and *right image* is from ERDC-CERL, 2021. Public Domain).

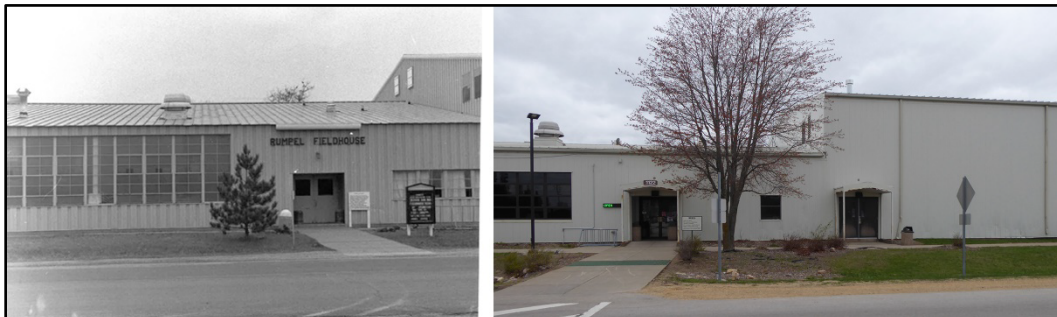
Figure 75. Comparison image of the east side of Building 1122, Rumpel Fitness Center. *Left* is historic photograph (no date) with original large multipane windows for the pool area, original recessed entry doors, original band of smaller metal windows, metal standing seam siding versus the *right image* from 2021 showing replacement windows for the pool, removal of the band of smaller windows, replacement entry doors with canopy, and replacement metal siding (*left image* is from Fort McCoy DPW, and *right image* is from ERDC-CERL 2021. Public Domain).

Building 1122 was constructed in 1967 as the Rumpel Fieldhouse (Figure 75–Figure 78). The design and construction of Building 1122 could not be linked to a specific architect for Criterion C significance. The building does not embody a distinctive characteristic of a type, period, or method of construction, does not represent the work of a master, and does not possess high artistic values. Military recreation is not a significant theme for broad patterns of history, and the construction of the building was not part of large program of military recreation construction funding. It is the recommendation of this report that Building 1122, Rumpel Fitness Center, is NOT eligible for the NRHP at the local, state, or national levels due to a lack of significance under Criteria A and/or C.

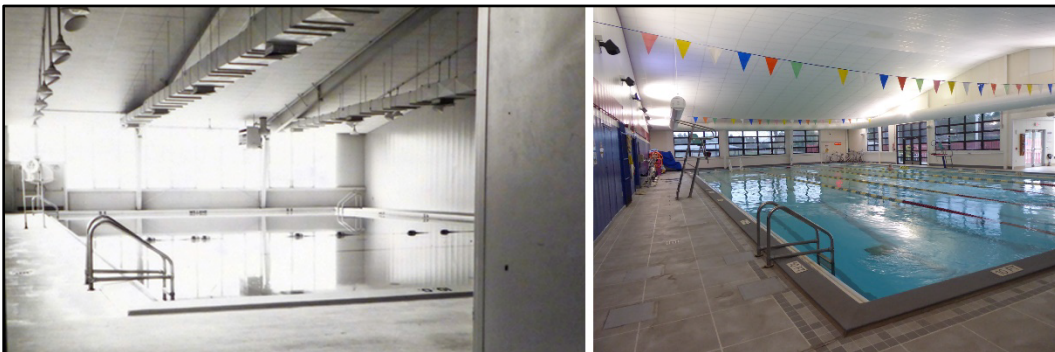
Figure 77. Comparison image of an interior view of the pool area looking southeast in Building 1122, Rumpel Fitness Center. *Left* is historic photograph (1978) with original vaulted ceiling, concrete flooring, wall of large multipane industrial-style windows on the east side and no window openings on the south wall versus the *right image* from 2021 showing newer concrete flooring, replacement windows on the east wall, newer windows and doors added to the south wall, and a solarium addition added off the south wall (*left image* is RG111-SCA, Album 402A, SC675942, NARA, College Park, MD, and *right image* is from ERDC-CERL, 2021. Public Domain).
