NUWC-NPT Technical Report 12,407  
19 August 2022

# **Coral Mitigation for Pier Construction at the Atlantic Undersea Test and Evaluation Center**

**Naval Undersea Warfare Center Division  
Newport, Rhode Island**

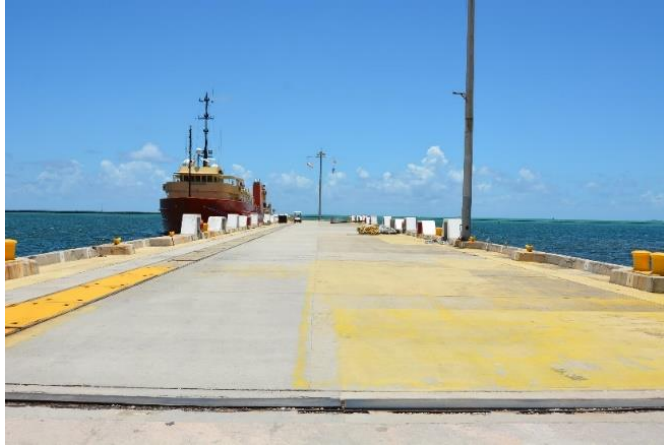
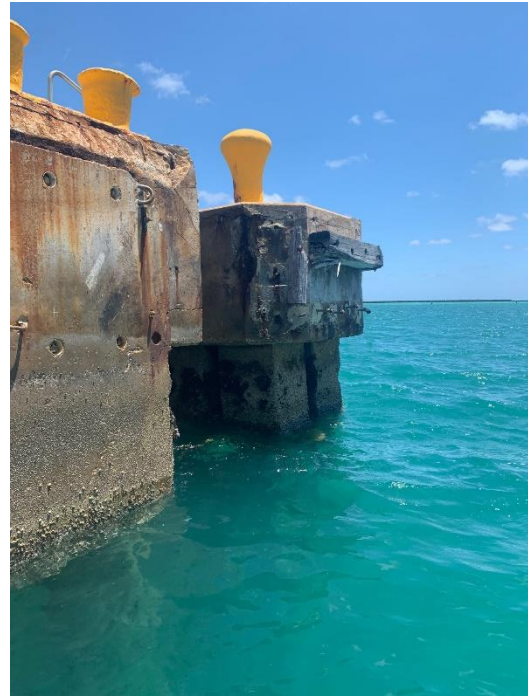
**Figure 2-1. AUTEC Pier (left) and South Dolphin Mooring (right)**

AUTEC Pier is located on the AUTEC installation on Andros Island, the largest island in the Bahamas, located between the extensive Bahamas Bank to the west and the Tongue of the Ocean to the east (Figures 2-1 and 2-2). The pier primarily supports berthing of range vessels for test operations and associated range users. Proposed pier repairs include replacement and repairs to structures.

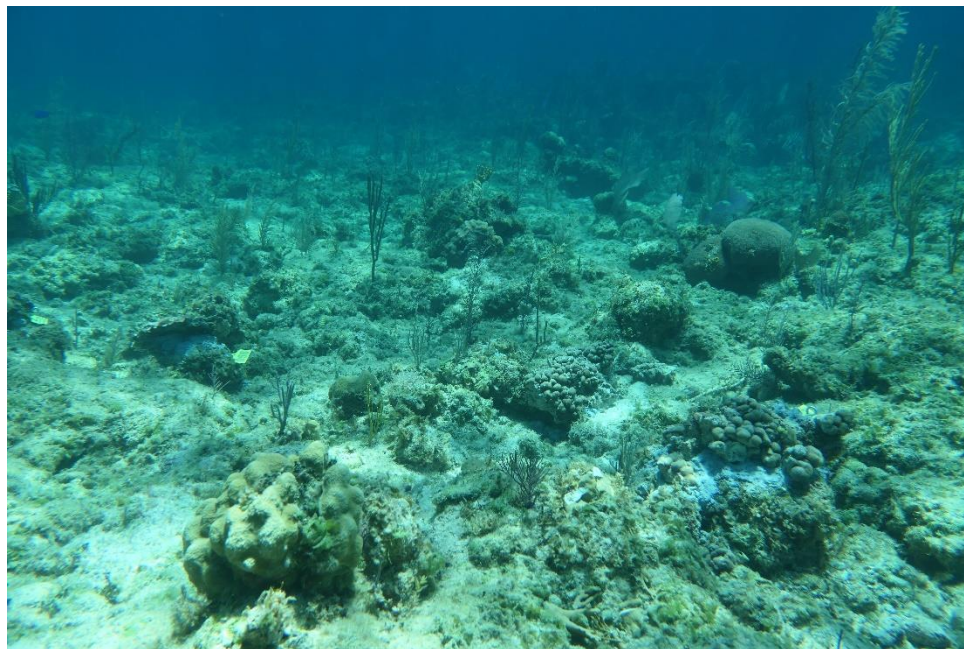
**Figure 2-3. Hog Fish Reef Underwater Relocation Site**

Hog Fish Reef is located 2.4 mi (3.9 km) from the AUTEC Pier. Hog Fish Reef has a maximum depth of 13 feet (ft; 4.0 meters [m]), with an average depth of 11 ft (3.6 m). During the translocation effort, water temperature at this site recorded from divers remained consistent at 78.8 degrees Fahrenheit (°F; 26 degrees Celsius [°C]) on the surface and on the bottom. The site was dominated by a limestone hard bottom covered by algal turf, and interspersed with small pockets of sand (Figure 2-3). This site also was interspersed with octocorals, including Gorgonians and sponges. There were multiple species of sporadic stony coral that were very healthy and sizable, including great star coral (*Montastraea cavernosa*), mountainous star coral (*Orbicella faveolata*), elliptical star coral (*Dichocoenia stokesii*), mustard hill coral (*Porites astreoides*), and *Agaricia* spp., as well as hydrocorals including branching fire coral (*Millepora alcicornis*). A small community of various fish species was observed here as well, including bluehead wrasse (*Thalassoma bifasciatum*), juvenile slippery dick (*Halichoeres bivittatus*), and juvenile rainbow wrasse (*Halichoeres pictus*).

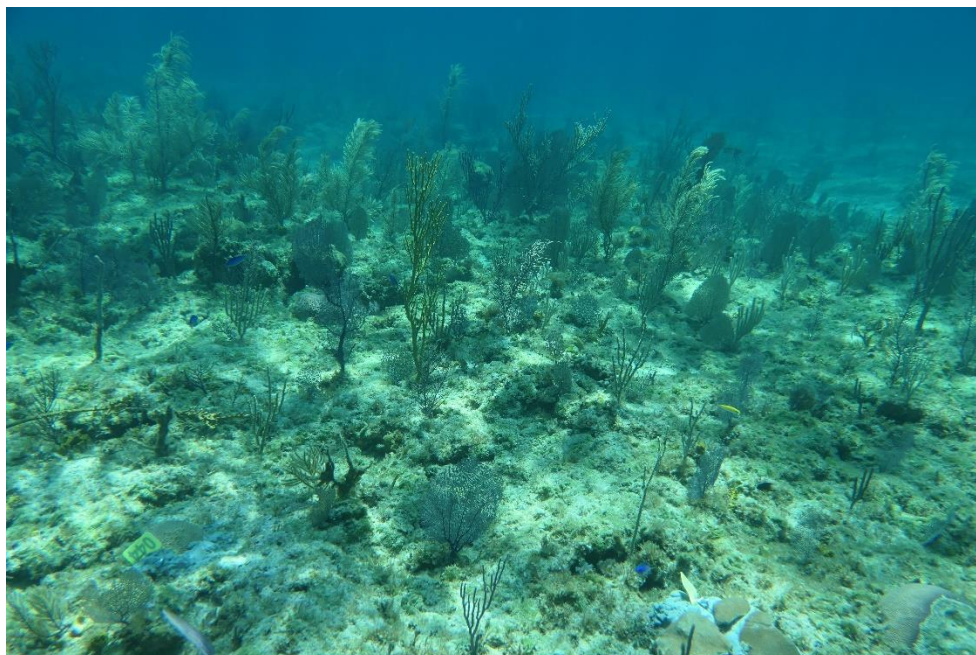
**Figure 2-4. Dallas Point Underwater Relocation Site**

Dallas Point, named after the USS DALLAS (SSN 700), which ran aground in this area in the 1980s, is located 2.9 mi (4.6 km) from the AUTEC Pier just seaward of the fringe and barrier reefs. The maximum depth at Dallas Point is 12 ft (3.7 m), with an average depth of 10 ft (3.0 m). During the translocation effort, water temperature recorded from divers at this site remained consistent at 26 °C (78.8 °F) at the surface and on the bottom. The bottom type was very similar to Hog Fish Reef, with a dominate limestone hard bottom covered by algal turf and interspersed with small pockets of sand (Figure 2-4). There were multiple species of sporadic soft and stony coral that were very healthy and sizable. Stony coral species included *M. cavernosa*, mountainous star coral, grooved brain coral (*Diploria labyrinthiformis*), elliptical star coral, mustard hill coral, branching fire coral, massive starlet coral (*Siderastrea siderea*), and *Agaricia* spp. As with Hog Fish Reef, a small community of various fish species were observed, including bluehead wrasse, juvenile slippery dick, and juvenile rainbow wrasse.

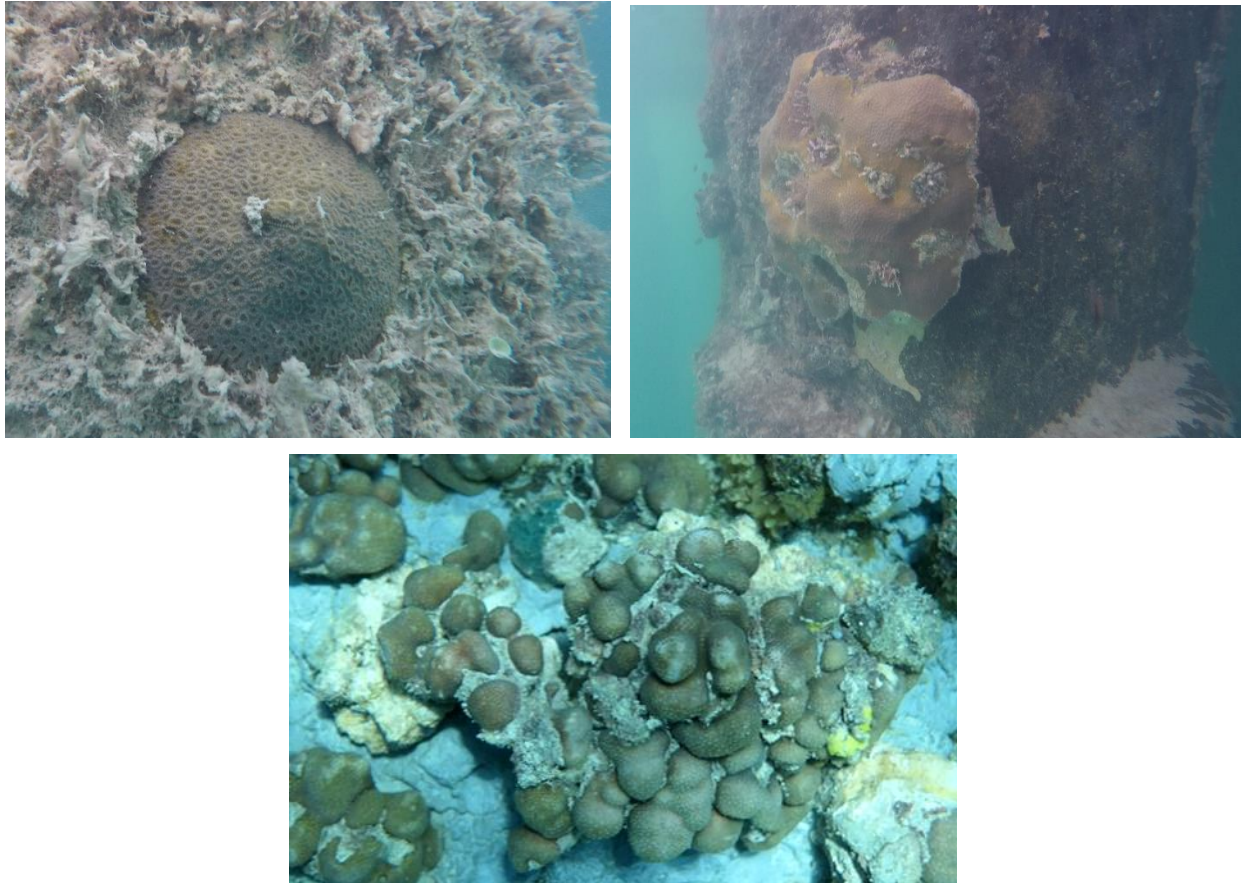
**Figure 2-5. *D. stokesii* (left) and *O. faveolata* (right) on the AUTEC Pier, and *O. annularis* (bottom) at a Relocation Site.**

Once the relocation sites were determined, the pilings and structures making up the AUTEC Pier were inspected to locate and identify rare or threatened coral species. The three protected species identified to be present on the pier structures were mountainous star coral (*O. faveolata*), lobed star coral (*O. annularis*), and elliptical star coral (*D. stokesii*) (see sections 2.2.1 through 2.2.3 for species descriptions). *O. faveolata* was found only in encrusting sheet morphology, while the *D. stokesii* was in dome form (Figure 2-5). *O. annularis* was found in irregular divided colonies of small mounds of lumps. It is recommended that candidate coral for relocation be healthy and greater than approximately 2–4 inches (in; 5–10 centimeters [cm]) in size (S. Smith, personal communication, 2020; U.S. Coral Reef Task Force 2016). However, the size best suited for increased likelihood of survivability can vary based on species and reproductive type (e.g., fragmenting). All but one coral colony was greater than 10 cm (4 in) in size, and with the exception of very small areas of mortality in a few corals due to algae, they were observed to be in good health.

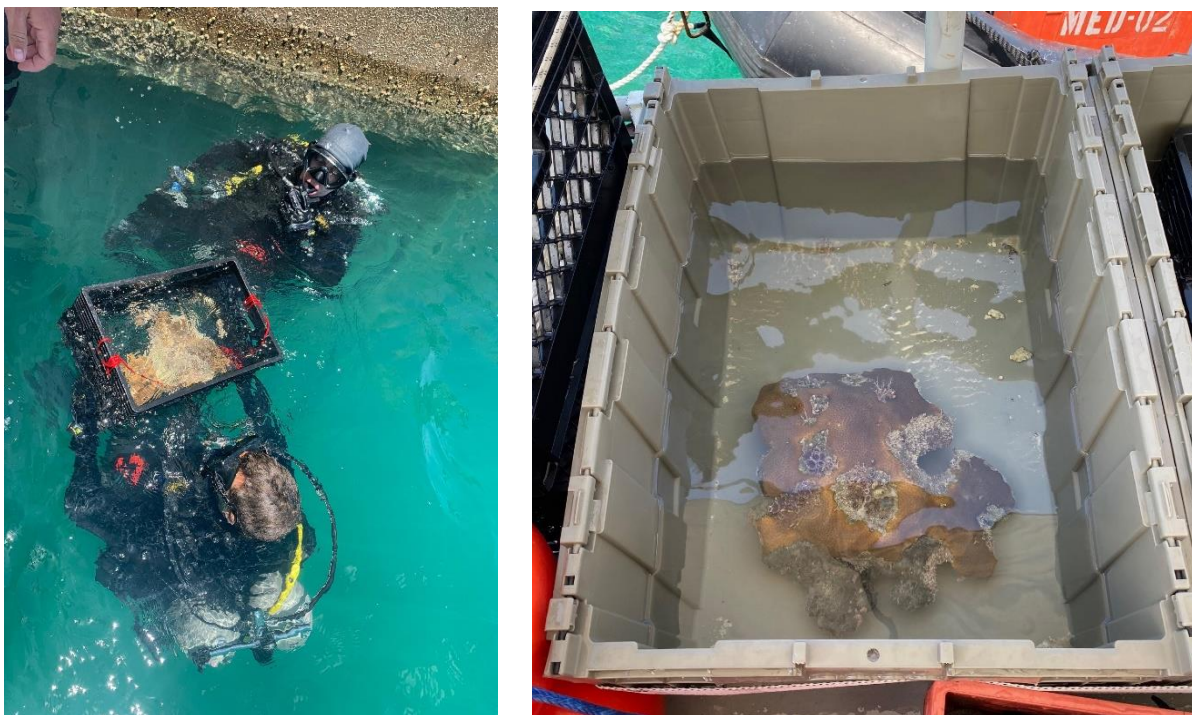
**Figure 2-6. Navy Divers with Recovered Coral from the AUTEC Pier (Left) and Removed Corals Ready for Translocation (Right)**

Using standard methodology by scientists to translocate corals (Frias-Torres et al. 2018, Smith and Hughes 1999; Yap and Molina 2003; Lirman et al. 2010), corals were systematically removed from the pier by divers using chisels and hammers. Removed coral was gently placed in plastic crates, allowing the coral to remain in seawater until ready to be transferred to the range vessel (Figure 2-6). Harvested colonies were placed in totes filled with seawater and secured on the boat during transport (Figure 2-7). The tubs were kept shaded by the vessel canopy and tote lids if necessary so that the colonies could remain completely submerged in water with a constant temperature and frequent water replenishment to increase the chances of survivability. Colonies were placed at depths similar to their origination.

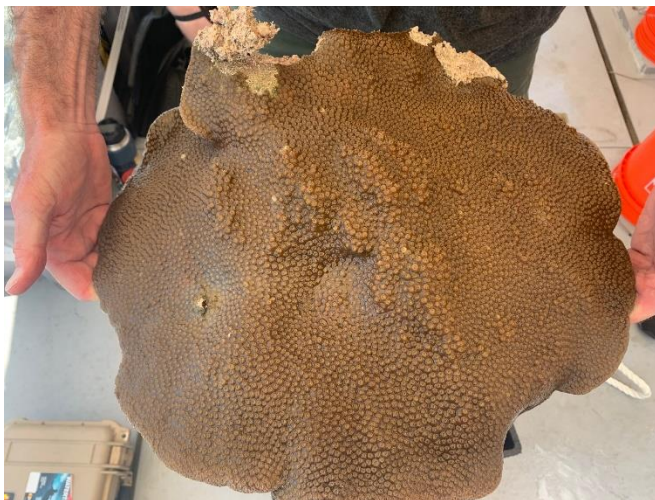
Mountainous star coral (*Orbicella faveolata*) has small, round polyps with exsert (protruding) walls in mounds with flanging edges or thick plates. They may fluoresce, and their color may vary to include brown, grey, or green. Colonies have been observed as wide and tall as 15 ft (4.6 m) (Lang and Marks, 2013). Their surfaces can be smooth, ridged, or with bumps aligned in vertical rows. *Orbicella* spp. can be the predominant coral species on fore reef slopes between 20 and 75 ft (6.1 and 22.9 m) and of the three species, *O. faveolata* is generally the most common (Humann and Deloach, 2013). A harvested colony of *O. faveolata* is shown in Figure 2-7.

**Figure 2-7. Harvested *O. faveolata* colony**

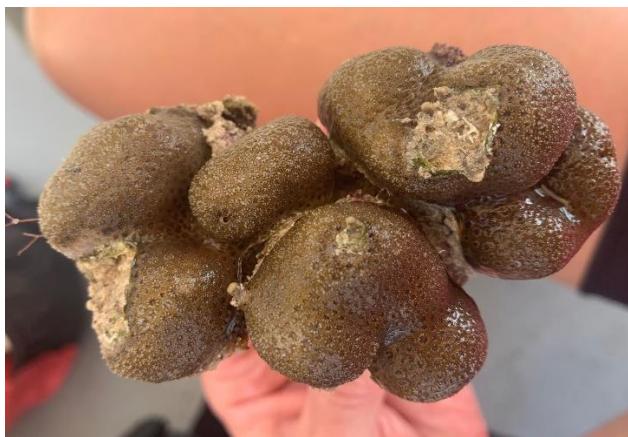
Lobed star coral (*Orbicella annularis*) has small, round, exsert polyps and can be light brown or yellow-brown, with shades of green or gray. Colonies have clusters of long, thick columns with enlarged dome-like tops, or it can grow in irregular mounds and encrustations with scattered lumps (Humann and Deloach, 2013). Thick plates can form at the colony sides or bases under low light conditions. This species differs from *O. faveolata* in that they subdivide to form columns with basal plates. *Orbicella* species, including lobed star coral, occur in most reef habitat types, although less commonly on the reef flat and in the shallow zones formerly dominated by elkhorn coral (Brainard et al., 2011; Goreau, 1959; National Oceanic and Atmospheric Administration, 2012b). *Orbicella* species are key reef-builders. A harvested fragmented colony of *O. annularis* is shown in Figure 2-8.

Figure 2-8. Harvested *O. annularis* colony

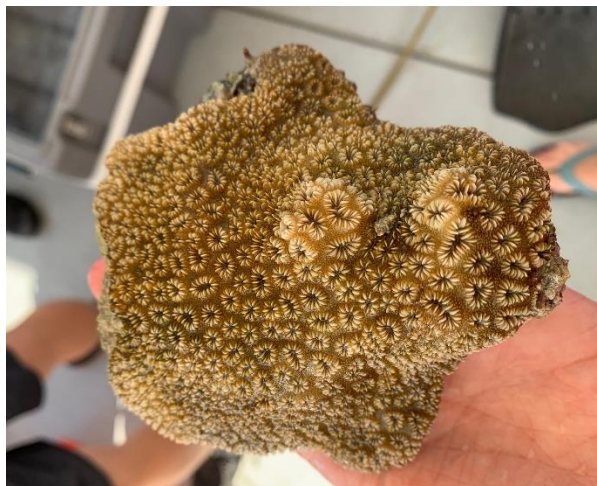
Elliptical star coral (*Dichocoenia stokesii*) has very exsert, Y-shaped polyps that vary from round to elliptical or elongate. The septa on vertical walls of a colony are more distinct. This species most commonly forms rounded domes and flattened plates (Humann and Deloach, 2013). Color can vary, including cream, yellow, or brown. There was one brown specimen that was translocated; the remaining *D. Stokesii* were yellow. Colonies can grow to 18 in (45.7 cm) (Lang and Marks, 2013). This species can be found at depths between 12 and 225 ft (3.7 and 68.6 m) (Humann and Deloach, 2013). A harvested colony of *D. Stokesii* is shown in Figure 2-9.

**Figure 2-9. Harvested *D. stokesii* colony**

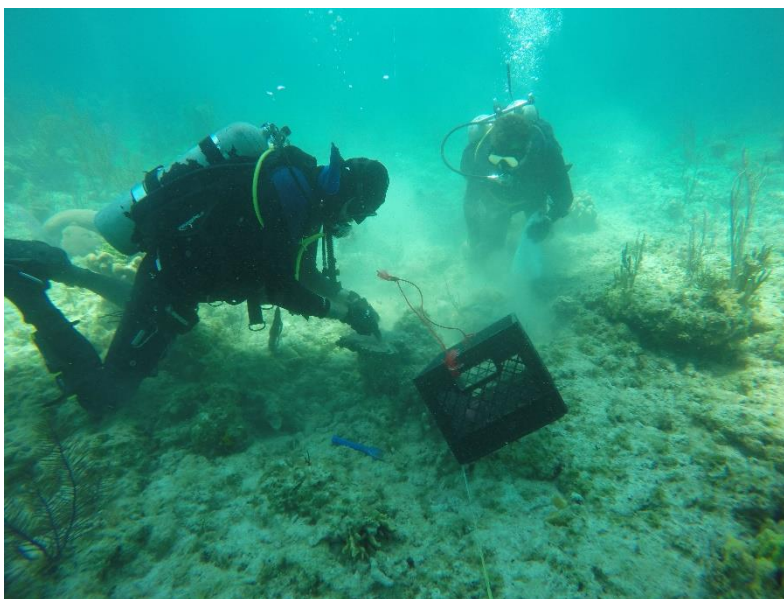
**Figure 2-10. Divers Securing Coral to the Seafloor**

Coral was temporarily stored in open plastic totes with seawater aboard a 36 ft (11 m) range craft while transported to the relocation sites on the reef. Using the proven method demonstrated by Unsworth et al. (2020), coral was adhered to the hard substrate on the seafloor with a combination of 10 parts Portland Type I/II cement to 1 part silica fume. This ratio was tested on shore prior to deploying on the range craft to ensure its effectiveness. Fresh water was added to the cement mixture in buckets on the dive boat. The cement mixture was then poured into plastic grout bags and lowered to the seafloor in a crate along with the coral and an identifying tag (Figure 2-10). Divers squeezed the cement mix onto the seafloor substrate and gently affixed the coral to the seafloor. Numbered tags were placed in the cement adjacent to each colony and photo-documented for ease of identification during monitoring efforts (Figure 2-11).

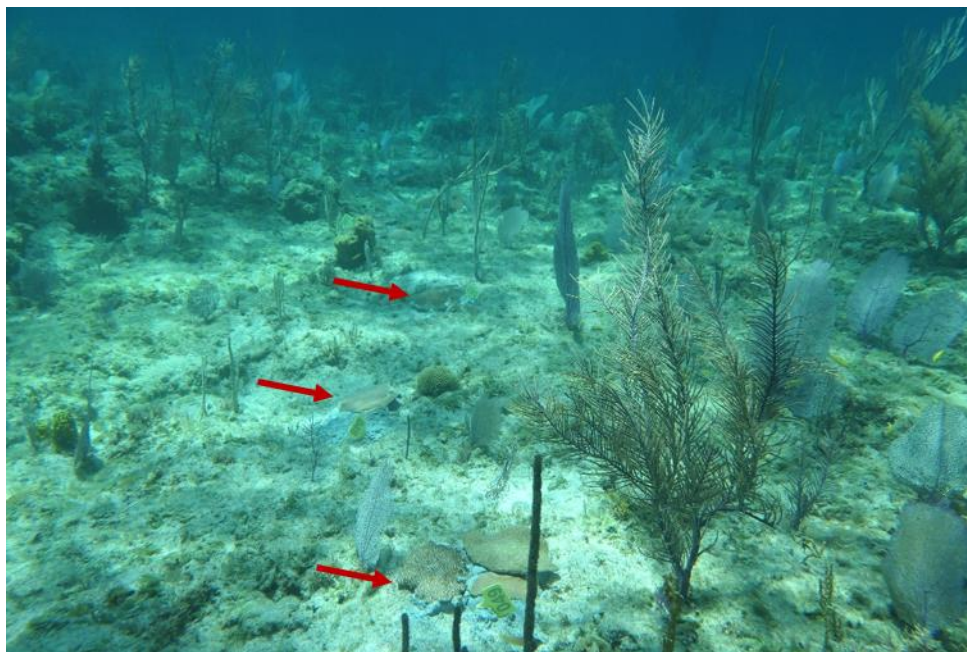
**Figure 2-12. Transect at the Dallas Point Site Showing Recently Translocated Coral (red arrows)**

One 32 ft (10 m) transect line was strategically laid out at Dallas Point, and a 36 ft (11 m) transect at Hog Fish Reef was laid. In order to deploy the transect tapes appropriately, a clump with a buoy at the surface was placed at the start and end of the transect. The transect tape was connected to the start buoy clump and unwound to the 10-m mark. The end buoy clump then was placed at the 10-m mark, slack was taken out, and the tape was secured to that clump. This ensured that the transect tape would stay in place and decrease potential movement of the tape by current. Each transect line marked 10 individual coral colonies at 1 m (3.4 ft) increments. By this design, 10 coral colonies were located at the Hog Fish Reef site and 11 at the Dallas Point site, for a total of 21 (Figure 2-12). The compass heading for the Hog Fish Reef transect was 90° east, while the heading for the Dallas Point transect was 007° north.

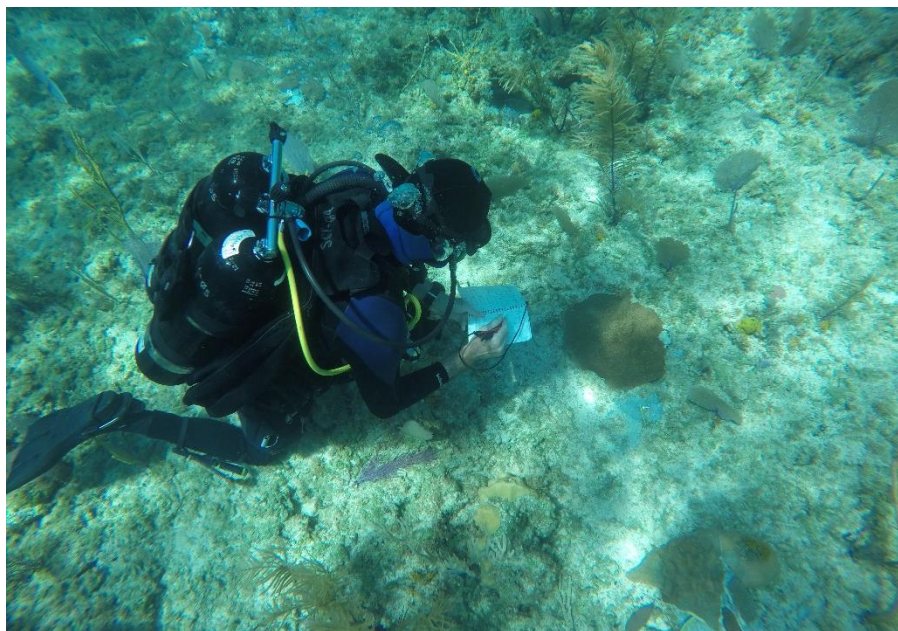
**Figure 2-13. Diver Recording Data on Recently Translocated Corals**

Detailed documentation of translocated coral colonies was obtained for the purposes of potential follow-on monitoring (Figure 2-13). Data collected included species, health (i.e., disease or bleaching), size (two longest dimensions of length and width), date of coral removal from the AUTEC Pier, and translocation information (e.g., depth, relocation site, substrate type [e.g., natural rock bottom], and environmental conditions [e.g., depth, visibility, current] at the time of placement).

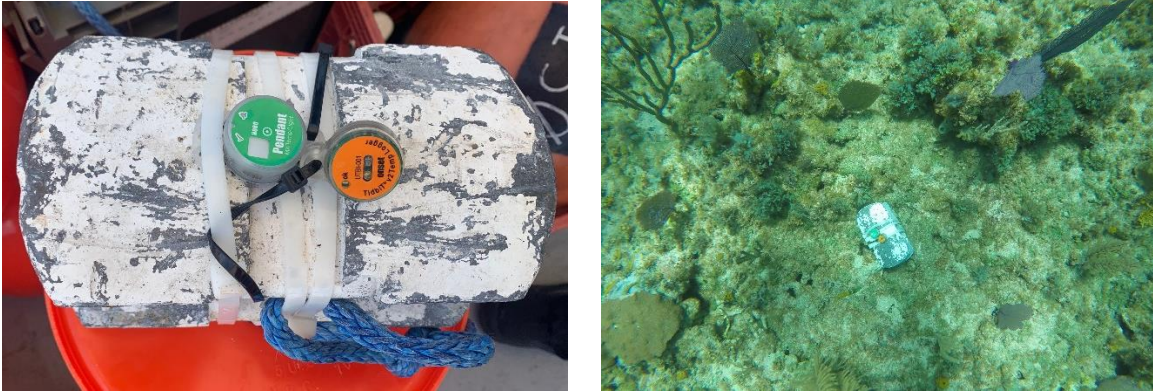
**Figure 2-14. Water Quality Data Logger Setup (left) and Deployment at Relocation Site (right)**

Water quality measurements (e.g., temperature and light) were taken with HOBO® temperature and light data loggers (HOBO Pendant® MX Temperature/Light Data Logger) at the pier within the AUTEC harbor, as well as at the relocation sites. Measurements were obtained to assure similarities in the conditions at the removal site and relocation sites, as well as probability of success at the relocation sites. Data loggers were deployed at the seaward end of the main pier at a depth of 12 ft (3.7 m) from 21–26 April. Data loggers were attached to a 70-pound clump weight and deployed on the seafloor at approximately 12 ft (3.7 m) depth at Hog Fish Reef from 27–28 April and Dallas Point from 26–28 April (Figure 2-14). Due to malfunction of the data loggers at Dallas Point, data was not available at this relocation site. However, given the close proximity of this site to Hog Fish Reef (0.6 mi [0.7 km]) and the similar depth, conditions would be expected to be similar and would reflect the environmental conditions at the time of the translocation effort.

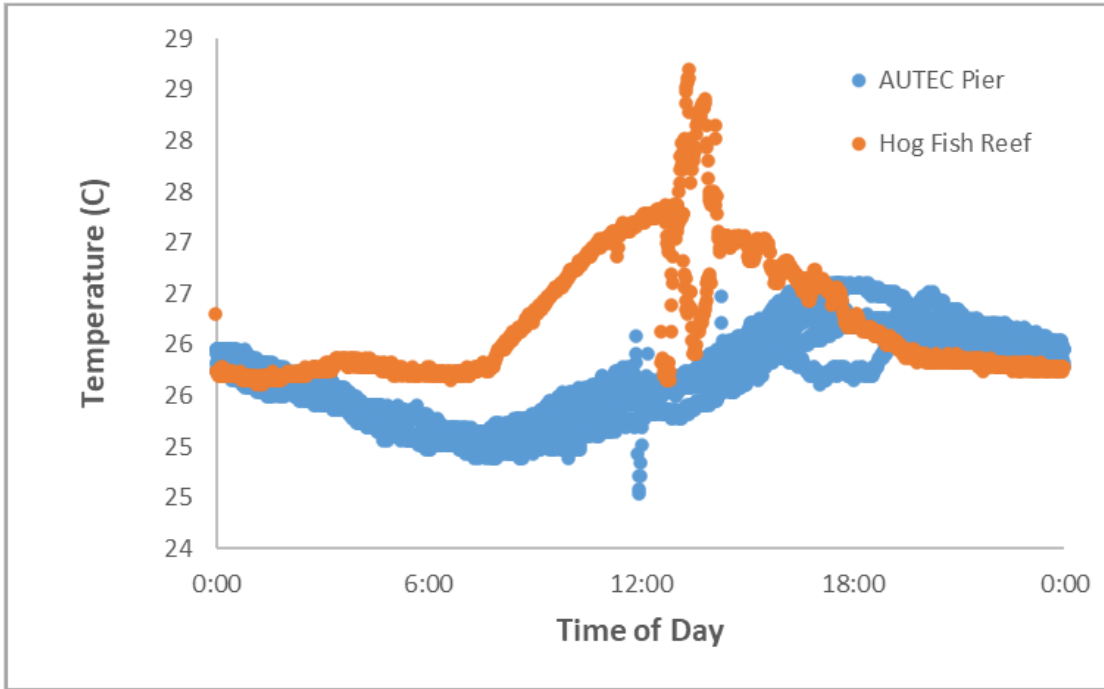
Figure 3-1. Temperature Data Collected at the AUTEC Pier and Relocation Site

The most recently available water quality data at AUTEC is shown in Figures 3-1 through 3-3. During the data collection period in April 2022, water temperatures within the AUTEC harbor ranged from 24.5 to 26.5 °C (76.1 to 79.7 °F), with an average of 25.6 °C (78.1 °F) (Figure 3-1). Temperature at the Hog Fish Reef relocation site ranged from 25.6 to 28.7 °C (78.1 to 83.7 °F), with an average of 26.3 °C (79.3 F) during this period. There was substantial overlap between the two sites, with night time temperatures generally similar, and daytime temperatures slightly warmer at Hog Fish Reef (Figure 3-2).

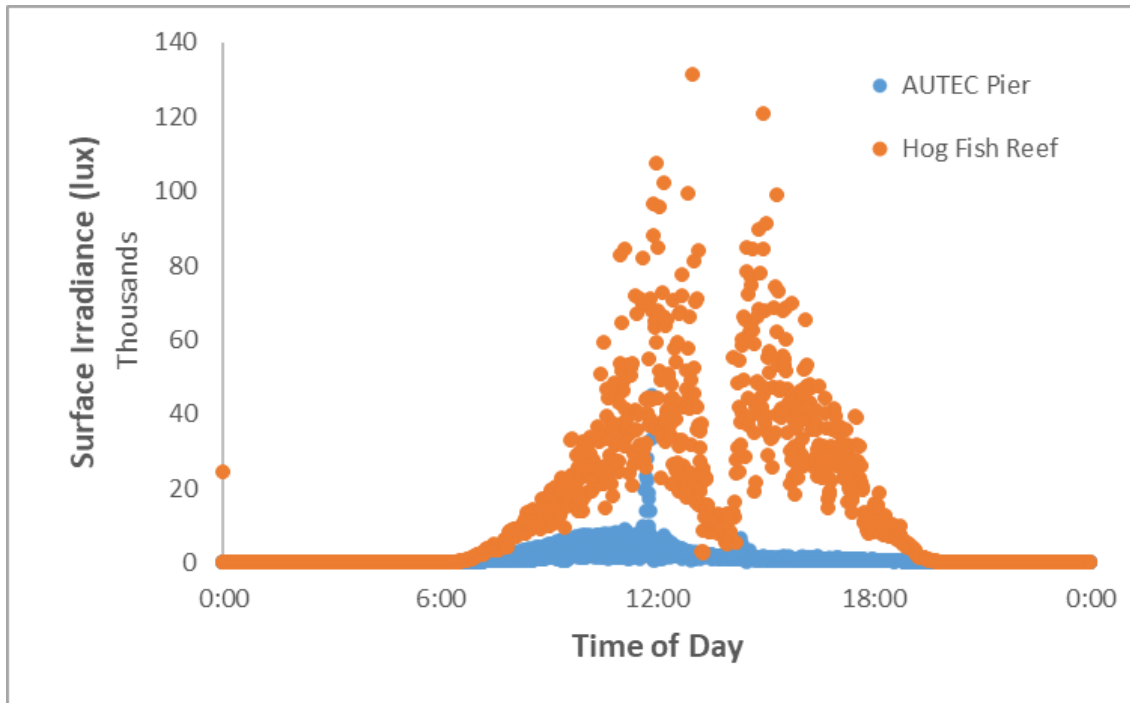
Figure 3-3. Light Data Collected at the AUTEC Pier and Relocation Site

Light was very different between the sites, with peak irradiance of approximately 45,000 lux at the 12 ft (3.7 m) depth of the AUTEC Pier, and over 131,000 lux at the same depth at the Hog Fish Reef relocation site (Figure 3-3). Average daytime irradiance also differed by approximately an order of magnitude, at about 26,700 lux for Hog Fish Reef and 2,040 lux at the AUTEC Pier.

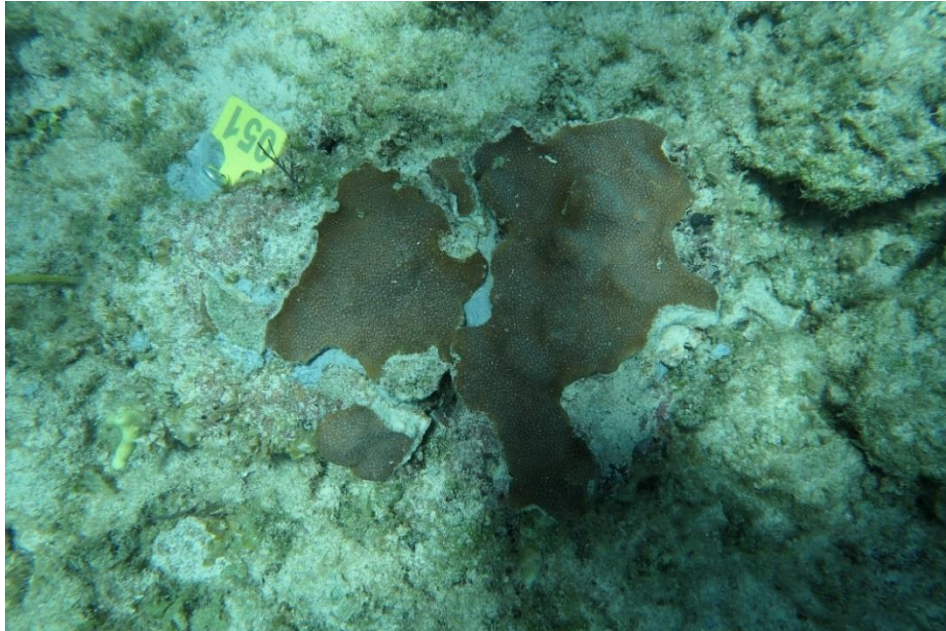
**Figure A-1. Translocated Coral #51 (fragments of *O. faveolata*). Minimal signs of mortality (1%).**

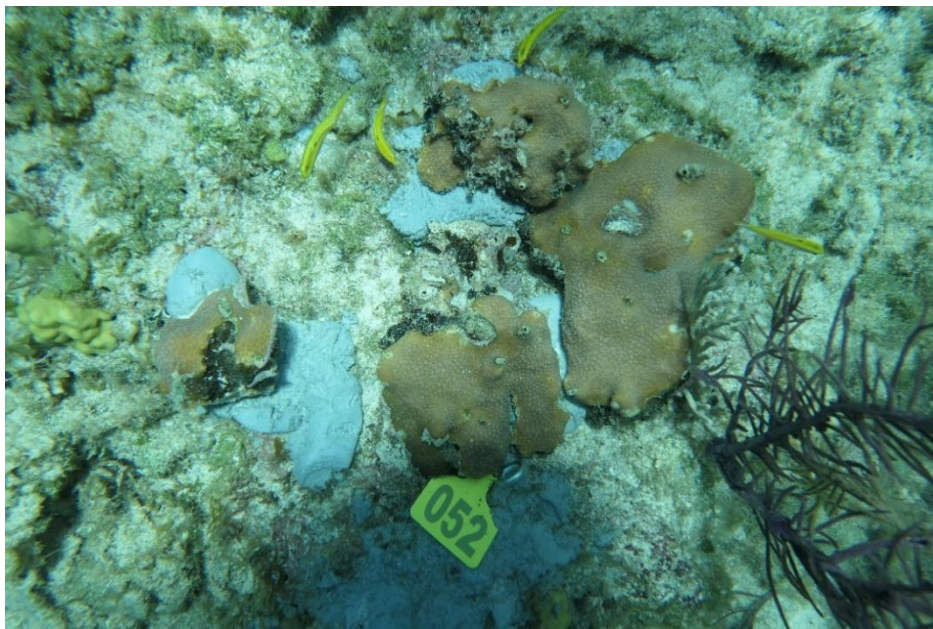
**Figure A-2. Translocated Coral #52 (fragments of *O. faveolata*). Sponges and tubeworms present, with minimal bleaching (1%).**

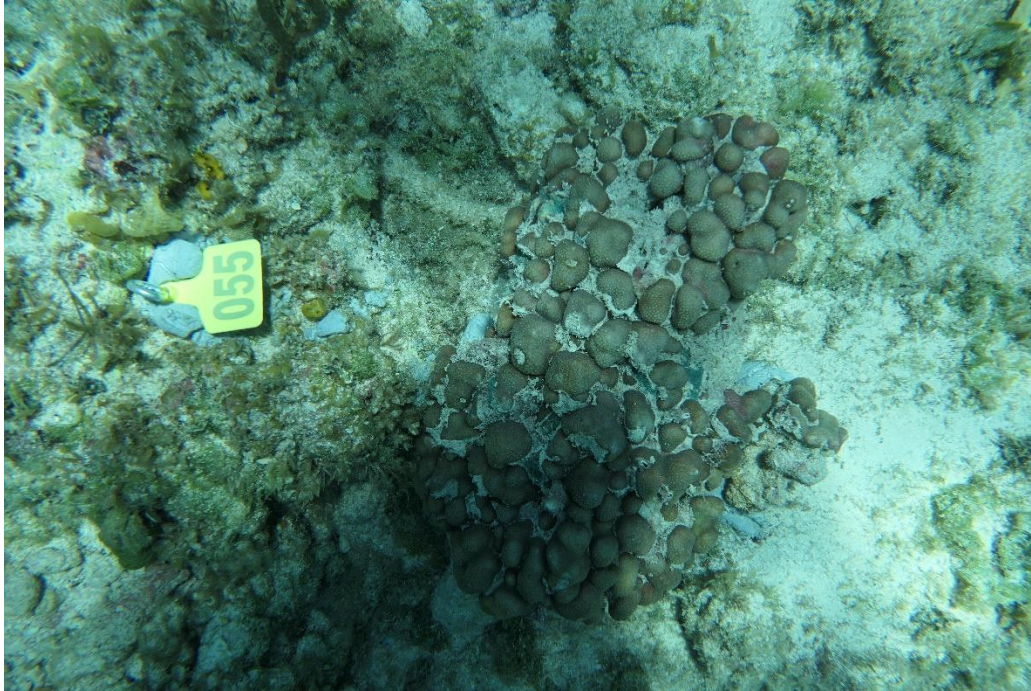
**Figure A-5. Translocated Coral #55 (fragments of *O. annularis*).  
Algae and sponges present, with some paling of the coral.**

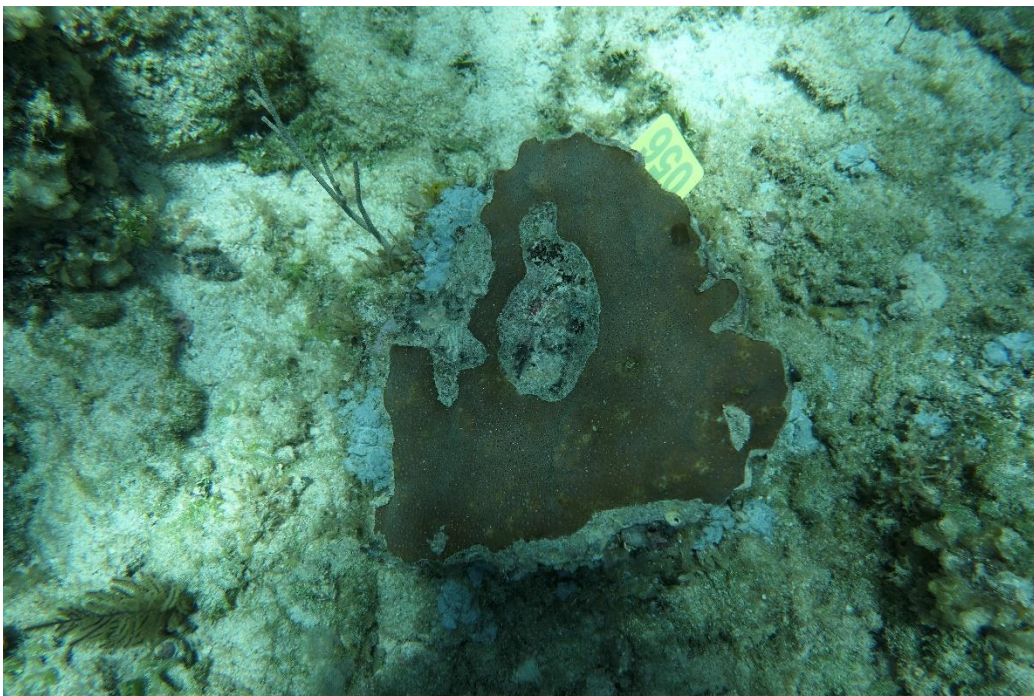
**Figure A-6. Translocated Coral #56 (*O. faveolata*).  
Some paling present, with 25% mortality.**

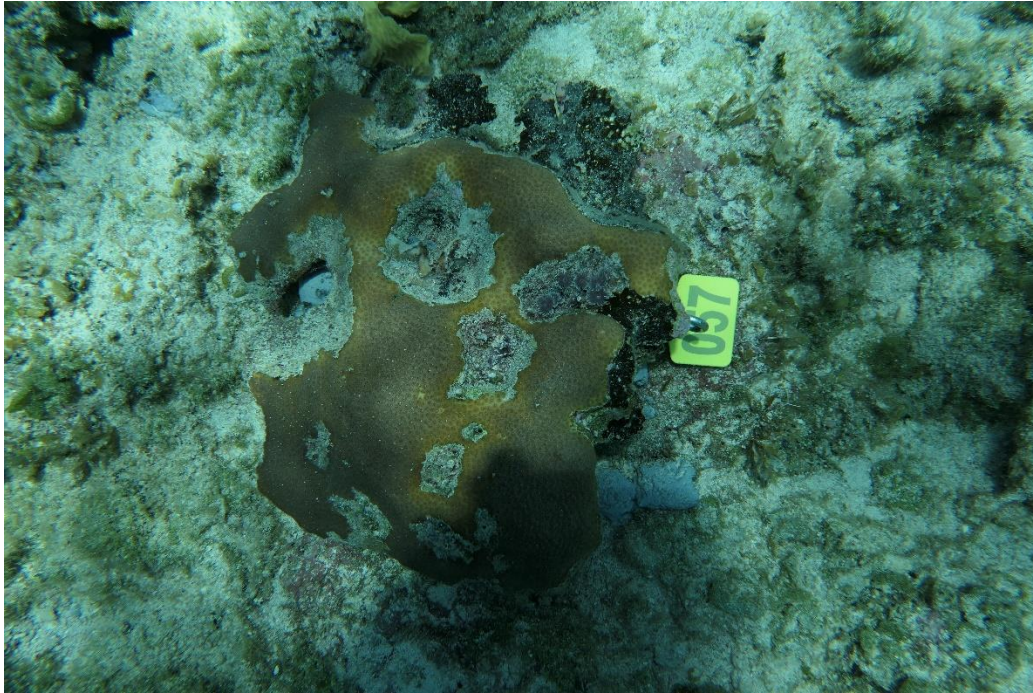
**Figure A-7. Translocated Coral #57 (*O. faveolata*).  
Tubeworms and algae present, with some paling of the coral.**

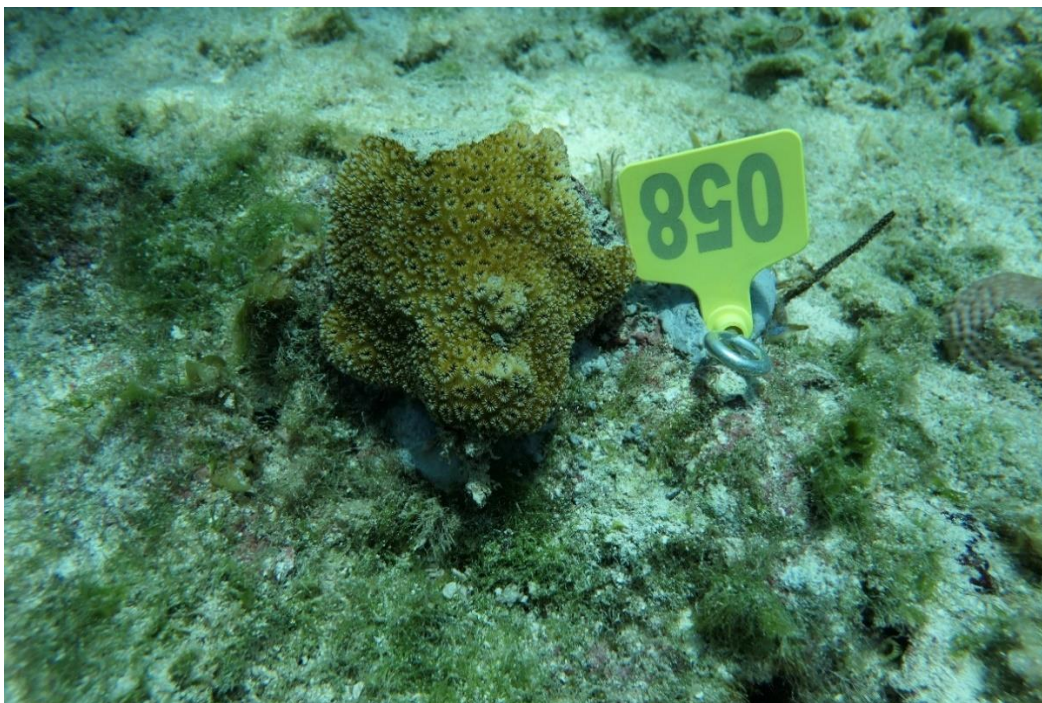
**Figure A-8. Translocated Coral #58 (*D. stokesii*).  
Some paling, with minimal mortality (1%).**

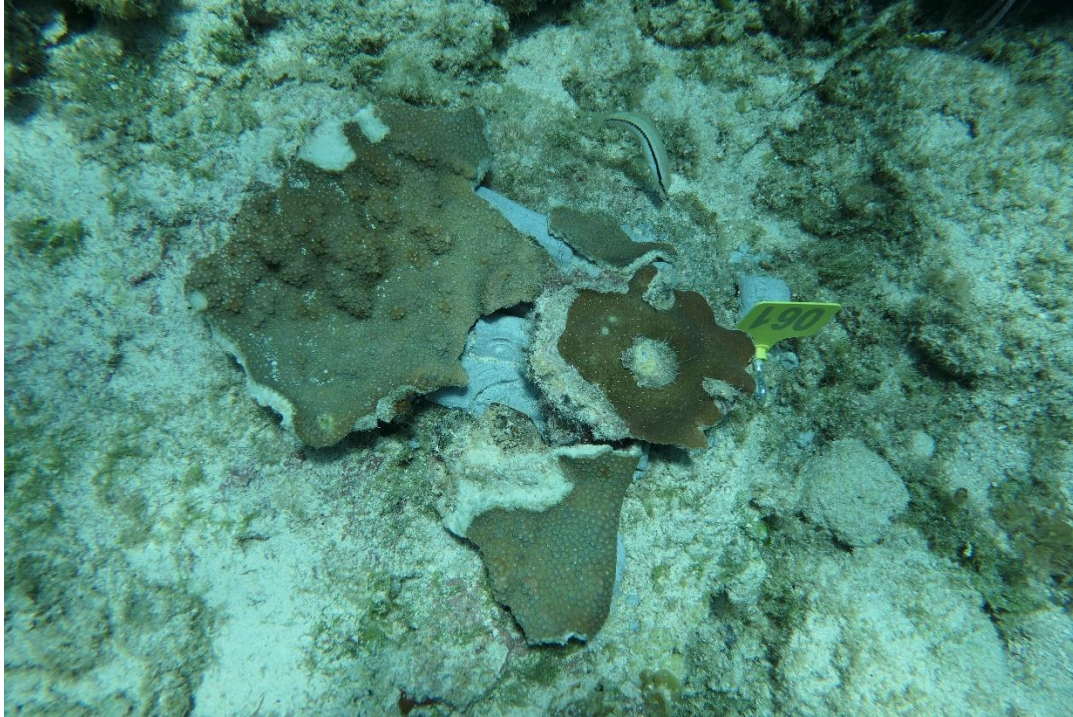
**Figure A-11. Translocated Coral #61 (fragments of *O. faveolata*). Some mortality (5%) present.**

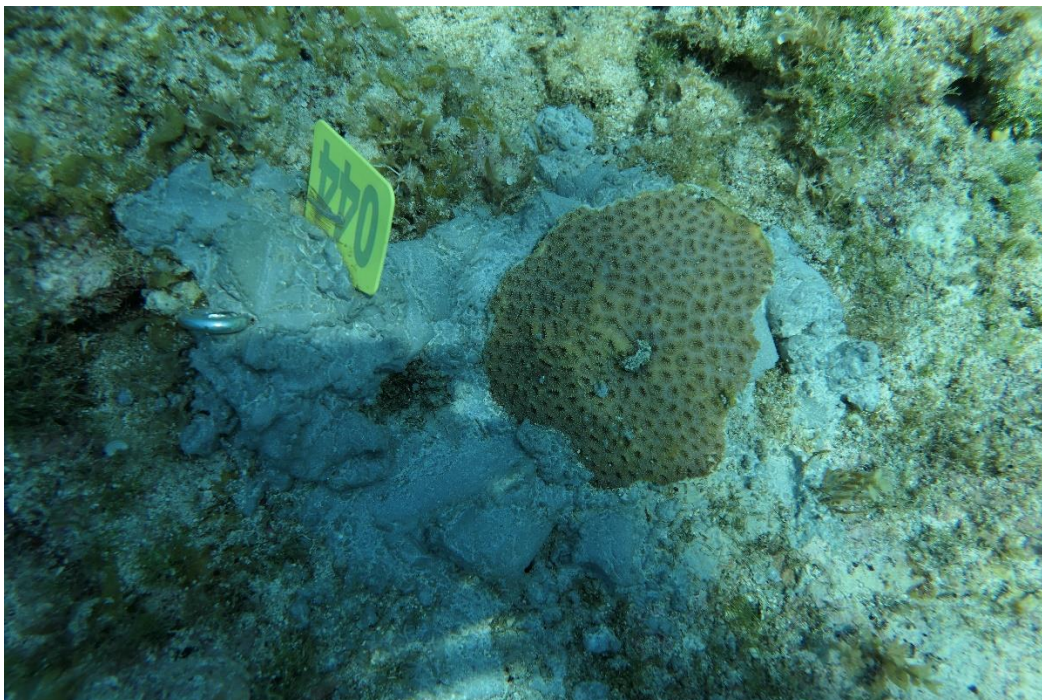
Figure A-15. Translocated Coral #44 (*D. stokesii*). Minimal paling (1%) present.

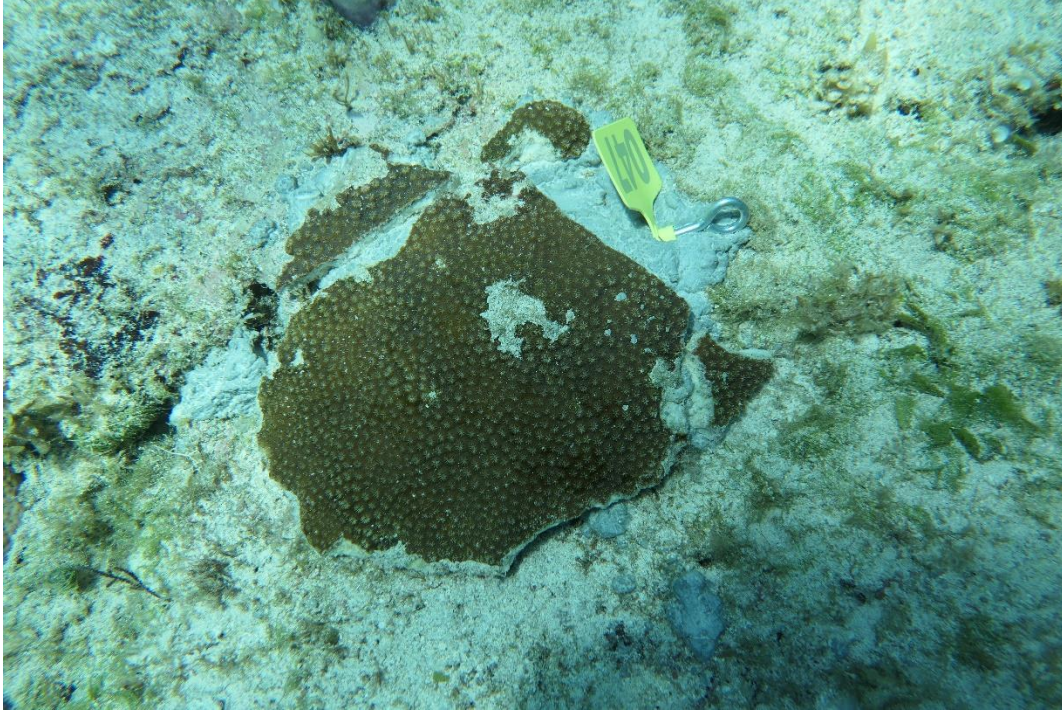
**Figure A-18. Translocated Coral #47 (fragments of *O. faveolata*). Minimal mortality (1%) present.**

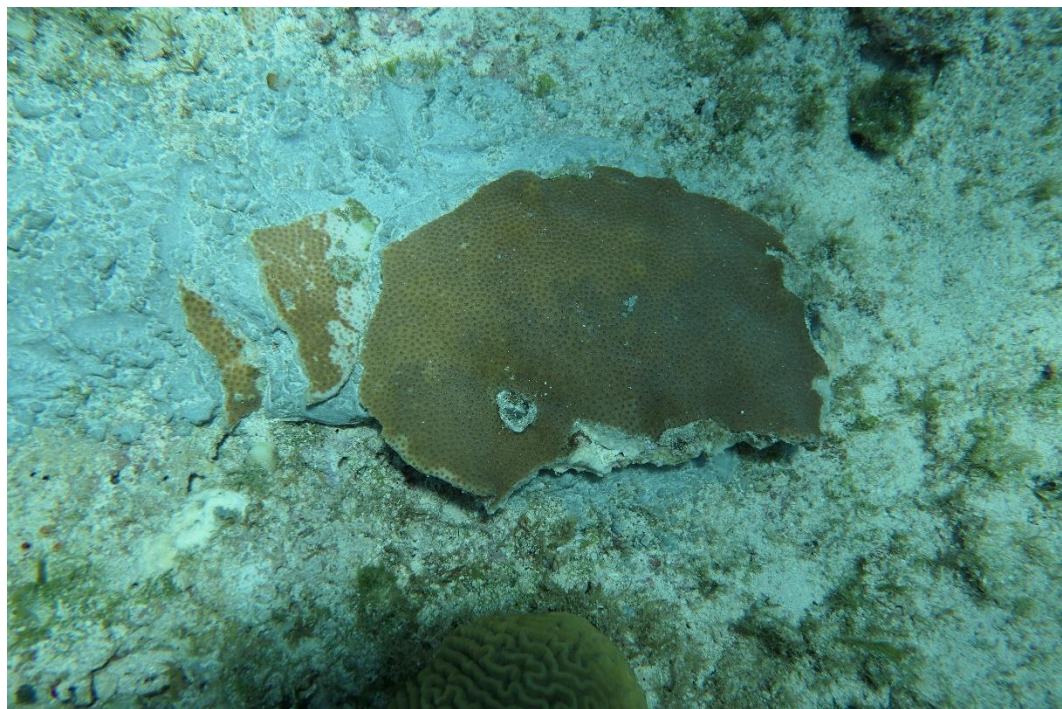
**Figure A-19. Translocated Coral #48 (fragments of *O. faveolata*). Minimal bleaching (2%) and mortality (1%) present.**

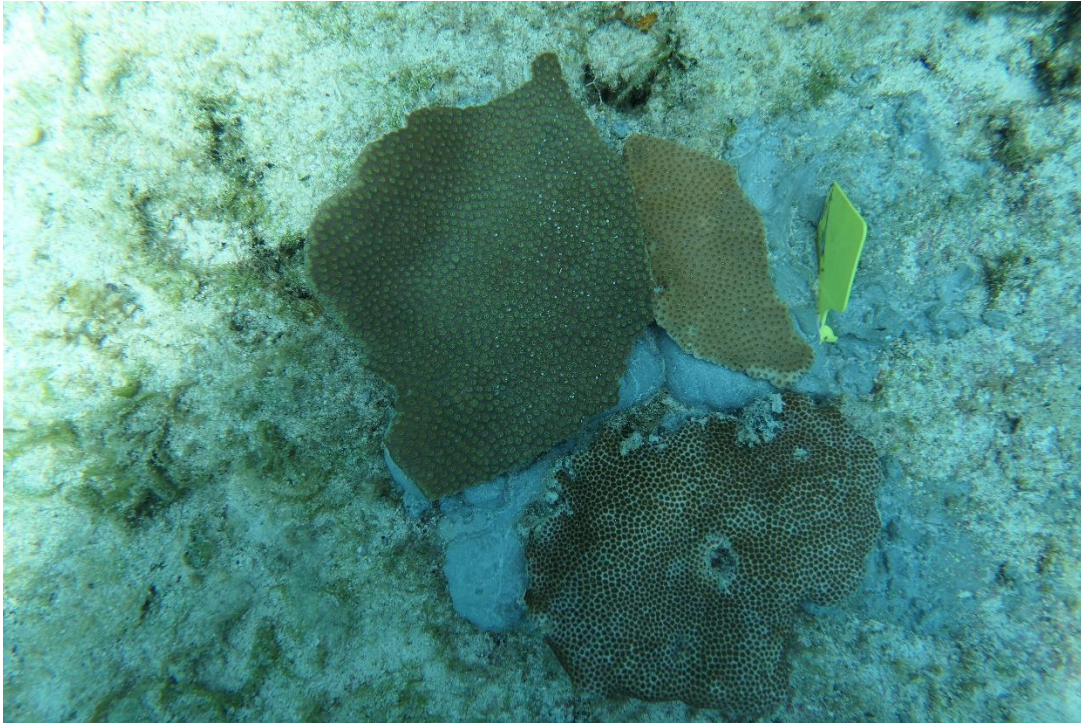
**Figure A-20. Translocated Coral #49 (fragments of *O. faveolata*). Additional fragment (bottom colony) of a non-protected species (*Stephanocoenia intersepta*) also translocated.**
