Characterization of 316 Stainless Steel and Inconel C-276 Degradation after Exposure up to 10 vol% H₂S at High-Temperatures up to 100 Hours

Theodore Burye^a & Talia Sebastian^b

U.S. Army Combat Capabilities Development Command Ground Vehicle Systems Center
Ground Vehicle Power & Mobility^a, Force Projection Technology^b

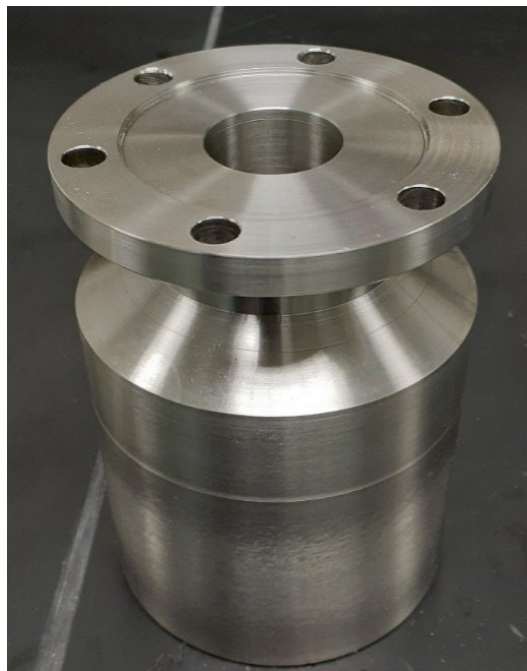
Figure 2 and Figure 3 show optical microscopy pictures of the reactor body and lid, respectively, before experimental testing occurred. As mentioned above, the reactor body and lid were constructed using Inconel C-276, which is a high-corrosion resistant material.

Figure 2: Machined Untested Reactor Body

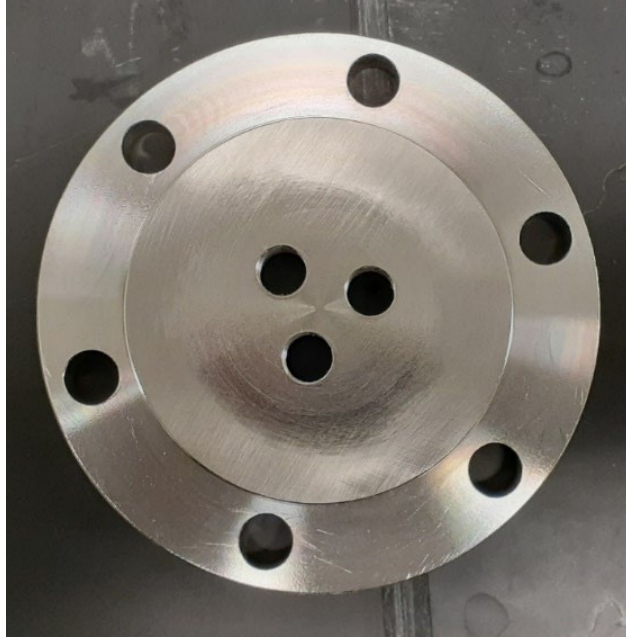
Figure 3: Machined Untested Reactor Lid

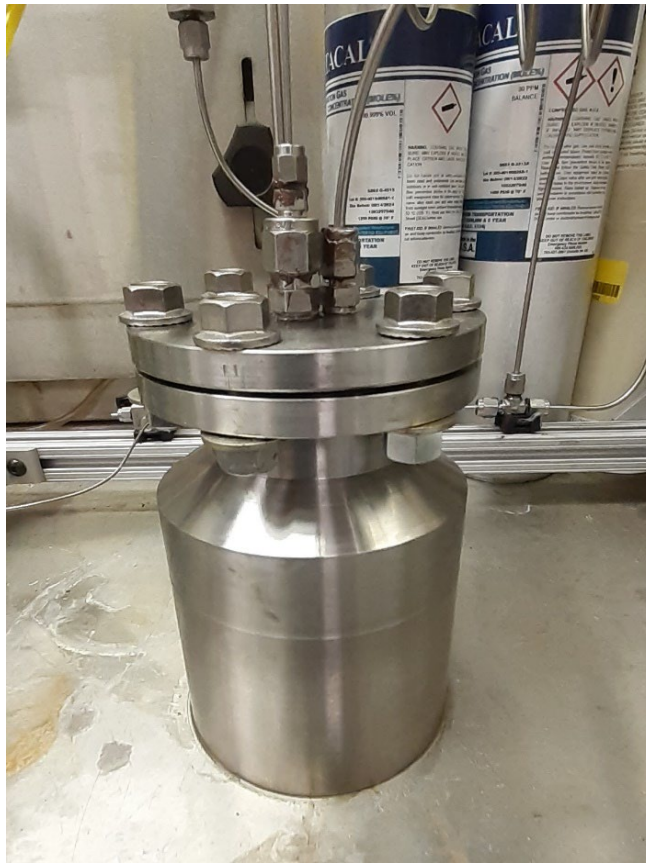
Figure 4 details how the reactor body, lid and other necessary fittings, inlet tubes, exit tubes were connected. The tubes and fittings entering and exiting the lid were constructed of 316 SS, which is not as corrosion resistant as Inconel C-286. The inlet extension tube and fitting on the underside of the lid, not visible here, were also constructed from 316 SS.

Figure 4: Machined Untested Assembled Reactor Body, Lid, Fittings and Tubing

After over 1,200 hours of experimentation exposing the different components to H₂S gas, with concentrations as high as 10 vol% and temperatures as elevated as 700°C, the reactor assembly (Figure 4) was disassembled for characterization, with the following objectives: first to characterize the 316 SS and Inconel C-276 exposure to prolonged periods of elevated H₂S concentration, of which knowledge is currently limited and therefore a better understanding of material degradation is needed, and secondly this analysis provides a basis on how reliable these materials are for future projects and whether these materials are adequate choices in the roles they were used in.

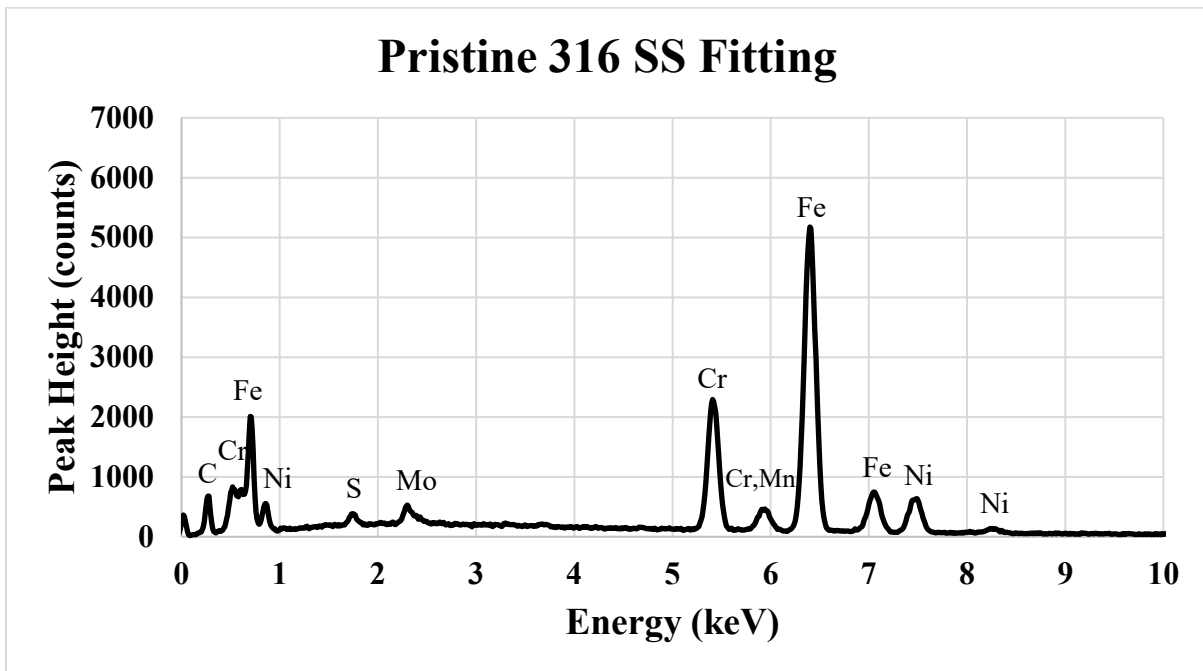
Figure 10 details the raw EDS results from an untested 316 SS fitting. This is a baseline to see if significant elemental changes occurred in samples. The primary elements are chromium, manganese, molybdenum, iron, nickel and silicon, with wt% values shown in Table 1. As mentioned above, the carbon and oxygen wt% values were omitted. Previous works of others, [1, 2] were used to verify this elemental composition and wt% values were consistent with 316 SS. The average wt% range found for 316 SS is shown in Table 2.

Figure 10: Raw EDS Results from Pristine 316 SS Fitting

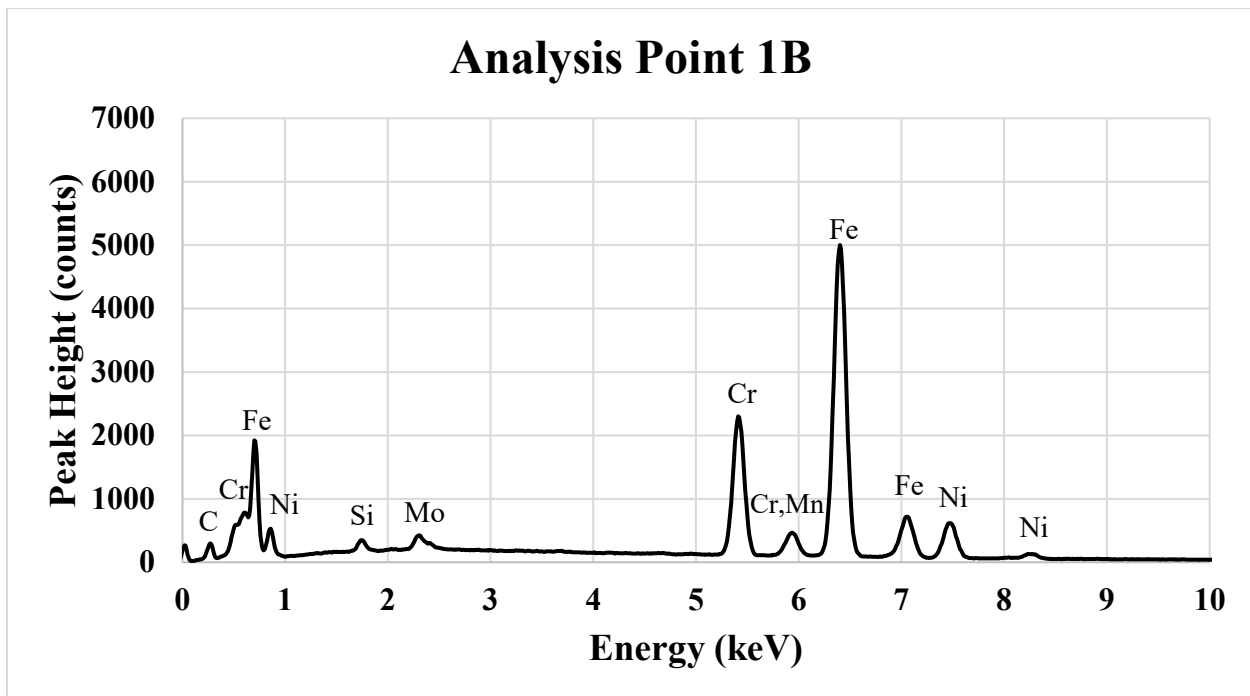
Figure 13 details the raw EDS results from the cross-section interior point #1B of the 316 SS sample fitting. The primary elements are chromium, manganese, molybdenum, iron, nickel and silicon, with wt% values shown in Table 4. All the elements and their wt% values are statistically within the range provided in Table 2, which indicates heat-related diffusion of sulfur, or any other element occurred.

Figure 13: Raw EDS Results from 316 SS Fitting at Analysis Point 1B for the Fitting Interior Metal

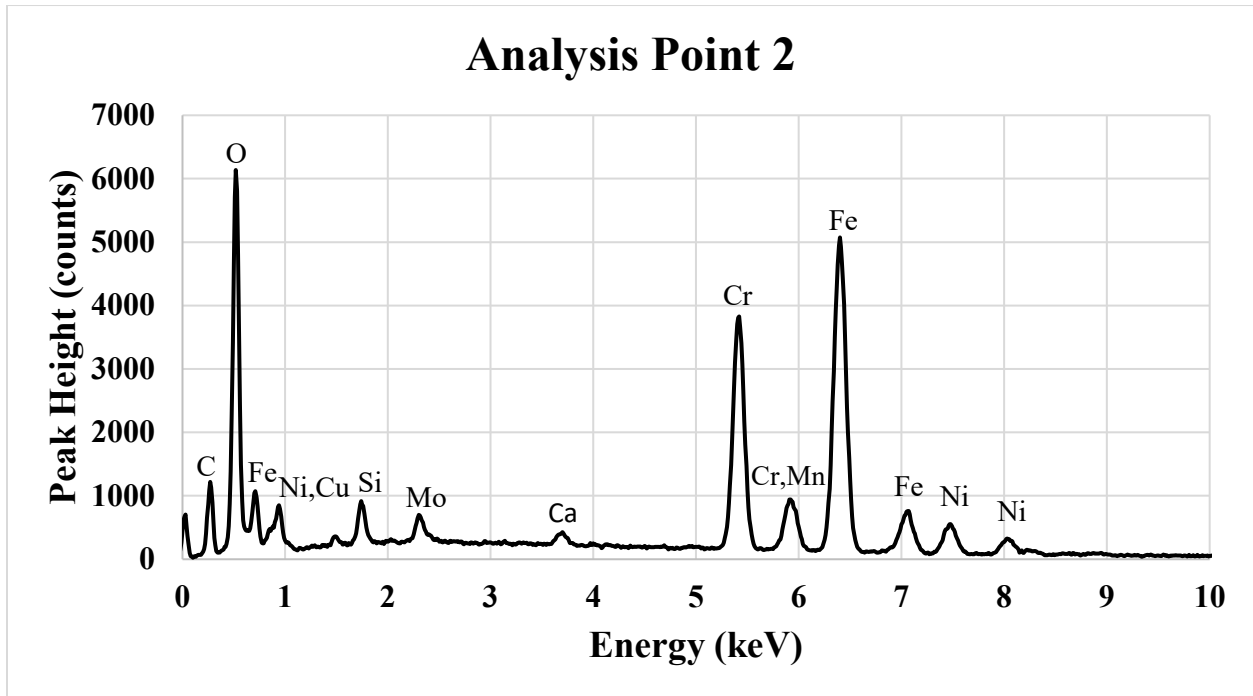
Figure 15 details the raw EDS measurements from the exterior surface point #2 of the 316 SS sample fitting. The primary elements are chromium, manganese, molybdenum, iron, nickel, copper, and silicon, with wt% values shown in Table 5. All the elements appear to be close to their original values except for iron and nickel, which have significantly lower values. Since this is the outside surface, exposed to air, it is hypothesized those elements are being oxidized and over time being eroded away. This hypothesis is also supported by the high oxygen peak observed in Figure 15. The copper is most likely from the high-temperature copper-based anti-seize lubricant applied to the threads of the fitting during the original assembly. The iron and nickel have been reduced 42.2% and 24.4%, respectively, which is a sizeable loss and could lead to structure changes currently or in the future.

Figure 15: Raw EDS Results from 316 SS Fitting at Analysis Point #2 for the Fitting Exterior Surface

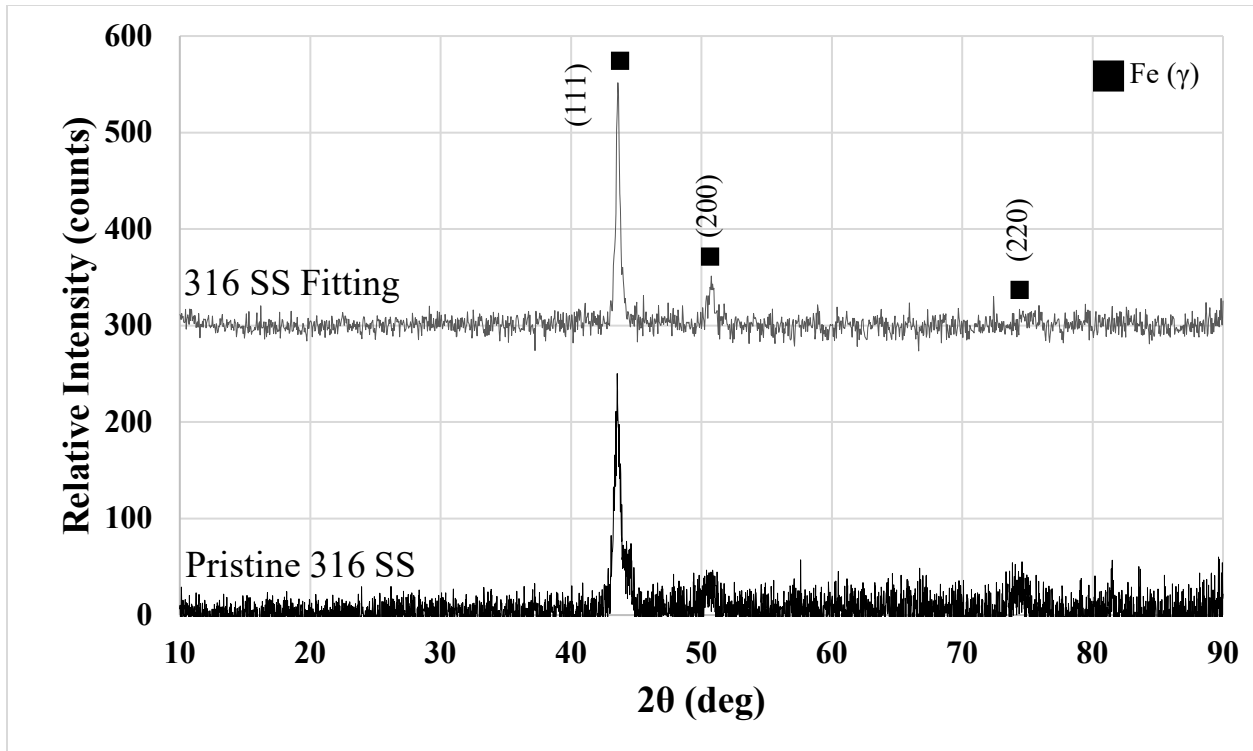
Figure 16 details the raw XRD measurements from both a pristine 316 SS sample (bottom) and the 316 SS fitting used for analysis points #1 and #2 (top), shown above. The contaminated fitting was analyzed across the cross-section cut where the interior (with metal-sulfide compounds) was exposed. The pristine sample had four peaks located at 43.54° , 44.52° , 50.74° and 74.08° 2θ . The miller indices, taken from literature [3], are shown below in Figure 16. Literature [3] also assigned the 44.52° peak as a combination of iron, chromium and nickel. Literature [3] does show that the 44.52° and 74.08° peaks can become diminished over time after a lengthy period of mechanical work has been applied.

The fitting sample had nearly the same peaks as the pristine sample except the 44.52° and 74.08° 2θ peaks were not visible, either because they were eliminated, or they became smaller than the background noise. The increased operating temperatures used in this paper could have resulted in the sample becoming more amorphous, as mechanical work does produce localized heat. Another possibility could be small amounts of contaminants diffused into the metal (undetected to the EDS) and reduced the crystallinity of the sample. Overall, the peak intensity ratios between the remaining two peaks stayed close for both samples, so the overall material crystal structure stayed otherwise similar.

Figure 16: Raw XRD Results for Pristine 316 SS and Sample Fitting

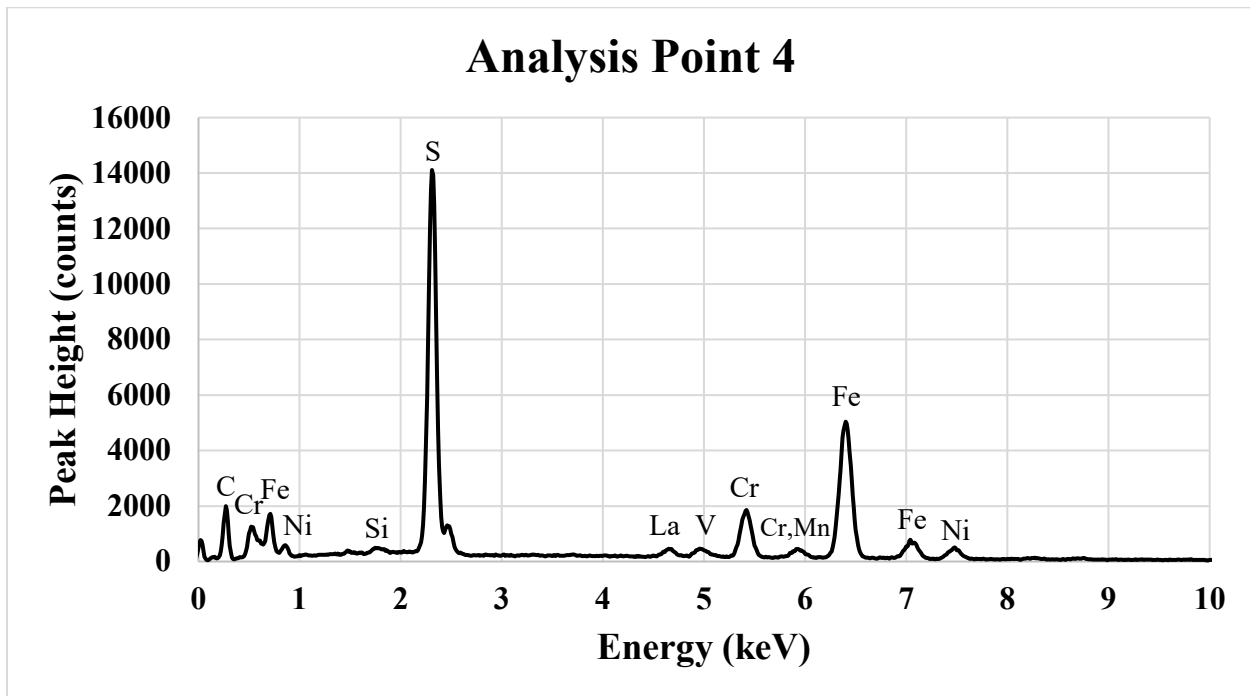
Figure 21 details the raw EDS results from the surface point #4 of the 316 SS tube sample. For this analysis point the exterior and interior surfaces of the tube are considered the same for the following reasons. First, the temperature gradient between the interior and exterior would be very small since the entire tube was inside the reactor. Second, the atmosphere would be the same for both surfaces since the H₂S gas concentration was very similar. The primary elements are chromium, manganese, sulfur, molybdenum, iron, nickel, silicon, lanthanum, strontium and vanadium, with wt% values shown in Table 8. The first thing to address is the presence of lanthanum, strontium and vanadium. Those elements are present on the surface since the tube was placed inside the LSV powder for optimal gas dispersal through the powder, so small amounts of those elements is expected. As observed previously there are a few metals that have lower wt% values, such as chromium, iron and nickel. Those were reduced by 42.3%, 30.8% and 53.2%, respectively. As observed with the 316 SS fitting, those elements, along with the high level of sulfur, are hypothesized to have formed a metal-sulfide surface layer.

Figure 21: Raw EDS Results from 316 SS Tube at Analysis Point #4 for the Tube Surface

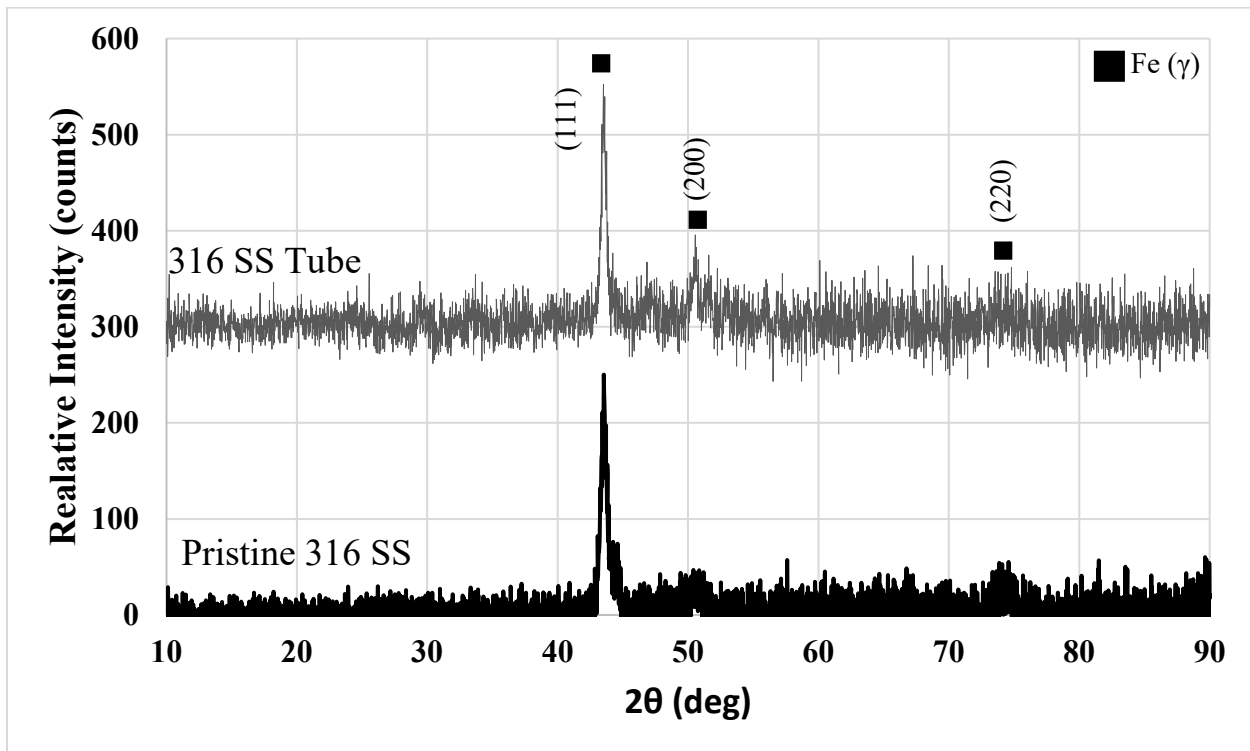
Figure 22 details the raw XRD results from both a pristine 316 SS sample (bottom) and the 316 SS tube used for analysis points 3 and 4 (top), shown above. Analysis of the tube, compared to the reference pristine 316 SS sample, was nearly identical as with the fitting sample. The only significant difference was the peak ratio between the 50.74° peak and the main peak increased, which indicates the sample was more amorphous than the fitting sample. This makes sense since the tube was exposed to higher temperatures inside the reactor compared to the fitting on the top of the lid, which was not directly heated by the heat tape.

Figure 22: Raw XRD Results for Pristine 316 SS and Sample Tube

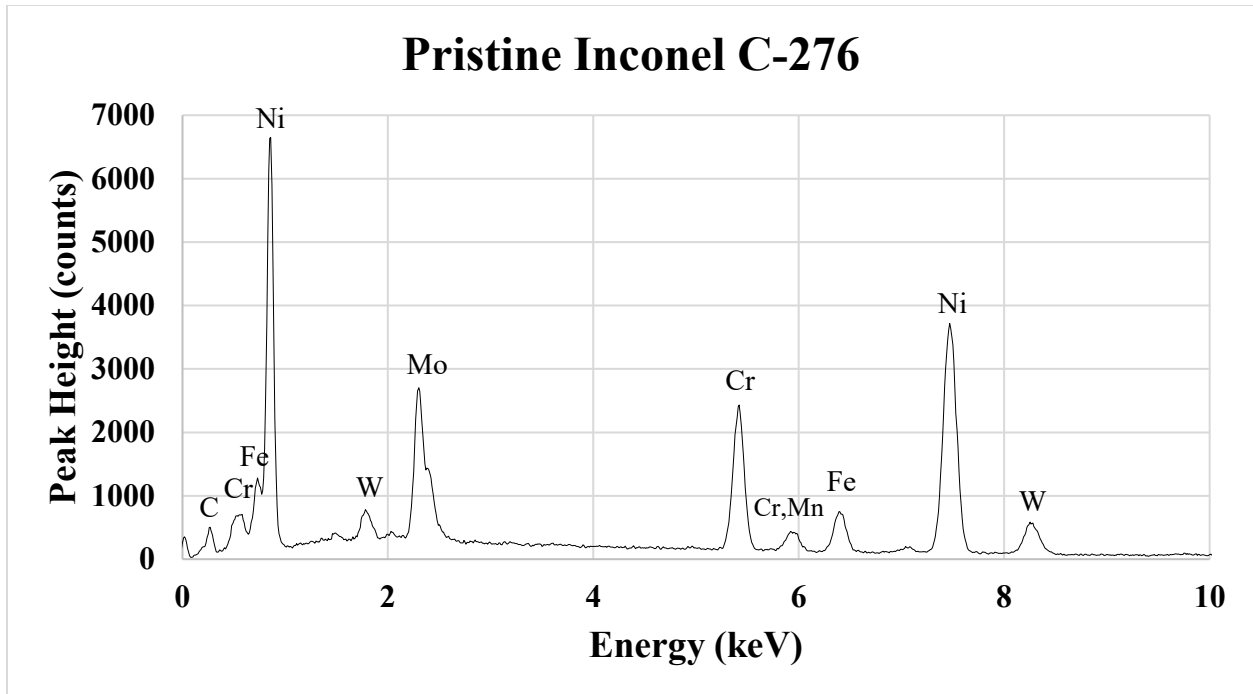
Table 10 details the element composition range reported online for pristine Inconel C-276. Comparing the elemental composition calculated from Figure 24 (reported in Table 9) against these reported values details the pristine Inconel sample is the same.

Figure 24: Raw EDS Results from Pristine Inconel C-276

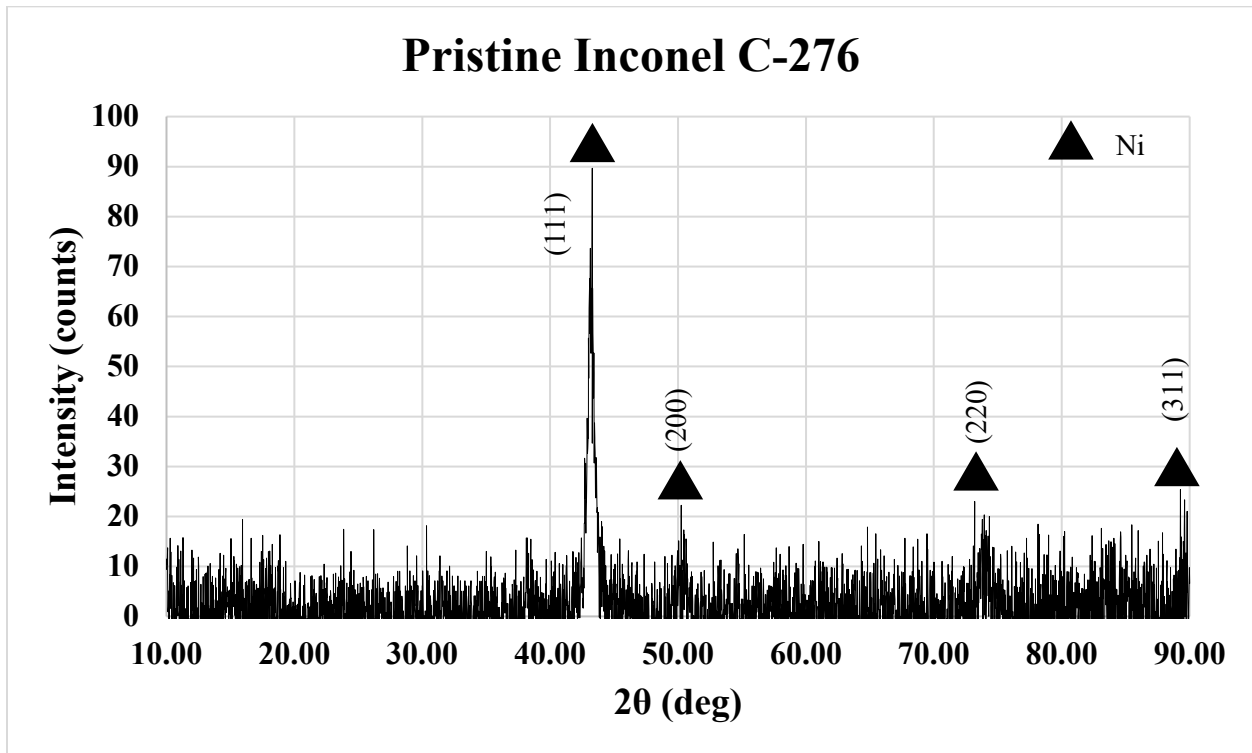
Figure 25 details the raw XRD results for the pristine Inconel C-276. The peaks are from nickel and the (111) peak is the most intense peak. While the peaks shown below are fairly well defined their intensity is lower than other pure Inconel studies found in literature. The lower peak intensity values found in the pristine reference, shown here, was probably due to either a smaller sample size used or a shorter scanning duration, compared to samples found in literature. All samples in this study were characterized using XRD for 40 minutes, which is typically adequate. Otherwise, this XRD data is consistent with other literature studies for peak positions and peak intensity ratios.

Figure 25: Raw XRD Results for Pristine Inconel C-276

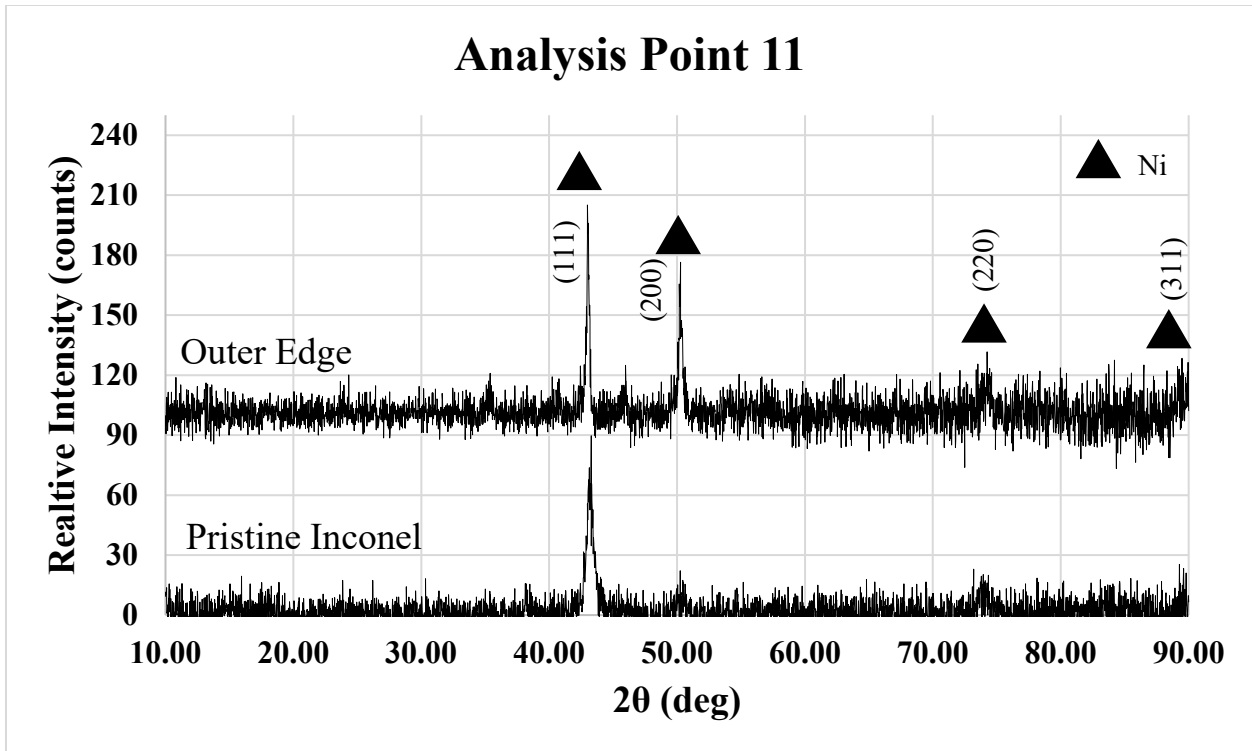
Figure 28 details the raw XRD results from both a pristine Inconel sample (bottom) and the outer edge used for analysis point #11, shown above. Analysis point #11 is similar to the untested sample, but does have two noticeable differences. First, the peak positions shifted to a slightly lower 2θ position, which indicates their lattice parameters changed. This is not surprising considering the change in elemental composition shown with the EDS results. Second, the (200) peak has considerably higher intensity compared to the pristine sample.

Figure 28: Raw XRD Results for Pristine Inconel and Outer Edge Sample

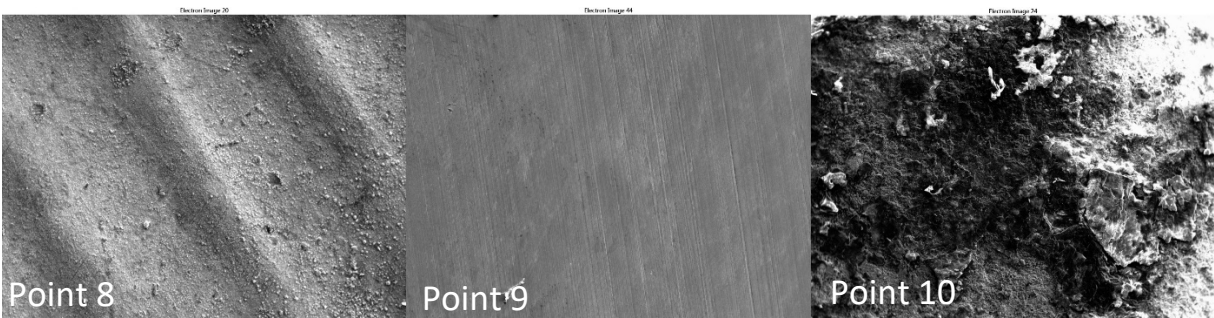
The following figures show the combined SEM, EDS and XRD results from analysis points #8, 9 and 10 since they all were taken from the same radial position with just different sample depths. Figure 29 details the SEM micrographs for the Inconel lid sample at analysis point #8 (left), #9 (middle) and #10 (right). Analysis point #8 is from the top surface and also details a coating of some type. Analysis point #9 was located in the center of the lid and appears smooth with small lines from the cutting saw. Finally, analysis point #10 is from the underside of the lid where a vermiculite seal was used and where the sulfur and LSV powder were exposed to the Inconel. The surface is coated with a large number of rough deposits.

Figure 29: Analysis Points #8 (left), #9 (middle) and #10 (right) SEM Micrograph of Inconel Lid

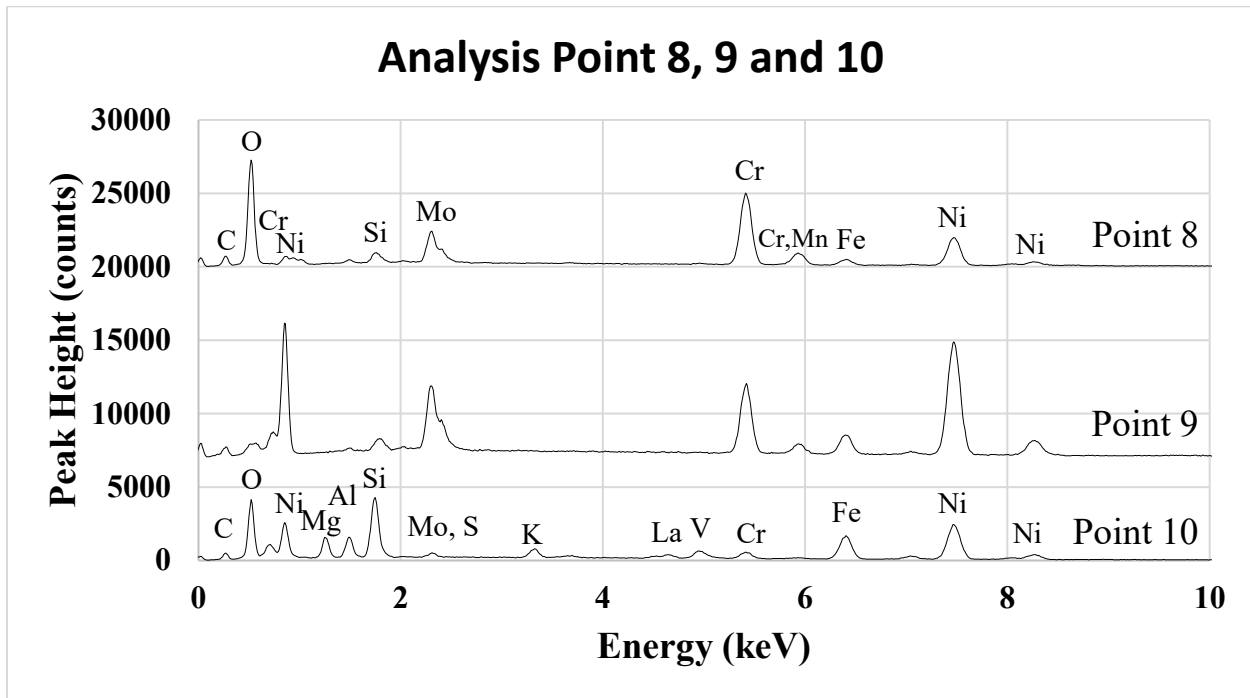
silicon. Point #9 had elemental concentrations that were consistent with the pristine Inconel sample, which details the contaminants or high operating temperatures did not elementally change the interior of this radial position. Point #10 at the bottom is a mixture of multiple elements and is very difficult to separate. The high silicon, magnesium and iron are consistent with the composition of the vermiculite used in the seal between the body and lid. The lower concentrations of nickel, chromium and molybdenum are hypothesized to be from the vermiculite masking those elements in the Inconel.

Figure 30: Raw EDS Results from Inconel Lid at Analysis Point #8, #9 and #10

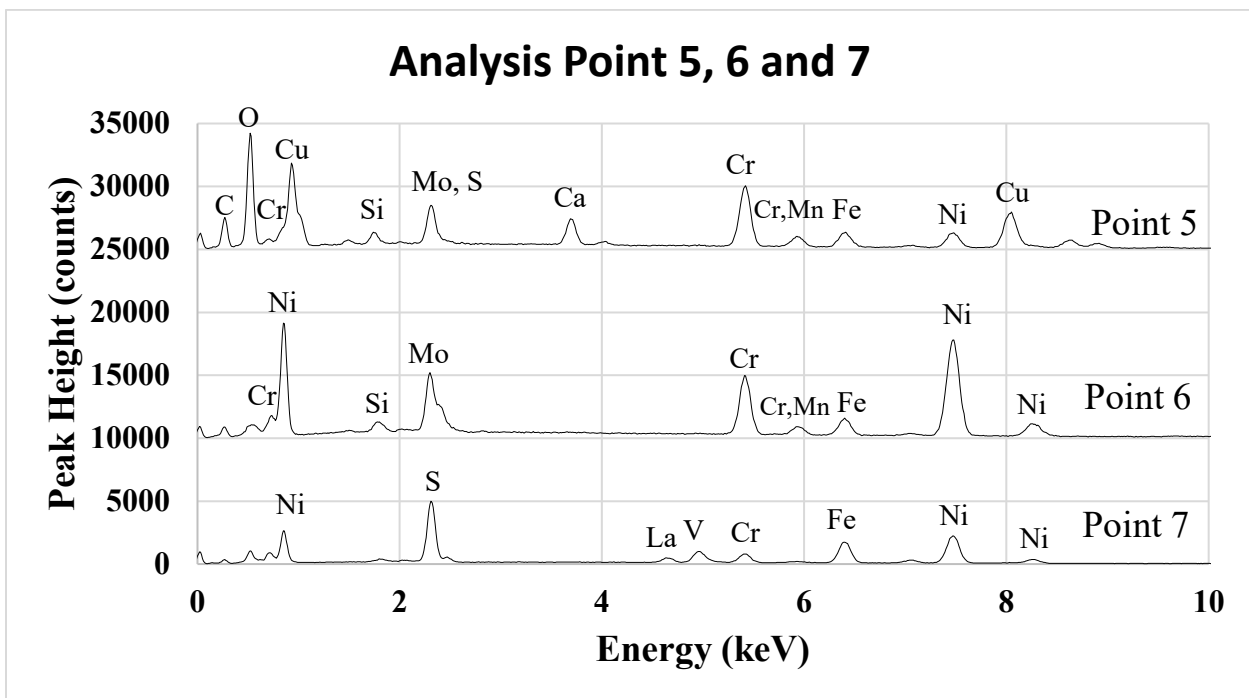
Figure 33 details the raw EDS results from the analysis points #5 (top), #6 (middle) and #7 (bottom). The wt% values calculated from these samples are shown below in Table 13. These results, again, are similar to the EDS analysis of points #8, #9 and #10. Similarities between both datasets can be seen through both top surfaces are dominated by oxygen and chromium, while the center is similar to the pristine Inconel sample. There are differences, which include copper on the top surface and high sulfur content (instead of an oxygen/silicon rich surface) on the bottom. The copper is attributed from the anti-seize compound used for the 316 stainless steel fittings, and the sulfur is from the H₂S gas used.

Figure 33: Raw EDS Results from Inconel Lid at Analysis Point #5, #6 and #7

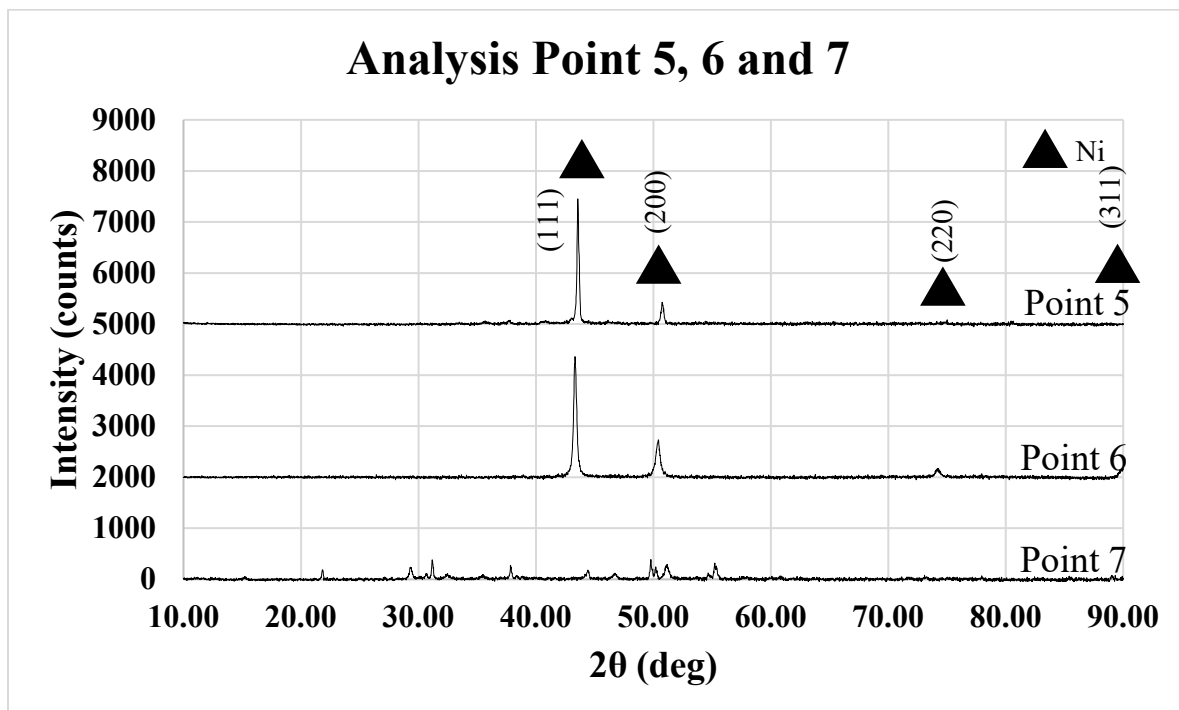
Figure 34 details the raw XRD results from analysis points #5 (top), #6 (middle) and #7 (bottom). Overall, the results here are very similar to the XRD results shown in Figure 31. Differences between points #7 and #10 is the former did not have vermiculite, but was exposed to sulfur, and the latter had vermiculite and less sulfur. Peaks were not labeled since there are many possible compounds present and would be difficult to separate.

Figure 34: Raw XRD Results Analysis Points 5,6 and 7

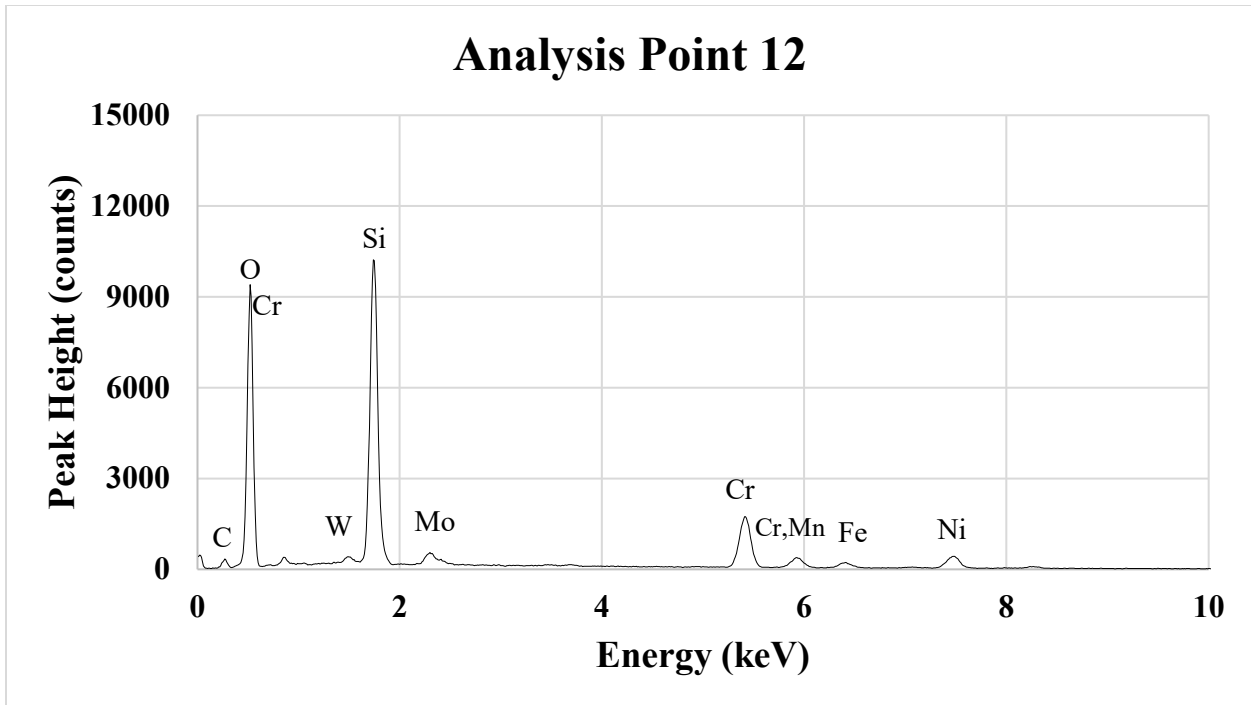
Figure 36 details the raw EDS results from analysis point #12. The wt% values calculated from these samples are shown below in Table 14. Unlike with the previous samples exposed to air this surface has significantly higher levels of silicon than before. The chromium is still significantly elevated from the pristine Inconel sample, but the silicon here dominates. The coating observed in the SEM image is very likely a silicate of some type or simply silicon dioxide.

Figure 36: Raw EDS Results from Inconel Body Outer Wall at Analysis Point #12

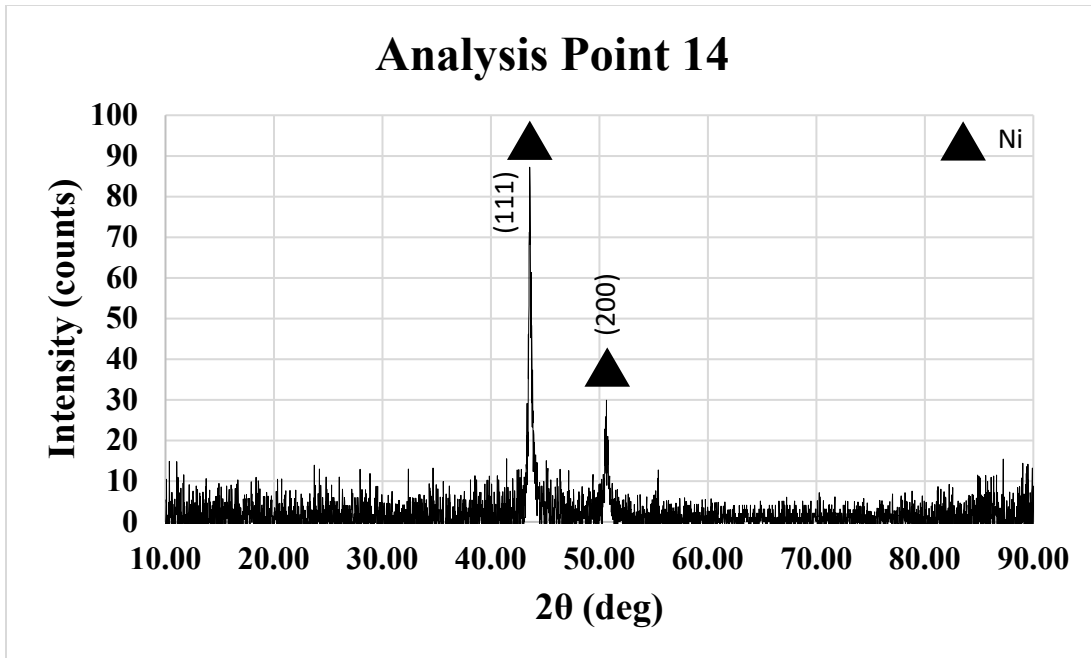
Figure 43: Raw XRD Results Analysis Point 14

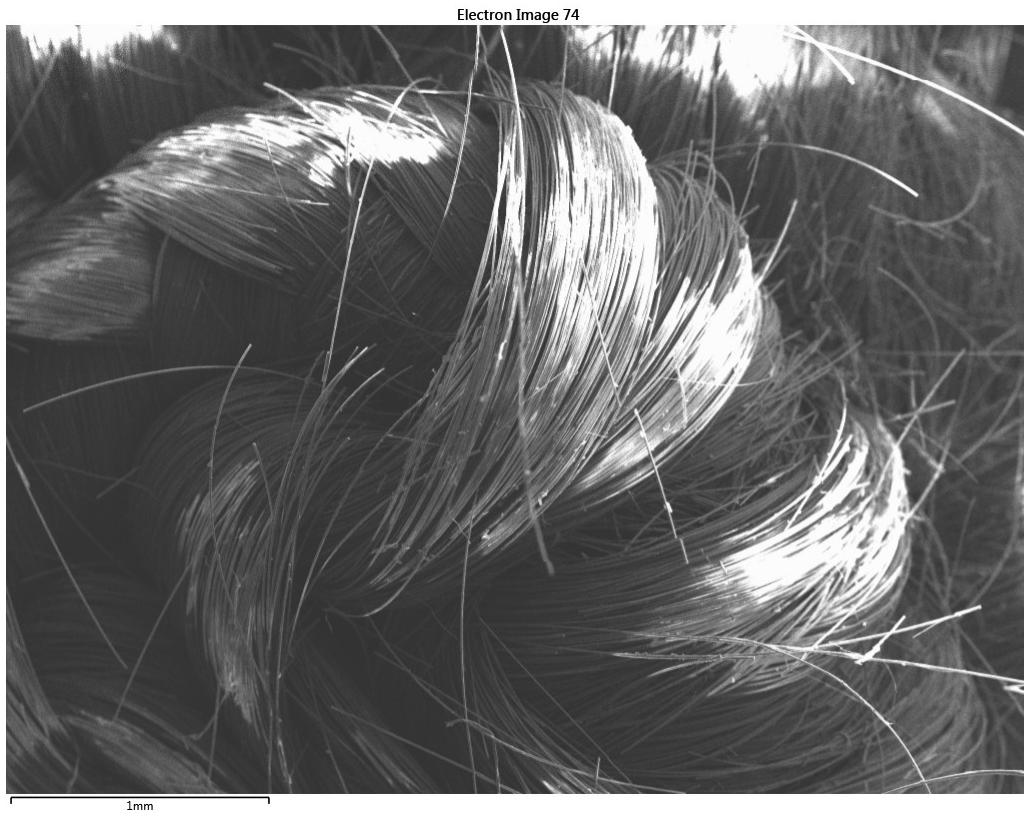
Figure 47: SEM Micrograph of Heat Tape

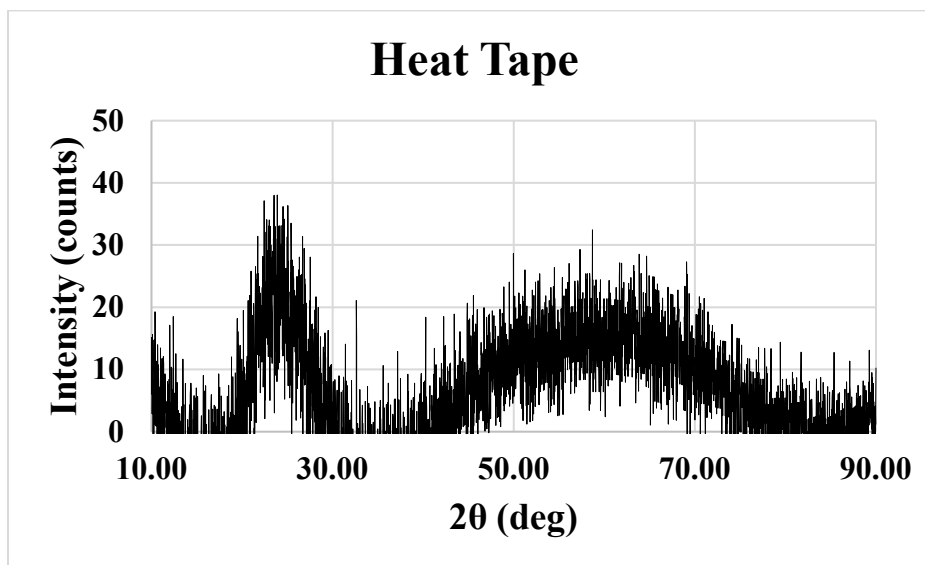
Figure 49: Raw XRD Results for Heat Tape
