NRL Report No. R-2160  
BuShips Prob. 335 T-C

SYSTEMS TESTS OF THE SL RADAR

Authorization: BuShips ltr. C-S67/36(435-1a) Serial C-485-6016 of 19 November 1942.

Date of Tests: 3 March 1943 to 29 April 1943, 9 January 1943 to 6 February 1943, and 11 January 1943 to 5 March 1943.

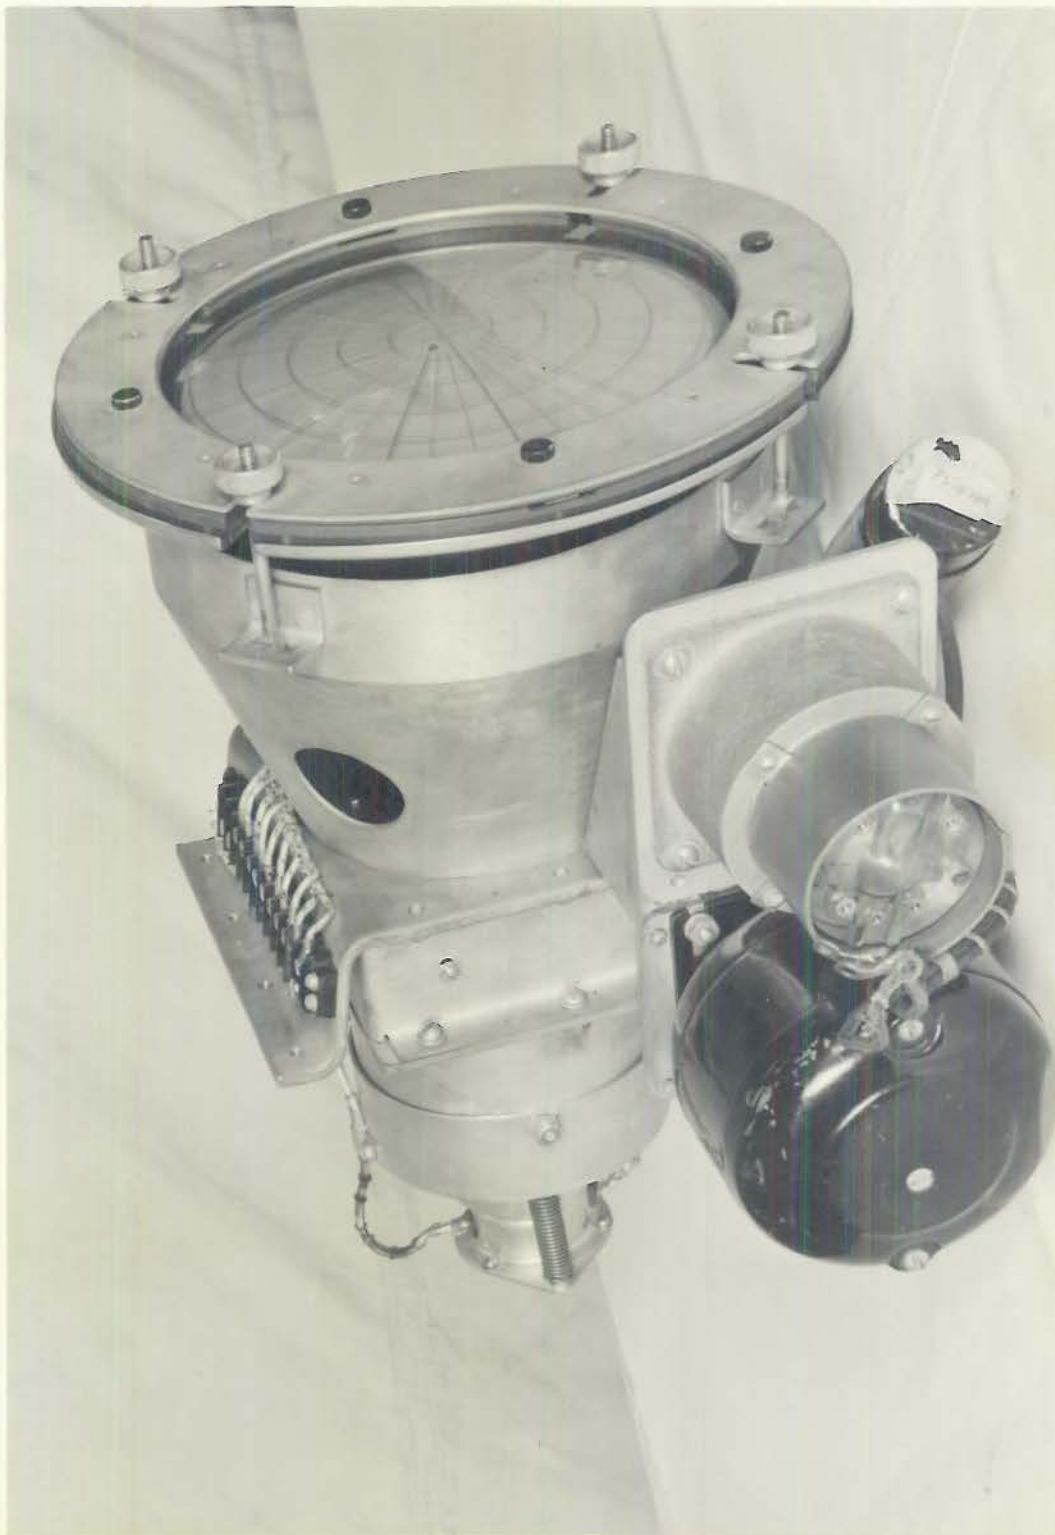
PLATE 206 SEC.3

3-4-2. Results of Tests - Operation of the receiver and indicator appeared to be normal throughout all forty-eight shocks with the exception of one feature. The position of the cathode-ray deflecting coil changed relative to the antenna, causing the azimuth mark to appear in an incorrect position. The error increased as much as 7° after some shocks. A failure as a result of shock was later found in the cathode-ray deflecting coil assembly. The bearing ring, shown at the left on plates 201 and 202 was firmly clamped in place, but the deflecting coil assembly shown at the right had dropped about 1/8 inch so that it rested on the focus coil assembly. This was possible because the deflecting coil assembly depended on friction with the inner ring of the bearing for support. Subsequent rotation during the temperature and humidity tests caused the scoring on the deflecting coil and focus coil assemblies shown on plate 203. Other views of the cathode-ray tube assembly are shown on plates 204, 205, 206 and 207.

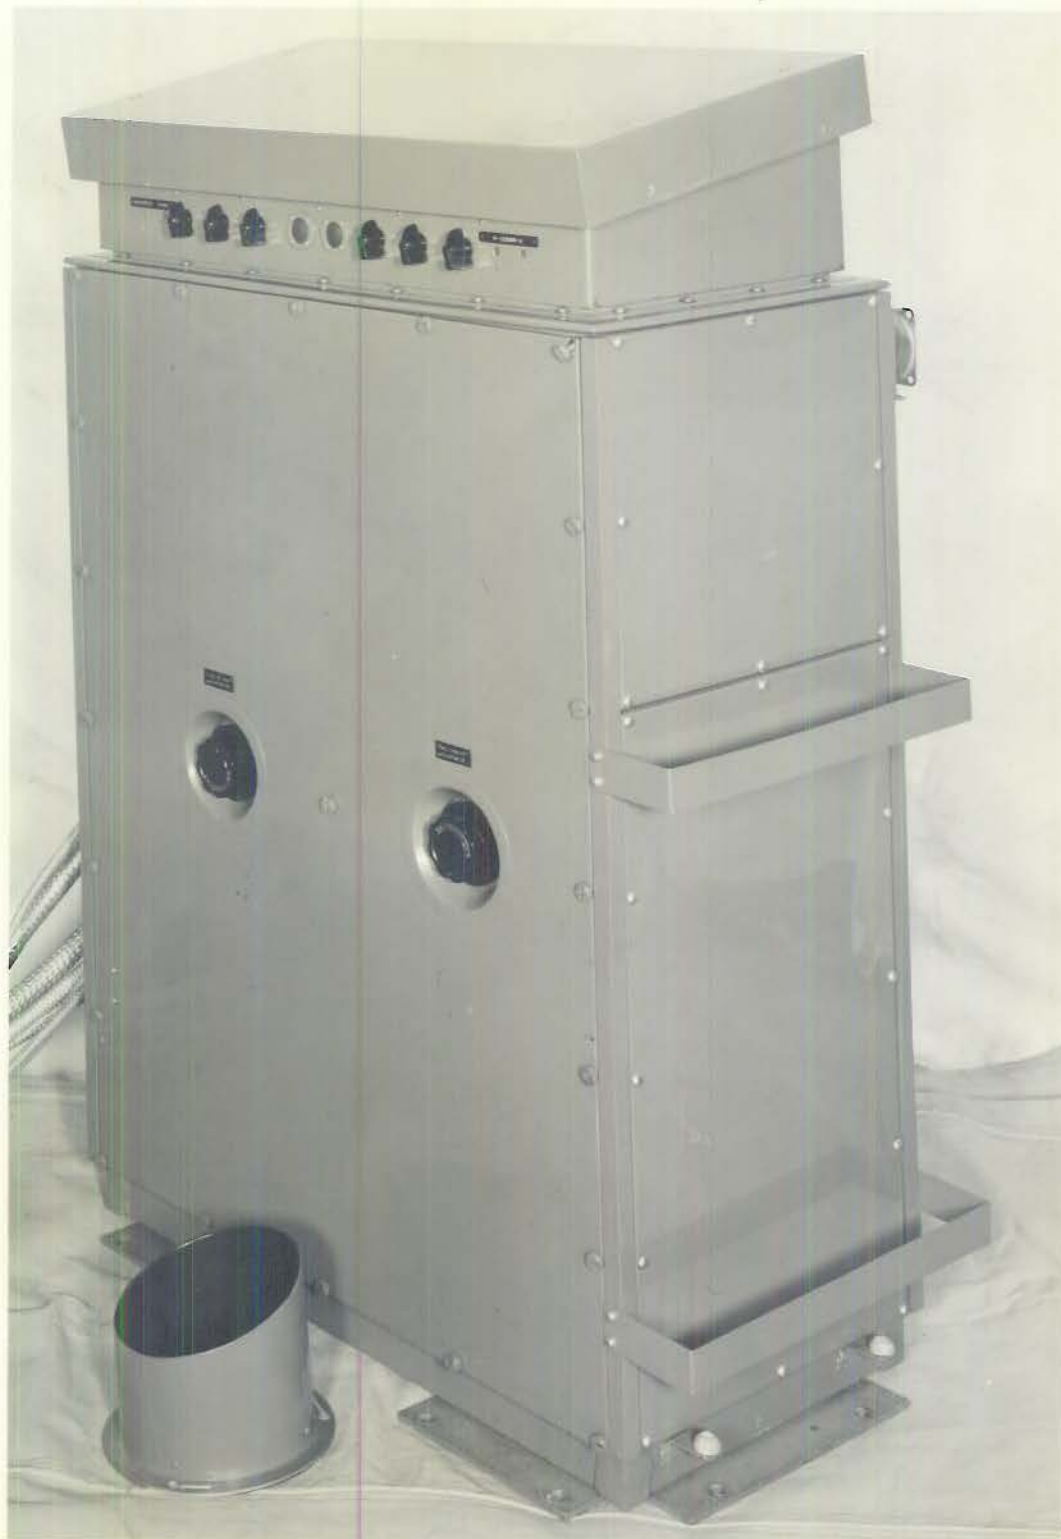
PLATE 215 SEC.3

- 3-17-1. Converter-Oscillator-Amplifier - These parts are located in the R-F Unit and are accessible through the removable side of that unit, as shown on plates 208 and 209. The chassis containing the beat oscillator and first two i-f amplifier stages can be removed from its cabinet by loosening the two front panel thumb screws, thus making the chassis readily available for servicing. Other views of this chassis are shown on plates 210, 211, 212, and 213. The crystal converter and TR box assembly are shown in place, mounted on the waveguide by plates 208 and 209. The partially disassembled components are shown on plate 214. All parts are accessible and replacements can be made readily. The R-F Unit, with the cover in place, is shown on plate 215.
