NRL Report No. M-2163

Second Partial Report

N.R.L. Shock-Fracture Test for Welded Joints  
in Connection with Welding Test #302

NAVAL RESEARCH LABORATORY  
ANACOSTIA STATION  
WASHINGTON, D. C.

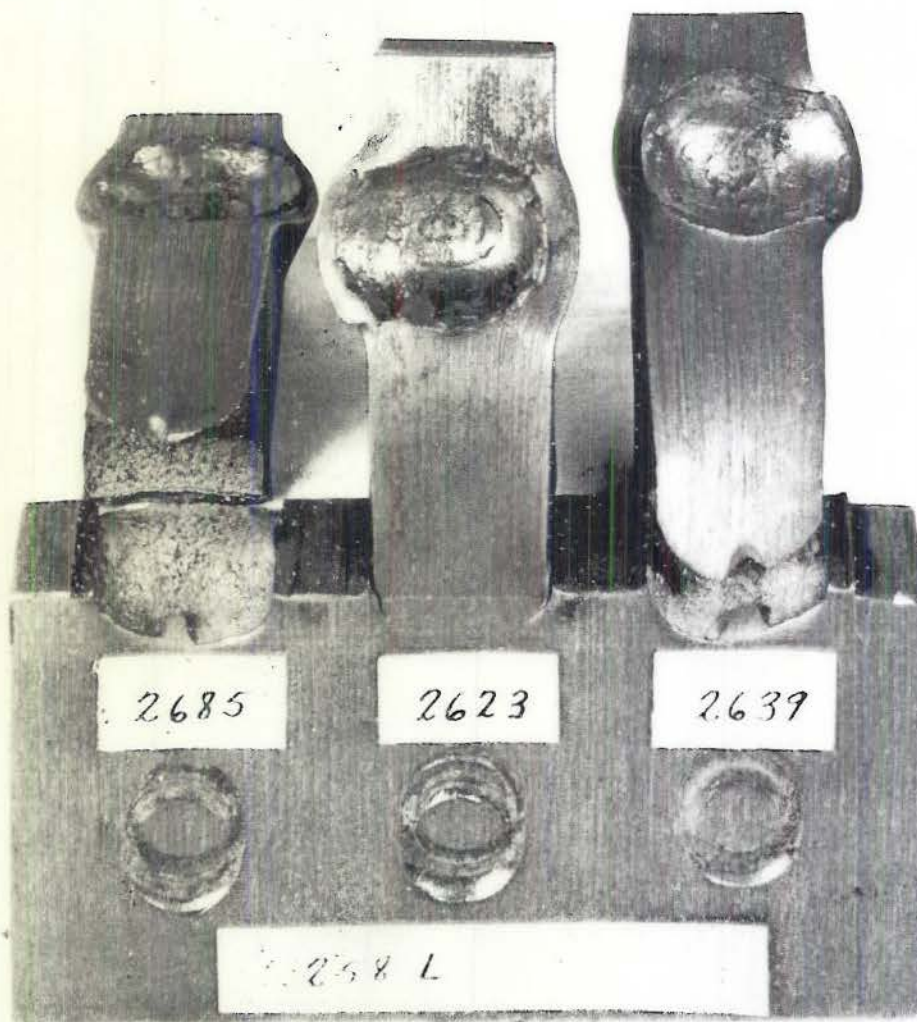
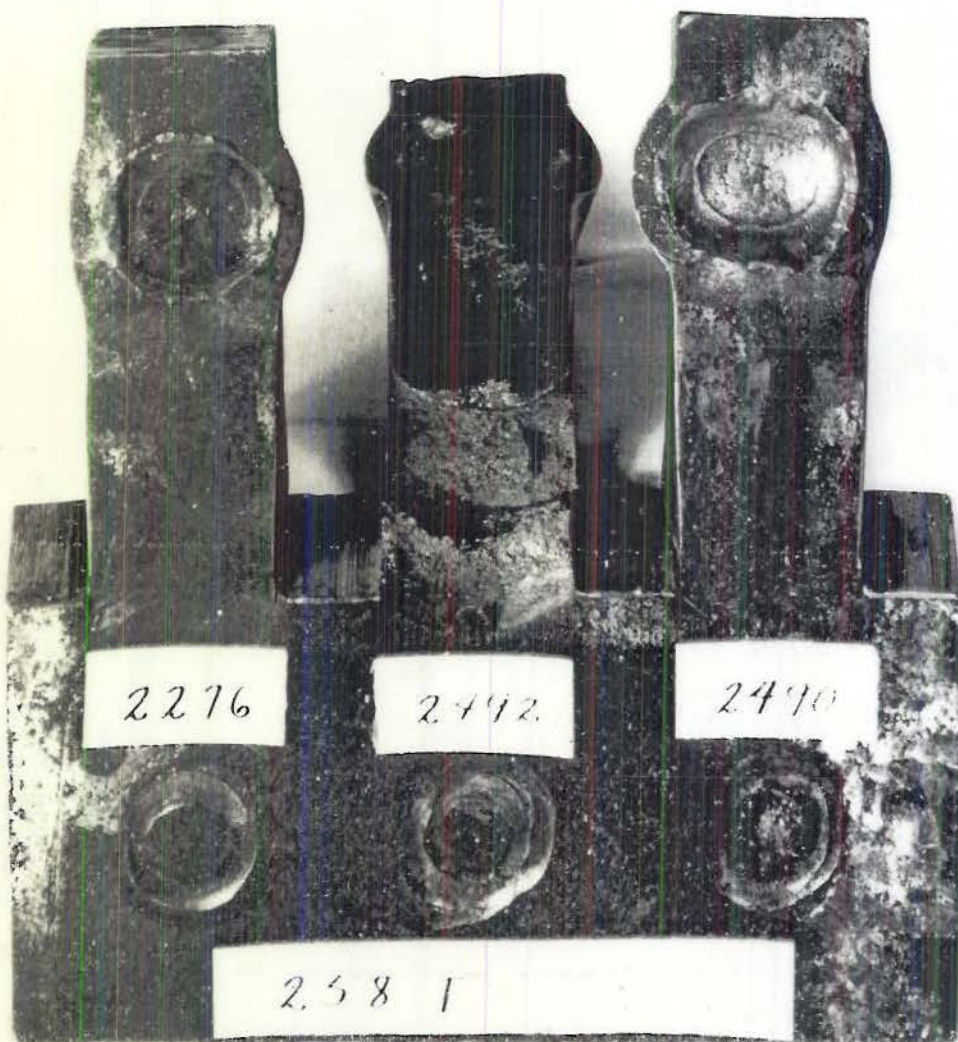
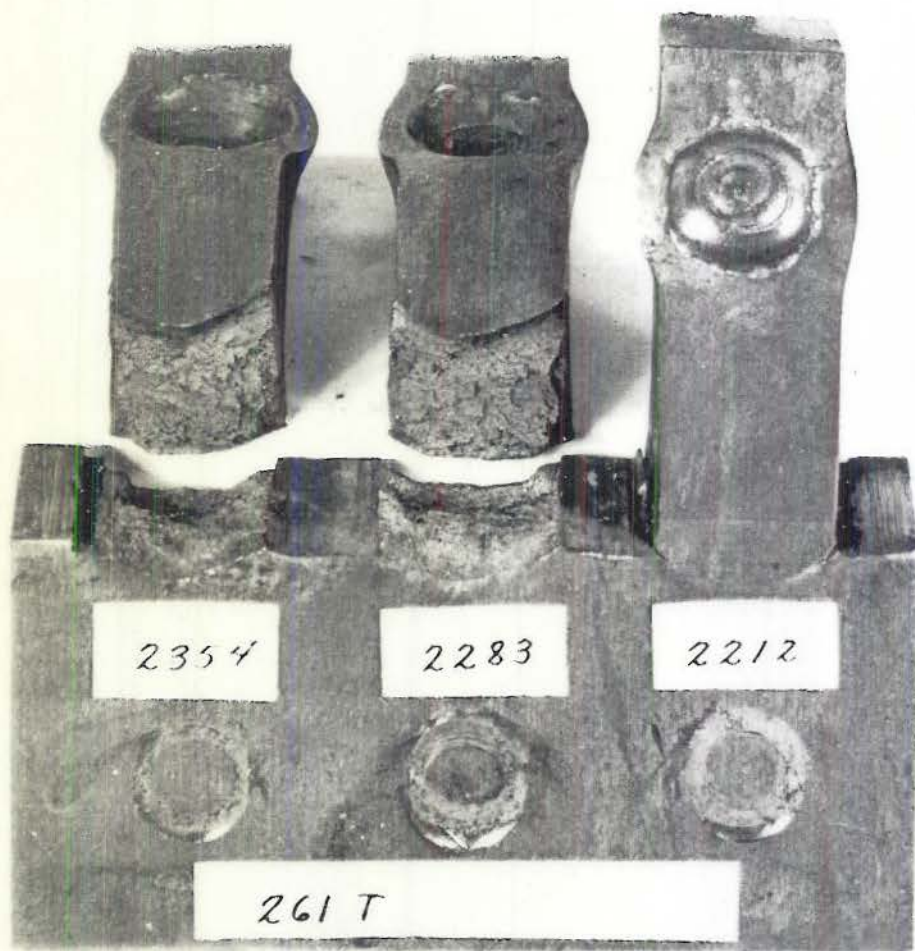
261 T

Results of shock fracture tests on low alloy ballistic steel #258(302-M-1), special treatment steel #261(302-N-1) and special treatment steel #206 (Data from NRL Report M-2050) are given in Table IV and Plates 4 to 7. For similar hardness values the specimens with the fingers in the direction of rolling had considerably higher limit velocities than those in the transverse direction. The limit velocities for longitudinal specimens of the three materials indicate that they had approximately the same shock-fracture resistance; greater variations in the limit velocities were noted for the transverse specimens.

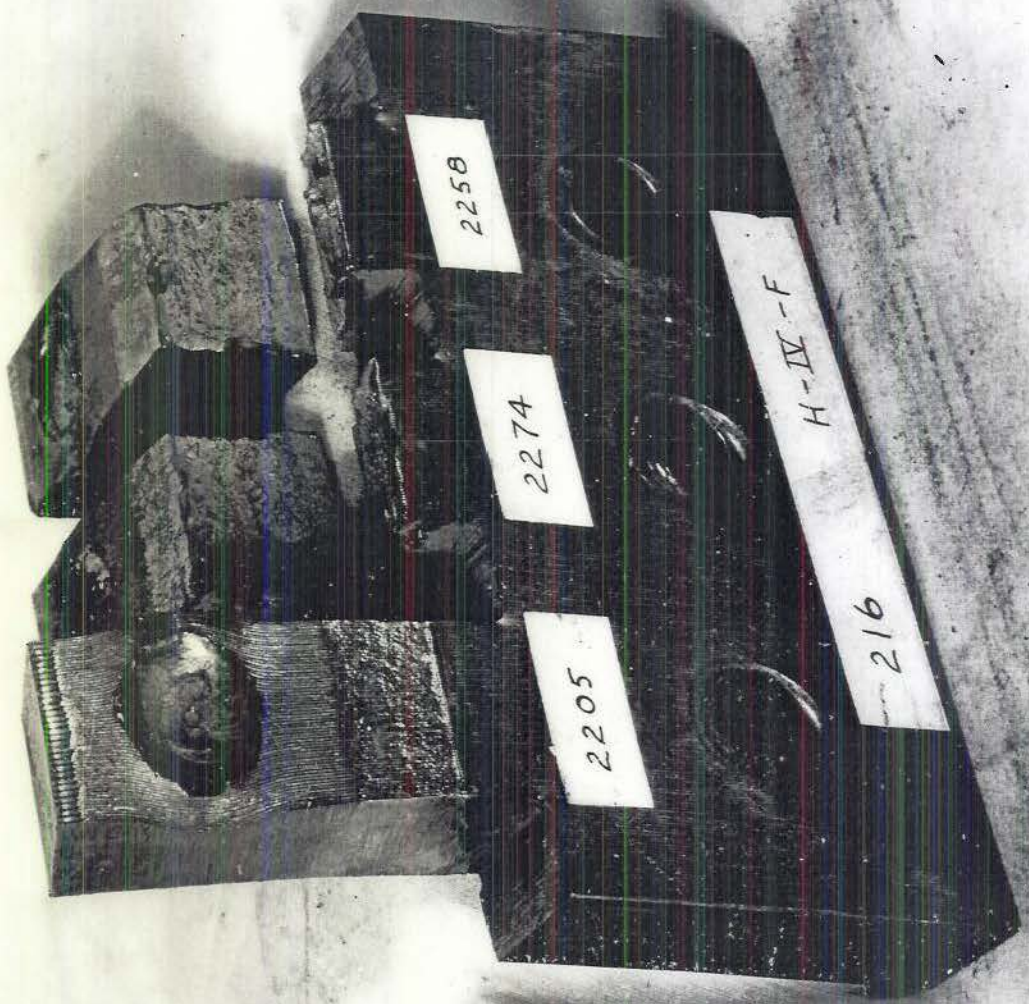
216

No. 216: Low alloy steel welded in the flat position with grade IV electrode. All fractures occurred along the fusion line and clearly showed the bead technique of the weld (Plate 8 and 13a). These fractures were typical of many of the failures for the weldments in this test.

H-IV-F

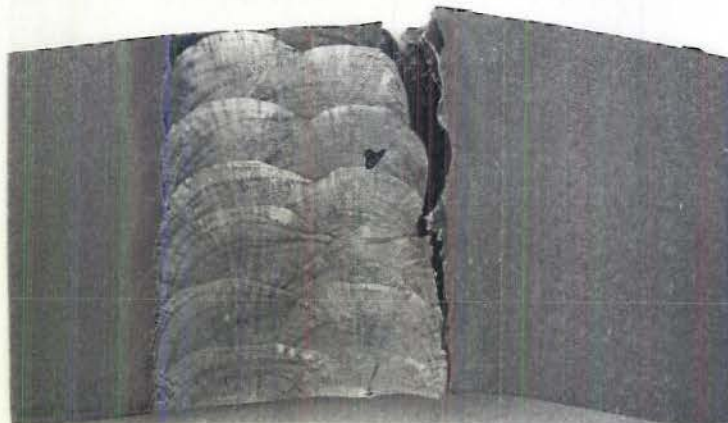
No. 222: S.T.S. armor welded in the flat position with grade V electrodes. Three of the fractures were fusion line failures similar to those of No. 216 (Plate 16 (a)). The other fracture (Impact No. 756) started at the fusion line and progressed into the weld about  $1/8$ " above the fusion line (Plate 16(b)). Some porosity was evident in these fractures. In Table I the results of the shock-fracture test of this weldment show that one ballistic specimen had a limit velocity above 2400 ft./sec. while the other two had a limit velocity of about 2000 ft./sec; this large discrepancy apparently is due to a variation in weld quality across the plate.

#222  
I-V-F  
2148 ft/sec.  
Impact 757  
(a)

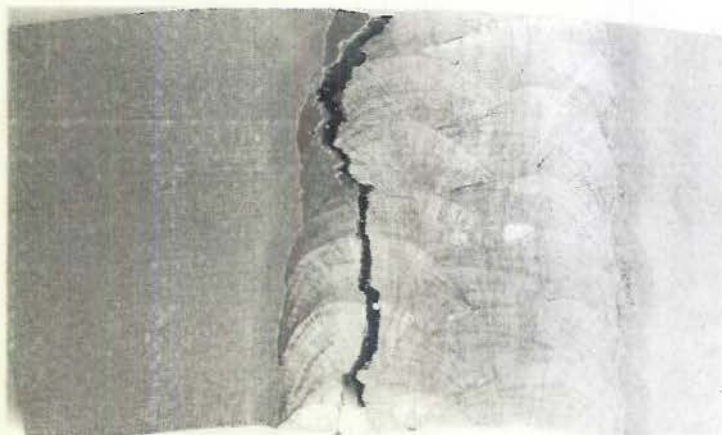
#222  
I-V-F  
2254 ft/sec.  
Impact 756  
(b)

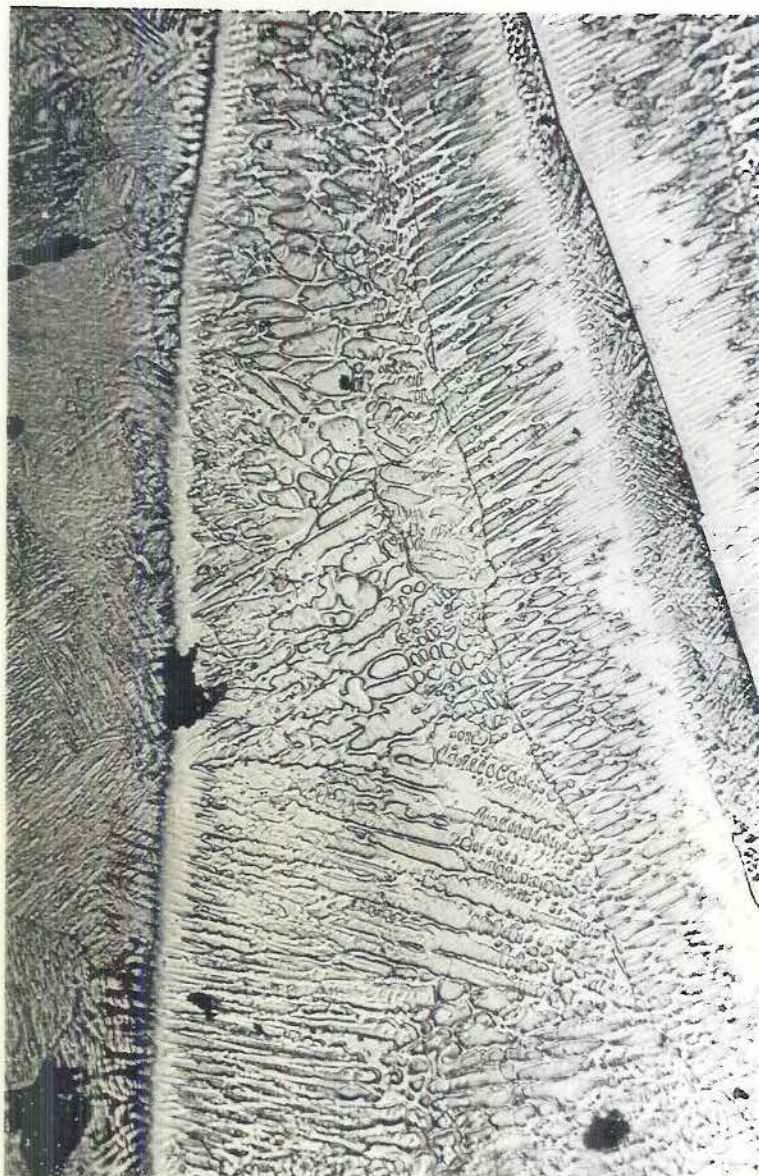
11. Metallographic specimens of the weldments were taken from Plate Nos. 216, 220 and 223. These specimens were prepared in the usual manner and etched electrolytically with 10 per cent oxalic acid to reveal the cored structure in the austenitic weld metal. A 5 per cent Nital solution was then used to etch the base metal. Examination disclosed a narrow unetched white band (approximately 0.0005" wide) which separated the weld and base metals (Plates 18 to 20). An attempt to etch this band with potassium ferricyanide was unsuccessful (Plate 19(b)). Micro-hardness surveys made with a Tukon hardness tester (.2 kg. load) indicated that the white band was of approximately the same hardness (I.H.N. 250) as the weld metal. All of the specimens exhibited a network of apparently unetched metal similar to the white band which extended into the base metal from the white band. Although most of the fractures would be considered fusion line failures, they followed the fusion line only approximately and did not coincide to any great extent with the white band. This seems to indicate that the white band was not the weakest part of the welded section (Plates 21 and 22)

#216  
H-IV-F  
275 X

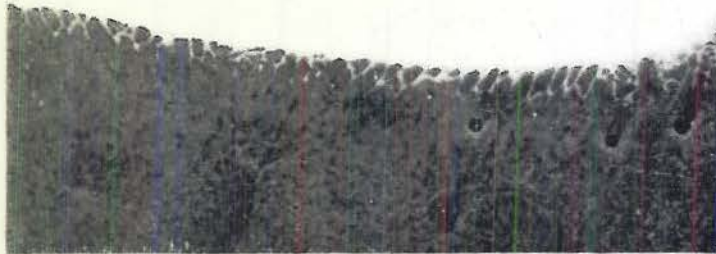
#220  
I-IV-F  
Etched Potassium  
ferricyanide and  
Potassium Hydroxide  
(b)

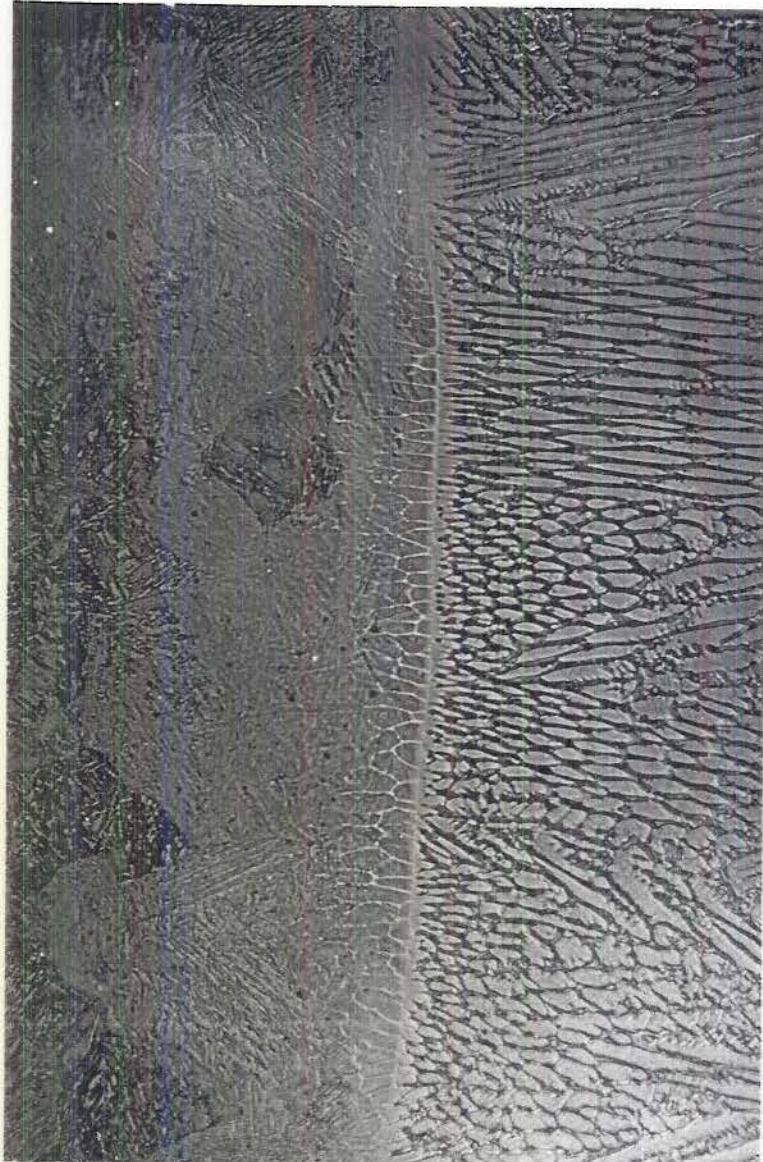
#223  
I-V-V  
Mg. 275x
