ARL-TR-9551 • SEP 2022

Results of Continuous Wave (CW) Laser Damage Measurements on Commercially Available Chalcogenide Optics at 1.07 μm

by John E McElhenny and Neal K Bambha

John E McElhenny and Neal K Bambha
DEVCOM Army Research Laboratory

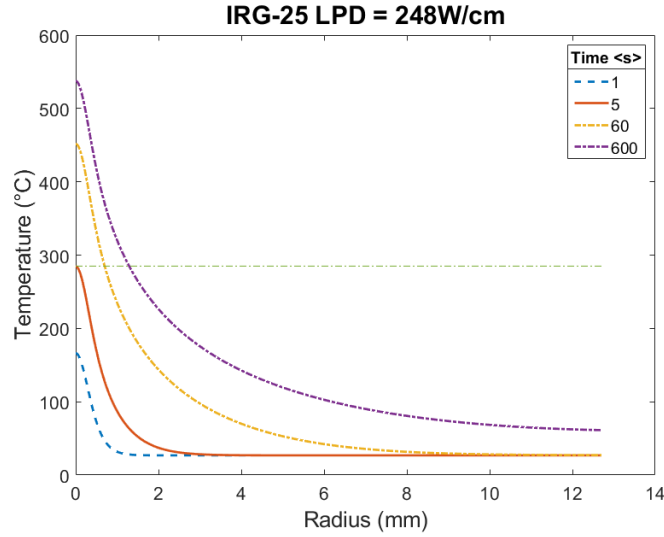
Fig. 3 Plot of temperature from the center of the IRG-25 sample to the edge for four different irradiance times with a constant LPD of 248 W/cm, the power at which the glass-transition temperature is reached after 5 s of irradiance

Once the simulated damage threshold linear power densities were determined, we also ran simulations for this fixed-LPD with varying times to get a feel for how quickly and how much the optics heated up, as can be seen for IRG-25 in Fig. 3. We see that, in this case, from 5 s to 10 min, the maximum temperature of the sample nearly doubles. Also, at only 1 s, the sample has already reached a temperature over halfway to the glass-transition temperature.

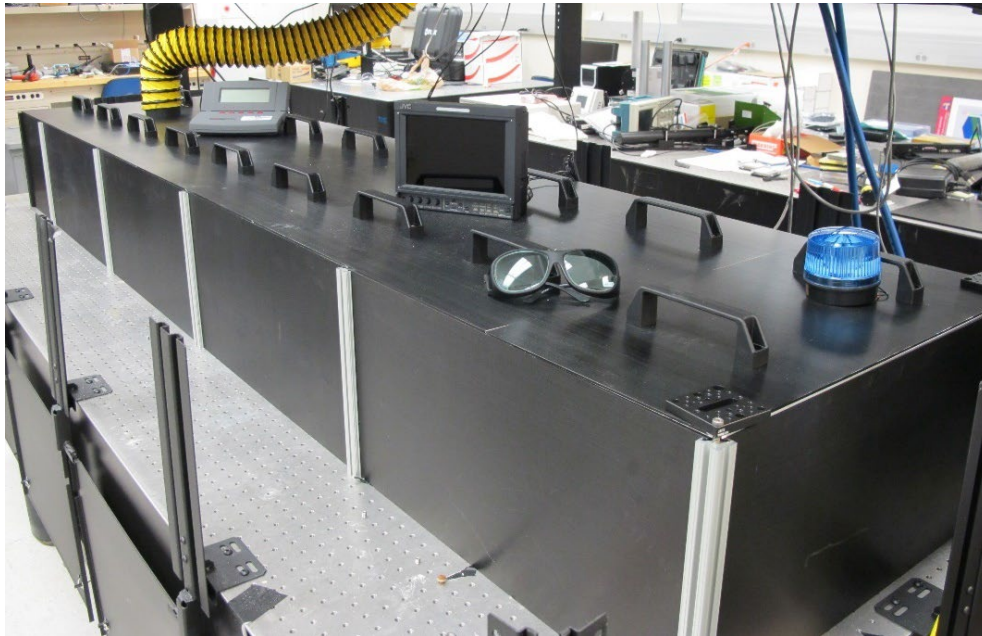
Fig. 5 KILTE

All LIDT measurements were performed in the HiPo CoW Laser Laboratory for Sensors and Optics inside the Kilowatt Interlocked Light-Tight Enclosure (KILTE) (Fig. 5). The enclosure is made of 0.25-inch-thick anodized aluminum, tested with powers up to 1 kW of 1.07- μm light focused down to roughly 200 μm for up to 100 s, and framed with 1-inch aluminum t-slotted framing.

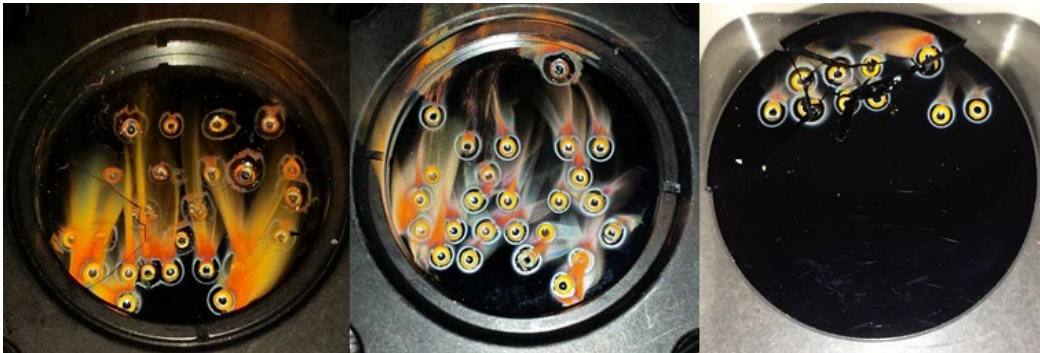
Fig. 12 Front surface of the three IRG-25 test samples after testing. Damage tests start from lower powers at the top left to higher powers at the bottom left, generally.

The powers ranged from the highest power for which no damage occurred on any of the runs (2.2 W) to the lowest power for which damage occurred on all 10 runs (2.7 W). All damage reported was large and visible to the naked eye, as can be seen in the images for each of the three samples; see Fig. 12.

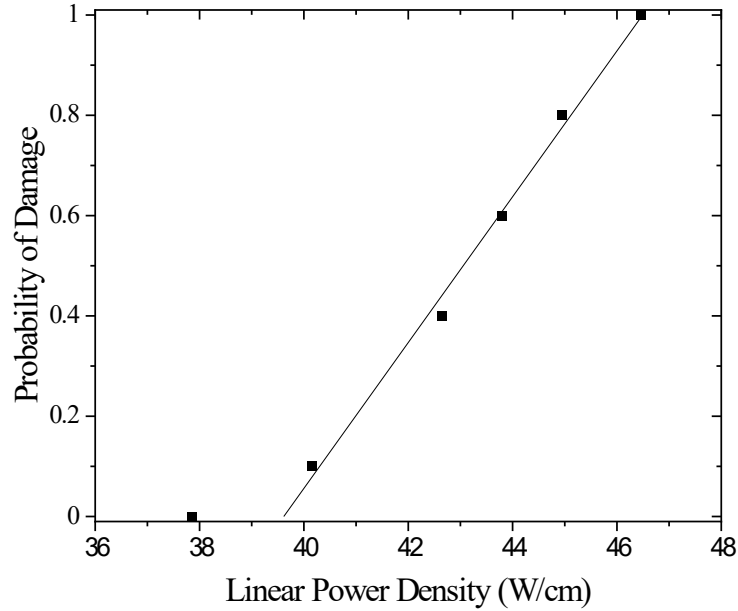
Fig. 13 Plot of the probability of damage as a function of the LPD for the SCHOTT IRG-25 window for a 587- μm effective diameter beam with a 5-s radiation time. The straight line is the linear fit of the probability, while the blocks are the probability of damage for specific LPDs.

Plotting the data (Fig. 13) and fitting it to a linear curve, we estimate the damage threshold, D_t , for an effective diameter of 587 μm and a radiation time of 5 s, to be 39.6 W/cm, and what we call the damage threshold with 90% likelihood, $D_{t,90}$, to be 45.9 W/cm. The SCHOTT IRG-25 has a much steeper threshold curve than IRG-24.

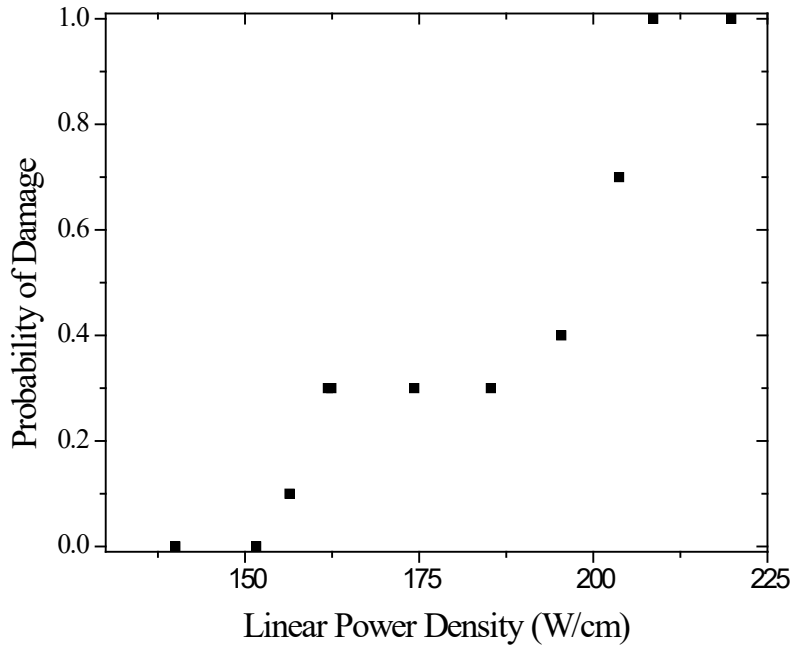
Fig. 25 Plot of the probability of damage as a function of the LPD for the Amorphous Materials Inc AMTIR-1 window for a 587- μm effective diameter beam with a 5-s radiation time. The straight line is the linear fit of the probability, while the blocks are the probability of damage for specific LPDs.

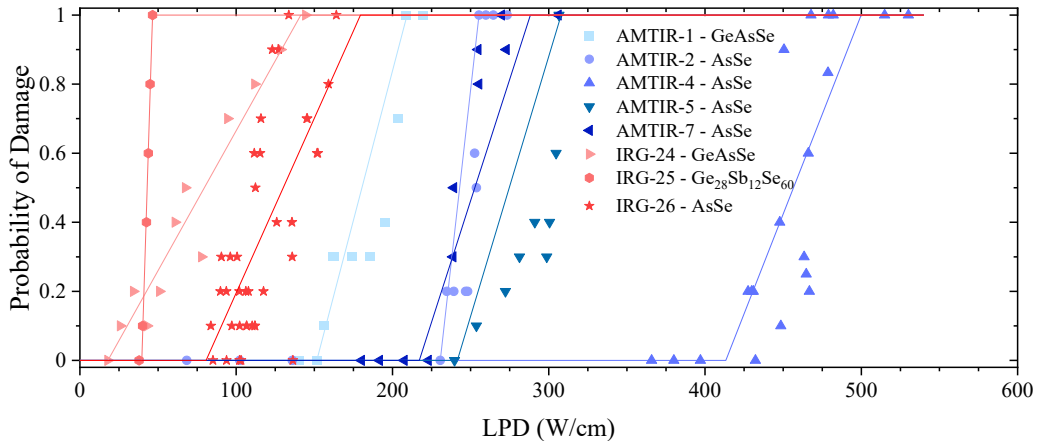
Fig. 42 Plot of the probability of damage as a function of the LPD for all samples tested, except for IRG-27 and AMTIR-6, which had a significantly higher damage threshold

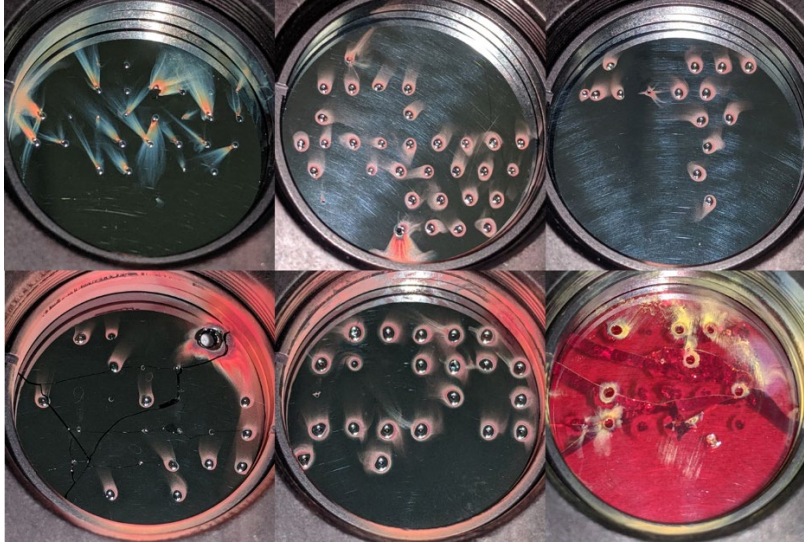
Fig. 43 Back face of the Amorphous Materials Inc ChGs. Top row, left to right: AMTIR-1, AMTIR, 2, and AMTIR-5. Bottom row, left to right: AMTIR-7, AMTIR-4, and AMTIR-6. The As-Se composition ChGs are listed in order of decreasing arsenic.

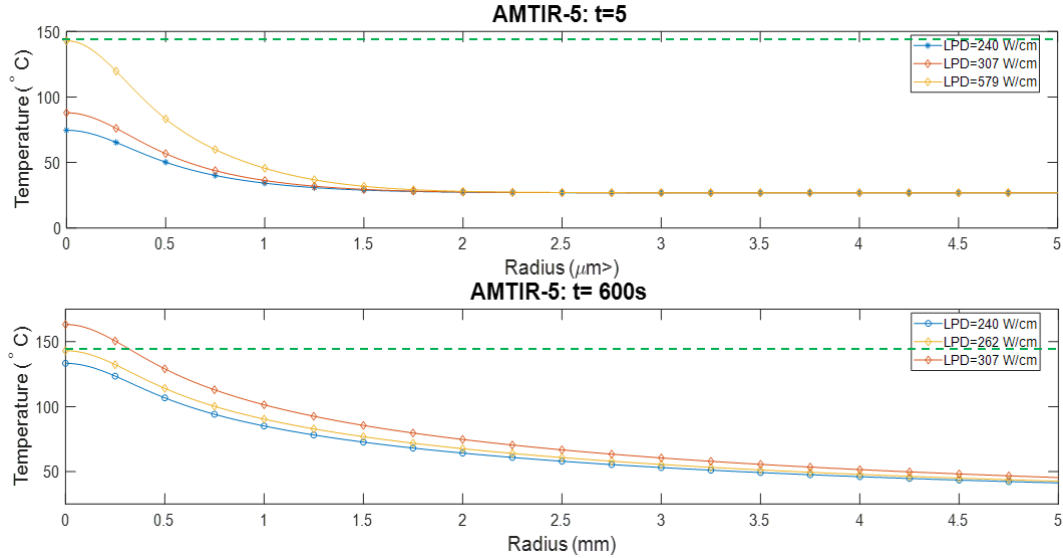
Fig. 45 Plot of temperature from the center of the AMTIR-5 sample to the edge for an irradiance time of 5 s (top) and 10 min (bottom) approaching steady state. Plot lines are for the experimental damage threshold values D_t (blue) and $D_{t,90}$ (orange) and the simulation-determined threshold values (yellow).
