White Sands Missile Range Thurgood Canyon Watershed

**Analysis of Range Road 7 for Development of Best Management Practices and
Recommendations**

September 2022

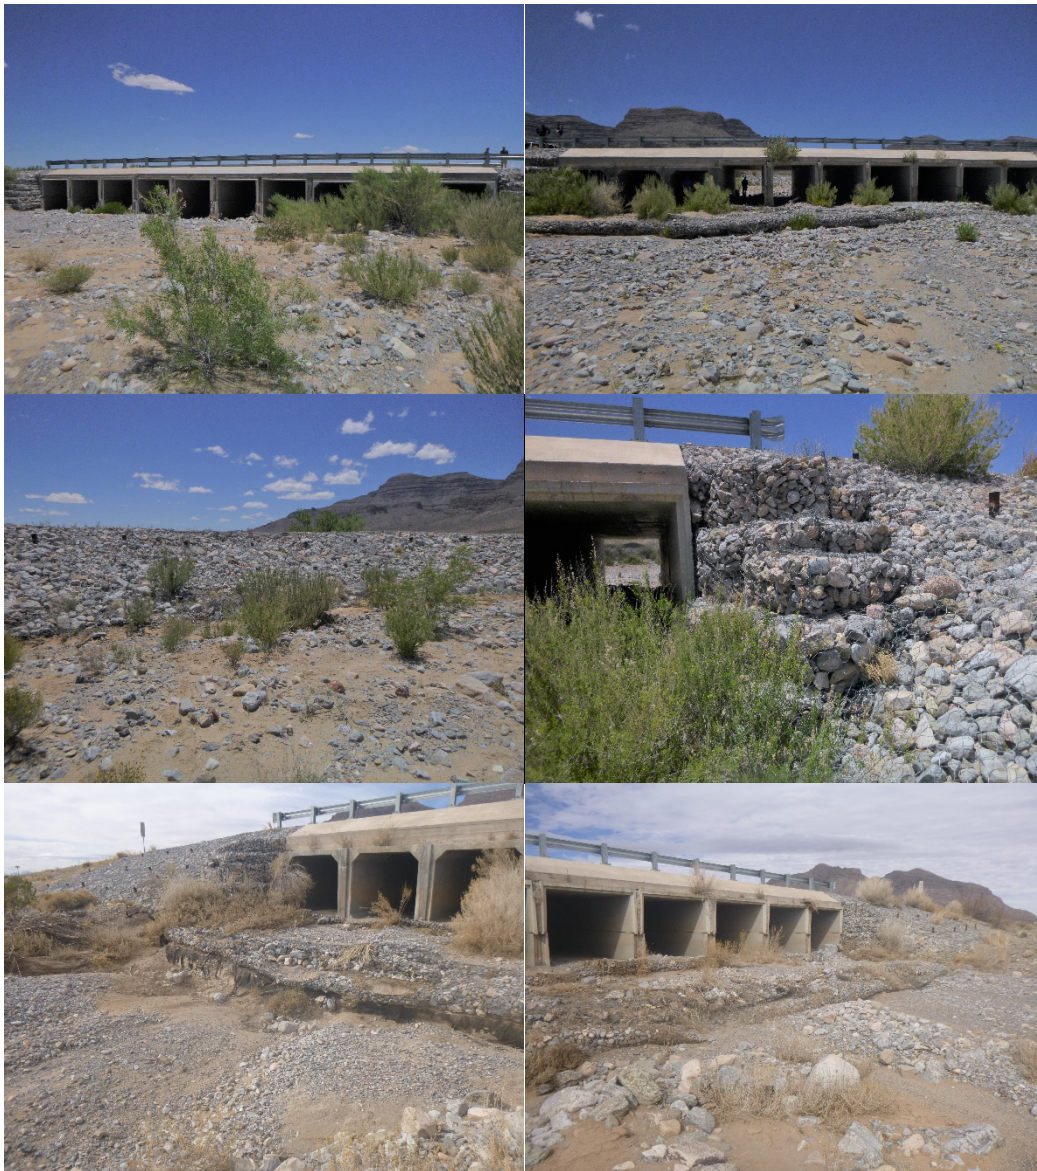
Culvert 1 is comprised of ten 2.44×2.44 m (8×8 ft) box culverts and is protected from scour on its abutments with gabion basket retaining walls.

In addition, the culvert is protected on the downstream side by a gabion mattress across the width of the culvert and extending 6 m downstream (Figure 4). Significant scour occurs at the downstream edge of the gabion mattress. The primary berm is made of dumped local material for most of its length but consists of riprap reinforced with wire mesh from RR7 to about 185 m upstream. To date, scour has not occurred along the reinforced section of the berm.

Figure 4. Culvert 1 upstream and downstream faces (*top left* and *top right*, respectively). Reinforced section of main berm (*middle left*) and gabion baskets (*middle right*). Gabion mattress scour BMP and toe scour (*bottom*).

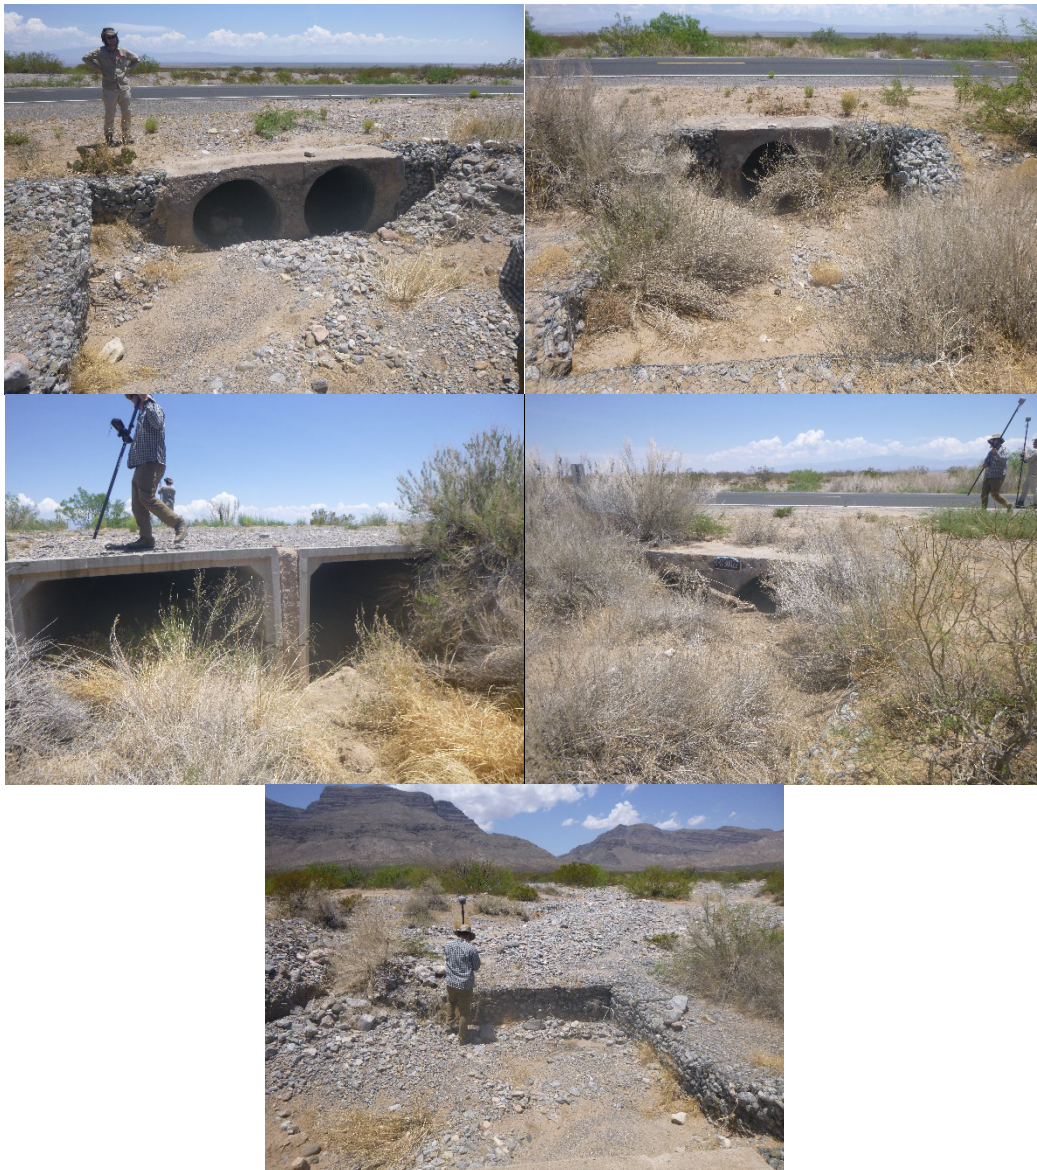
Culverts 2–5, located south of the main channel, allow drainage under RR7 (Figure 5). All four culverts have a gabion basket drop structure just upstream. Culverts 2 and 4 are twin, 1.22 m (4 ft) diameter corrugated metal pipe (CMP) culverts with concrete headwalls. Culvert 4 is half plugged with sediment. Culvert 3 is a single, 1.22 m CMP with a concrete headwall. Culvert 5, furthest south, is a twin, 2.44 × 2.44 m box culvert.

Figure 5. Culverts 2–5 (*top left, clockwise*). Typical gabion basket drop structure (*bottom*).

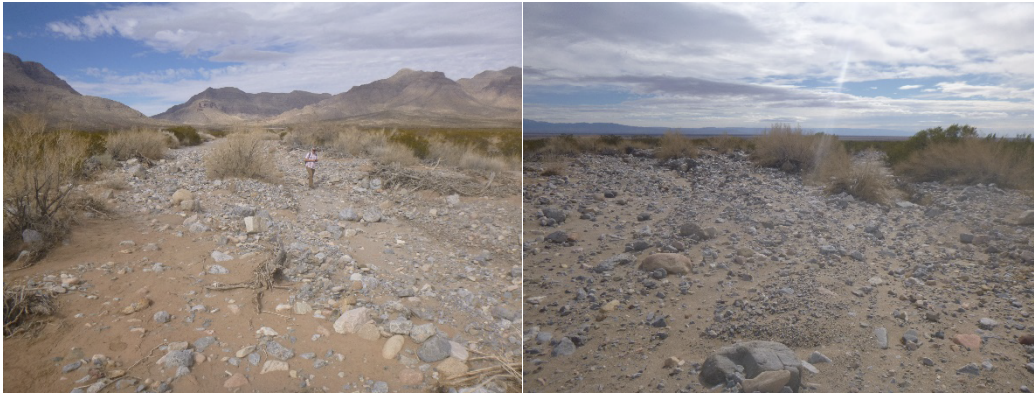
The flow downstream of RR7 becomes unrestricted (Figure 6). The primary avulsion zone (where the confined channel ends) is approximately 475–500 m downstream of RR7. The avulsion zone is where surface flow begins to shift to new channel(s). These channel(s) change over time or

from event to event, and the flow spreads out over a wider portion of the fan (Figure 6). The area downstream of the confined channel is also called the active lobe. The active lobe is where a large amount of deposition begins due to the energy lost by the flow as it spreads out over a wider area and into small channels. Further downstream, different portions of the runoff evaporate, infiltrate into the soil, or reach Salt Creek via surface or subsurface drainage. A major difference of the Thurgood fan from a typical active alluvial fan is that the flow diversion berms and the RR7 structure on the Thurgood fan constrain the main channel, causing the active lobe of the fan to be located east of RR7.

Figure 6. Avulsion zone downstream of RR7 looking upstream (*left*) and downstream (*right*).

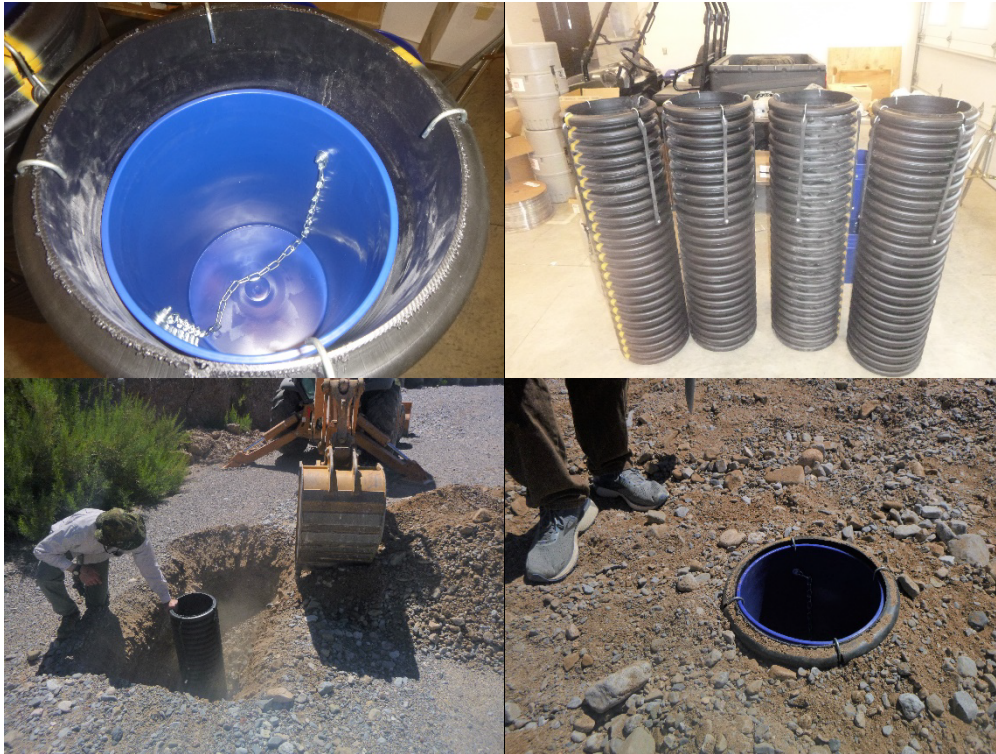
The pit traps used were based on Church et al. (1991) and McMahon (2013) with small modifications. The design of the pit trap is shown in Figure 7. A corrugated five-foot section of HDPE pipe housed a five-gallon bucket. Tarp straps were secured to the outside of the pipe, keeping the bucket secured on the inside. Chains were added to aid in bucket retrieval. The traps were then buried into the main channel flush with the surface. The pit trap design was intended to withstand both the harsh climate and long-term deployment on the order of several months while also being of significant size and volume to ensure representative capture of the bedload.

Figure 7. Pit trap samplers and installation.

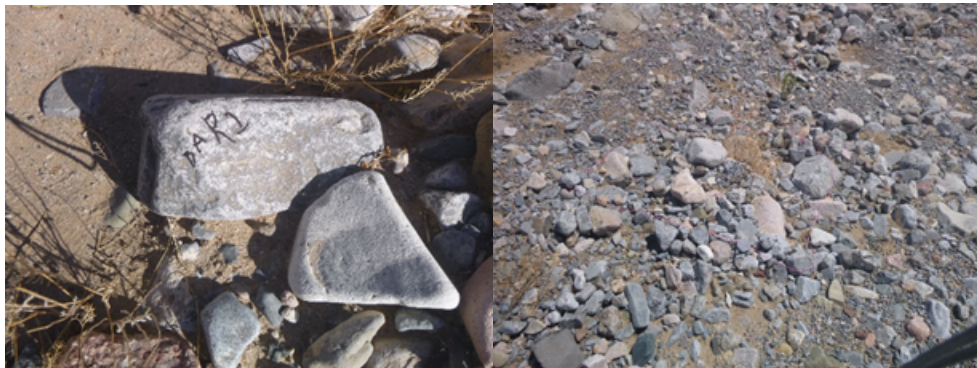
measurement was a square meter area; particles on the surface larger than gravel size were measured by hand on all three axes. Composite samples of the streambed were collected at the locations downstream of RR7 for sieve analysis. Sample locations are shown in Figure 9, while typical sample sites are shown in Figure 10. The locations were 250 and 130 m upstream of RR7 and 85, 200, 330, 475, and 600 m downstream of RR7. Sample boxes C and D (475 m downstream of RR7) were located approximately where the main channel becomes unrestricted.

Figure 10. Typical composite and channel surface sample locations.

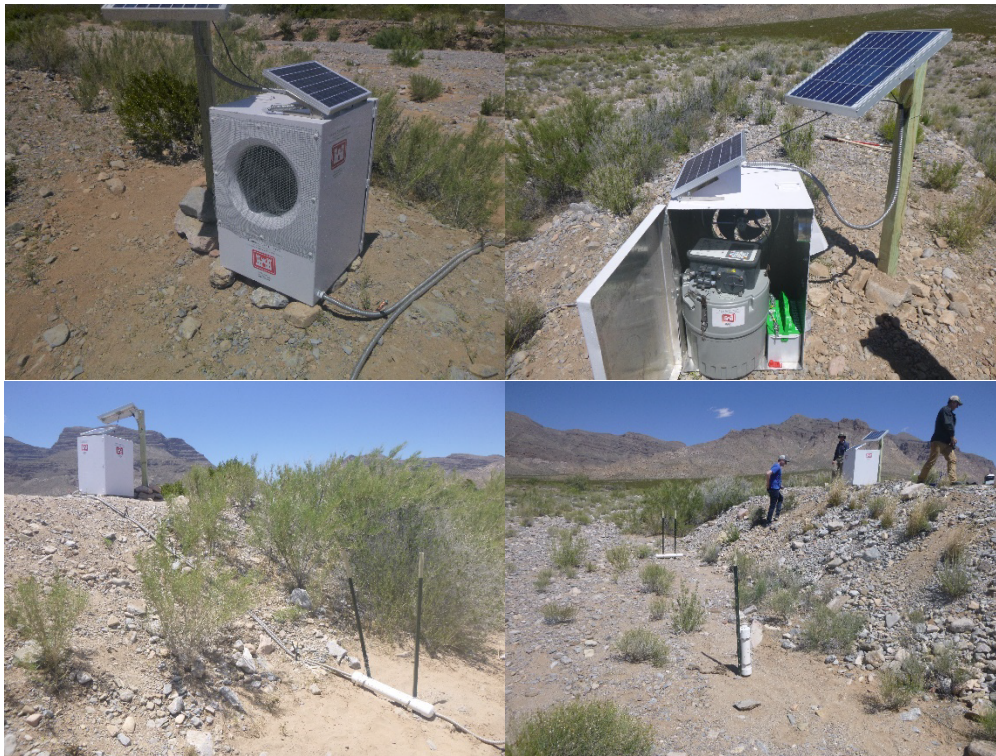
Teledyne ISCO 3700C portable samplers were installed. The samplers are used to determine suspended sediment load during flow events (Figure 11). A configuration of 24 bottles, each 500 ml, was used to collect multiple, separate samples during flow events at 10-minute intervals, providing a sampling window of 240 minutes (4 hours). A water sensor was installed in the channel to activate the sampling program once water flow was detected. Samples were collected every ten minutes, allowing for a maximum four-hour sampling duration. One sampler was placed near the fan apex, while the other was placed just upstream of the RR7 culvert (Figure 8). The downstream sampler was located on the south side of the channel during the 2019 and 2020 sampling seasons. For the 2021 sampling season, the downstream sampler was moved to the north side of the channel due to a shift in the preferred flow path from the south to north side of the main channel. The ISCO samplers were placed in vented, white metal boxes, whereas the suction lines and intakes were placed in flexible metal conduit and PVC, respectively, to provide all components with protection from the harsh environment and animals (Figure 11).

Figure 11. Typical ISCO installation (*top*), typical installation of samples, suction lines, and intakes (*bottom*).

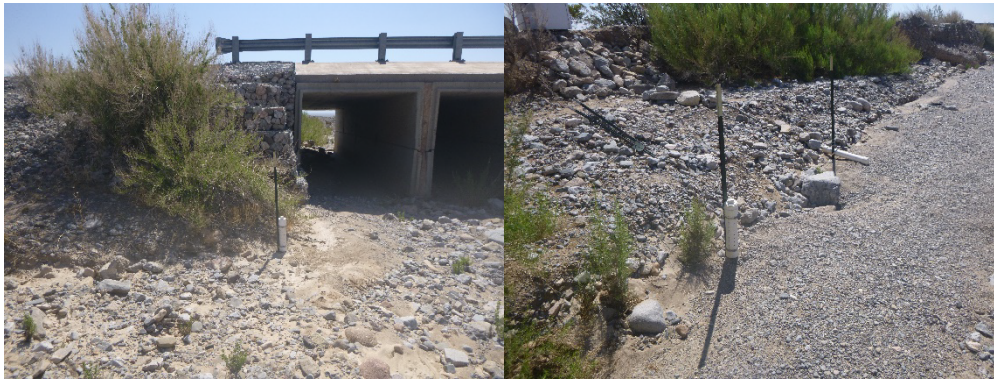
HOBO Water Level Data Loggers were installed near the ISCO samplers and the RR7 culvert (Figure 8) to provide continuous monitoring of pressure and temperature at 10-minute intervals (Figure 13). The downstream HOBO was relocated with the downstream ISCO at the beginning of the 2021 sampling season, while the sensor directly upstream of RR7 was installed at the same time. HOBO 30-Foot Depth Water Level Data Loggers (Part # U20-001-01) were utilized and were factory calibrated and designed for continuous use. The sensors were housed in perforated PVC tubes to protect them from the harsh environment and large bedload particles (Figure 14). Survey data were used at sensor locations to develop rating curves, which can be used with the logged flow-depth data to generate flow hydrographs, using the same methods implemented at USGS gauge sites.

Figure 14. Typical HOBO installations.

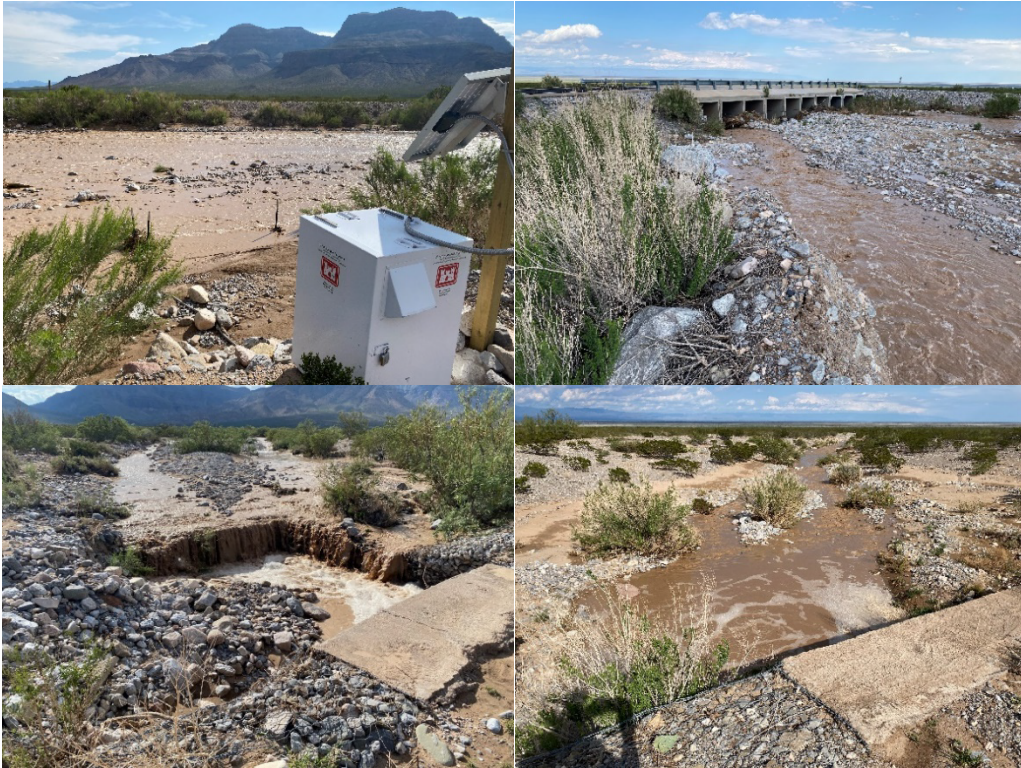
On 7 July 2021 at 17:00 local time (22:00 Zulu), ITAM staff observed an active flood event at the Thurgood main channel (culvert 1) and the first culvert to the south (culvert 2). Flow observations from the HOBO samplers indicate flow in the main channel was approximately 2.0 m³/s (see Figure 18). Due to the short duration of flow events at the study site, this was the first time flow had been witnessed and documented in person.

Figure 18. 7 July 2021 flood event at downstream gauge station (*top left*), upstream face of culvert 1 (*top right*), culvert 2 looking upstream (*bottom left*), and culvert 2 looking downstream (*bottom right*).

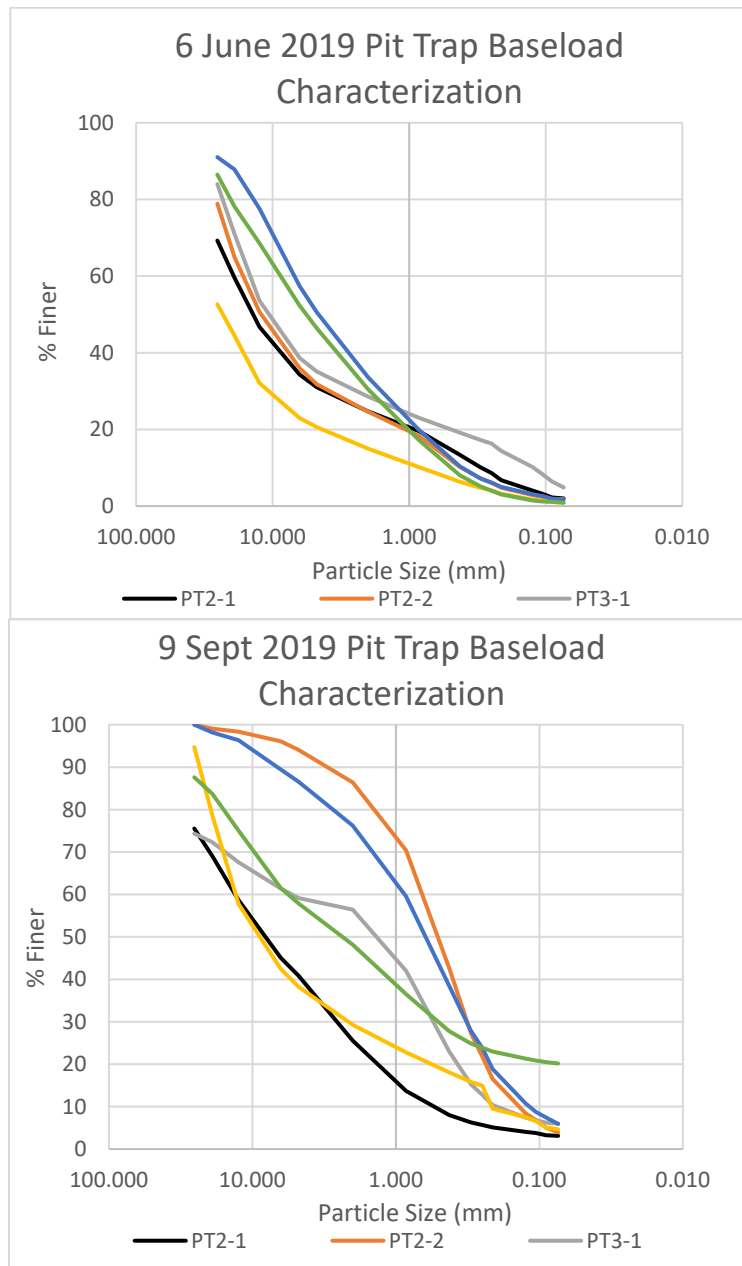
Samples were collected from pit traps 2–4 following the 6 June 2019 and 5 September 2021 events (Figure 20). No discernable pattern in particle sizes could be determined between the upstream and downstream locations or with regards to the pit trap locations within the channel, but the particle size difference between the events is large. The 6 June event had a peak flow of 31.8 m³/ss, compared to a significantly smaller peak of 10.0 m³/s during the 5 September event. The average particle size difference between each trap was 290%, 320%, and 180% for traps 2, 3, and 4, respectively (Table 5). The large material that didn't pass the 25.4 mm (2

Figure 20. Composite samples from all pit traps for 6 June 2019 event (*top*) and 5 September 2019 event (*bottom*).

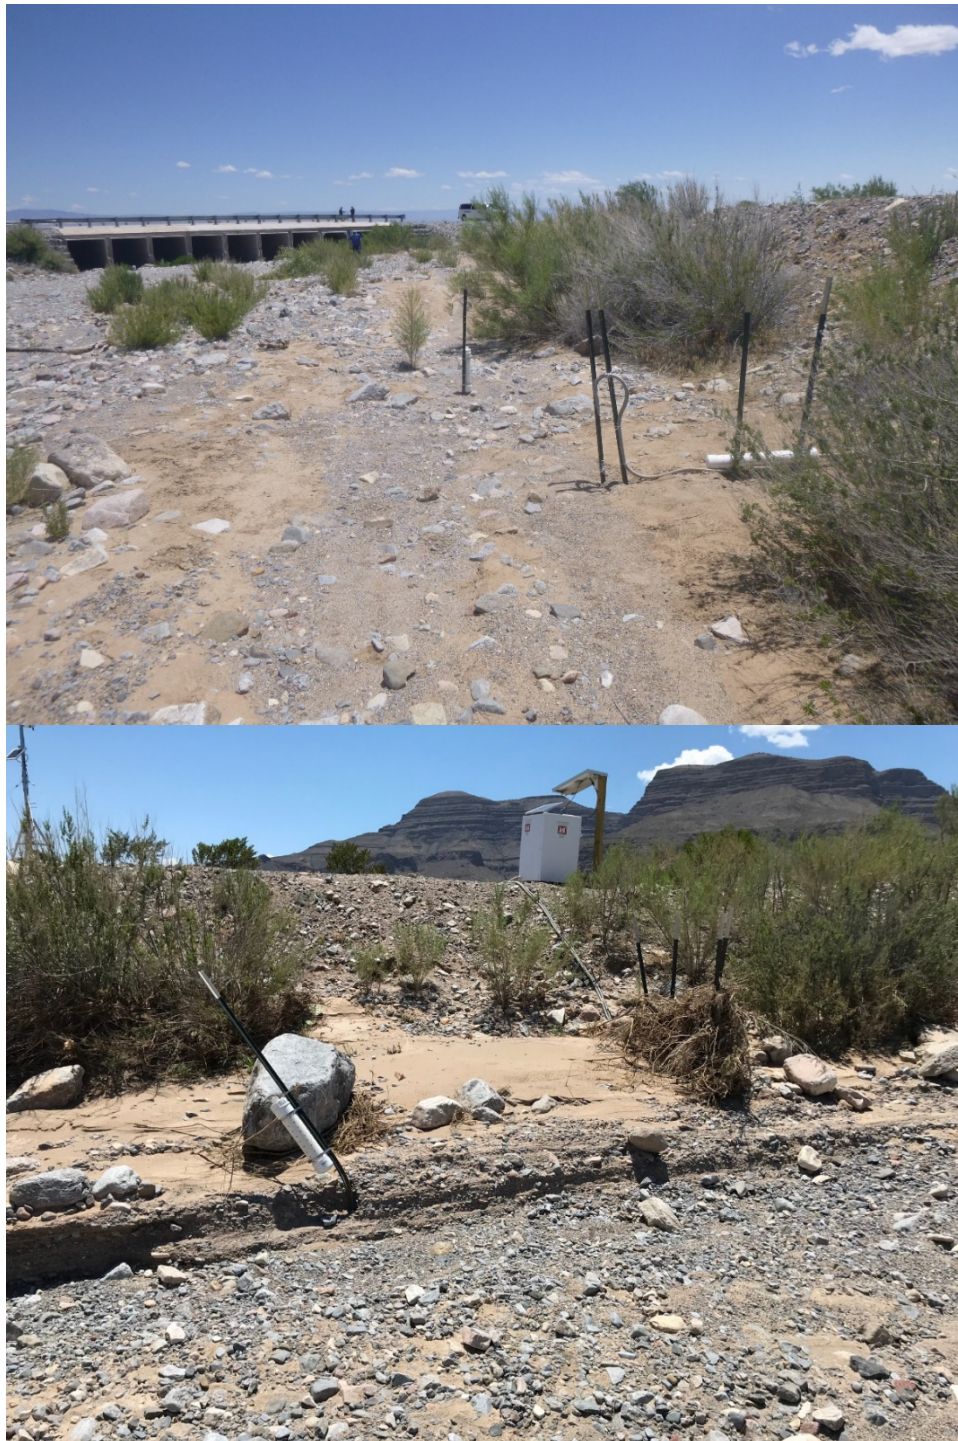
Excessively large materials were moved during the July 2019 event that could not have been collected in the pit traps. Figure 21 shows the downstream HOBOLocation after installation in May 2019 and the same location following the July 2019 event. A large boulder (0.4 × 0.4 × 1 m) came to rest next to the HOBOLocation following the July 2019 event. Such large particles were mobile during the event but could not have been collected in the pit traps, indicating that the pit traps underestimated the particle distribution.

Figure 21. Downstream HOB0 and ISCO sampling location (2019–2020) in May 2019 (*top*) and following the July 2019 event (*bottom*).

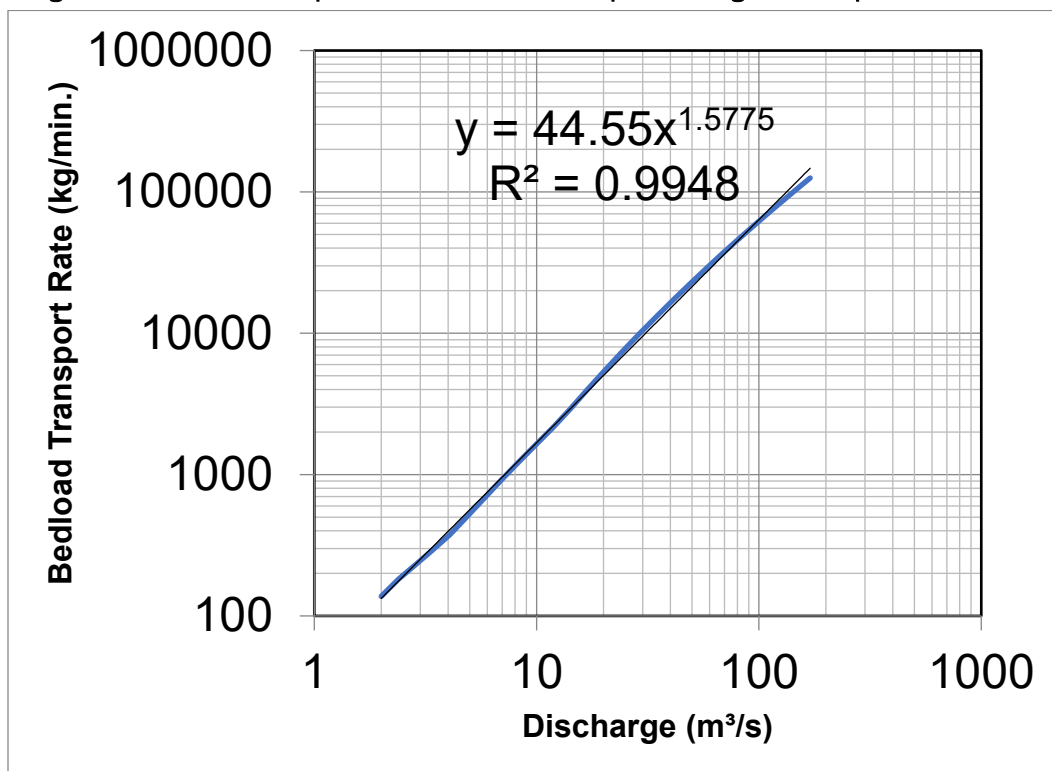
Figure 23. Bedload transport rate estimate at fan apex for range of anticipated flow rates.

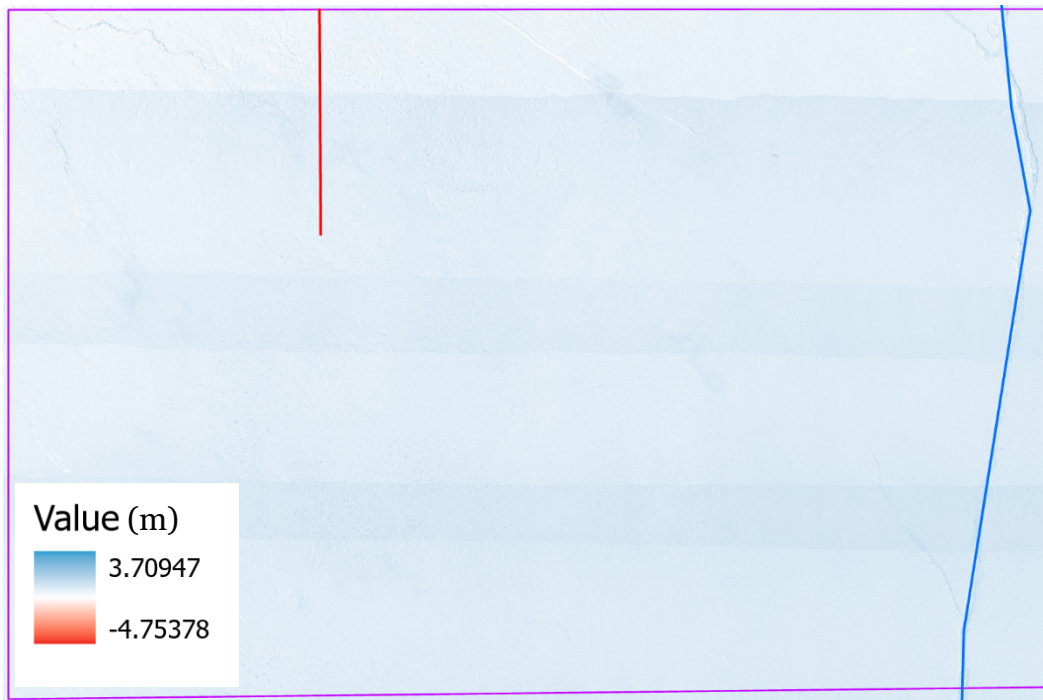
DEM comparisons between 2019 and 2013 of the lower fan show no apparent changes to the fan surface or to existing or developing channels from the main channel, indicating Thurgood Canyon drainage did not affect Salt Creek directly during the 2013–2019 time frame (Figure 26). Channelization caused by flow from the main drainage channel can be seen in the northwest corner of Figure 26; however, it fades starting around 2.6 km from RR7 and no changes in channels can be detected starting about 3 km downstream of RR7.

Figure 26. 2019 DEM minus 2013 DEM just west of Salt Creek (*purple box* in Figure 25). Salt Creek is on the *right (blue)*. The *red line* indicates where fan channels end about 3 km from RR7.

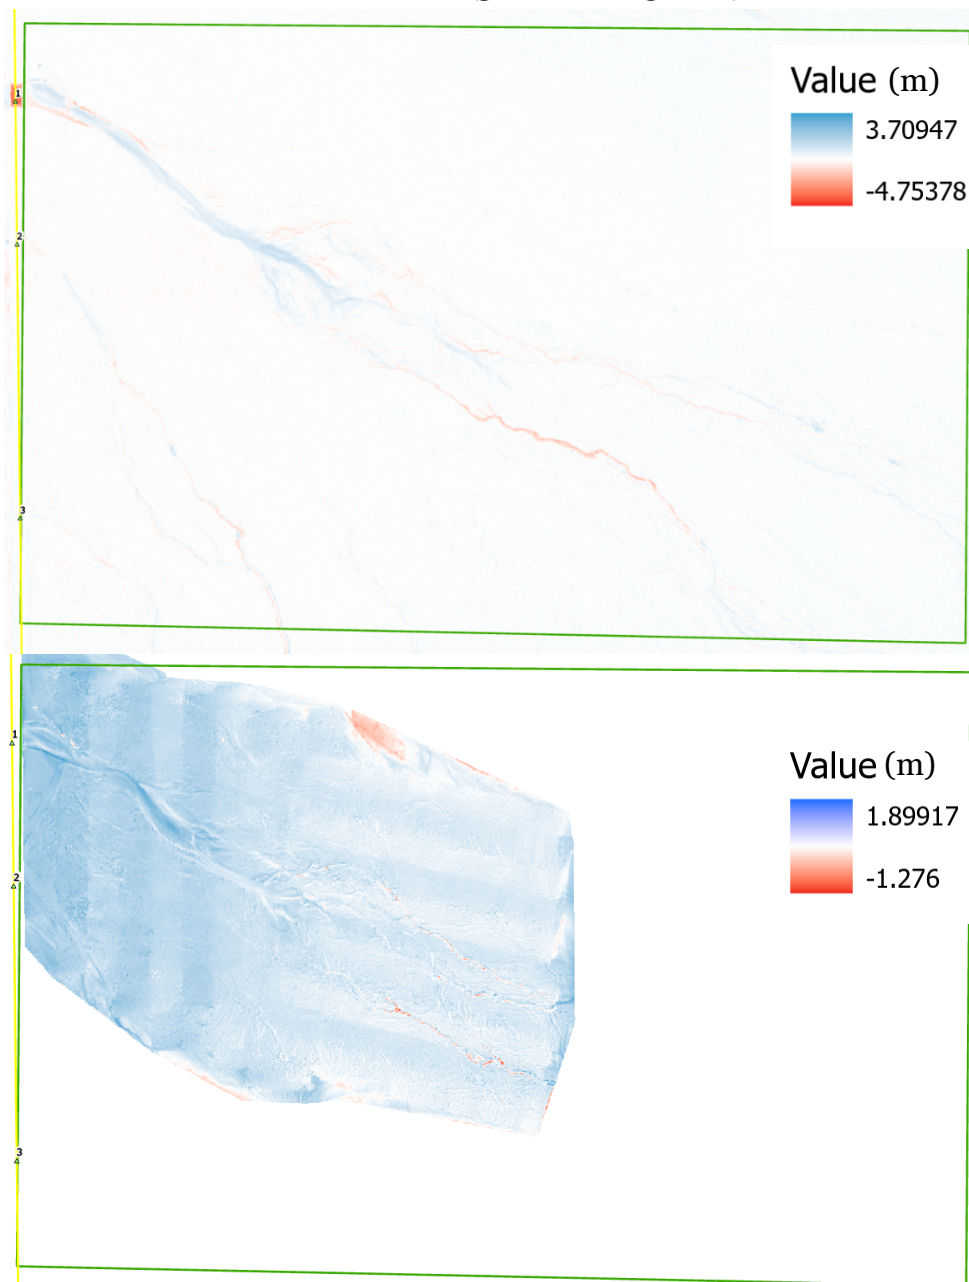
Downstream of the RR7 box culvert, there is a moderate amount of deposition seen in the main channel before flow spreads into numerous smaller channels downstream (Figure 28). The areas of deposition and the preferred flow path (channel) development can be seen over the two periods. Minor flows through the channels causes deposition in some old channels, while major flows cause the water to travel much further southeast and create or enlarge new channels. As noted above, these overland channels do not extend more the 3 km downstream of RR7.

Figure 28. 2019 DEM minus 2013 DEM (*top*) and 2021 DEM minus 2019 DEM (*bottom*) just downstream of RR7 (*green box* in Figure 25).

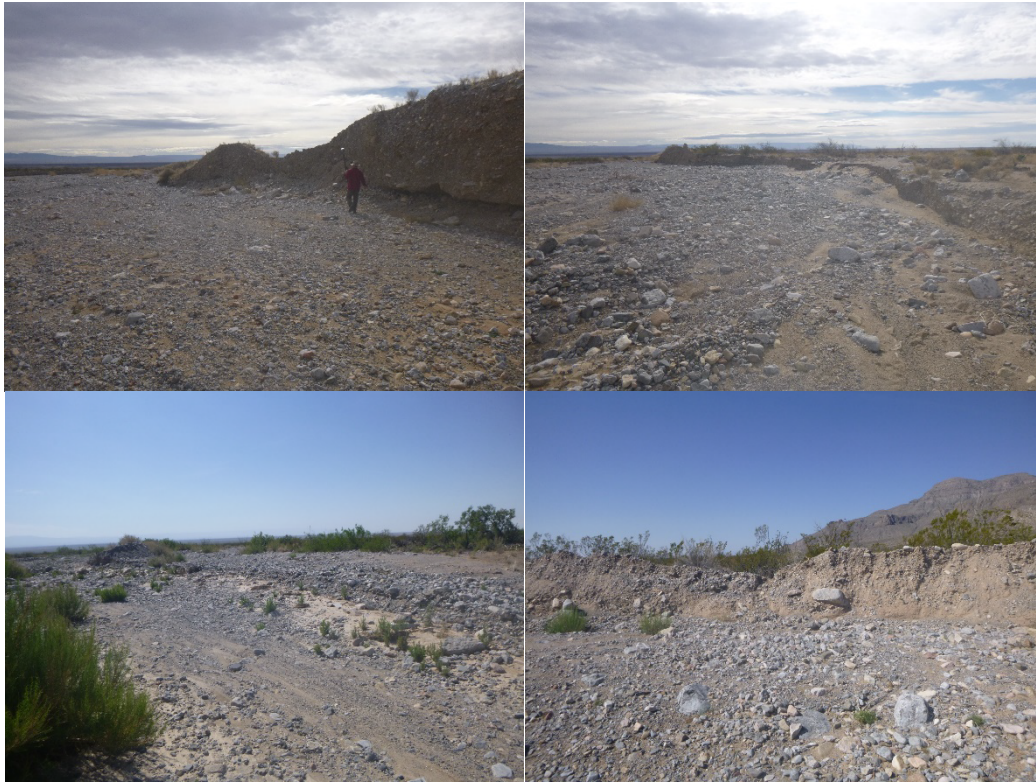
Figure 34. Scour locations 1–4 (starting *top left*, clockwise) as of March 2022.

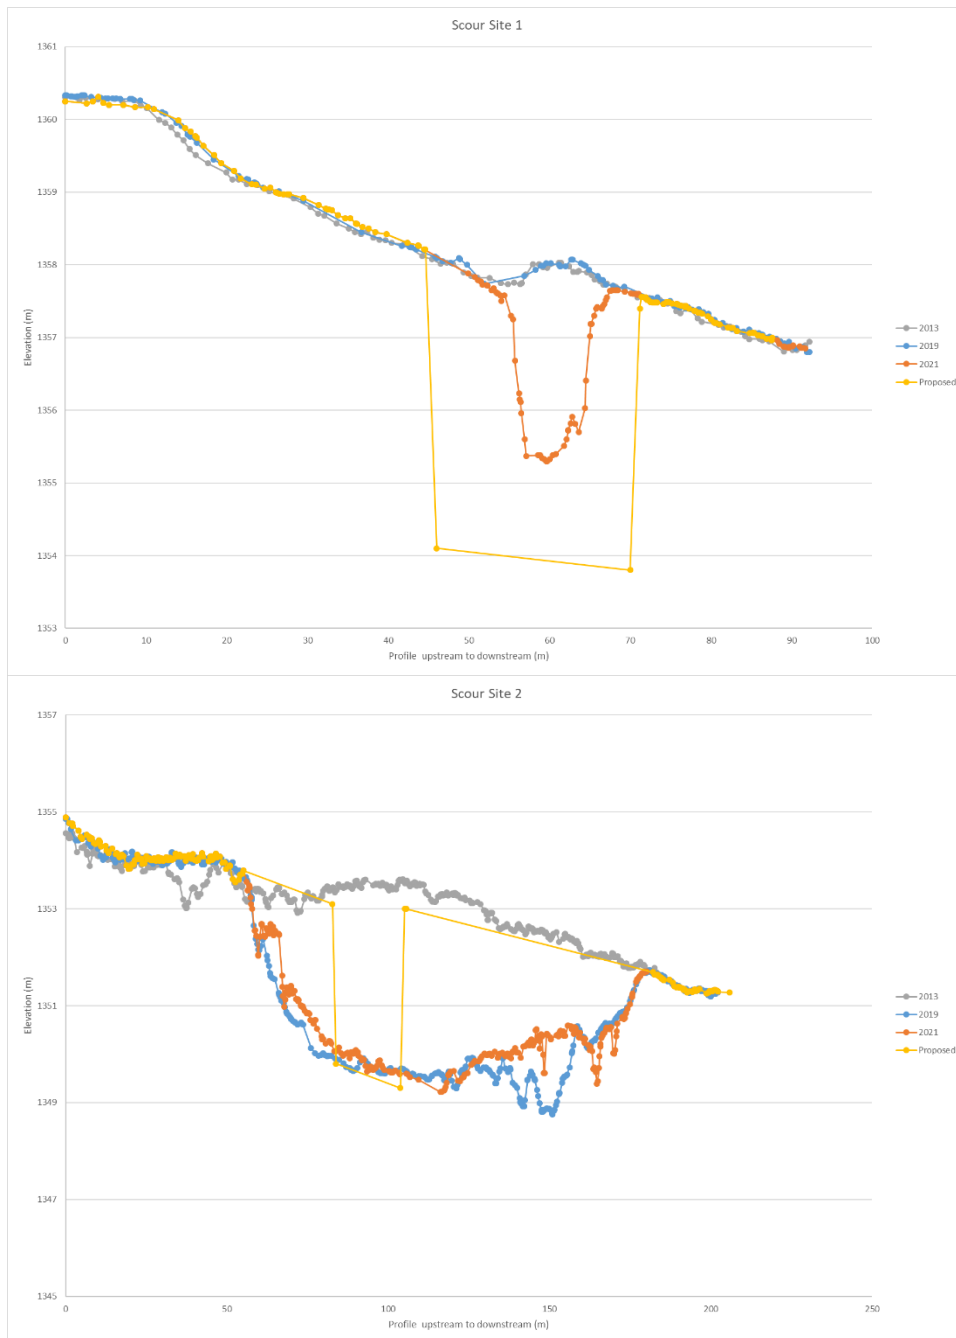
Figure 42. Scour hole shape and size progression from 2013 to 2021, including dimensions of proposed constructed diversion weirs, at scour locations 1 and 2.

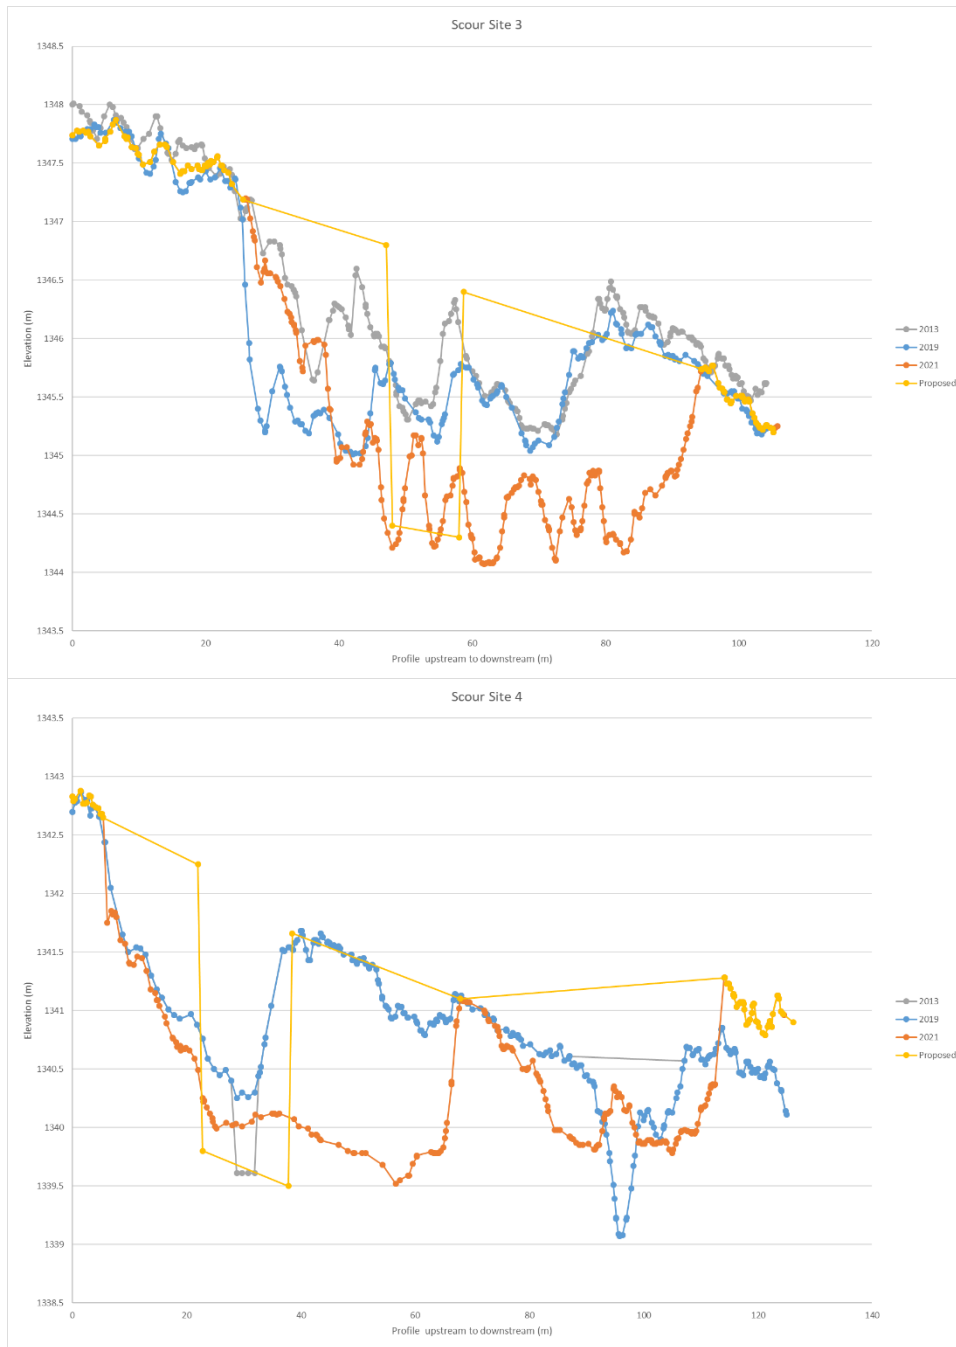
Figure 43. Scour hole shape and size progression from 2013 to 2021, including dimensions of proposed constructed diversion weirs, at scour locations 3 and 4.

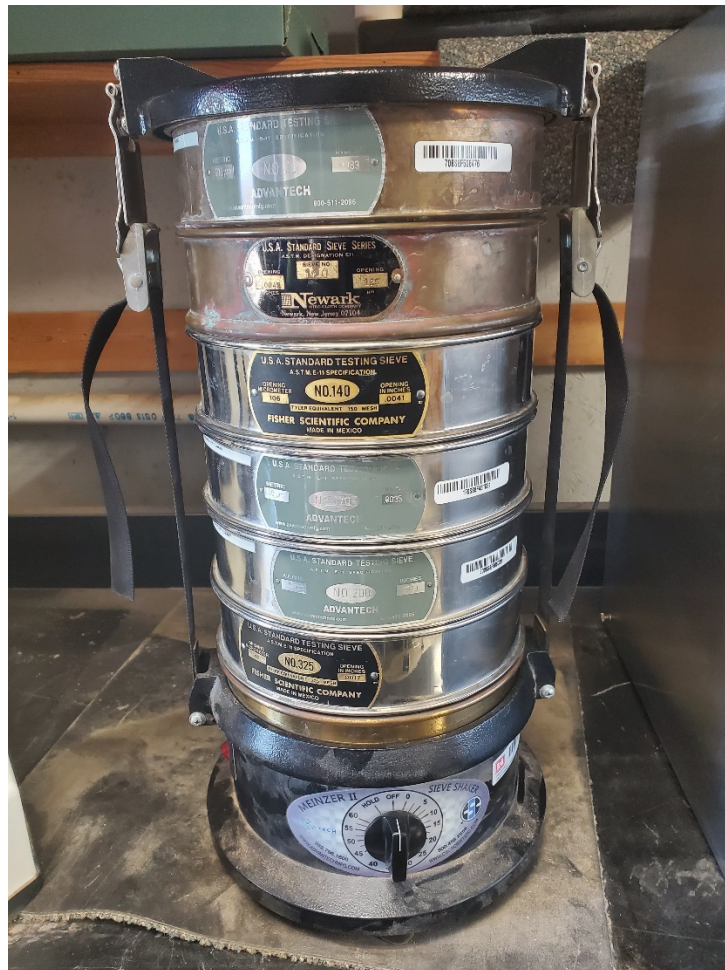
ERDC-CERL used the standardized ASTM D6913 sieve analysis for all bedload and shovel samples (Figure A-1). Samples that contained 5% of the total sample or 50 grams or greater on sieve #200 mm were separated out, and hydrometer analysis was conducted on that portion to determine clay content.

Figure A-1. Sieve nest in sieve shaker.

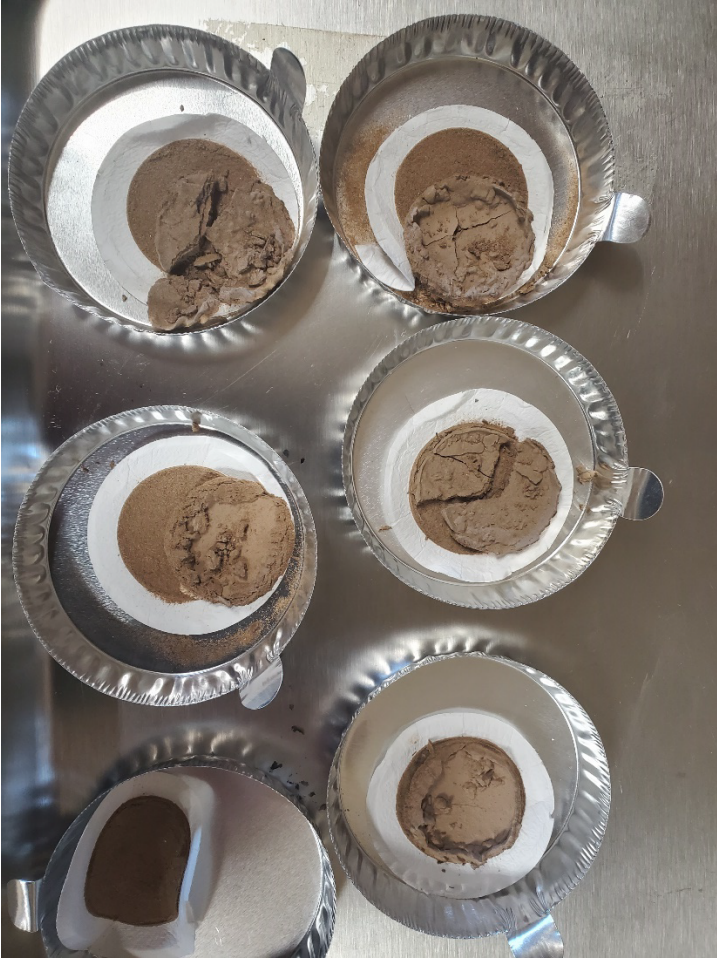
ISCO samples were analyzed using ASTM D5907-09. All water samples were refrigerated upon receipt. Each bottled sample was treated as a single sample due to size. Total suspended soils were calculated by taking the weight of the dried sample divided by sample volume. Figure A-2 shows the product of the completed test of suspended sediment.

Figure A-2. Suspended sediment on filter paper.
