The Modification and Test of the Model CXFR Jamming

Transmitter

NRL Report R-2291  
Problem S623T-C

Report on

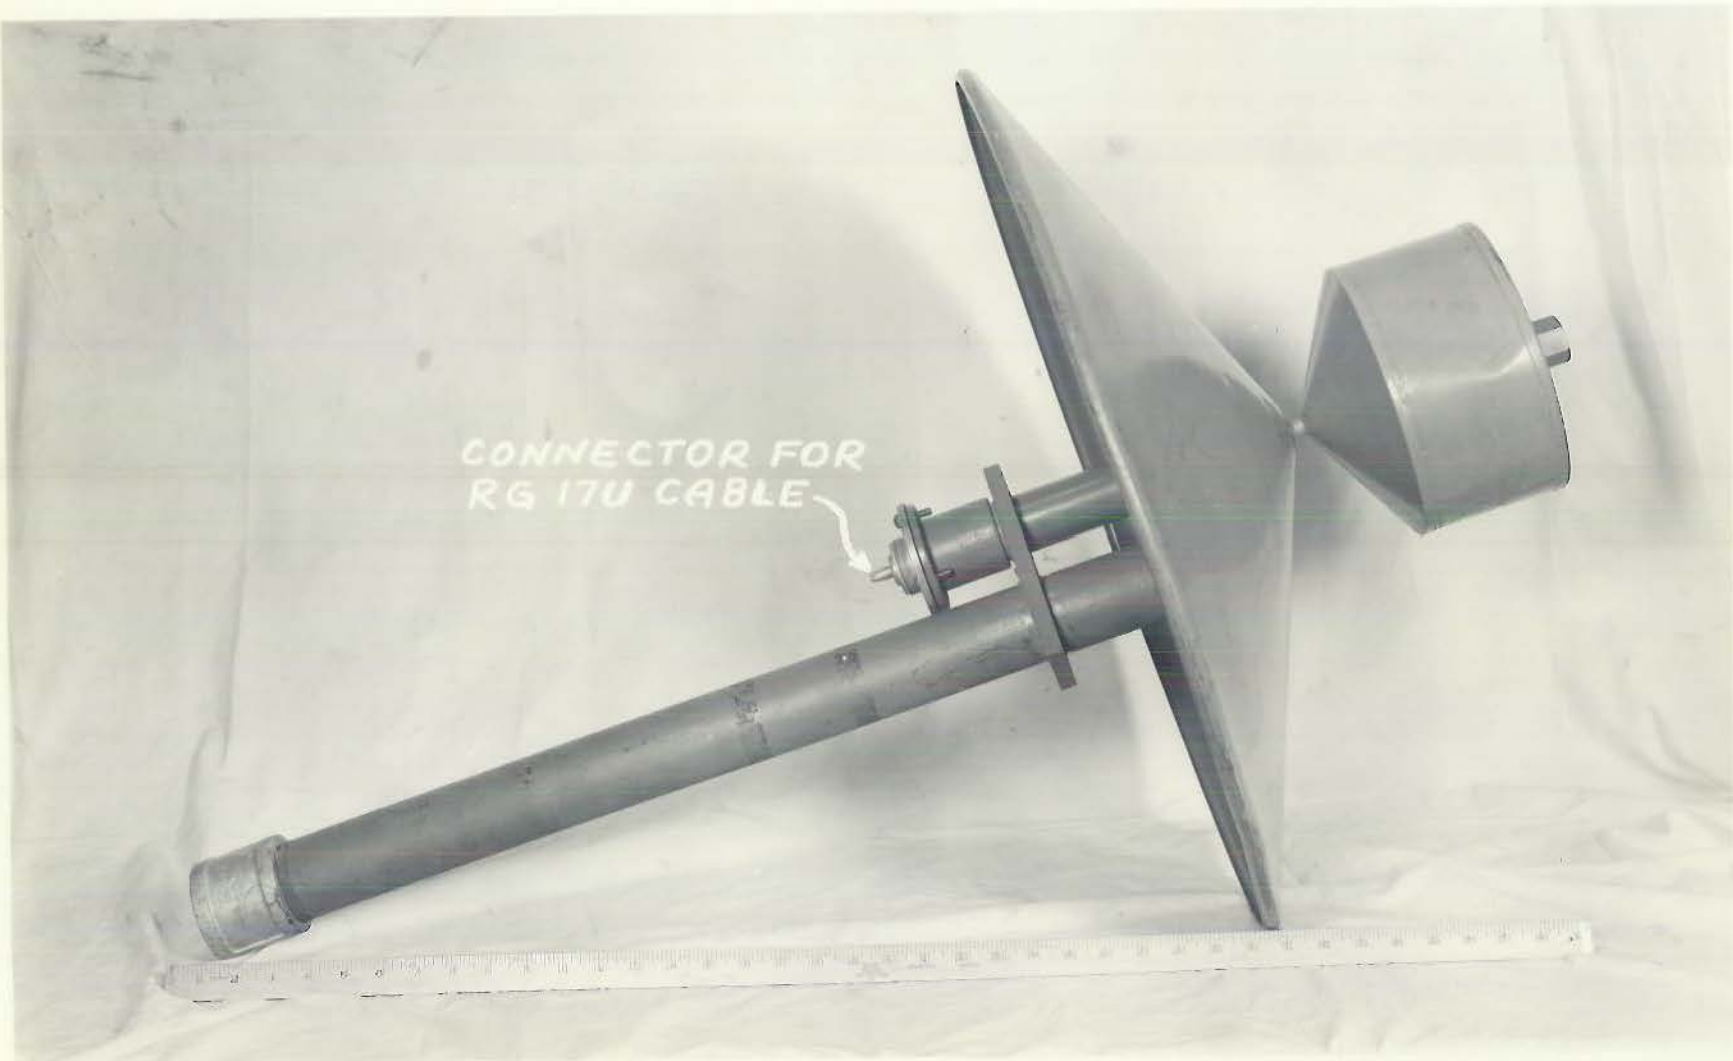
4-6. The types of antennas available for use with the CXFR are shown in Plates 4 and 5. The broad band type shown in Plate 4 is the one originally planned for use with the CXFR, and can be used over the entire range of the oscillator. Over this range the transmission line standing wave ratio does not exceed 2:1, and the radiation pattern shifts only slightly. The direction of maximum radiation is approximately perpendicular to the axis of the cones, varying somewhat over the frequency range.

CONNECTOR FOR  
RG 17U CABLE

BROAD - BAND ANTENNA  
FOR CXFR

6-2-5. On 7 March further operational tests of the CXFR were made to corroborate previous results and to obtain additional data. In the afternoon of this date the performances of the CXFR and "Carpet" on the FD, "Hot Dog", and Mark 5 radar frequencies were demonstrated to a group including representatives of the Bureau of Ships, the Radio Research Laboratory, and the General Electric Company. The effect of using various types of antennas was demonstrated, in addition to the general demonstration of comparative performance of the equipments. The type GAKZ-66AHM and GAKZ-66AHN antennas (Plate 5) were found to have approximately 3 db gain relative to the "broad band" CXFR antenna (Plate 4).

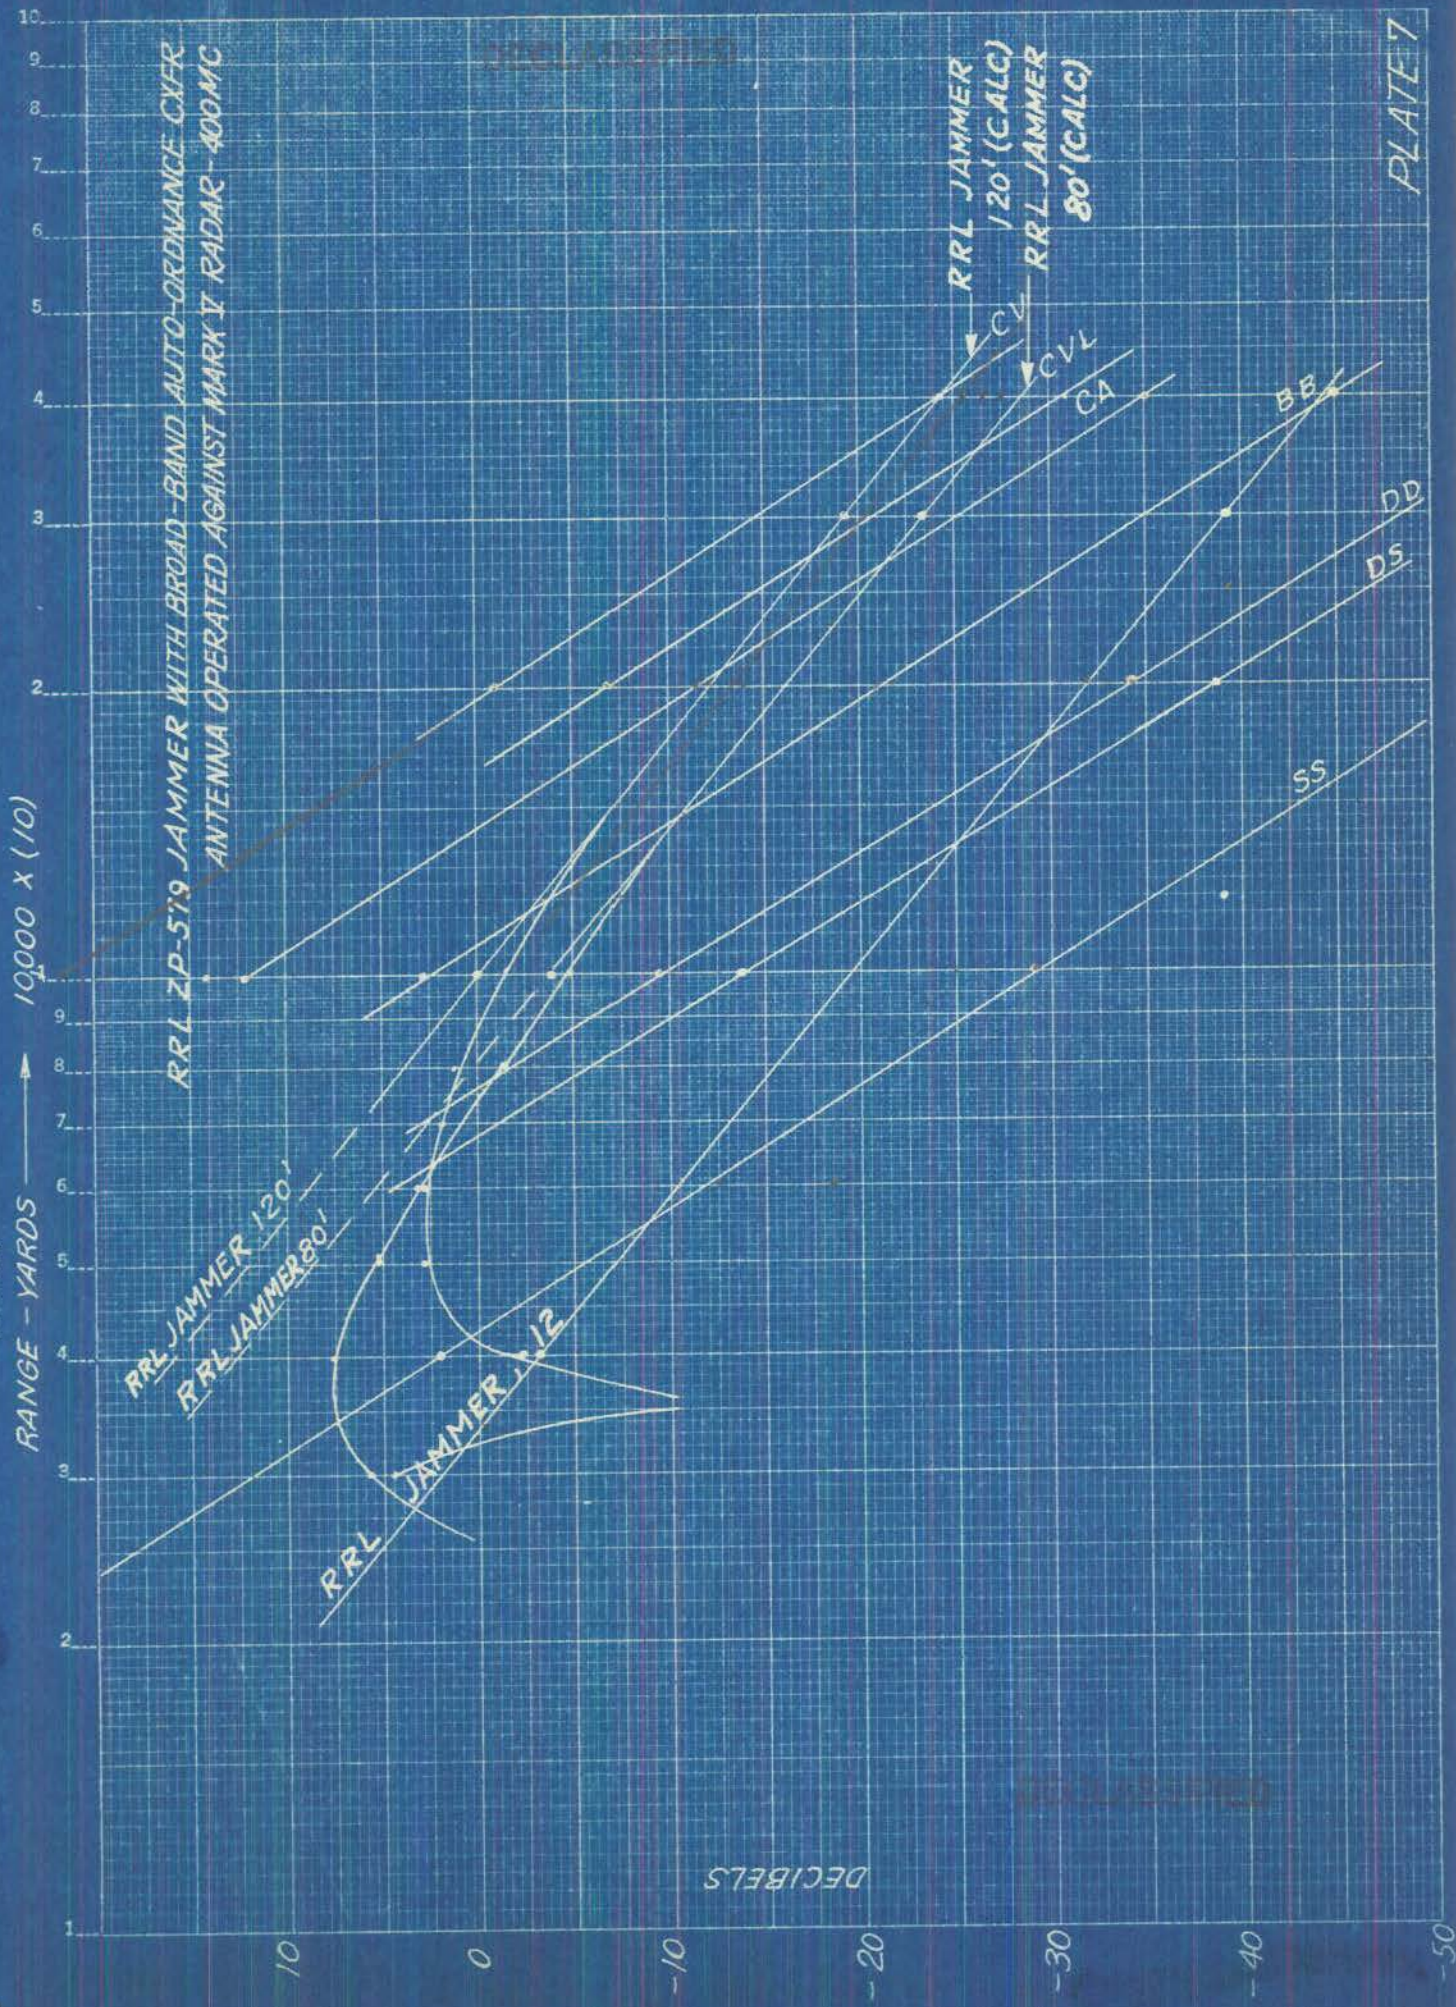
6-1-13. Plate 8 shows the results of tests made on the Auto Ordnance CXFR broad band antenna. Tests were made to determine the percent reflection over a frequency range of 300-800 Mc with the antenna connected to 17 feet of RG-17/U cable, and a comparison was made with the results obtained from a developmental model constructed at this laboratory. Recommendations were made to decrease the spacing of the cones and to provide more positive means for locking the upper cone to the supporting spike. It was thought that the greater spacing of the cones was the reason for the high percentage reflection at frequencies above 500 Mc, so 1/8" separation was requested.
