FRACTURE RESISTANCE OF GLASS-CERAMIC AND ZIRCONIA CROWNS
AFTER ENDODONTIC ACCESS

A thesis submitted to the Faculty of the
Comprehensive Dentistry Graduate Program
Naval Postgraduate Dental School
Uniformed Services University of the Health Sciences
in partial fulfillment of the requirements for the degree of
Master of Science
in Oral Biology

June 2020

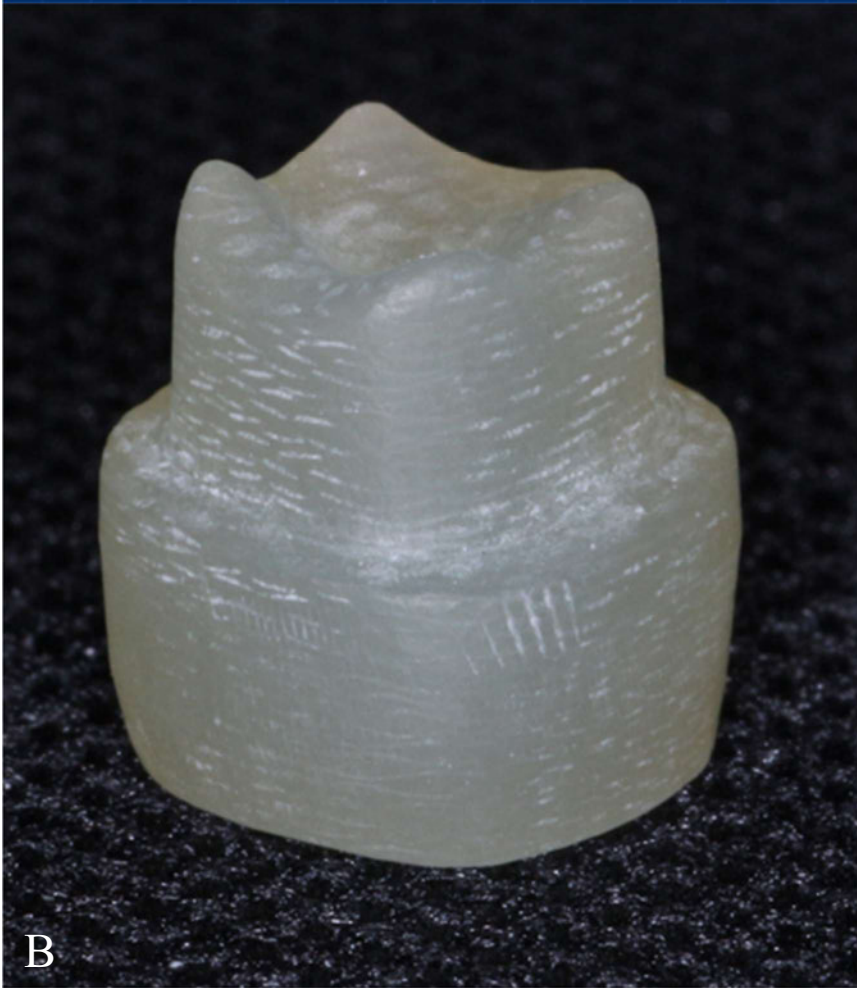
Figure 1: DentalCAD master die design (A) and NEMA Grade G10 master die (B).

Mandibular first molar analog dies were designed by scanning (Freedom HD; DOF Inc.; Seongdong-gu, Seoul, South Korea) a mandibular first molar typodont tooth (T-1560 #19; Columbia Dentoform; Lancaster, PA) and using digital reduction through DentalCAD (Exocad GmbH; Darmstadt, Hesse, Germany). Dies were milled (CORiTEC 350i Loader; imes-icore GmbH; Eiterfeld, Germany) from NEMA Grade G-10 continuous filament woven fiberglass bonded epoxy resin (The Gund Company, St. Louis, MO).

The dies were digitally prepared with set parameters in DentalCAD. A chamfer margin was reduced by 1.0 mm and at an angle of 30 degrees. The occlusal reduction was 1.5 mm. The buccal and lingual areas were reduced by 1.5 mm. 4.0 mm of preparation height was ensured.

Through the DentalCAD software, a digital base was added to the die design to ensure consistent orientation of the die on the jig mounted on the universal testing machine (MTS Insight 5; MTS Systems Corporation; Eden Prairie, MN) (Figure 1).

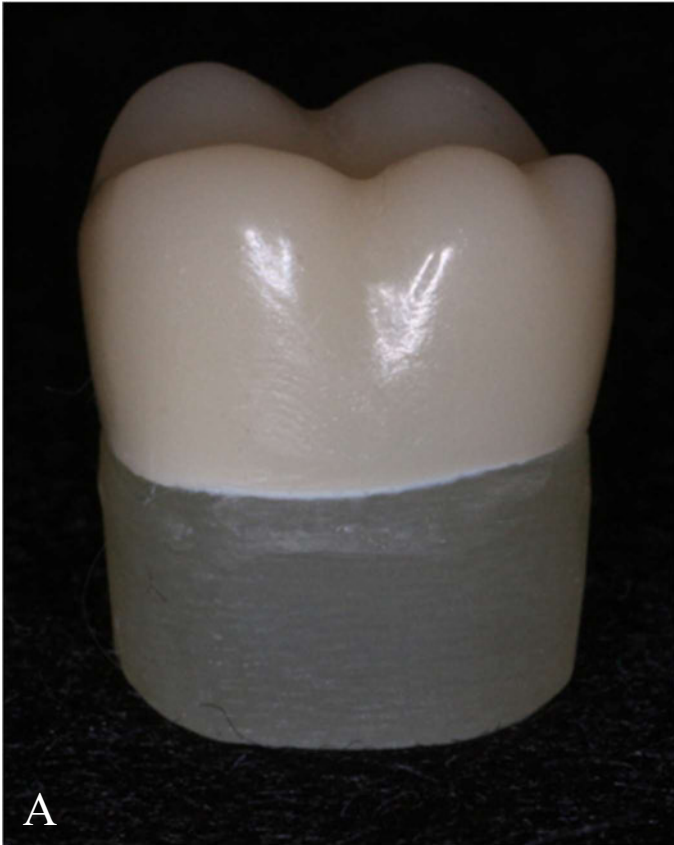
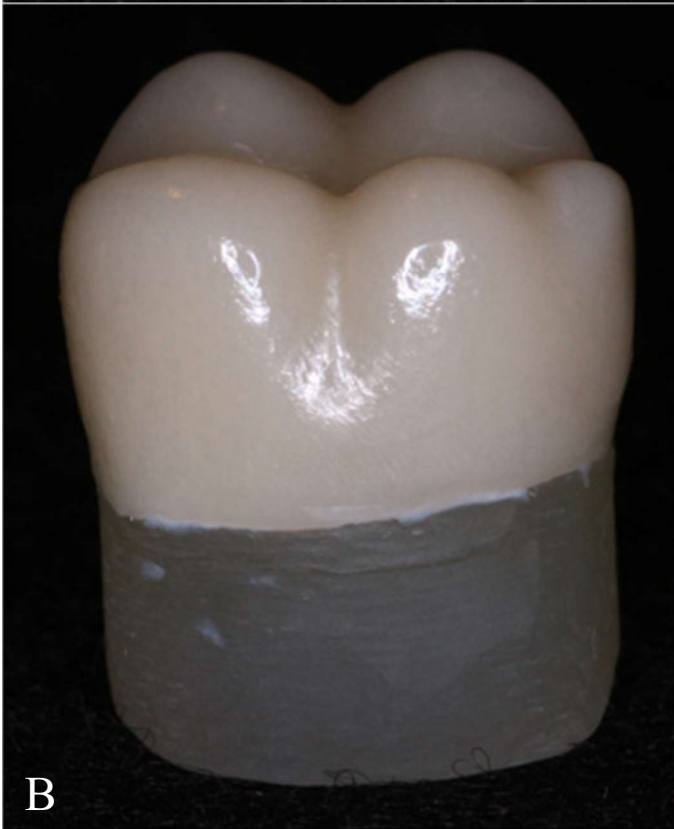
Figure 2: Lithium disilicate (A) and zirconia (B) crowns cemented on NEMA Grade G10 dies.

Monolithic lithium disilicate crown cementation – Pretreatment of the 20 lithium disilicate restorations was initiated with 5% hydrofluoric acid (IPS Ceramic Etching Gel, Ivoclar Vivadent Inc.) applied to the intaglio surface for 20 seconds, then rinsed with tap water and gently air dried with an air/water syringe tip. Next, a silane coupling agent (Monobond Plus; Ivoclar Vivadent Inc.) was placed on the intaglio surface for 60 seconds and gently air dried. All 20 dies to receive IPS e.max lithium disilicate CAD crowns

IPS e.max zirconia CAD crown cementation – Pretreatment of the 20 zirconium CAD restorations started by air abrading the intaglio surface with 100 μm aluminum oxide (Al_2O_3) at a maximum 1 bar of pressure. All subsequent steps followed the same cementation process for lithium disilicate restorations detailed above (Figure 2).

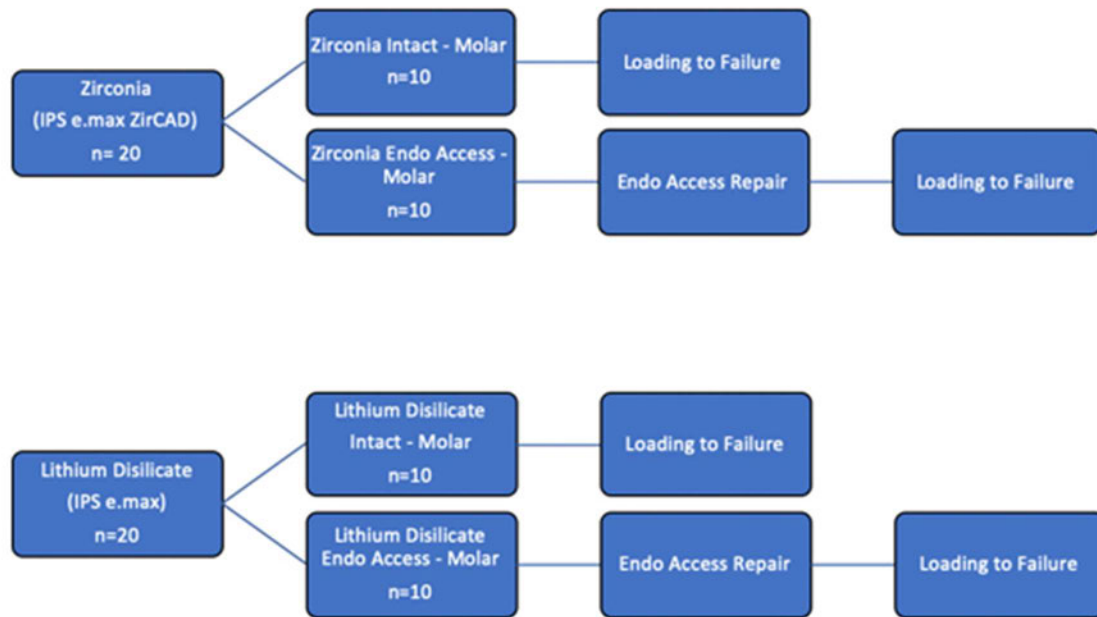
Figure 3: Study Design - crowns for each material cemented on NEMA Grade G10 dies (n=20) and divided into two groups: intact (n=10) and accessed (n=10).

border and 2 mm on the distal border.²⁴⁻²⁶ This access outline was marked. A stencil of the typodont tooth was created from a clear vacuform matrix material (Copyplast 1.5mm/125mm – Round; Great Lakes Dental Technologies; Tonawanda, NY) with the access outline removed to serve as the transfer template. 10 lithium disilicate and 10 zirconia crowns were randomly selected and access outlines marked using the transfer template (Figure 3).

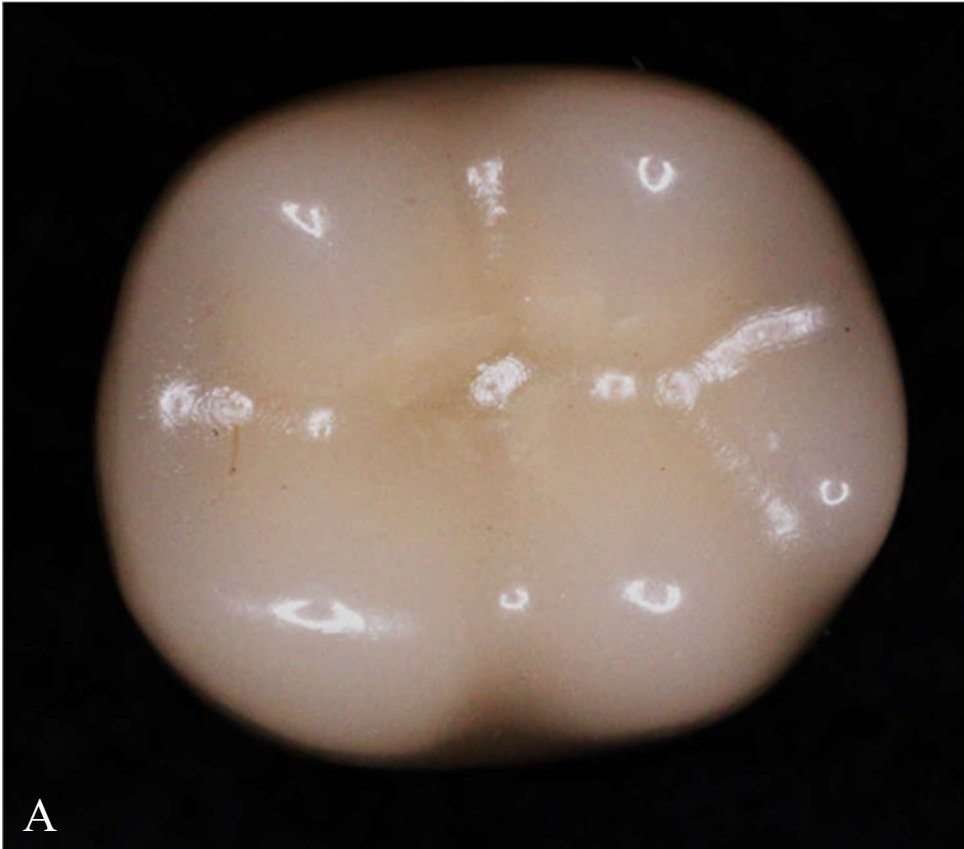
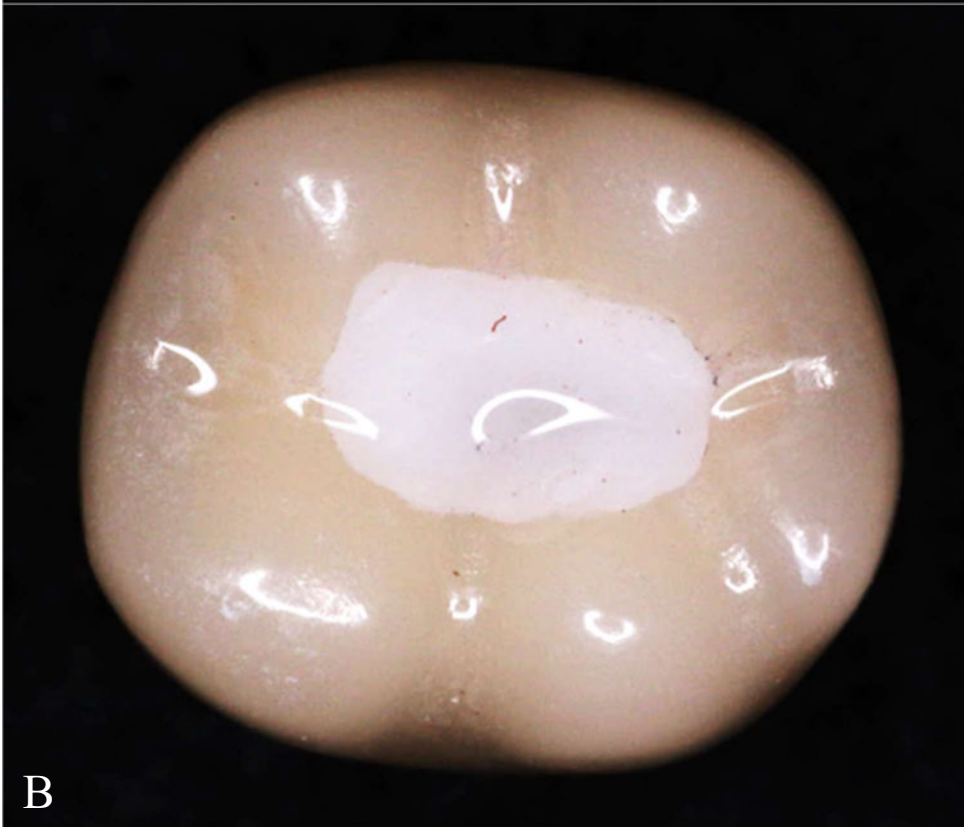
Figure 4: Intact lithium disilicate crown (A) and accessed/repared lithium disilicate crown (B).

Endodontic Access Repair - Accessed restorations were repaired with a light cured resin-based composite (Filtek Supreme Ultra; 3M USA; St. Paul, MN). The anatomy of the repaired occlusal surfaces was adjusted to be flush with the adjacent lithium disilicate or zirconia material with a football white stone bur (Dura-White Stones; Shofu Incorporated; Kyoto, Japan). Finishing (Enhance Tip System Kit; Dentsply Sirona) and polishing (Enhance PoGo Complete Kit; Dentsply Sirona) of the occlusal surface was completed (Figure 4).

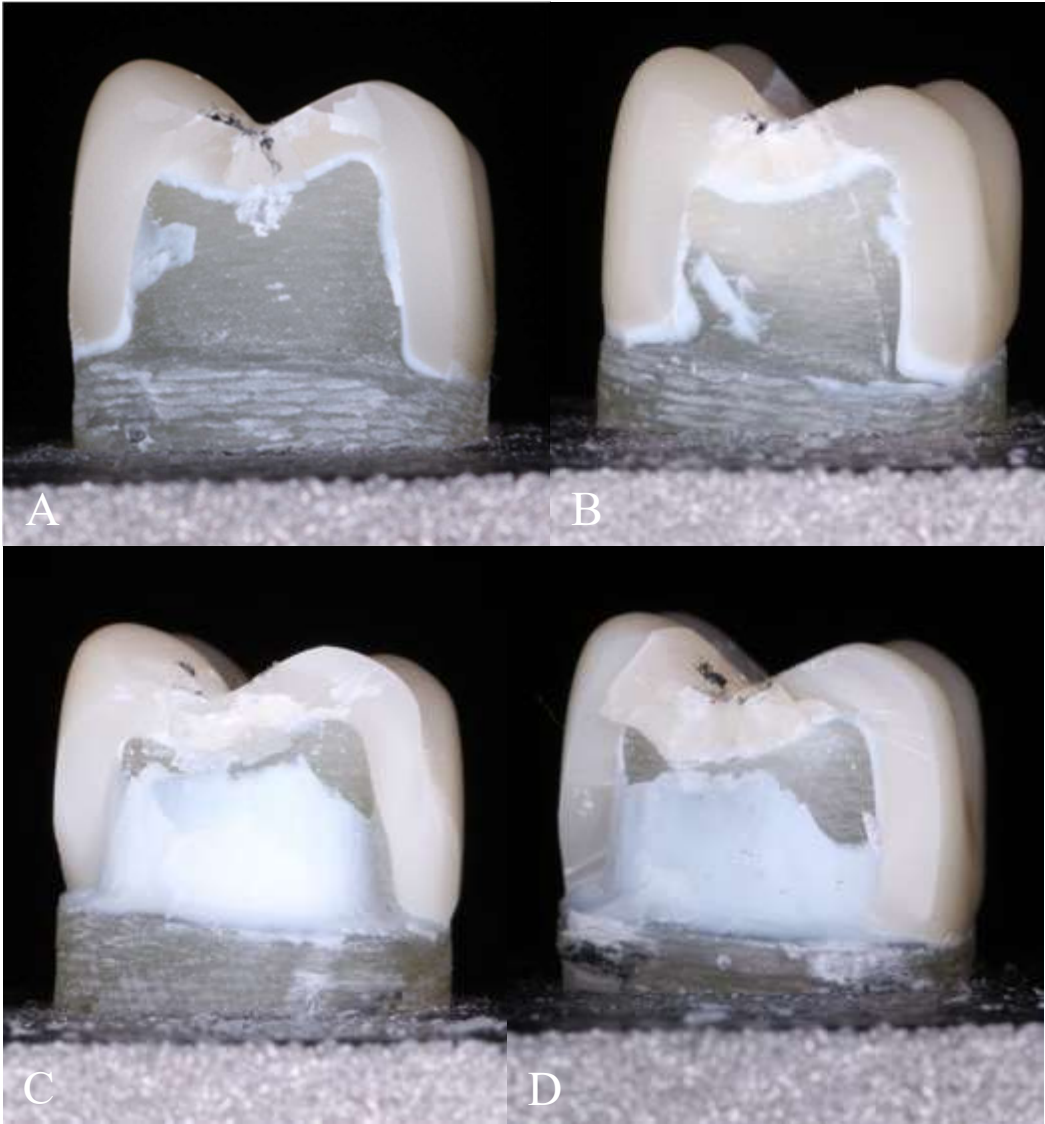
Figure 6: Failed intact (A) and accessed/repared (B) lithium disilicate crowns. Failed intact (C) and accessed/repared (D) zirconia crowns

loading was conducted parallel to the long axis of the specimen. The tip was placed with a crosshead speed of 0.5 mm/min on the mesial marginal ridges of both the intact and repaired crowns (Figure 5). Using MTS Testworks 4 software, increases in the fracture loads were continuously recorded in Newtons (N) starting at 100 N. Progressive force was applied until complete fracture of the crown. Stress-strain curves were analyzed for the first discontinuity representing a drop in the load and called “failure load.” Complete failure load was designated by the peak load prior to a greater than 5% drop in load (Figure 6).

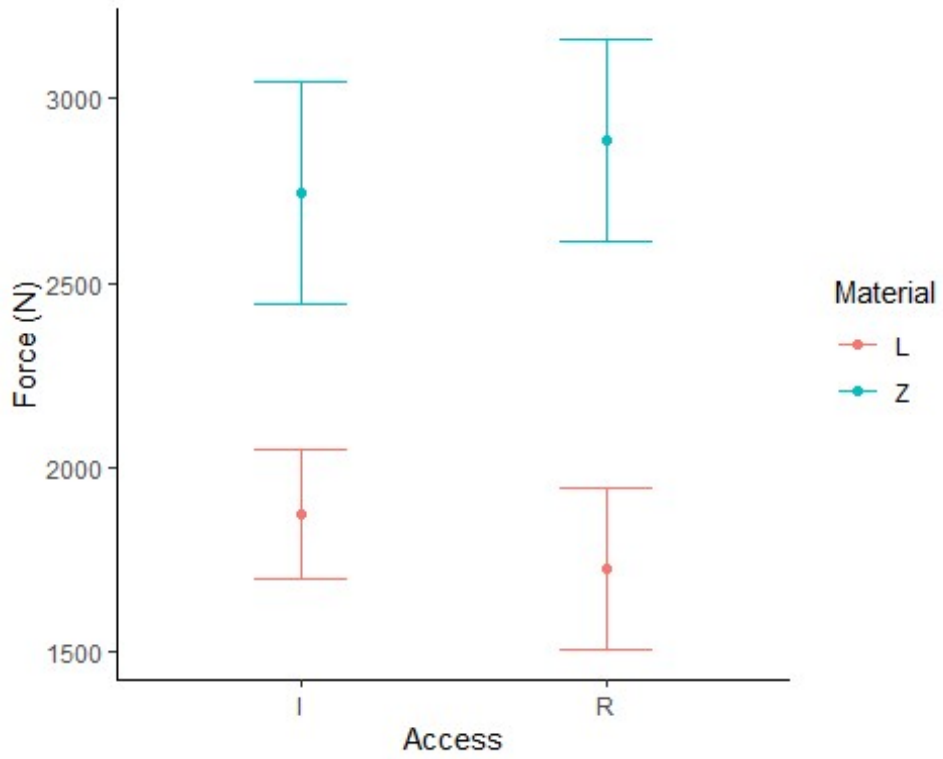
Figure 7: Mean force loads with standard deviations (N=Newtons) for intact (I) and repaired (R) lithium disilicate (L) or zirconia (Z) crowns.

Figure 7 shows the mean failure loads for each material for both intact and restored crowns. The force required to fracture intact crowns ($2310\text{N} \pm 557\text{N}$) was statistically equivalent ($p=.98$) to the force required to fracture repaired crowns ($2307\text{N} \pm 683\text{N}$). However, there was a large and statistically significant difference ($p<.0001$) between the force required to fracture monolithic zirconia ($2814\text{N} \pm 398\text{N}$) and monolithic lithium disilicate ($1802\text{N} \pm 281\text{N}$). There was no significant interaction between material and access type ($p=.19$).

Planned comparisons between the fracture resistance of intact vs. restored crowns for each material revealed no significant difference for either monolithic lithium disilicate ($p=.35$) or monolithic zirconia ($p=.36$).
