THESIS APPROVAL PAGE FOR MASTER OF SCIENCE IN ORAL BIOLOGY

**Effect of Axial Wall Height and Total Occlusal Convergence of 3Y-TZP Zirconia
Implant Abutments on the Retention of Adhesively Bonded 3Y-TZP Zirconia
Crowns**

By
Maj Jens D. Nelson, DMD
Prosthodontics Resident, Air Force Postgraduate Dental School and Uniformed Services
University of the Health Sciences Postgraduate Dental College

24 May 2021

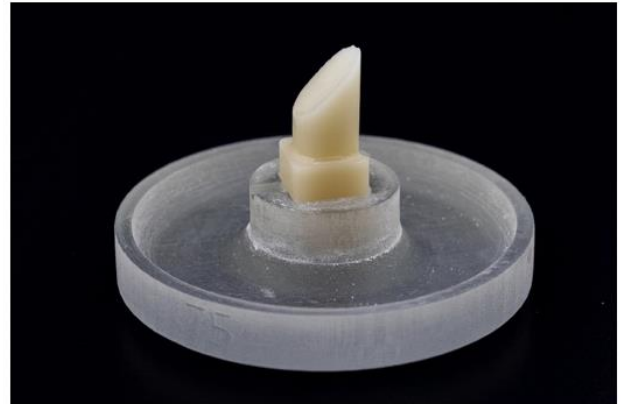
Figure 4. Crown seating index base

allowed to react for 60 seconds, then dispersed with a mild stream of compressed, filtered, oil free air at 30 PSI for 2 seconds. Subsequently, Panavia V5 (Kuraray America, Inc., New York, NY) adhesive cement was applied to the intaglio surface of the crown, the crown was placed on the abutment and seated, using a 3D-printed resin crown seating index with 10 pounds of pressure for 30 minutes (Mannix Timer) [Figures 4, 5, & 6].

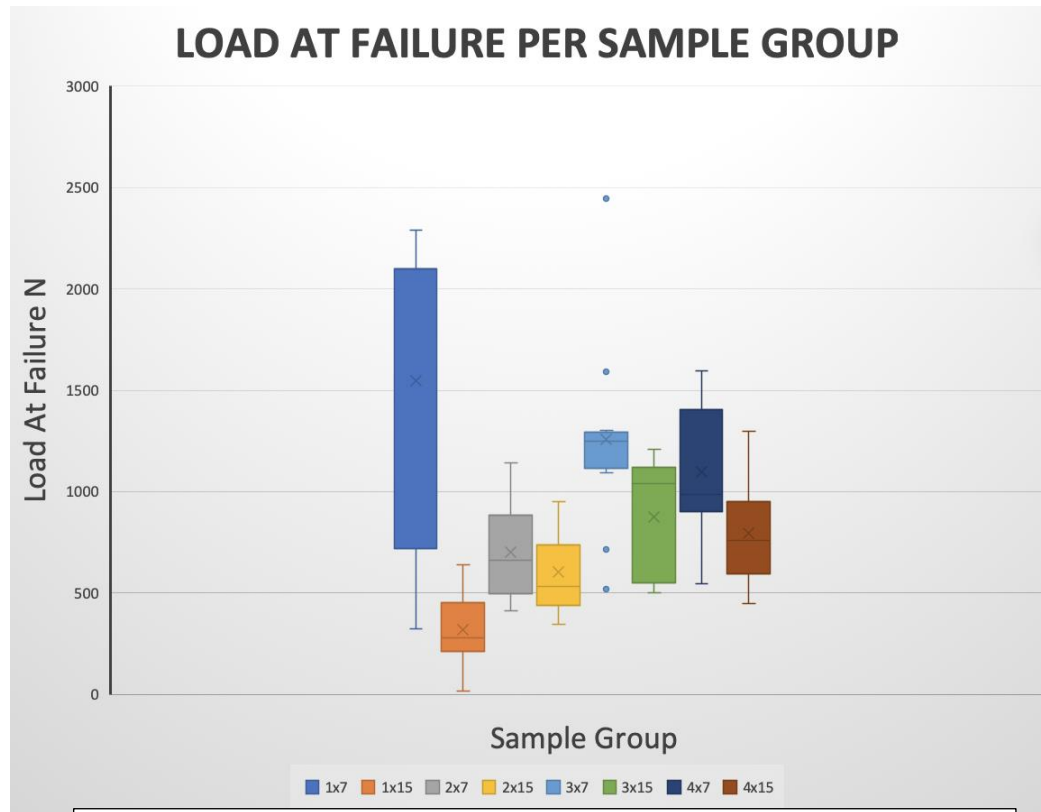
SPSS computer software was used to calculate and tabulate the data. The load at failure for each test group are summarized [Table 2] and the range of the data is shown in a box plot [Figure 8].

Figure 8. Boxplots of load [N] at failure for each sample group
