ARL-TR-9607 • Oct 2022

Experimental Investigation of $\text{Yb}_2\text{Si}_2\text{O}_7$ with Molten Calcia-Magnesia-Alumina-Silicate (CMAS) Deposits

by Christopher Louzon, Anindya Ghoshal, and Andrew J Wright

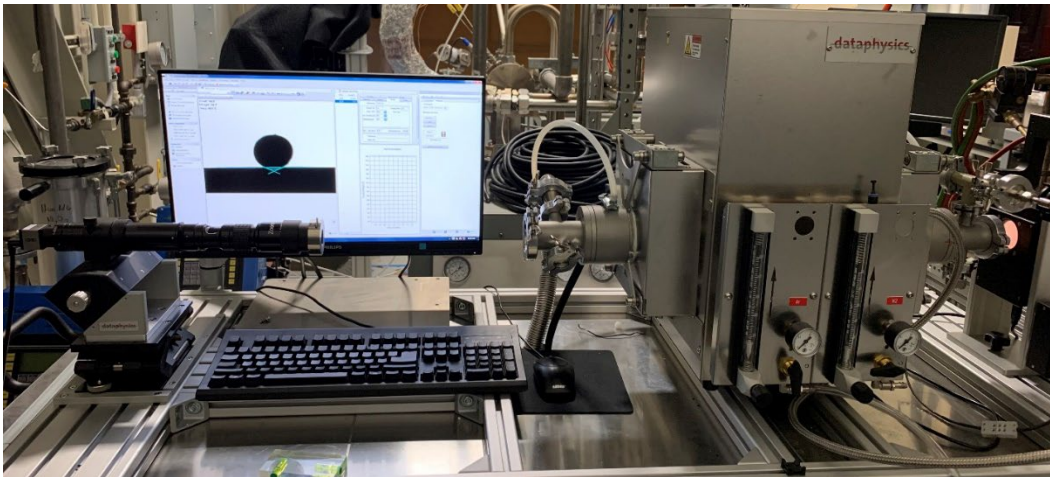
Fig. 2 Contact-angle test measurement setup for a standard sample

CMAS was mixed with ethanol to create a thick paste, which was then rolled into a 0.19824-g ball 6.042 mm in diameter. The ball was placed in the top center of the sample. The sample was then loaded into high-temperature contact angle measurement hardware with a tube furnace (DataPhysics Instruments) and heated to 1278 °C at a rate of 5 °C/min. The sample was observed using a digital camera. The sample was held at 1278 °C for 30 min, then cooled to room temperature at a rate of 5 °C/min. The instrument software (DataPhysics Instruments) continuously calculated the contact angle during image recording (Fig. 2).
