AIRBORNE RADIO DIVISION

FR-2581

13 July 1945

AIRBORNE TELEVISION - RESULTS
OF TEST OF TYPE CIX-59AAF CONVERSION
UNIT, FOR MODELS ATJ OR ATK TELEVISION
EQUIPMENT

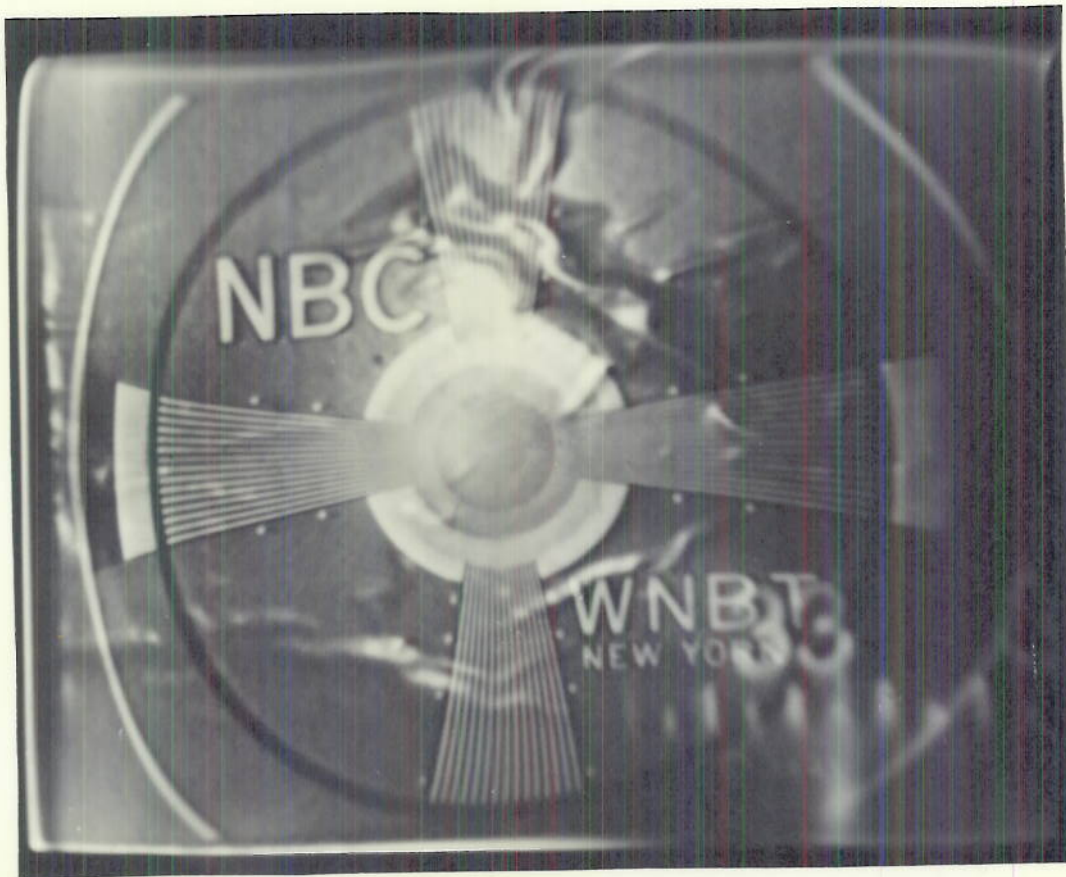
(n) The unit performance at -30°C and $+50^{\circ}\text{C}$ was satisfactory. Plates 8 and 9 show the photographs made at these temperature levels.

MONITOR SCREEN - CONVERSION UNIT 50°C

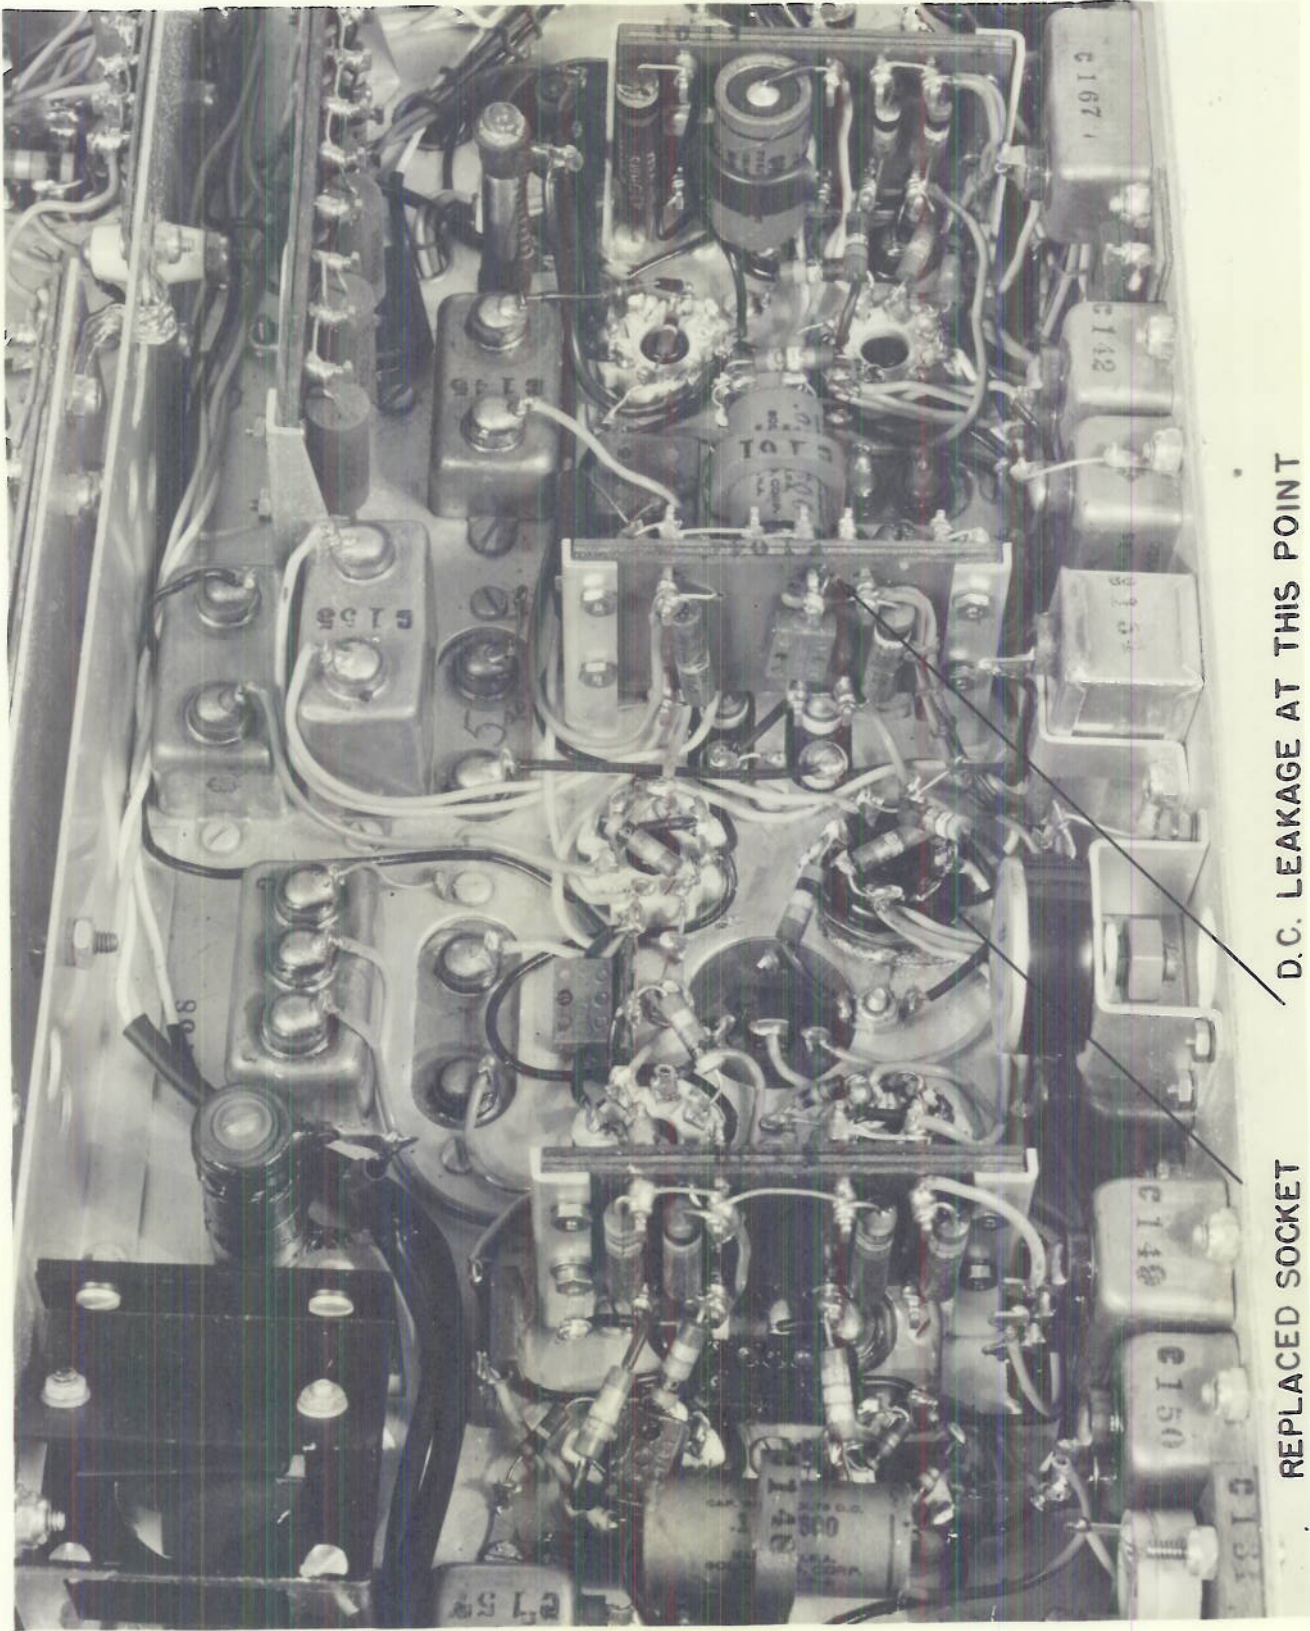
(o) After a storage period of 48 hours at $+50^{\circ}\text{C}$ and a relative humidity of 95% the conversion unit failed to operate correctly. There was no vertical synchronization pulse output and no video signal output after a warm-up period of one hour. The test chamber was then turned off and the door opened. Investigation disclosed that the shutter was stuck due to rusting of the wire that actuates it. After remedying this condition, the video output signal showed an enlarged ion spot. Equipment operation was continued for an additional hour, during which time the video signal output improved and the vertical sweep frequency came in at 80 c.p.s. It was later found that a two megohm resistance tied between grid and plate of the vertical oscillator, V124-A, would cause oscillator failure. The same effect was produced when a fine spray of water was directed on the isolantite tube socket. Comparison tests made on a similar socket and one made of bakelite, showed that the isolantite socket (which was not glazed) was porous and absorbed and retained moisture. The bakelite socket was found to be superior in this respect because the moisture accumulated in globules and evaporated. Plate 10 is a photograph showing the bakelite replacement socket. It is to be noted that the accumulation of dust particles on the isolantite socket would aid in holding moisture and maintaining leakage resistance between socket lugs.

(p) Another humidity test was made after replacing the vertical oscillator tube socket with one made of bakelite. The vertical sweep frequency output was 80 c.p.s., but after a 15 minute warm-up time, it changed to approximately 24 c.p.s. The video signal was mostly due to the enlarged ion spot which gradually decreased. However it took one hour for the picture to come in. Subsequent investigation revealed that the low sweep frequency was caused by d.c. leakage of positive supply voltage ($+250$ volts) to the grid of the synchronized relaxation oscillator, V125, through R225 (1 meg.). The resistor (R225) and d.c. voltage connections are in close proximity on terminal strip E-104. A simulated leakage resistance of 8 megohms between these two points reproduced the low frequency sweep. The terminal strip in question is shown in Plate 10. After R225 and C156 were removed from the strip and reconnected, the vertical sweep frequency remained at 40 c.p.s. during another humidity test.

(q) Loss of the video signal was also traced to faulty terminal strip design. It was found that this was caused by d.c. leakage of positive voltage to the negative bias supply line feeding the video amplifier. It is believed that this occurred in more than one terminal strip so that even though leakage resistance in any single strip might not seriously affect the video signal, a number of leakages in parallel would be sufficient to do so.

D.C. LEAKAGE AT THIS POINT

REPLACED SOCKET

TERMINAL STRIP E-104

(c) Performance of the conversion unit under conditions of high temperature and humidity was poor.

- (a) The focus control be made less critical in adjustment.
- (b) The plate supply voltage lead on terminal strip E102 be relocated so that a short circuit cannot occur.
- (c) Performance of the conversion unit under conditions of high temperature and humidity be improved to meet specifications.
