FR-2586

SHIP-SHORE RADIO DIVISION - SEARCH RADAR SECTION

PERFORMANCE TEST
OF CXFA TRANSMITTER
AND 527 VACUUM TUBE

This report is a broad summary of tests conducted at the Naval Research Laboratory between July 1943 and September 1944 on the CXFA/X5000 transmitter and on the type 527 vacuum tube used in the oscillator of this transmitter. The tests were made under NRL problem S423T-C. The transmitter, built by the Eitel McCullough Co., was a prototype of that subsequently incorporated in the SK-1M radar, manufactured by the General Electric Co. for the U.S. Marine Corps. The object of the tests was two-fold: To determine the behavior, primarily the life expectancy, of the 527 tube, and to ascertain and correct any faults in, and otherwise improve, the transmitter. During the first eight months of the tests, approximately, the 527 was still under development. Samples of several evolutionary stages including the final model of the tube were life tested. These tests, together with their results, are described for each developmental model tested. Life in general was satisfactory. An improved keying circuit was developed and incorporated. Some simplifying modifications of the high fre

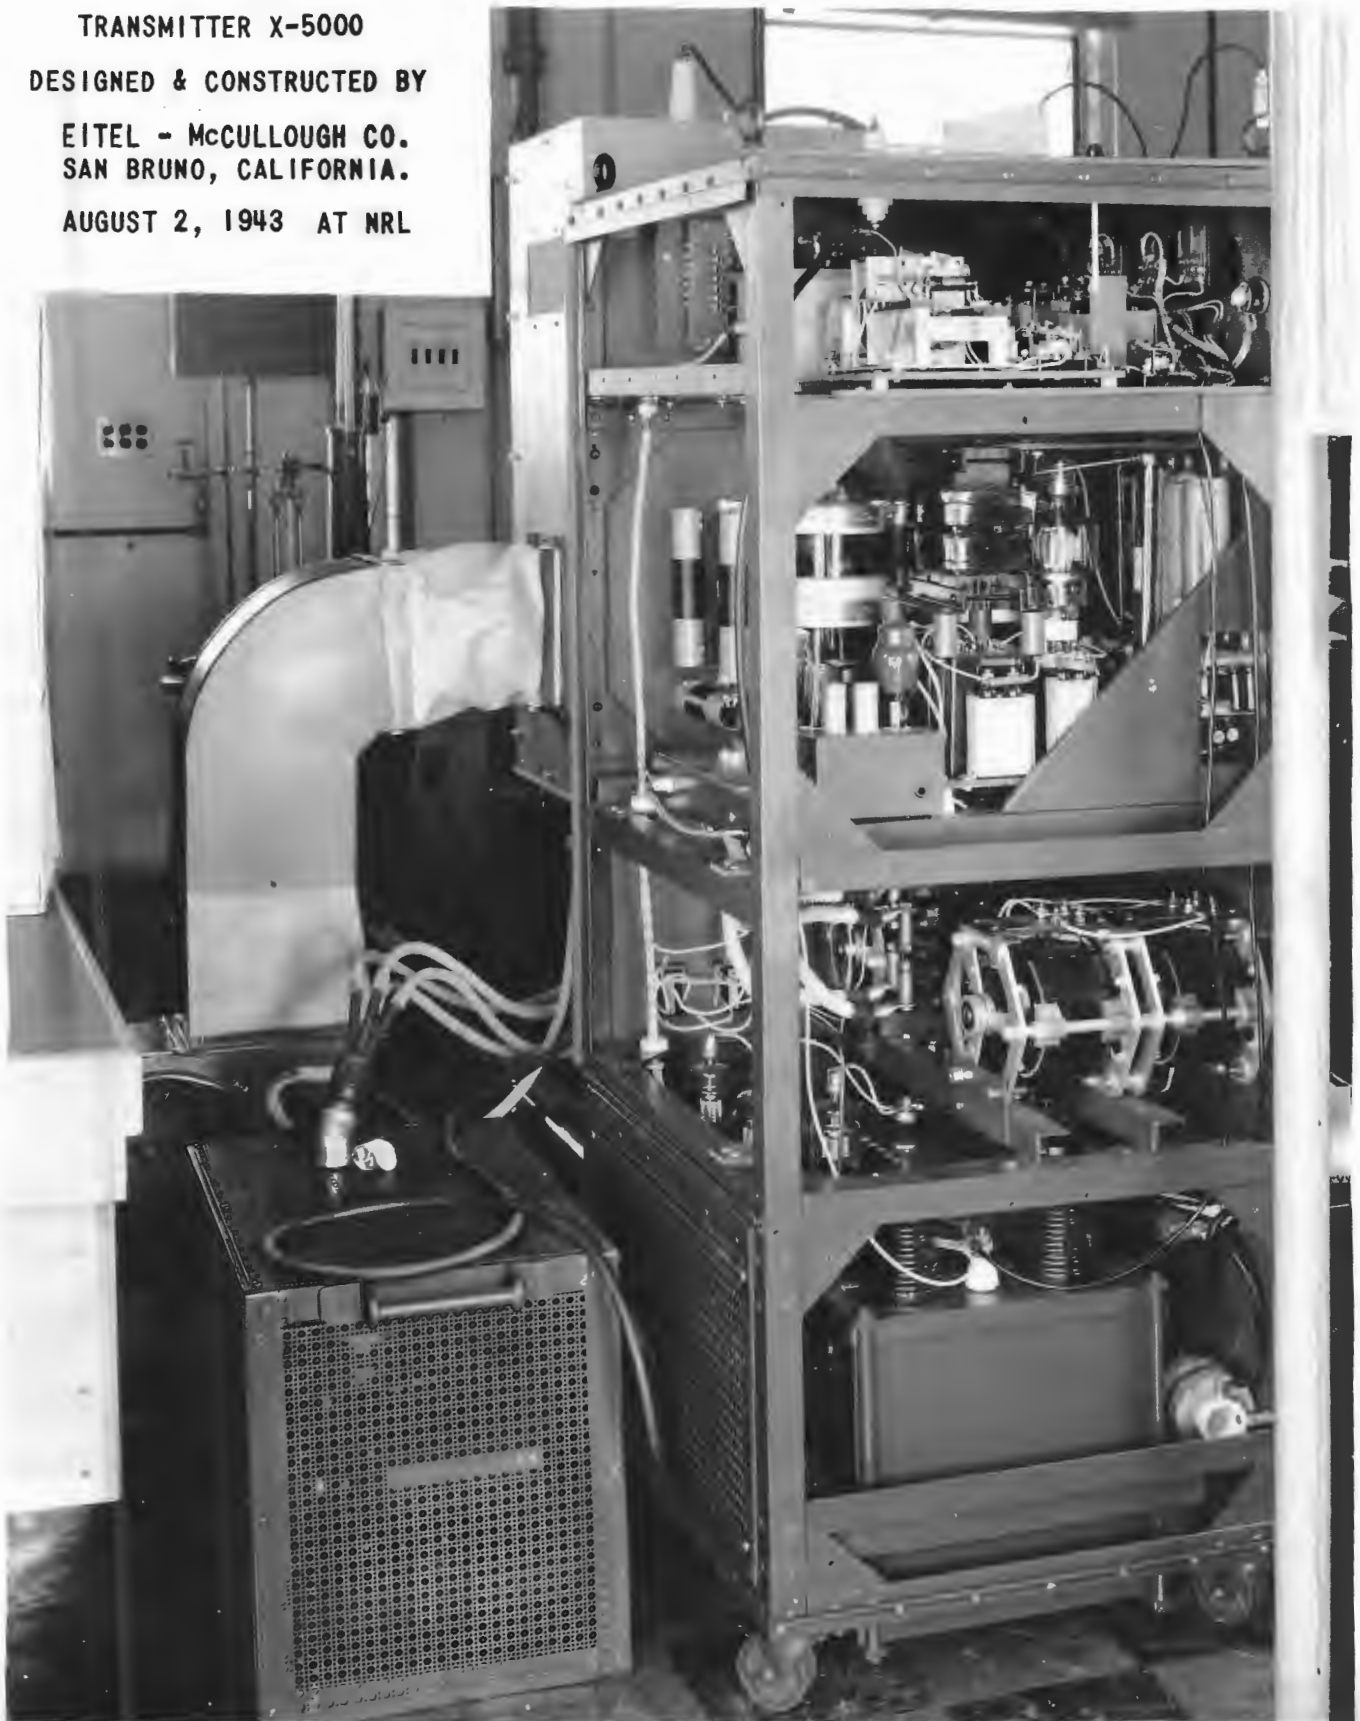
PLATE 6

TRANSMITTER X-5000
DESIGNED & CONSTRUCTED BY
EITEL - McCULLOUGH CO.
SAN BRUNO, CALIFORNIA.
AUGUST 2, 1943 AT NRL

1-4-2. Two air cooling supplies for the oscillator were provided. They are shown in Plates 1 and 6. One blower furnished the main cooling stream into the lower back of the oscillator box. This stream travelled upward past the tubes and out through the viewing windows and the top (which was customarily left open in operation, although a top with ventilating holes was originally furnished for the box). A second and somewhat higher

1-4-3. The input power supplies and control circuits were housed in a cabinet (Plates 1 and 6) separate from the oscillator box. The power supplies were in the first and second decks of the cabinet, from the bottom. A high voltage transformer rated at 22 kv and 150 ma, four tube bridge rectifier using type 100-R tubes, and filter consisting of a 2500 ohm resistor and $\frac{1}{2}$ microfarad condenser furnished the plate power. The filaments were heated by a transformer rated at 6 v and 600 a. Both plate and filament voltages were variac controlled in the primary circuits of their supply transformers. The grid modulation circuit, on the third deck, was of the self-quenching type using control of the discharge timing of the quench capacitor for repetition rate control. A six-section, 50 ohm, 5 microsecond artificial line was used to form the pulse, and discharge timing was controlled by a variable discharge resistance, type 304-T discharge tube and a driving transformer for this tube which could be fed either from the 60 cycle line supply or from a 180 cycle audio oscillator-amplifier. By using the resistance alone to discharge the artificial line, variable time-constant-controlled repetition rates were available, or by using the keying tube with the line or audio oscillator controlling frequency, synchronized rates of 60 and 180 pps respectively could be had. Control relays at the top of the cabinet, were arranged for overload protection of the plate supply (with provision for locking off after a certain number of "tripouts" within a predetermined interval), and for shut down in case of water failure to the dummy load.
