GAS PULSATOR

- Report O-2650

PARTIAL REPORT  
ON  
GAS PULSATOR

ABSTRACT

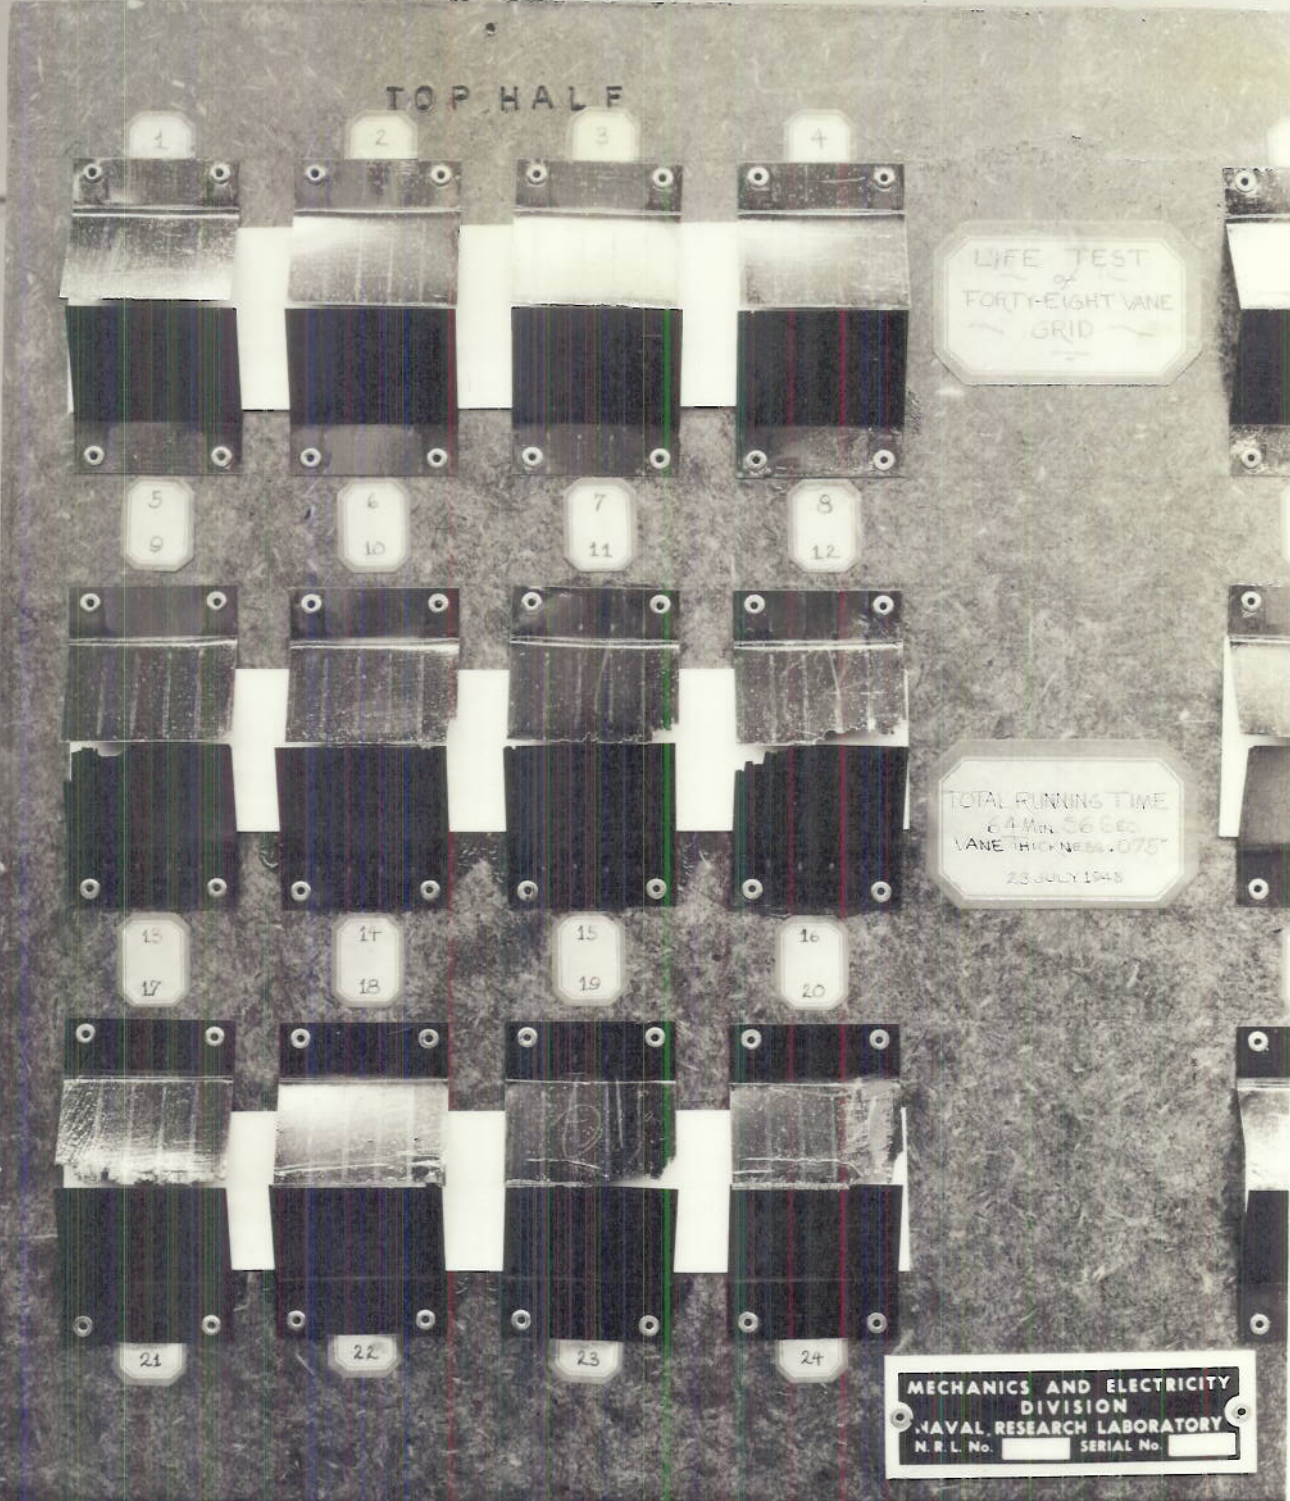
TOP HALF

TOTAL RUNNING TIME  
64 MIN. 56 SEC.  
VANE THICKNESS .075"  
23 JULY 1945

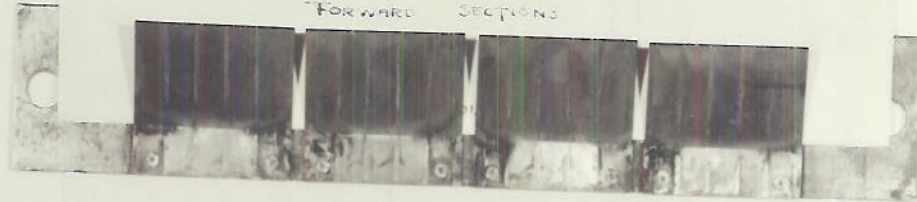
48 VANE GRID (.010" VANES)  
WITH  
24 VANE SIDE ENTRY VALVE (.008" VANES)  
RUNNING TIME - 9 MINUTES  
MAX FUEL RATE - 620 LBS/HR  
TOP OF GRID

FORWARD SECTIONS

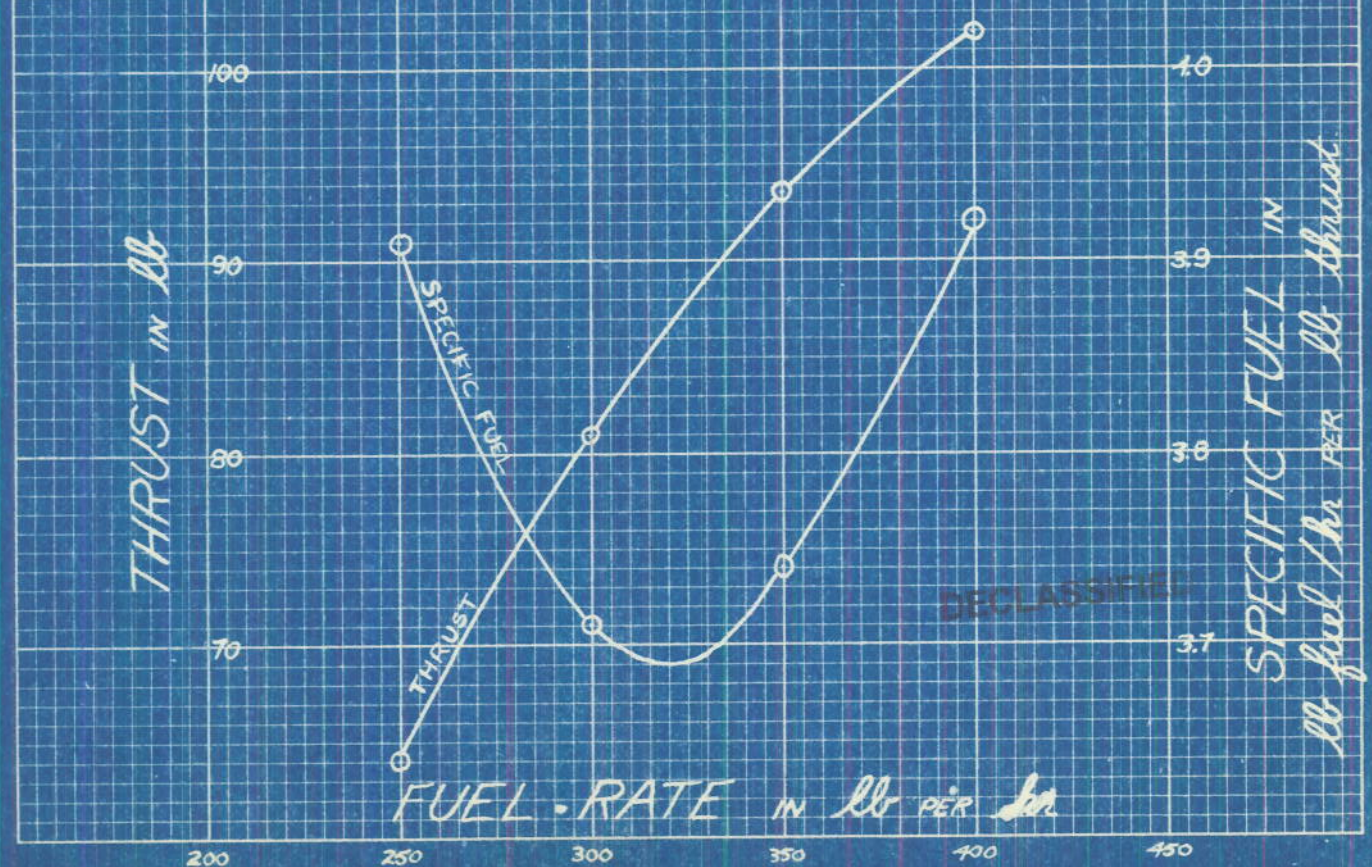
PLATE 43

GAS MOTOR - TYPICAL OPERATING CONDITIONS

(Forty-eight 0.010" vanes, opened; Two internal fuel jets; Internal spark-plug ignition, 2 1/2" from front)

11. Typical Data. Although the fundamental problem of the current experimental work has been to increase valve life, sometime has been devoted to the development of methods of determining all operating characteristics. Measurements of fuel flow, thrust, air flow, and frequency have been made for various physical set-ups and data taken at different operating conditions as exemplified in Plate 42 by typical data taken for 48 of the standard 0.010" vanes. From these data computations are made for specific fuel rate and air-fuel ratio. Typical curves for thrust, specific fuel rate, air flow, and air-fuel ratio versus fuel flow are shown in Plate 43. The corresponding curve of frequency against
