PARTIAL REPORT  
ON  
GAS PULSATOR

Report O-2730

2d PARTIAL REPORT  
ON  
GAS PULSATOR

# ABSTRACT

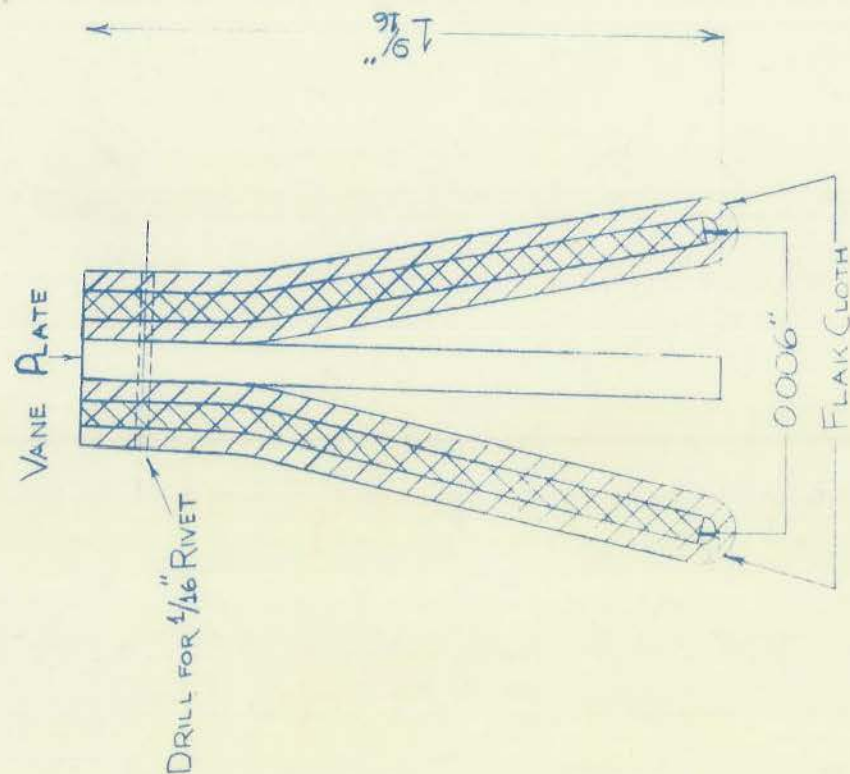
PLATE 6

# DIAGRAM OF CUSHIONED VANE

| | Plate No. |
|---|---|
| Drawing, #F-6-F | 6 |

13. #F-6-F (30 minutes). The protection of spring-steel Eichelberg valves by means of ceramic covers has been suggested in Ref. (4) where initial investigations are reported. This type of protector would insulate against the heat of combustion and might also serve as a buffer against impact shock. First trials were made with a fiberglass cloth impregnated with ethyl-cellulose. This particular ceramic is commonly known as "Flak" cloth. Each protector was cut slightly narrower than the steel vane but twice as long; folded over the combustion, or vibrating, end of the 0.006-inch steel vane; and riveted to the standard vane plate. This assembly is illustrated in Plate 6. In this case, the ethyl-cellulose coat was placed on the outside. A 30-minute run demonstrated that the ceramic covers successfully protected the steel vane. Plain 0.006-inch spring-steel vanes last about 6 minutes. Protectors of flak cloth extended this life to over 30 minutes. However, the ethyl-cellulose coating was not sufficiently heat-resistant, but burned off the combustion side. This resulted in a program to test other types of ceramics and other methods of protecting steel vanes.

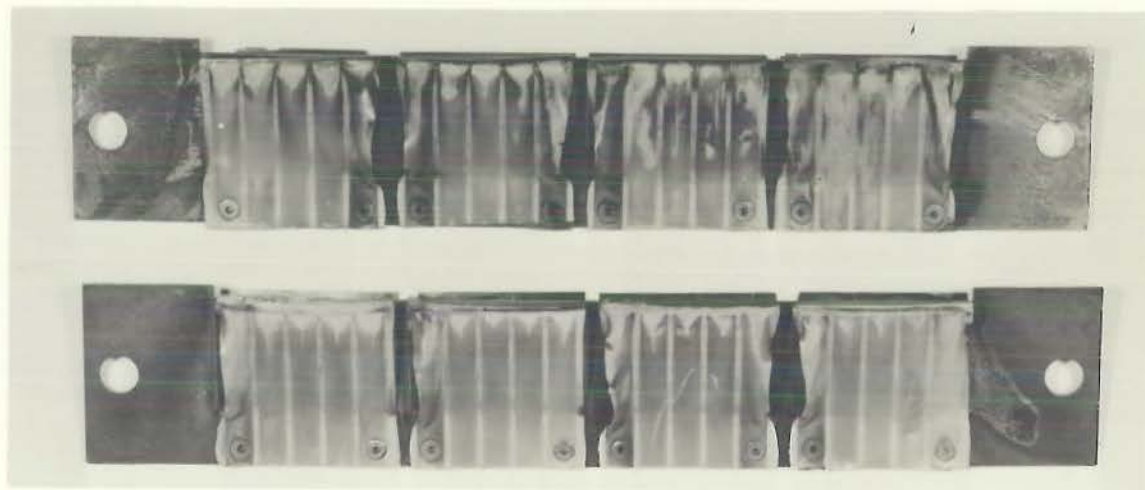
PLATE 7

SAMPLES OF VANES PROTECTED WITH POLY-F PLASTIC  
TIME OF RUN 31 MIN.  
(.006" VANES)

15. #P-6-P (30 minutes). Another ceramic which was suggested for use as a wrap-around protector was Poly-F 116, a high-temperature plastic. Some 0.011-inch thick Poly-F 116 was therefore assembled with 0.006-inch spring steel in a valve similar to that sketched in Plate 6. A 30-minute run indicated that this plastic did not furnish adequate protection but curled up from the heat and split out at the edges as shown in Plates 7 and 8.

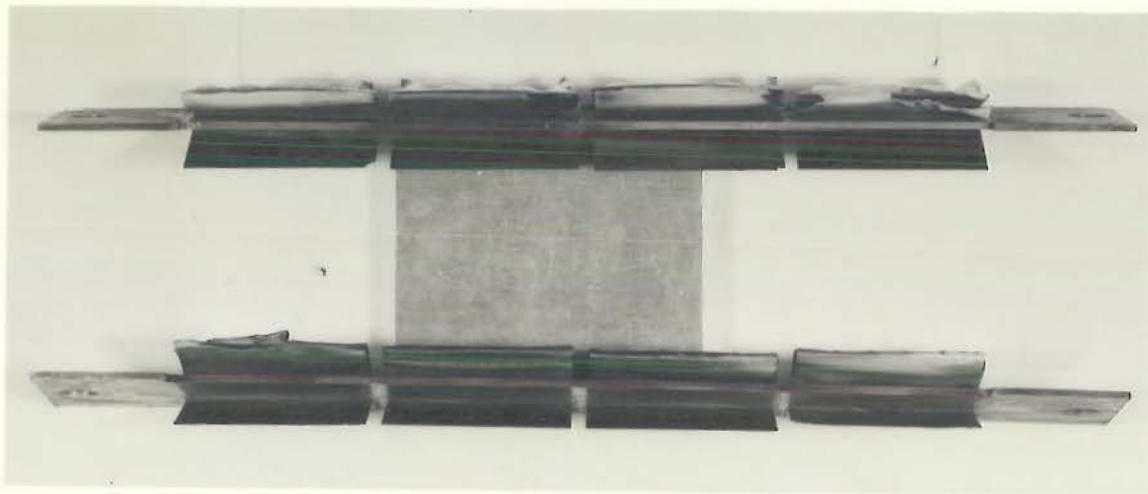
SAMPLES OF VANES PROTECTED WITH POLY-F PLASTIC  
TIME OF RUN 31 MIN.  
(.006" VANES)

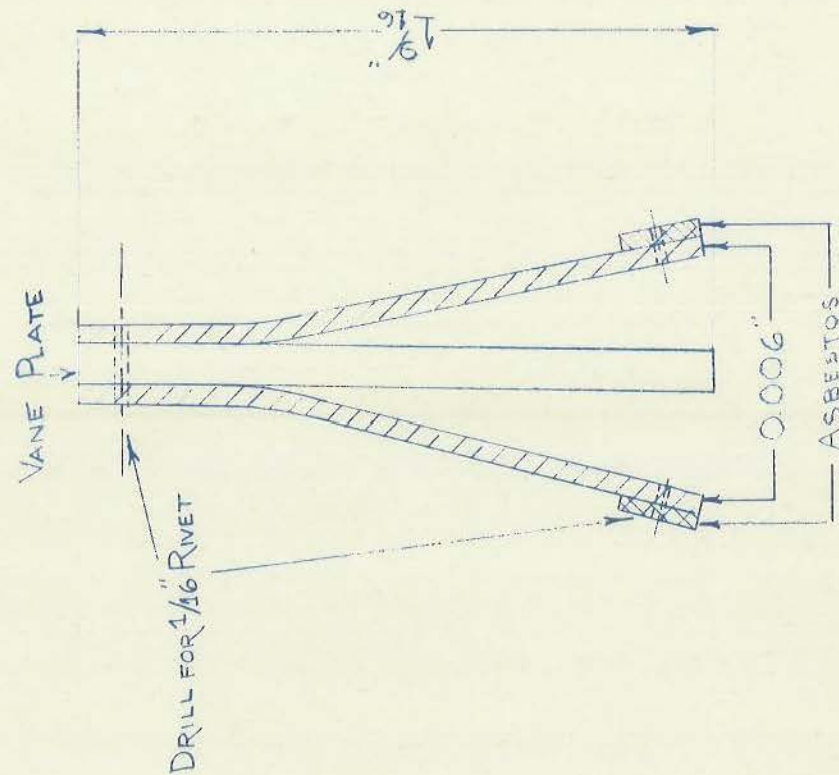
PLATE 9

# DIAGRAM OF CUSHIONED VANE

tip, or vibrating end, an attempt was made to protect the tip from shock by means of reinforcements. Plate 9 shows an arrangement whereby a strip of asbestos material one-sixteenth inch thick and three-eighths inch wide was riveted to the tip of each 0.006-inch steel vane on the striking side. It should be noted that this would be poor aerodynamic design since the raised obstruction of asbestos and rivets would interfere with smooth air flow. However, this reinforcement was tried in order to determine if tip breakage could be prevented. A 30-minute test demonstrated that the asbestos strips failed to stay on the tips of the vanes. Despite the reinforcing strips, vanes chipped at the ends. Moreover, vane seats were roughened by the severe action of these valves.

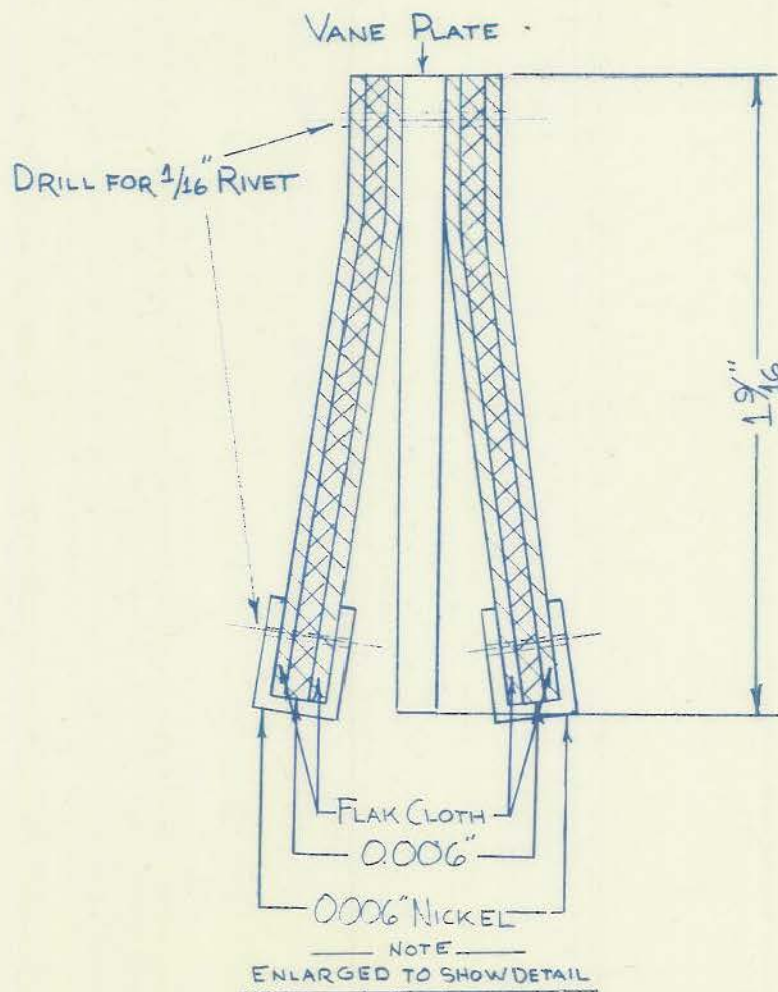
PLATE 10

# DIAGRAM OF CUSHIONED VANE

18. #n-F-6-F-n (30 minutes). Another special valve assembly featured reinforcement of the tip of a steel Eichelberg valve which was also covered by a wrap-around protector. A standard 0.006-inch spring-steel vane was covered with flak cloth and a protecting shoe of 0.006-inch nickel was riveted onto the tip, as depicted in Plate 10. A 30-minute test demonstrated that this assembly was unsatisfactory. The nickel shoe broke under impact, the vane chipped at the tip, and the vane seat became roughened because of the pounding.

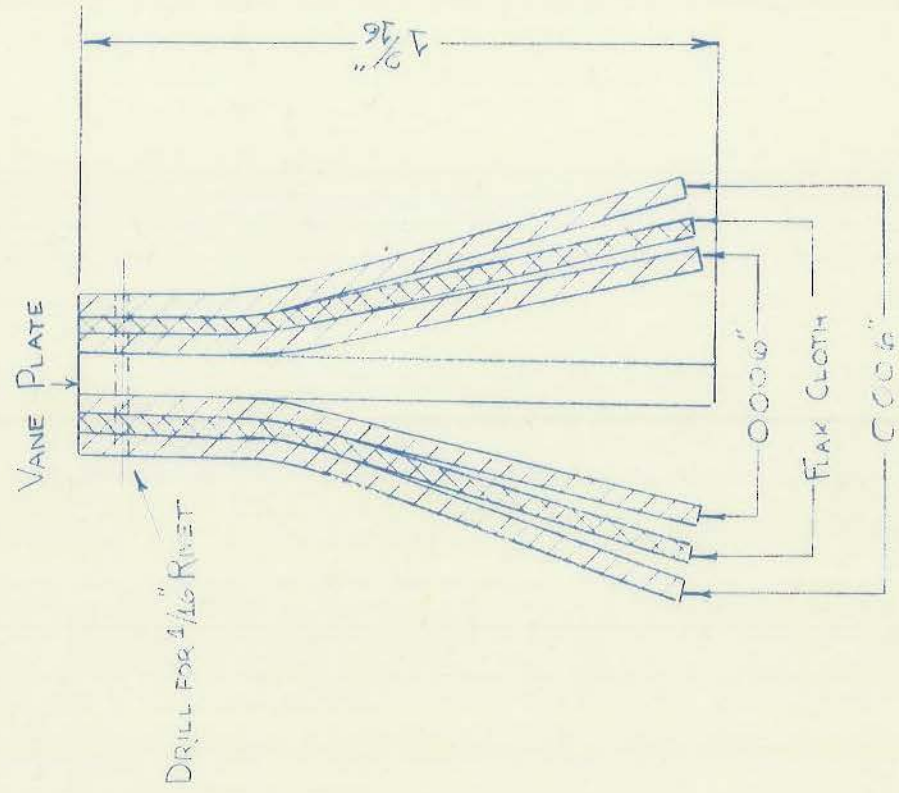
PLATE 11

# DIAGRAM OF CUSHIONED VANE

20. #6-F-6 (30 minutes). The first trial of laminated vanes was made with ethyl-cellulose-coated glass-cloth sandwiched between 0.006-inch spring-steel vanes as illustrated by Plate 11. A 30-minute run demonstrated that the striking vane tended to chip, whereas the combustion-side vane remained intact. Hence, a complete seal was maintained and the valve assembly prevented leakage of combustion gases. This arrangement was satisfactory for short runs but was subsequently improved.

21. #6-S-6 (30 minutes). Another ceramic was tried in lamination with steel vanes in order to compare it with flak cloth. A glass fabric coated with silicone rubber was sandwiched between 0.006-inch spring-steel vanes in an arrangement similar to that shown in Plate 11. This ceramic proved to be

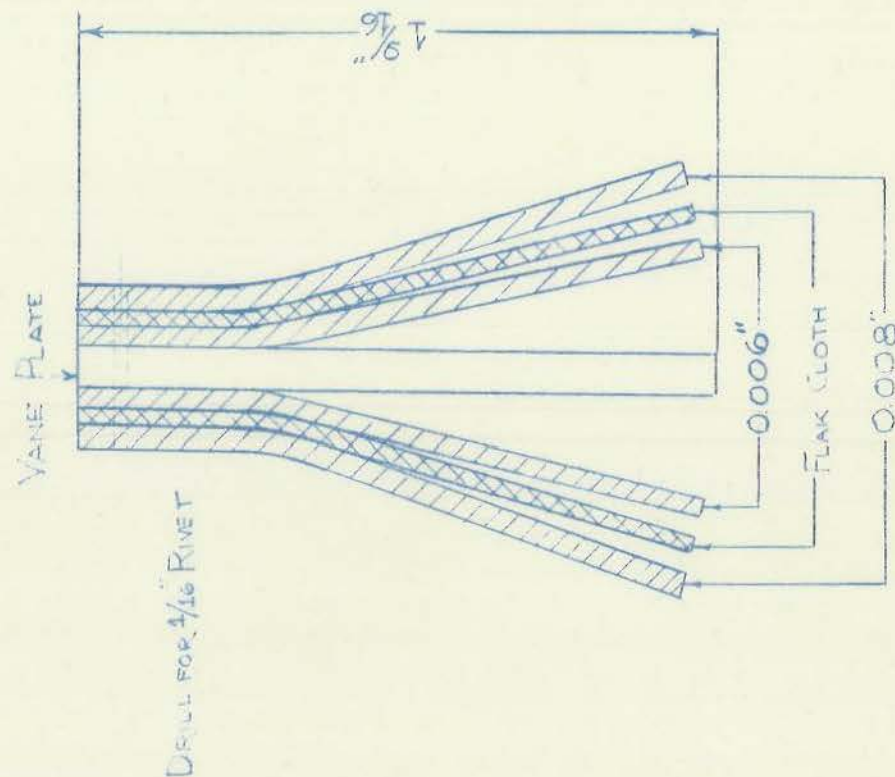
PLATE 12

# DIAGRAM OF CUSHIONED VANE

23. #8-F-6 and #8 (240 minutes). Because of the chipping of the 0.006-inch steel vanes on the striking side during first trials of sandwich vanes, 0.008-inch steel vanes were tried in this position. Tests reported in Ref. (4) demonstrated that plain 0.008-inch steel vanes lasted longer than either 0.006-inch or 0.010-inch ones. The sandwich vane then consisted of an 0.008-inch spring-steel vane on the striking side, a 0.006-inch spring-steel vane on the combustion side, and a piece of flak cloth sandwiched between, as illustrated in Plate 12. The motor grid was assembled with a combination of thirty-two #8-F-6 sandwich vanes and sixteen #8 vanes as discussed in paragraph 22. Tests were run at a Rotameter fuel rate of 350 lbs/hr or an average rate of 334 lbs/hr calculated from weight readings. This latter value for a 48-vane grid is approximately 7 lbs/hr of fuel per vane. All runs were of 30 minutes duration except for Runs 3 and 9 which were only 15 minutes long. Thrust was measured from Run 4 through Run 9. During Run 4, 102.5 pound thrust was produced at a specific fuel rate of 3.25 pound of fuel per hour for each pound of thrust. In Run 5 the thrust had dropped to 99 pounds and specific fuel rate had risen to 3.42. In Run 6 the thrust dropped to 89 pounds for a specific fuel rate of 3.76. The cause of this drop in thrust was found to be the deterioration of the #8 vanes in single vane positions #1, 4, 45, 46, and 48. Chipping and tearing of the edges of these plain vanes permitted leakage of combustion gases, loss of pressure, and decrease in thrust. Plate 13 shows the condition of the plain vanes at the end of Run 6 with a total running time of 2 hours and 45 minutes. On the other hand, the special laminated vanes in positions of more severe heating were still intact. As a result of the replacement of eight plain #8 vanes, the thrust in Run 7 was 103 pounds for a specific fuel rate of 3.24. The plain #8 vanes in grid positions of only moderate treatment ran 165 minutes before replacement. Runs were continued for a total running time of 4 hours with the condition of the vanes after that time shown in Plates 14 and 15. The sandwich vanes were still in good running condition since all 0.006-inch steel vanes were perfect. Some chipping had occurred in the 0.008-inch steel vanes on the striking side of the laminated assemblies. However, intact 0.006-inch vanes on the combustion side prevented leakage of

24. #8 -F-6 (385 minutes). Because of the good showing of the sandwich vanes when used in combination with plain vanes, another series of tests was made on a complete set of forty-eight of these vanes. Each valve consisted of an 0.008-inch spring-steel vane on the striking side, a 0.006-inch spring-steel vane on the combustion side, and a piece of flak cloth sandwiched in between. The assembly is illustrated in Plate 12. Data in Plate 2 show that thirteen runs were made with this set of vanes. Each run was for thirty minutes except for the last which was only twenty-five minutes long. The total running time was six hours and twenty-five minutes. Fuel rate was set at 350 lbs/hr by Rotameter. Weighed readings gave a computed fuel rate of 334.6 lbs/hr. This was approximately seven pounds of fuel per hour for each vane in the forty-eight vane grid. Frequency measurements by Vibrometer indicated 41.5 to 43.0 cycles per second. Plates 16 and 17 show the vanes after removal from the motor at the end of Run 13. One of the head gaskets blew out during this run and probably allowed excessive leakage of combustion gases on the side. Deterioration was rapid during this run although all vanes had been in good shape at the end of Run 12. Perhaps the deterioration of vanes during Run 13 could be attributed to gasket failure. Leakage through the valves had been negligible during Runs 1 to 12. Therefore, at least six hours running time could be safely expected from an assembly of #8-F-6 sandwich vanes on the 13-inch gas pulsator. Plate 16 shows that vanes 1 and 42 were chipped badly enough to allow excessive leakage. Plate 17 shows that vanes 8, 16, 24, 31, 32, 38, and 40 were also badly chipped. Thus 9 vanes out of 48, or about 18.7 percent, were in bad condition. This series of runs confirmed the tests reported in paragraph 23 whereby four hours running time was accumulated for #8-F-6 laminated vanes placed only in those positions where vane failure had been most noticeable in previous tests. The #8-F-6 vanes were still in useable condition at the end of this 4-hour test. These two sets of runs clearly demonstrated the value of sandwich vanes combining ceramics with spring steel.

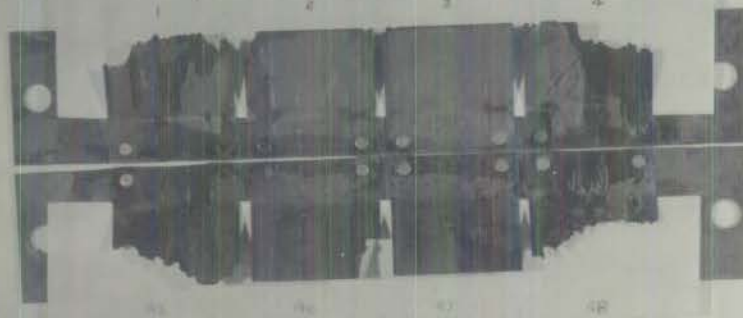
PLATE 13

SINGLE .008" VANES FROM  
LIFE TEST OF DOUBLE VANES  
WITH FLAK CLOTH BETWEEN  
TOTAL RUNNING TIME 2HR 15MIN.

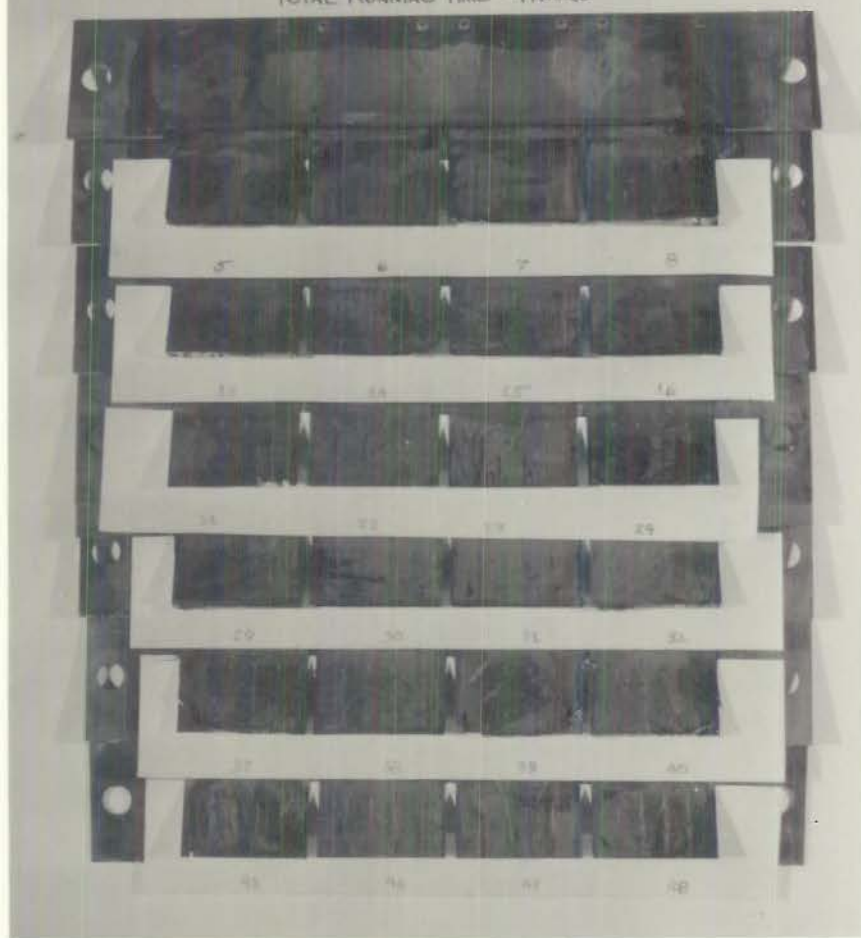
PLATE 15

LIFE TEST  
of  
DOUBLE VANES WITH FLAK CLOTH BETWEEN  
STRIKING VANE - .008" THICK  
BOTTOM VANE - .006" THICK  
TOTAL RUNNING TIME - 4 HOURS

combustion gases through the grid assembly. This test furnished a reliable comparison between #8-F-6 sandwich vanes and plain #8 vanes. The fact that it was possible to operate these vanes for four hours clearly demonstrated that the flak cloth was effective as a shock absorber and as a heat insulator.

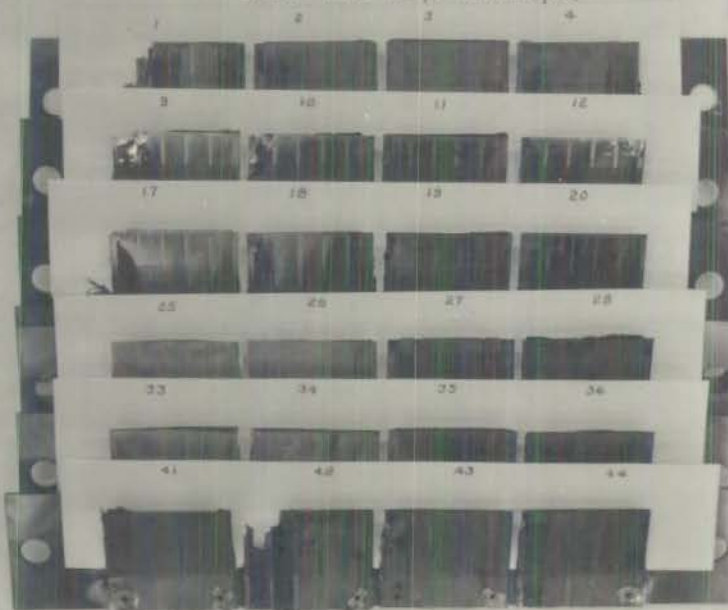
PLATE 16

FORTY-EIGHT VANE GRID  
— from —  
GAS PULSATOR  
TOTAL RUNNING TIME — 6 HRS. 25 MIN.

REDS — STRIKING VANE — .008" THICK.  
DACKING VANE — .006" THICK.  
SINGLE PLATE CLOTH SEPARATOR

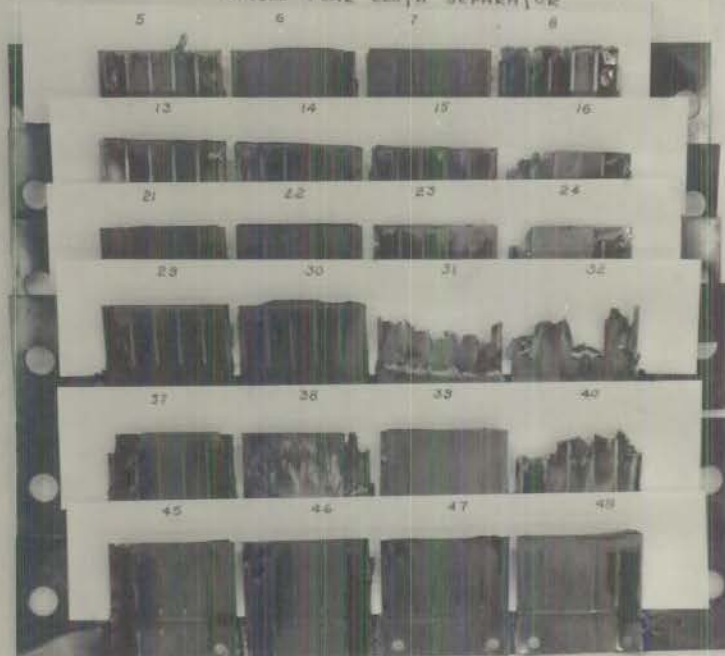
PLATE 17

FORTY-EIGHT VANE GRID  
— from —  
GAS PULSATOR

TOTAL RUNNING TIME — 6 HRS. 25 MIN.

REDS — STRIKING VANE — .008" THICK.  
BACKING VANE — .006" THICK.  
SINGLE FLAK CLOTH SEPARATOR

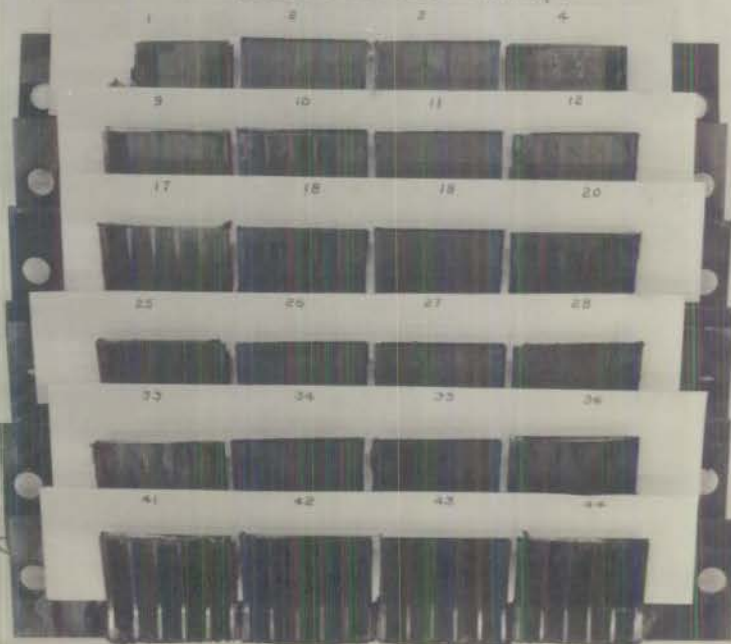
PLATE 19

FORTY-EIGHT VANE GRID  
— FROM —

TOTAL RUNNING TIME - 2 HRS 30 MIN.

REELS — STRIKING VANE — .008" THICK.

BACKING VANE — .008" THICK.

DOUBLE FLAK CLOTH SEPARATOR.

25. #8-F-F-6 (150 minutes). Another test of laminated vanes was made to see if a double thickness of flak cloth might be better than a single thickness. Therefore, sandwich-type Eichelberg valves were assembled as illustrated in Plate 18. An 0.008-inch spring-steel vane was placed on the striking side, a 0.006-inch spring-steel vane on the combustion side, and a double thickness of flak cloth was sandwiched between with the ethyl-cellulose coating facing the steel vanes. The pulsator was run at a Rotameter fuel rate of 350 lbs/hr and a weighed rate of 334 lbs/hr. After five runs of thirty minutes each, five of the vanes were damaged sufficiently to permit serious leakage of combustion gases. Plates 19 and 20 show the condition of the vanes after two and one-half hours running. The double thickness of flak cloth did not prove to be as satisfactory as the single thickness reported in paragraph 23. However, this may have been due to the mechanical stresses caused by the extra size. Difficulty was experienced during assembly because of the additional bulk of the double thickness of cloth which caused mechanical distortion of the entire grid assembly. Some redesign or machining of the grid pieces may be necessary in order to test this type of sandwich vane more fairly.

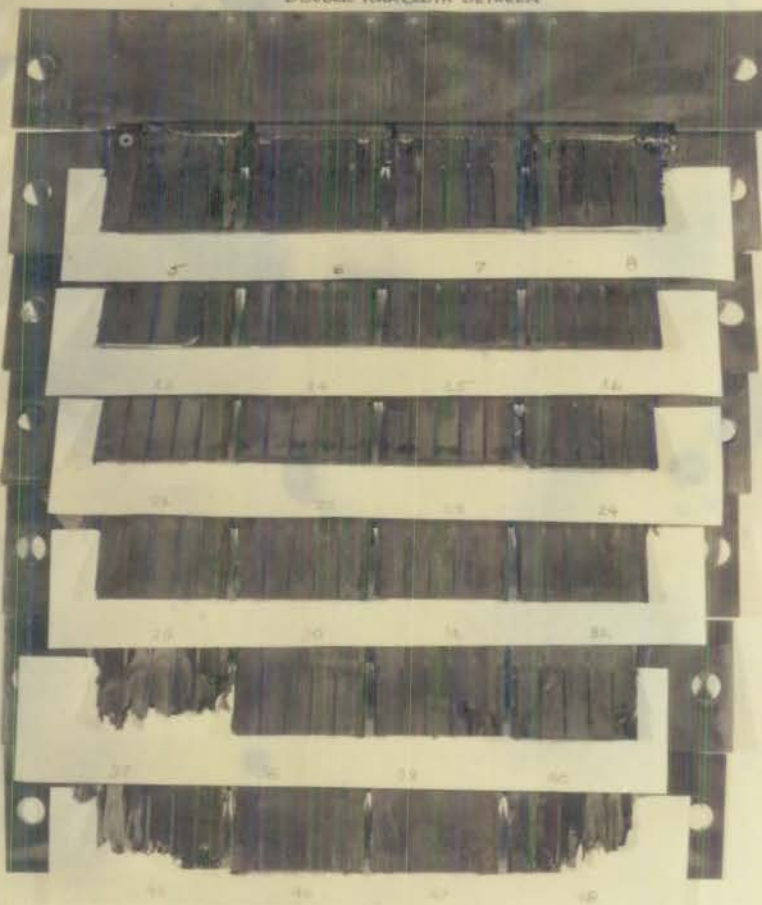
PLATE 20

FORTY-EIGHT VANE GRID  
FROM  
GAS PULSATOR

TOTAL RUNNING TIME 2HR 30MIN.  
REEDS - STRIKING VANE - .008" THICK  
BACKING VANE - .006" THICK  
DOUBLE FLAK CLOTH BETWEEN
