ARL-TR-9660 • MAR 2023

Investigation of Crucial Properties for Polymeric Recoater Materials in Metal Additive Manufacturing

by Alex Butler and Brandon McWilliams

Brandon McWilliams
DEVCOM Army Research Laboratory

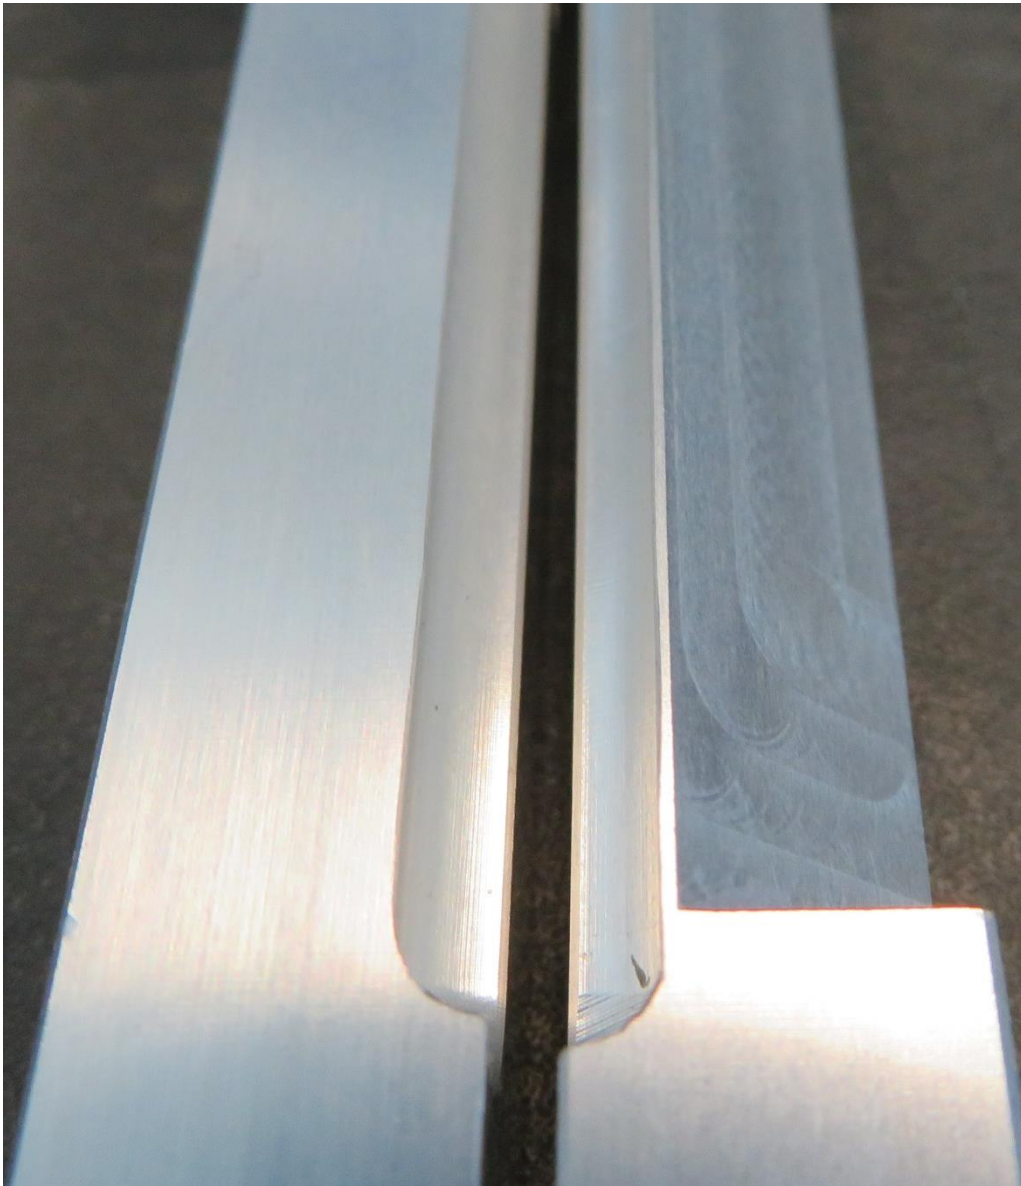
Fig. 1 Aluminum recoater arms with grooves

The mechanism that spreads the powder across the build area, called a recoater, is shown in Figs. 1 and 2.

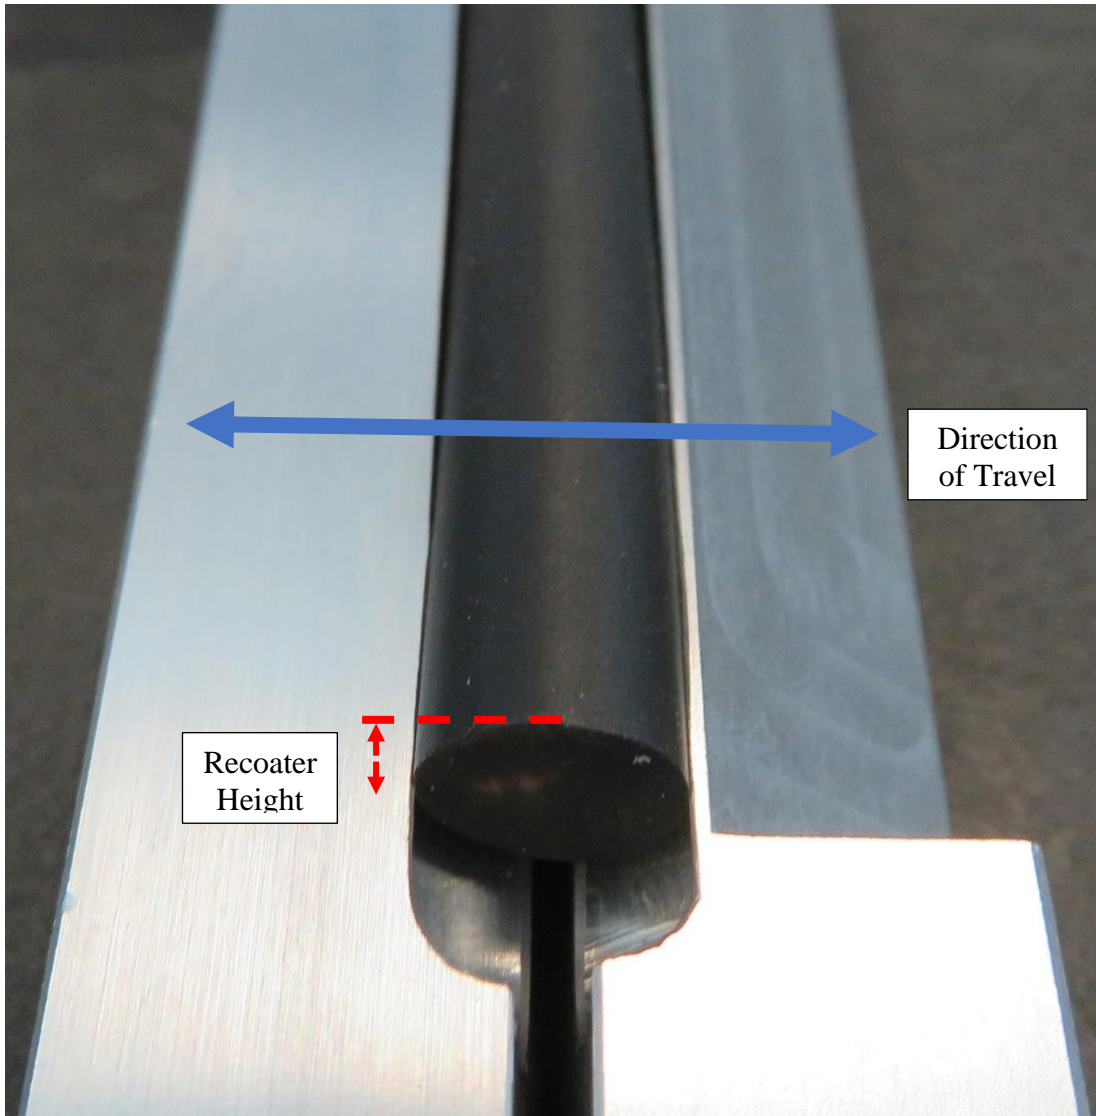
Fig. 2 Aluminum recoater arms with recoater insert placed in the grooves and the direction of travel, reference features, and measured height annotated

In the Renishaw system the soft recoater is clamped between two aluminum bars with a groove machined into them to accommodate the polymeric rod (Fig. 2). The recoater materials were loaded into four different new recoater arms. Before each print the recoater arms were scanned using the Keyence VHX7000 optical microscope. At least three 2D height profiles were created parallel to the direction of travel for the recoater arm. The height is defined as the distance the polymeric recoater protruded above the aluminum recoater arms (Fig. 2). These profiles were exported and analyzed in Excel.

Method no. 1 was used for the smaller diameter recoaters. In this method a linear line was created from a local minimum on either side of the recoater. These minimums corresponded to a small gap where the recoater contacted the arm, shown in Fig. 2.

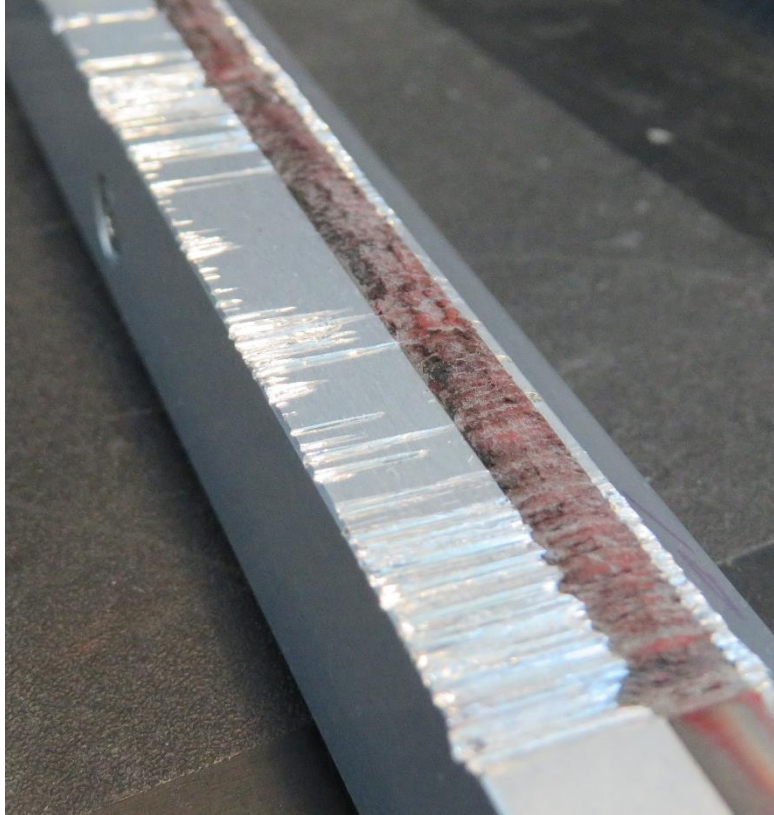
Fig. 3 Example of recoater crash damaging the recoater assembly

A consistent powder bed is critical for ensuring high mechanical properties and nonporous parts.¹ Additionally, build failures due to interactions between the recoater and the build, called recoater crashes, can occur. Some crashes are not catastrophic, and the build can be stopped and adjusted. However, this influences the thermal history of the part, which can create more part distortion and lead to more crashes.² These crashes are especially bad in machines that do not have a method of detecting recoater crashes. In these cases the build will continue, and the print can heavily wear the recoater and possibly damage the part and recoater assembly, Fig. 3 being an example of this. Recoater crashes increase the overall cost of the part as failed builds can be common and, in some cases, constant supervision is required by a trained technician in case intervention is needed.

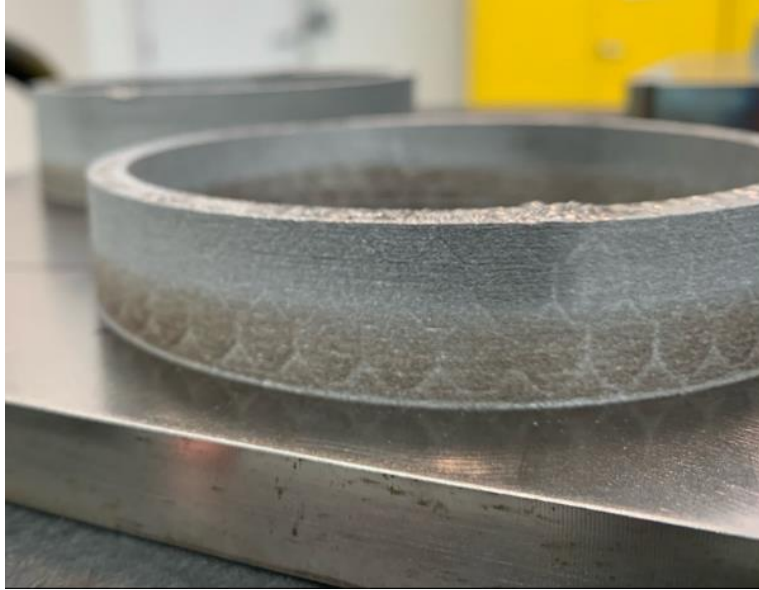
Fig. 4 Premature print failure due to uneven powder dispersion caused by a heavily worn elastomeric recoater

The Renishaw AM400 LPBF system at the US Army Combat Capabilities Development Command (DEVCOM) Army Research Laboratory (ARL) uses softer polymer recoaters, and on some longer builds we have observed heavy, localized wear on the recoater. These areas of heavy wear inhibit even powder distribution and can lead to build failures as shown in Fig. 4. This wear over time allows for regions of the recoater to wear heterogeneously and disperse powder

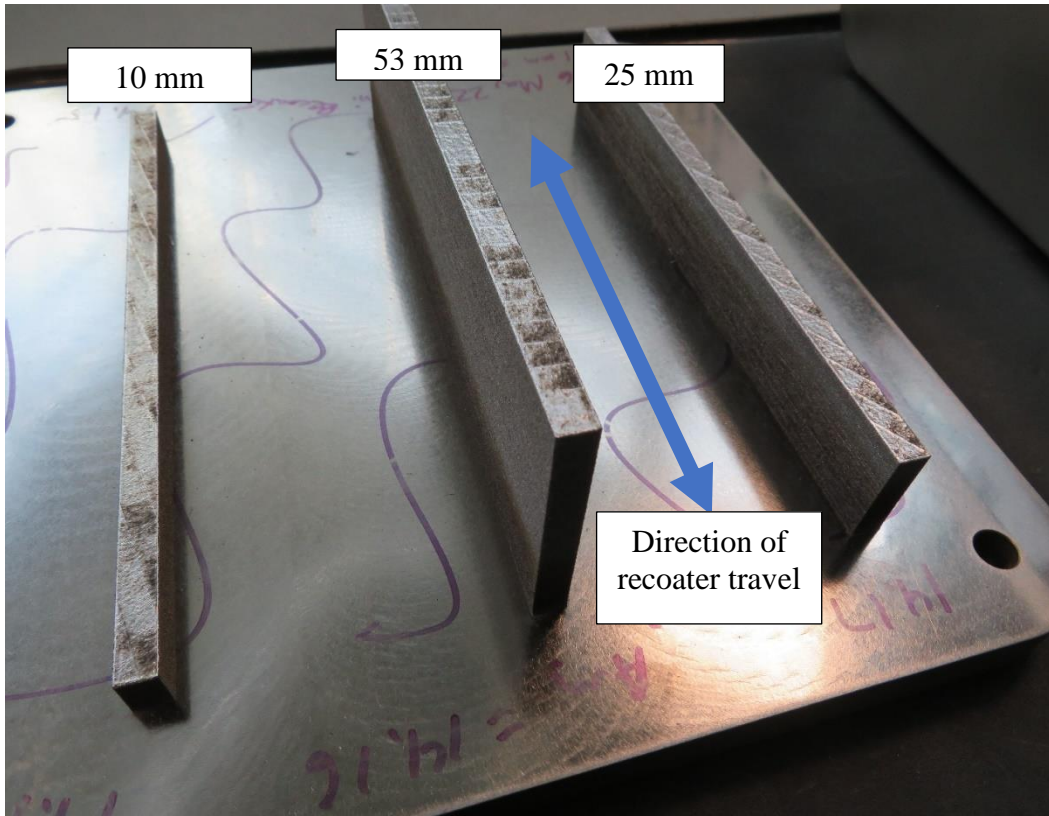
Fig. 5 Printed walls labeled with heights

Multiple prints using AF9628 steel powder were done on the Renishaw AM400 LPBF system to quantify the wear behavior of four different elastomeric recoater wiper materials. All prints were completed using a layer thickness of 30 μm and a 170 °C baseplate heating temperature. All prints consisted of three 180-mm-long by 7-mm-wide walls, shown in Fig. 5.

Each wall had a different height to try to quantify a wear rate as a function of contact distance/time. The walls had heights of 10, 25, and 53 mm, which correspond to contact distances of 60, 150, and 318 m, respectively. By using a stopwatch during the process an estimated recoating time of 2 s was obtained, which yields contact times of 0.2, 0.5, and 1.0 h for the 10-, 25-, and 53-mm walls, respectively. This yields three distinct locations where the built material contacted the recoater material for different amounts of time. A micrometer was used to measure the dimensions of the printed part to evaluate the dimensional accuracy of each. The average of three measurements was taken. To find the amount the printed part deviated from the original dimensions, the following formula was used:

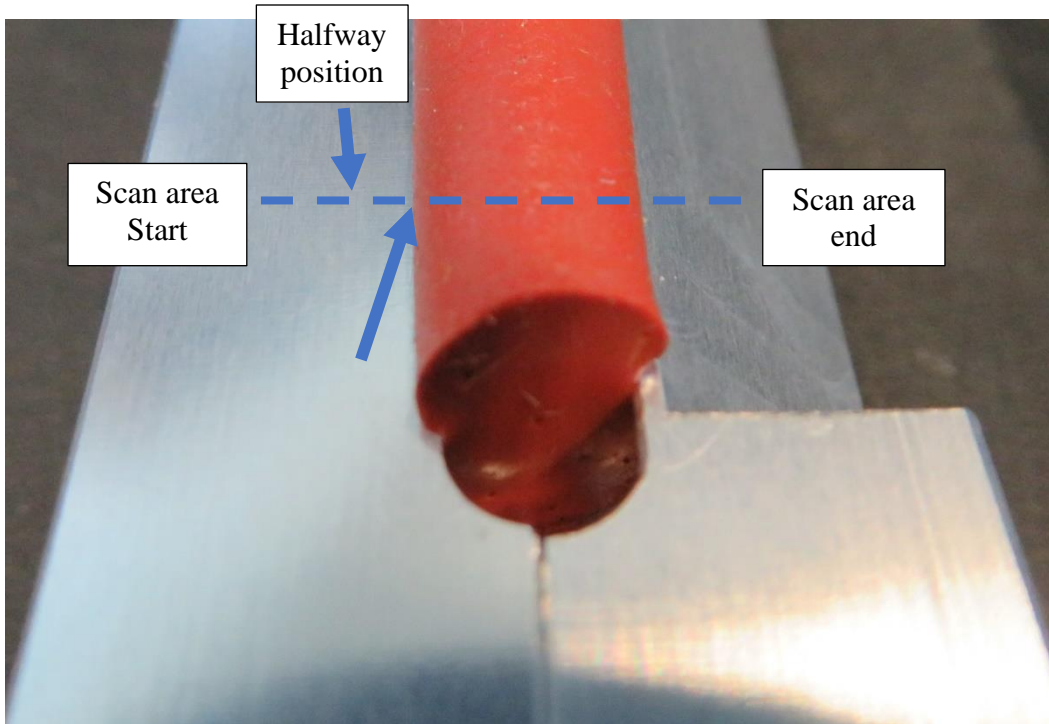
Fig. 6 Larger diameter recoater with Method no. 1 reference features not visible

However, this did not work for the larger diameter recoaters. These materials bulged out when compressed into the recoater arm and obscured the reference plane, so no minimums could be measured (Fig. 6). Therefore, a different method must be used to standardize the data.

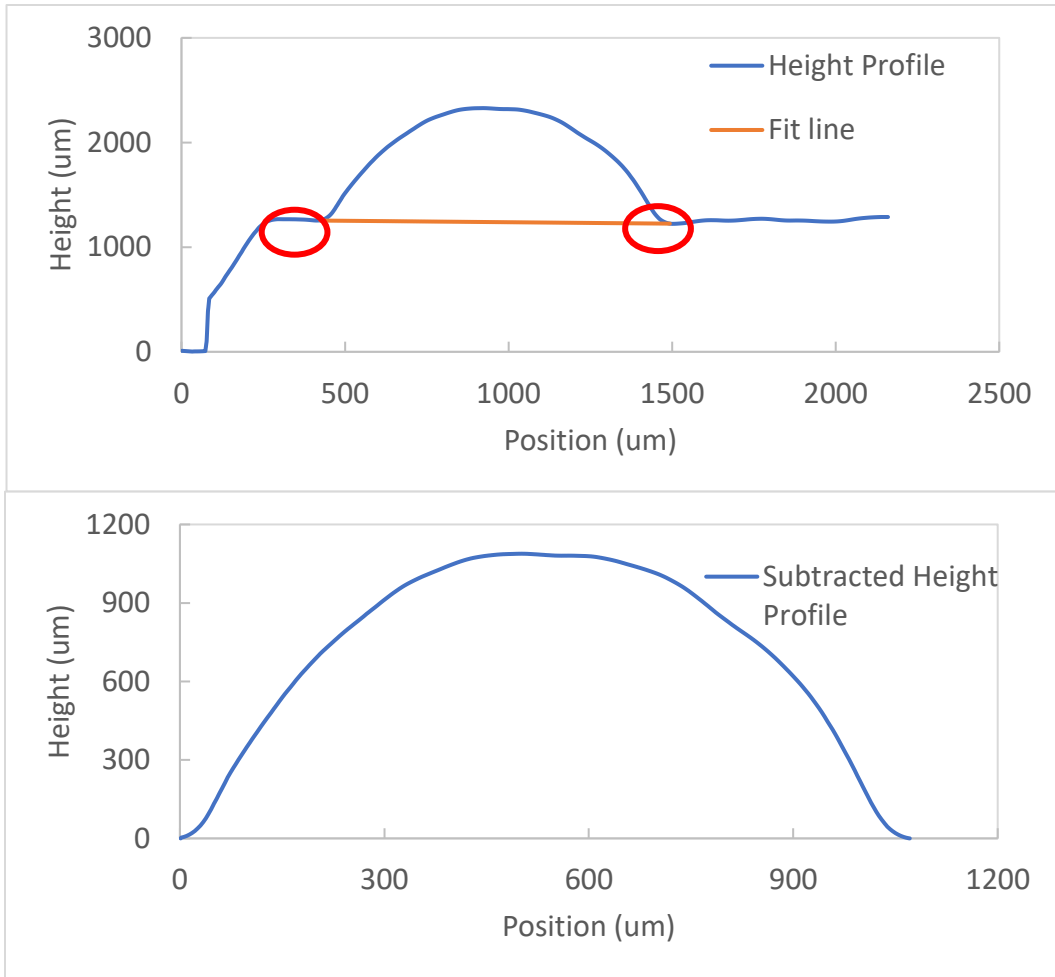
Fig. 7 Example of recoater height normalization using Method no. 1 with local minimums annotated

Method no. 2 was used to normalize the data of the larger diameter recoater materials. This involved roughly identifying the position where recoater material begins, then a linear trendline was fit using the data from the start of the scan area to halfway to the position where the recoater material starts. This ensures a line is fit to a known flat reference surface that does not include any recoater material. Normalized height profiles were created by subtracting the height profiles by the lines created by their respective normalization method. Examples of these methods are shown in Figs. 7 and 8.

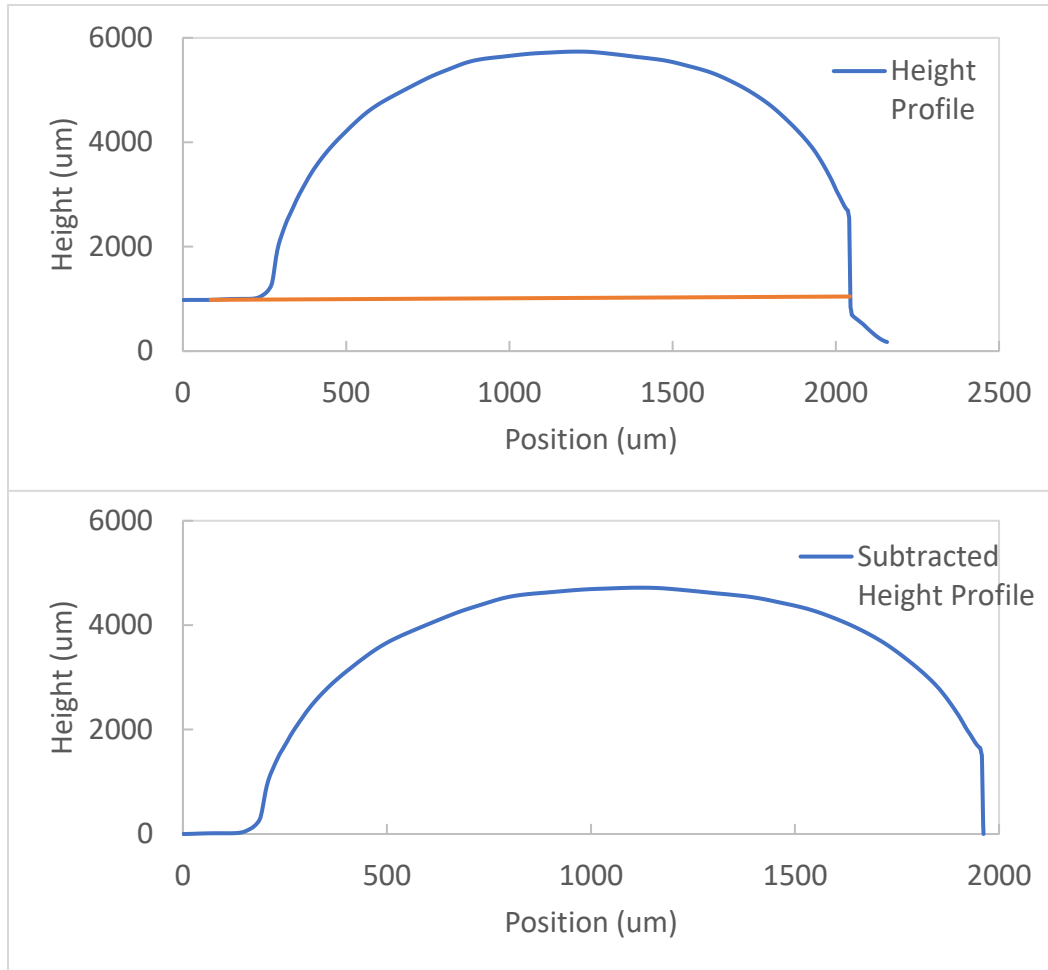
Fig. 8 Example of recoater height profile normalization using Method no. 2

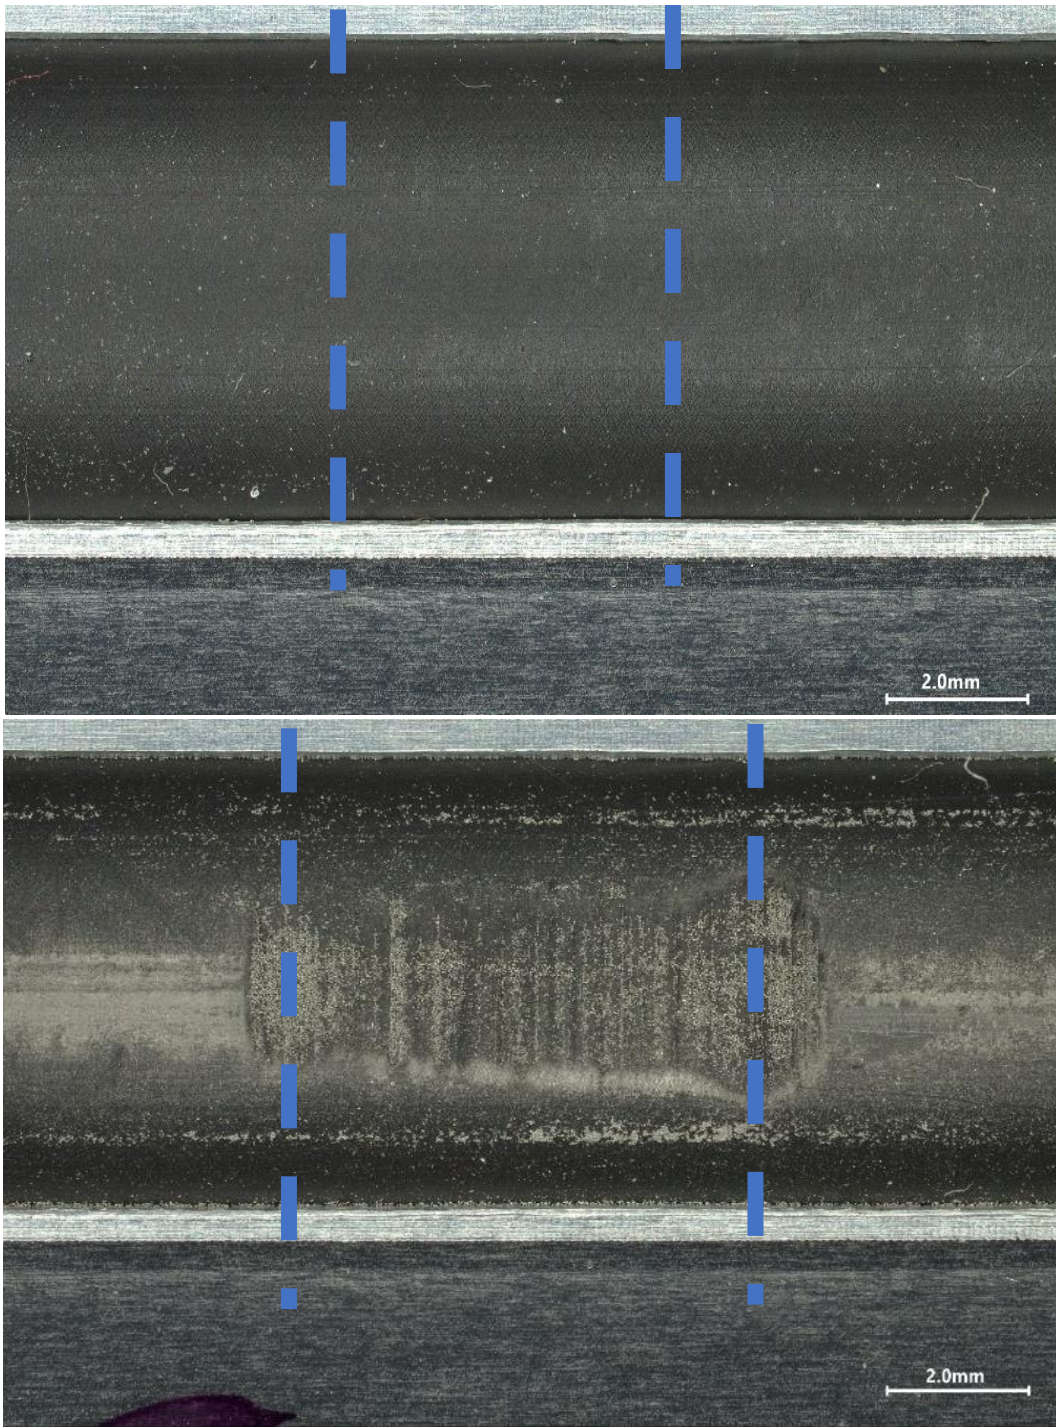
Fig. 9 Example of height profile locations before (top) and after (bottom) the print for Recoater no. 1

Height profiles were measured using the same microscope and method after the print. At least two profiles were created at each of the three locations of contact between the recoater material and the print (Fig. 9). The wear on the recoater was typically nonuniform in the region that was in contact with the printed parts, so the goal was to quantify the location with the largest height change. The same methods of normalization previously described were used to standardize the data after the build. Note that even though two different methods of normalization were used, the same approach was used for the before-build and after-build for each recoater to determine the change in height caused during the build.

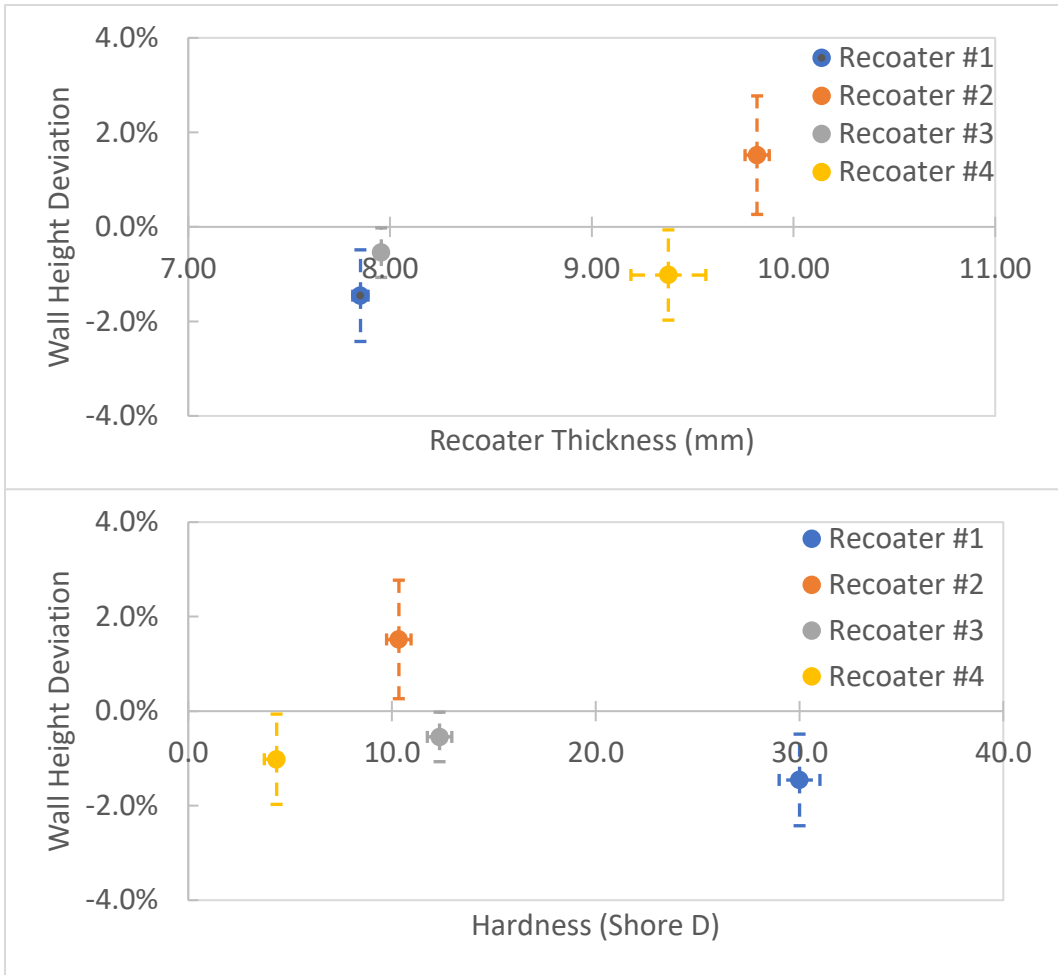
Fig. 10 Wall height deviation as a function of recoater thickness (top) and hardness (bottom)

The notional and actual printed part dimensions are presented in Table 2. The percent deviations are presented in Figs. 10 and 11. All printed parts had less than approximately 2% deviation in dimensions, and no statistically significant trend was seen regarding the effects of hardness or thickness of the recoater on the dimensional accuracy of the printed parts. The dimensional accuracy did vary slightly between recoaters, with Recoater no. 3, the one provided by the OEM, having the least deviation from the original part dimensions. For all walls the thickness deviation was greater than the height deviation. Overbuilding in this dimension is common for AM parts and was expected. Although not particularly

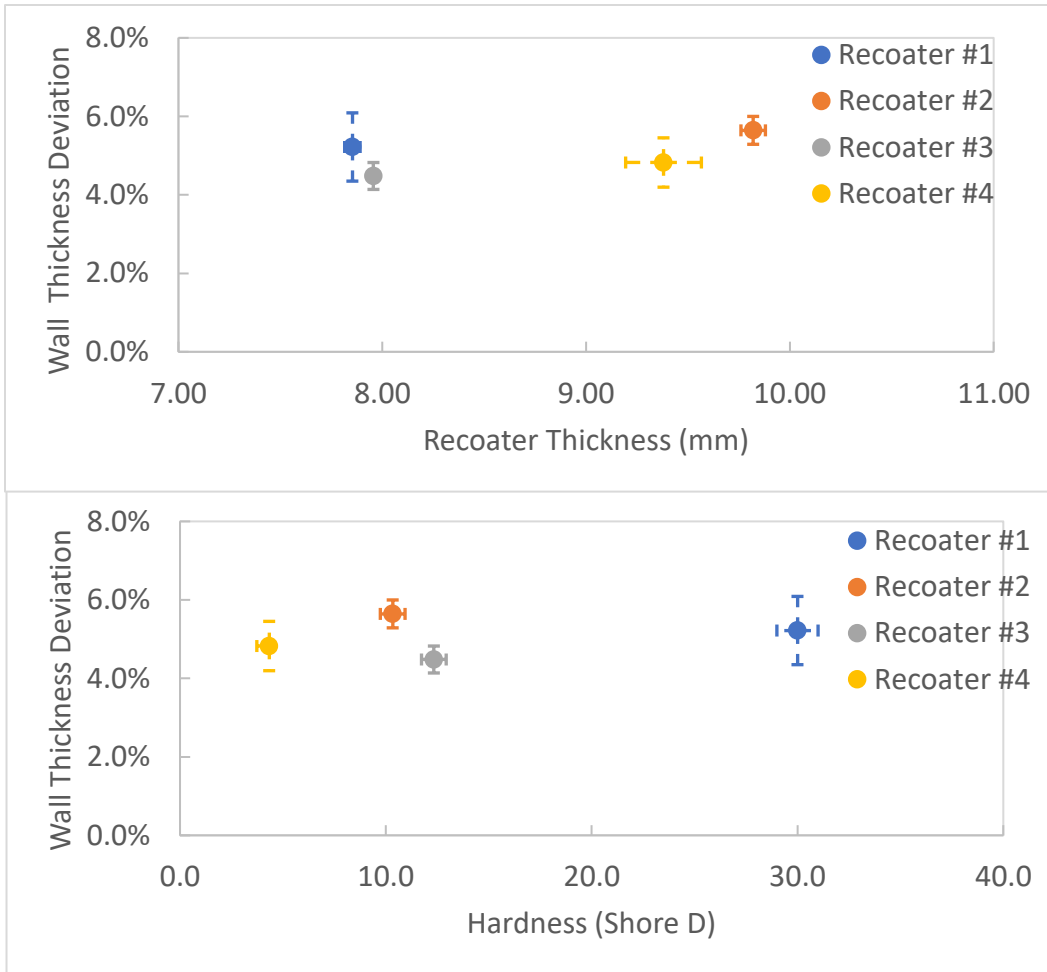
Fig. 11 Wall thickness as a function of recoater thickness (top) and hardness (bottom)

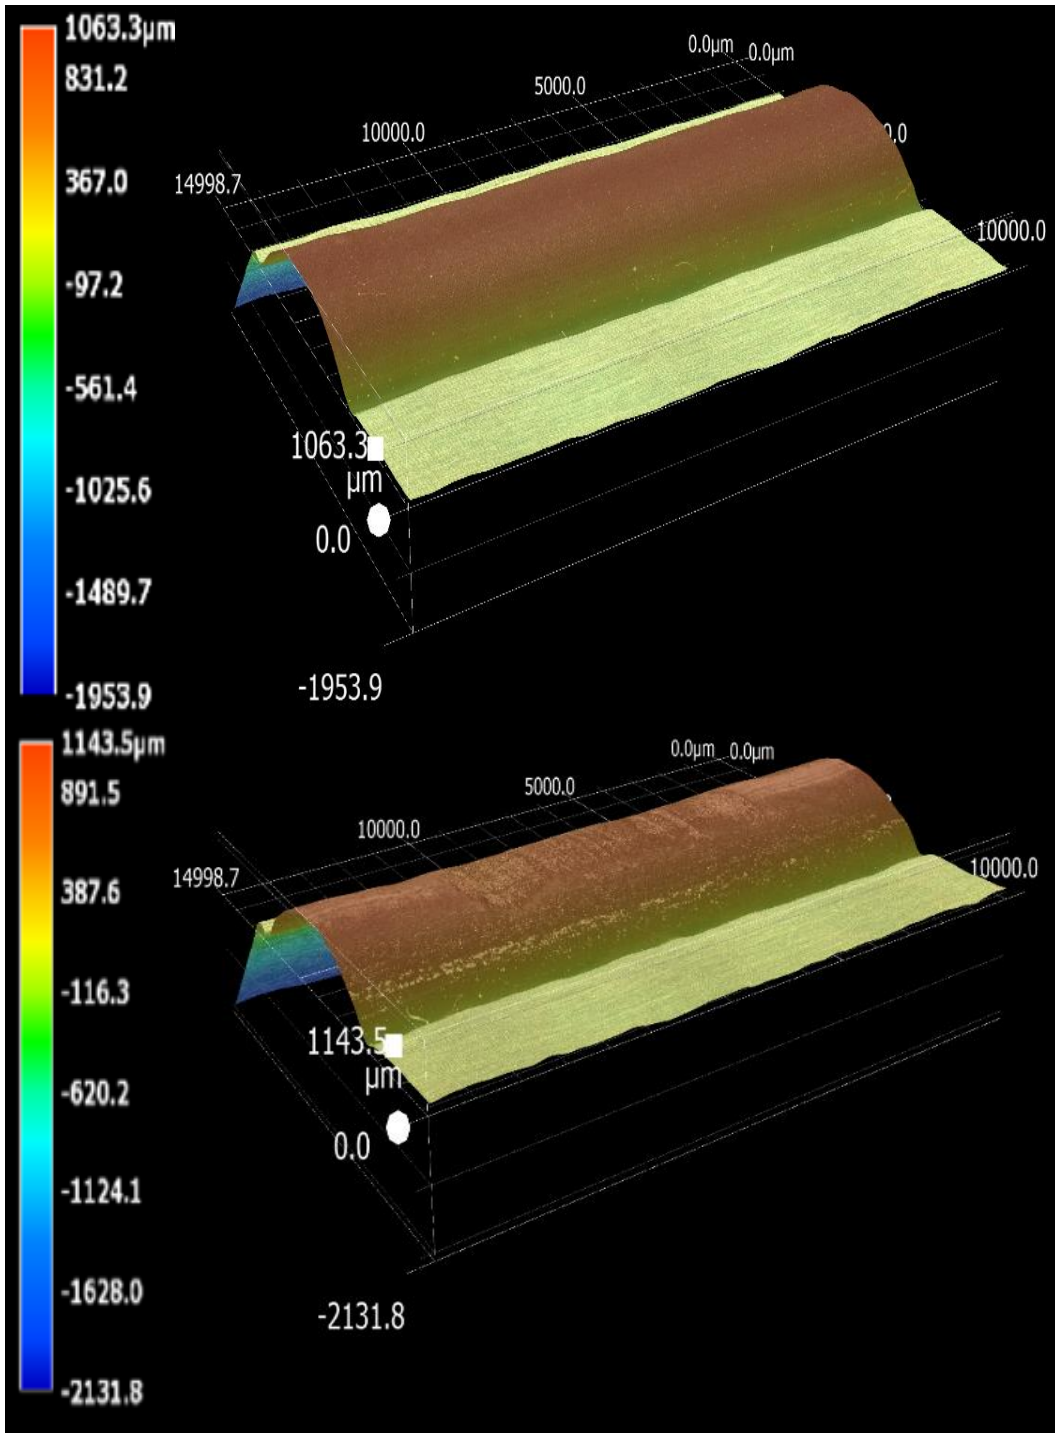
Fig. 12 3D profiles of Recoater arm no. 1 before (top) and after (bottom) the print

Figures 12–18 show 2D and 3D scans of the recoater arm before the print. All 2D and 3D scans of the recoater arm after the build show the contact location that saw the highest height change after the print. Note that the scales are not consistent across all figures. Wear markings from contact with the printed wall can be seen on the surface of the surface Recoater nos. 1, 3, and 4.

When analyzing the height profiles of each recoater, we can see some evidence that shed light on the mechanism by which height changes occurs. Recoater nos. 1 and 3, the hardest materials, show a flat spot being worn into the top of the recoater due to material removal during use. This is supported by wear marks seen in the 2D images of the wear areas. Recoater no. 2 shows no clear wear marks as well as no flattening of its height profiles. It is assumed that the material is soft enough to deform out of the way of the build, compressing and undergoing creep, similar to how it deformed when inserted into the machine. Recoater no. 4, however, shows clear signs of material wear on its surface with little flattening of its curve. It is theorized that this material was so soft that it made material removal extremely easy but was able to maintain a constant thickness due to recovery of the elastic strain, and/or creep deformation, imparted during compressing the recoater into the arms.

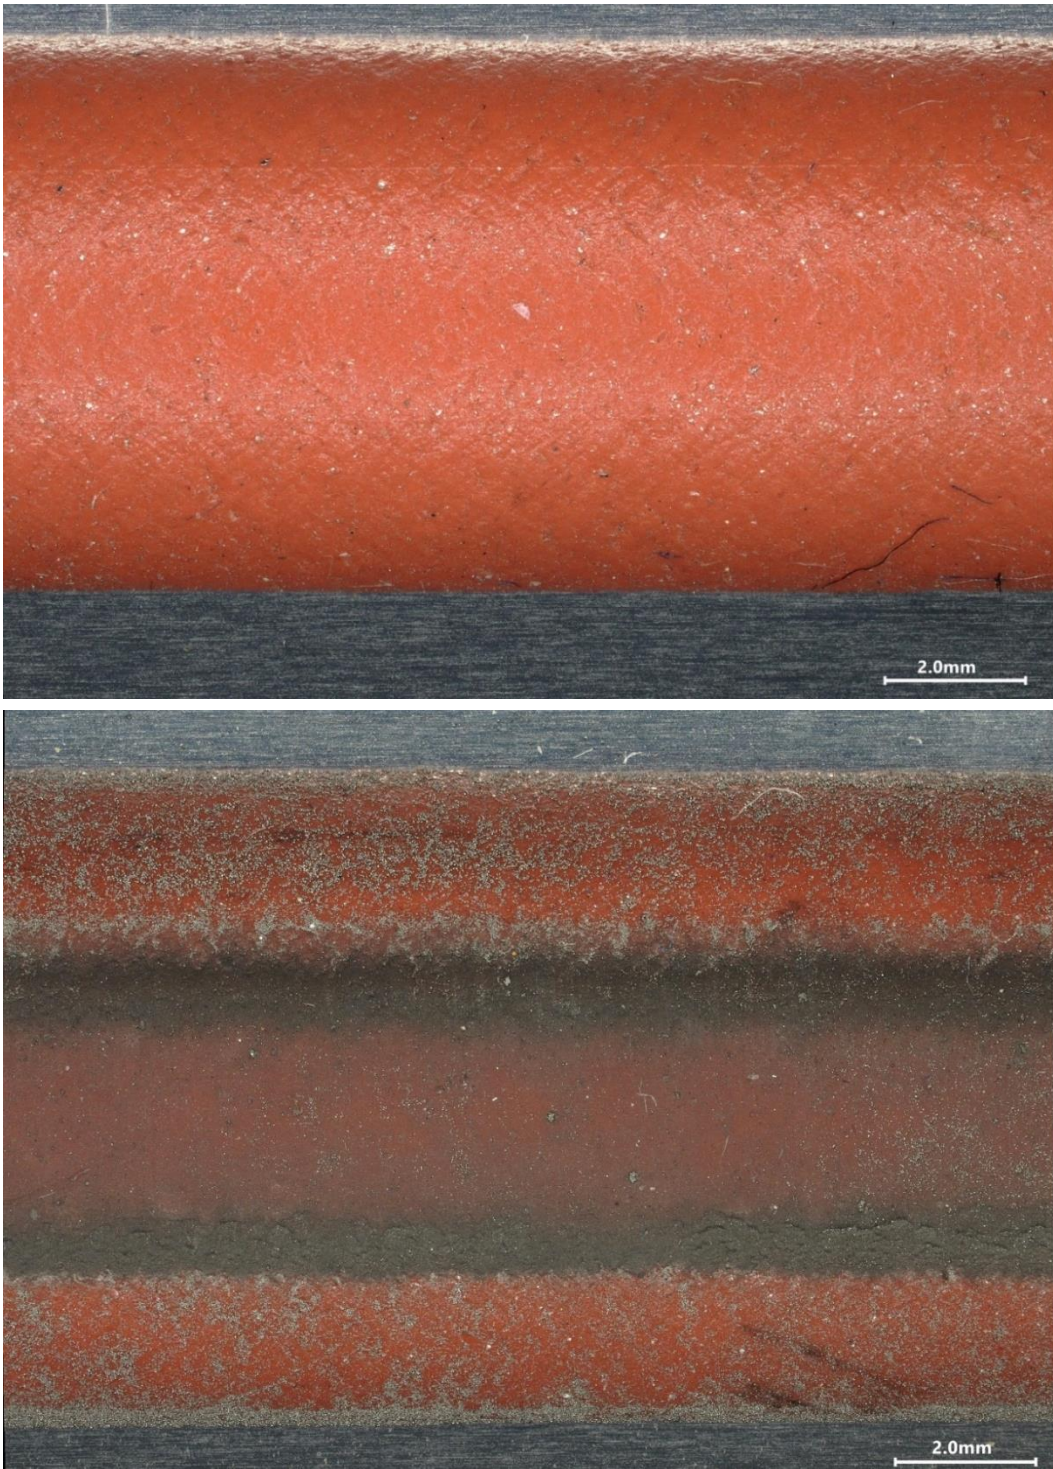
Fig. 13 Recoater arm no. 2 before (top) and after (bottom) the print

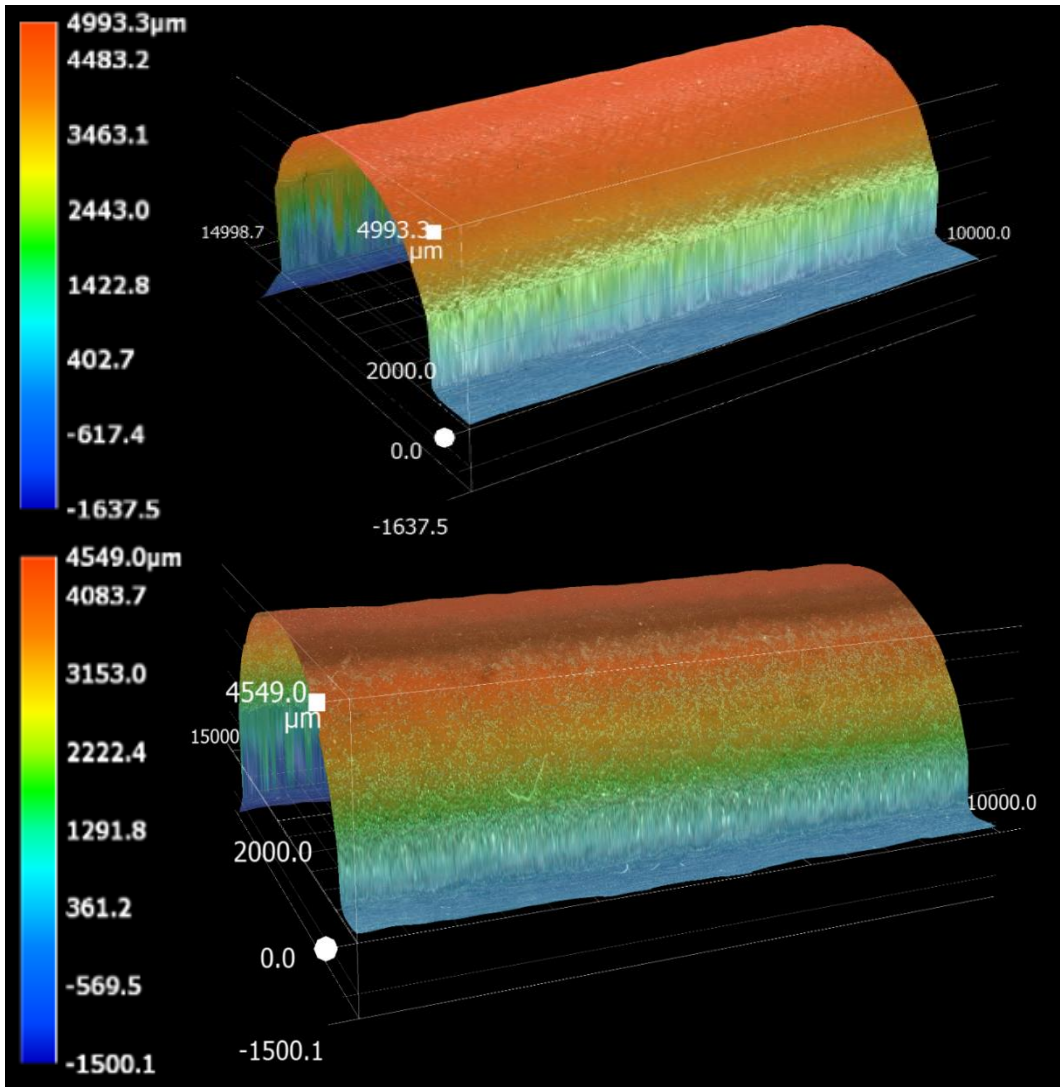
Fig. 14 3D profiles of Recoater arm no. 2 before (top) and after (bottom) the print

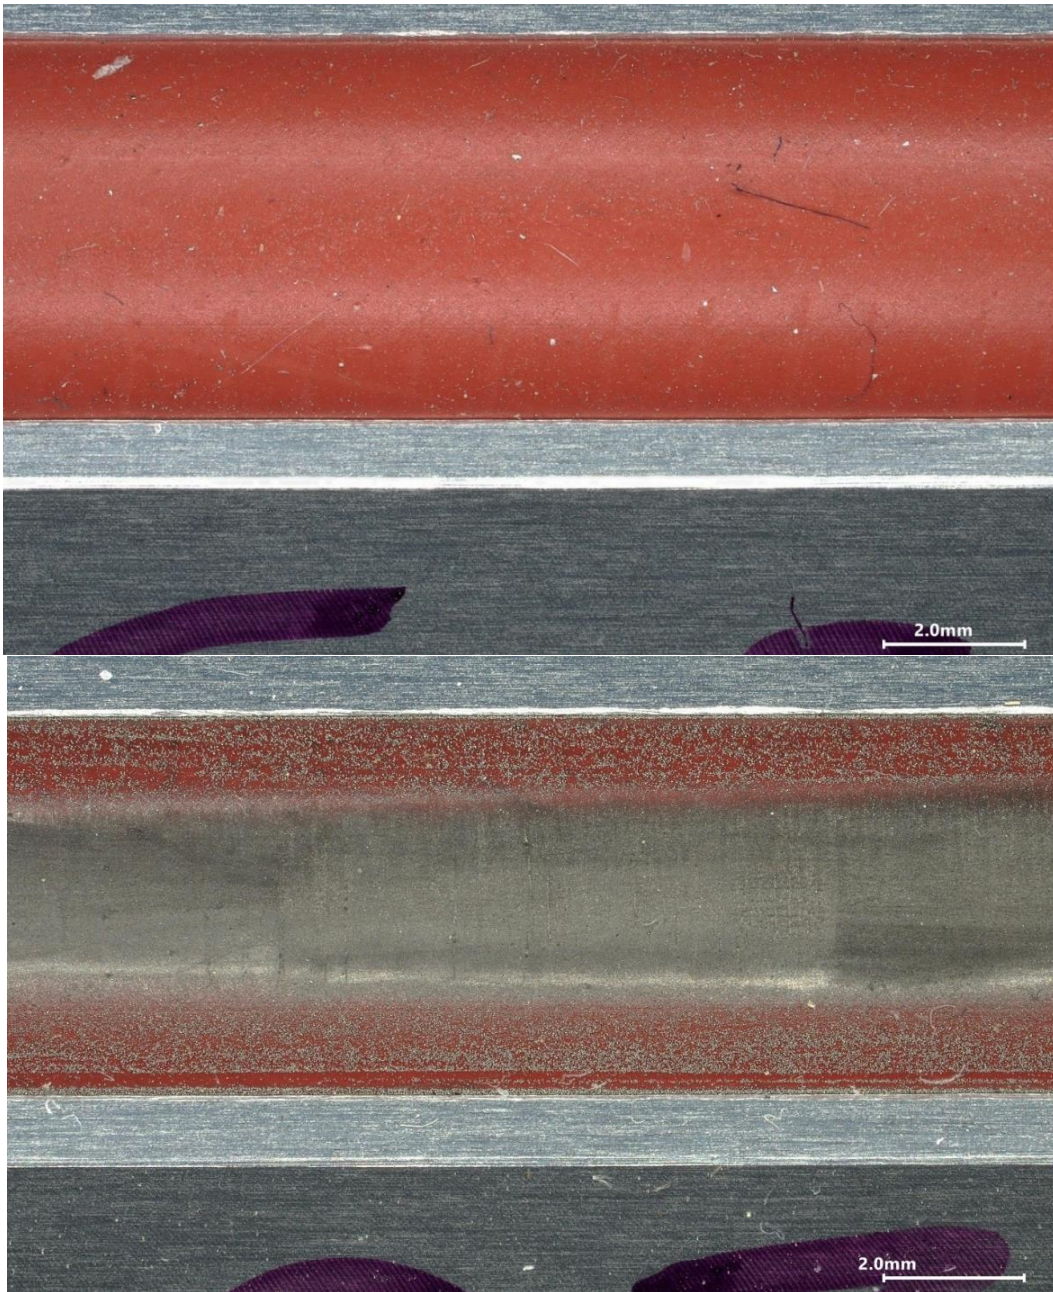
Fig. 15 Recoater arm no. 3 before (top) and after (bottom) the print

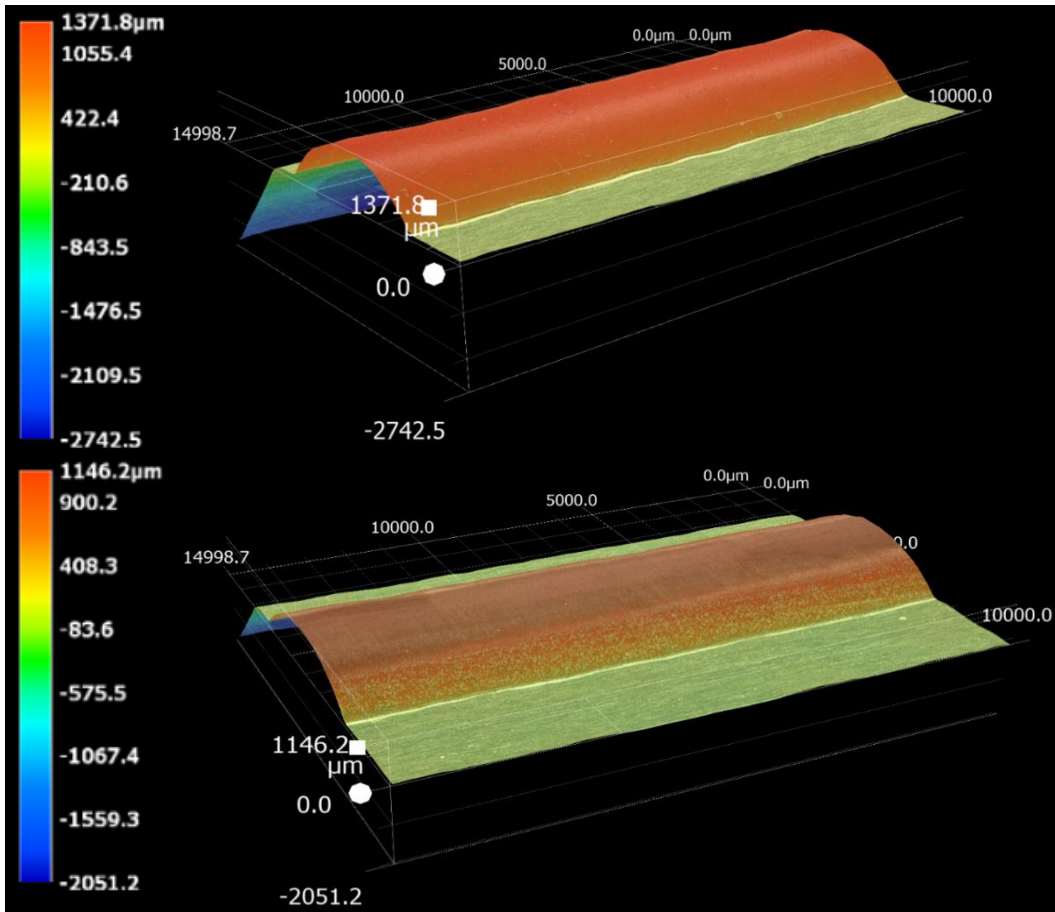
Fig. 16 3D profiles of Recoater arm no. 3 before (top) and after (bottom) the print

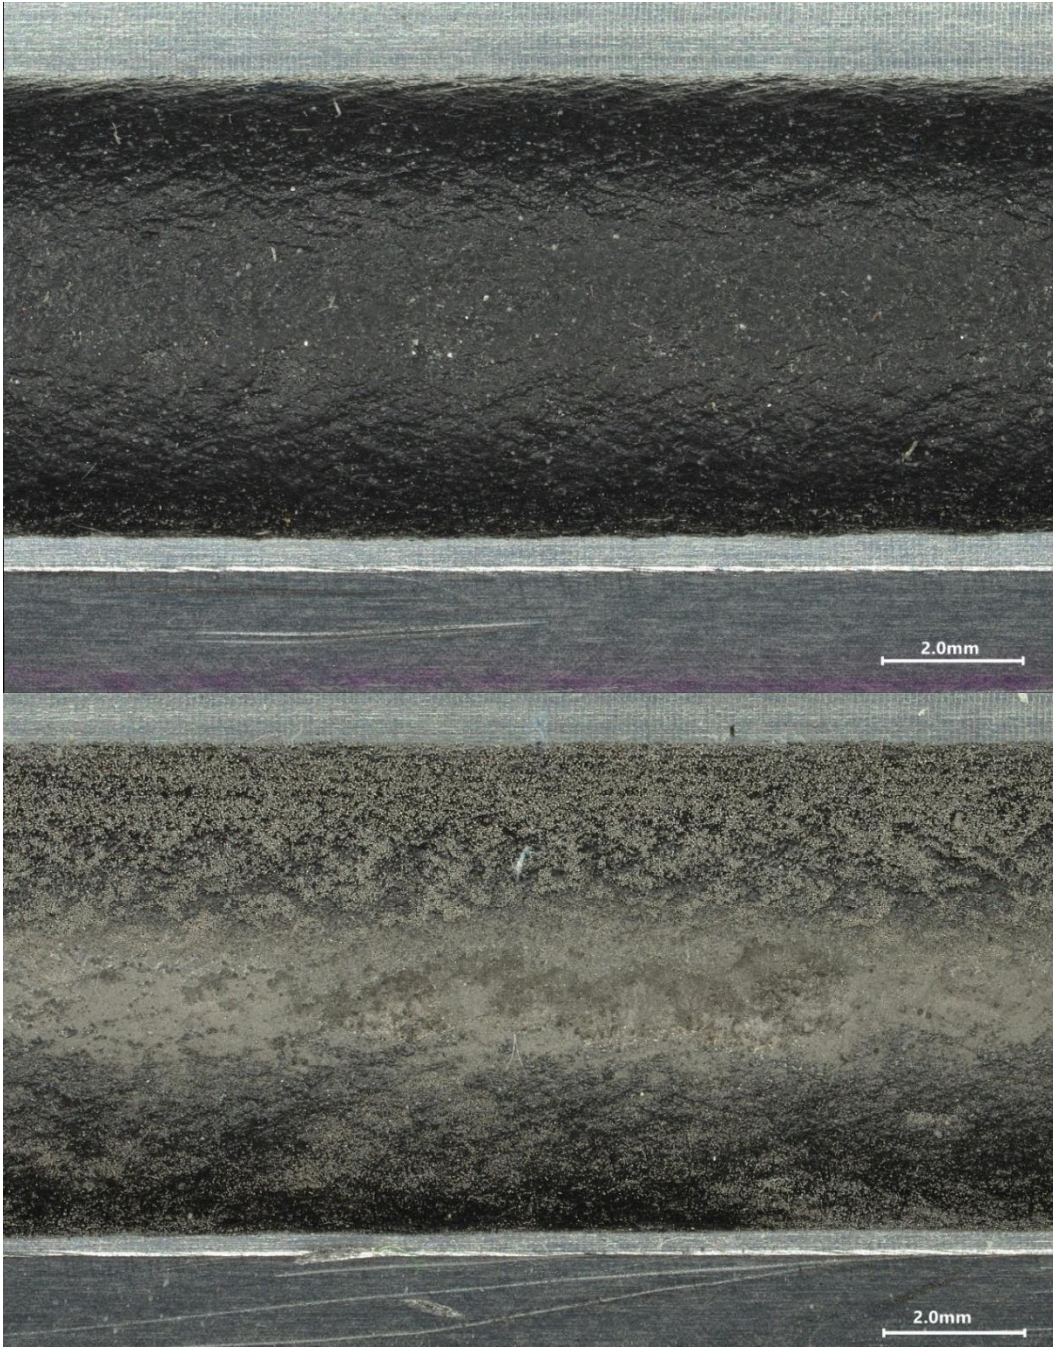
Fig. 17 Recoater arm no. 4 before (top) and after (bottom) the print

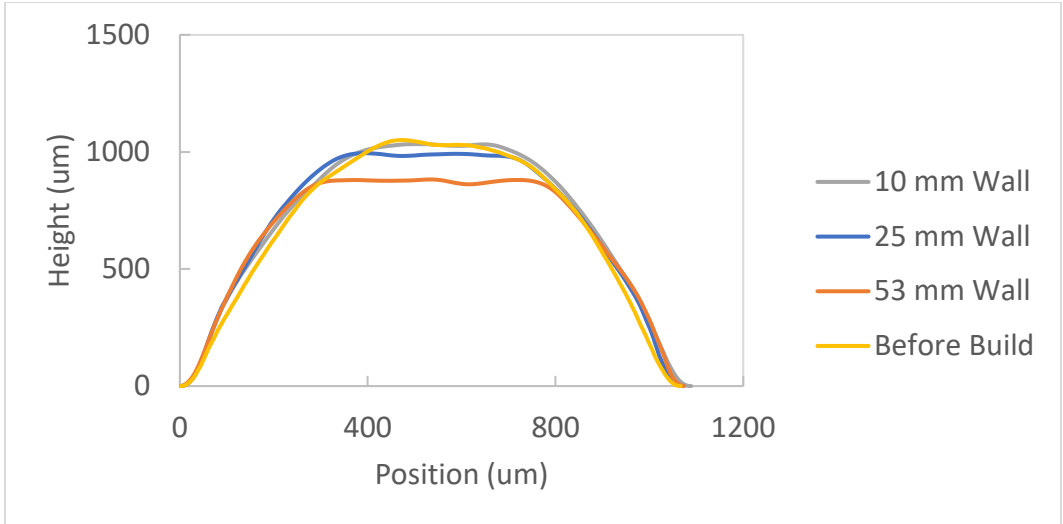
Fig. 19 Maximum height change profiles for Recoater no. 1 compared to baseline profile

Figures 19–22 show the curves with the largest height change profiles for each wear position compared to their baseline profile. The baseline profile depicted here represents the average normalized maximum height value for that recoater.

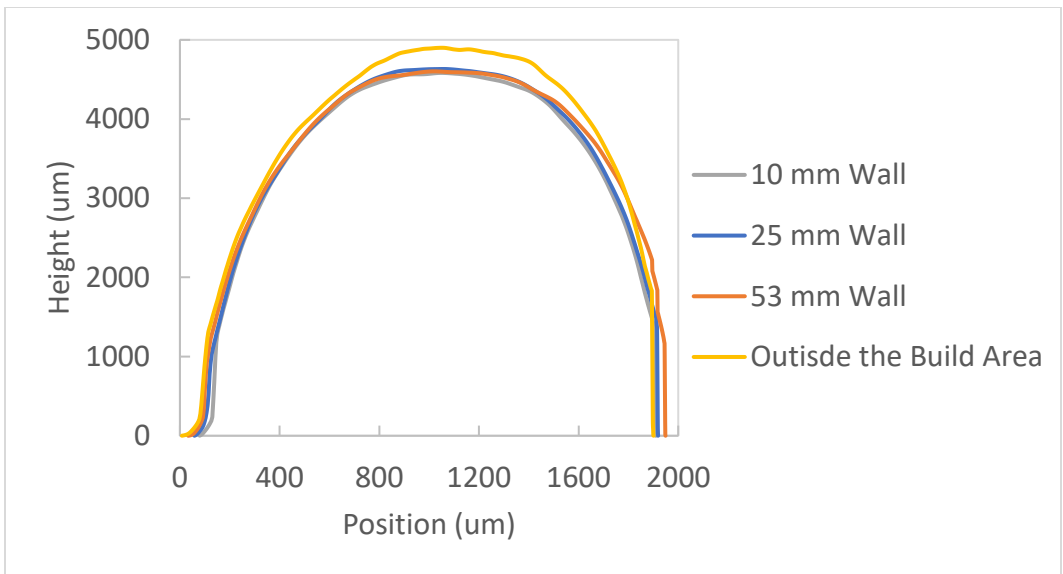
Fig. 20 Maximum height change profiles for Recoater no. 2 compared to baseline profile

When loading Recoater no. 2 into the machine there were some issues securing the arm due to the thickness of the recoater material. Even with the recoater arm mounting set screws moved all the way up, the recoater material was still contacting the build plate and the bottom of the chamber with considerable pressure. With some effort the recoater arm was loaded into the machine with the recoater material compressed. The material remained compressed as the machine heated up to begin the build. We believe that this sustained pressure along with the heating of the chamber allowed the recoater material to permanently deform due to creep, reducing the initial height of the recoater material as compared to the measurements
