ARL-TR-9660 • MAR 2023

Investigation of Crucial Properties for Polymeric Recoater Materials in Metal Additive Manufacturing

by Alex Butler and Brandon McWilliams

Brandon McWilliams
DEVCOM Army Research Laboratory

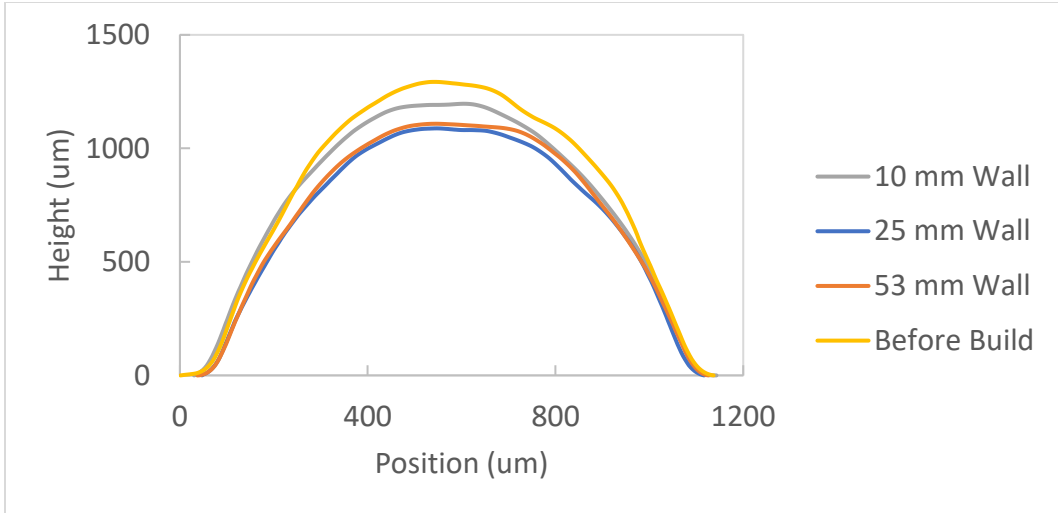
Fig. 21 Maximum height change profiles for Recoater no. 3 compared to baseline profile

Figures 19–22 show the curves with the largest height change profiles for each wear position compared to their baseline profile. The baseline profile depicted here represents the average normalized maximum height value for that recoater.

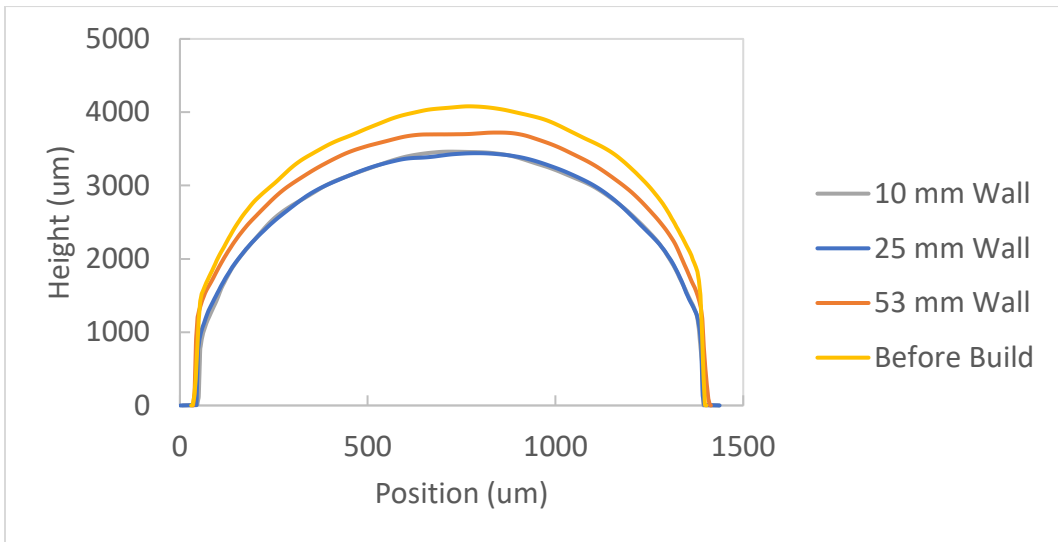
Fig. 22 Maximum height change profiles for Recoater no. 4 compared to baseline profile

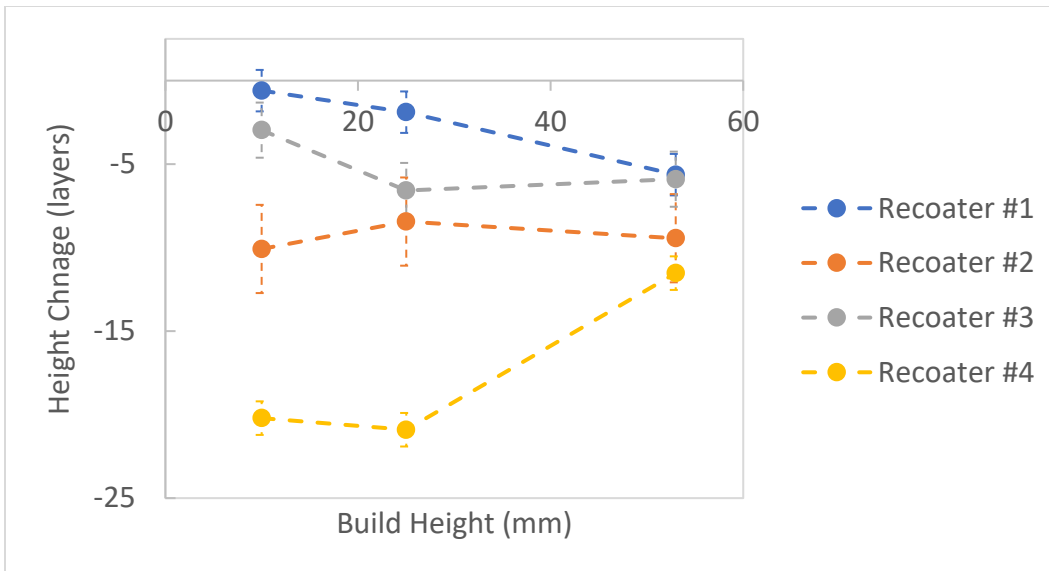
Fig. 23 Height change in the recoater materials represented in build layers (1 layer = 30 μm) as a function of build height

The maximum height change at each wear position on the recoater arm for each recoater material is displayed in Fig. 23. Additionally, the maximum height change across all three walls for each recoater is plotted as a function of hardness and thickness in Figs. 24 and 25, respectively. The standard deviation and error bars come from the standard deviation of the baseline maximum height, as this shows the uncertainty of the height change due to inconsistencies in the baseline height.

inconsistencies in the powder distribution on the build platform. The data shows no consistent trends regarding the height change as a function of material thickness. Additionally, only Recoater no. 1 showed monotonically increasing height change with contact time, and Recoater no. 2 shows relatively consistent height changes independent of contact time.

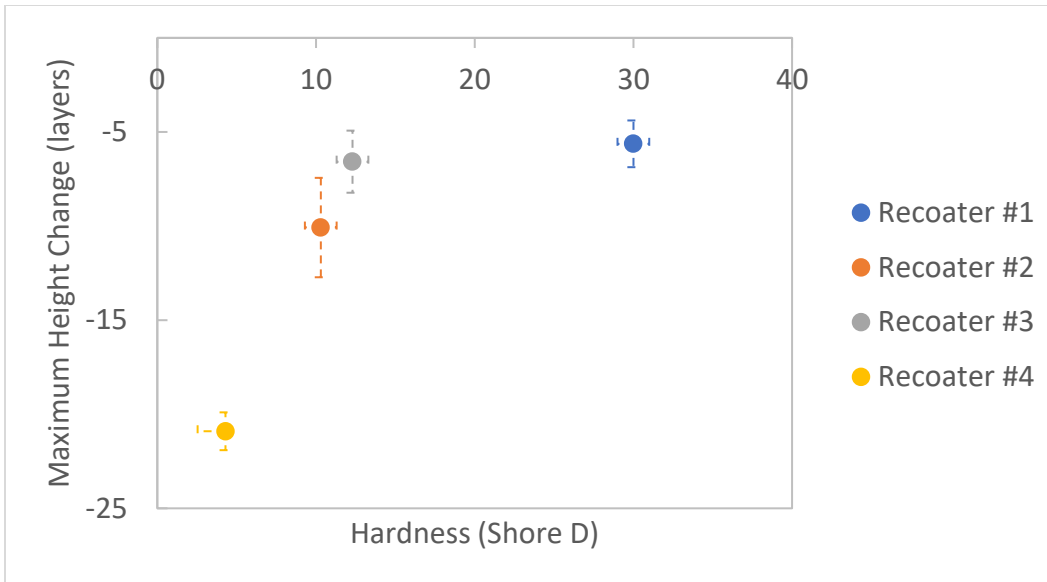
Fig. 24 Maximum height changes in each recoater material as a function of hardness

The maximum height change varied between recoaters as did the trends regarding contact time. The data shows height change decreasing with increasing hardness in a somewhat logarithmic relationship. This means the harder the recoater materials, the less of a gap change between the recoater and the build and therefore fewer

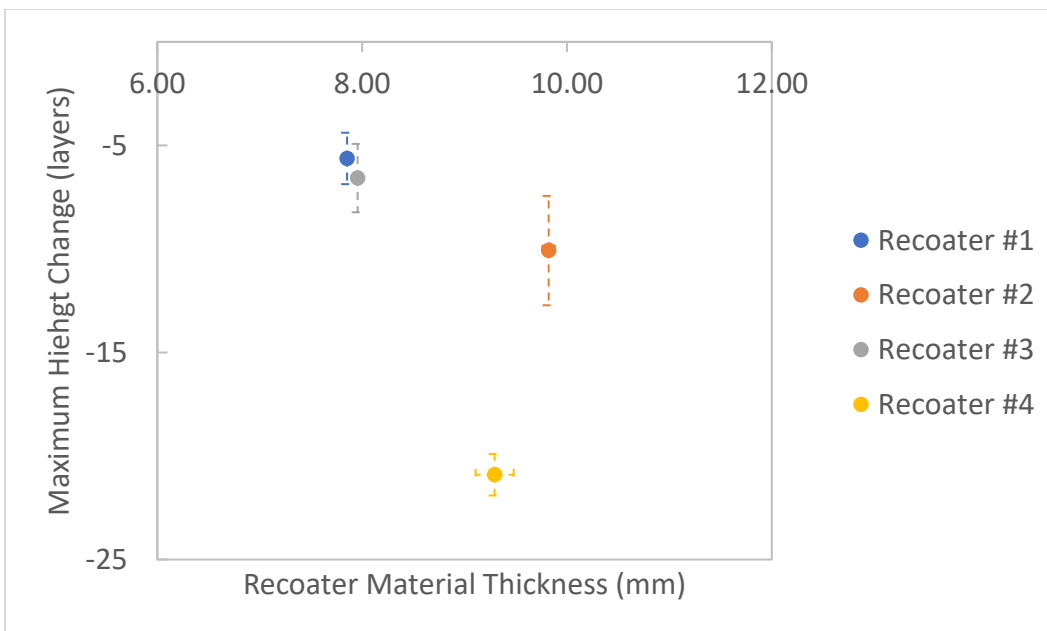
Fig. 25 Maximum height changes in each recoater material as a function of recoater material thickness
