# U.S. ARMY COMBAT CAPABILITIES DEVELOPMENT COMMAND – GROUND VEHICLE SYSTEMS CENTER

ILIR Equipment Elemental and Thermal Conductivity Property Characterization  
for Super-Alloy Inconel C-276 after Prolonged Caustic High-Temperature  
Operation

# Motivation – ILIR Equipment and Testing Operation

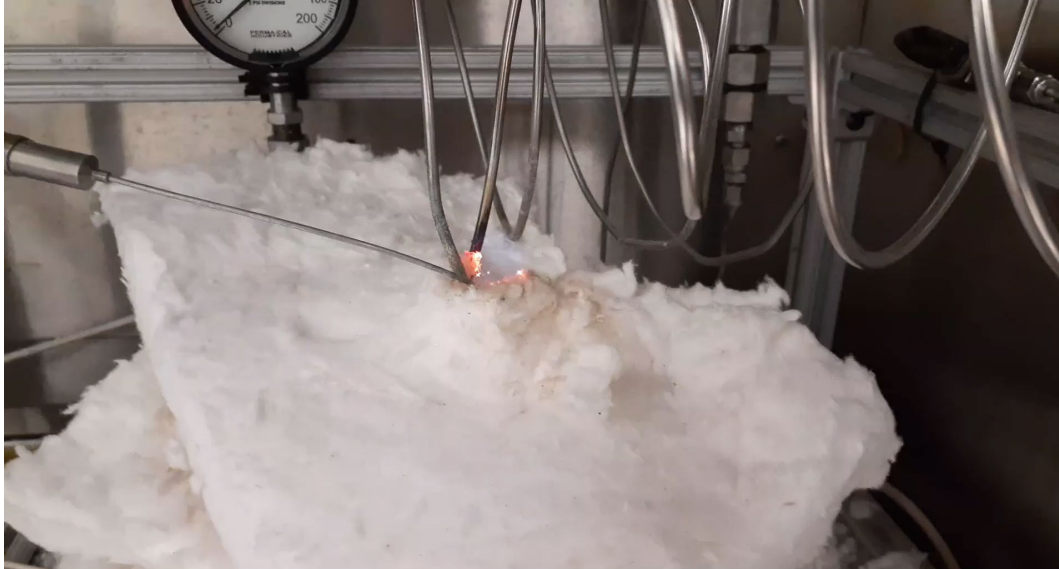
## Equipment Operation Malfunction - Methane Flame

- Methane flame resulted from oxidation corrosion around fittings in lid (discussed in another presentation), which were made of 316SS.
  - Inconel could not be found for fitting material
  - Safety concern

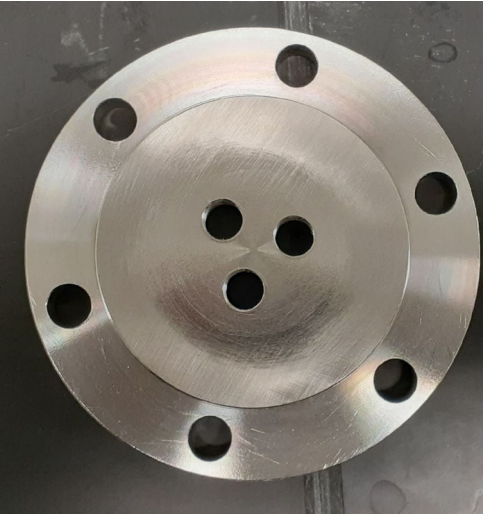
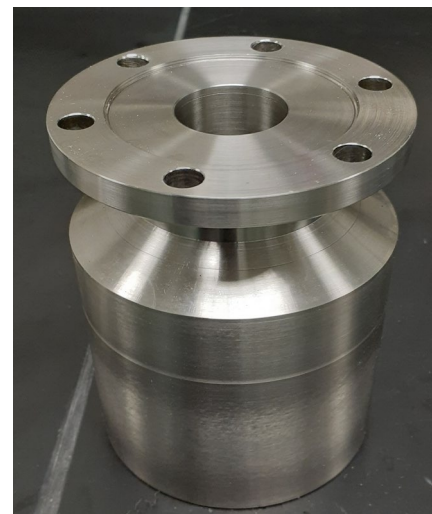
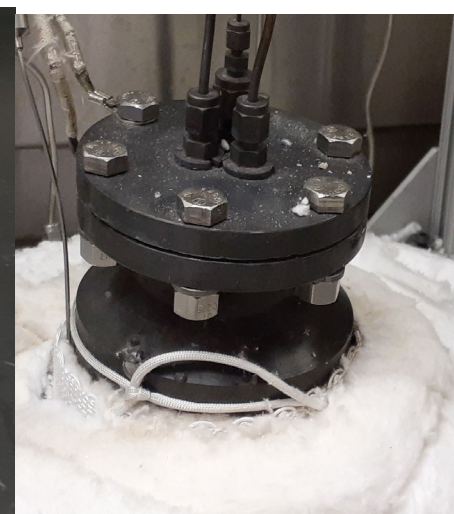
Lid Initially

Lid Post Test

Body Initially

Body Post Test

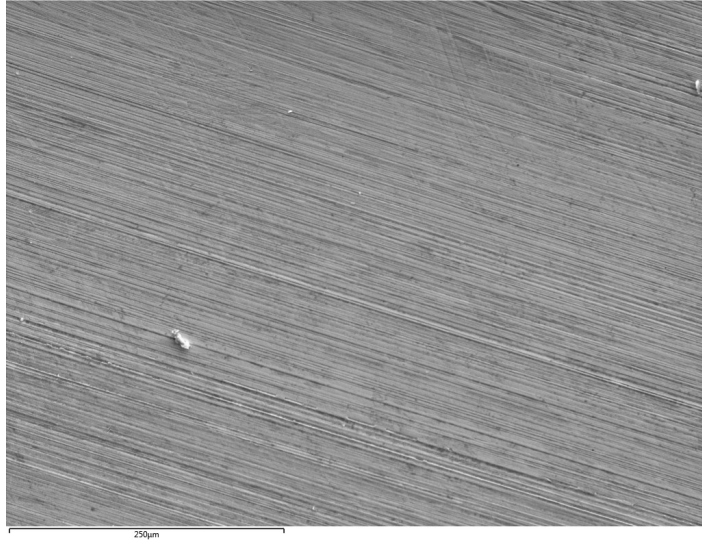
Electron Image 47

Element Type	Interior Sample Weight %	Literature Weight %
Silicon	0.00	0.00-0.08
Chromium	16.16	14.50-16.50
Manganese	0.44	0.00-1.00
Nickel	55.80	50.99-69.50
Molybdenum	16.35	15.00-17.00
Iron	6.23	4.00-7.00
Cobalt	0.10	0.00-2.50
Vanadium	0.18	0.00-0.35
Tungsten	4.03	3.00-4.50

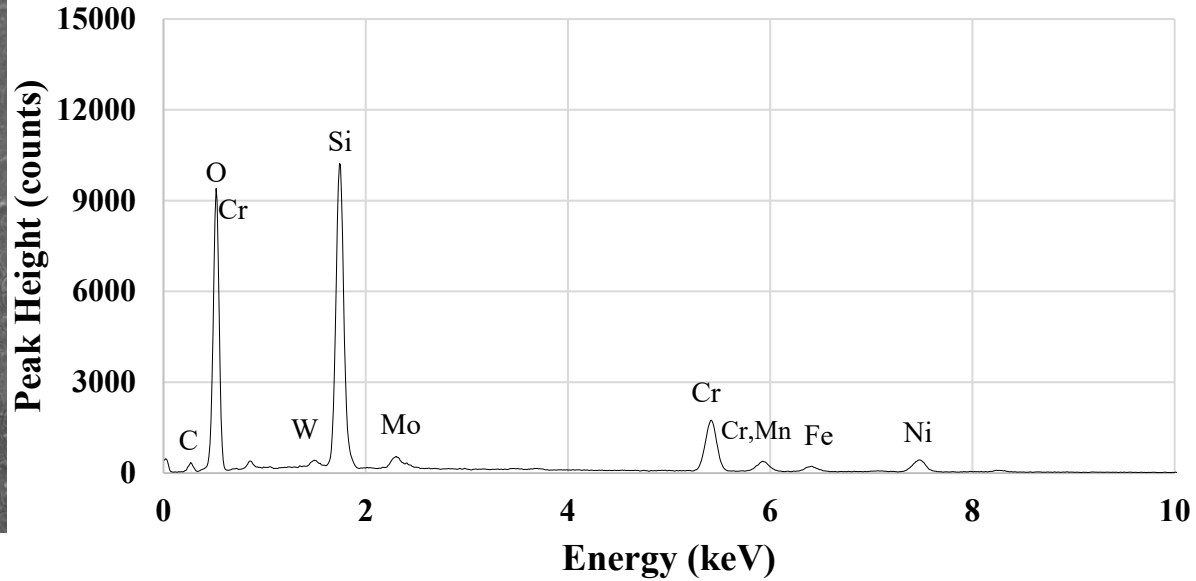
Electron Image 59

Element Type	External Surface Sample Weight %	Literature Weight %
Silicon	<b>46.92</b>	0.00-0.08
Chromium	<b>25.70</b>	14.50-16.50
Manganese	<b>2.13</b>	0.00-1.00
Nickel	<b>12.63</b>	50.99-69.50
Molybdenum	<b>6.24</b>	15.00-17.00
Iron	<b>3.64</b>	4.00-7.00
Cobalt	0.00	0.00-2.50
Vanadium	0.16	0.00-0.35
Tungsten	<b>1.04</b>	3.00-4.50

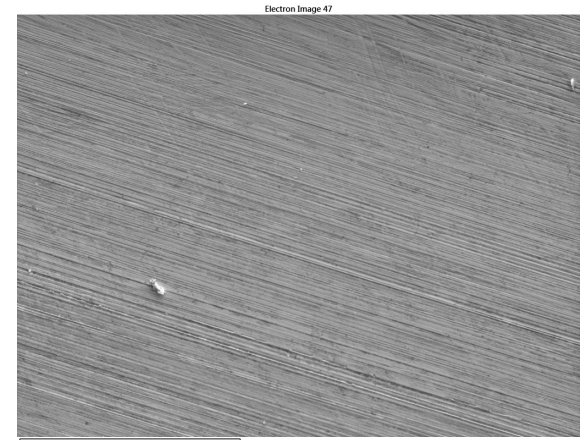
- Contamination just a surface layer, low penetration.
  - 100 μm = 0.004 inch (Human hair = 70 μm ± 20 μm).
  - Wall thickness = 1.5 inches
- Embrittlement and corrosion cracking internally unlikely as internal structure elementally unchanged. Unlikely to form leaks/cracks in parts made of Inconel.
  - No internal cracks observed either

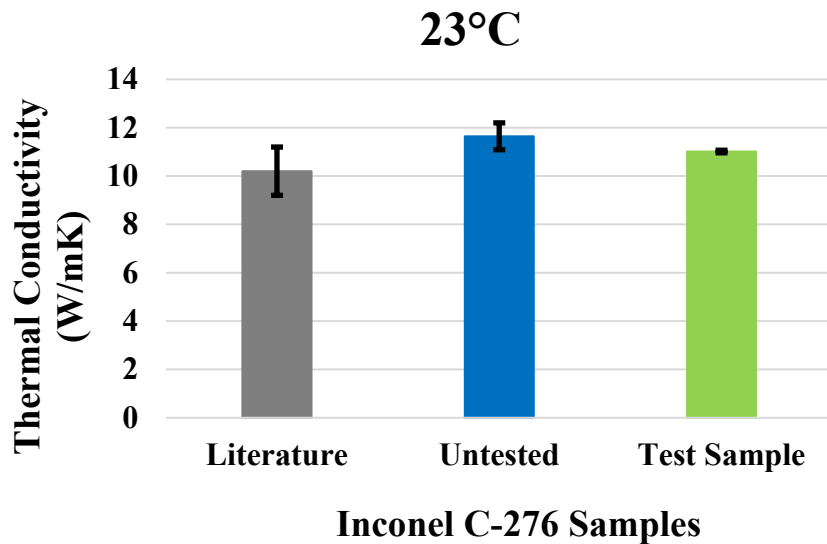
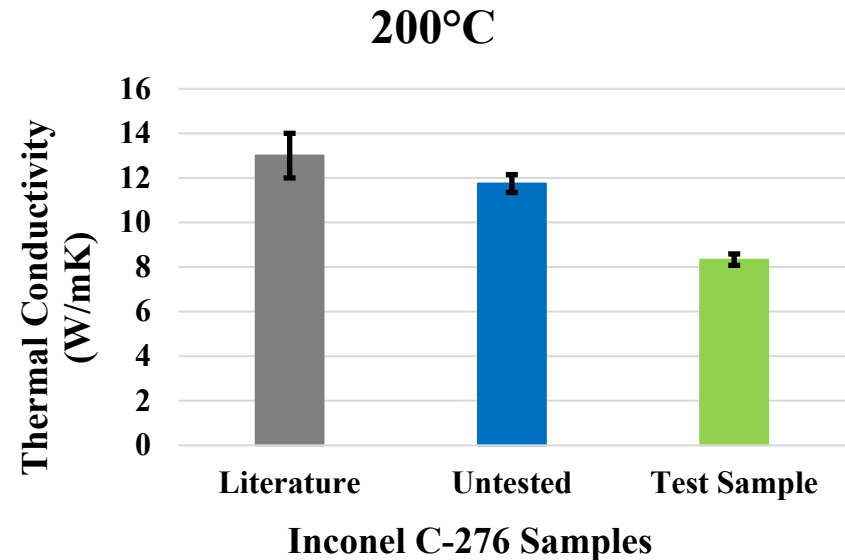
- No statistically significant difference
- Test sample ~36% lower than literature
- This was the lid, which only had 1.96wt% Si. Body had 46.9wt%.
- This was 200C. Difference between literature and sample could be much greater at 700C.
- Further decreased thermal conductivity could realistically result in hot spots and cause failure.

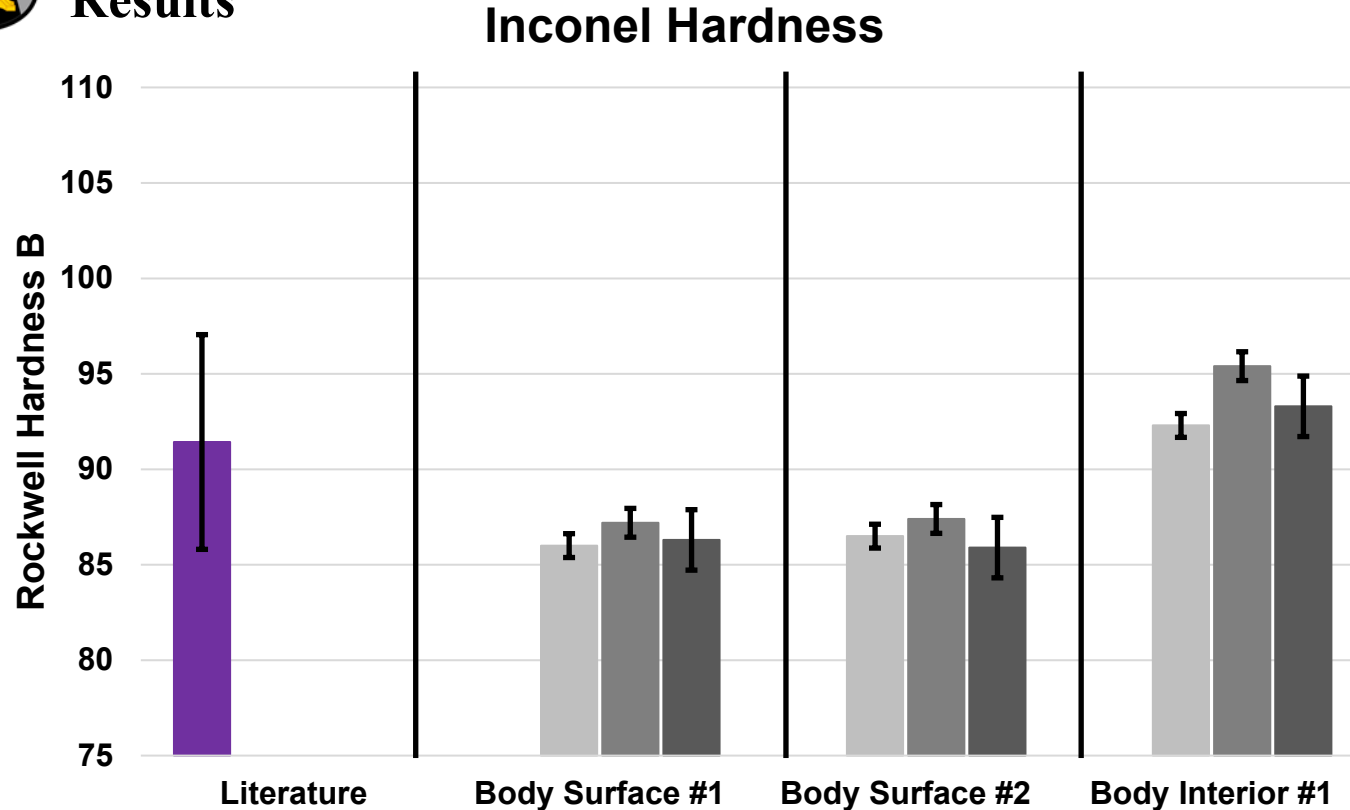
- Three samples tested:
  - 2 exterior body samples near heat tape
  - 1 interior body sample
- Three measurements taken per sample
- Some variability, but all samples within the standard deviation from literature
- Overall, no noticeable changes to material hardness from heat or elemental changes
