Naval Expeditionary Runway Construction Criteria

P-8 Poseidon Pavement Requirements

Final report

Prepared for Naval Facilities Engineering and Expeditionary Warfare Center (NAVFAC EXWC)
1100 23rd Ave.
Port Hueneme, CA 93043

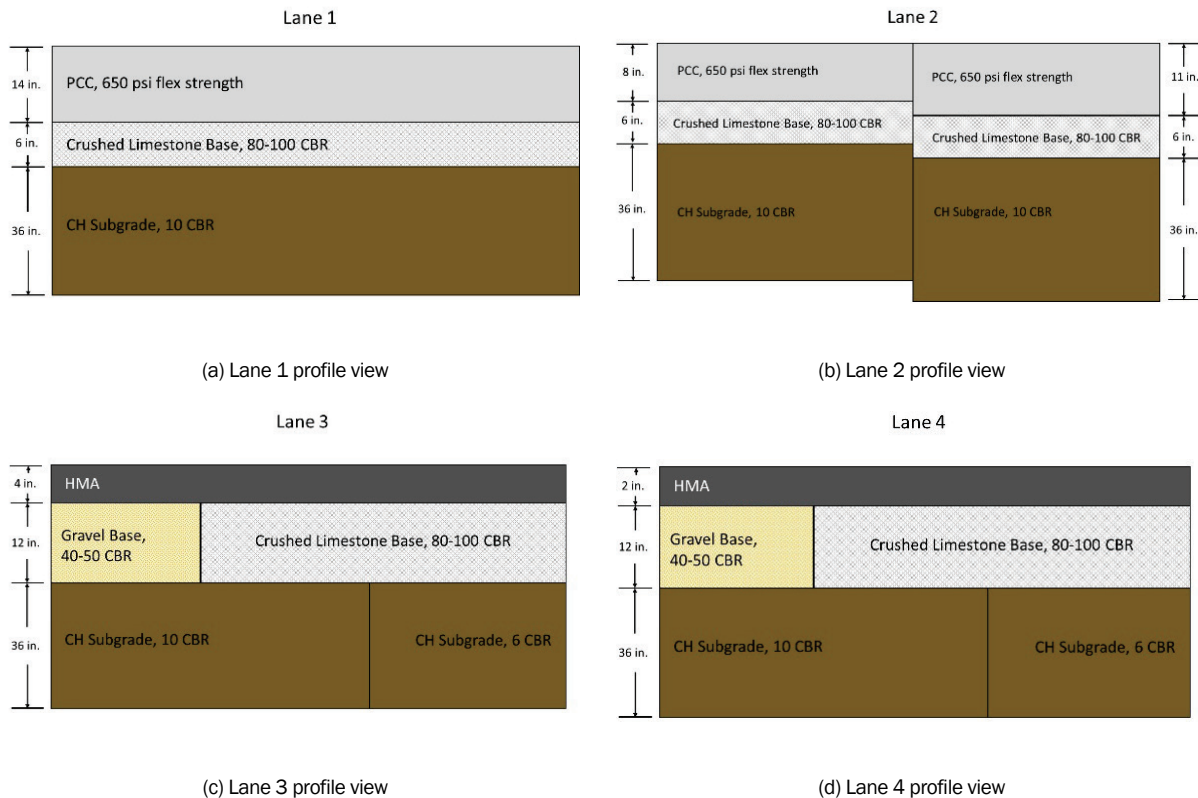
Figure 2. Profile view of P-8 construction criteria test lanes.

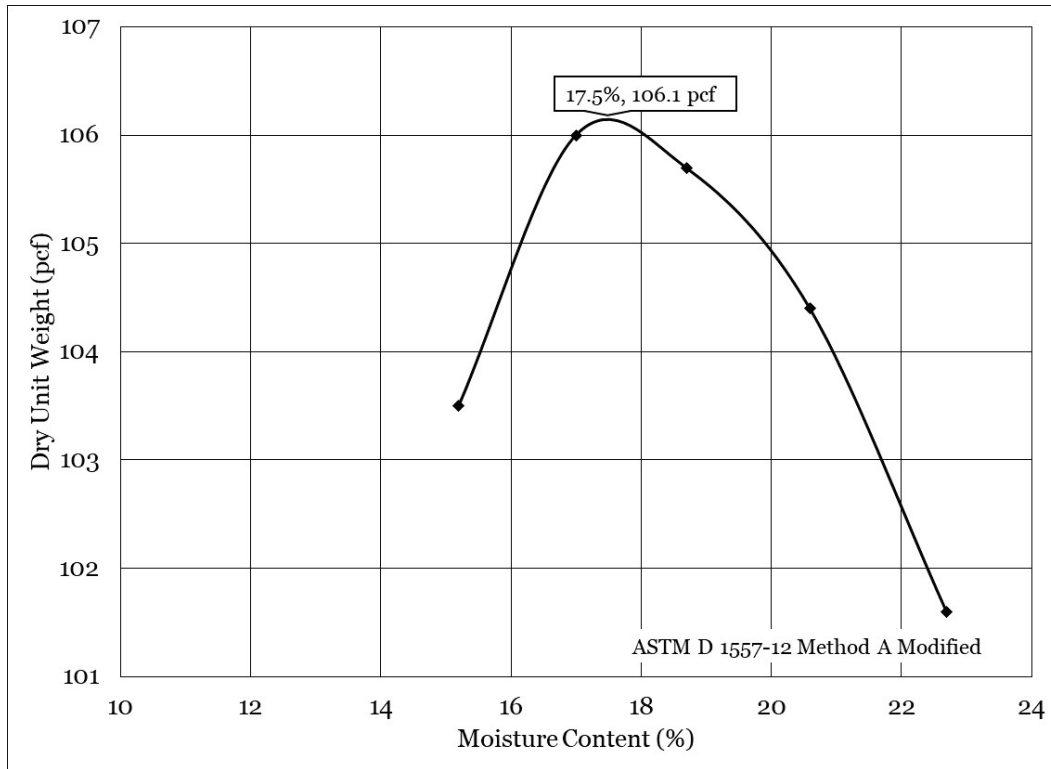
Figure 3. Clay subgrade moisture/density relationship.

Modified Proctor compaction tests (ASTM D1557 [2012]) were performed to determine the relationship between moisture content and dry density. The maximum dry density was found to be 106.1 pcf at an optimum moisture content of 17.5% (ASTM 2012). Graphical results of the moisture-density relationship test are shown in Figure 3.

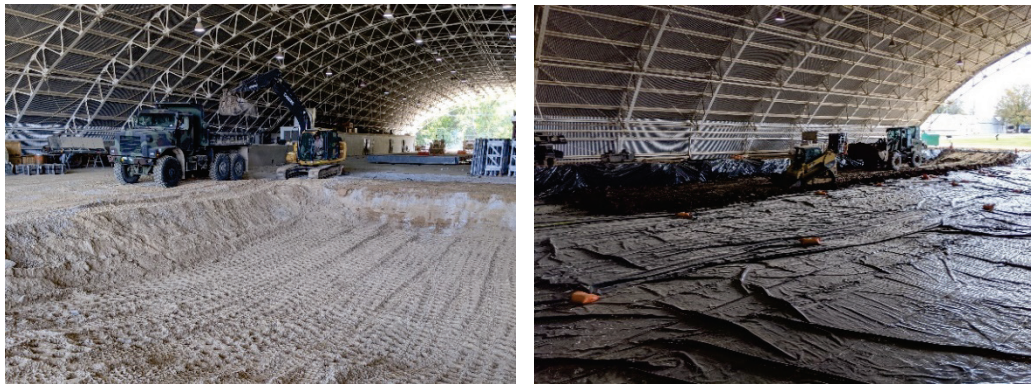
Figure 10. Test section excavation and preparation.

A 140 ft by 65 ft test section was constructed in ERDC's Hangar 2 Accelerated Pavement Test Facility. The test section consisted of four lanes, each with a different pavement and subgrade combination that are described in detail in Chapter 2. Excavation was completed to a depth of approximately 5 ft using a John Deere 130G tracked excavator (Figure 10). The excavated area was uniformly graded using a motor grader and was recompactd using a smooth drum vibrator roller. After excavation, the bottom and sides of the test section were lined with a 6 mil plastic sheeting to separate the natural subgrade from the constructed subgrade and to encapsulate the pavement test section to prevent moisture migration into/out of the design pavement layers.

(a) John Deere 130G tracked excavator

(b) 6 mil plastic sheeting in bottom of excavation

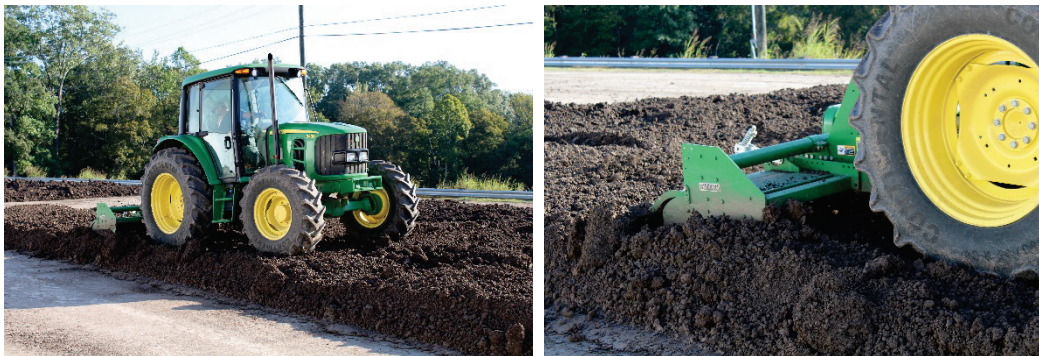
Figure 11. Mixing and processing equipment.

(a) John Deere 6430 tractor

a hydroseeder. Mixing and tilling of the material was performed using a John Deere 6430 tractor with a Frontier RT2308 tiller attachment (Figure 11) to ensure a uniform moisture content was obtained throughout the material. The material was tilled, restockpiled, respread, and tilled again to achieve moisture uniformity. This process was repeated multiple times until moisture uniformity was achieved. Moisture samples were taken frequently throughout the process to monitor changes in moisture content. After the material achieved the desired moisture content, it was stockpiled and covered with a heavy-duty tarp to mitigate moisture content changes prior to placement in the test section.

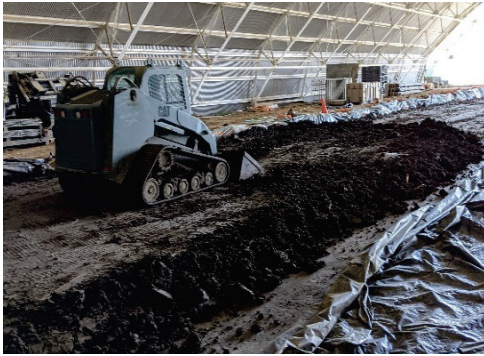
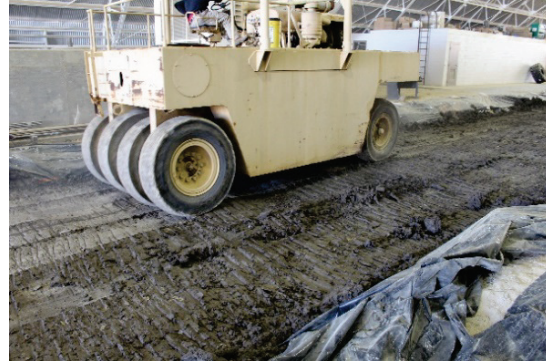
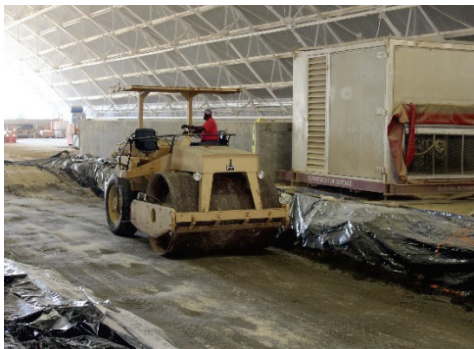
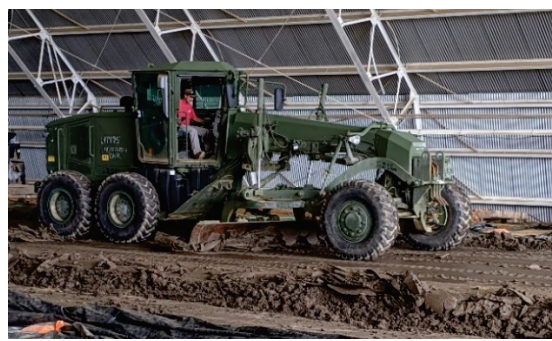
Figure 12. Material placement equipment.

To prepare the test section for subgrade placement, wooden grade stakes ensured each lift of clay was placed and compacted near a uniform height. Front-end loaders were used to place material within the test section. A CAT 277 Compact Track Loader (CTL) (Figure 12) was used to spread the clay in the test section. After each loose lift was placed, the material was compacted using an Ingram 10000 pneumatic roller and a Dynapac CA25 smooth wheel roller. The Ingram 10000 pneumatic roller had a gross weight of approximately 70,000 lb applied to sets of pneumatic tires inflated to 120 psi. During the compaction process, a Troxler 3440 nuclear density gauge (ASTM D6938) was used to measure density (ASTM 2017b). After completion of the compaction process for each lift, the clay layer was covered with 6 mil plastic sheeting to mitigate a loss of moisture from the placed clay layer. Quality control testing was performed on each lift to ensure strength requirements were achieved and to measure uniformity throughout the test section. The ASTM D4429 field CBR test (ASTM 2009a) was performed on each lift as a quality control test. After all lifts of the subgrade were completed, a motor grader was used to finalize the desired elevation of the test section. Gauges were installed after the grading process was complete.

(a) CAT 277 CTL

(b) Ingram 10000 pneumatic roller

(c) Smooth-drum vibrator roller

(d) Motor grader

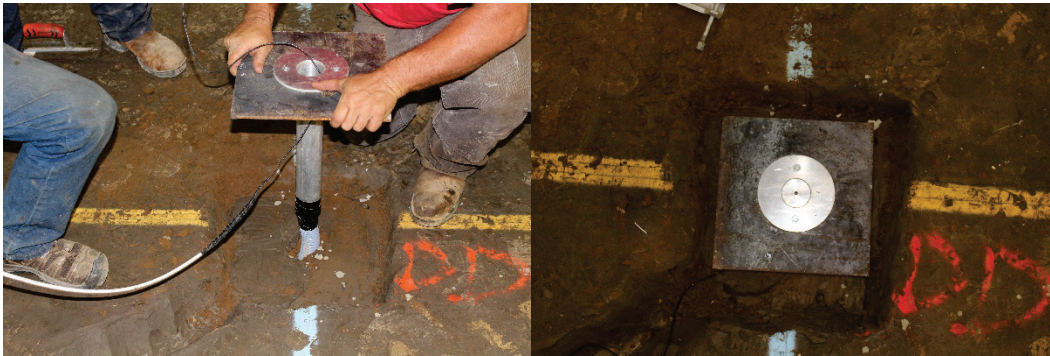
(a) Advancing borehole

(b) Placing concrete anchor

(c) Setting gauge assembly

(d) Completed installation

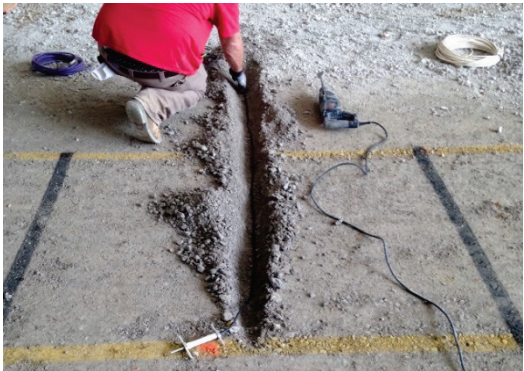
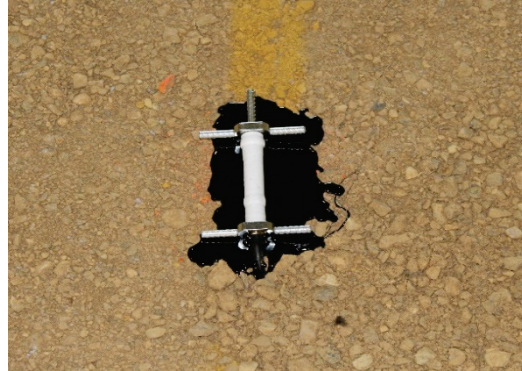
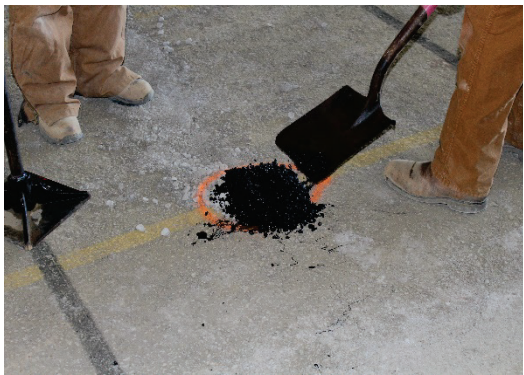
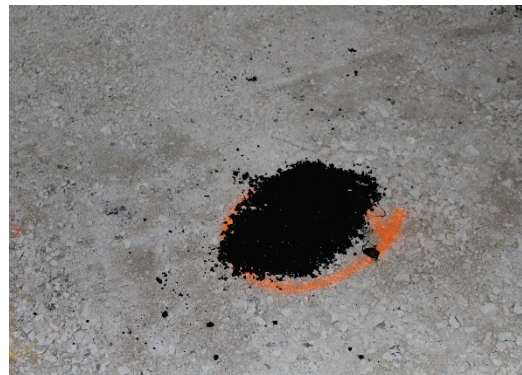
Figure 21. ASG installation.

Tensile strain at the bottom of an HMA layer provides a quantitative measure of the pavement response during trafficking. The tensile strain at the bottom of the HMA is a key response parameter linked to fatigue damage in the HMA layer. For this study, strain at the bottom of the HMA surface was measured using dynamic ASGs in the longitudinal (i.e., with traffic) direction. The ASGs were manufactured by Tokyo Sokki and could measure a range of $\pm 5,000$ microstrains. The gauges were adhered to the surface of the base course with a heated asphalt binder, and HMA from the asphalt paver was placed as cover over each of the gauges immediately prior to paving the entire test section. This process is shown in Figure 21.

(a) Trenching for wire

(b) Adhered to surface

(c) Covering with HMA

(d) Compacted prior to paving

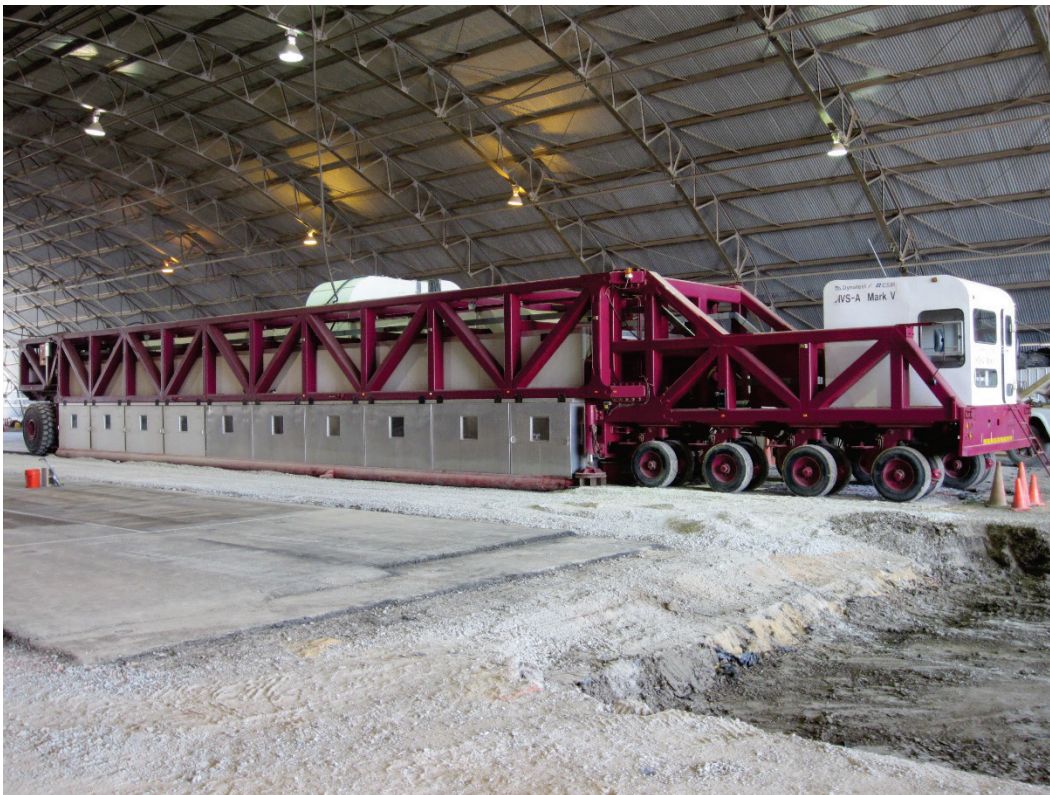
Figure 22. ERDC Heavy Vehicle Simulator (HVS-A).

Accelerated test traffic was applied using a dual-wheel P-8 gear mounted on ERDC's HVS-A. The HVS is a fully automated pavement trafficking device capable of applying wheel loads ranging from 10,000 lbf to 100,000 lbf. Total traffic length is approximately 45 ft at speeds ranging from 4 to 9 mph. Additionally, the HVS has an integrated climate control system that controls the temperature of the test area. While not critical for PCC pavement testing, HMA pavements are sensitive to fluctuations in pavement temperature. Thus, the climate control system was used to maintain the HMA pavement temperature at $77 \pm 5^\circ\text{F}$ during test section trafficking. An alarm system was activated to notify the operator if temperatures inside the test chamber exceeded the preset threshold. A photograph of the ERDC HVS-A is shown in Figure 22.

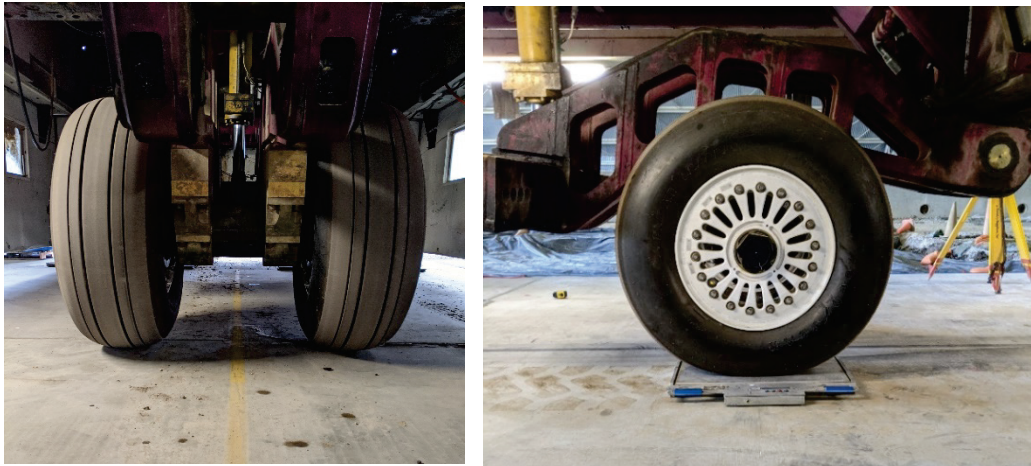
Figure 23. P-8 gear on HVS.

The P-8 gear configuration used for trafficking all test items is shown in Figure 23. The P-8 gear consisted of two actual P-8 tires and wheels with a custom machined axle for securing the tires to the HVS carriage. The

total load on the dual-wheel configuration was 89,000 lbf; this load was verified prior to traffic testing using a set of portable aircraft scales. The tire inflation pressures were monitored daily and maintained at 220 psi.

(a) Front view

(b) Side view

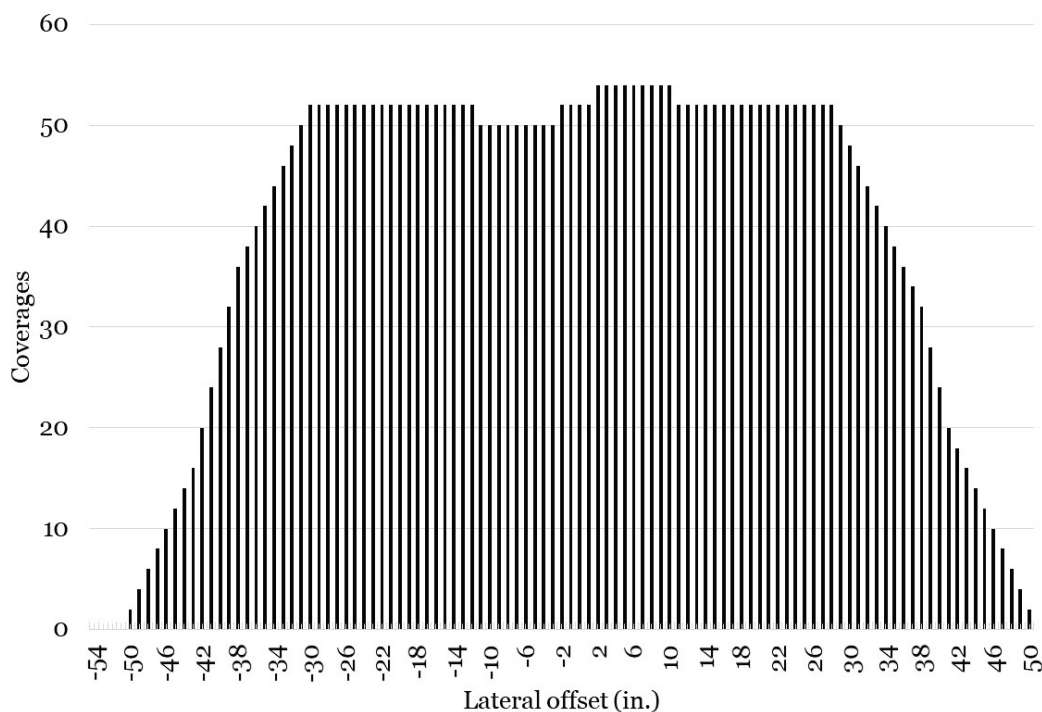
Figure 25. Bidirectional normally distributed wander pattern.

expected in a real-world trafficking scenario. The wander pattern used for this study is shown in Figure 25. The pattern consisted of a long sweep and a short sweep, where 158 total passes of the HVS comprised a full wander pattern resulting in a minimum pass-to-coverage ratio of 3.04.

Traffic was started for each test item with the center of the dual-wheel P-8 gear aligned on the centerline of the test section. The HVS applied test traffic parallel to the test item centerline on the forward pass and shifted one end of the carriage beam 2 in. on the return pass. Prior to initiating the next pass, the opposite end of the carriage beam shifted 2 in.; thus, the beam returned parallel to the traffic centerline (Figure 26). This process was repeated throughout the entire wander pattern; therefore, odd pass numbers were parallel to the traffic centerline, and even pass numbers were at a slight skew to the traffic centerline. It is important to understand the traffic operation and gear positioning of the HVS, particularly in early traffic and in relation to installed instrumentation, such that pertinent observations can be made.

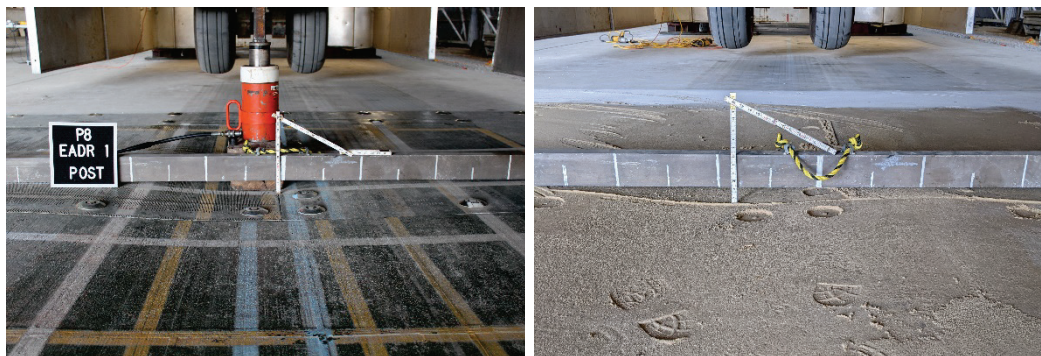
Figure 94. Photographs of geogrid stabilized backfill—posttraffic.

P-8 gear before reaching the 1.5 in. failure criteria. No mat breakage and/or cracking was observed prior to failure. Photographs of the loaded FRP at the conclusion of traffic are shown in Figure 94.

(a) Loaded FRP

(b) Sand surface posttest

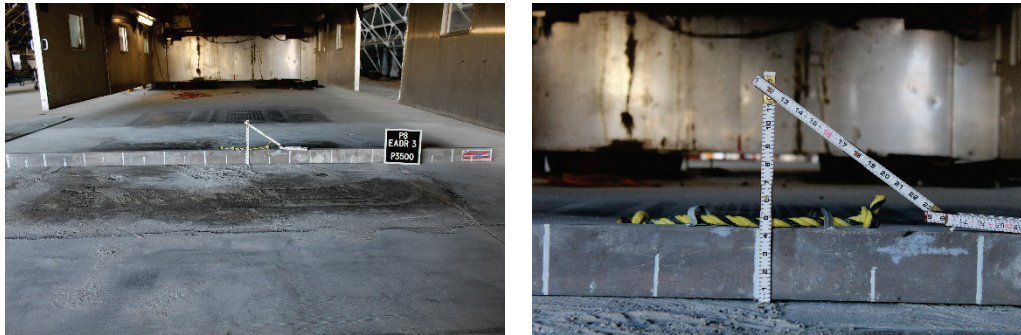
Figure 98. Photographs of posttest cement stabilized backfill.

Results of loaded deformation for cement stabilized sand backfill with FRP are provided in Figure 97. Permanent deformation was measured using rod and level, and rut depth was measured using a straightedge and machined depth wedge. Little permanent deformation was observed. Traffic was halted at 3,500 total passes, which is considered a sustainment level of traffic. At the conclusion of traffic, approximately 0.25 in. of permanent deformation was measured. Thus, a cement-stabilized repair technique could sustain P-8 traffic passes well beyond a contingency (500-pass) scenario. Posttraffic photographs of the cement-stabilized repair are shown in Figure 98.

(a) Overall view

(b) Close-up view

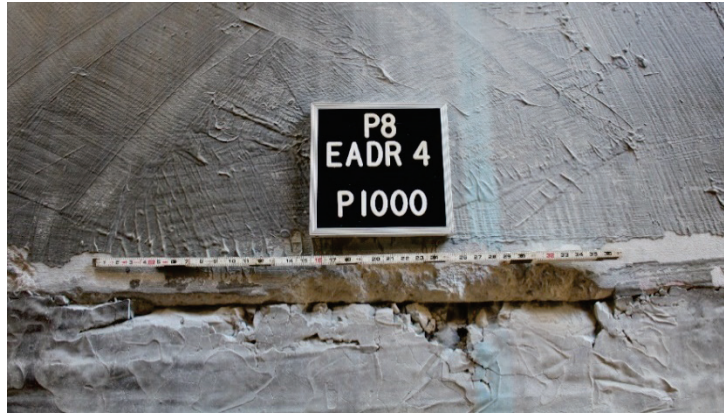
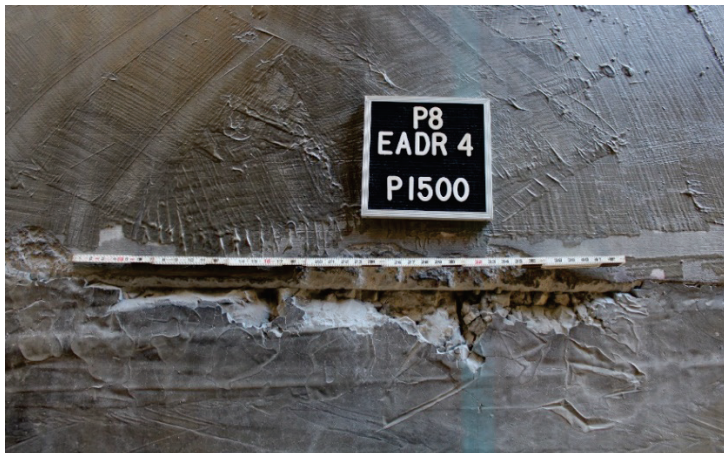
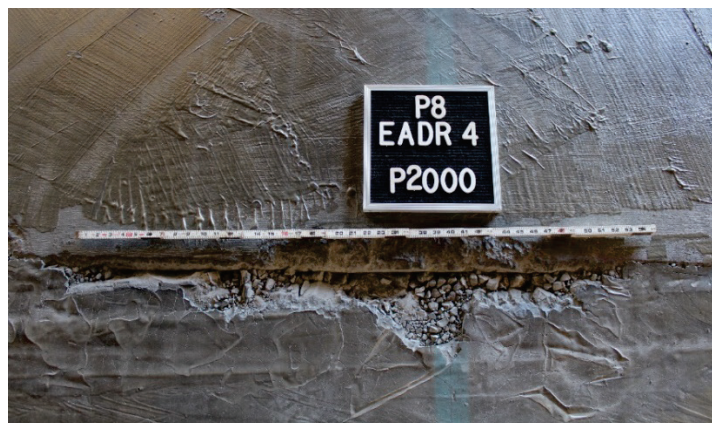
Figure 99. Spalling in stone and grout repair.

Results of the trafficking test indicated that the stone and grout repair technique reached the limiting spall criteria at 2,000 passes. No damage was observed at the 500-pass inspection. Damage was first noted at the 1,000-pass inspection. While the spall met the limiting failure criteria at 2,000 passes, it did not present an operational concern for the HVS, and test traffic was continued until 3,500 passes. Photographs of spall progression are shown in Figure 99.

(a) Joint spalling at 1,000 passes

(b) Joint spalling at 1,500 passes

(c) Joint spalling at 2,000 passes

was 2,385 kips/in. The final ISM for the stone and grout repair technique was 335 kips/in., representing a meaningful reduction in estimated load carrying capacity due to damage to the repair from traffic application.

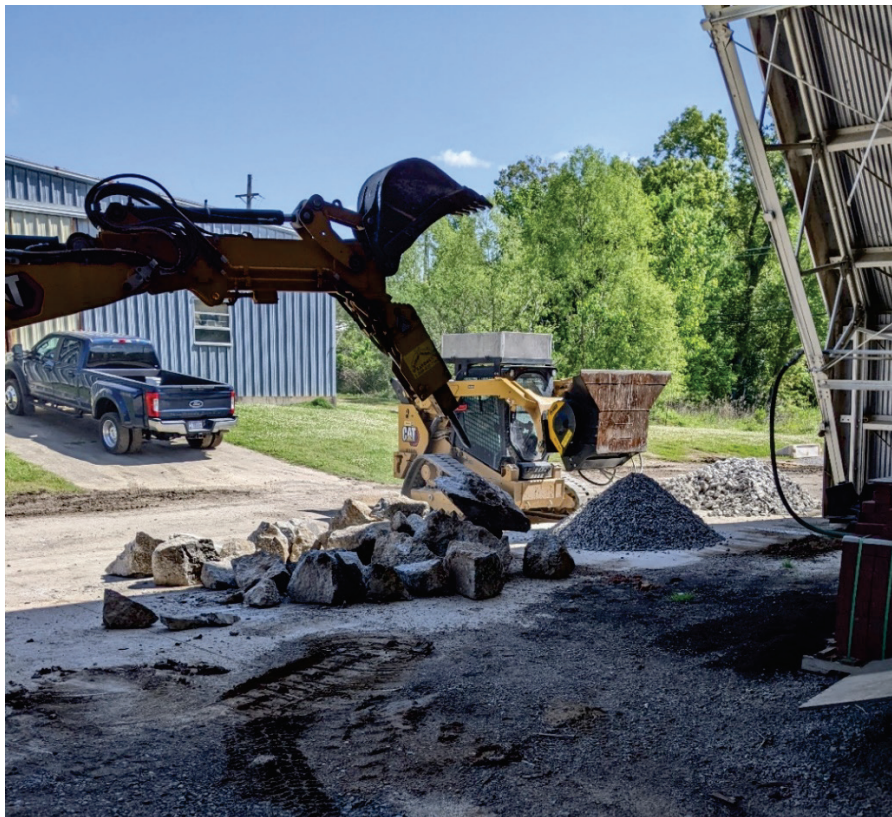
Figure 100. Processing debris backfill.

Repair 5 consisted of the placement of debris backfill that was surfaced with a calcium-sulfoaluminate (CSA) concrete cap. A simulated crater was excavated to a depth of 26 in. Oversized debris was broken using a breaking attachment on a backhoe to a maximum aggregate size of approximately 12 in. (Figure 100). The 12 in. size debris was placed in a single layer in the bottom of a simulated crater (Figure 101a). A layer of sand was placed over the large-size debris and uniformly spread to fill in void space between the debris (Figure 101b). Thereafter, a layer of 9 in. size debris was placed in a single layer, and subsequently backfilled with sand to further fill remaining void space (Figure 101c and Figure 101d, respectively). The sand layer was placed in sufficient thickness such that the final CSA concrete capping layer would be 7 in. thick. The sand layer was compacted with a pneumatic jumping jack; a total of two uniform coverages were applied. Finally, a plate compactor was used to complete final compaction and to provide a uniform final surface. The depth was checked in multiple locations using a straightedge and folding carpenter's ruler, and any areas not meeting the thickness requirements were adjusted.

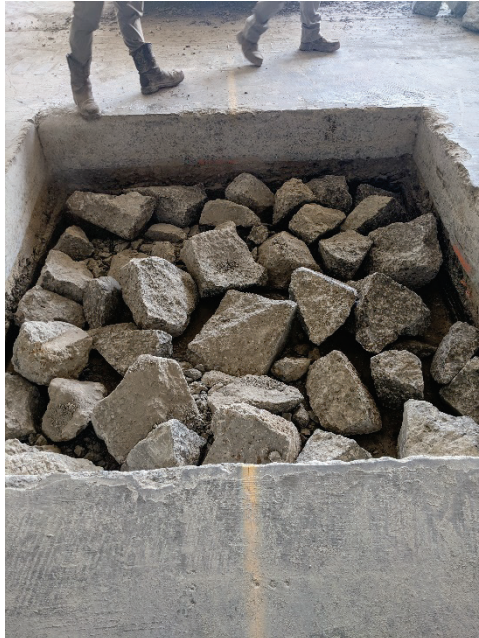
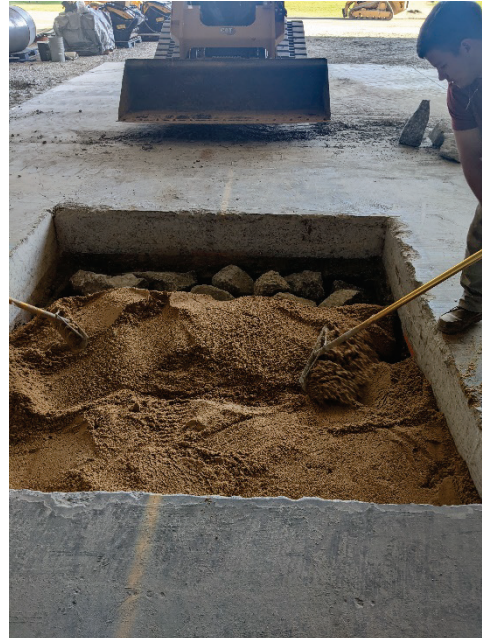
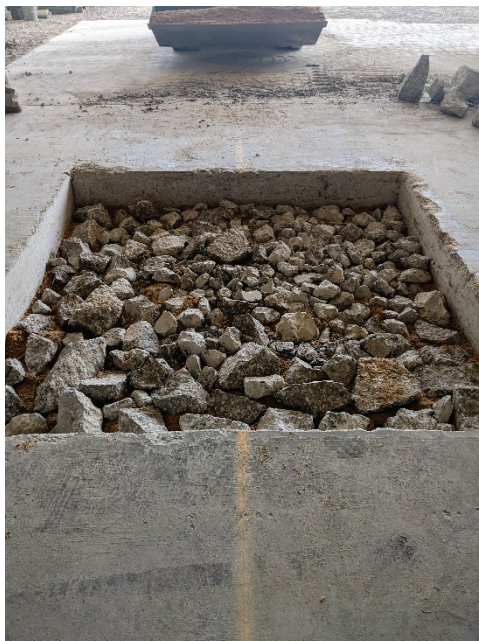
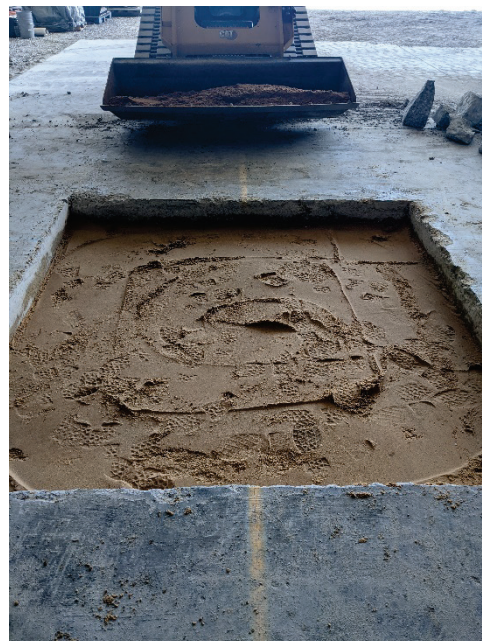
Figure 101. Backfill placement process.

(a) Placement of 12 in. debris

(b) Placement of sand layer over 12 in. debris

(c) Placement of 9 in. debris

(d) Final sand layer prior to CSA placement

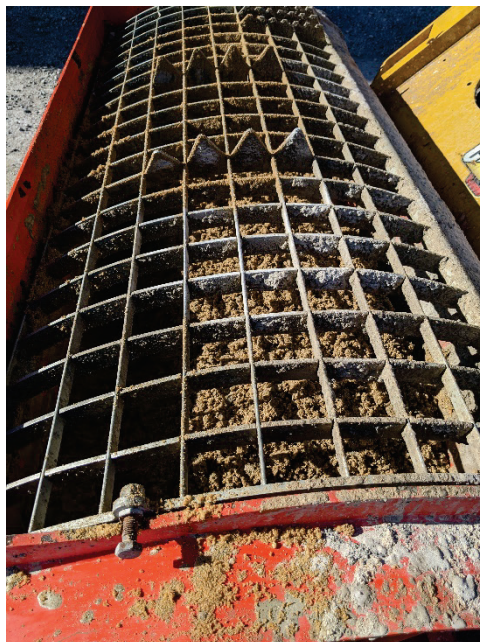
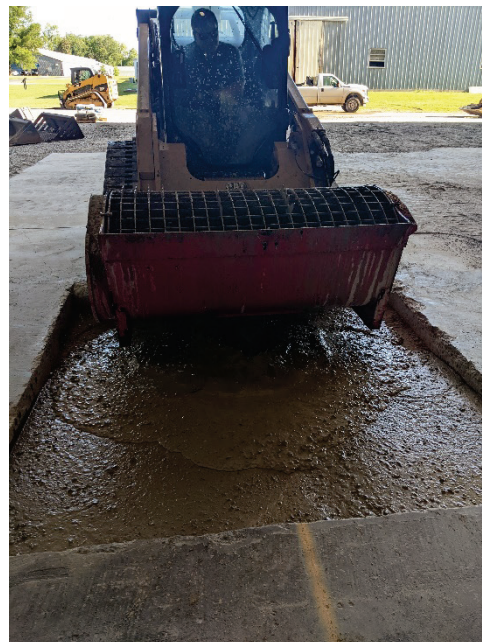
Figure 102. CSA placement process.

The CSA concrete surface material was prepared using a CTL mixing attachment. A second CTL with a split RCA/sand bucket was used to collect and transport component materials (Figure 102a). The RCA/sand bucket was divided with a steel plate such that the proper amount of each material type could be loaded on each side. The process consisted of initially loading the mixer attachment with the RCA and then adding the concrete sand. This aggregate combination was mixed for approximately 30 sec. Three 50 lb bags of CSA cement (Figure 102b) and one 47 lb bag of Type I portland cement were added to the mixture and dry mixed for approximately 30 sec (Figure 102c). Thereafter, approximately 17 gal. of water and a set-retarding admixture were added. The completed mixture was agitated for approximately 90 sec, and the completed mixture was discharged into the simulated crater (Figure 102d). This process was repeated until sufficient material was produced to achieve the target finish elevation.

(b) Loading CSA cement into CTL mixer attachment

(c) Close-up of CTL mixing attachment chamber

(d) Placement of CSA mixture into crater

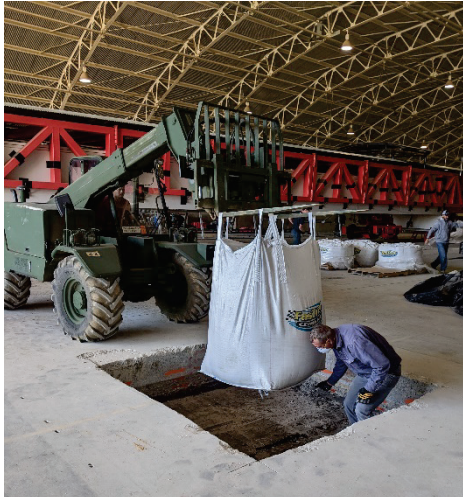
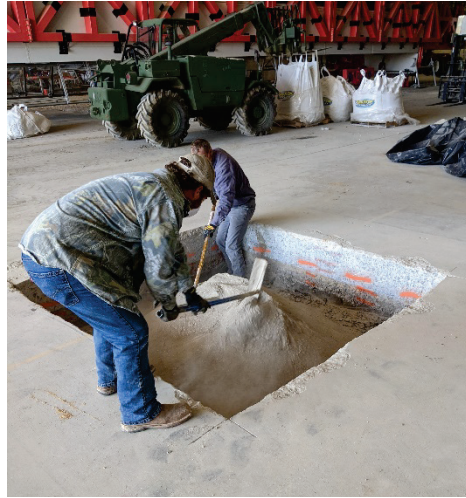
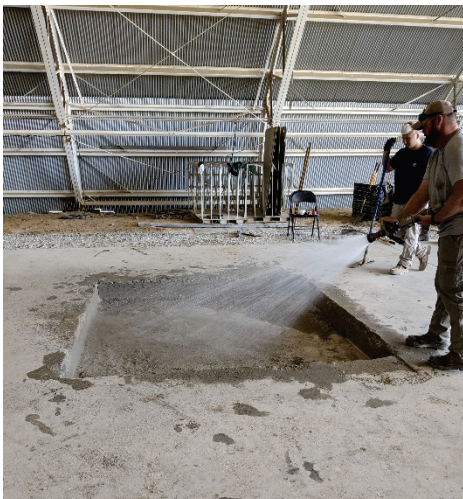
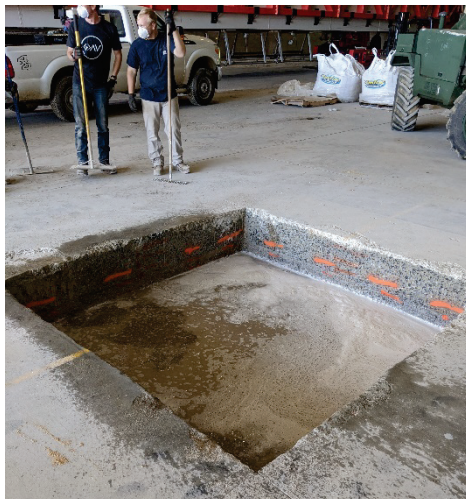
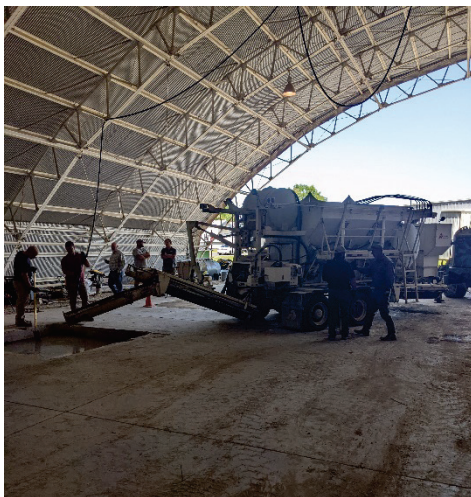
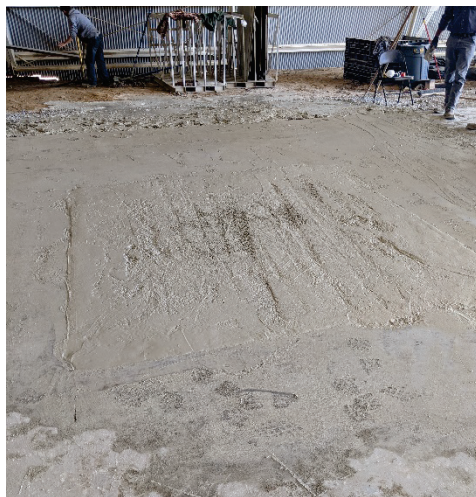
Figure 106. Placement of rapid-setting flowable fill/concrete cap.

(a) Positioning flowable fill over crater

(b) Spreading flowable fill to a uniform thickness

(c) Applying water to flowable fill layer

(d) Completed flowable fill lift

(e) RS mixture placement with volumetric mixer

(f) Completed rapid set crater surface

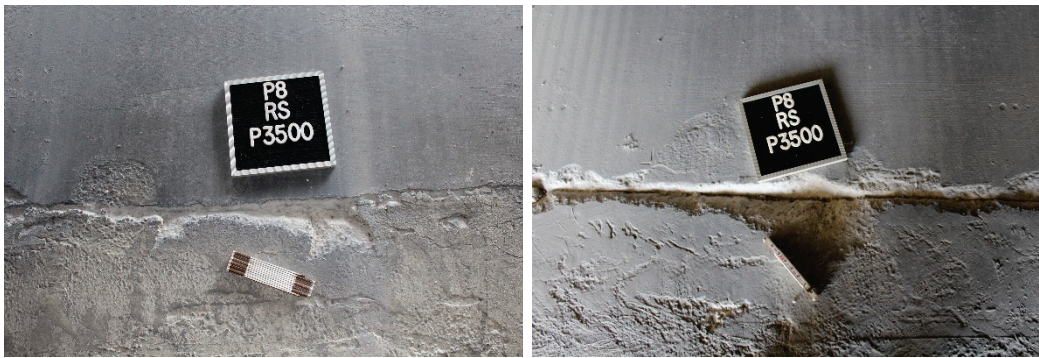
Figure 107. Joint spalling at 3,500 passes on rapid-setting (RS) crater repair.

(a) Joint spall at north edge

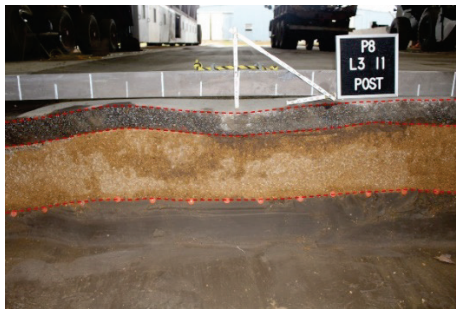
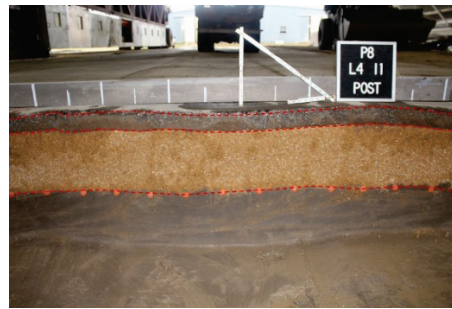
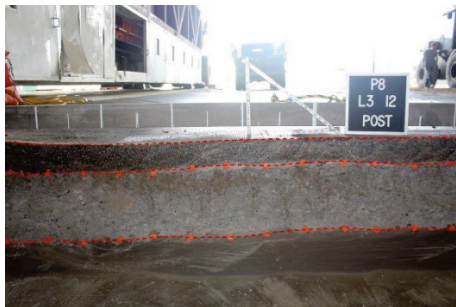
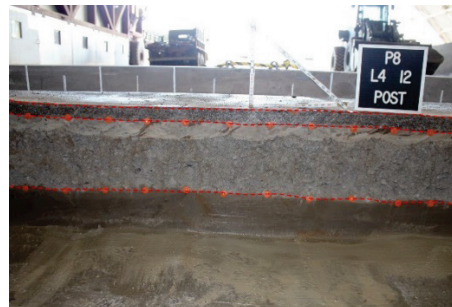
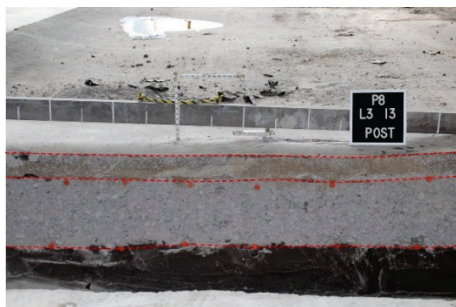
Figure 115. Photographs of excavated cross sections.

A robotic total station was used to determine permanent layer deformation at 6 in. intervals on the surface of each excavated pavement layer. These results are shown in Figures 109 to 114. Photographs of the excavated cross sections are shown in Figure 115. Layer interfaces are highlighted by a red dashed line. Rutting in each layer was calculated by averaging the maximum elevation (upheaval) on each side of the wheel path and subtracting the minimum elevation (bottom of rut) within the wheel path. Additionally, a similar analysis technique was made on construction cross-section elevation measurements to remove any abnormalities during construction. This approach “zeroed” the data and allowed for capturing only deformation that could be attributed to traffic application. Thus, calculated rut-depth values via total station measurement techniques (Table 20) may be different from those measured with a straightedge. However, the measurements are useful in examining the magnitude of rutting in each layer relative to each other and understanding how each layer contributed to overall observed failure.

(a) 4HMA, GR, 10CBR

(b) 2HMA, GR, 10CBR

(c) 4HMA, LS, 10CBR

(d) 2HMA, LS, 10CBR

(e) 4HMA, LS, 6CBR
