SUPERSONIC MEASUREMENT OF WALL THICKNESS  
IN DIESEL LINERS

Report S-2932

This report covers the results of Diesel liner wall thickness inspections with the Sonigage made subsequent to the initial inspections described in NRL Report 3-2850. Twelve model 248 Diesel liners were inspected at New York Naval Shipyard and nineteen at Norfolk Naval Shipyard.

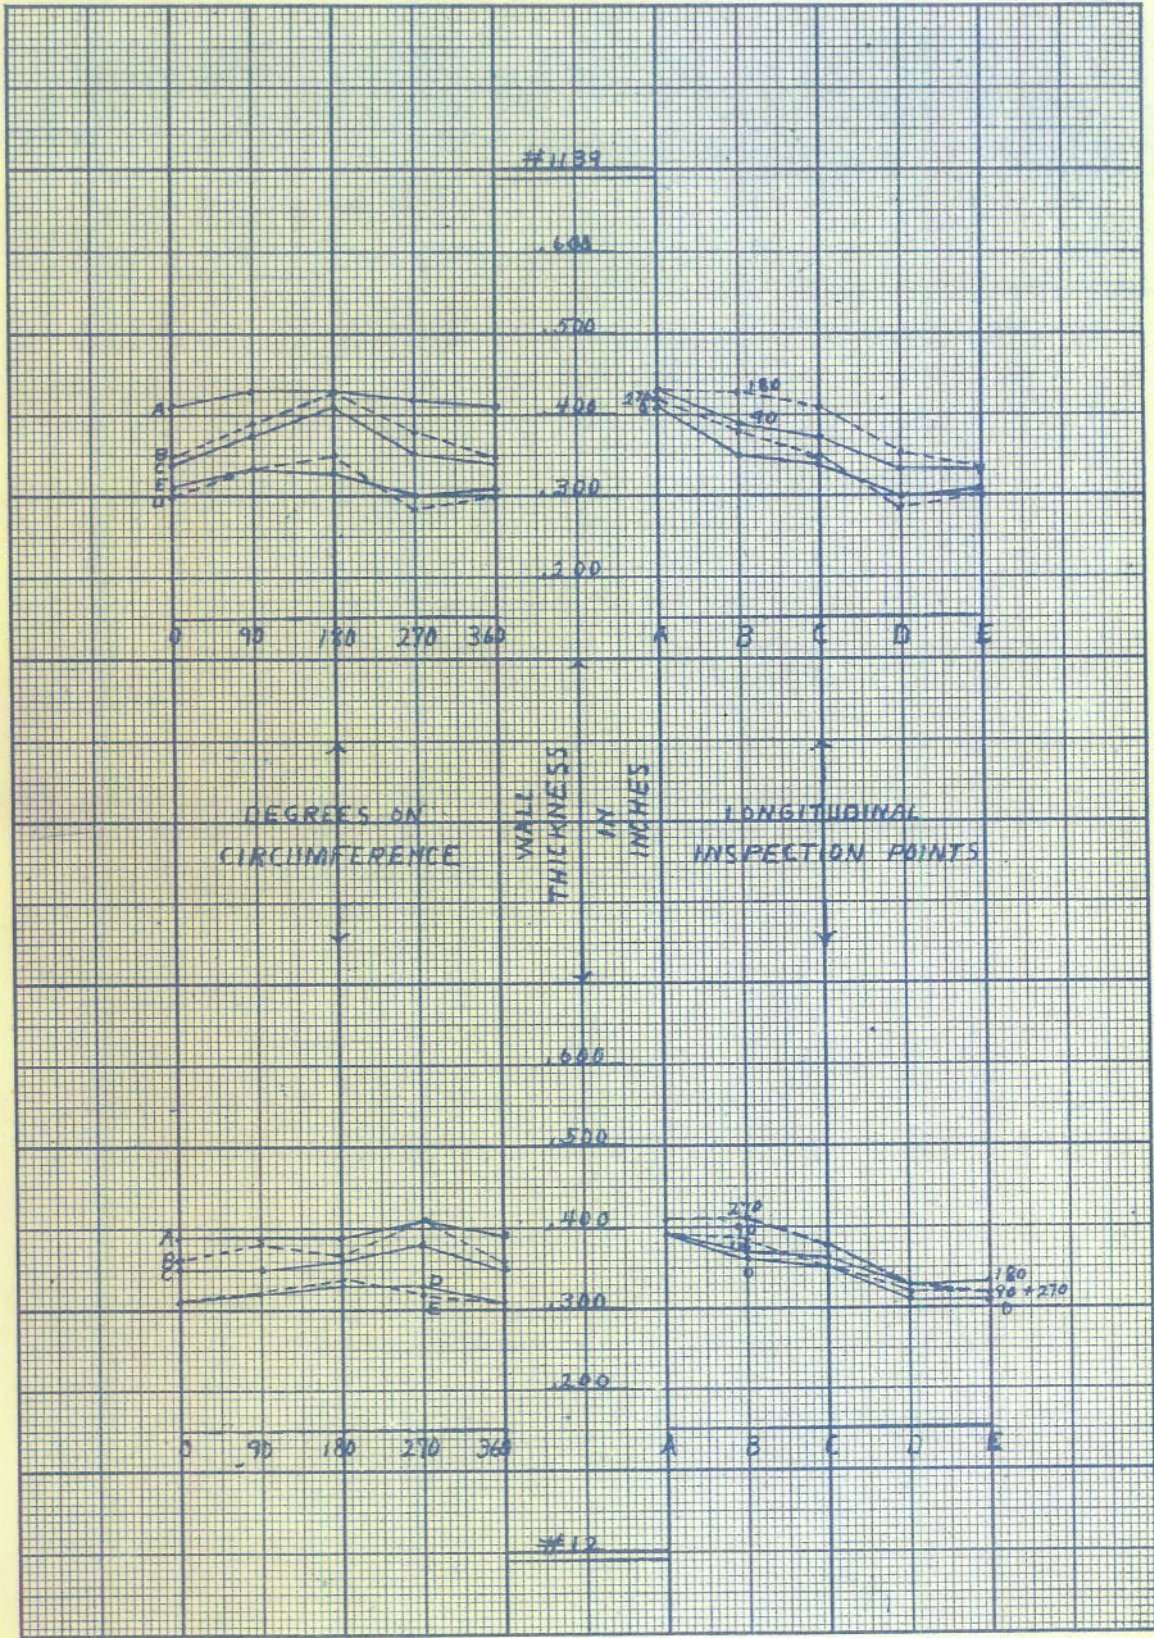
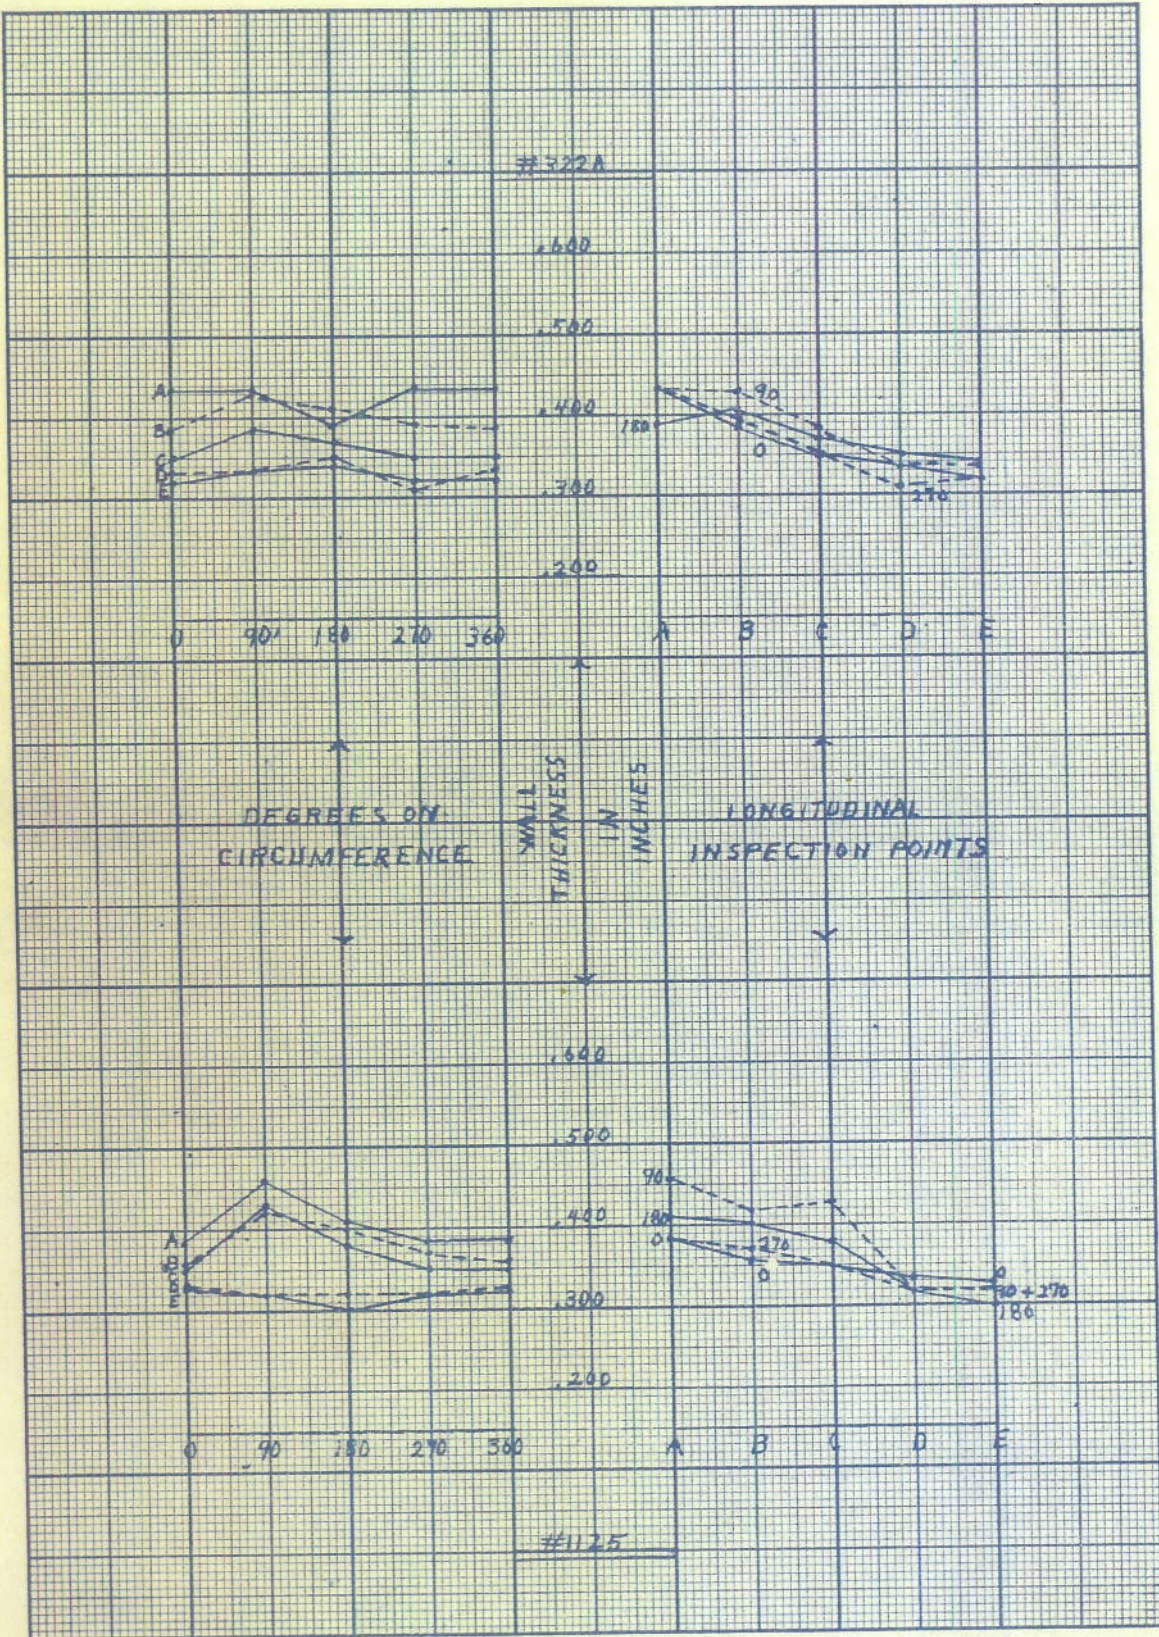
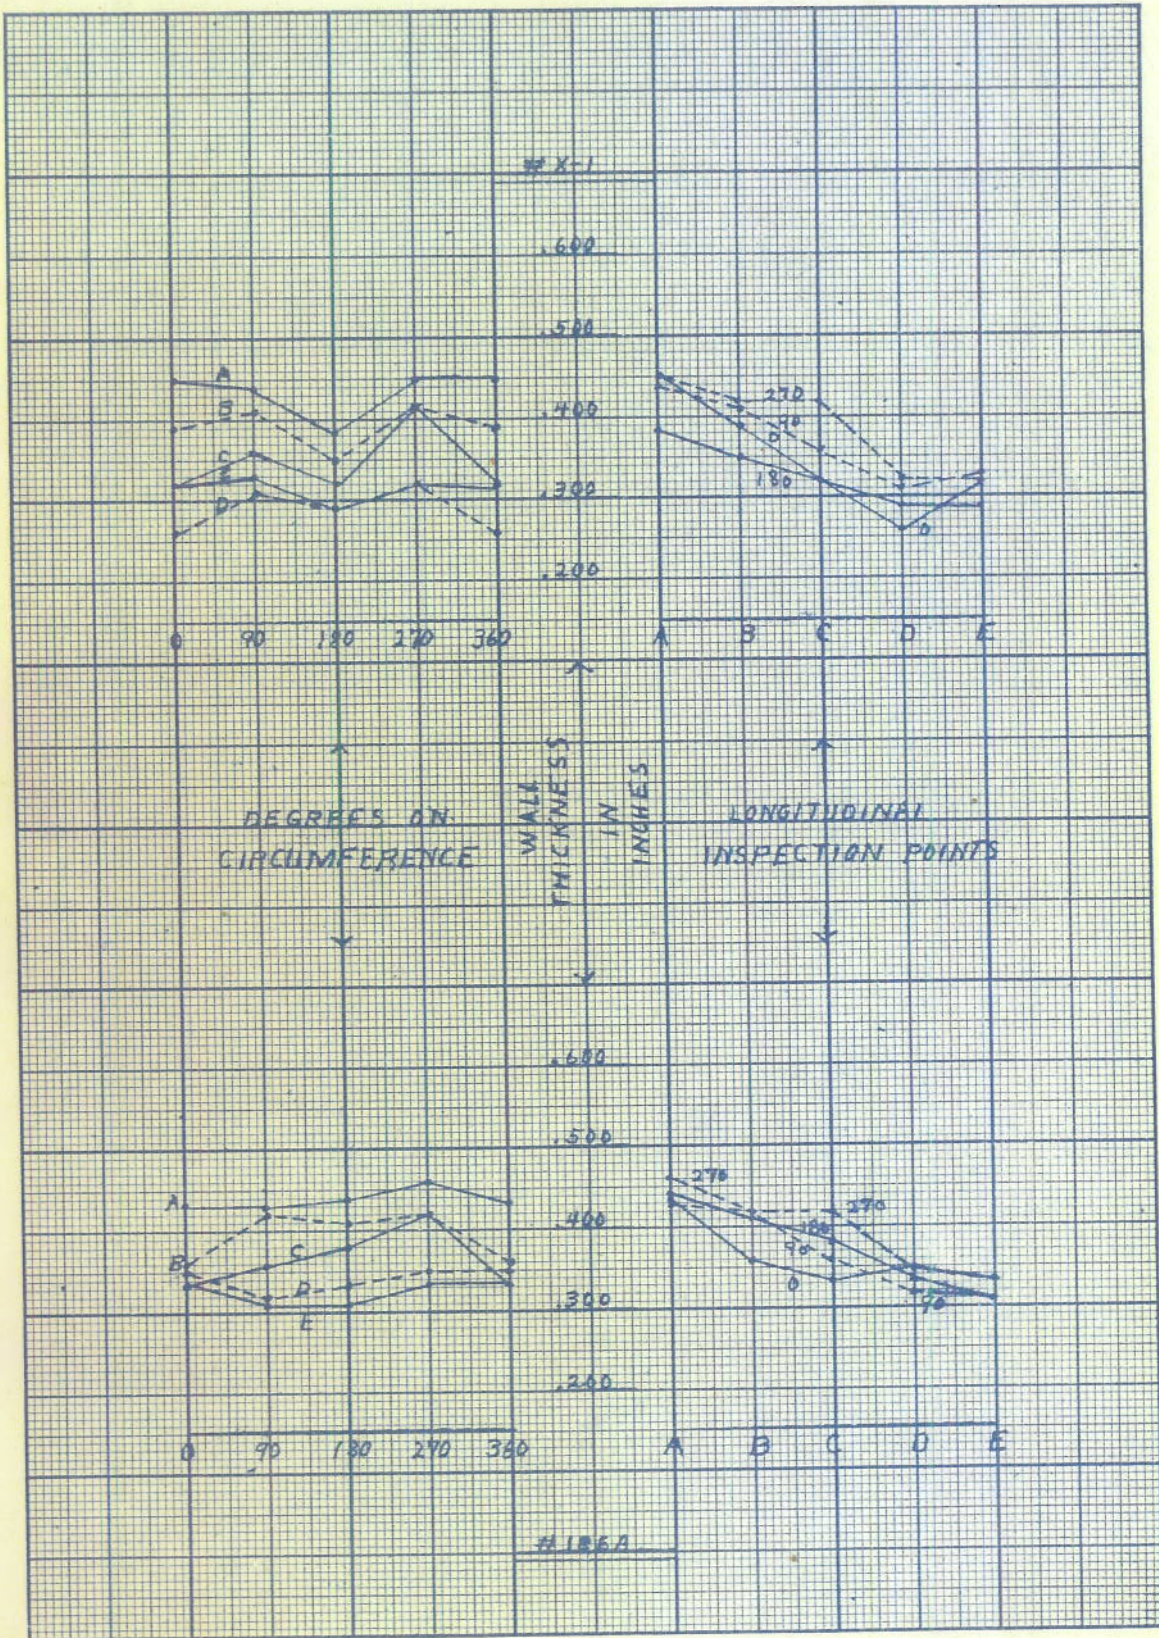
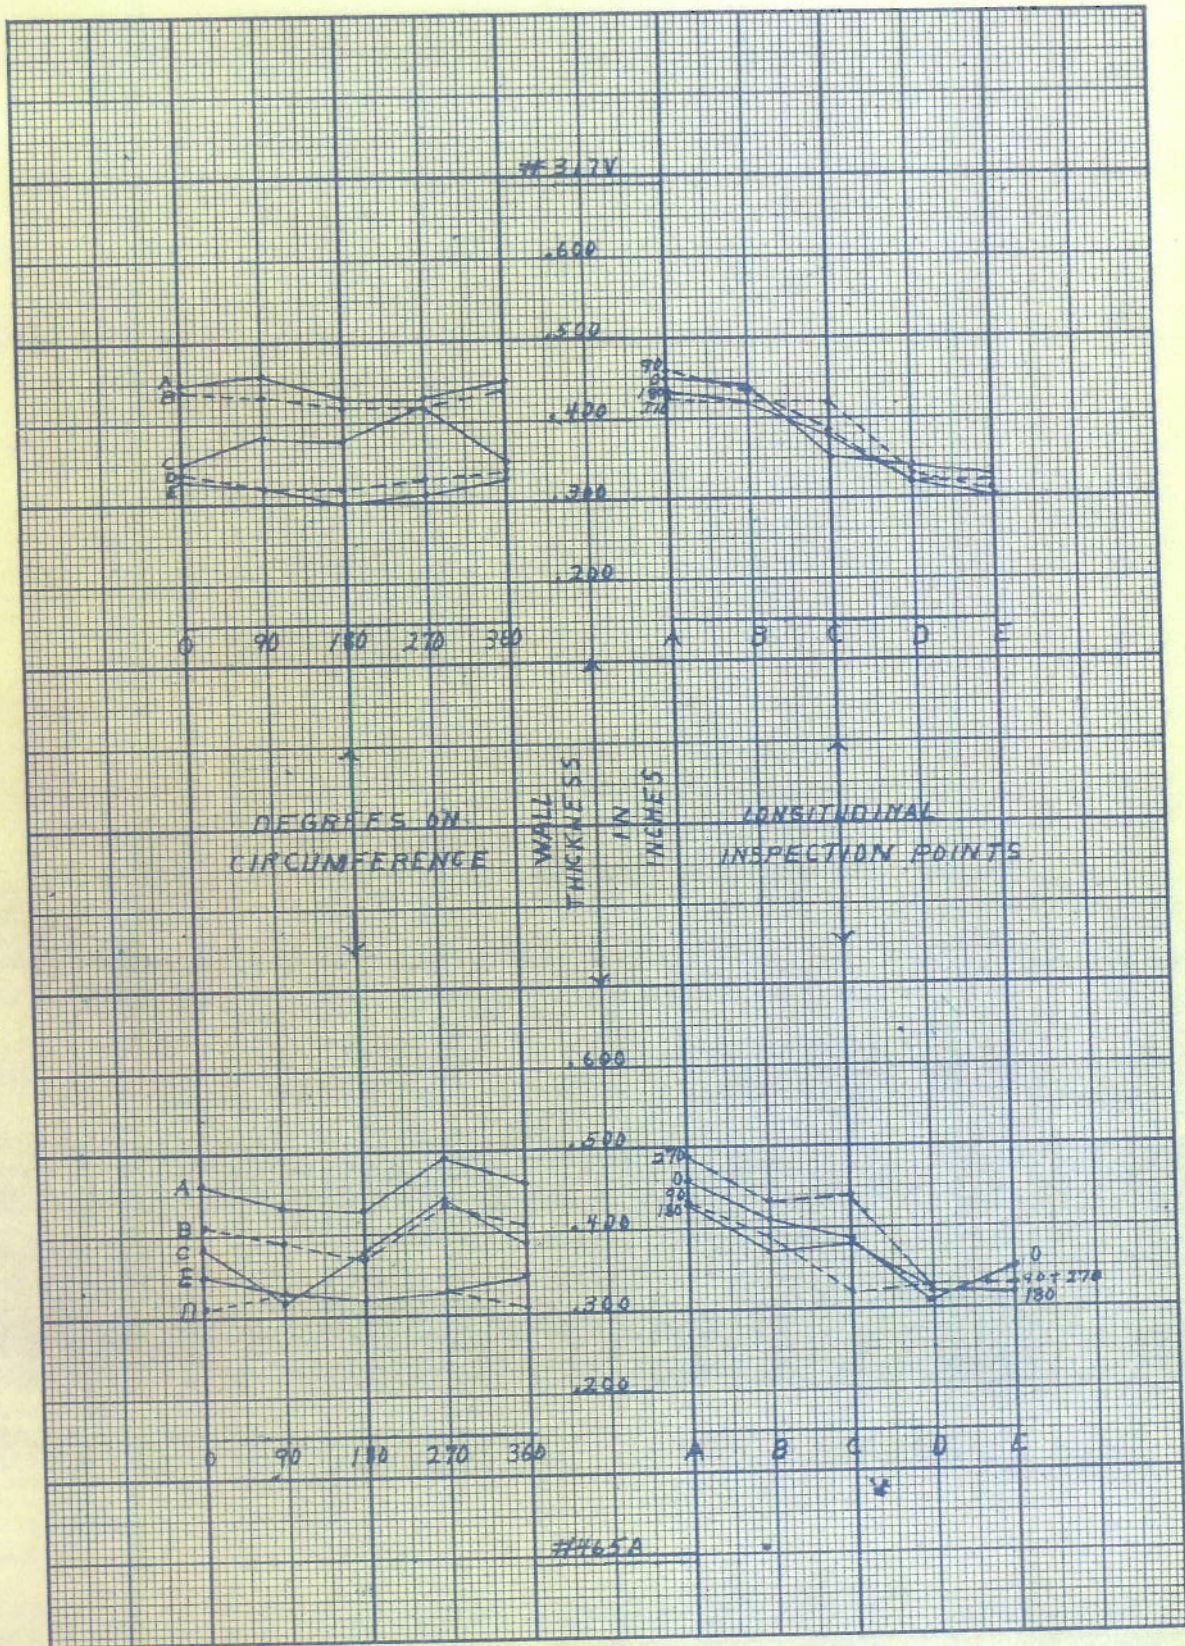
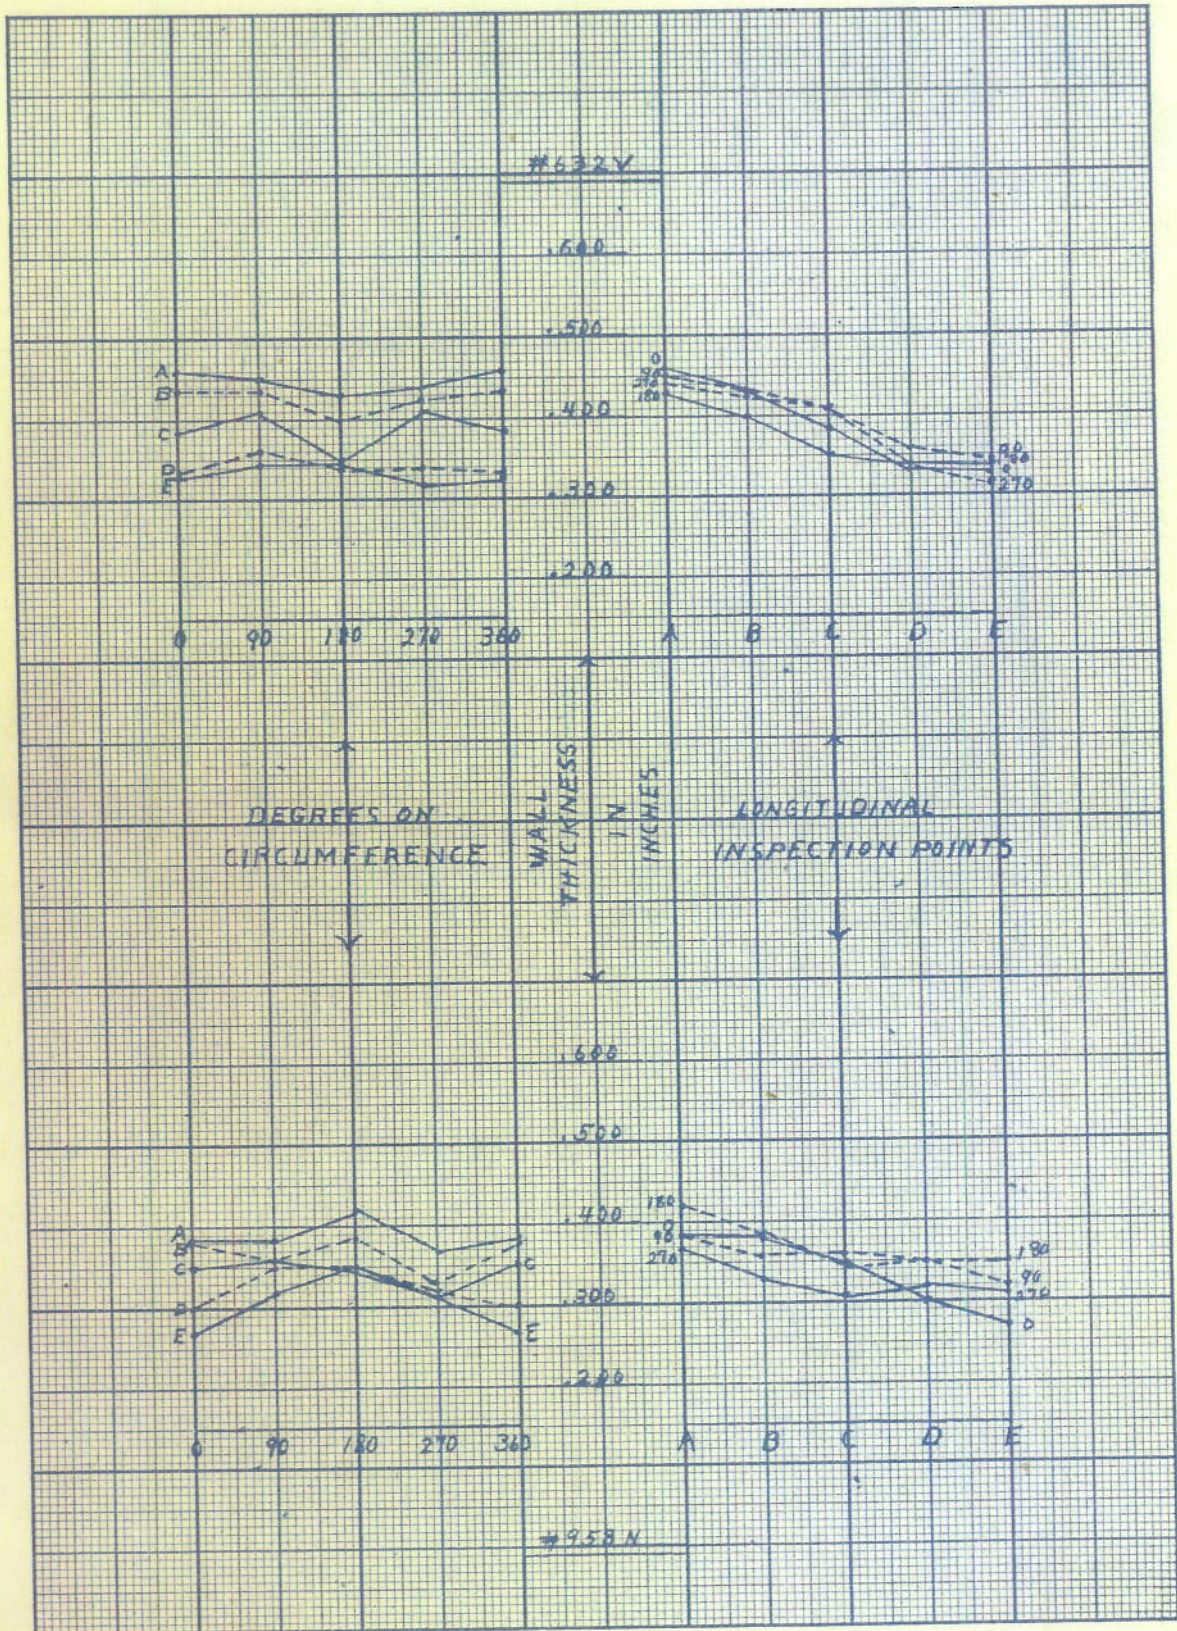
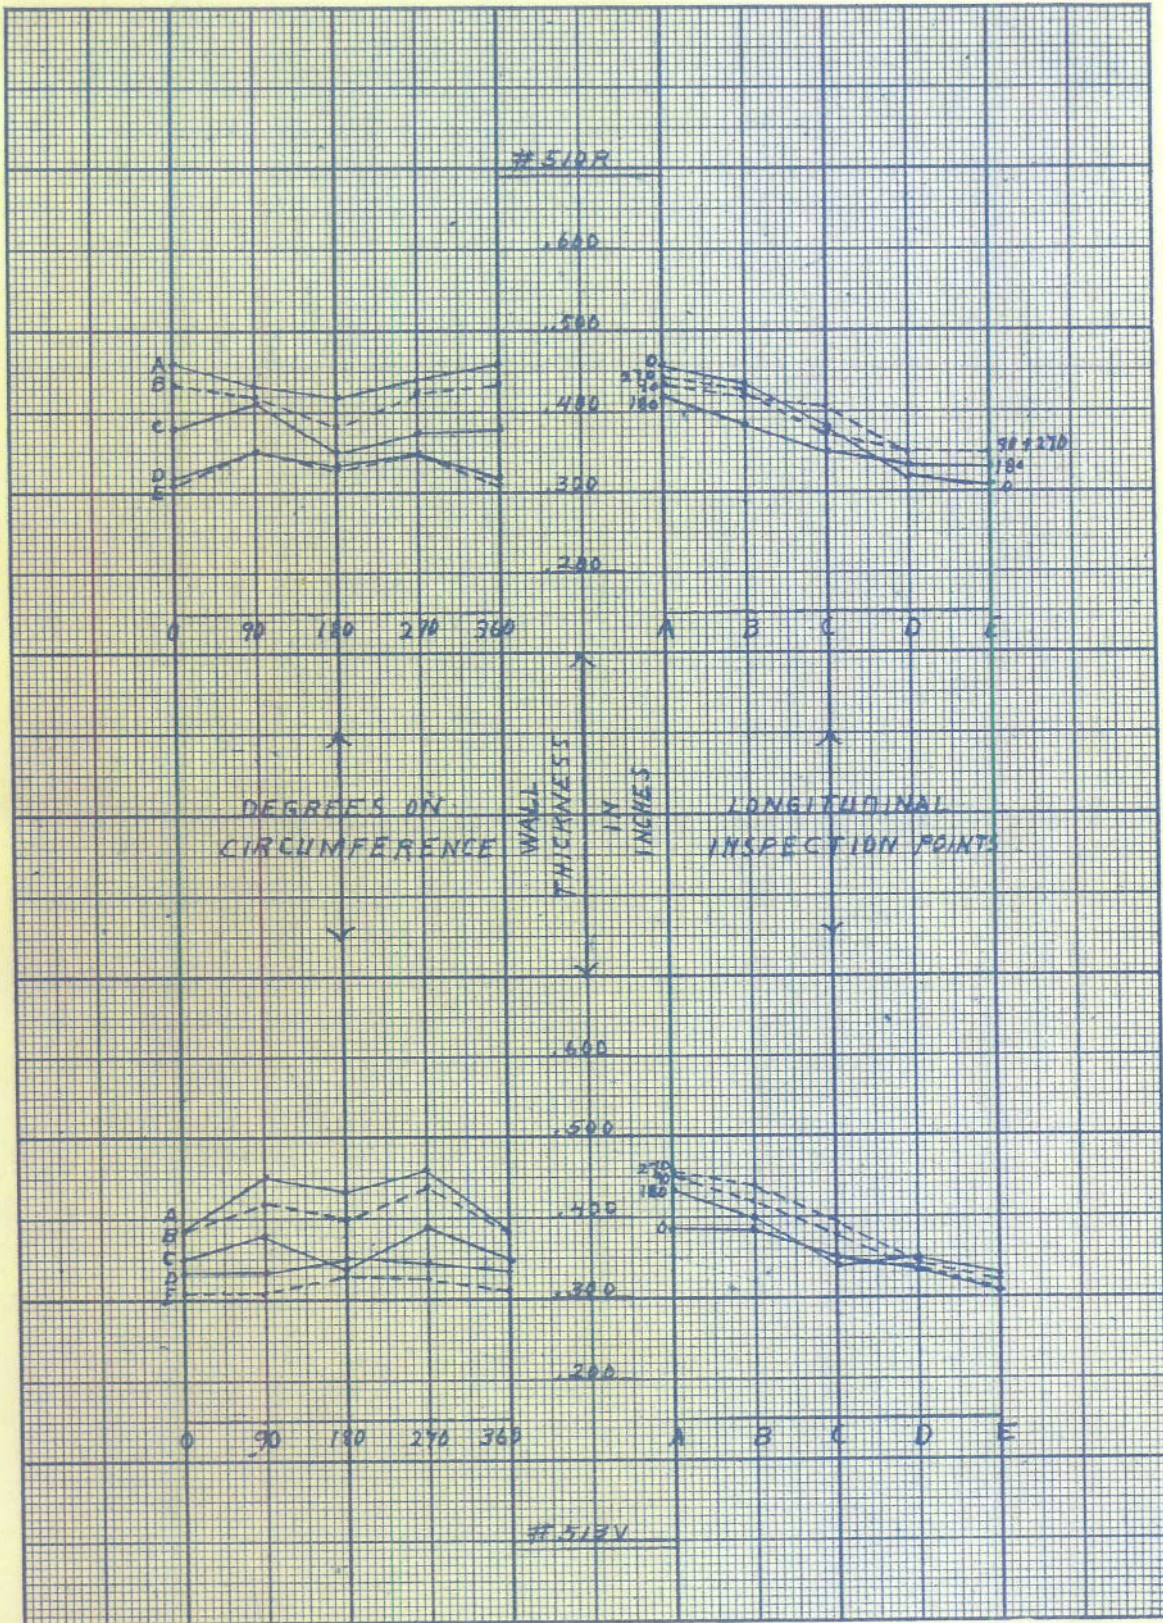
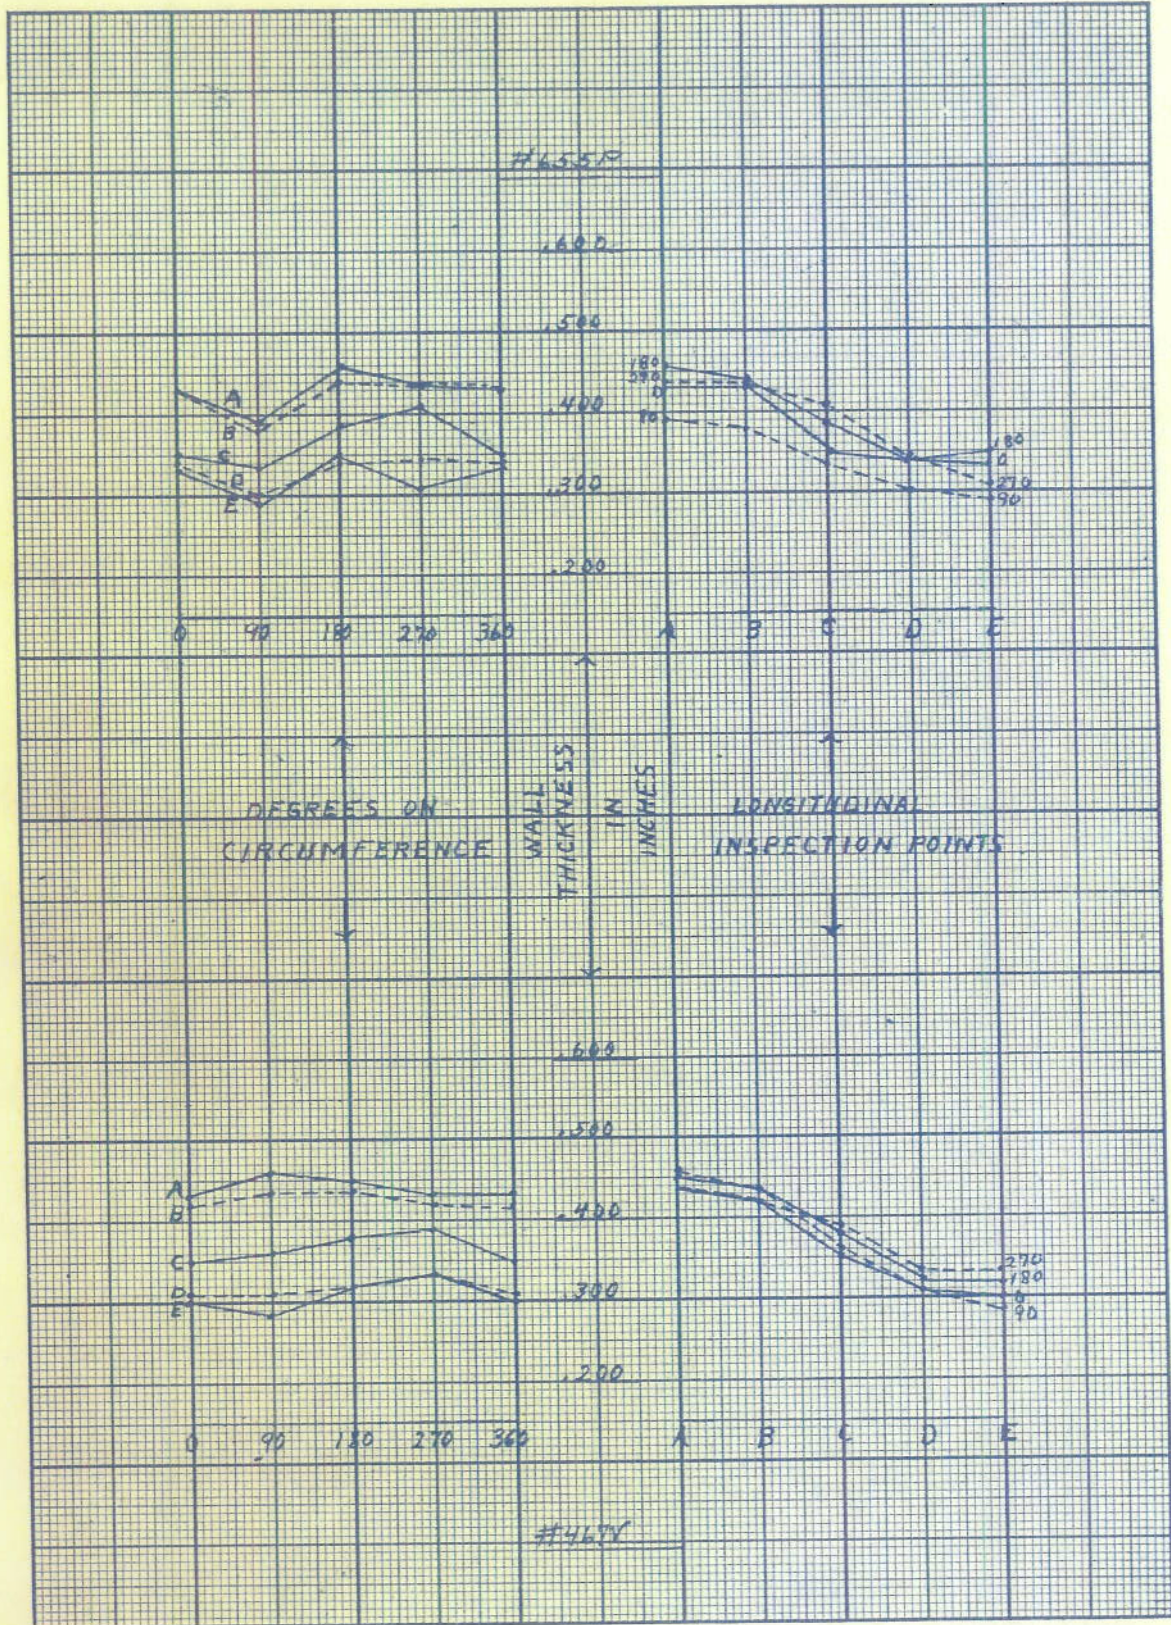
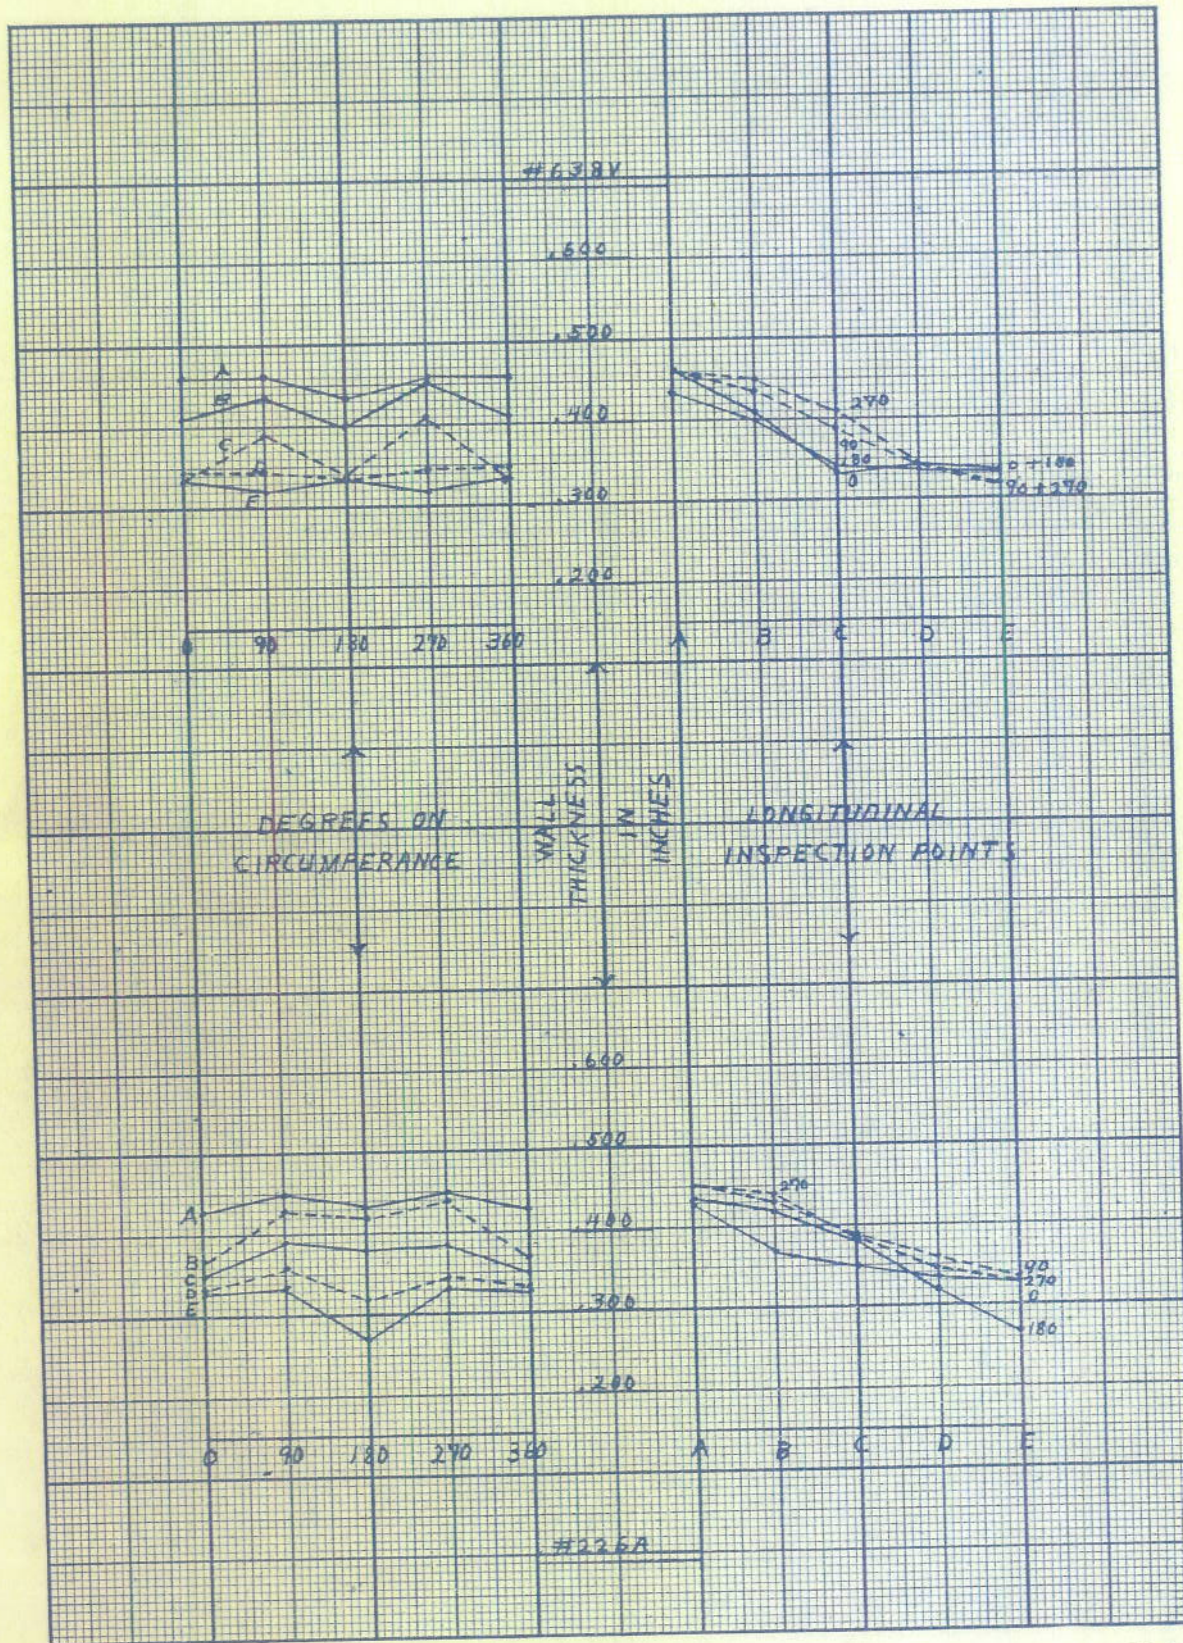
17. Improved inspection technique discloses certain areas appearing to be porous, confined largely to the low pressure end opposite or near the water outlet opening. These were noted in the Model-278 liners #476V, 186A, X-1, 226A, and 638V. Slight core shifting was suggested in eleven liners of this model, but was not significant in the remaining eight.

LIVER SERIAL NUMBER	GRAPH PLATE NUMBER	DEGREES ON CIRCUM- FERENCE	LONGITUDINAL INSPECTION POINTS THICKNESS IN INCHES				
			A	B	C	D	E
476 V	VA	0	.450	.430	.370	.360	.320
		90	.460	.420	.410	.320	.310
		180	.385	.385	.385	.360	.320
		270	.440	.440	.430	.350	.340
483 R	VA	0	.390	.330	.310	.320	.320
		90	.430	.420	.380	.320	.300
		180	.390	.360	.350	.320	.310
		270	.390	.360	.360	.320	.320
12	VB	0	.390	.360	.350	.310	.310
		90	.390	.385	.350	.320	.320
		180	.390	.370	.360	.330	.335
		270	.410	.410	.380	.330	.320
1139	VB	0	.410	.350	.340	.300	.310
		90	.430	.390	.375	.335	.335
		180	.430	.430	.410	.350	.330
		270	.420	.380	.350	.285	.300
1125	VC	0	.385	.360	.350	.335	.330
		90	.460	.420	.430	.320	.320
		180	.410	.400	.380	.320	.300
		270	.385	.370	.350	.320	.320
322 A	VC	0	.435	.385	.350	.335	.320
		90	.435	.430	.385	.335	.335
		180	.390	.410	.370	.350	.340
		270	.435	.390	.350	.310	.320
186 A	VD	0	.435	.360	.335	.350	.335

90	.430	.420	.360	.320	.310
		180	.440	.410	.380	.335	.310
		270	.460	.420	.420	.350	.335
X-1	VD	0	.450	.390	.320	.260	.320
		90	.440	.410	.360	.310	.330
		180	.385	.350	.320	.290	.290
		270	.450	.420	.420	.320	.320
465 A	VE	0	.460	.410	.385	.310	.350
		90	.435	.390	.320	.330	.330
		180	.430	.370	.380	.320	.320
		270	.490	.435	.440	.330	.330
317 V	VE	0	.450	.440	.350	.340	.330
		90	.460	.435	.385	.320	.320
		180	.435	.420	.380	.320	.300
		270	.430	.420	.420	.330	.310

LINER SERIAL NUMBER	GRAPH PLATE NUMBER	DEGREES ON CIRCUM-FERENCE	LONGITUDINAL INSPECTION POINTS THICKNESS IN INCHES				
			A	B	C	D	E
958N	V F	0	.385	.380	.350	.300	.270
		90	.385	.360	.360	.350	.320
		180	.420	.385	.345	.350	.350
		270	.370	.330	.310	.320	.310
632V	V F	0	.460	.435	.385	.335	.330
		90	.450	.435	.410	.360	.345
		180	.430	.400	.350	.340	.340
		270	.440	.425	.410	.340	.320
513V	V G	0	.385	.385	.350	.335	.310
		90	.450	.420	.380	.335	.310
		180	.435	.400	.340	.350	.330
		270	.460	.440	.390	.345	.325
510R	V G	0	.460	.435	.380	.320	.310
		90	.435	.420	.410	.350	.350
		180	.420	.385	.350	.335	.330
		270	.440	.425	.375	.350	.350
467V	V H	0	.435	.420	.350	.310	.300
		90	.460	.435	.360	.310	.285
		180	.450	.435	.380	.320	.320
		270	.435	.420	.390	.335	.335
655P	V H	0	.430	.430	.350	.340	.335
		90	.390	.380	.335	.300	.290
		180	.460	.440	.385	.340	.350
		270	.435	.435	.410	.345	.310
226A	V I	0	.430	.370	.350	.335	.330

90	.450	.430	.390	.360	.335
		180	.435	.420	.380	.320	.270
		270	.450	.440	.385	.345	.330
638V	V I	0	.460	.410	.335	.345	.335
		90	.460	.435	.390	.345	.320
		180	.435	.400	.340	.335	.335
		270	.460	.450	.410	.345	.320
478R	V J	0	.420	.400	.350	.300	.285
		90	.435	.435	.410	.350	.330
		180	.410	.370	.360	.330	.320
		270	.440	.440	.390	.340	.310
