STIC Note

Laser Corrosion Removal Machines

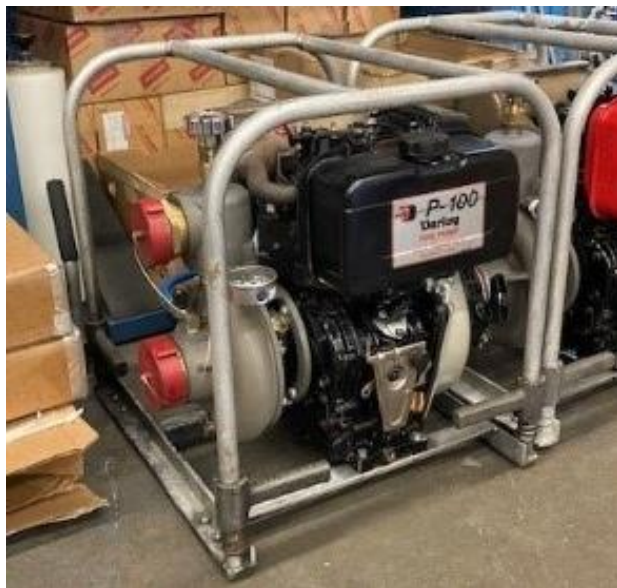
Figure 1. P100 pump. (Source: USCG)

The U.S. Coast Guard is required by statute to respond to missions that occur in or on the seas, navigable waterways, and their tributaries. The equipment needed for these missions has to be ready and functional. Equipment surfaces and internals are often required to be refurbished to remove corrosion and other materials because they are subjected to sea water. The present corrosion removal method is to blast with media (either walnut husks or sand).

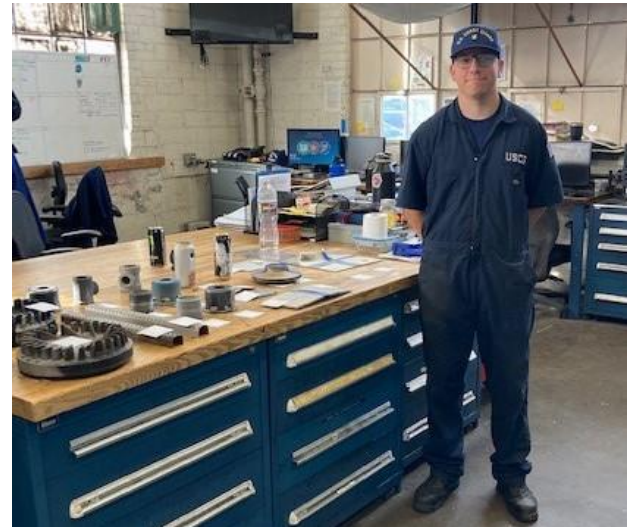
Figure 2. PO Eiden, Array of samples for ablation. (Source: USCG)

Several parts were ablated using both methods applied to several substrates and coatings.

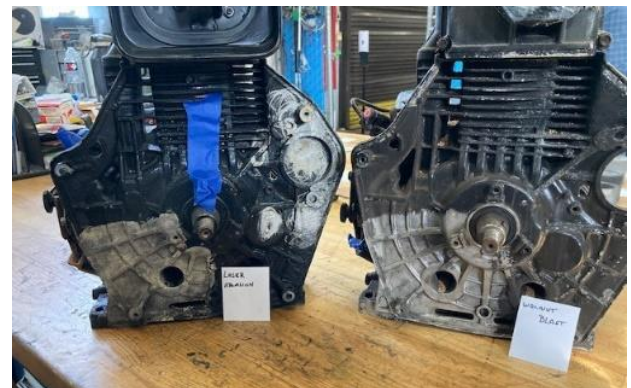
Figure 3. Engine blocks – Left: Laser ablation, Right: Walnut media blast. (Source: USCG)

The laser corrosion removal machine was able to effectively ablate by layers. In other words, depth was well-controlled and the laser was able to remove just corrosion. A second pass demonstrated that primer or paint is eliminated while barely removing substrate. Controlling the media blast was not precise. Media blast generally cleaned to the substrate and removed substrate material. Depth of the penetration of substrate material is not controllable with the media blast process. This condition may not be an issue depending on the application.

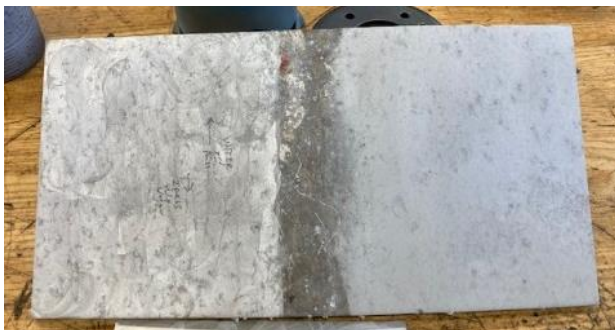
Figure 4. Aluminum plate, center surface corrosion – Left: Laser, Right: Sand blast. (Source: USCG)

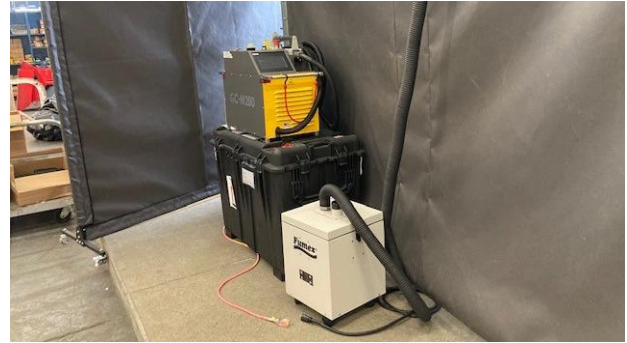
Figure 5. Laser machine (Source: USCG)

Market research found that there are many laser ablation machines allowing improved control of the depth during contaminant removal. One of these machines was procured for operational evaluation.

A technique to enhance the laser is to spray water vapor onto the part for hard-to-reach areas. There are other lenses that can be used to change the beam shape, which may be better for some materials.
