**Quarterly Progress Report No. 5
On the Measurement of the Physical and
Chemical Properties of the Sodium-Potassium Alloy**

C. T. Ewing, H. B. Atkinson, Jr. and R. R. Miller

December 9, 1947

CORROSION OF CERTAIN METALS
BY POTASSIUM-SODIUM

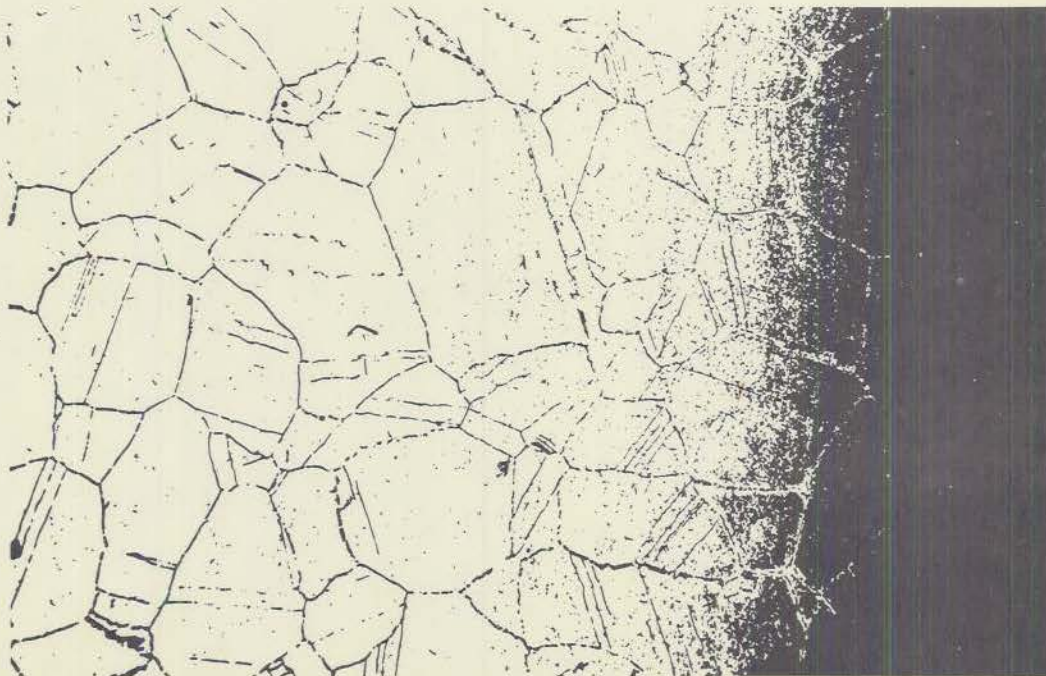
X 250

FIGURE 7 (8659) CARBURIZED CASE .004-.006" FOUND ADJACENT TO BLACK STREAK ON I.D. OF TUBE.

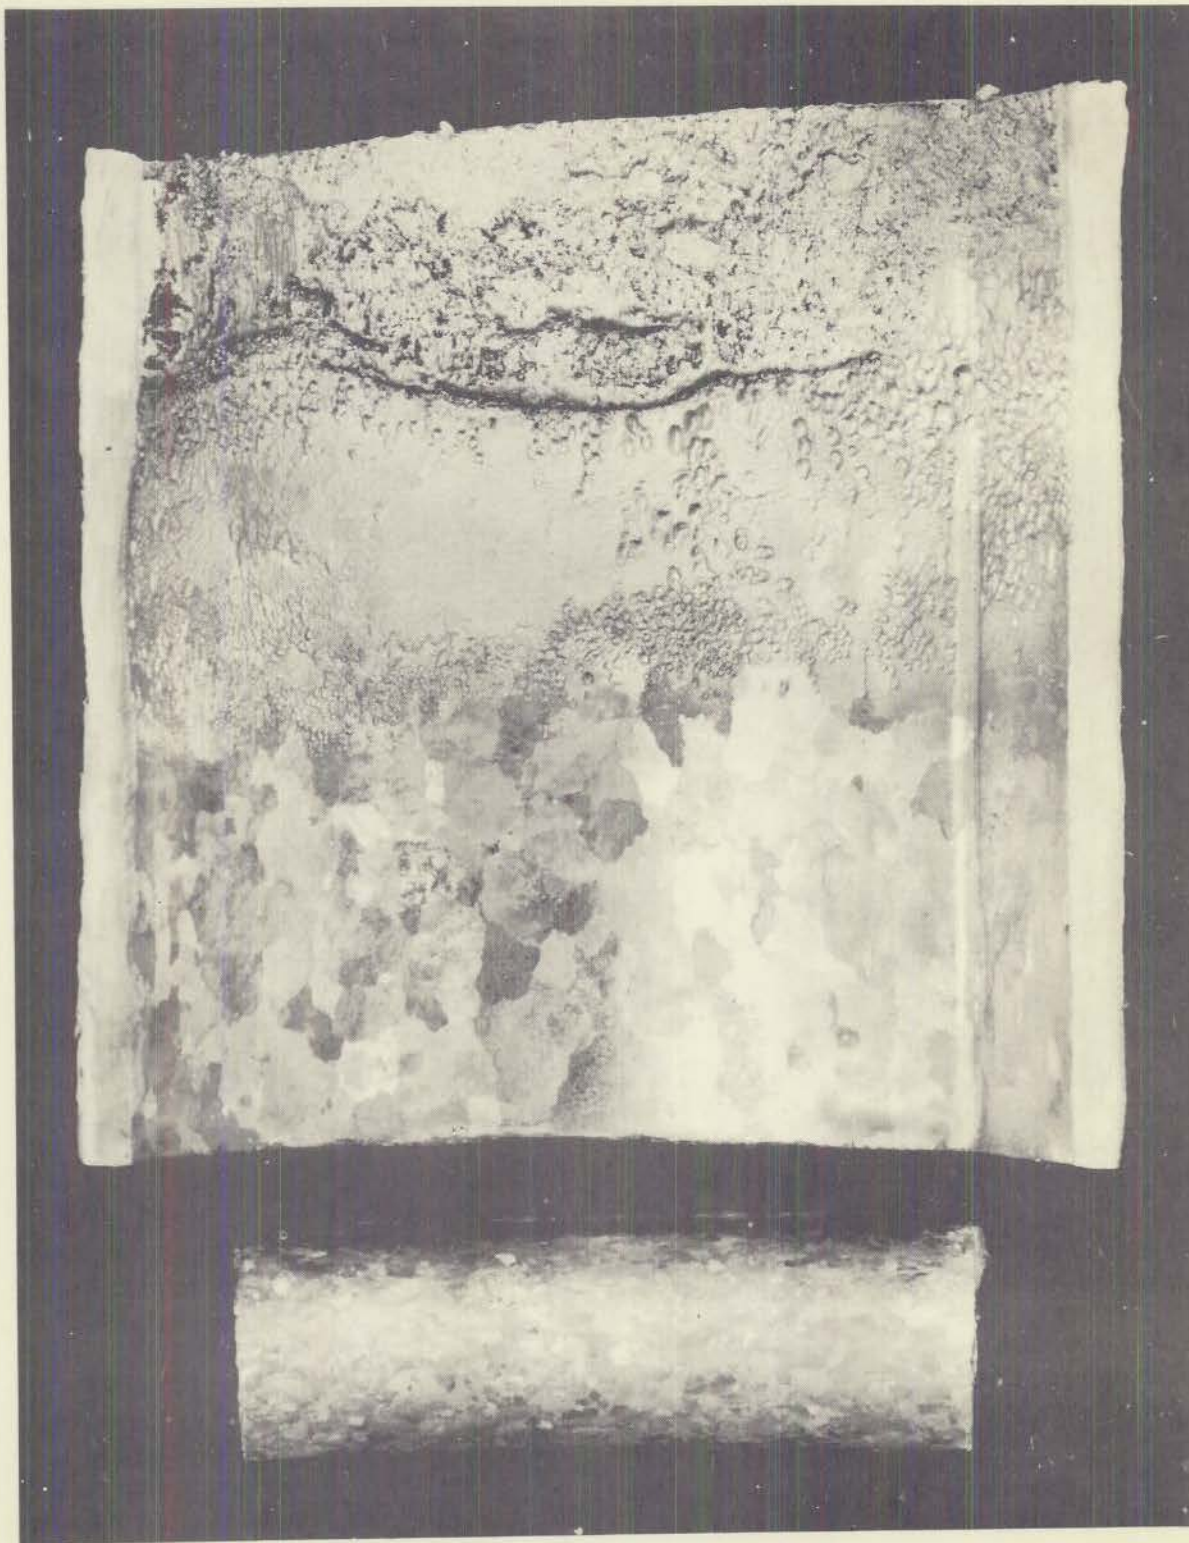
FIGURE 16. (P-2414)

EXAGGERATED GRAIN GROWTH ON BOTTOM
PORTION OF RETORT AND NITROGEN TUBES
IN WROUGHT IRON TEST.

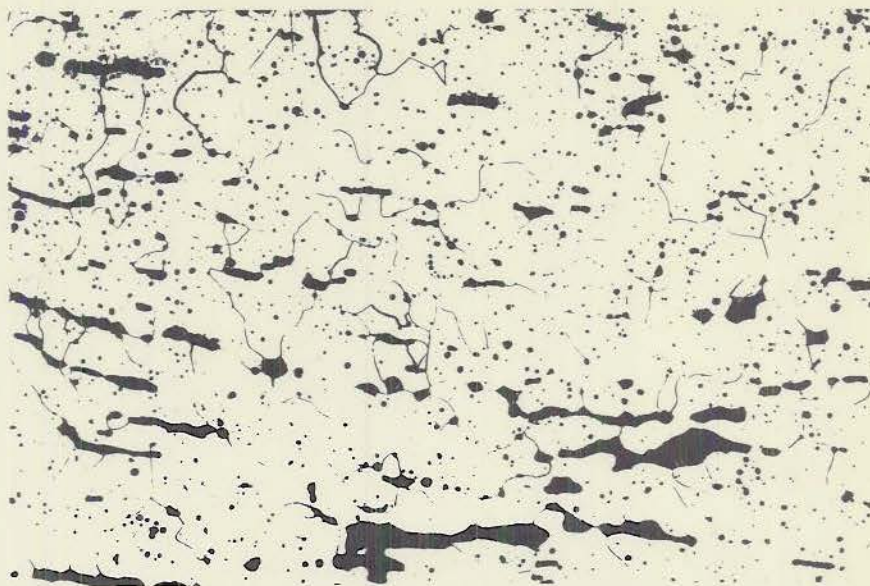
X 100

FIGURE 17 (8847) REPRESENTATIVE STRUCTURE OF WROUGHT IRON BLANK.

Examination of the microstructure of the samples showed no evidence of KNa or N₂ diffusion. Fig. 17 shows the structure of the blank, depicting the slag streamers and practically pure alpha ferrite grains. ASTM grain size of the blank was 3-4, while the grain size of the 500 hour liquid sample was 2-3 indicating some grain growth. Further growth could have been halted by the restraining action of the slag fibers.

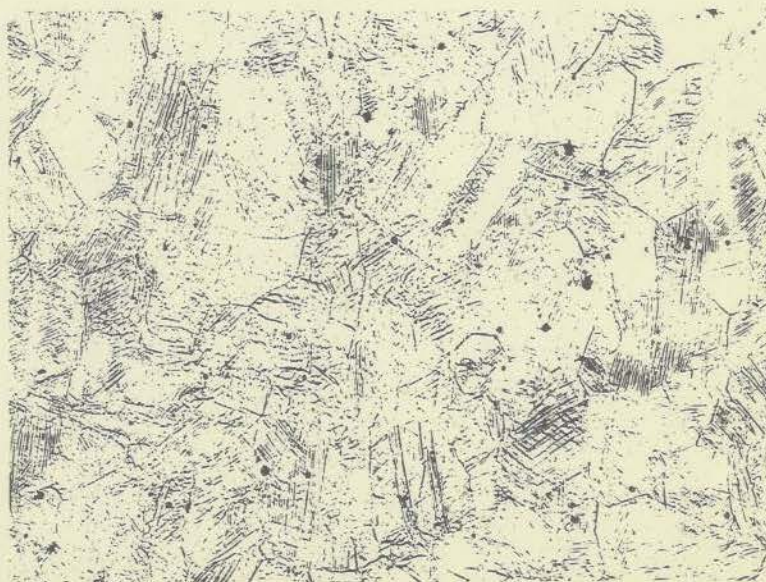
X 100 ETCHANT: OXALIC ACID
FIGURE 24 (9073) TYPE 310 BLANK SHOWING
STRAINED CONDITION.

The intermetallic compound FeCr, commonly designated as sigma phase, was developed in all of the specimens. Fig. 24 shows the original conditions. Fig. 25 shows the presence of the sigma phase. At the temperatures at which the test was conducted, sigma is rapidly produced. Its presence seemed to promote a certain amount of embrittlement as indicated by the ductility tests on the 500 hour samples. The increase in hardness of the 500 hour samples over the 100 hour samples is believed due to the increasing amounts of the hard and brittle constituent - sigma phase.

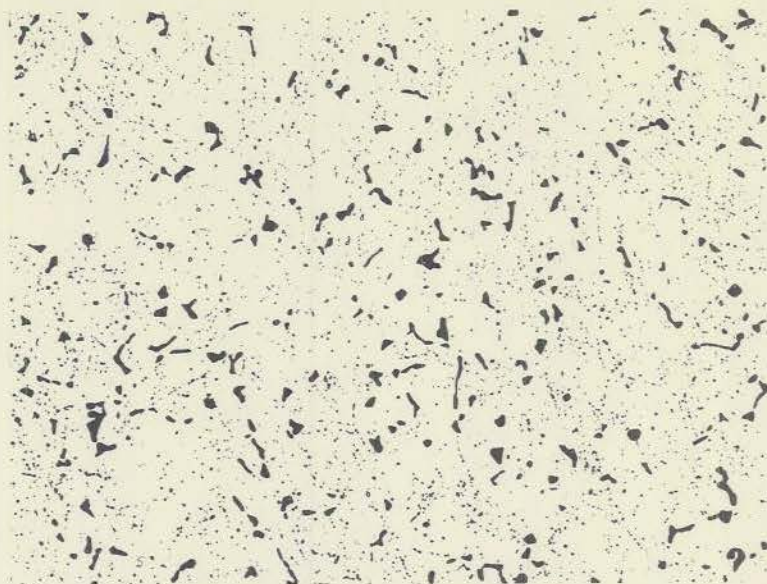
X 250

FIGURE 25 (9085) SIGMA PHASE AND CARBIDES IN
TYPE 310.

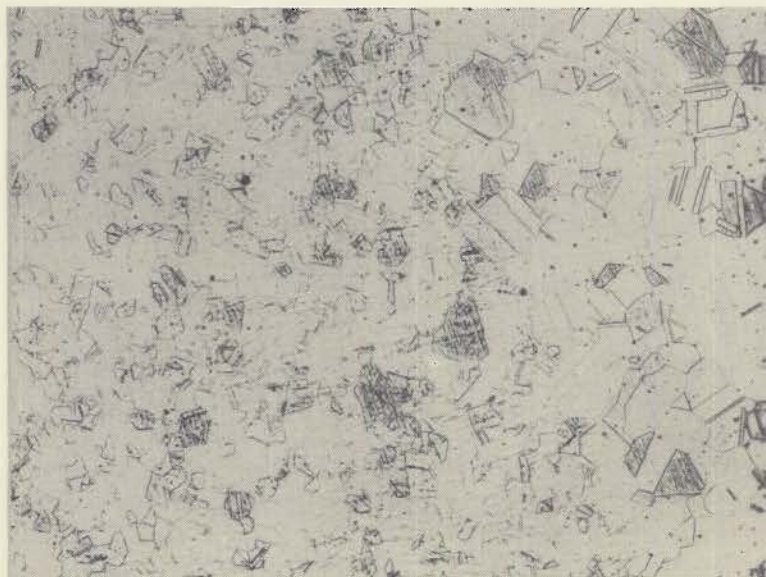
FIGURE 26 (0066) TYPE 304 BLANK.

The micro-structure of the blank is shown in Fig. 26. Fig. 27 shows the structure of the vapor sample and the diffusion attack on the steel. The same condition is shown in Fig. 28 except that the sample was etched to show that the attack was intergranular. These diffusion products were identified by X-ray diffraction methods as Na₂O. This diffusion penetrated to a depth of 0.015 - 0.025".

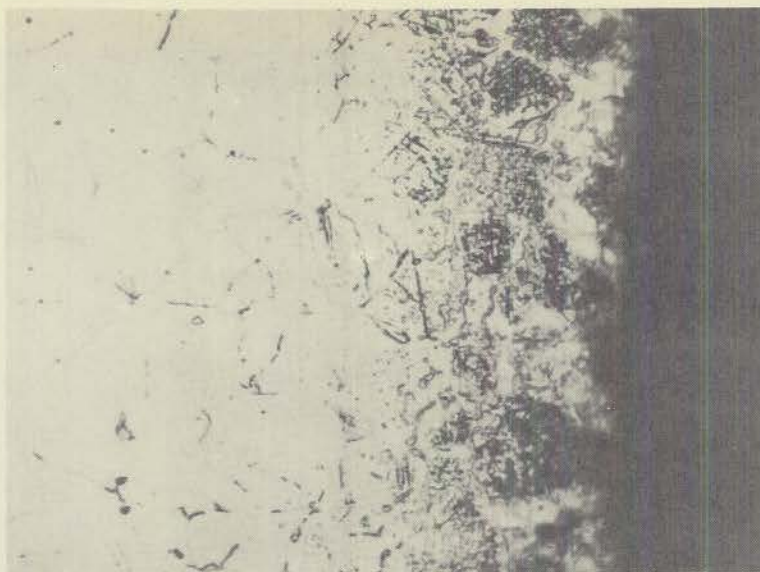
X 500

FIGURE 29 (0065) TYPE 304 - STRUCTURE OF K VAPOR SAMPLE SHOWING DIFFUSION ATTACK.

Micro-examination indicated that both liquid and vapor samples suffered diffusion attack similar in appearance to that noted in the previous test. This diffusive action is clearly shown in Fig. 29. In this case the diffusion products could not be identified by X-ray diffraction. The depth of the attack was somewhat less than in the case of the sodium, penetration occurring to a depth of only 0.002 - 0.005".
