NRL REPORT F-3404

FULL SCALE SHOCK TESTS - USS NIAGARA APA87

PART 1 - TECHNIQUES AND INSTRUMENTATION

January 17, 1949

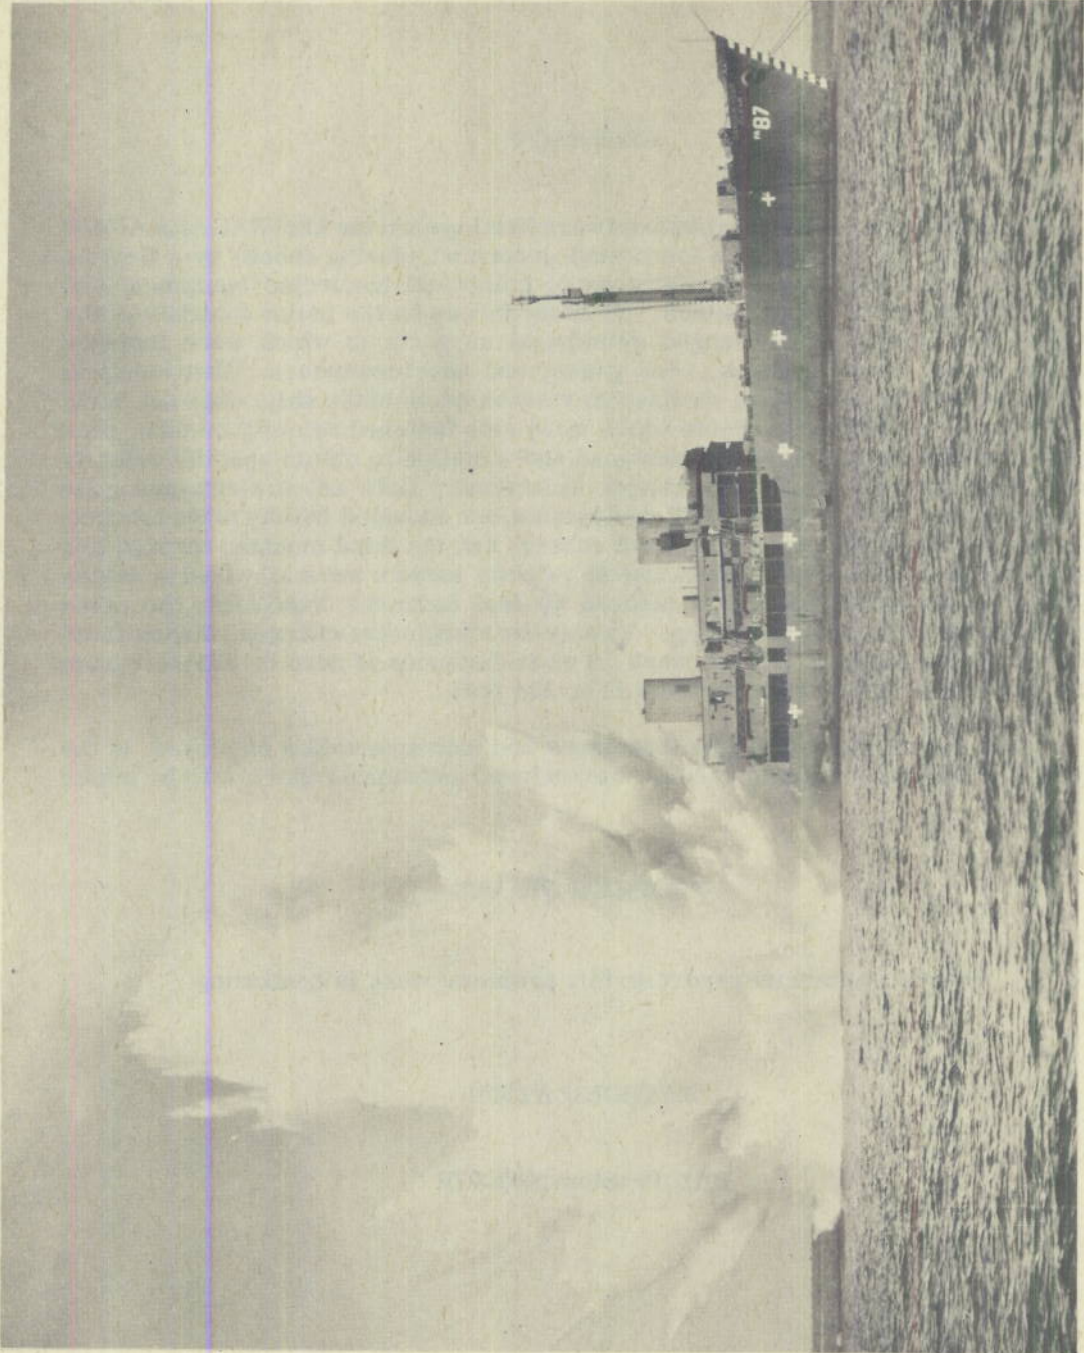
Frontspiece - Shot 12 - 1200 pounds of HBX-1,
70 feet down and 185 feet from the starboard beam
