## Research & Development Center

# CSSC Marine Safety Risk Assessment – Interim Summary

February 2013

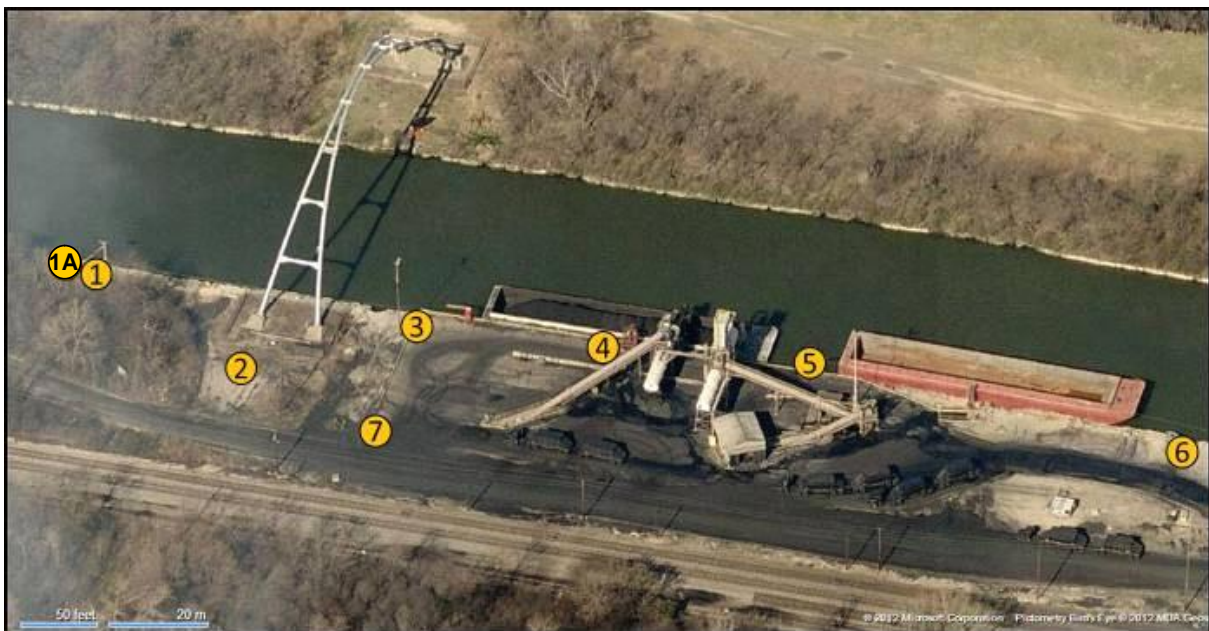
Figure 1. Oxbow Facility with shore measurement test points.

Voltage measurements & data analysis showed during present, routine barge-loading activities (e.g., boarding, mooring/unmooring, shuttle movement, & loading) workers are not normally exposed to hazardous electrical currents. To convert the actual voltage measurements to electrical current, we used a nominal human-body resistance of 500 ohms, a widely accepted value that assumes electrical contact with bare, damp skin. In reality, resistance through a human body varies: lower if electrical contact includes puncturing the skin, higher if the skin is dry. Standard industrial hygiene and personal protective gear (e.g., rubber-soled boots, dry gloves, etc.) provides an even higher degree of electrical safety protection. During 3-1/2 days of set-up, testing, and demobilization, none of the 4-person test team perceived any electrical current, besides the voltage traces indicated on the test equipment video monitor.

At all test points, a distinct 5 Hz signal correlated to the maximum measured voltage. At multiple test points, particularly near the pipeline arch, a 60 Hz signal provided significant electrical “noise.” At the southernmost test points, measurements indicated relatively higher voltages than elsewhere.

Barge movements, particularly multiple-tow transits through Barrier I, appear to impact electrical currents. The highest voltages measured during the experiment were near the southern mooring-shuttle-block during a northbound tow. (Note: the effect of tow-transit on electrical field was not designed as part of this experiment.) The testing did indicate anomalous water-to-ground voltage measurements at the southernmost extent of the Oxbow area (beyond present use-area) during an upbound, 3 x 2 tow transit while the tow was near the vicinity of Barrier I.

3. Measurements at Oxbow did not indicate hazardous electrical currents under present operating procedures. At the extreme southern end of the facility (south of the pipeline arch), the team measured higher voltages (and currents), and noted anomalous, higher measurements when a tow was proceeding northbound through and adjacent to Barrier I.

3. Oxbow loading facility: We do not have enough information to make a recommendation whether Oxbow operating procedures should allow them to shuttle barges to the southern turning block (between Point 1 and point 1A in Figure 1).

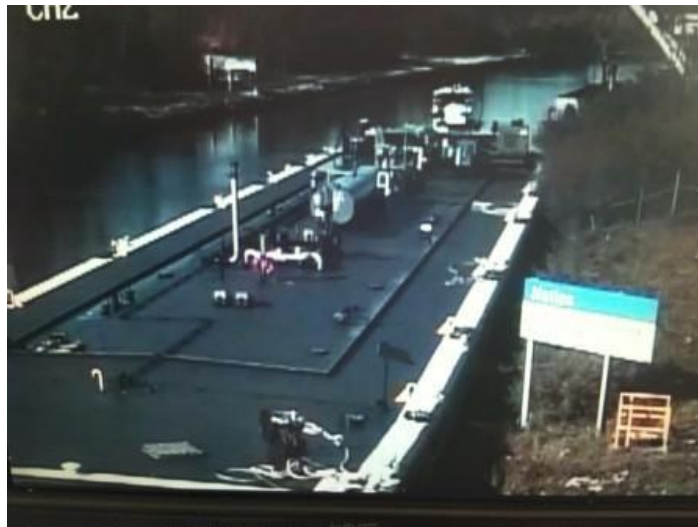
Figure 2 is shows a situation that caused the project team to consider whether non-compliance with 33 CFR 165.923 is intentional or due to misunderstanding the rule.

Figure 2. Tow alongside CSSC East bank.

Figure 2 is a frame-capture, seven minutes into a one-hour video segment of vessel activity in the CSSC. The tow, a downbound single, jumbo-sized tank barge (not fully-laden), lays-up against the east bank, between the Enbridge pipeline arch (upper-right in figure) and the sign marking the north-end of the barrier zone (just north of Barrier I). Fifteen minutes later, a second downbound tow of two hopper barges abreast, passes the tank barge. Thirty-five minutes later, an upbound towboat noses into the bow rake of the tank barge, and two crew climb the boat's push-knees, go to the port and starboard extremes of the barge rake, and make up the towboat as a bow-boat, climb back aboard the boat, and then the newly made-up tow proceeds downstream, through the barriers.

As this particular example indicates multiple instances of rule non-compliance, the project team presumed that the tow needed a bow boat, and waited a full hour for one, though not complying with multiple other sections of the rule. Because of this, the project undertook a review of the rule, itself.
