Water Transport during Normal Operations of Towboats and Barges in the Illinois River

January 2011 (Updated October 2012)

Technical Report Documentation Page

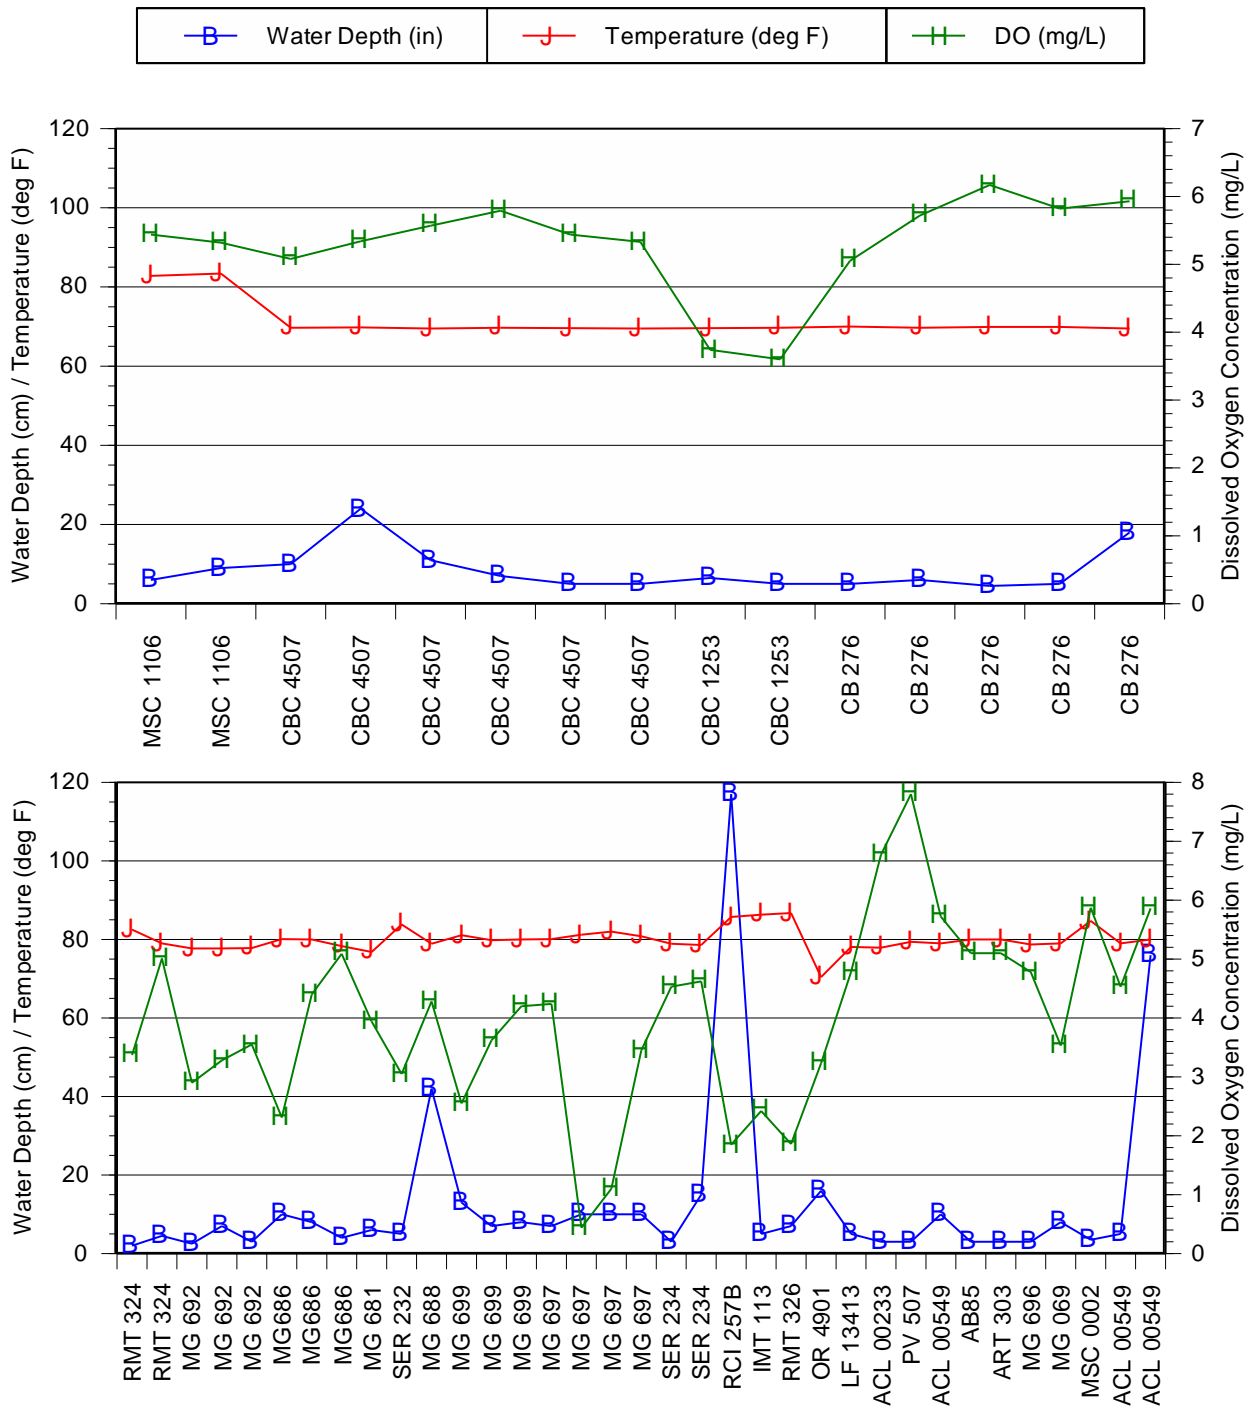
Figure 2. Water depth (inches), water temperature (°F), and DO concentration (mg/L) for deck barge (top) and hopper barge (bottom) ballast tanks sampled in August 2010.

Between August 16 and 25, 2010 a total of 969 individual ballast tanks were inspected on 132 barges and 14 towboats. Data obtained during the survey is provided as a table in Appendix A. The photographs in APPENDIX B show several barge types, hatch arrangements, and clearances under bridges. Barges sampled included 19 deck barges, 99 hopper barges, and 14 tank barges. Of the 969 ballast tanks inspected, 50 ballast tanks (5.2 percent), all of which were on barges, had measurable levels of water. Water depths in these ballast tanks ranged from a low of 2 inches to a high of 117 inches (Figure 2). Water depth in deck barges ranged between 4.5 – 24 inches, while hopper barges ranged between 2 – 117 inches (Figure 2). No measurable water was found on tank barges.

For all barges with measurable water in their ballast tanks, overall average water depth was just over 11.0 inches. When three hopper barge tanks with depths of 42, 76, and 117 inches are excluded, water depth averaged 7.2 inches. No information was available to determine why these three tanks contained more water than the remaining 47 tanks with measurable water.

DO concentrations in the water of the 50 ballast tanks ranged between 0.44 - 7.80 mg/L and were highly variable. For deck barges, DO ranged between 3.60 - 6.17 mg/L, with an average of 5.29 mg/L (Figure 2). For hopper barges DO concentrations ranged between 0.44 - 7.80 mg/L. Average DO in hopper barges was 3.98 mg/L. No apparent trends in DO concentration were observed between barges with more water compared to those with less water in their ballast tanks. Tank barges did not contain sufficient water to measure DO. This is not unexpected since tank barges are inspected by Coast Guard after collisions, elisions, etc and, if leaks are found, are removed from service until repairs are made.

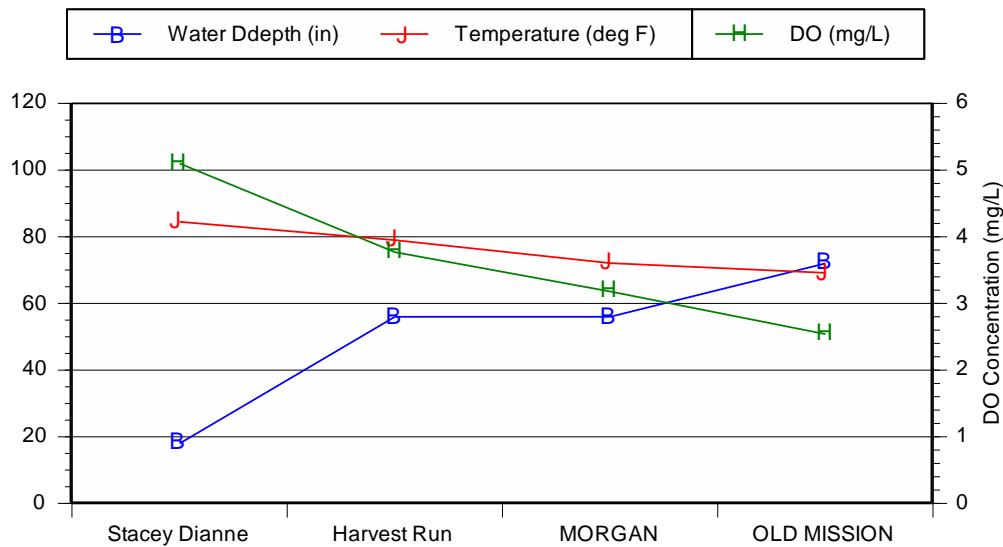
Figure 3. Water depth (inches), water temperature (°F), and DO concentration (mg/L) for towboat ballast tanks sampled in August 2010.

Of the 14 towboats inspected in August 2010, only four had measurable amounts of water in their ballast tanks. Water depths for towboats ranged from a low of 18 inches to a high of 72 inches (Figure 3). Average water depth for towboats was 50.5 inches. No information regarding the ballasting of the towboats was available. Towboat operators indicated that ballasting is not routinely conducted.

Water temperature in towboat ballast tanks ranged between 69.2 - 84.5 °F (Figure 3) with higher temperatures found in those tanks with less water. Similarly, the ballast tank with the most water (72 inches) had the lowest temperature. Average water temperature in towboat ballast tanks was 76.2 °F.

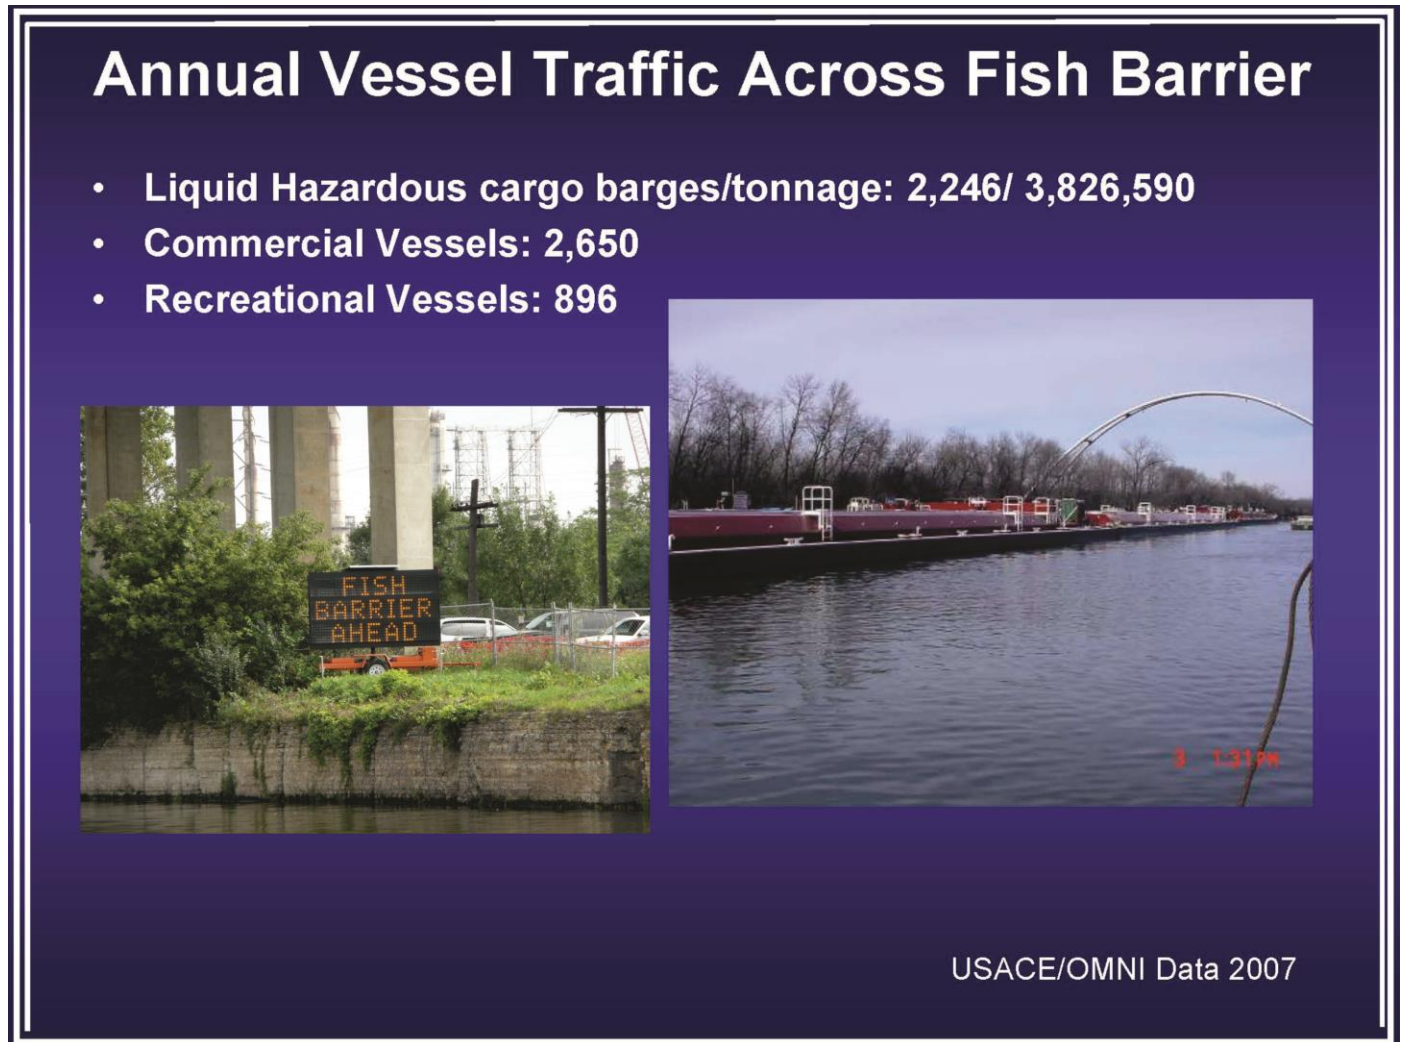
Figure 4. Annual vessel traffic across the electric fish barrier in 2007 (Source USACE/OMNI).

Annual vessel traffic across the electric fish barrier was obtained from USACE for 2007 and is presented in Figure 4. A total of 5,792 vessels crossed the electric fish barrier in Romeoville in 2007, including 2,246 liquid hazardous cargo barges, 2,650 commercial vessels, and 896 recreational vessels. A variety of barge types cross the electric barrier each year, including hopper, tank, and deck barges similar to those inspected in this study.

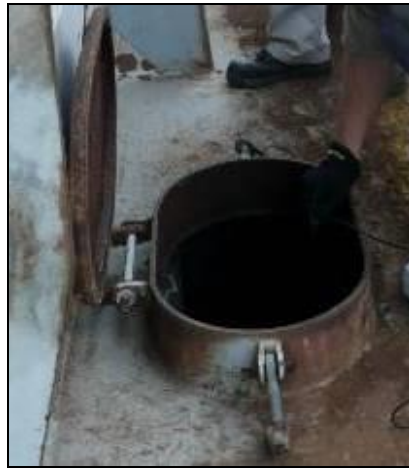
Figure 5. Ballast tank hinged manhole hatch.

Of the 39 barges inspected, the majority were in generally good condition. Most were empty and all were rafted along various portions of the CSSC. Barge ballast tanks were typically accessible through a hinged manhole type hatch (Figure 5) with a rubber seal and edge hatch dogs to latch securely. All hatches were closed but none were found latched. A few barges used a round removable tank manhole cover (Figure 6). A small number of these covers were found loosely sitting over the access hole and not mated tightly closed.

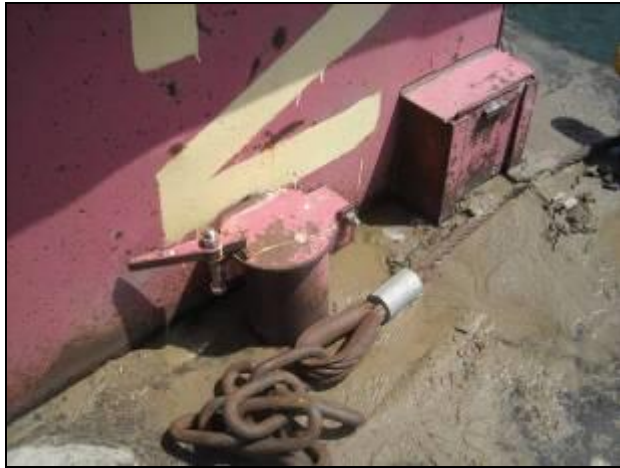
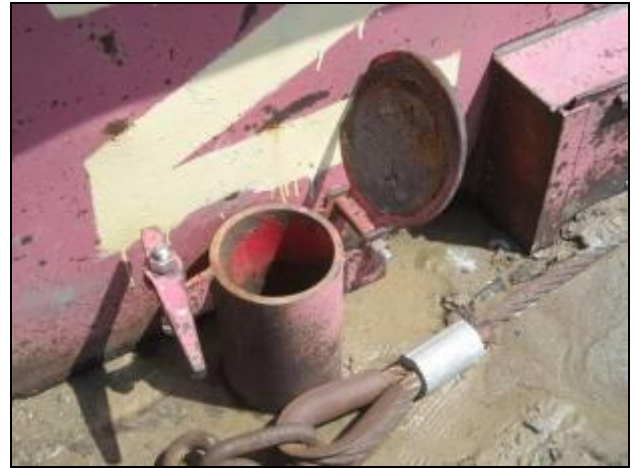
Figure 7. Ballast tank access tubes.

Some barges also incorporated 7-inch tank access tubes (Figure 7). This type of access tube was not reported in the 2010 survey and appeared to be on older barges. These tubes are covered with a hinged cap and are used to conveniently insert pump hoses when needed. The barge crewmen stated these tubes were used as a primary access to the tank when sounding or when pumping into/out of the tanks. Because the crewmen prefer to regularly use these smaller tank accesses, many of the associated larger tank hatch covers were rusted shut from lack of use. The inspection team was able to evaluate the tank water level and perform measurements using these tube accesses.

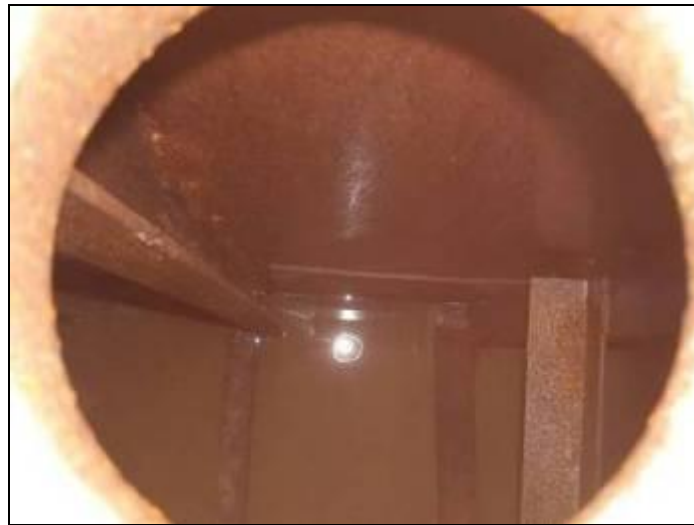
Figure 8. Typical tank inspection view.

Barge ballast tanks were approximately 10 feet deep. Typically only a small amount of water was found in the tank and the bottom 4-inch cross-members were usually visible (Figure 8).

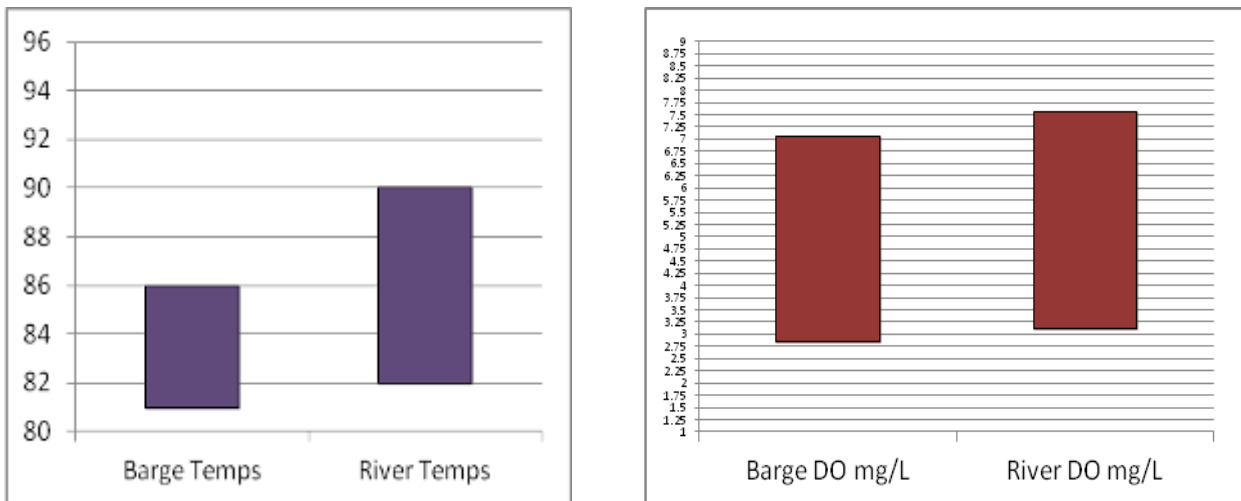
Figure 9. Water Temperature and Dissolved Oxygen Comparisons.

Water temperature in barge and towboat tanks ranged between 81.1 - 86 °F. DO in tanks ranged between 2.85 - 7.07 milligram per liter (mg/L) (Figure 9). Tank water in the STACY DIANE was 90 °F and had a DO reading of 3.11 mg/L when measured during mid-morning. The WINDY CITY bow had a temperature of 84.5 °F and DO was 6.65 mg/L when the water was measured in the afternoon. River baseline measurements of temperature and DO were 82.1 to 90 °F and 3.11 to 7.55 mg/L, respectively.

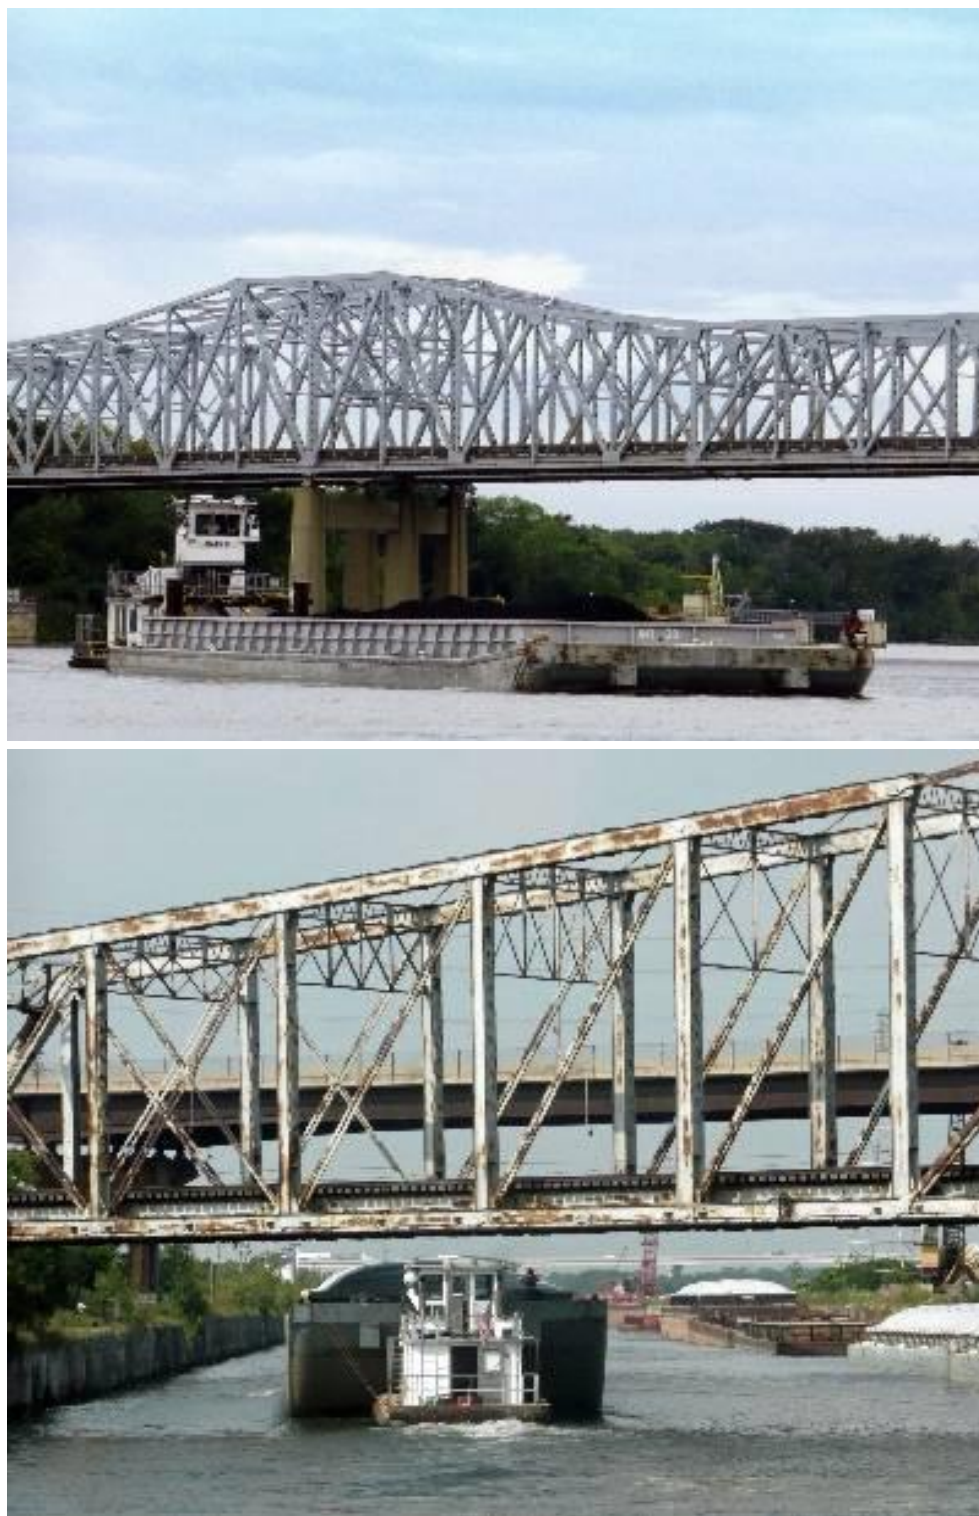
Figure B-1. Loaded (upper) and unloaded (lower) barges. Note minimal clearance under bridge.

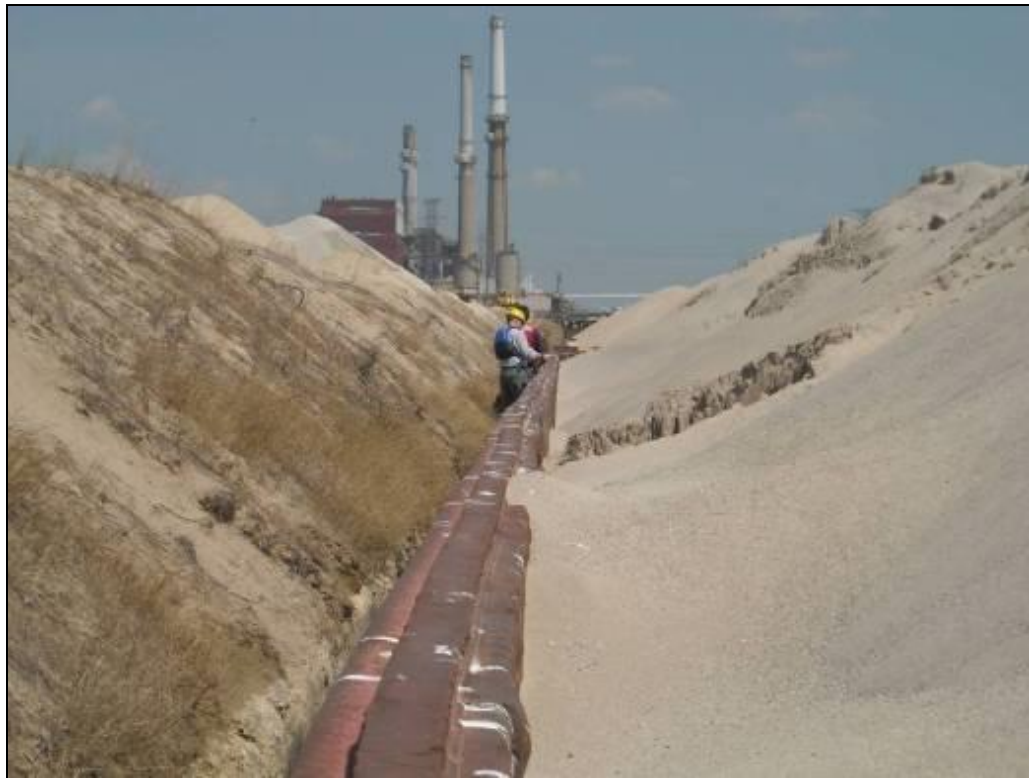
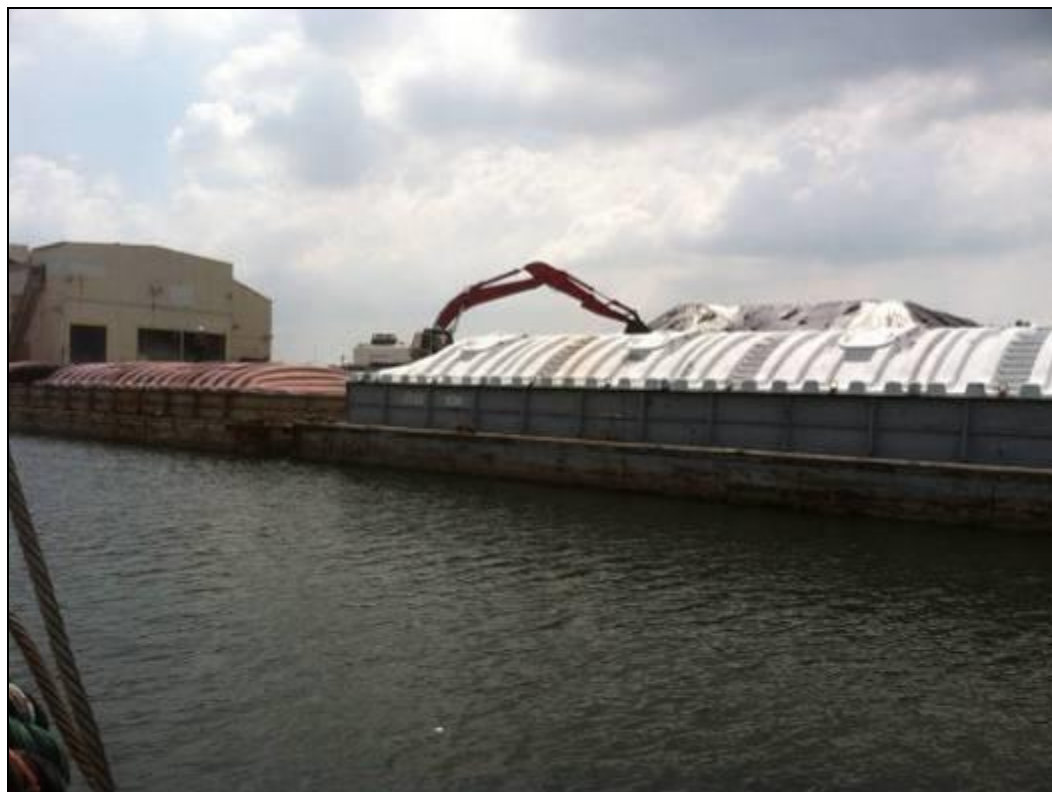
Figure D-2. Loaded barges rafted at construction materials site (upper). Covers being installed to protect cargo on hopper barge, note added height (lower).

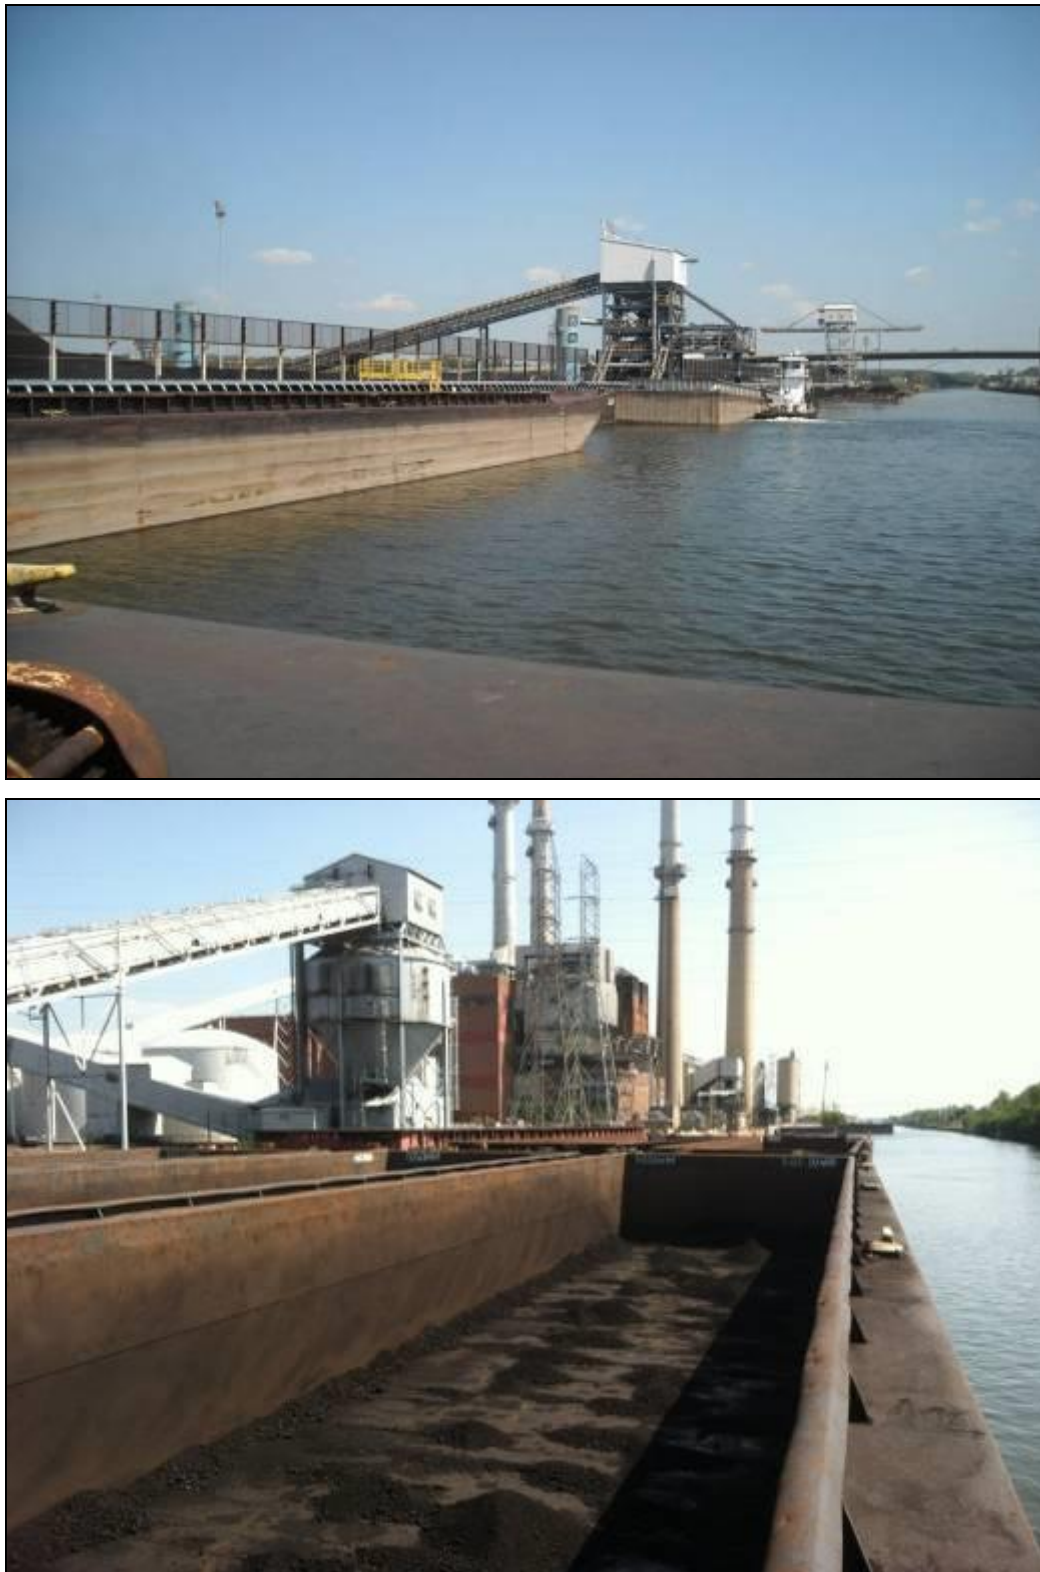
Figure D-3. Barge being loaded with loose material near dispersal barrier (upper). Empty hopper barge at Midwest Generation on CSSC (lower).
