## **Evaluation of a Visible Light Responsive Photocatalytic Coating to Resist Microbial Contamination and Increase Indoor Air Quality**

Final Report

Under Project 474139, "Evaluation of a Photocatalytic Sol-Gel Coating to Resist  
Fungal Colonization and Increase Indoor Air Quality," MIPR 11605877

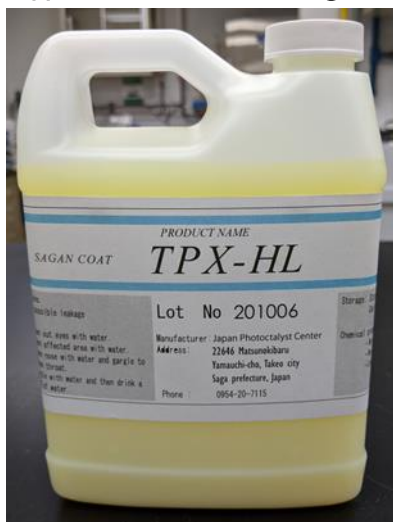
Figure 2. Green Millennium supplied TPX-HL, an indoor-light-reactive photocatalytic coating.

ultraviolet light (approximately 365 nm) for activity, but TPX-HL is truly unique in that the distributor claims it to be reactive under visible light from 510 nm and lower.\* Therefore, the coating should be reactive under most indoor lighting sources (fluorescent, incandescent, or LED), and coated surfaces should act as purifiers capable of destroying microorganisms as well as VOCs. Furthermore, unlike other TiO<sub>2</sub>-based catalytic coatings, TPX-HL can achieve highly photocatalytic activity and hardness after drying at room temperature. Other photocatalytic formulations require high heat (greater than 600°C) to achieve similar film hardness and photocatalytic activity. Therefore, TPX-HL can be applied in situ on almost any surface and environment.

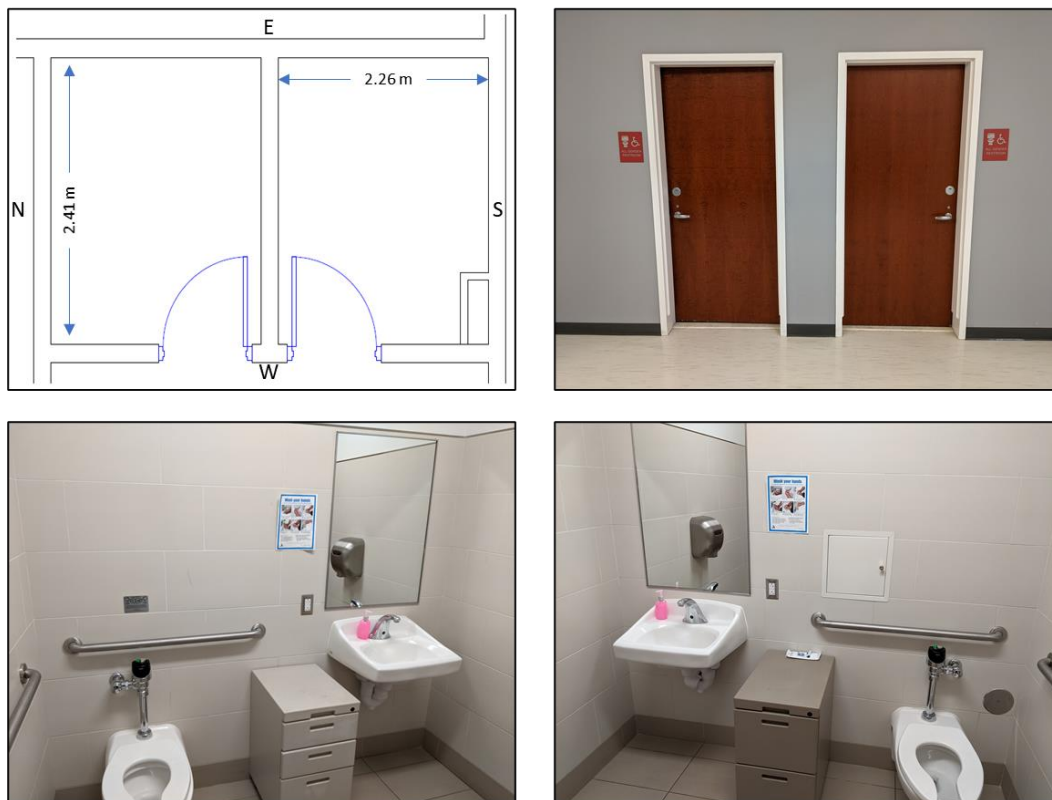
Figure 3. Indoor-light-responsive photocatalytic coating demonstration area located at the Engineer Research and Development Center, Construction Engineering Research Laboratory (ERDC-CERL), east of the Shaffer Auditorium. Dimensions and orientation of each all-gender restroom (top left), image of entrance (top right), the east wall of the north (bottom left), and the south (bottom right) restrooms.

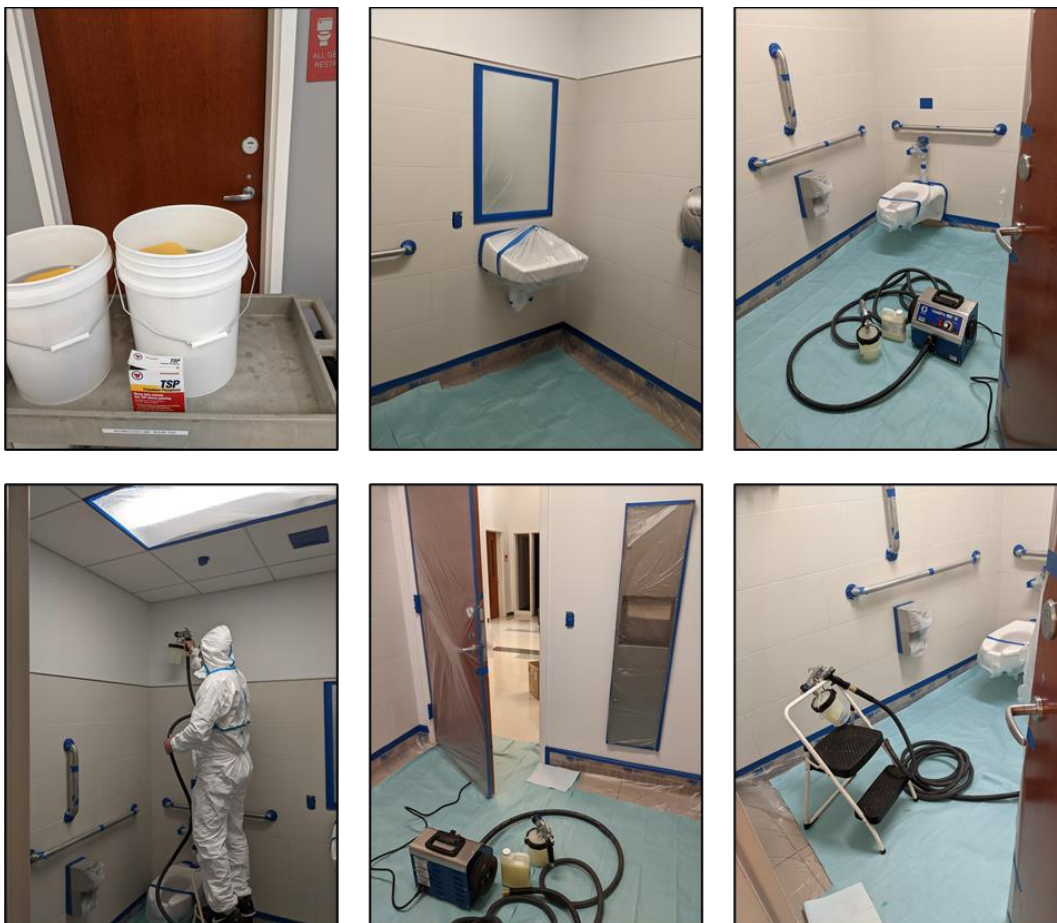
Figure 4. Demonstration area surface preparation and treatment with TPX-HL. Surfaces in each restroom were cleaned with trisodium phosphate solution (TSP) (*top left*). Masking off of all surfaces not to be treated is shown in the *top middle* and *top right* images. Application of photocatalytic coating to walls and ceiling with a high-pressure, low-volume (HPLV) sprayer (*bottom left*) and area after application (*bottom middle and right*).

applied in alternating directions. The painted gypsum, wall tiles, and ceiling tiles were coated with TPX-HL. The mirror, toilet, sink, door, and stainless-steel fixtures were not coated. Additionally, the floors were not coated because that would have required stripping of the surfaces and the durability of TXP-HL on a heavily trafficked surface was unknown. All treated materials were allowed to dry for 17 hr before use.

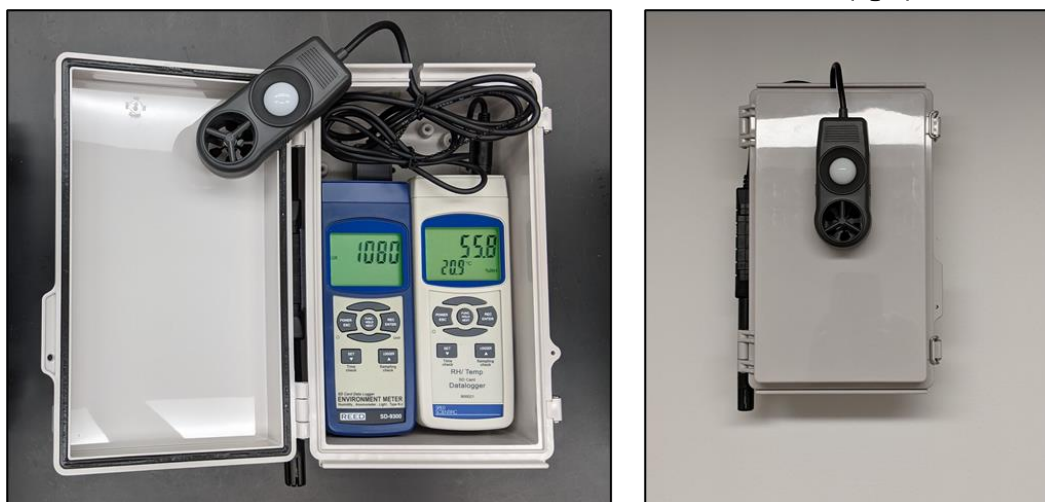
Figure 5. Humidity, temperature, and light data loggers in weatherproof case (left) and loggers mounted on the west wall above the entrance of the restroom (right).

Temperature, humidity, and light were monitored with data tracking sensors every 60 seconds for 5–8-day intervals (depending on the data logger's battery life), five separate times throughout the duration of the demonstration in each bathroom to ensure environmental conditions were consistent between each of the areas being monitored. Room illumination was measured with a Reed SD-9300 data logger equipped with a lux probe (Wilmington, North Carolina), and relative humidity and temperature were measured using a Sper Scientific 800021 data logger with a combination temperature and humidity probe (Scottsdale, Arizona). The data loggers were placed in weatherproof boxes, and the combination temperature and humidity probes were mounted on the side of the box with the probe tips approximately 2.5 cm. below the base of the boxes to allow air to flow freely around the probes (Figure 5). The lux meters were attached to the front of the boxes vertically to measure the illumination

on the wall surfaces. Both meters were mounted in the same location above the entry door in each restroom in relation to the source of light, which was approximately 2.3 m above the floor in the center of the west walls in each restroom.

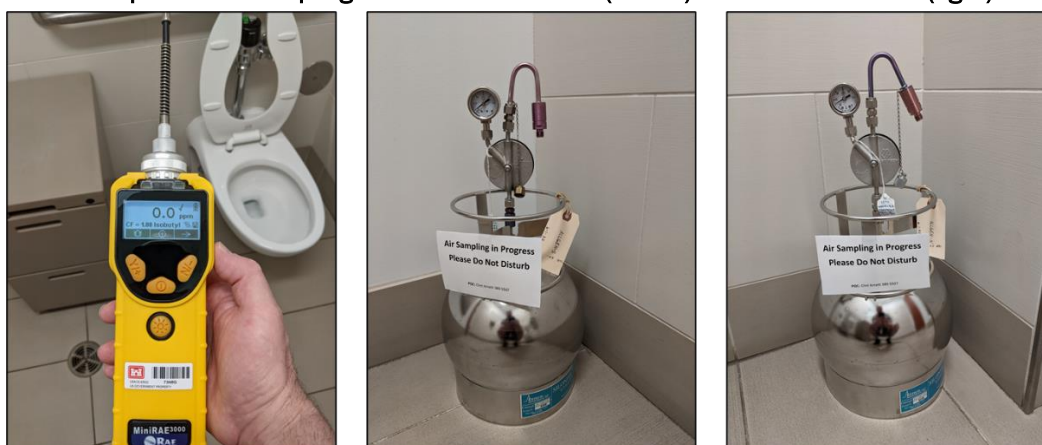
Figure 10. Air sampling for volatile organic compounds (VOCs) using a handheld meter in real time (*left*) and vacuum-pressurized summa canisters. Air samples of 6 L were collected over a 24 hr period. Air sampling in the north restroom (*center*) and south restroom (*right*).

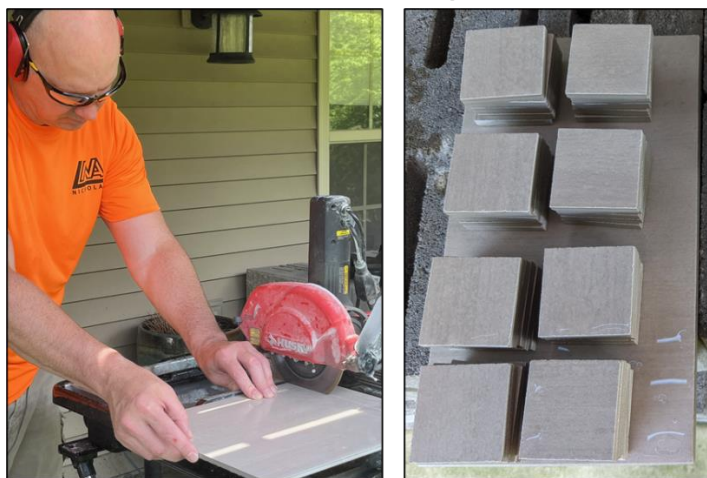
Figure 11. Fabrication of ceramic test coupons used to evaluate the antimicrobial activity of TPX-HL. Remnant restroom tiles being cut with a wet saw (left) and finished  $5 \times 5$  cm coupons (right).

Both tiles were cleaned with TSP solution and allowed to dry for 48 hr before coating one tile with TPX-HL under the conditions described above. Both tiles were cut into  $5 \times 5$  cm squares using a wet saw equipped with a diamond cutting blade (Figure 11). Tiles were allowed to air dry for 2 weeks before use. All microbial and viral species used in the coating testing were purchased from the American Type Culture Collection (ATCC) (Manassas, Virginia).

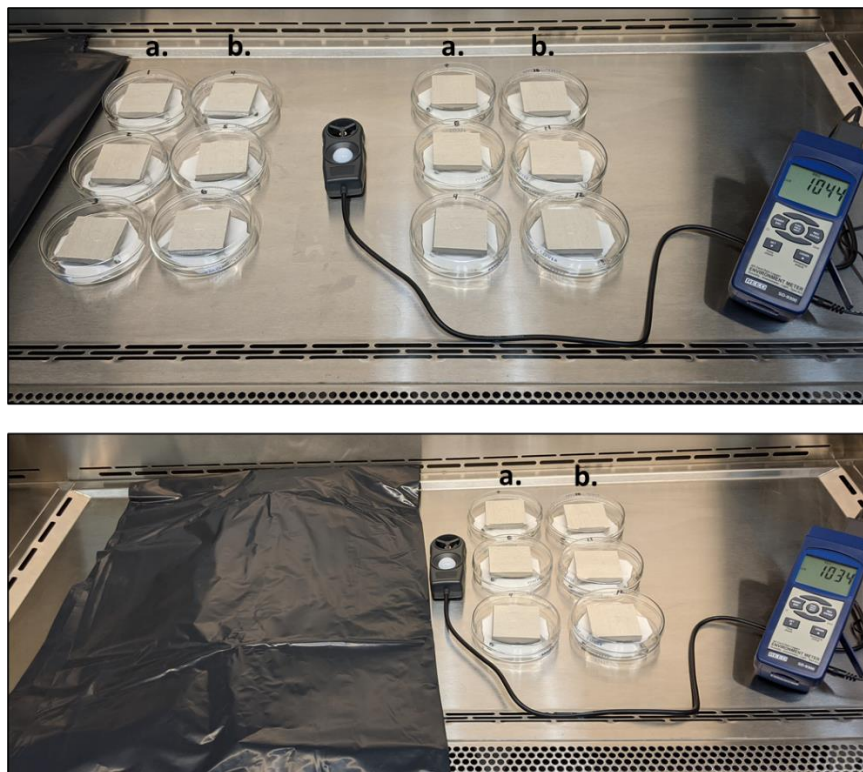
Figure 17. Uncoated and photocatalyst-coated ceramic coupons being irradiated with approximately 1,000 lux florescent light for 17 hr: (a) uncoated, (b) TPX-HL coated, and test specimens incubated in the dark under a black plastic bag (bottom).
