**Project Final Report and Retrospective of Work 2013-2021**

***Compressor Airfoil Protective Coating for  
Turbine Engine Fuel Efficiency***

***Demonstrated on the T56, AGT 1500, and T700 Engine Platforms***

**Project Number WP-201009**

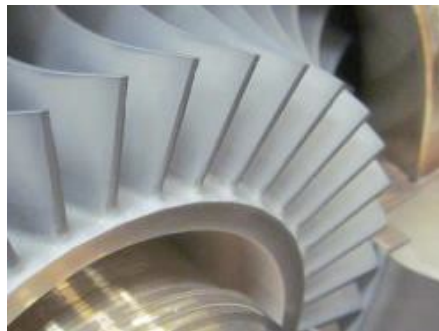
Figure 4: Coated Impeller near interim inspection point

The application of the BlackGold<sup>®</sup> coating provided chord loss improvement for LP rotor blade stages 2-5 and for HP stages 1-4. The uncoated LP rotor stages 4&5 and HP rotor stages 2-4 exceeded  $C_{ML}$  and would have been scrapped at the interim inspection point; whereas, the BlackGold<sup>®</sup> coated blades did not exceed  $C_{ML}$  and could be re-inducted for a second tour at the interim inspection point.

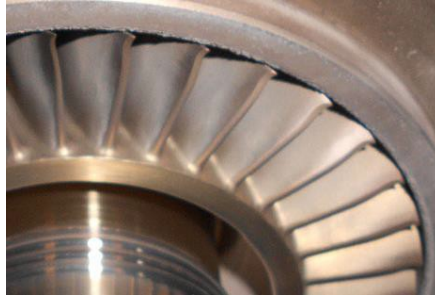
*Figure 5: Coated impeller with very little damage*

The coated impeller demonstrated improvement over the uncoated part. The coated impeller (Figure 5) shows very little damage compared to the uncoated part after similar erosion at the interim inspection point). The application of the BlackGold® coating provided enough protection that it is projected that a coated impeller will operate for at least one additional tour versus an uncoated impeller.

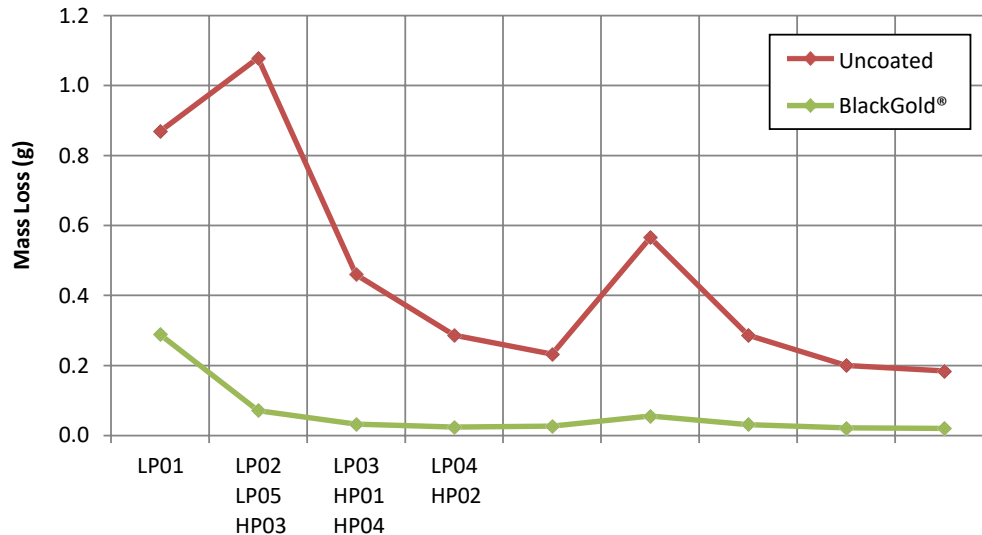
Figure 6: Average Mass Loss/RED Represents Uncoated while GREEN represents Coated

The difference between the mass of the LP and HP rotor blades at the start and end of the is presented below in Figure 6.

The BlackGold® coating significantly reduced the mass loss of the rotor blades, averaging a 14X improvement factor across all stages.

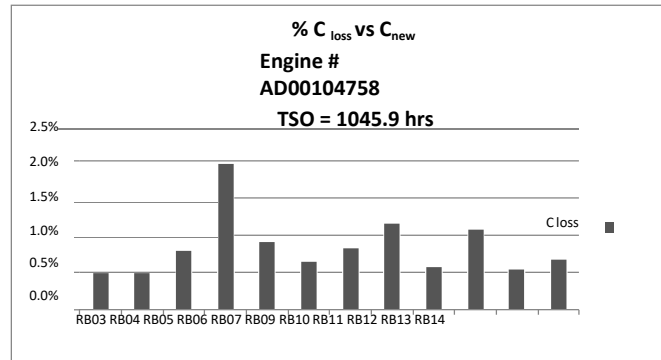
Figure 9: Initial Chord Loss of Compressor Rotor Blades Used for Coated Engine Configuration

MCT cleaned the 3<sup>rd</sup> through 14<sup>th</sup> stage rotor blades and applied its BlackGold<sup>®</sup> coating on these rotor blades in the “as-is” condition. The 1<sup>st</sup> through 13<sup>th</sup> stage vane sectors were also cleaned and coated with the BlackGold<sup>®</sup> coating in the “as-is” condition. The 14<sup>th</sup> stage full-ring sector was not coated and was tested in the uncoated, bare material configuration. Two BlackGold<sup>®</sup> coating configurations were supplied for the coating configuration:

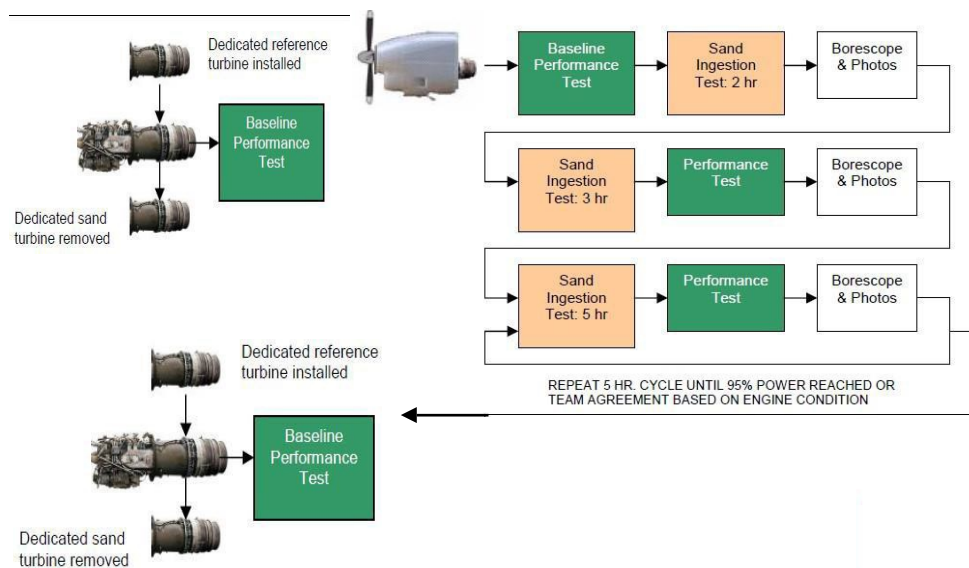
Figure 12: Engine Test Sequence

The (Figure 12) schematic depicts the engine test sequence at both SA WPG and SASAI. Performance tests were conducted at SA WPG with the uncoated and coated engines in the reference turbine configuration and the sand ingestion tests were conducted at SASAI at the intervals depicted.

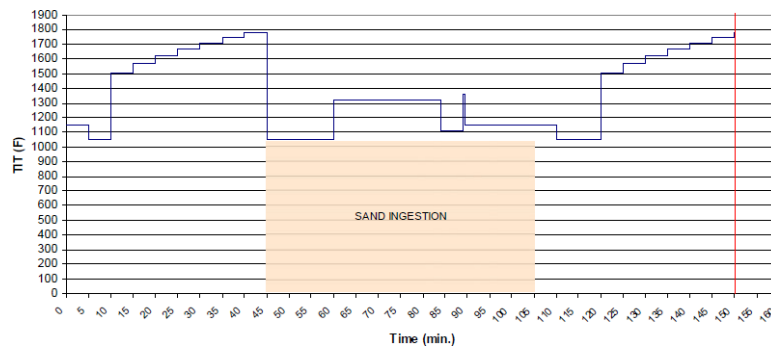
Figure 13: Nine-Point Performance Check & Sand Ingestion Power Settings

On the METS, performance runs were conducted on the uncoated and coated engines after the 2nd and 5th hour of ingesting sand. Thereafter, performance runs on the METS were conducted on the uncoated and coated engines after every 5th hour of ingesting sand.

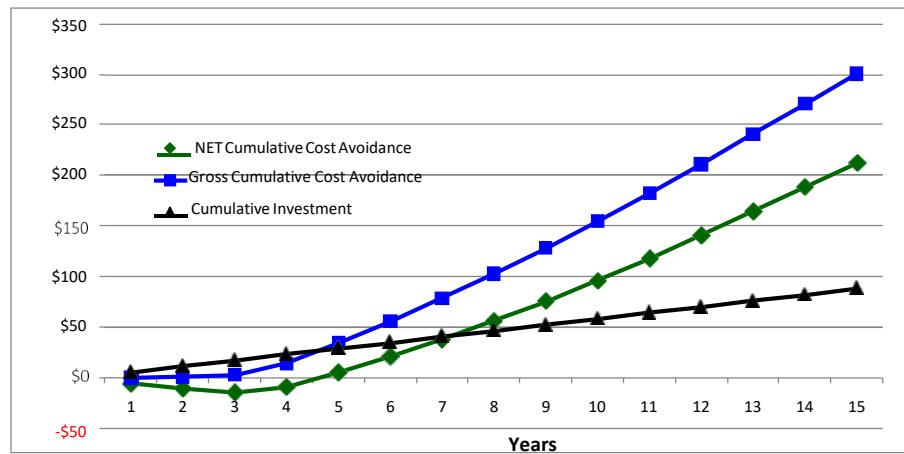
Figure 19: ROI Sensitivity for Middle Case Analysis Over 15 Years

In this scenario, the cumulative investment is returned by the fourth year as noted by the positive “net cumulative cost avoidance” curve at the fourth year. An almost 20% ROI (1.18 factor, \$5.38M return) would be realized by the fifth year. The ROI would increase appreciably after five years as the erosion/corrosion resistant compressor coating becomes fully implemented in the C-130 fleet and the coated engines, on average, keep operating beyond the current ETOW.

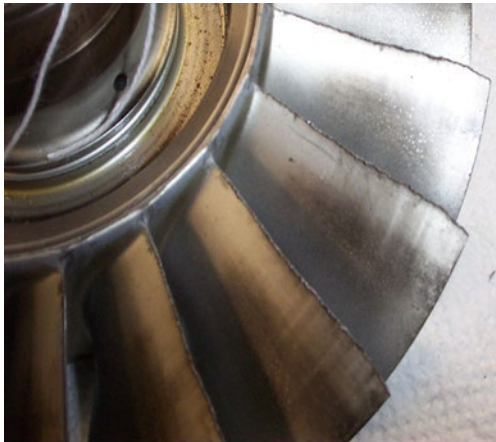
*Figure 23: T700 with Sharp LE 1st Stage Blisk Airfoils Establishing LE Curl*

Figure 23 shows the typical LE curl exhibited on uncoated 1<sup>st</sup> stage, T700 blisks.
