DEVCOM DAC-TR-2024-031
March 2024

The Impact and Injury Response of Male and Female PMHS, Hybrid III 50th Percentile ATDs, and WIAMan under Blast-Induced Accelerative Loading

**by Warren N. Hardy, David Boyle, Davide Ceritano, Amanda Agnew,
John H. Bolte IV, Kerry A. Danelson, Hollie A. Pietsch, and
Kathryn L. Loftis**

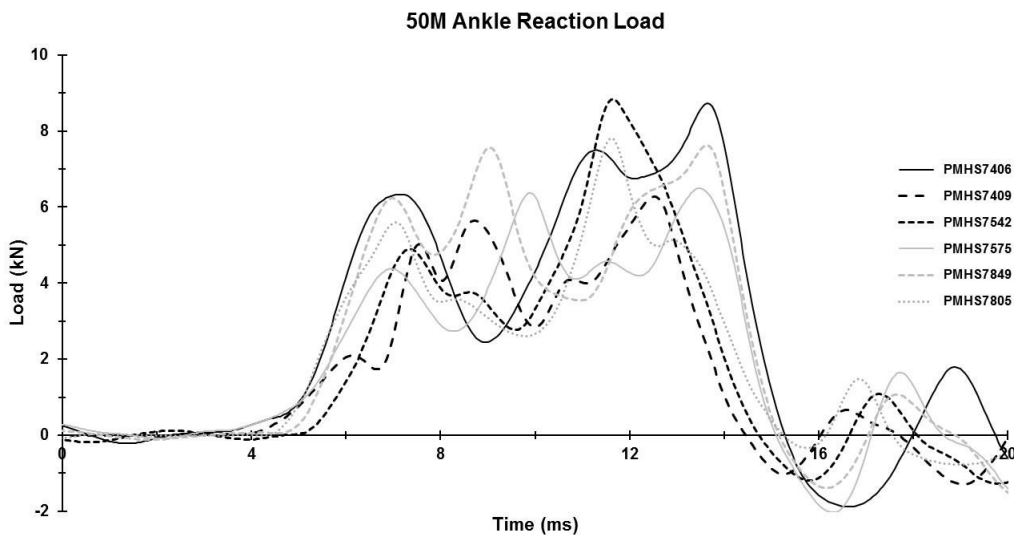
Figure 4. 50th percentile male (50M) reaction loads from cam testing of right ankles

Figure 4 shows the load-time histories for 50M PMHS ankle testing. The loads follow similar patterns and are tightly grouped. Figure 5 shows the load-time histories for 75F PMHS ankle testing. Again, all traces show similar shapes and durations. However, the range between the calcaneus fracture loads is larger than that of the 50M. As noted in previous reporting, PMHS2366 experienced a talus fracture (first peak) prior to the calcaneus fracture (and in the absence of a distal tibia fracture), obfuscating the determination of the calcaneus fracture load. Data from this test are not included in the statistical analyses. Figure 6 shows the load-time histories for 5F PMHS ankle testing. These traces exhibit the least degree of between-test similarity and the most variation in calcaneus fracture load for the three anthropometric categories/groups examined as part of this study. PMHS7630 experienced a late talus fracture, while the calcaneus was continuing to crush. Data from this test are included in the statistics.

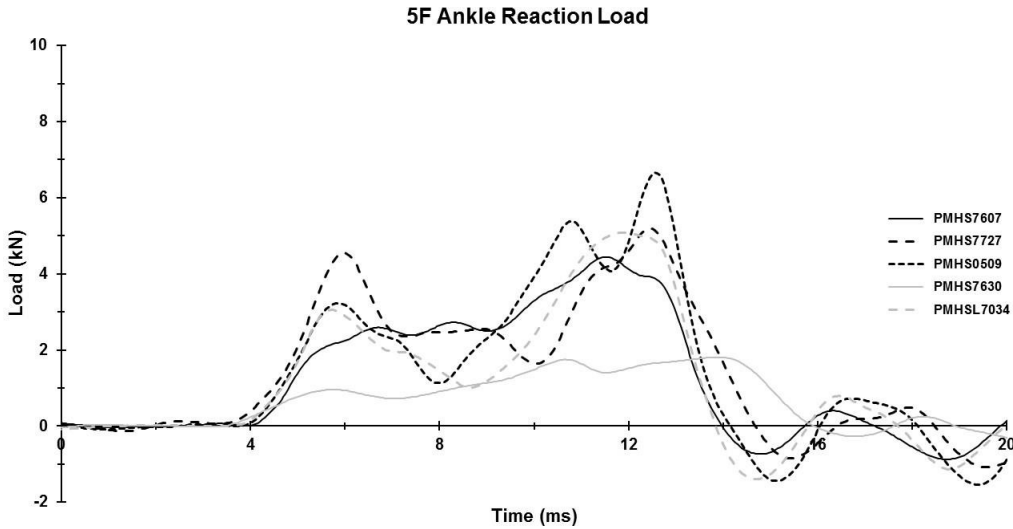
Figure 6. 5th percentile female (5F) reaction loads from cam testing of right ankles

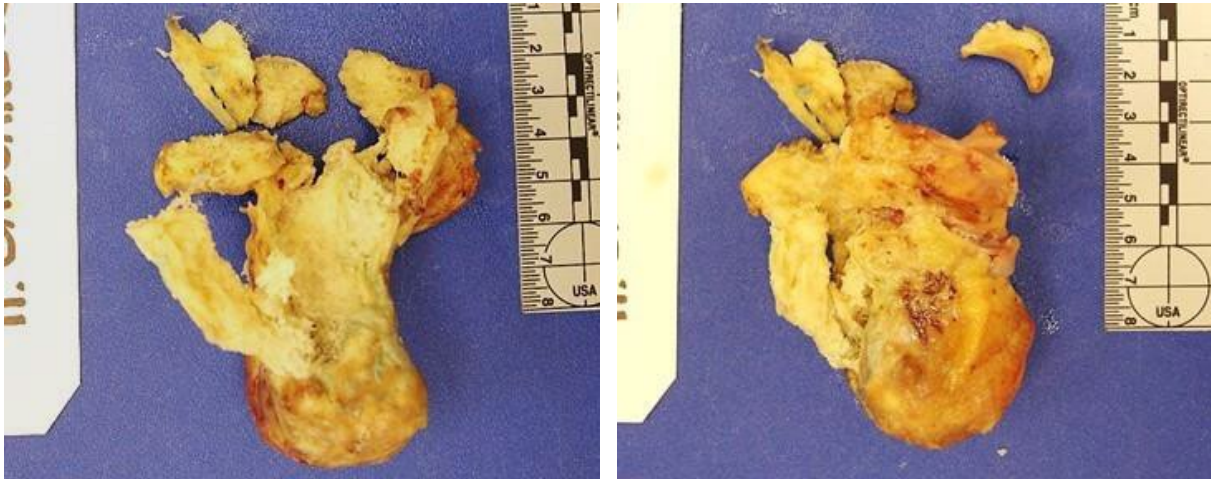
Figure B-1. Fracture of the right calcaneus plantar view (left) and sagittal view (right) of PMHS7409

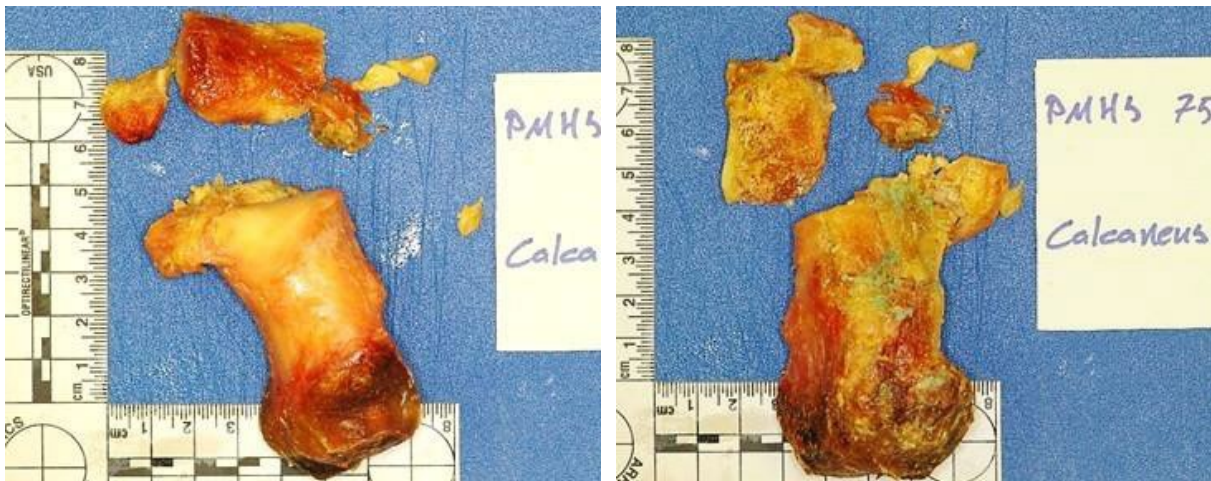
Figure B-2. Fracture of the right calcaneus plantar view (left) and sagittal view (right) of PMHS7575

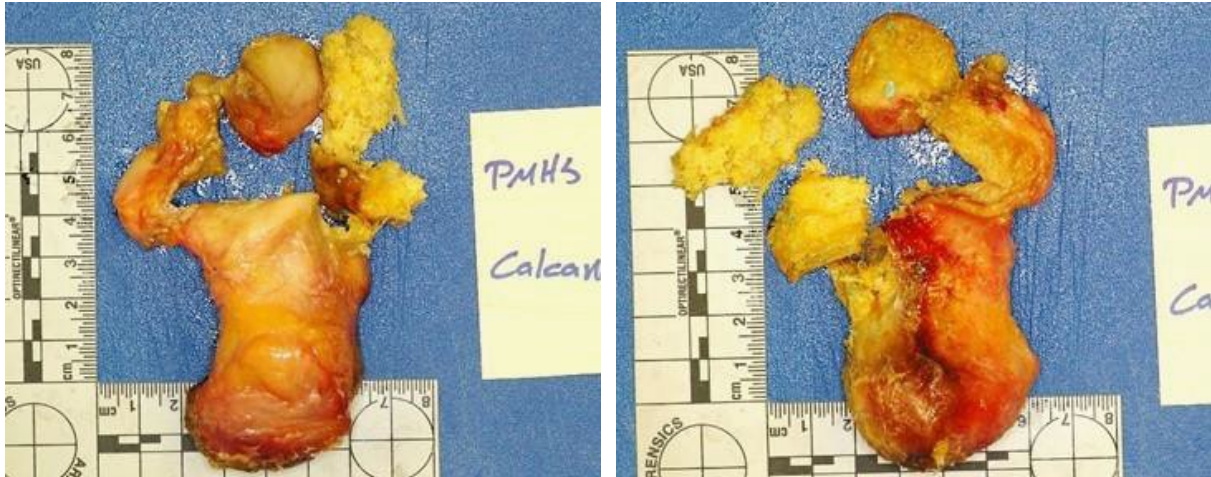
Figure B-3. Fracture of the right calcaneus plantar view (left) and sagittal view (right) of PMHS7542

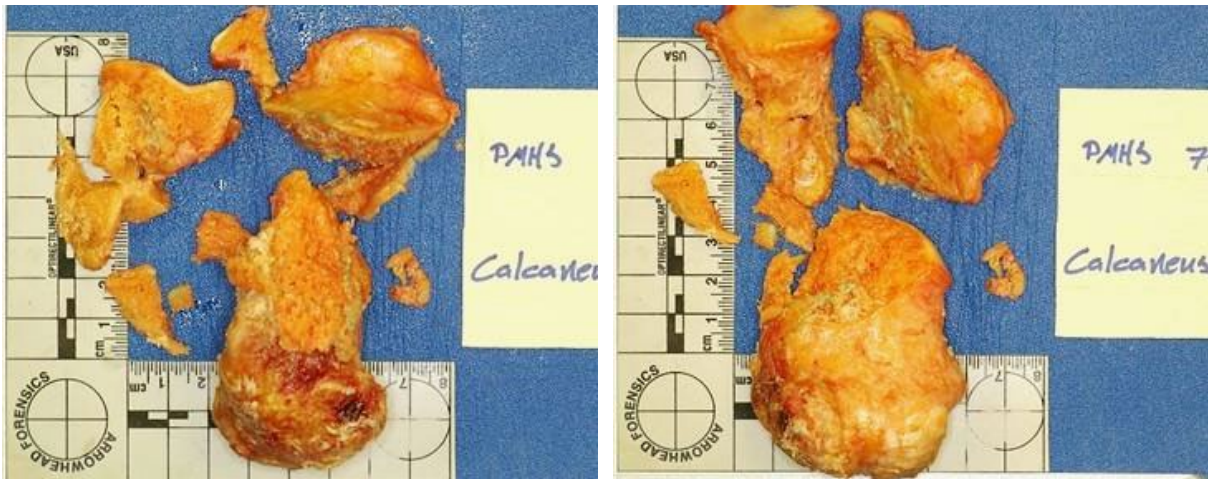
Figure B-4. Fracture of the right calcaneus plantar view (left) and sagittal view (right) of PMHS7805

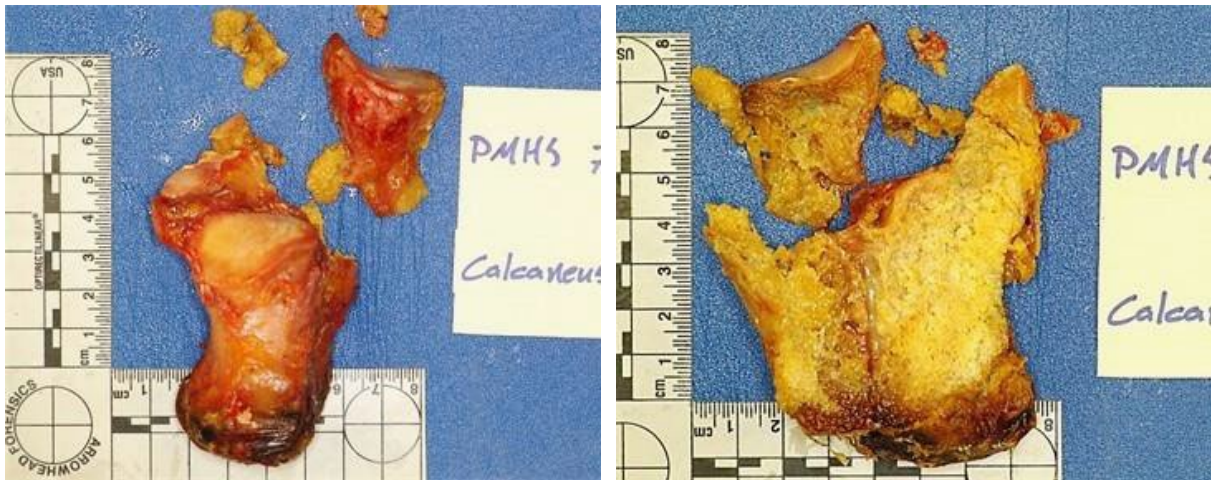
Figure B-5. Fracture of the right calcaneus plantar view (left) and sagittal view (right) of PMHS7406

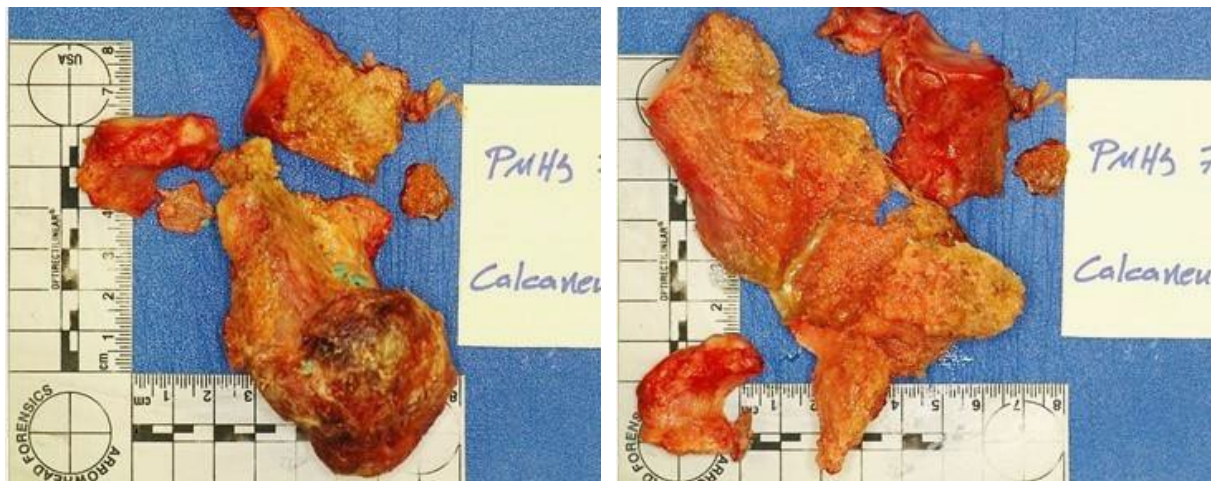
Figure B-6. Fracture of the right calcaneus plantar view (left) and sagittal view (right) of PMHS7849

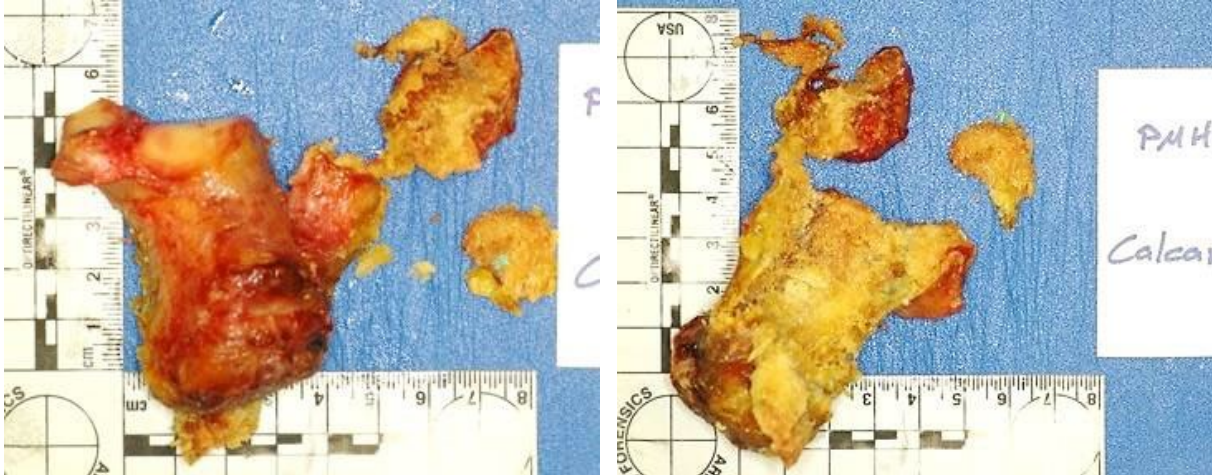
Figure B-9. Fracture of the right calcaneus plantar view (left) and sagittal view (right) of PMHS7618

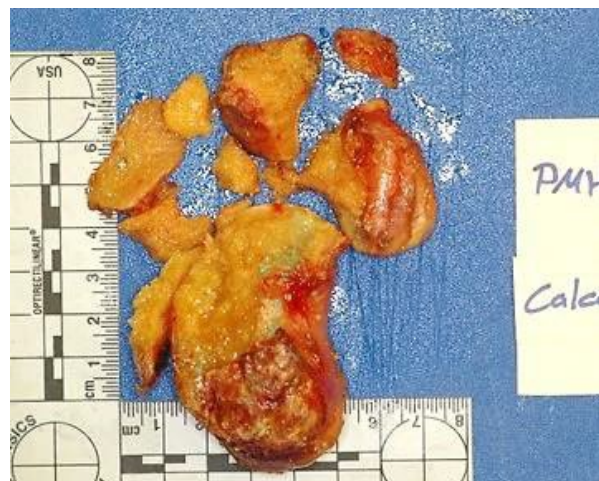
Figure B-11. Fracture of the right calcaneus plantar view of PMHS7834

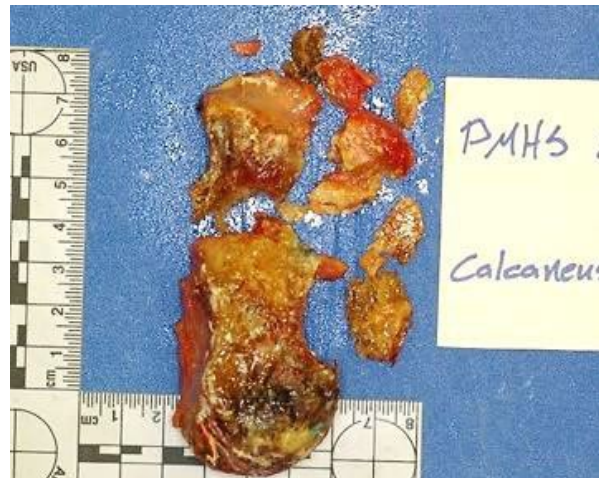
Figure B-12. Fracture of the right calcaneus plantar view (top) of PMHS2366 and the right talus of PMHS2366 (bottom left and right)

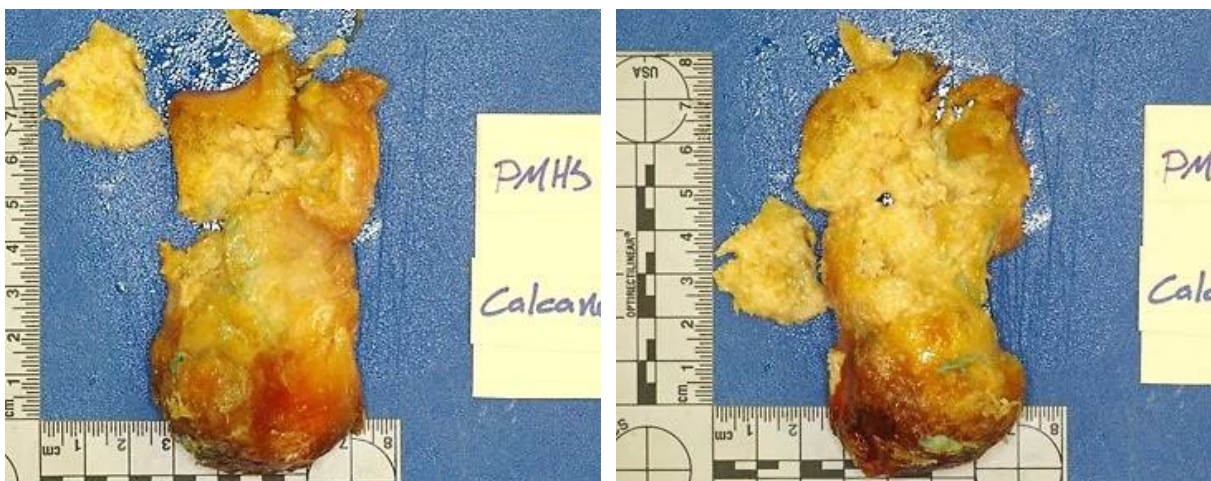
Figure B-13. Fracture of the right calcaneus plantar view (left) and sagittal view (right) of PMHS7607

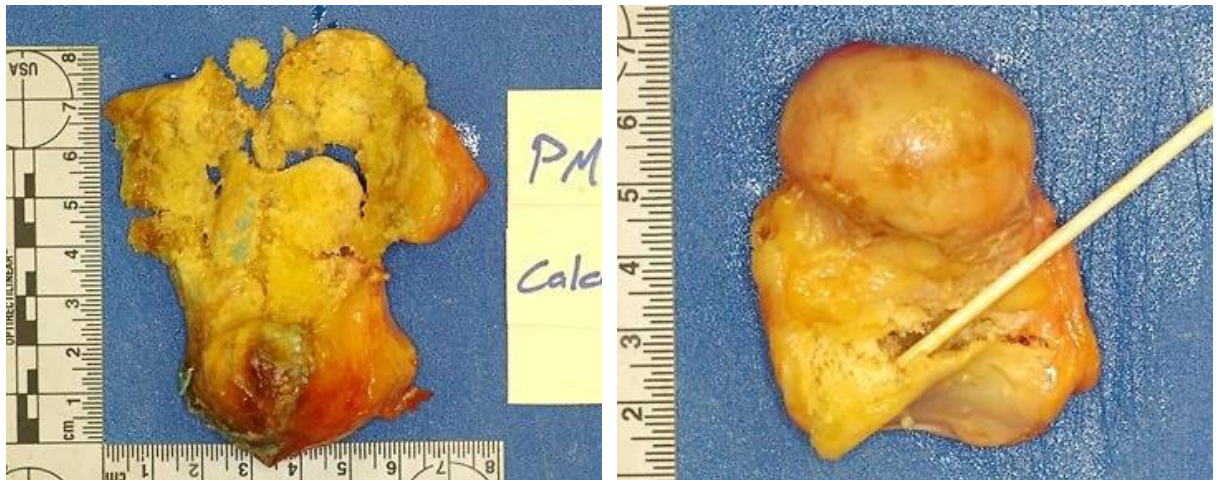
Figure B-14. Fracture of the right calcaneus plantar view (left) of PMHS7630 and the right talus of PMHS7630 (right)

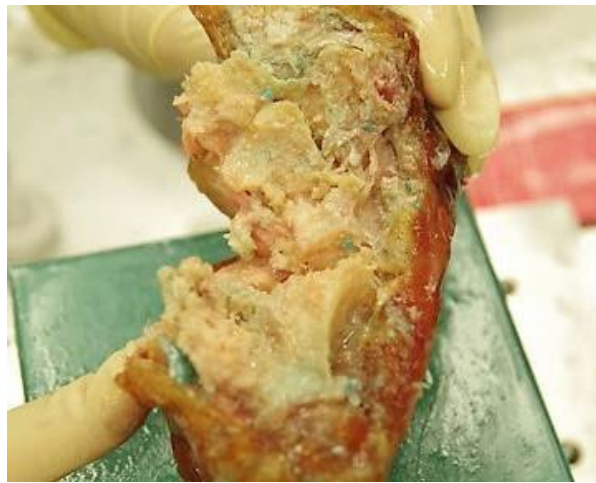
Figure B-15. Fracture of the right calcaneus oblique view (left) of PMHS0509 (TRR5)

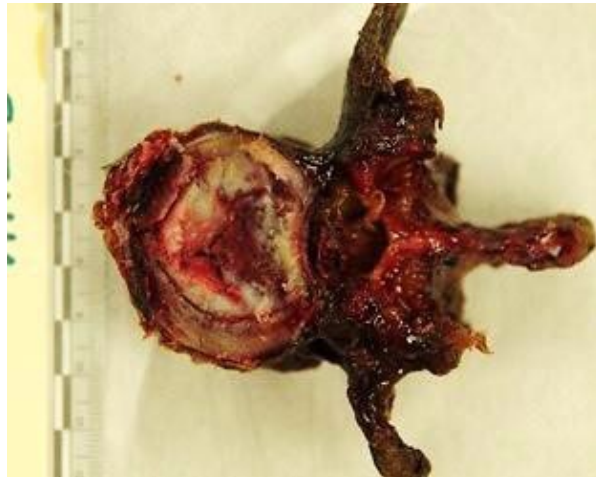
Figure C-12. Lumbar spine damage to PMHS2366 and L4 superior perspective (TRR6)

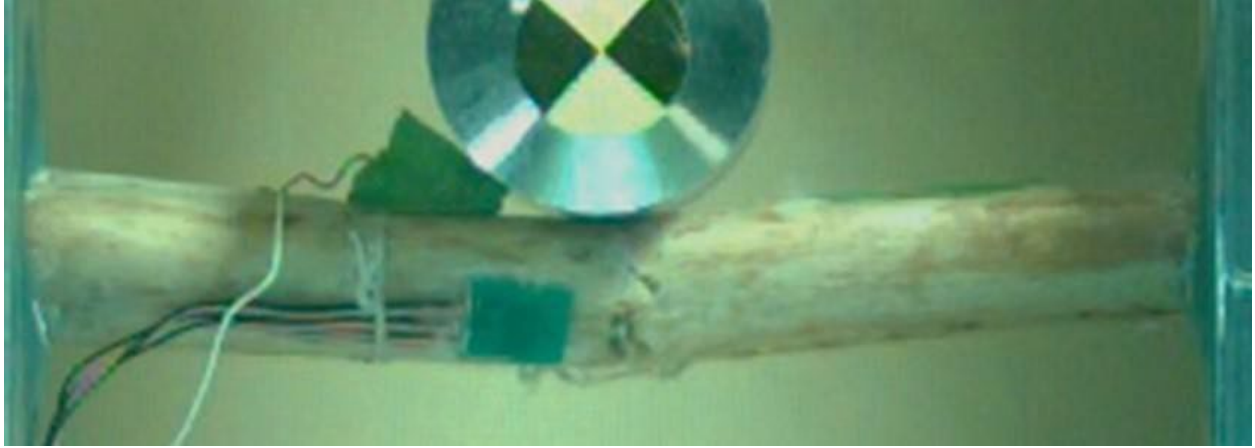
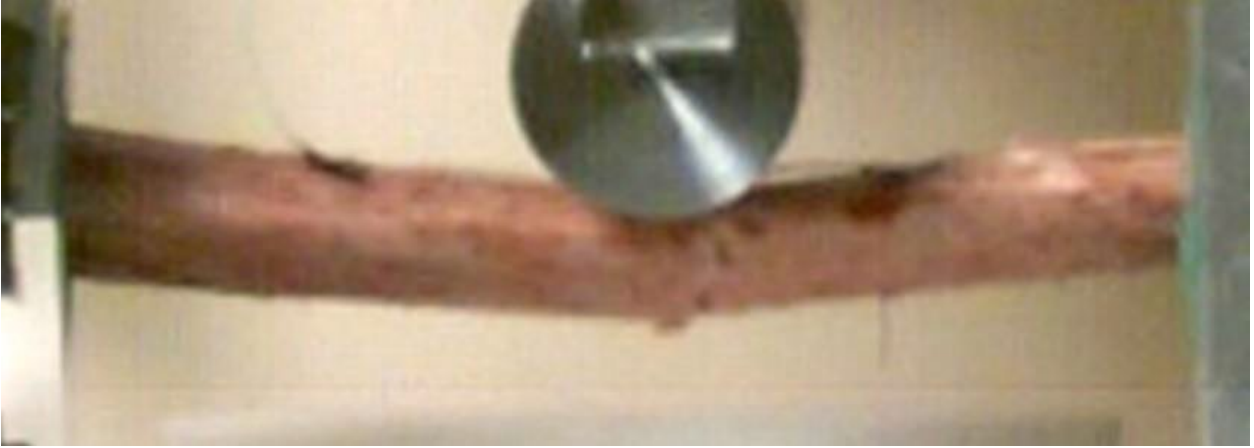
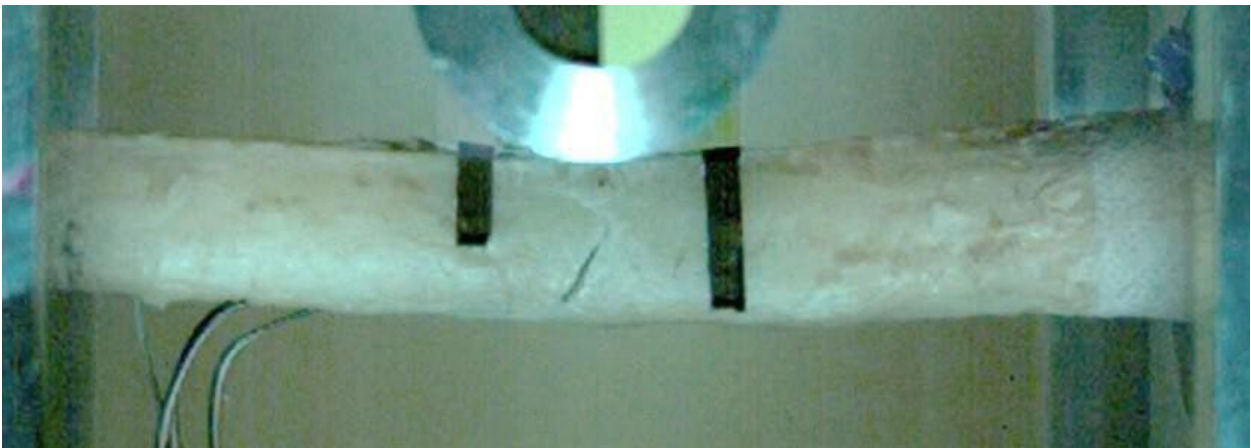
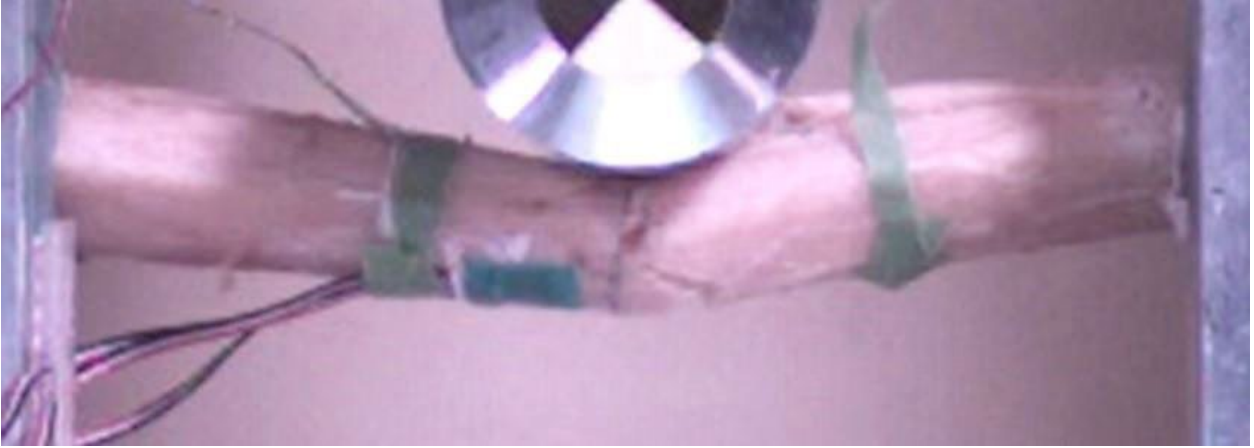
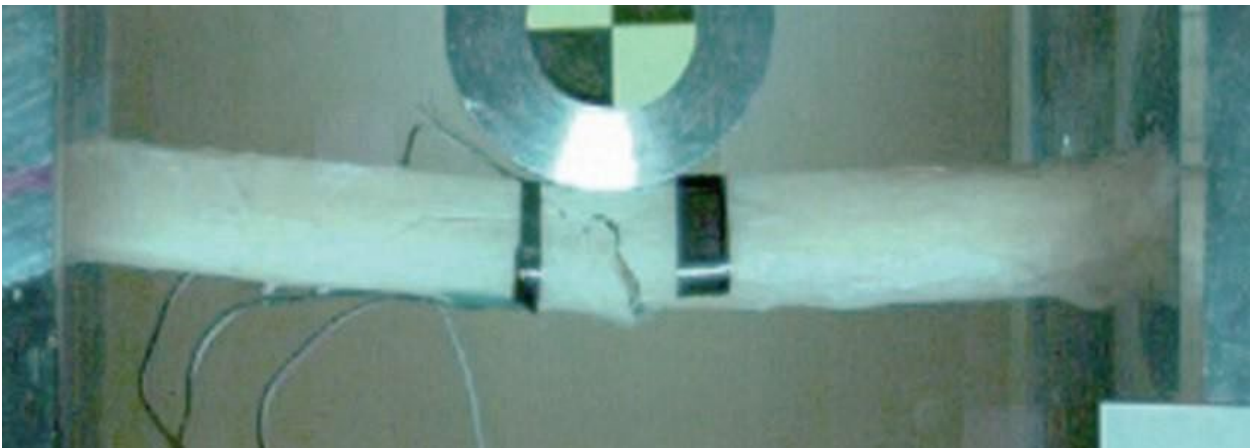
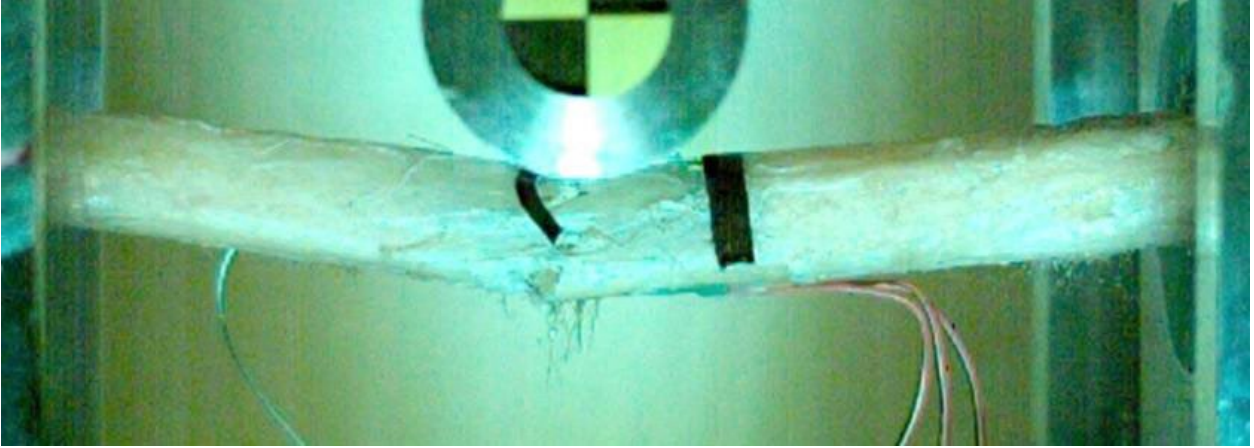
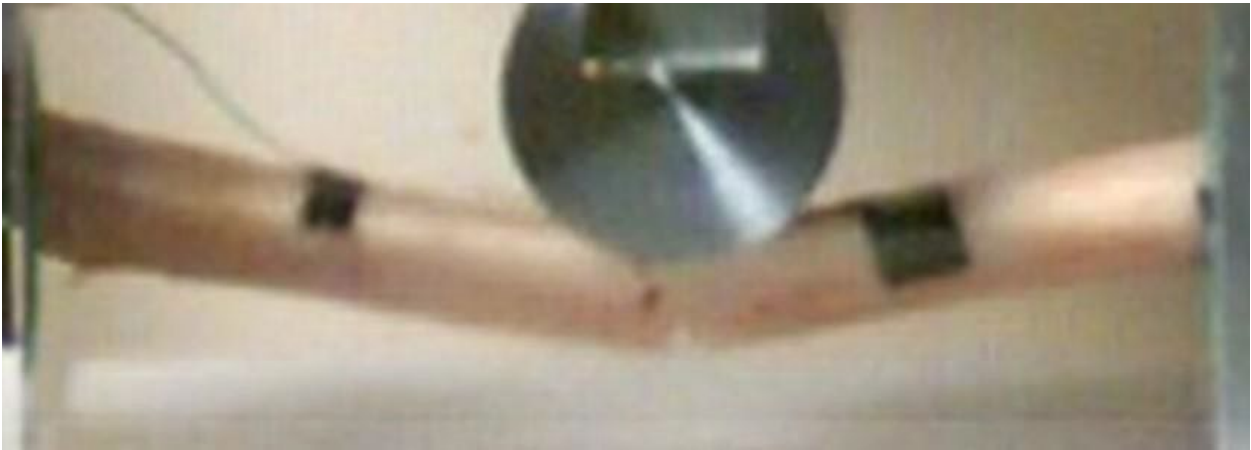
Figure D-1. Early stages of left tibia mid-diaphysis fracture of PMHS7409

Figure D-2. Early stages of left tibia mid-diaphysis fracture of PMHS7575

Figure D-3. Early stages of left tibia mid-diaphysis fracture of PMHS7542

Figure D-4. Middle stages of left tibia mid-diaphysis fracture of PMHS7805

Figure D-5. Early stages of left tibia mid-diaphysis fracture of PMHS7406

Figure D-6. Early stages of left tibia mid-diaphysis fracture of PMHS7849

Figure D-7. Early stages of left tibia mid-diaphysis fracture of PMHS9584M

Figure D-8. Early stages of left tibia mid-diaphysis fracture of PMHS7654

Figure D-9. Early stages of left tibia mid-diaphysis fracture of PMHS7282

Figure D-10. Early stages of left tibia mid-diaphysis fracture of PMHS7469

Figure D-11. Early stages of left tibia mid-diaphysis fracture of PMHS7618

Figure D-12. Early stages of left tibia mid-diaphysis fracture of PMHS7058

Figure D-13. Early stages of left tibia mid-diaphysis fracture of PMHS7834

Figure D-14. Early stages of left tibia mid-diaphysis fracture of PMHS2366

Figure D-15. Early stages of left tibia mid-diaphysis fracture of PMHS7607

Figure D-16. Early stages of left tibia mid-diaphysis fracture of PMHS7630

Figure D-17. Early stages of left tibia mid-diaphysis fracture of PMHS0509

Figure D-18. Early stages of left tibia mid-diaphysis fracture of PMHS7727

Figure D-19. Early stages of left tibia mid-diaphysis fracture of PMHSL7034

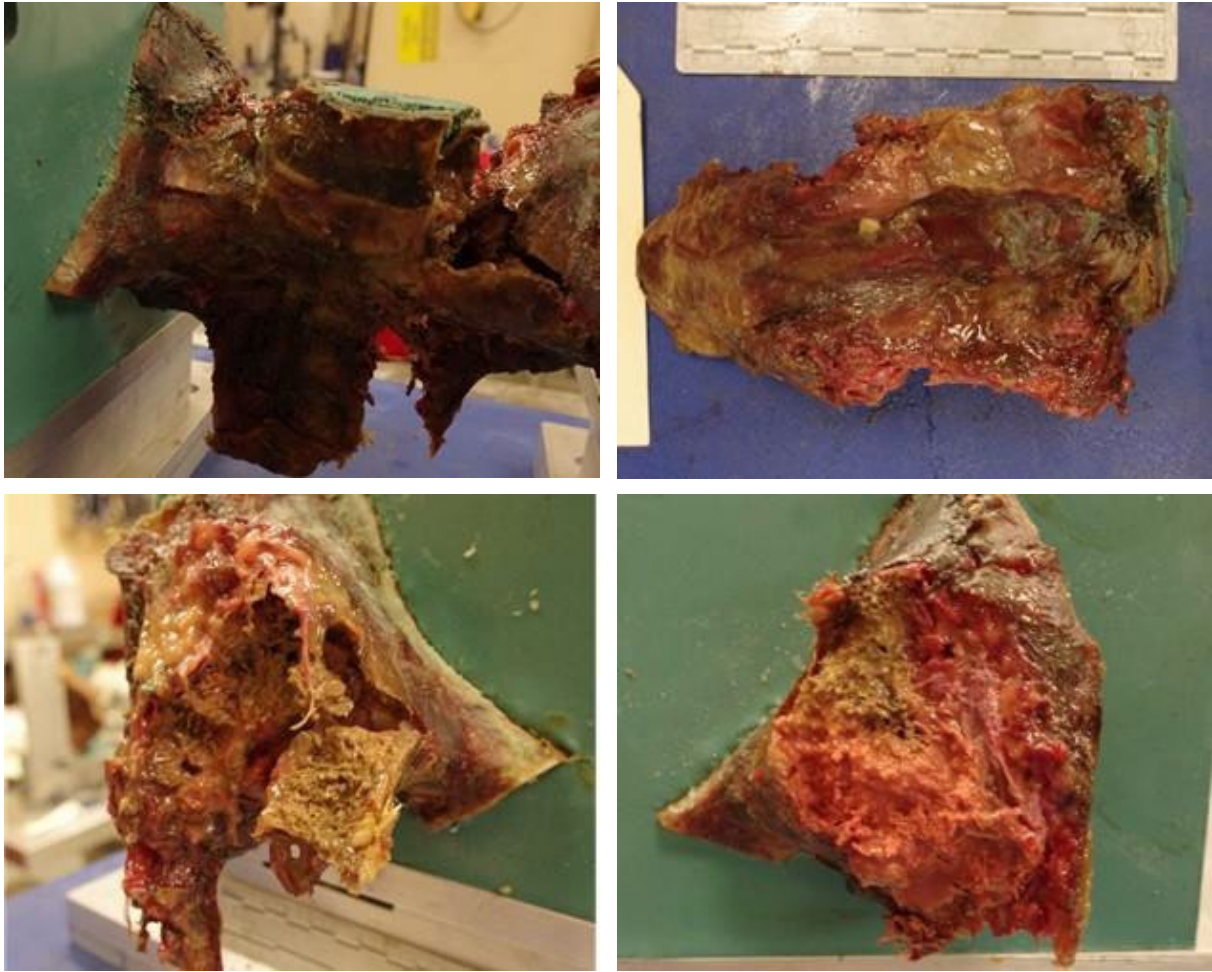
Figure E-1. Sacrum/pelvis damage for PMHS7654: Pelvic perspective (top left), dorsal sacrum (top right), left costal elements (bottom left), and right costal elements (bottom right)

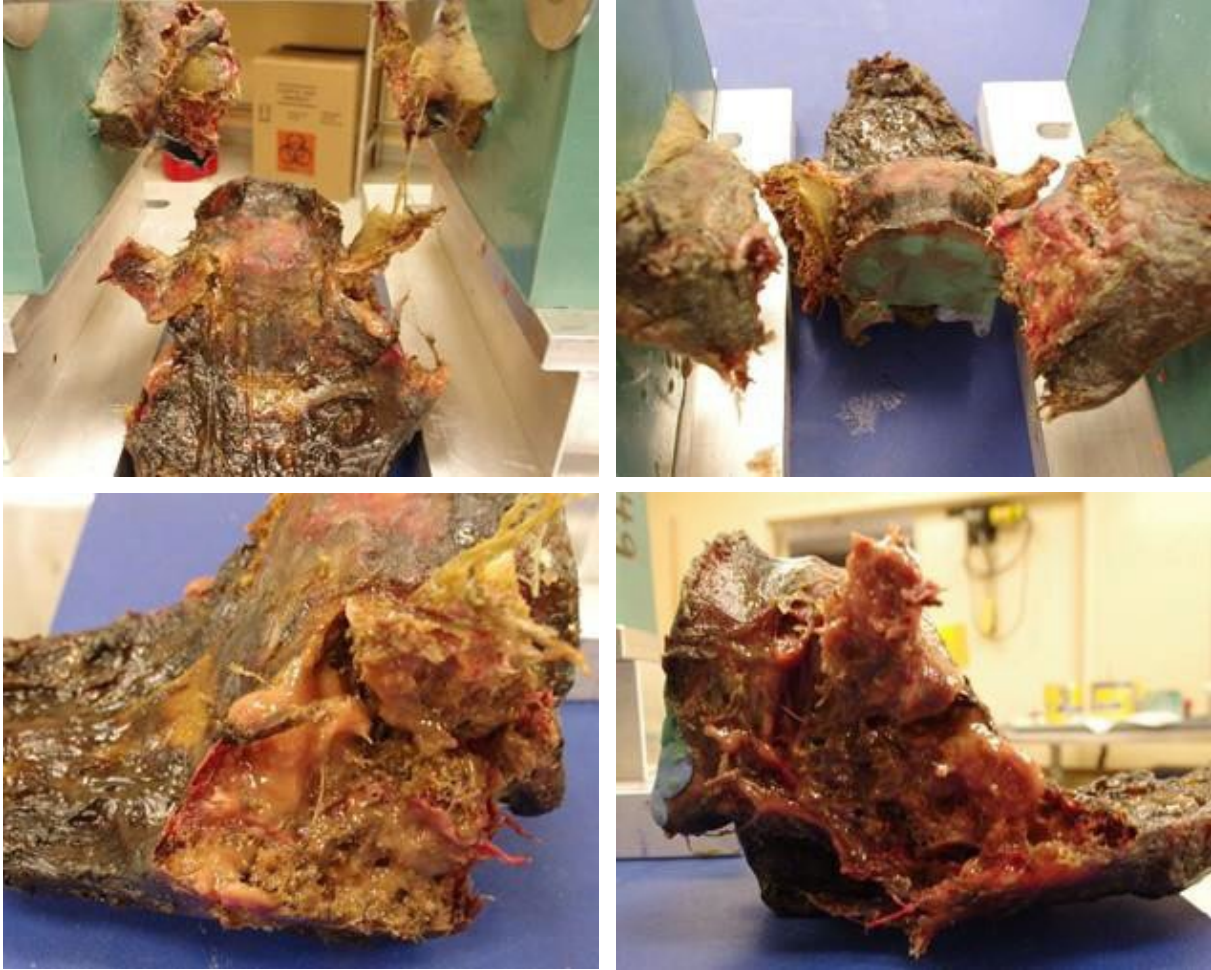
Figure E-4. Sacrum/pelvis damage for PMHS7849: Inferior pelvic perspective (top left), superior pelvic perspective (top right), left costal elements (bottom left), and right costal elements (bottom right)

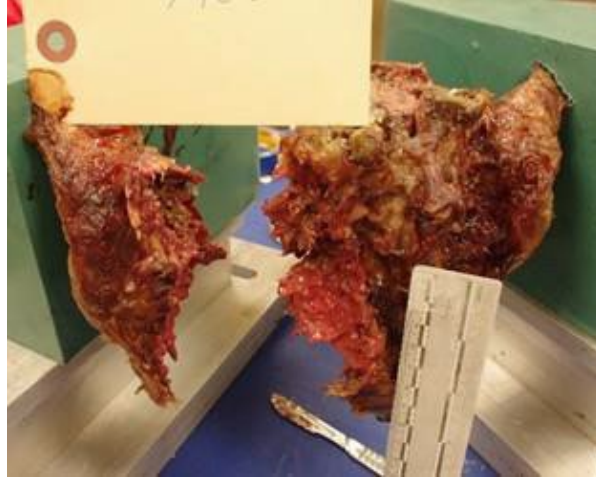
Figure E-5. Sacrum/pelvis damage for PMHS7406: Dorsal perspective (top), left costal elements (bottom left), and right costal elements (bottom right)

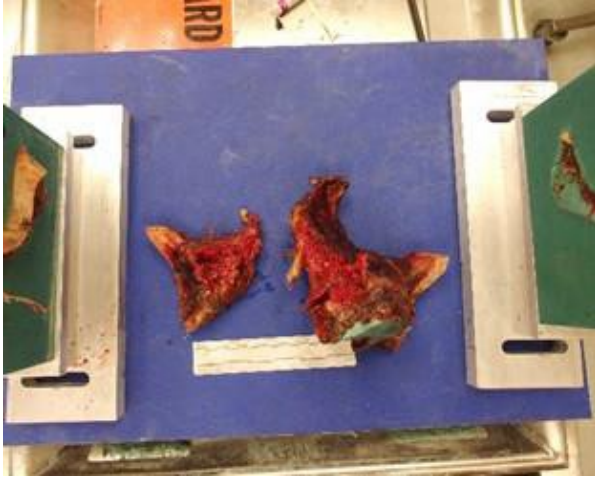
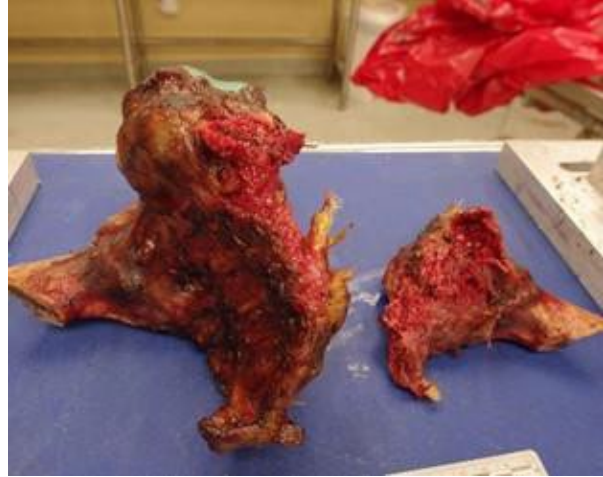
Figure E-8. Sacrum/pelvis damage for PMHS7618: Sacrum and ilium fragments (top left and right), left ilium (bottom left), and remaining potted right ilium (bottom right)

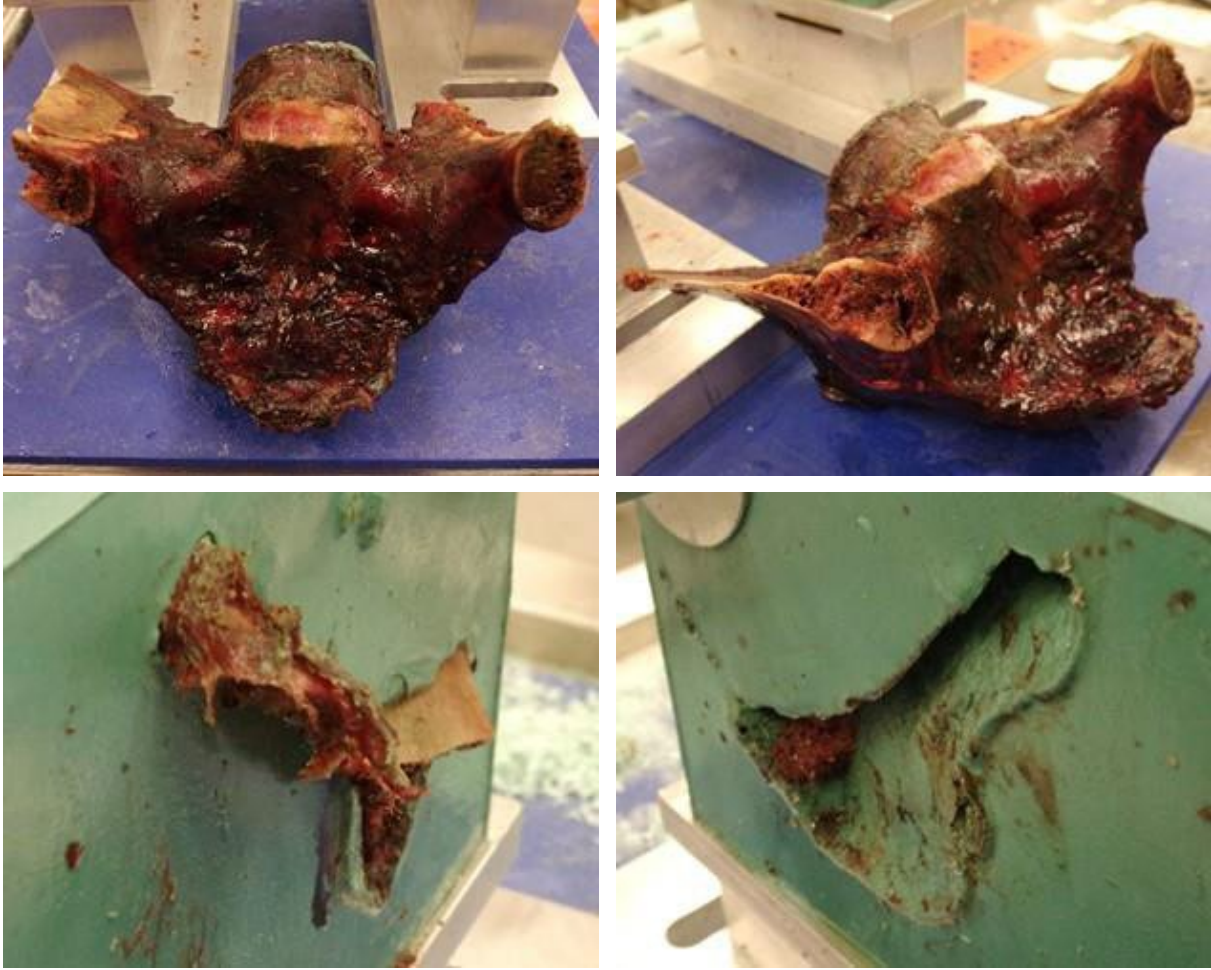
Figure E-12. Sacrum/pelvis damage for PMHS7727: Pelvic perspective (top left), oblique perspective (top right), left costal elements (bottom left), and remnants of right costal elements still potted (bottom right)

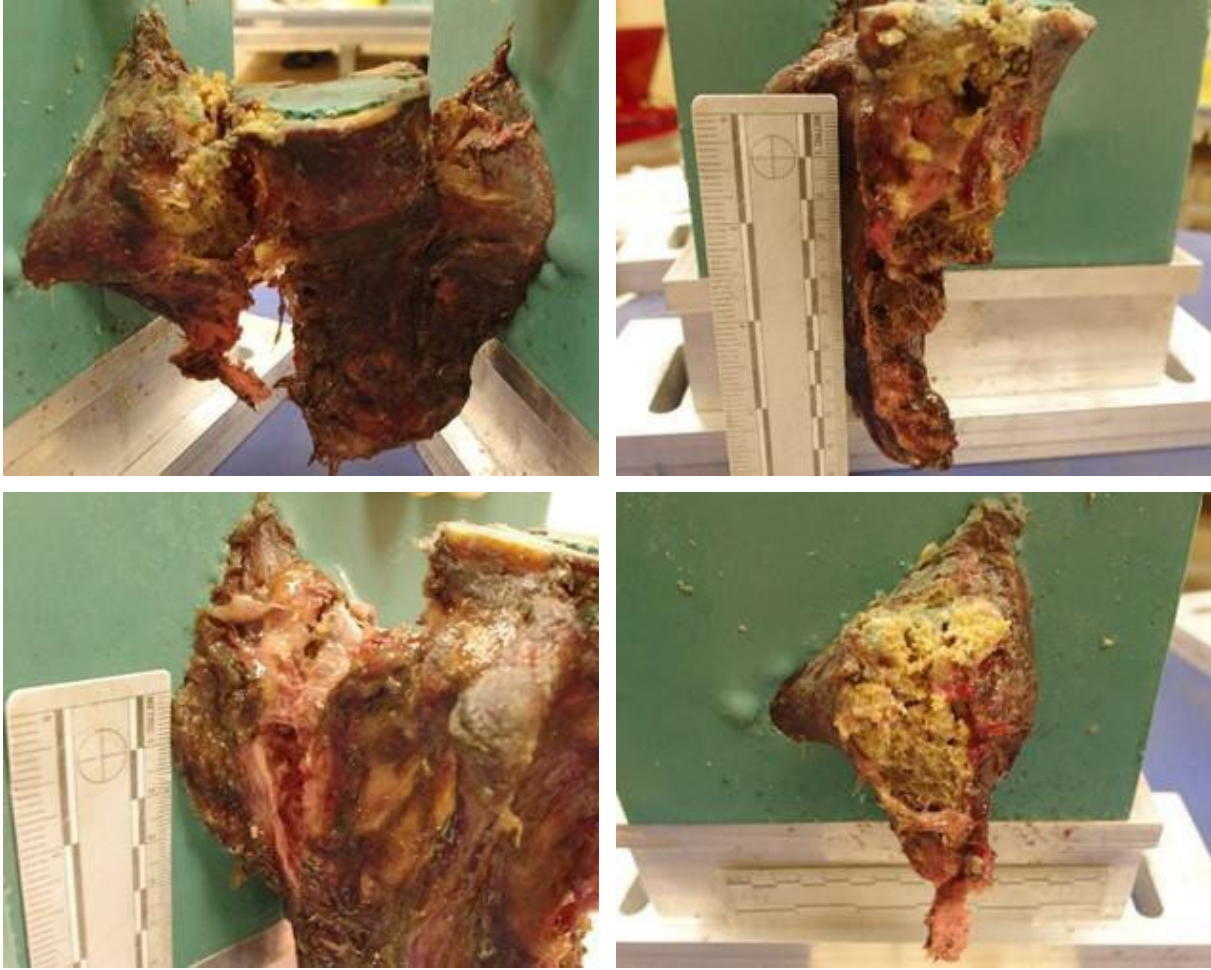
Figure E-13. Sacrum/pelvis damage for PMHSL7034: Pelvic perspective (top left), right sacral alae (top right), left sacral alae (bottom left), and right costal elements (bottom right)
