**FINAL REPORT**

# Selective Atmospheric Plasma Coating Removal for Composite Substrates

## January 2024

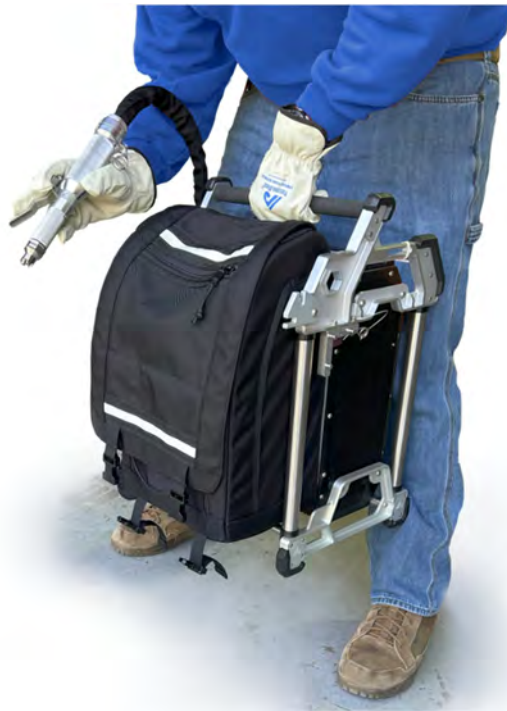
*Figure 1: PB-7000M APCR system*

APCR is a potential solution to many of the issues faced by maintenance personnel as it removes many of the hazardous conditions and chemicals involved with other coating removal methods. Non-thermal plasma processes have been traditionally used for their unique cleaning and surface activation properties that can increase the adhesion strength of new coatings or adhesives to a surface. Atmospheric Plasma Solutions, Inc. (APS) offers a commercially available APCR device, the PB-7000M seen in Figure 1, which was used throughout this study.

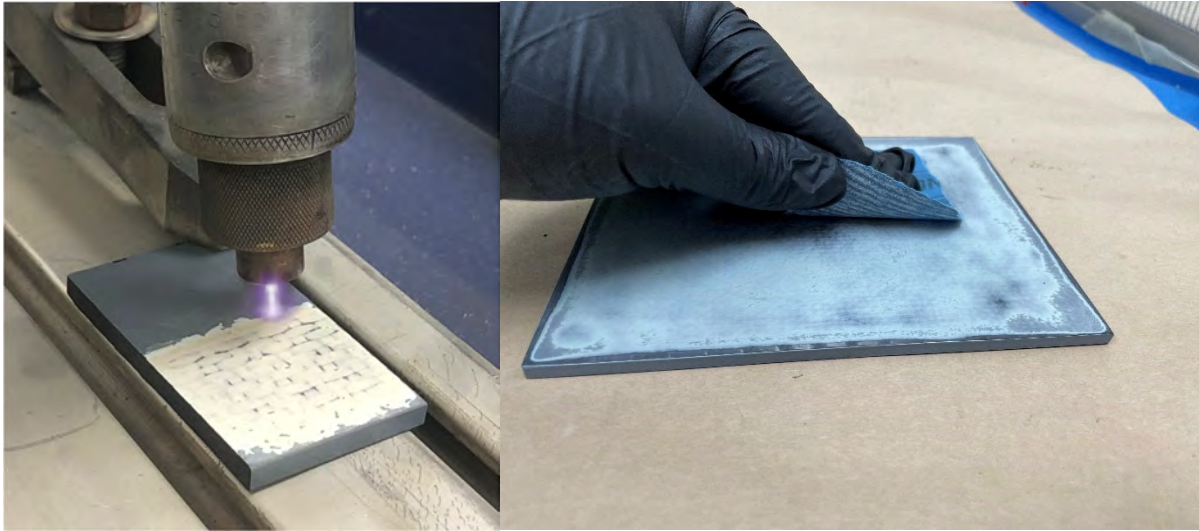
*Figure 11: Plasma coating removal being performed on smaller cutout piece for parameter DoE (left) and hand sanding being performed (right)*

Plasma coating removal parameters were determined through a small study based on adjustments to the system power supply and movement parameters of the plasma end-effector. Variables of system power setting, standoff distance, inter-pass spacing, and raster speed were assessed for general removal efficacy and surface finish. Power setting adjustments proved to have the least impact on removal efficacy of the variables tested, so power was kept constant at 2000 W for all plasma treated samples. Raster speed was also set to a single value of 400 inch/minute in order to reduce variables in this limited scope study. The combination of power setting and raster speed is thought to have limited heat transfer through the primer layer and into substrate, but further investigation may need to be done in order to verify the extent to which this is valid. These assessments were done to the naked eye by experienced technicians, and the best results were examined under microscopy up to 20x. The best 3 conditions were selected for further study.

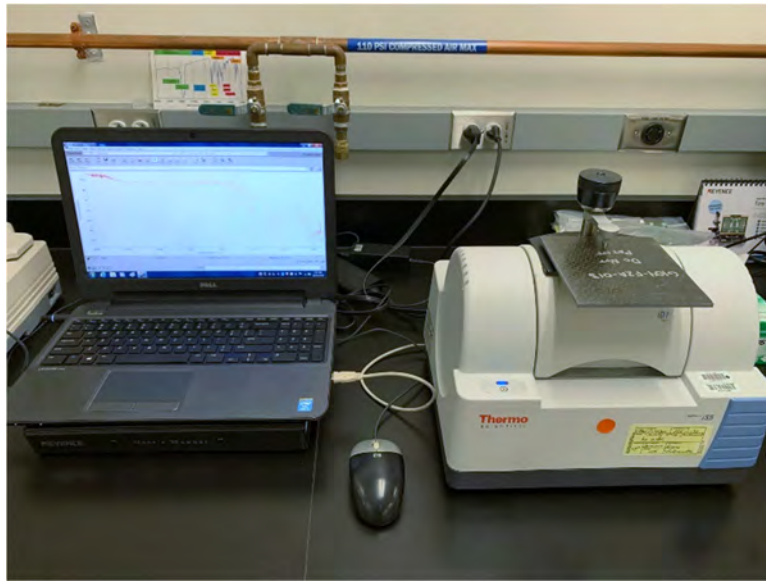
*Figure 14: ThermoFisher Scientific Nicolet iS5 FTIR Spectrometer*
