## **Flowering Rush Control in Hydrodynamic Systems**

Part 2: Field Demonstrations for Chemical Control of Flowering Rush

Bradley T. Sartain, Damian J. Walter, and Kurt D. Getsinger

Final Technical Report (TR)

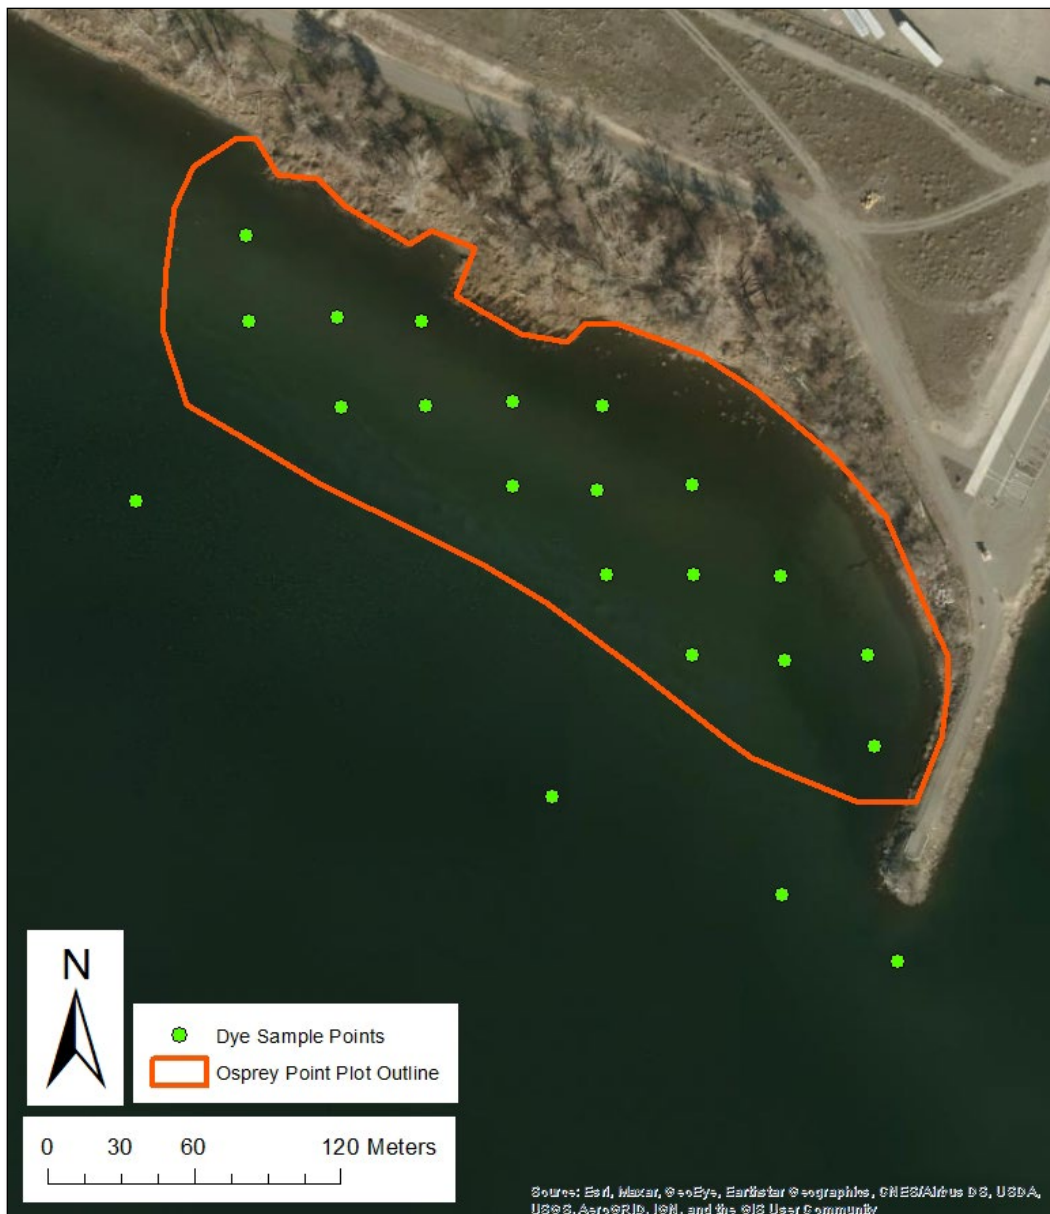
Figure 2. Outline of Osprey Point study plot with rhodamine water tracing (RWT) dye sampling points. Direction of river flow is Northwest to Southeast.

RWT dye was applied on the morning of 23 July 2019 (start: 0835 hours, end: 0847 hours) under favorable weather conditions (water and air temperatures 20°C and 80°C, respectively) with south-southwest winds at 8–16 kmh (5–10 mph). Immediately following application, dye concentrations were measured at 1/3 and 2/3 depth of the water column using a Turner Designs Databank handheld data logger equipped with a Cyclops-7F sensor with Rhodamine WT optics (Turner Designs, Sunnyvale, California) at 18 predetermined sampling points evenly distributed throughout the plot. Dye sampling points were also established outside the plot to track dye dissipation from the treatment area (Figure 2). Measurements were taken at 0.5, 3, 6, and 8 hours after treatment (HAT). Total water discharge and forebay elevation (EL) at McNary Dam was 144.10 thousand cubic feet second (KCFS) and 339.40 EL at 0800 hours.

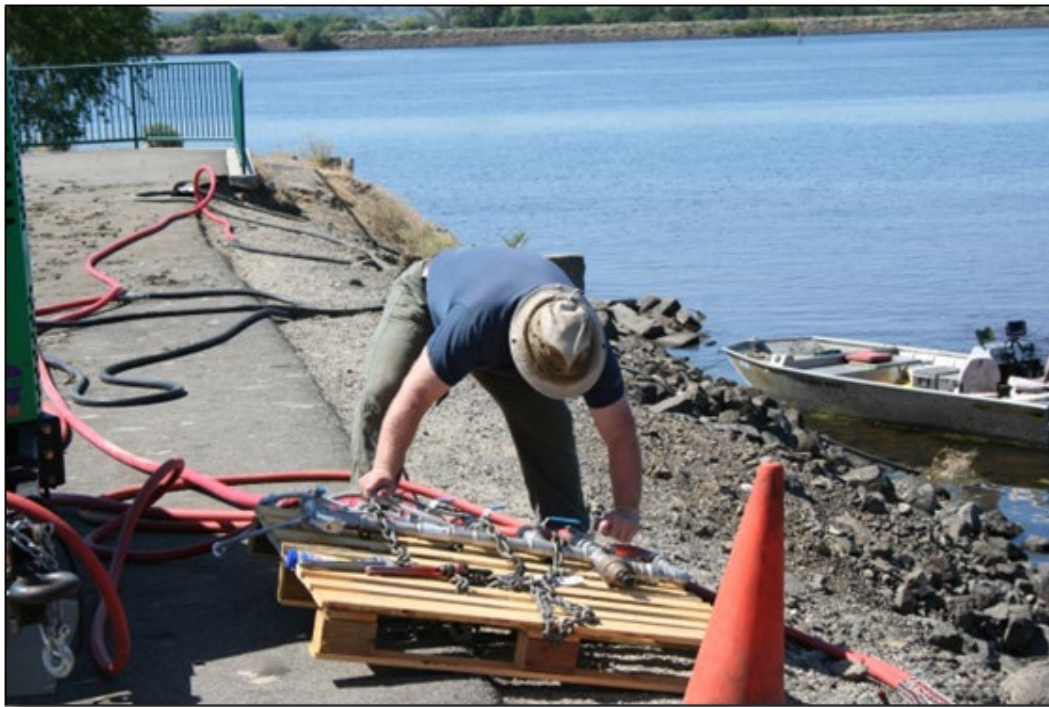
Figure 3. Six-valve manifold equipped with a pressure gauge and bleeder valve that provided constant air flow throughout each bubble curtain during the water exchange studies at Osprey Point in 2019.

Two sections of bubble curtain, 115 and 91 m total length, were used for bubble curtain evaluation #1 on 24 July 2019. The curtain was powered by a single Doosan HP375 diesel powered air compressor stationed on a small peninsula that extended toward the main river channel, which made up the downstream shoreline of the plot. A heat resistant 1.9 cm ID hose affixed to the compressor was fitted to a six-valve manifold equipped with a pressure gauge and bleeder valve (Figure 3). Two feeder lines (2.54 cm ID)

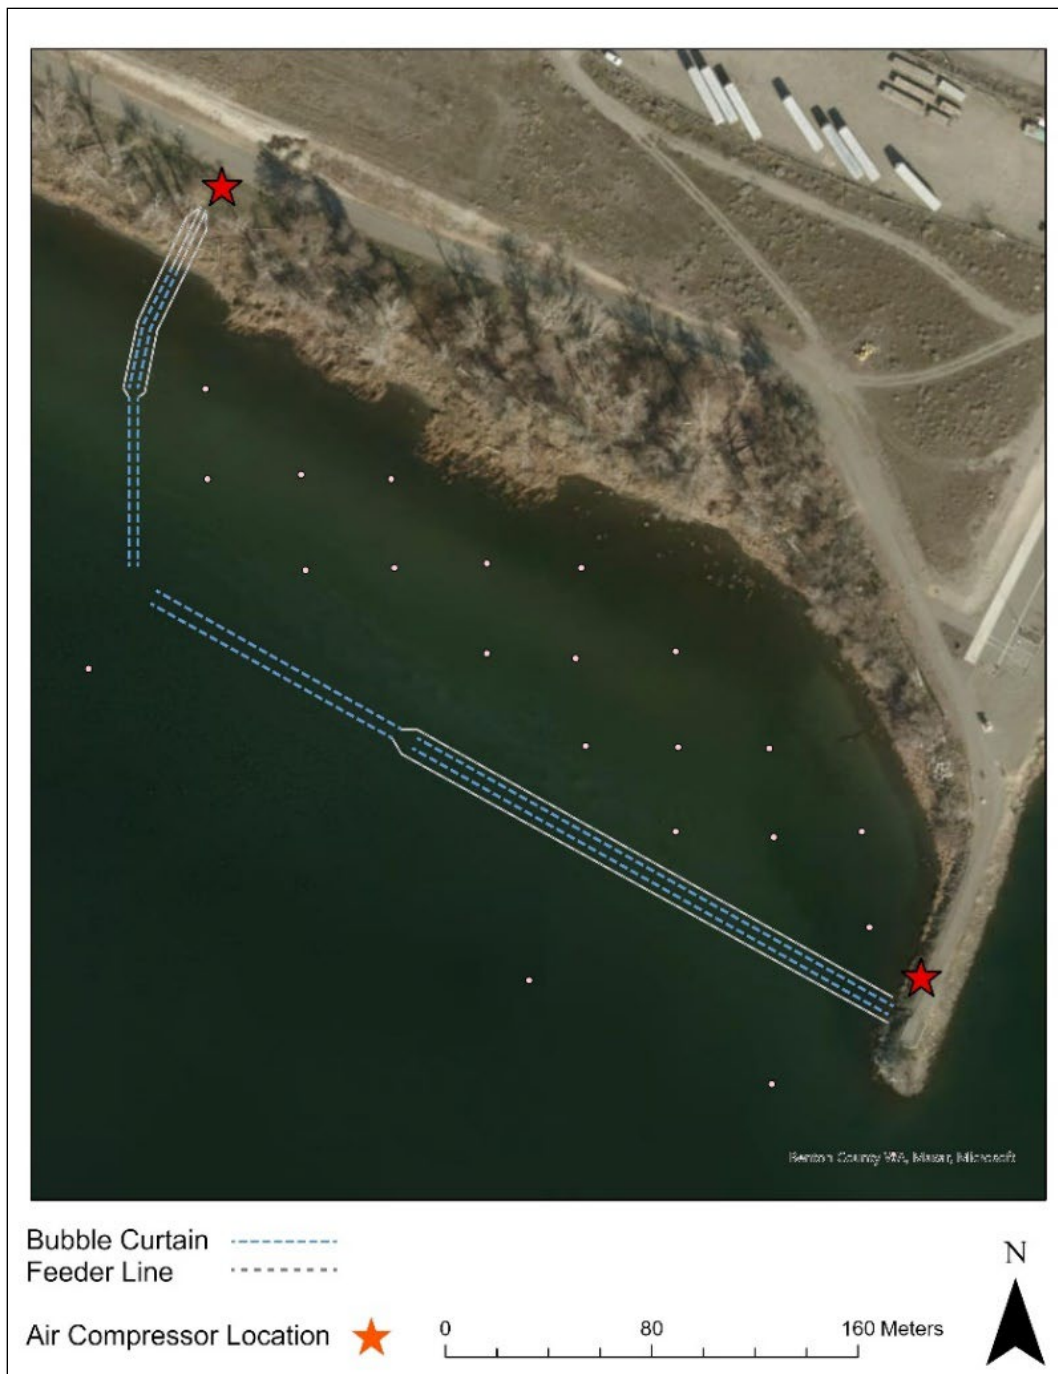
Figure 6. Arrangement of the double bubble curtain at the Osprey Point Study Plot on 26 July 2019. Direction of river flow is northwest to southeast.

Bubble curtain evaluation #3 was conducted on 26 July 2019 and consisted of a double curtain arrangement that enclosed the entire treatment plot. This required two Doosan HP375 diesel powered air compressors positioned on the upper and lower end of the treatment plot (Figure 6). One double curtain extended from the small peninsula on the lower end of the plot and ran parallel to the main river channel. Like the previous evaluations, heat resistant 1.9 cm ID hose affixed to the compressor was fitted to a six-valve manifold equipped with a pressure gauge and bleeder valve (see Figure 3). Four feeder lines (2.54 cm ID) were connected to the six-valve manifold and used to join each bubble curtain segment. Prior to joining each feeder line and bubble curtain segment, a one-way flow valve was installed to prevent back flow of water into the feeder line. Two of the four feeder lines were connected to each 115 m curtain segment at the water edge. Two additional feeder lines extended into the water and ran parallel to each 115 m curtain segment and were connected to a pair of 91 m curtain segments at the termination of the 115 m segments. This provided the double curtain arrangement that extended from the downstream shoreline of the demonstration plot 206 m upstream. The second compressor, positioned at the upper end shoreline of the plot, was rigged in the same manner as the first compressor. A section of the heat resistant, 1.9 cm ID hose was affixed to the compressor and fitted to a six-valve manifold equipped with a pressure gauge and bleeder valve. Four feeder lines (2.54 cm ID) were connected to the six-valve manifold and used to join each bubble curtain segment. Prior to joining each feeder line and bubble curtain segment, a one-way flow valve was installed to prevent back flow of water into the feeder line. Two of the four feeder lines were connected to 61 m curtain segments at the water edge. Two additional feeder lines extended into the water and ran parallel to each 61 m bubble curtain segment and connected a pair of 76 m curtain segments at the termination of the 61 m segments.

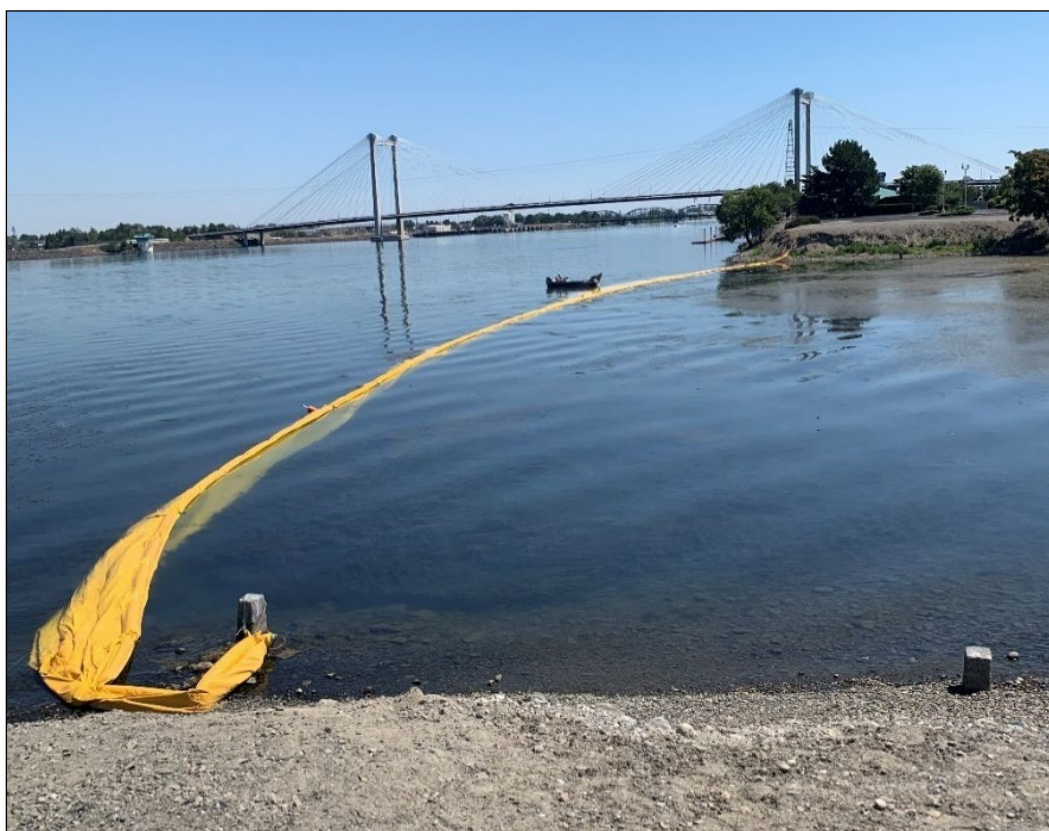
Figure 7. Barrier curtain deployed at the Clover Island study plot 29 July 2019.

A barrier curtain was installed to evaluate the efficiency at decreasing bulk water exchange and draw comparisons to water-exchange data previously collected, with and without a bubble curtain, at the Clover Island site in

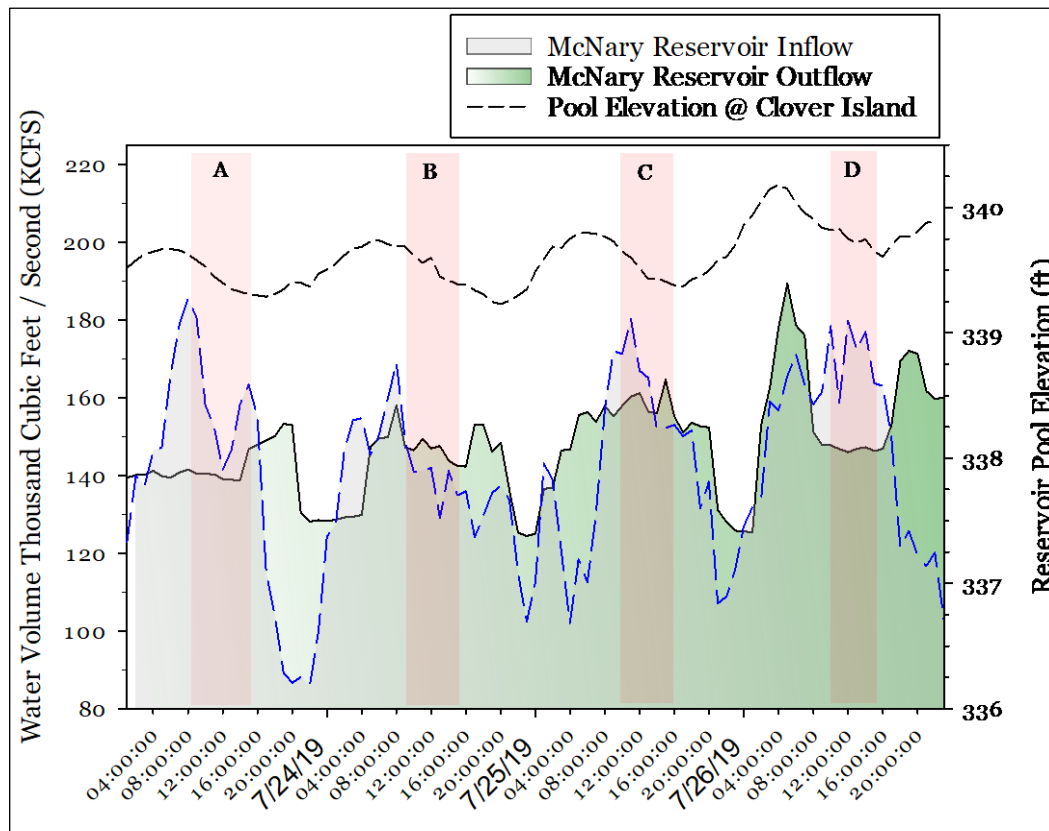
Figure 10. Inflow and outflow of water into McNary Reservoir and pool elevation at Clover Island gauge station. *Red transparent boxes* indicate the occurrence of a water-exchange evaluation for (A) no bubble curtain, (B) bubble curtain evaluation #1, (C) bubble curtain evaluation #2, and (D) bubble curtain evaluation #3. McNary Reservoir inflow is estimated based off discharge data at Priest Rapids Dam, Ice Harbor Dam, and the Yakima River. Priest Rapids, Ice Harbor, and McNary Dam discharge data are presented on an 18-, 8-, and 2-hour time of travel, respectively.

These data suggest the rates of water inflow and outflow were not synchronous across all water-exchange evaluations; however, pool elevation data indicates that each evaluation was somewhat synchronous as water levels declined based on the nearest pool elevation gauge 2.4 km (1.5 miles) upstream. Given the small size of the study site and the number of confounding variables that can ultimately affect water exchange, it is increasingly difficult to pinpoint a single factor that led to the no curtain evaluation to have less water exchange compared to each bubble curtain evaluation. However, these data provide valuable information and support findings from Wersal et al. (2022) that demonstrate exposure time of a submersed

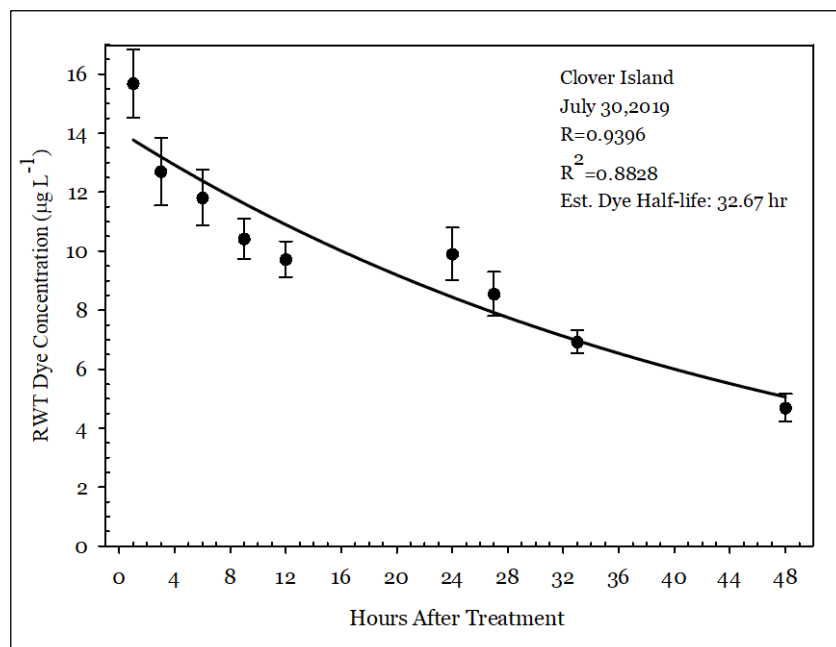
Figure 11. Mean RWT dye concentration ( $\pm$ SE [standard error]) for each sampling period during the barrier curtain assessment at the Clover Island 30–31 July 2019. Dye dissipation and dye half-life was estimated using nonlinear regression (exponential decay,  $f = a \exp[-b \lambda]$ ).

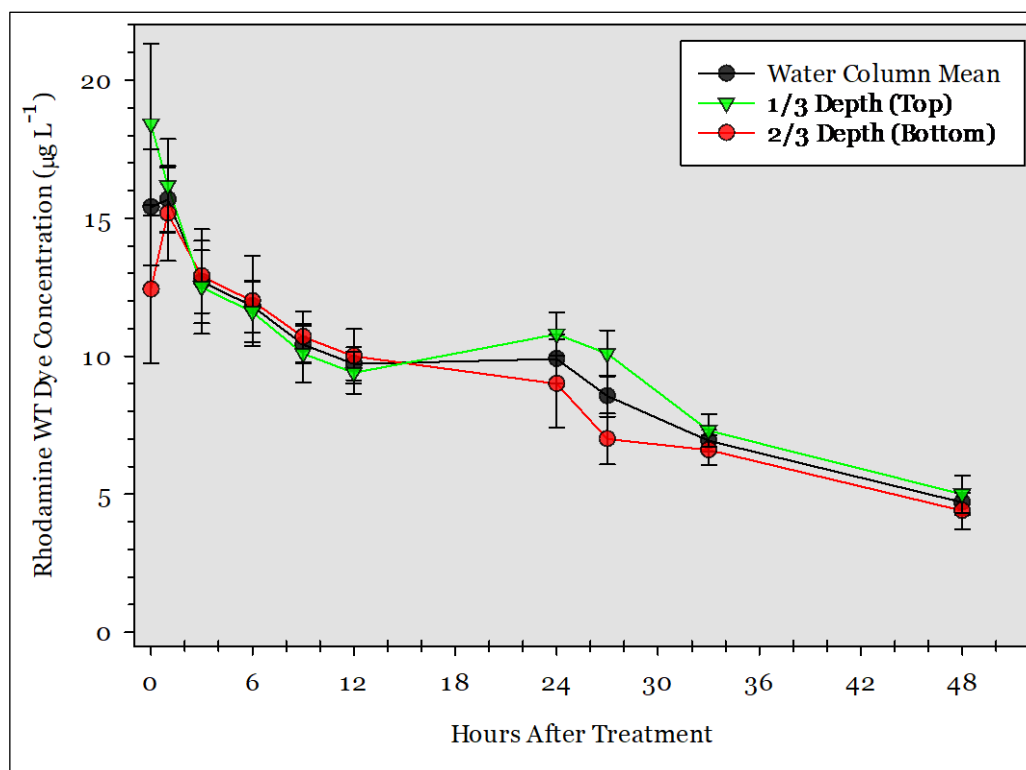
Figure 12. Mean RWT dye measurements collected at 1/3 and 2/3 depths of the water column and mean across depths during each dye sampling event during the barrier curtain assessment at Clover Island 30–31 July 2019.

From 12 to 24 HAT, aqueous dye concentrations within the plot remained relatively stable with higher concentrations being detected in the top portion of the water column. This was somewhat unexpected as previous readings indicated a consistent dissipation rate of RWT from 0 to 12 HAT. Building off the discussion in the previous section, McNary Reservoir inflow, outflow, and pool elevation at Clover Island (location of barrier curtain study site) are shown in Figure 14. McNary Reservoir inflow was estimated based off discharge data at Priest Rapids Dam, Ice Harbor Dam, and the Yakima River. Priest Rapids Dam discharge data are presented on an 18-hour time of travel, while Ice Harbor Dam discharge is presented on an 8-hour time of travel. Water discharge at McNary Dam is presented on a 2-hour time of travel. Pool elevation data are presented in real time and the duration of the barrier curtain evaluation is indicated by the highlighted portion of the graph (Figure 14). These data show that from 12 to 24 HAT, pool elevation increased by approximately 1 ft at the study site. The rise in water level likely led to a backflow of water reducing the dissipation of RWT dye and enabling concentrations to remain relatively stable in the treatment area for an extended period.

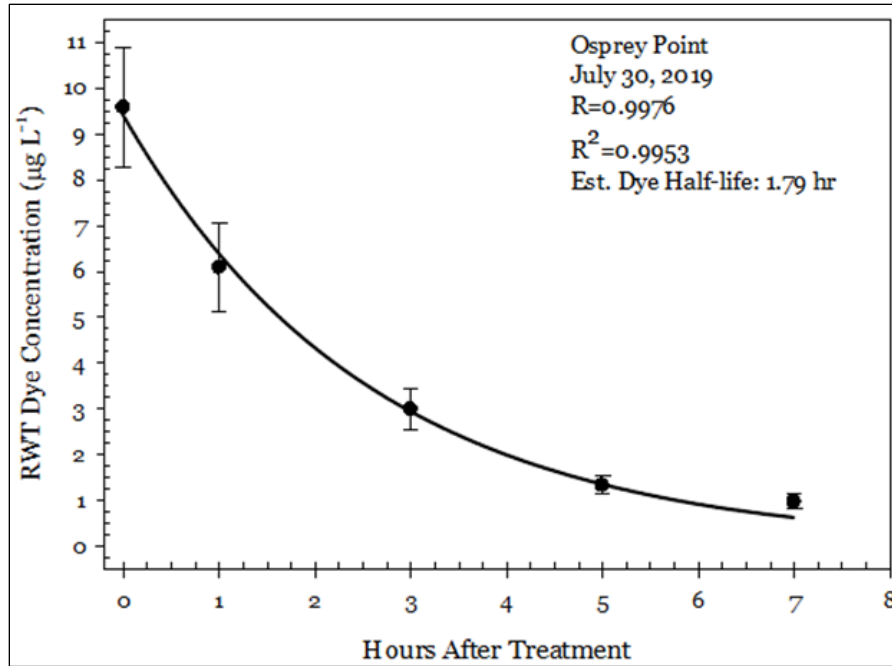
Figure 15. Mean RWT dye concentration ( $\pm$ SE) for each sampling period during the RWT dye plus diquat treatment at Osprey Point 30 July 2019. Dye dissipation and dye half-life was estimated using nonlinear regression (exponential decay,  $f = a \exp[-b \lambda]$ ).

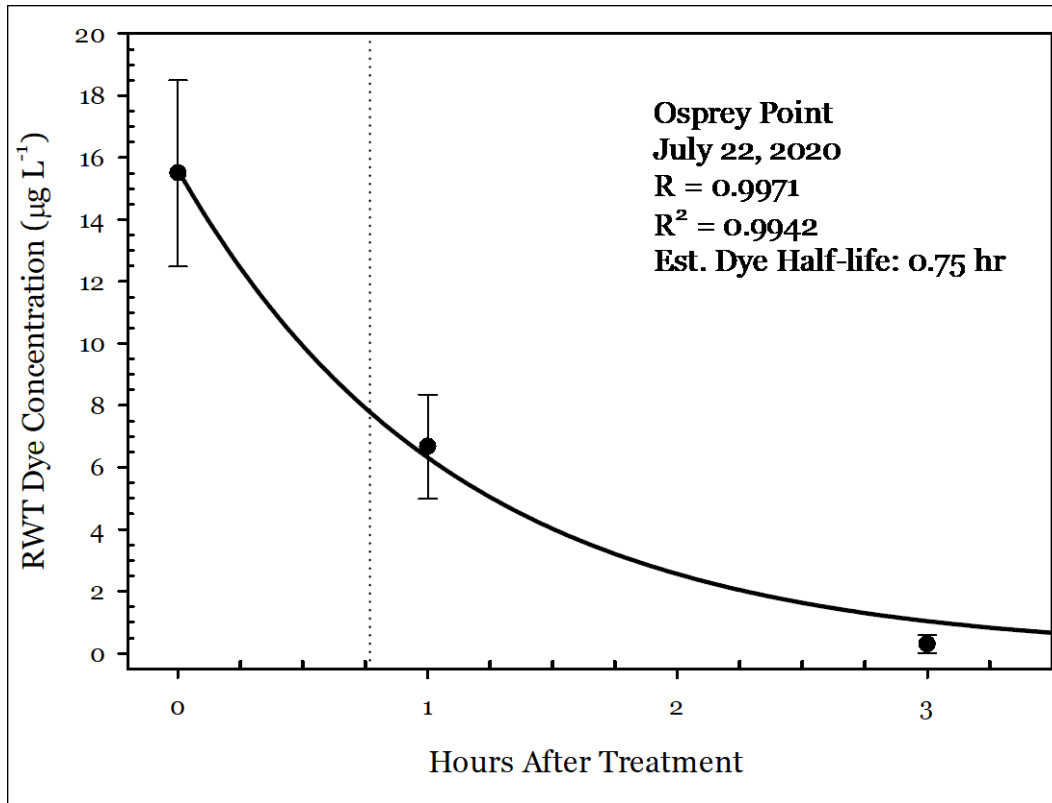
Figure 17. Mean RWT dye concentration ( $\pm$ SE) for each sampling period during the RWT dye treatment at Osprey Point on 22 July 2020. Dye dissipation and dye half-life was estimated using nonlinear regression (exponential decay,  $f = a \exp[-b \lambda]$ ).

The water-exchange process at Osprey Point on 22 July 2020 was extremely rapid and resulted in a RWT dye half-life of 0.75 hours (Figure 17). The whole-plot dye concentration immediately following treatment was  $15.5 \pm 2.9 \mu\text{g L}^{-1}$  with higher concentrations being detected in the mid to downstream portion of the plot. Measurements 1 HAT indicated whole-plot dye concentrations had decreased an estimated 53% to  $6.65 \pm 1.6 \mu\text{g L}^{-1}$ . The average concentration measured at sampling points in the upstream portion of the plot failed to exceed  $3.3 \mu\text{g L}^{-1}$ , whereas elevated levels (greater than or equal to  $10 \mu\text{g L}^{-1}$ ) were still being detected at sampling locations on the downstream end, indicating that the applied dye was rapidly dissipating downstream. Three hours after treatment no dye was detected at nine of the 18 sampling locations within the plot, and locations where dye was detected were less than  $1.1 \mu\text{g L}^{-1}$ . Dye distribution throughout the water column remained relatively consistent across sampling periods, with slightly higher concentrations being detected at the bottom compared to the upper and middle portion of the water column (Figure 18). During this study period, pool elevation at McNary Dam forebay remained relatively consistent (Figure 19). Pool elevations remained consistent with normal summertime operations since increased volumes of water needed to be discharged from McNary Dam to accommodate the

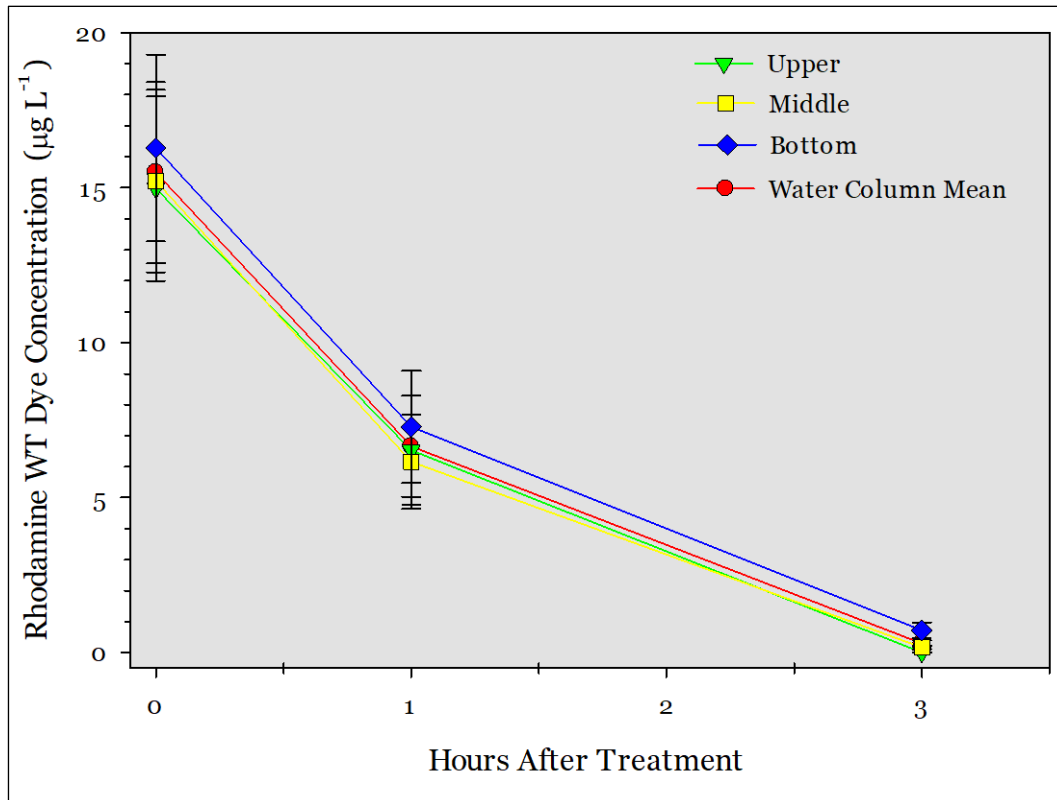
Figure 18. Mean RWT dye concentration measured at upper, middle, and bottom depths of the water column and mean across depths during each dye sampling event of the barrier curtain assessment at Clover Island in July 2019.

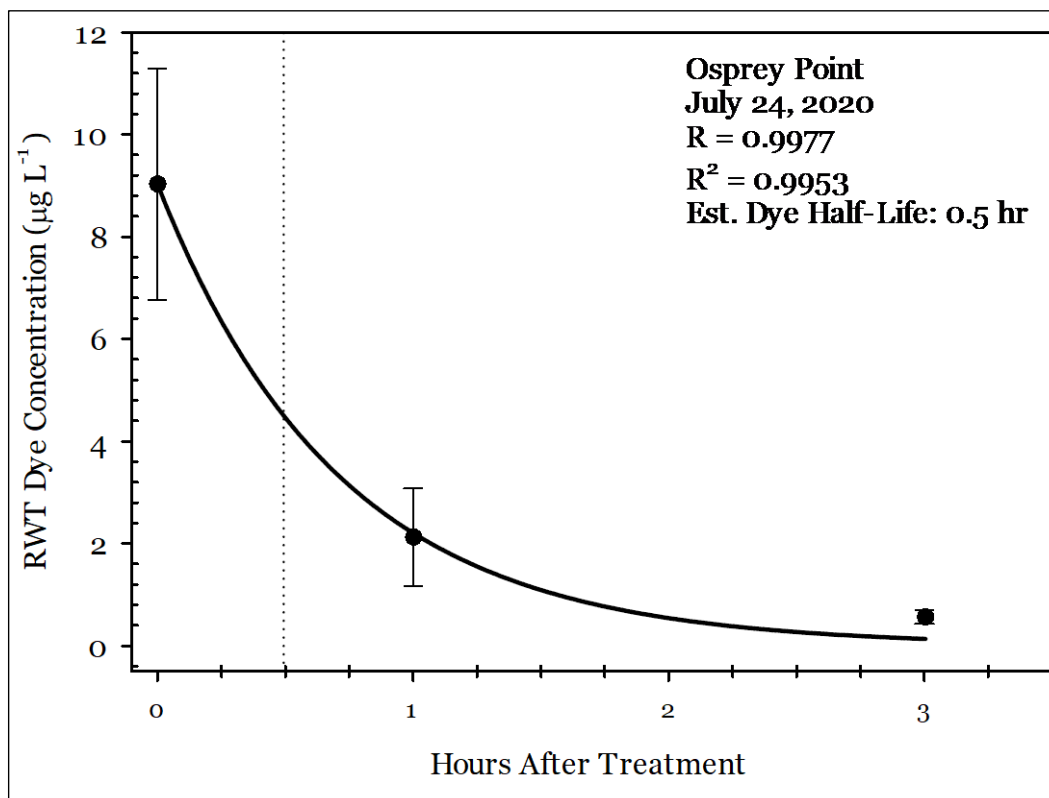
Figure 20. Mean RWT dye concentration ( $\pm$ SE) for each sampling period during the RWT dye plus diquat herbicide treatment at Osprey Point on 24 July 2020. Dye dissipation and dye half-life was estimated using nonlinear regression (exponential decay,  $f = a \exp[-bx]$ ).

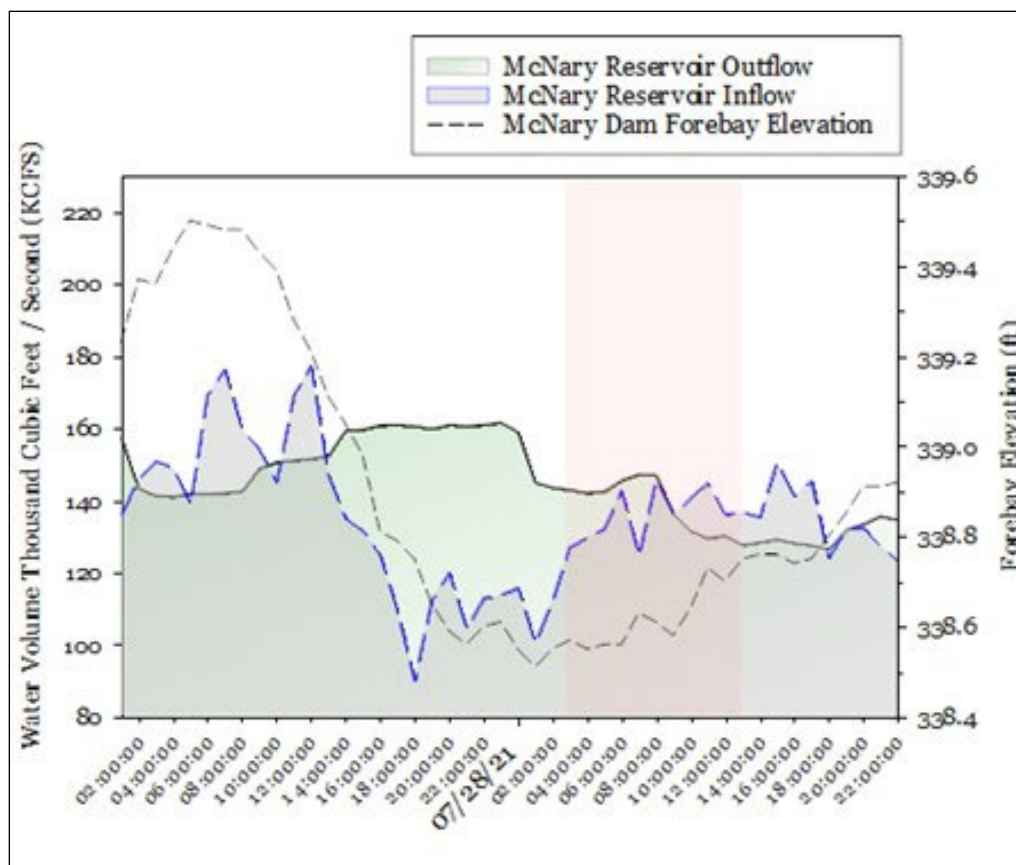
Figure 22. Inflow and outflow of water at McNary Reservoir and pool elevation at the McNary Dam Forebay 27–28 July 2021. The *red transparent box* represents the sampling duration of RWT dye plus diquat herbicide treatment. McNary Reservoir inflow is estimated based off discharge data at Priest Rapids Dam, Ice Harbor Dam, and the Yakima River. Priest Rapids, Ice Harbor, and McNary Dam discharge data are presented on an 18-, 8-, and 2-hour time of travel, respectively.

Unlike the previous studies, water-exchange evaluations with RWT dye alone were not performed prior to the 2021 herbicide field demonstration. Using previously collected water-exchange data, the herbicide plus RWT dye application in 2021 was planned to coincide with a period of minimum McNary Dam discharge and an increasing pool elevation. This approach has been shown to significantly extend herbicide contact times in Noxon Rapids Reservoir, Montana (Wersal et al. 2022) and demonstrated promise following the 2019 water-exchange evaluations. Therefore, to extend potential herbicide contact time, the application of diquat plus RWT dye was administered during the early morning hours (treatment start: 0243, end: 0305) on 28 July 2021. Herbicide and dye were uniformly applied throughout the water column using a boat-mounted spray boom affixed with eight equally spaced weighted hoses. Immediately following application, dye concentrations were measured at 1/3 and 2/3 depth of the water column with a Turner Designs Databank handheld data logger equipped with a Cyclops-7F sensor with Rhodamine WT optics (Turner Designs, Sunnyvale, California) at 18 predetermined sampling points evenly distributed throughout the plot. Dye sampling points were also established outside the plot to track dye dissipation from the treatment area. Measurements were taken immediately after treatment and at 1, 3, 5, 8, and 10.5 HAT. Total water discharge and forebay elevation at McNary Dam was 142.4 KCFS and 338.57 ft at 0300 hours (at treatment) and 127.6 KCFS and 338.73 ft at 1100 hours (8 HAT). McNary Reservoir inflow, outflow, and pool elevation at McNary Dam (55 km downstream from study site) during the water-exchange evaluation are presented in Figure 22. McNary Reservoir inflow was estimated using discharge data at Priest Rapids Dam, Ice Harbor Dam, and the Yakima River. Priest Rapids Dam discharge data are presented on an 18-hour time of travel while Ice Harbor Dam discharge is presented on an 8-hour time of travel. Water discharge at McNary Dam is presented on a 2-hour time of travel.

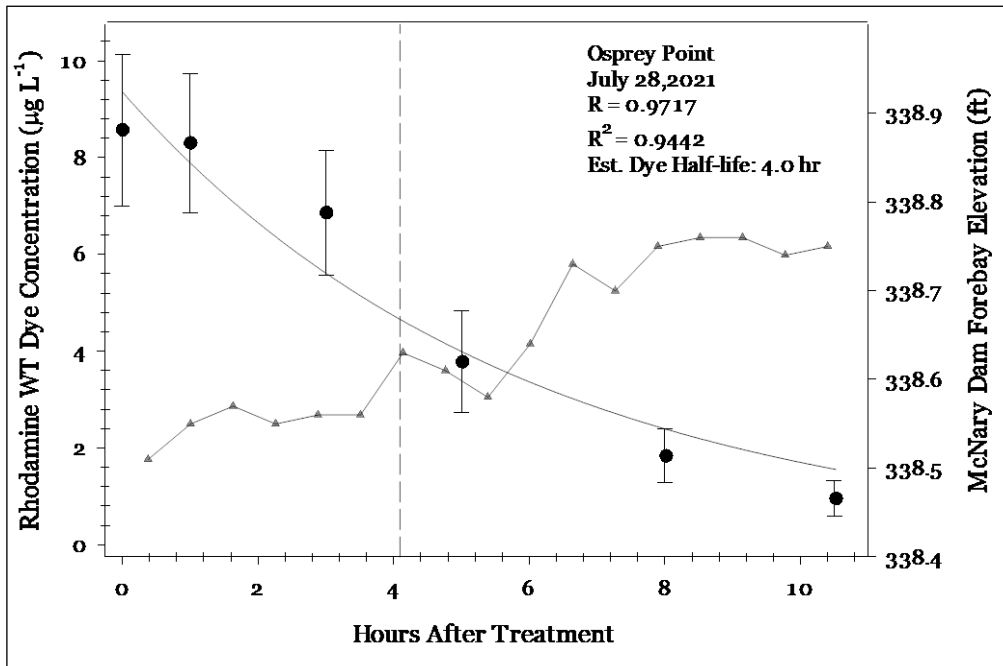
Figure 23. Mean RWT dye concentration ( $\pm$ SE) for each sampling period during the RWT dye plus diquat herbicide treatment at Osprey Point 28 July 2021. Dye dissipation and dye half-life was estimated using nonlinear regression (exponential decay,  $f = a \exp[-b x]$ ). The  $\blacktriangle$  represent McNary Dam Forebay elevation at HAT.

The precise timing of the RWT dye plus diquat herbicide application resulted in an estimated dye half-life of 4 hours (Figure 23), which was a two-fold increase in the half-life of applied RWT compared with previous water-exchange evaluations at Osprey Point from 2018 to 2020 (Sartain et al. 2022). Immediately following treatment, the whole-plot dye concentration averaged  $8.0 \pm 0.6 \mu\text{g L}^{-1}$  and decreased by approximately 20% at 3 HAT. Distribution of RWT throughout the water column remained consistent from 0 to 3 HAT and ranged between 40% and 50% in the lower water column and 50%–60% in the upper water column (Figure 24). From the 3 to 8 HAT sampling interval, the most significant decrease in dye concentration was observed. Dye measurements indicated a reduction from  $6.0 \pm 0.3$  to  $1.0 \pm 0.6 \mu\text{g L}^{-1}$  RWT at 3 and 8 HAT, respectively. At the 5 and 8 HAT samplings, greater proportions of dye were being detected in the upper water column compared with the lower water column.

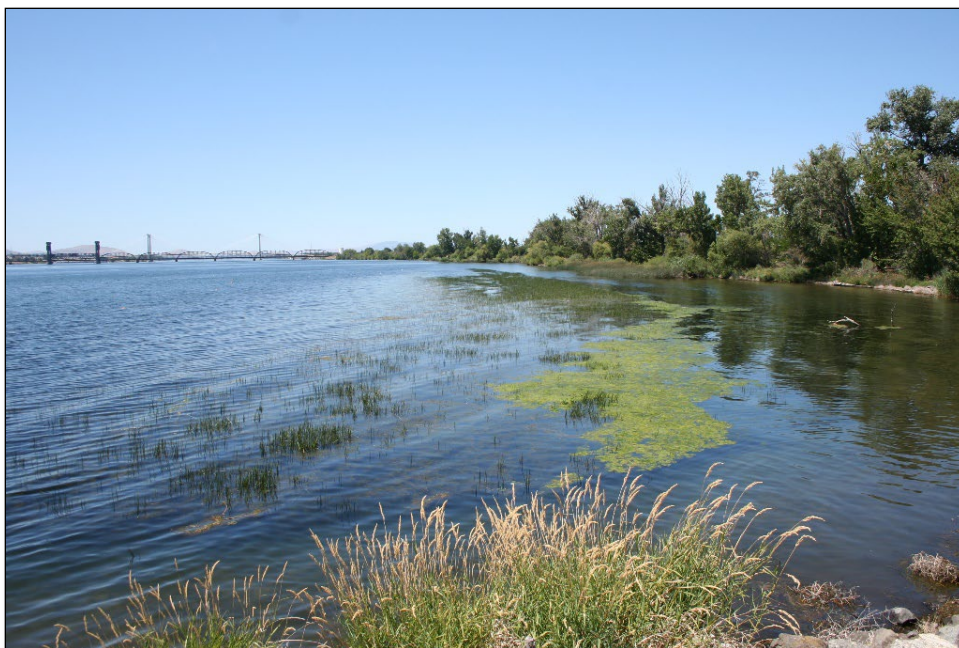
Figure 26. Emergent flowering rush occurring throughout the Osprey Point treatment plot prior to herbicide treatment in July 2019.

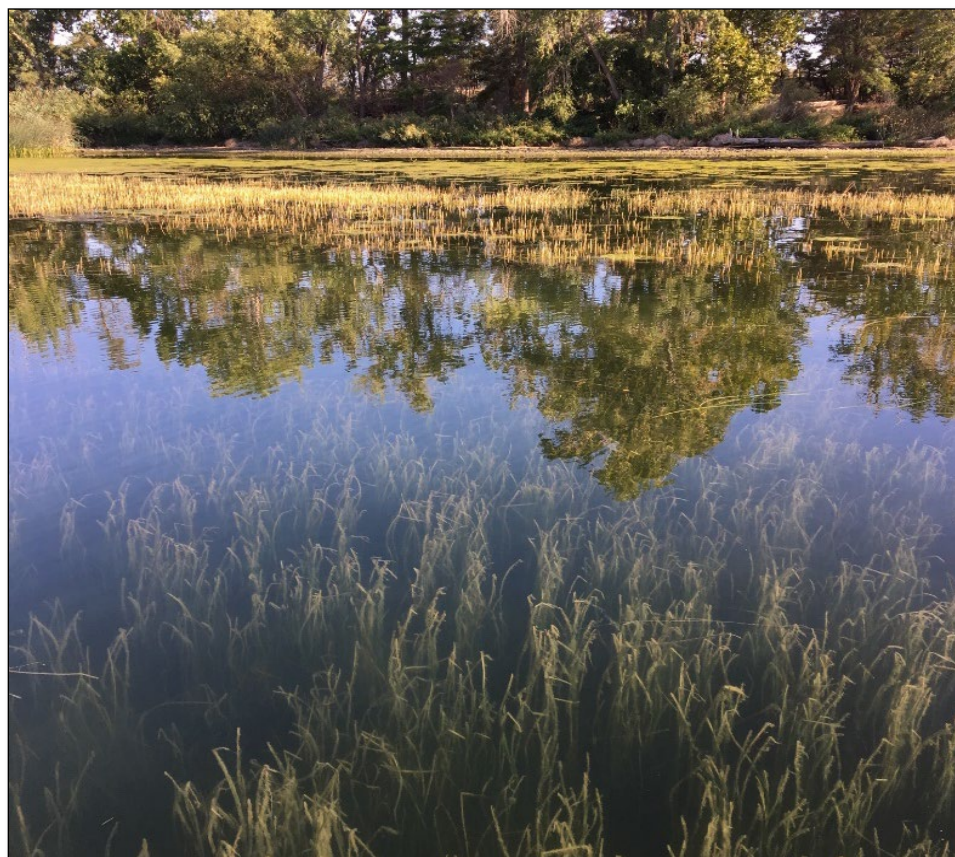
Figure 27. Diquat herbicide injury to submersed and emergent flowering rush 4 weeks after treatment (WAT) at Osprey Point in August 2019.

Visual observations 4 WAT indicated flowering rush plants exhibited typical diquat injury symptomology (e.g., chlorotic, and necrotic shoots), as shown in Figure 27. Herbicide injury was most prevalent along the upper portions of leaves, whereas green viable plant tissue persisted at the base of the plant near the sediment-water interface. Submersed plants occurring at greater depths greater than 1.5 m) did not appear to be as injured as emergent/submersed plants found in shallower waters (less than 1.5 m). Flowering rush remained at 100% occurrence at 4 WAT, since injured plants had not begun to deteriorate. However, all predominate co-occurring species displayed a decrease in percent occurrence (see Table 1). Injury to nontarget vegetation was not surprising, as diquat is a broad-spectrum contact herbicide and many of the co-occurring species are sensitive to the herbicide rate applied. By 8 WAT, flowering rush occurrence had decreased by 44%. While the herbicide treatment likely contributed to this decline, it is probable that the onset of fall senescence for flowering rush and other aquatic plant species (e.g., leafy pondweed) contributed, especially since plant occurrence rapidly decreased from 8 to 10 WAT. A similar trend was observed from 8 to 10 WAT for flowering rush and co-occurring species in the nontreated reference plot (see Table 2).

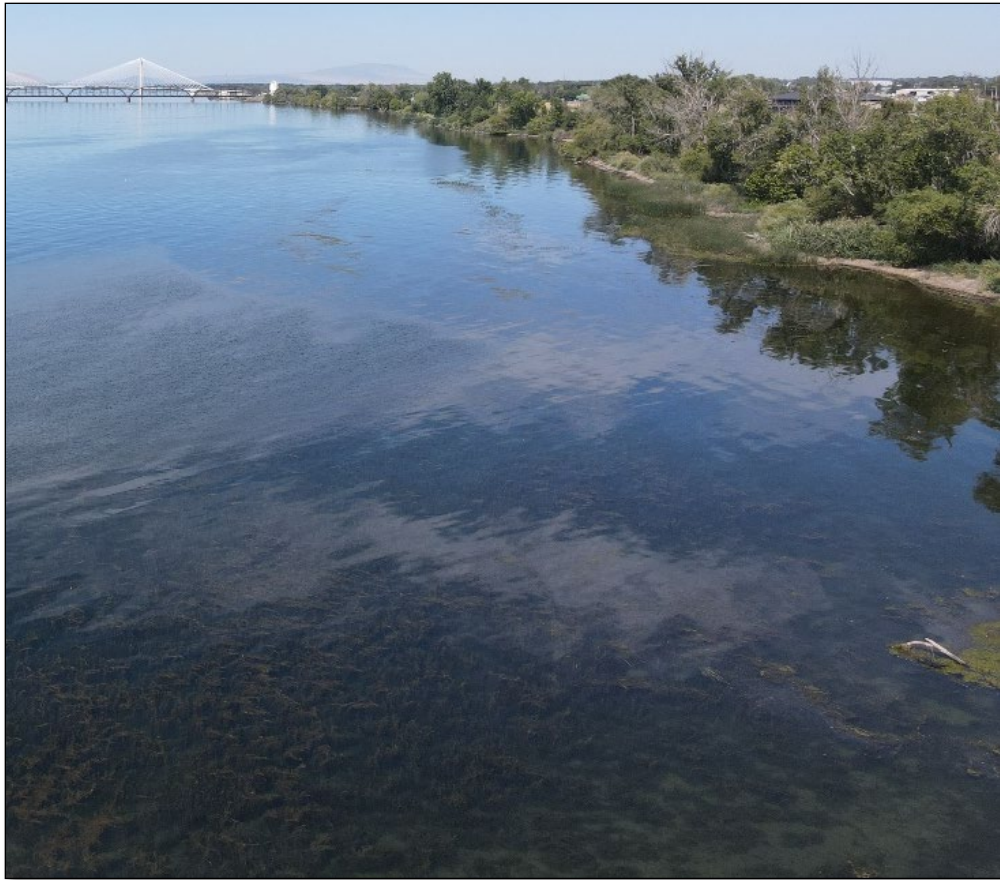
Figure 28. Aerial view of the Osprey Point treatment site 4 WAT in August 2020.

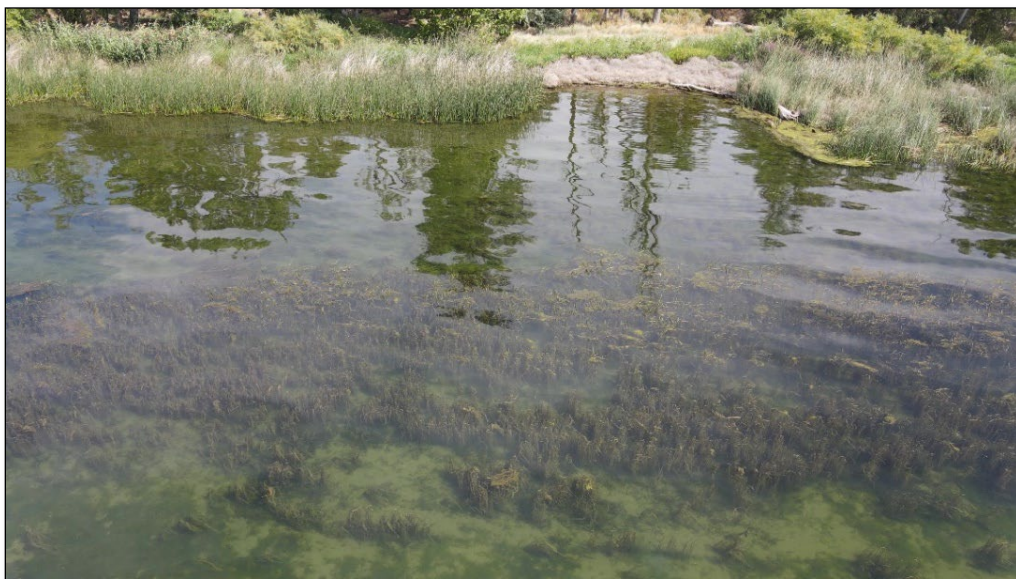
Figure 29. Submersed flowering rush documenting moderate diquat herbicide injury 4 WAT at Osprey Point in August 2020.

During the diquat treatment in 2020, water-exchange rates were extremely rapid (estimated dye half-life 0.5 hours), resulting in minimal herbicide to target-plant exposure. Because of high bulk water exchange, visual herbicide injury to flowering rush 4 WAT was expected to be negligible; however, moderate injury was noted to plants at the downstream end of the plot (Figures 28 and 29). It is likely that these plants were subjected to prolonged herbicide exposure. Like the 2019 study, flowering rush frequency of occurrence was 90% at 4 WAT in 2020 following a single diquat application, whereas coontail, Eurasian watermilfoil, and multiple pondweed species increased in occurrence (see Table 1). This trend was also observed at the reference plot where all co-occurring species, except for Eurasian watermilfoil, increased from July to August 2020 (see Table 2).

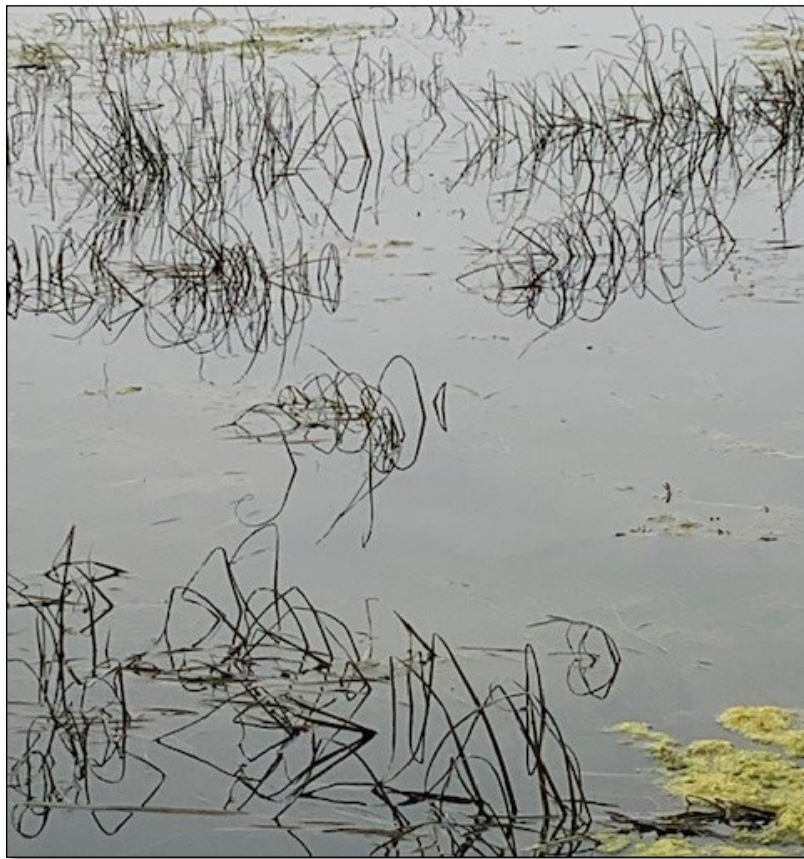
Figure 30. Flowering rush displaying diquat herbicide injury 72 HAT in July 2021.

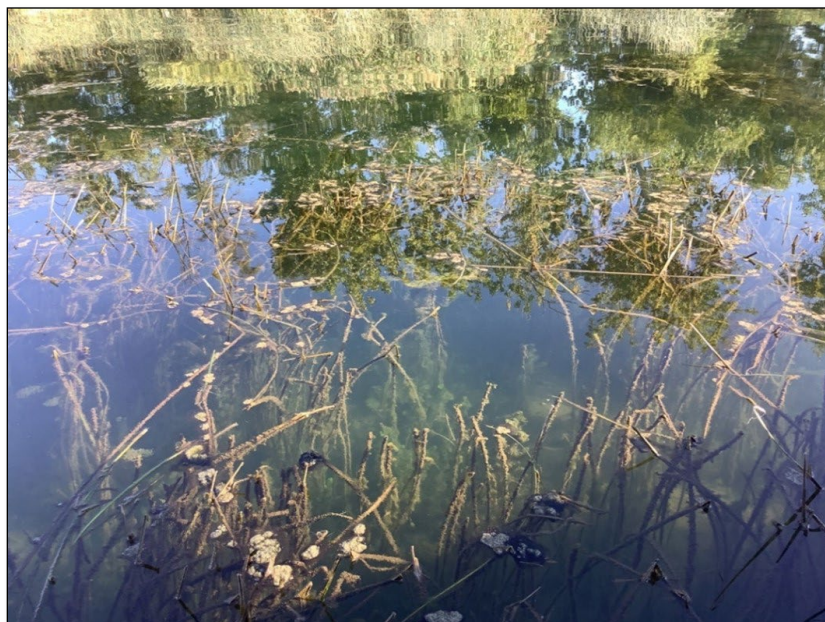
Figure 31. Flowering rush displaying diquat herbicide injury 6 WAT in September 2021.
