PROTOTYPE DEVELOPMENT AND TESTING
AUTOMATED ASTRONOMIC POSITIONING
SYSTEM

Control Data Corporation

Air Force Cambridge Laboratories

25 October 1974

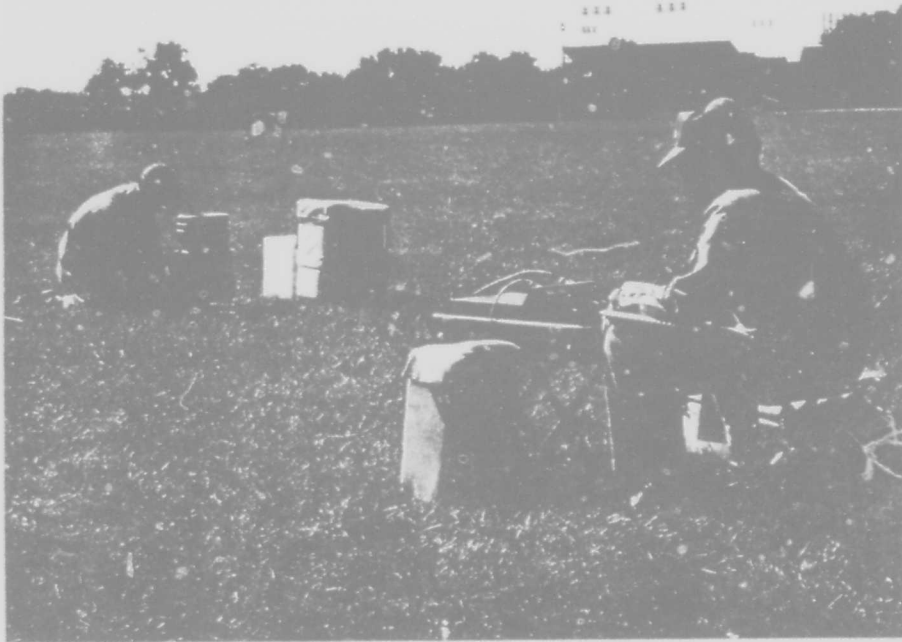
Figure 3. AAPS Site Deployment

These are divided into site and base portions. The site equipment includes sensor head, control unit, and battery pack and is shown in field deployment in Figure 3; there the sensor head is being coarse leveled prior to operation. Figure 4 gives a closer view of the grouped instrumentation. In both figures the transport soft-packs for the sensor head and the control unit are also shown. The sensor head contains the optics, slit reticle, and photodetectors required for the measurement of star transits as shown in Figure 1; it also contains filter and detection electronics and an active leveling system provided by Hughes Research Laboratories, Malibu Beach, California. The control unit contains a 469 miniature computer, precision clock, and a control panel for operation and monitoring.

The control unit, sensor head, and battery are then transported to the first site to be occupied and set up in a manner similar to that depicted in Figure 3. (A maximum separation of 50 feet is allowed between control unit and sensor head. During cold weather, the operators and control unit could remain in a heated vehicle.) The sensor head is mounted on a relatively stable base (concrete pier, sidewalk, roadway, blocks, etc.). It is then aligned within 5° of celestial north and coarse-leveled using the footscrews and external bubble levels. A screen is erected around the sensor head after alignment to protect it from wind gusts and to provide shielding from neighboring lights.

The sensor head is an important piece in the AAPS system and has been shown in the field photos of Figures 3 and 4; it is also shown in outline form in the drawing of Figure 8. It is 19 3/4 inches high by 12 1/2 inches in diameter (50.1 x 31.8 cm), weighs 30 kg (66 lbs.), and fits into a soft-pack having outside dimensions 17 x 17 x 24 inches (43.2 x 43.2 x 60.9 cm). Its major constituents are: optics, leveling system, photodetectors and electronics, reversal bearing, and motor. These are each described separately in subsequent paragraphs.

The optical elements and level subsystem are shown assembled in Figure 13. This portion of the sensor head is covered during operation by the light-colored top seen in Figures 3 and 4.

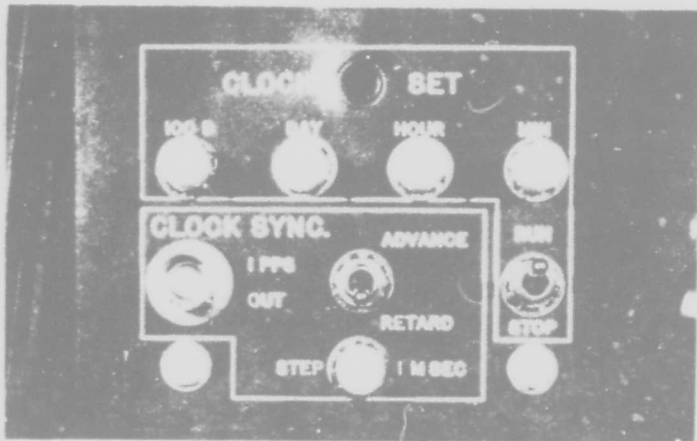
Figure 21. AAPS Clock Controls and Waveforms

Controls for the clock itself are located on the control/display panel on the front of the control unit. Figure 21 shows the controls along with waveform photos used in clock alignment. The clock is simply set by putting the RUN/STOP switch into the STOP position and incrementing the upper four buttons until the display shows the proper day of the year, hour, and upcoming minute. When a time service broadcast, such as WWV, is listened to, the RUN/STOP switch may

(a) Clock controls on front panel of control unit

(b) 1 pps output pulses (5 v/cm, 200 msec/cm)

(c) Two views of WWV "Tick" reception

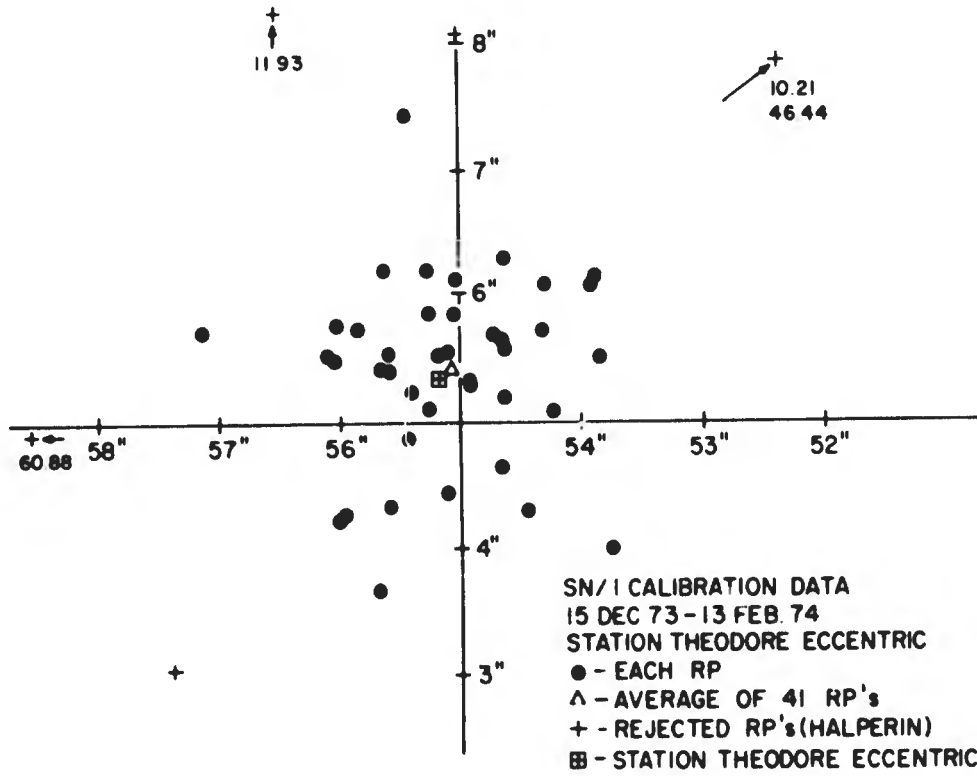
Figure 26. Calibration Test Results: December 15, 1973 through February 13, 1974

The results of this testing are shown in Figures 26 and 27 as scatter plots. Each plotted point (dot or cross) represents the result of a single pair of direct/reverse sets. The crosses represent reversal pairs which were later rejected on a Halperin basis (see the discussion in Section V-D). Those crosses or dots enclosed in circles (acceptance data, Figure 27 only) were associated with anomalous sky or weather conditions (again, refer to Section V-D).

Data recorded up to February 13 (Figure 26) was used to derive slit calibrations and offsets using the 6600 computer at Control Data Corporation in Minneapolis. A final AAPS system tape was generated in early February including these calibrations. From that point on, the 469 computers in the control units were the only source of computation (acceptance data, Figure 27).
