STORABILITY INVESTIGATIONS OF WATER  
LONG-TERM STORAGE EVALUATION

Aerojet Liquid Rocket Company

Air Force Rocket Propulsion Laboratory

December 1974

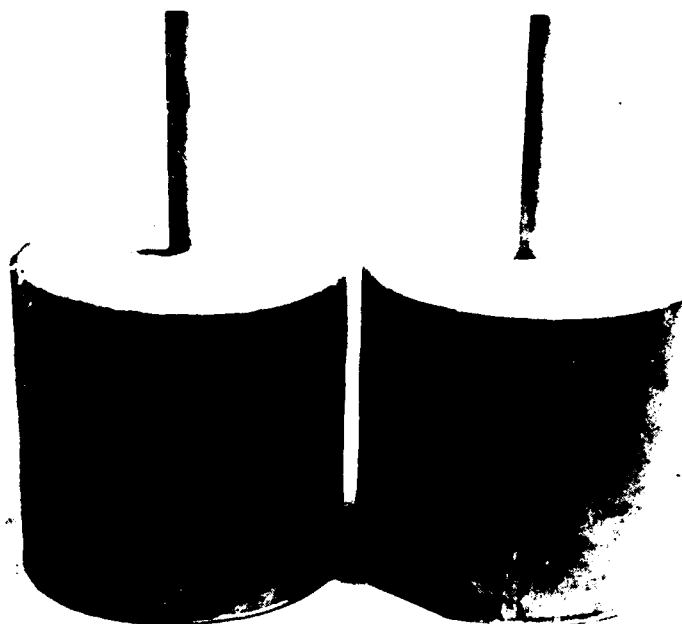
The external appearance of the containers is documented photographically in Figures 1 through 5. The internal appearance of the containers is documented photographically in Figures 6 through 15. Examination of these surfaces without visual aids showed full penetration for the full length of all weldments. Other conditions resulting from fabrication and cleaning procedures were: (1) etching of A-286 containers during pickling; (2) isolated dark areas, a tightly adherent smut, and isolated shiny deposits of material in the 17-4pH stainless steel containers; (3) a tightly adherent smut in the Inconel 718 containers; and (4) isolated areas of residual titanium oxide, localized circular areas of attack, and a general mottled appearance including fingerprint contamination in the 6Al-4V titanium containers.

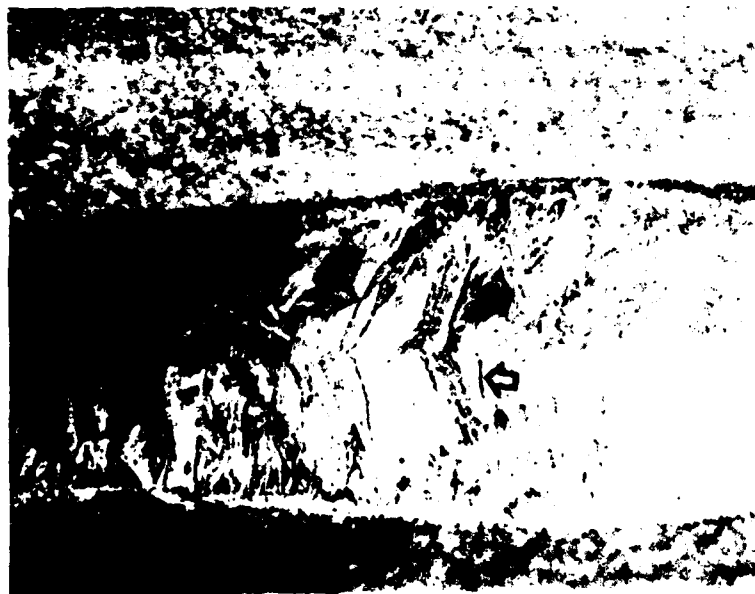
Figure 24. Weld Shrinkage Cracks in Inconel 718 No. 4 Container (arrows)

c. Dye penetrant inspect welds then trim tubes to required length. No cracks allowed.
