CATAPULT AND ARRESTED LANDING FATIGUE
TESTS OF THE MODEL E-2A/B AIRPLANE

REPORT DOCUMENTATION PAGE		READ INSTRUCTIONS BEFORE COMPLETING FORM
1. REPORT NUMBER NADC-74199-30	2. GOVT ACCESSION NO.	3. RECIPIENT'S CATALOG NUMBER AD/A005 770

S U M M A R Y

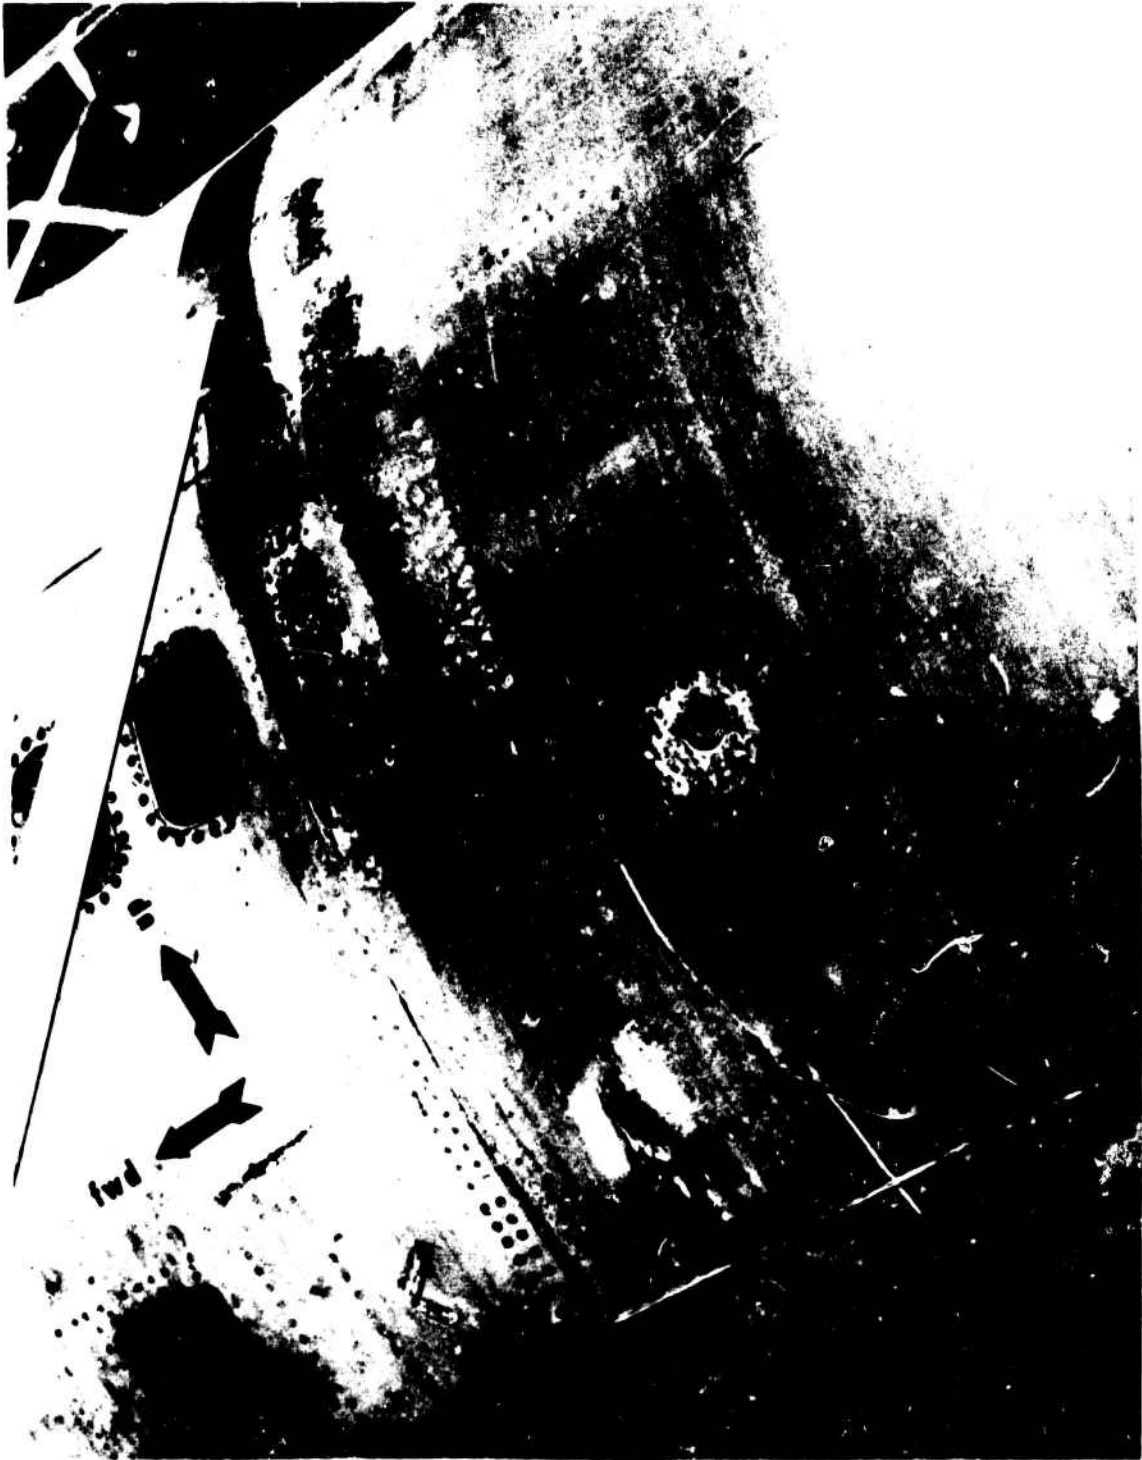
During cycle number 2798, a skin failure occurred on the left side between FS 150 and FS 159. This failure, shown in figures 7 and 8, occurred because of extensive skin corrosion in that area. Figure 9, which is a close-up of one of the fracture surfaces, clearly shows the material degradation caused by the corrosion. Examination of skin revealed other corroded areas aft of the failure, therefore, a section of skin extending from FS 141 to FS 203 was cut out and a .050 7075-T6 repair patch was installed. This repair is shown in figure 10.

FIGURE 7 - Skin Failure - Cycle No. 2798

FIGURE 8 - Skin Failure - Cycle No. 2798 - View Inside Fuselage

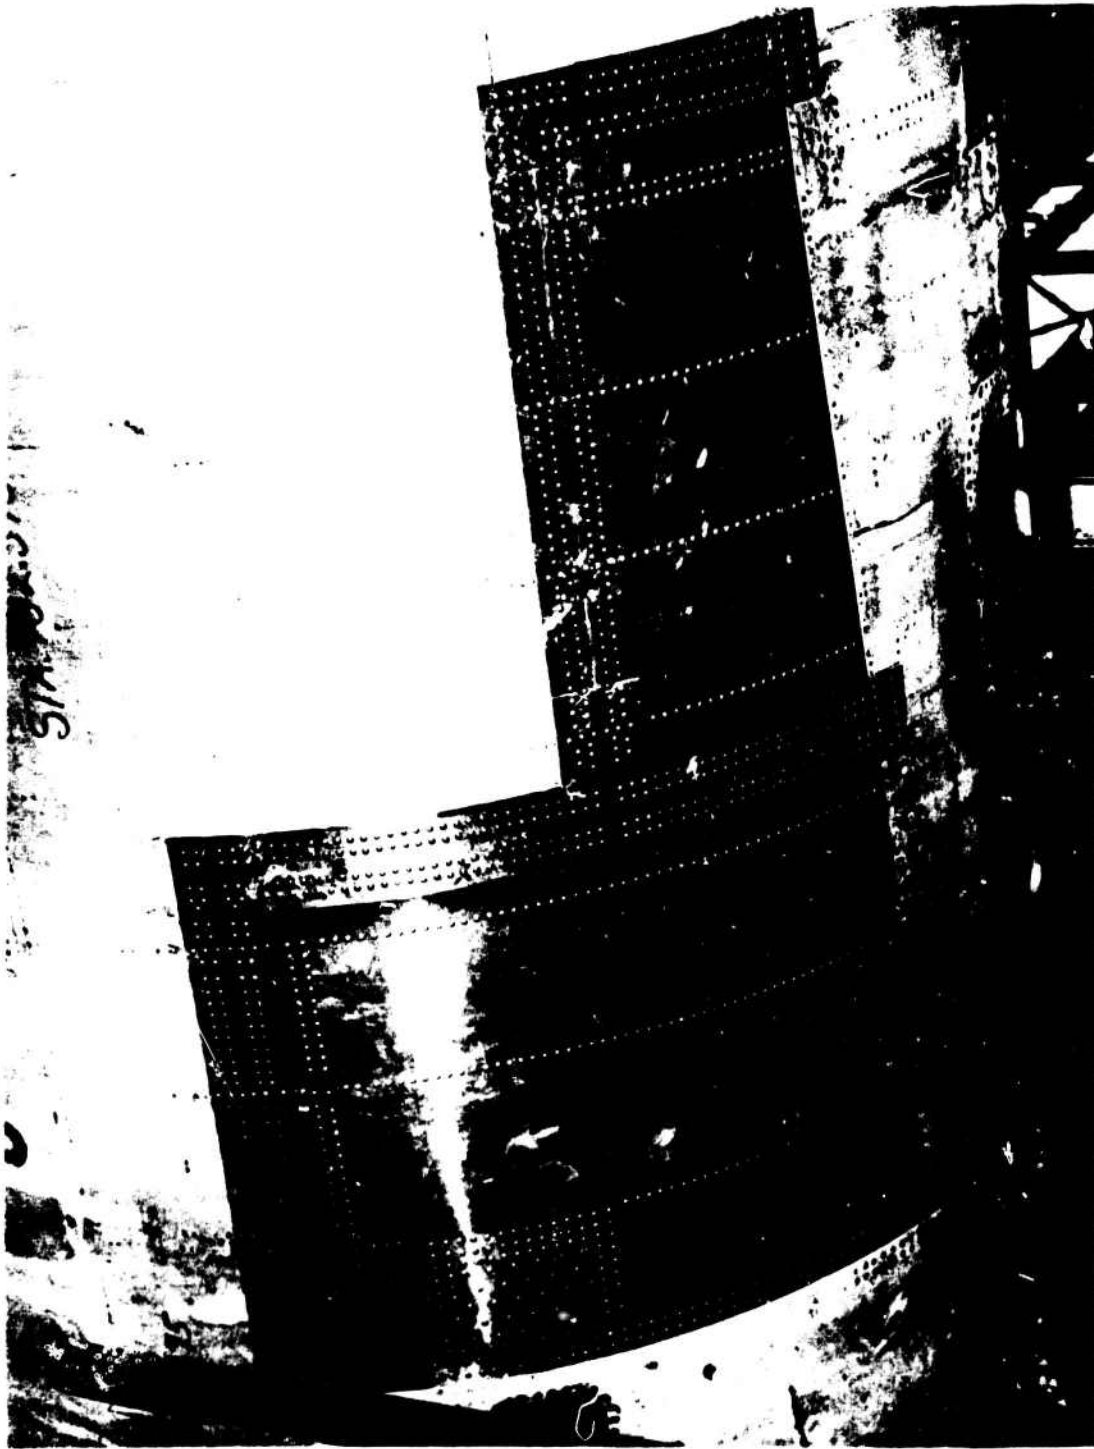
FIGURE 10 - Skin Repair

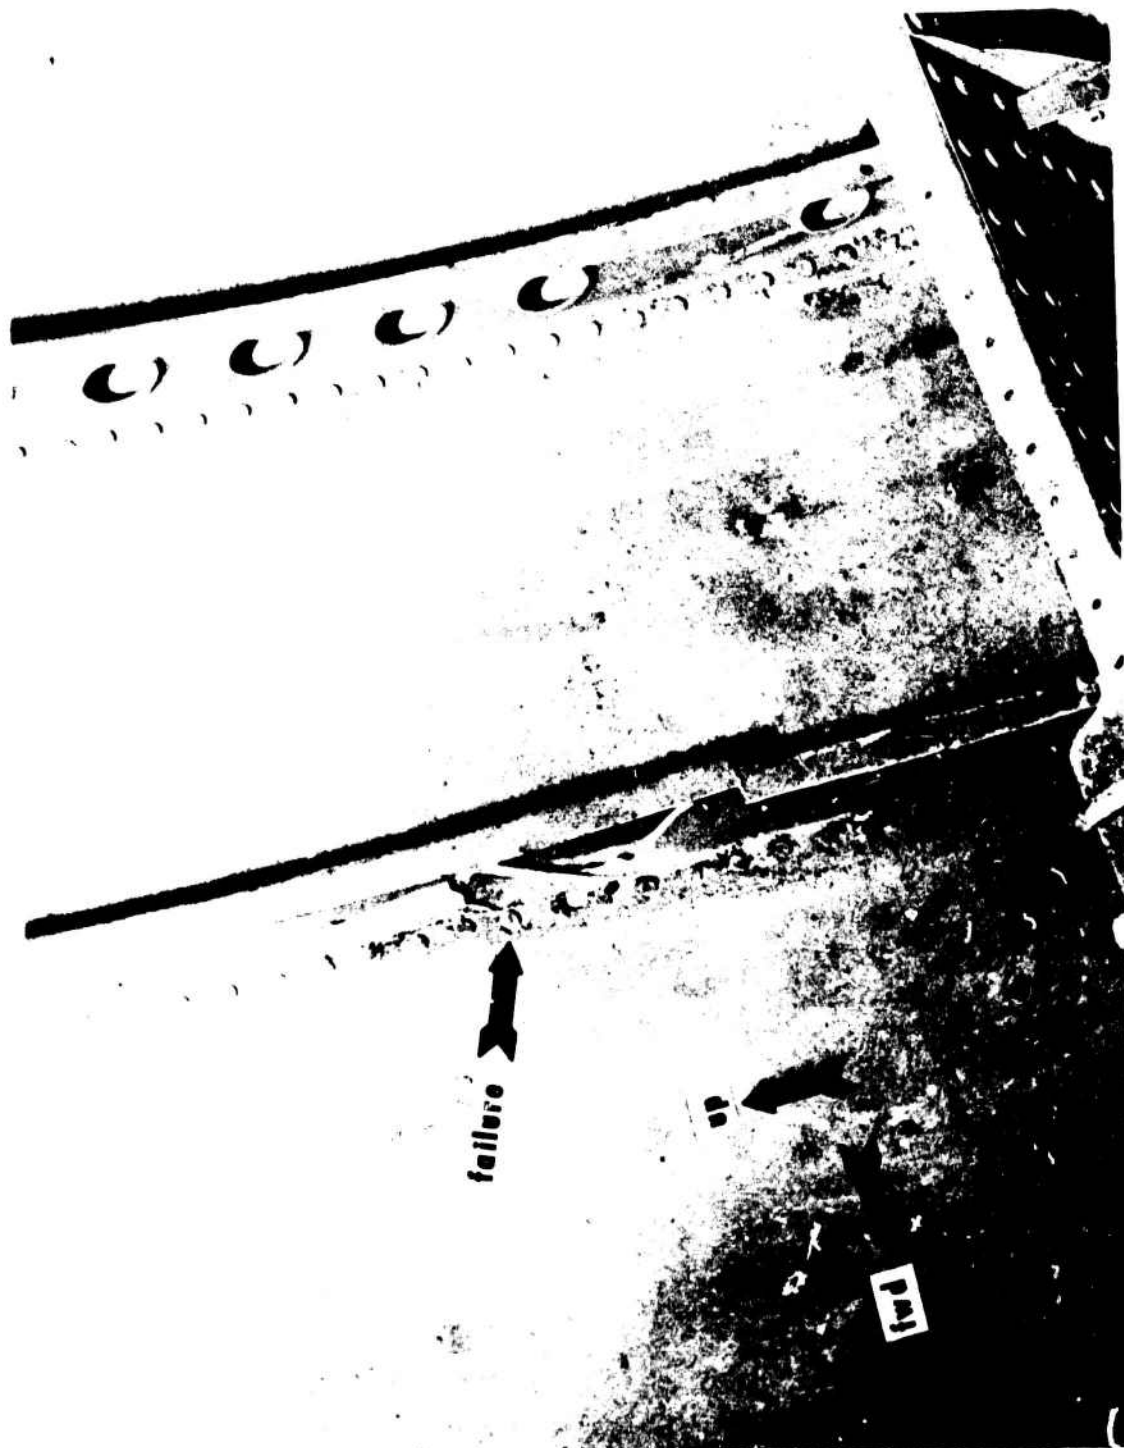
During cycle number 3910, a loud noise occurred and the test was stopped so that the cause of the noise could be located. Inspection revealed that the fuselage frame at FS 183 (stbd. side) had failed. The failure is shown in figure 11. The frame was repaired and testing

FIGURE 11 - Fuselage Frame FS 183 - Failure at Cycle 3910

resumed. Examination of the fracture surface indicated that the failure originated at a rivet hole (see figure 11) and propagated along the radius between the web and lower flange and finally through the web and upper flange of the frame. The origin of the crack was heavily corroded indicating that the crack had existed for quite some time and had originated prior to this test. This theory is further substantiated by the fact that there was a dent on the outside of the fuselage at the exact location of the origin of the failure before this test began.

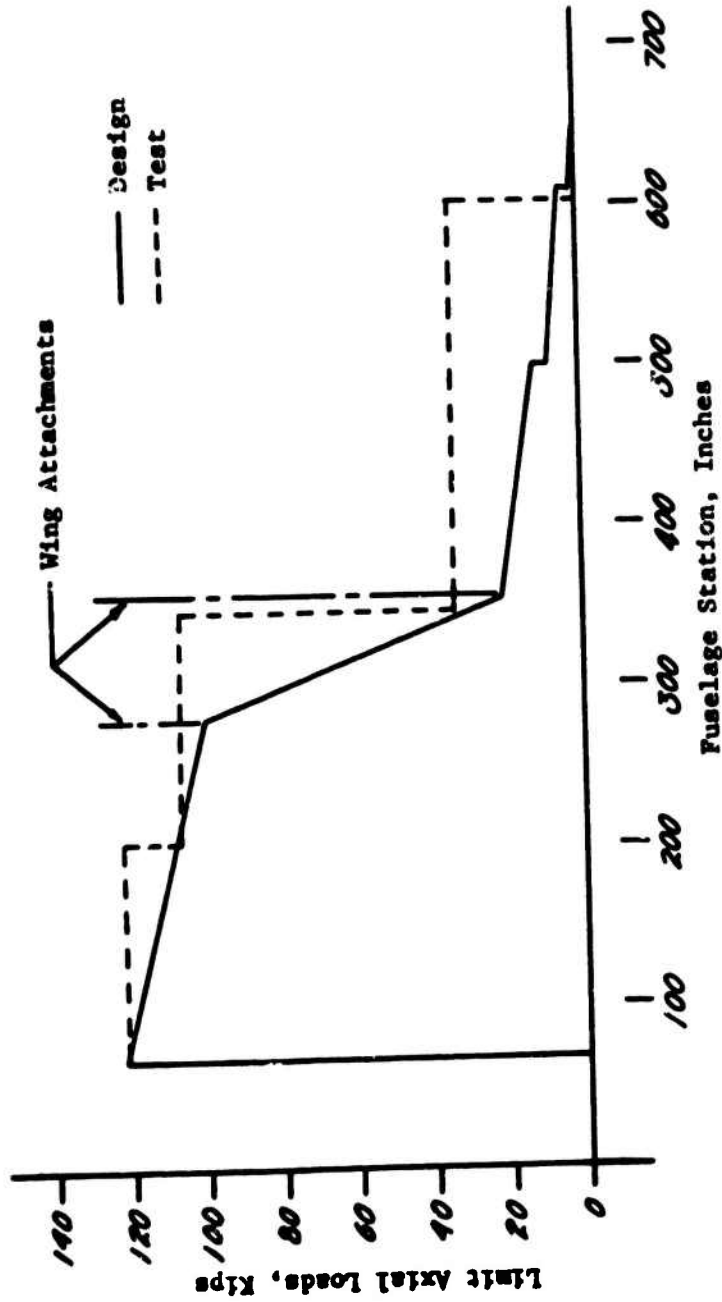
The distribution of loads is shown in tables A-5 and A-6. Comparisons of the design and test curves are shown in figures A-10 through A-15. These comparisons show good agreement in the critical area forward of the wing. It should be noted that since the design curves show the nose gear loads as a concentrated load at one point (page 14, reference (d)), the test curves also treat them as a concentrated load for the sake of clarity.
