THE EFFECT OF SONIC BOOM ON THE NESTING  
AND BROOD REARING BEHAVIOR OF THE  
EASTERN WILD TURKEY

Alabama Cooperative Wildlife Research Unit

January 1975

# Technical Report Documentation Page

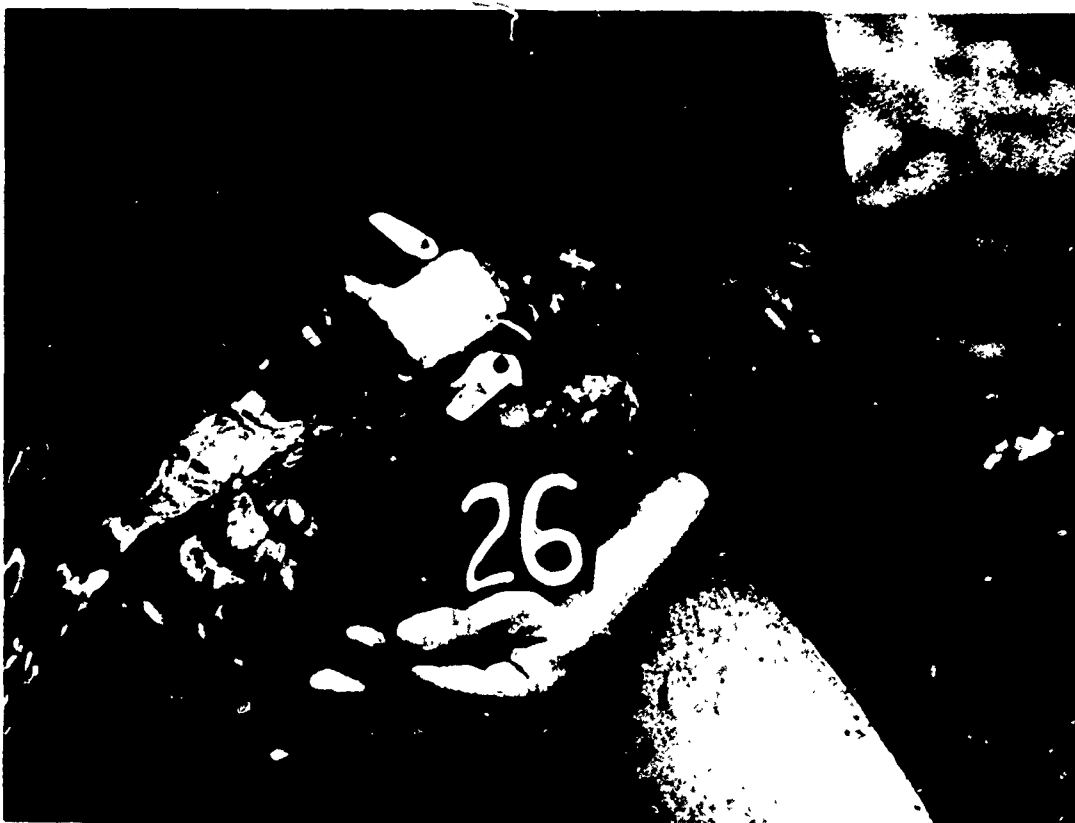
Figure 2. Wild turkey hen with transnitter and wing-marker.

The turkeys were then equipped as described by Williams (1968) with 164 MHz transmitters weighing approximately 90 grams (Figure 2). This consisted of placing the transmitter "backpack fashion" on the back of the turkey and securing with 3/8 inch surgical tubing tied beneath the wings. Transmitters were manufactured by Sidney L. Markusen Electronic Specialties, Cloquet, Minnesota. Each turkey had a different transmission frequency. The turkeys were then returned to their holding boxes and when fully recovered were released at their capture sites, usually the following day.
