MECHANICAL FAILURE PROGNOSIS THROUGH  
OIL DEBRIS MONITORING

Exxon Research and Engineering  
Company

Army Air Mobility Research and  
Development Laboratory

January 1975

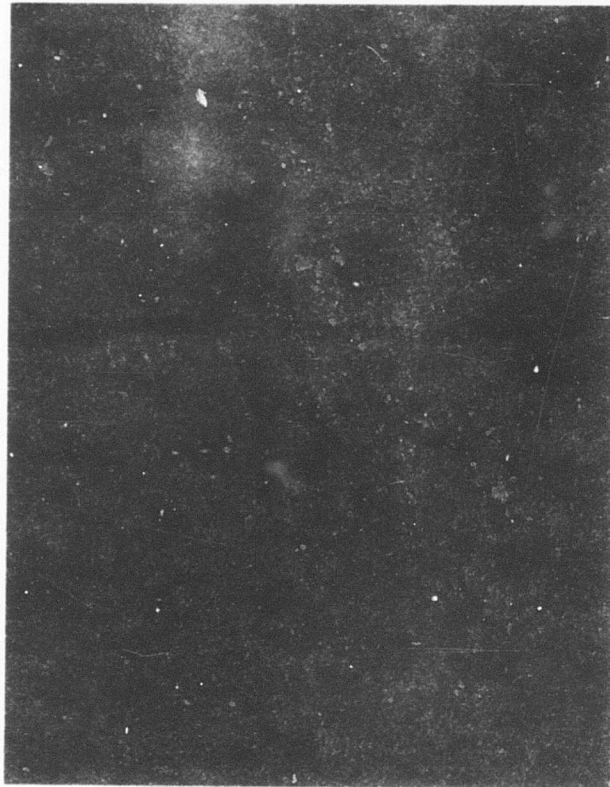
Figure 8. Low-Cycle Sliding Fatigue Particles.

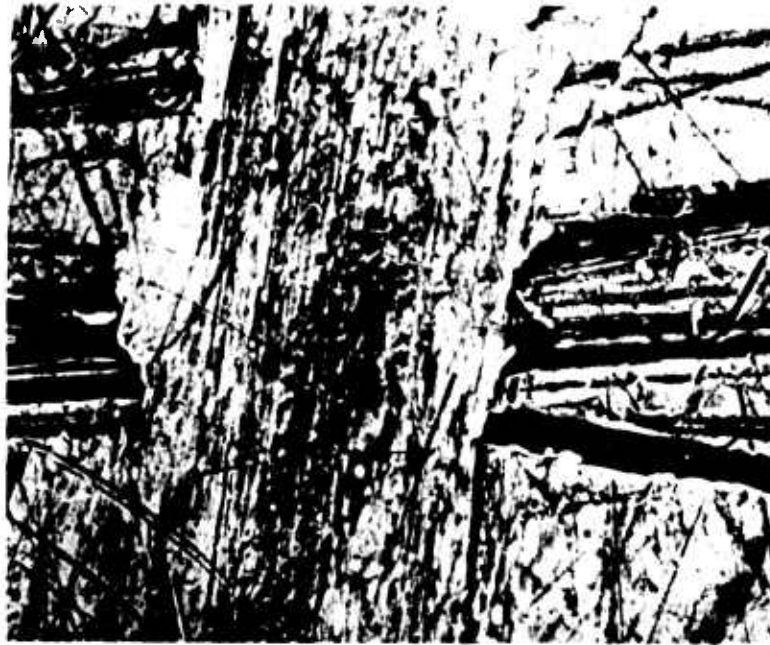
Figure 33. SEM Microgram (500X) Showing Smeared Surface.
