EVALUATION OF M9M1 LANDING MAT

Army Engineer Waterways Experiment Station  
Vicksburg, Mississippi

July 1963

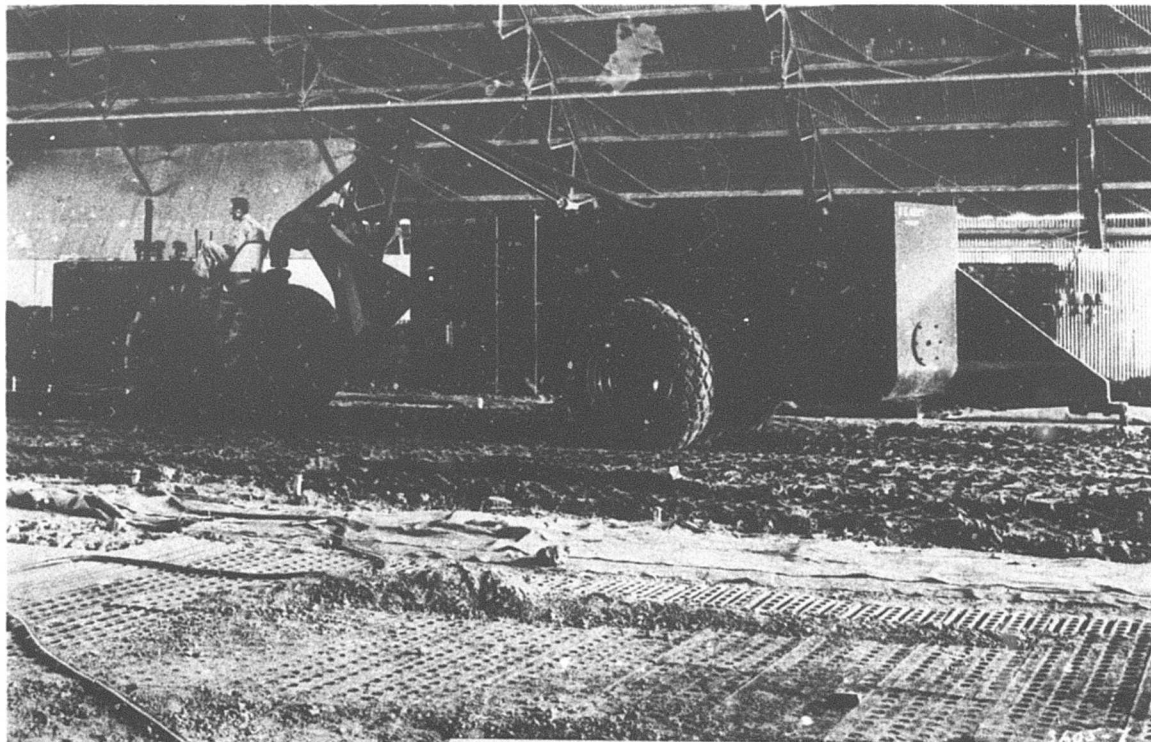
Fig. 1. Roller used in compaction of items 1 and 2

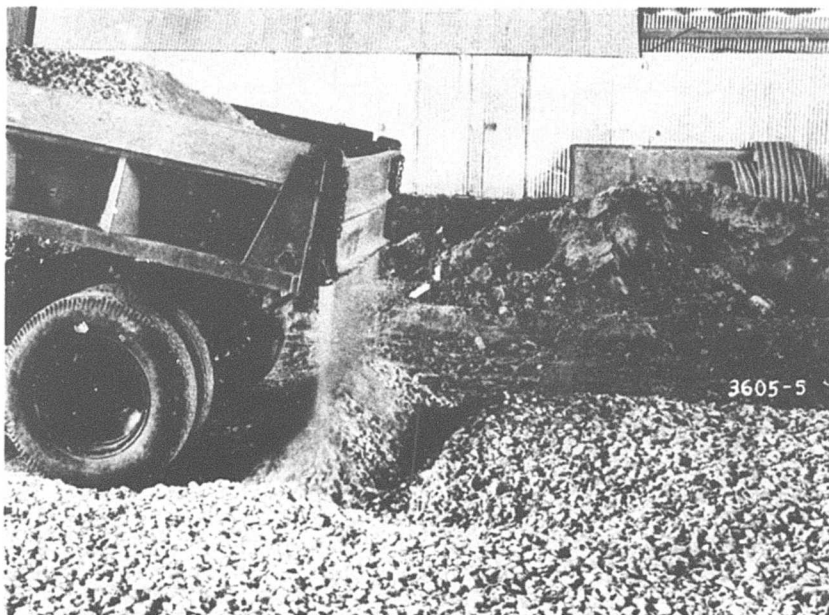
Fig. 2. End-dumping  
rock in item 3

9. Items 3 and 4. Item 3 consisted of 12 in. of uncompacted, loose rock that was end-dumped (fig. 2) and spread by hand. Due to the coarseness of the material and the loose state in which it was placed, no attempt

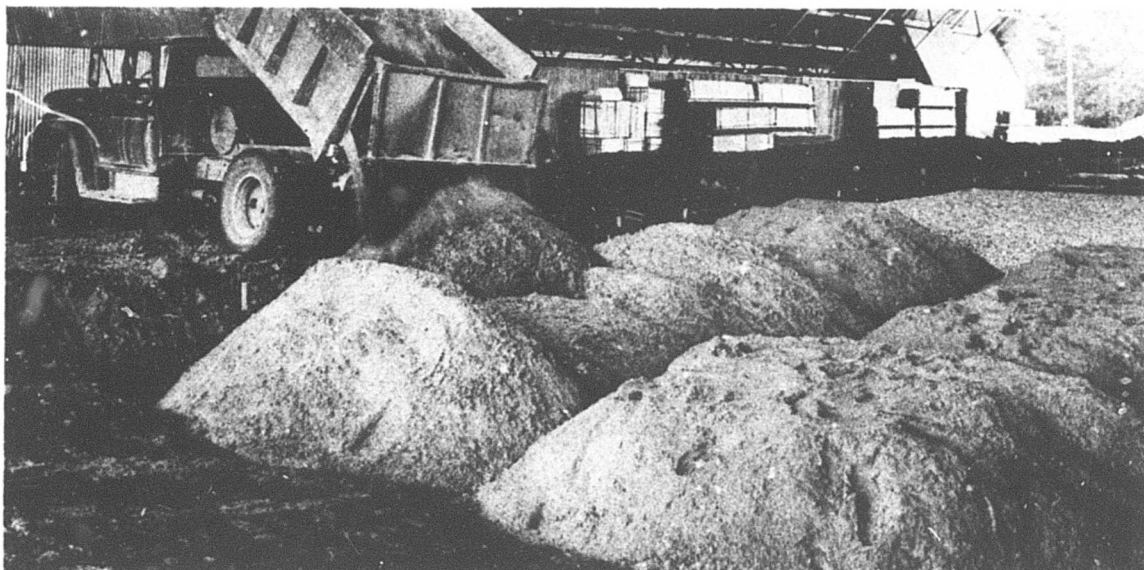
Fig. 3. End-dumping sand in item 4

10. Item 4 consisted of 24 in. of sand that was end-dumped (fig. 3)

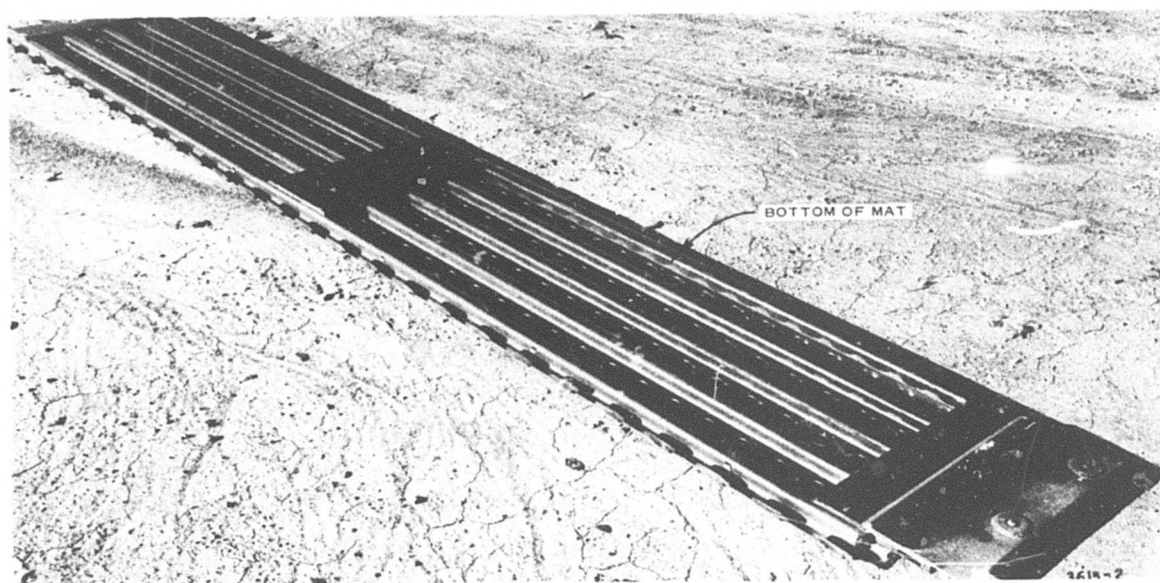
Fig. 5. M9M1 landing mat

12. The M9M1 landing mat, shown on NAEL drawing No. 608942 and in fig. 5, is Corps of Engineers M9 aluminum mat modified by riveting and welding of a solid aluminum plate (5/32 in. thick) to the top of the mat. Aluminum alloy used in the M9 mat is 6061-T6, and that used in the top plate is 5456-H321. Two cap screw-pilot nut combinations are used to form

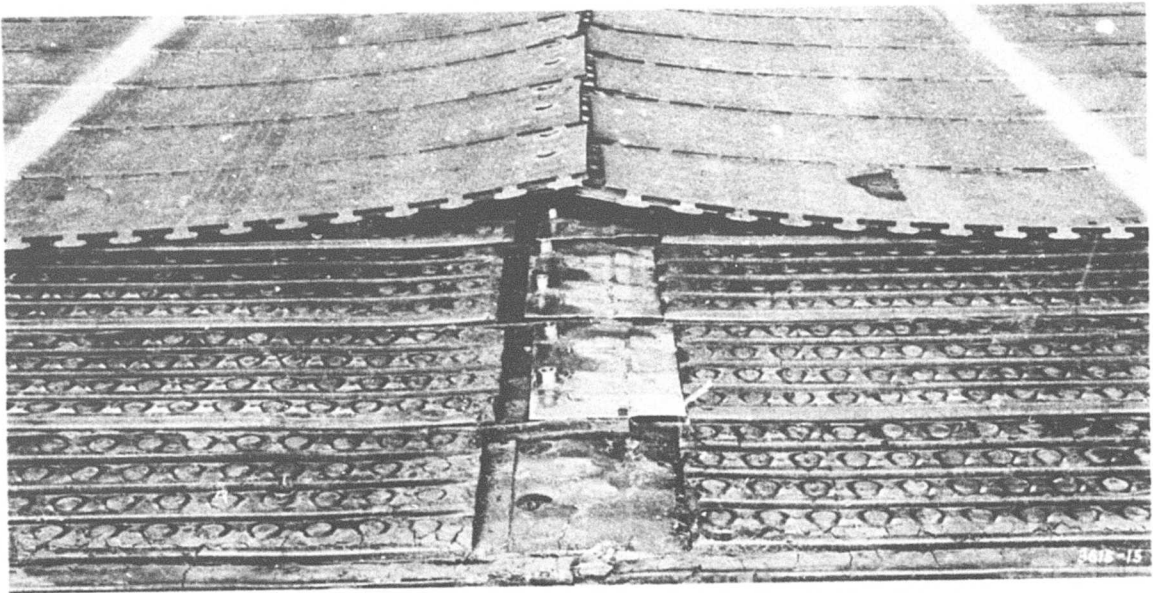
Fig. 8. Sheared end plates after six coverages

21. When the mat with the straight-line end joints was removed from the test section, it was found that most of the solid end plates had completely sheared loose, as shown in fig. 8. It was believed that the plates on the bottom of the mat (see fig. 5b, page 7) hindered embedding of the planks and might have contributed to their deformation and curling. To determine whether there would be any difference in the performance of the

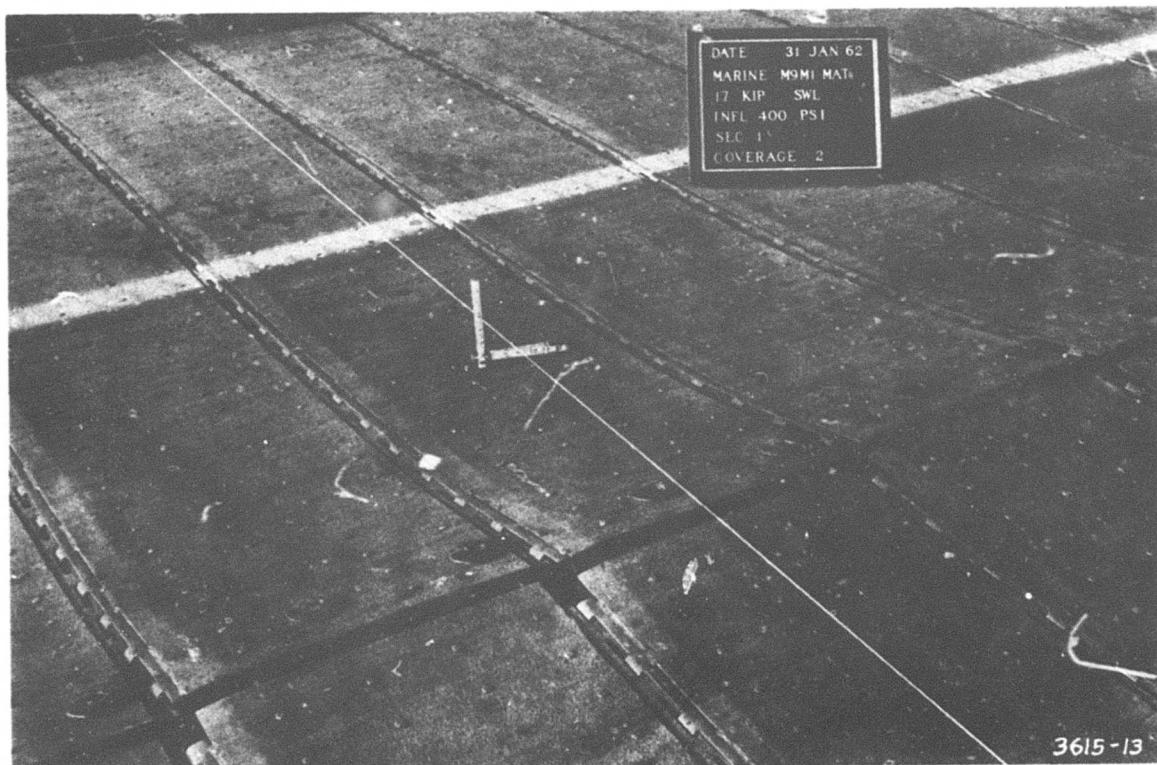
Photograph 1. Item 1 after 2 coverages had caused end joints to arch up

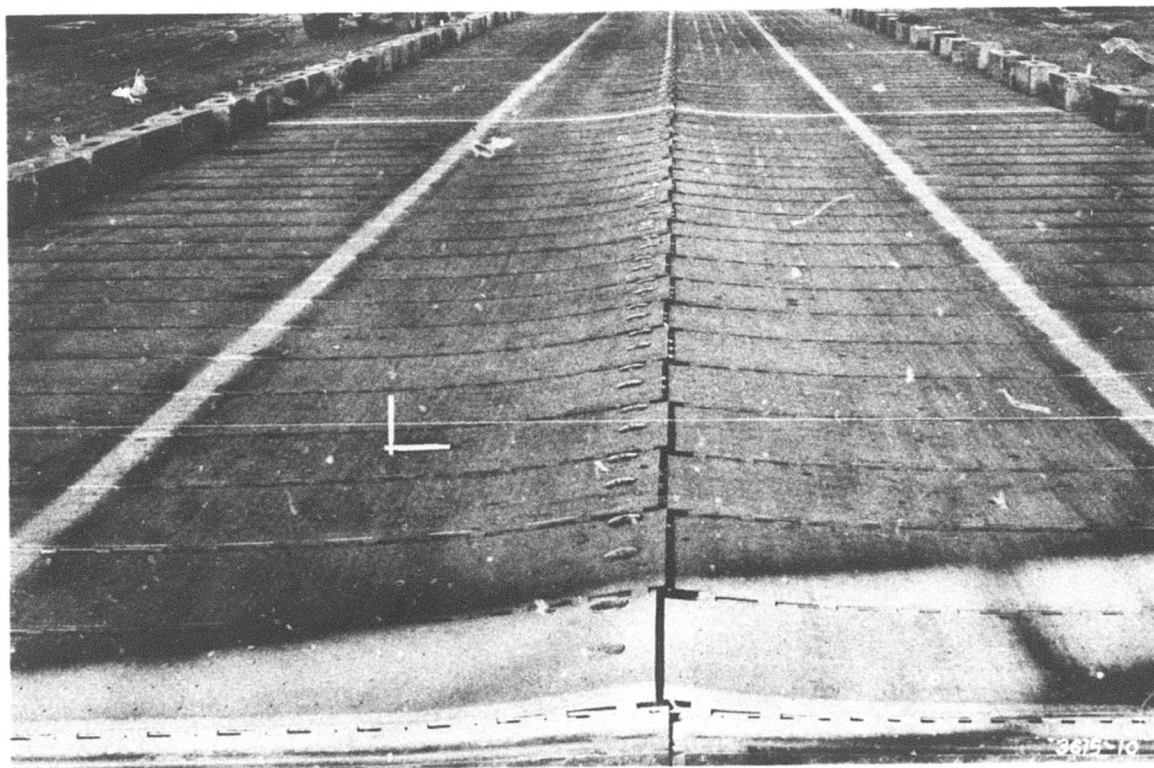
Photograph 2. Test section with end joints in straight line after 6 coverages. Note deformation of planks

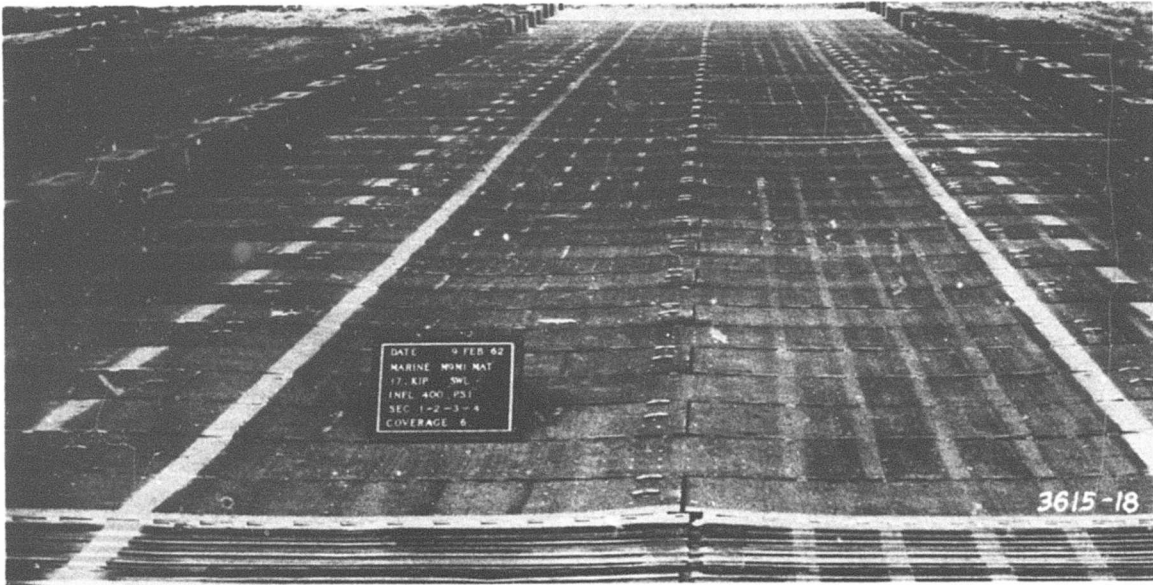
Photograph 3. Test section with staggered end joints after 6 coverages

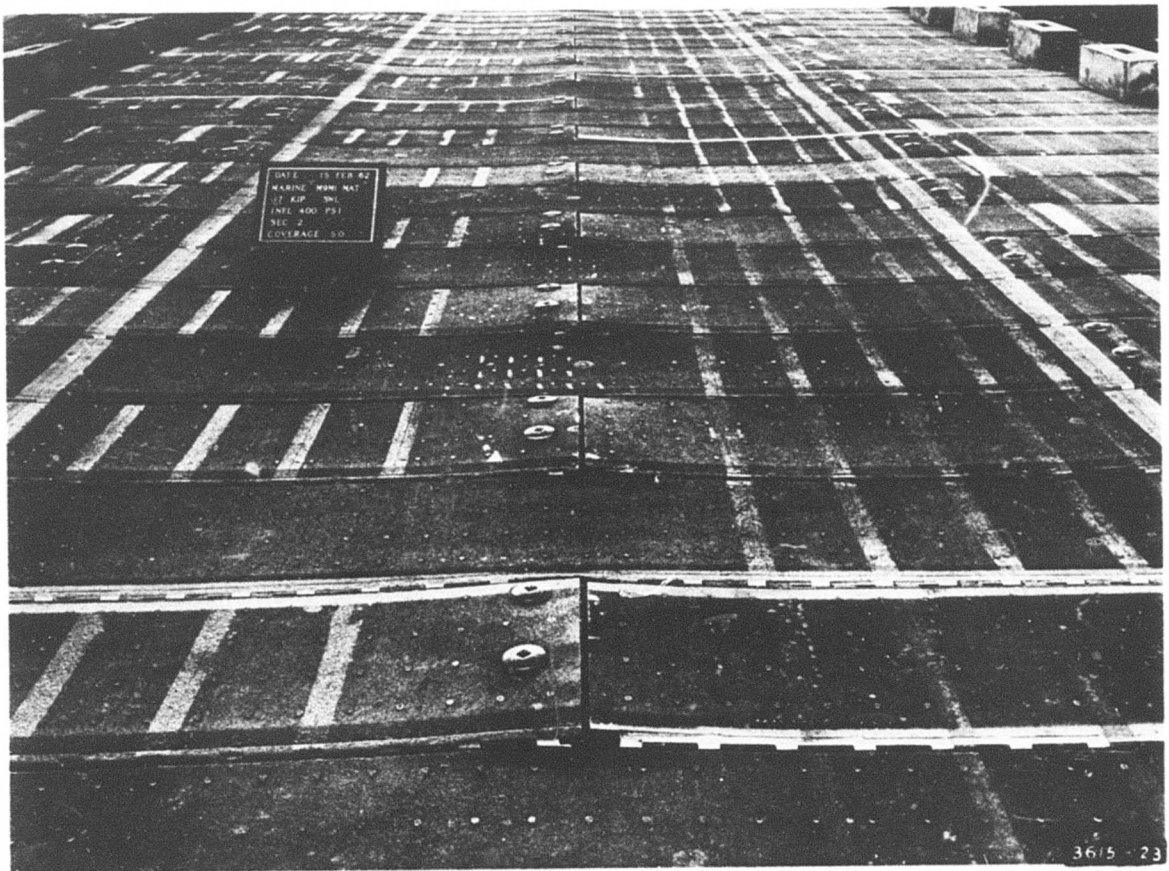
Photograph 6. Item 2 after 50 coverages

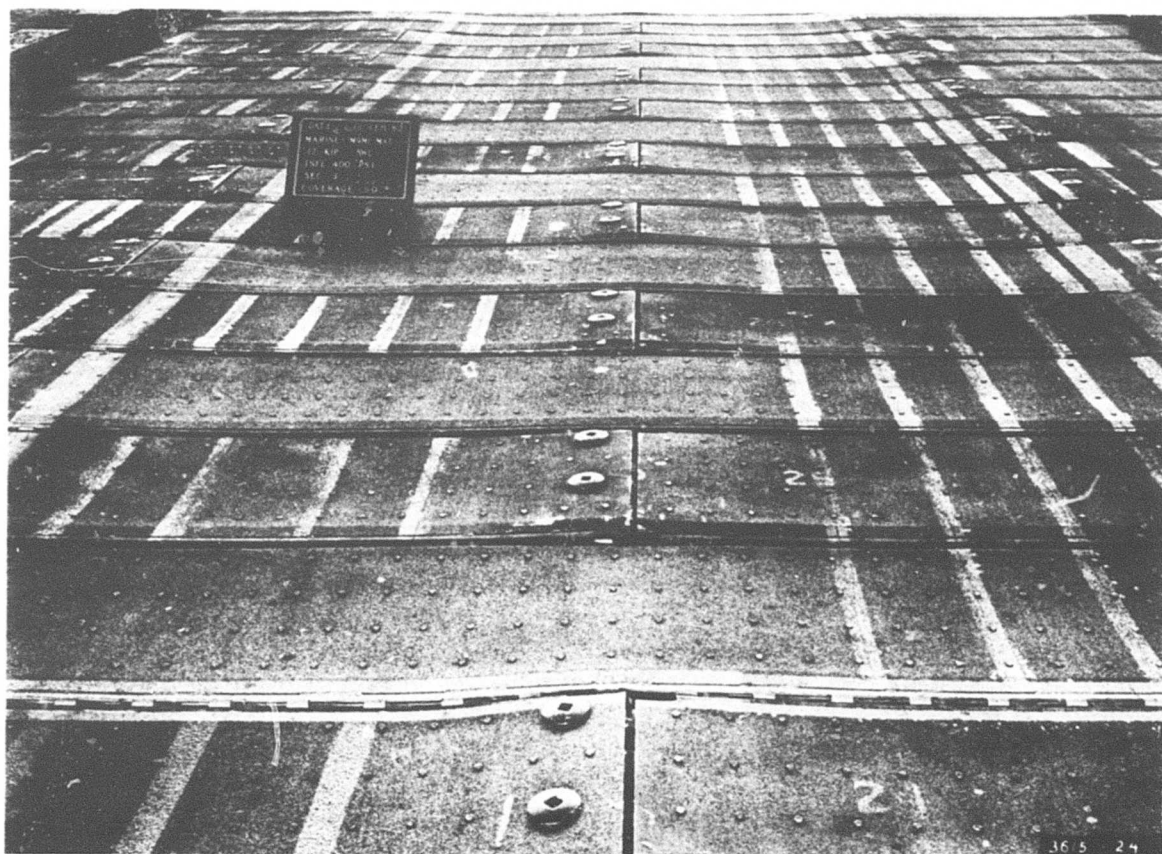
Photograph 7. Item 3 after 50 coverages

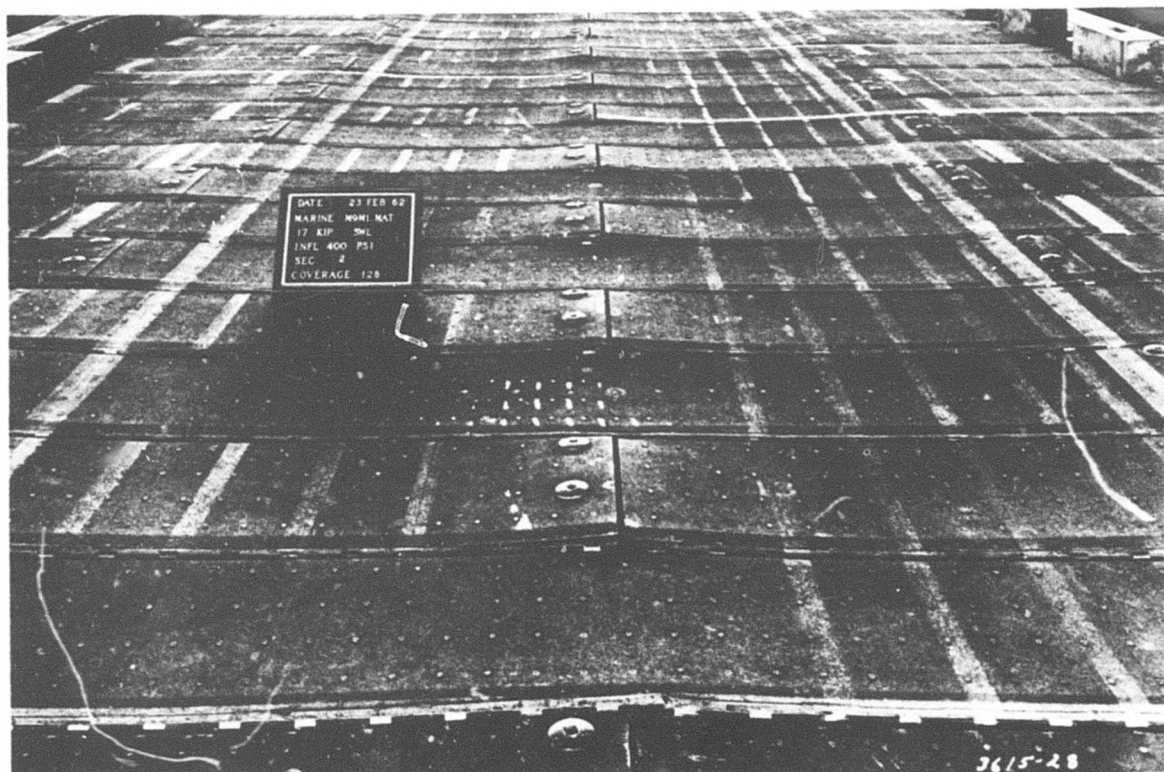
Photograph 9. Item 2 after 128 coverages

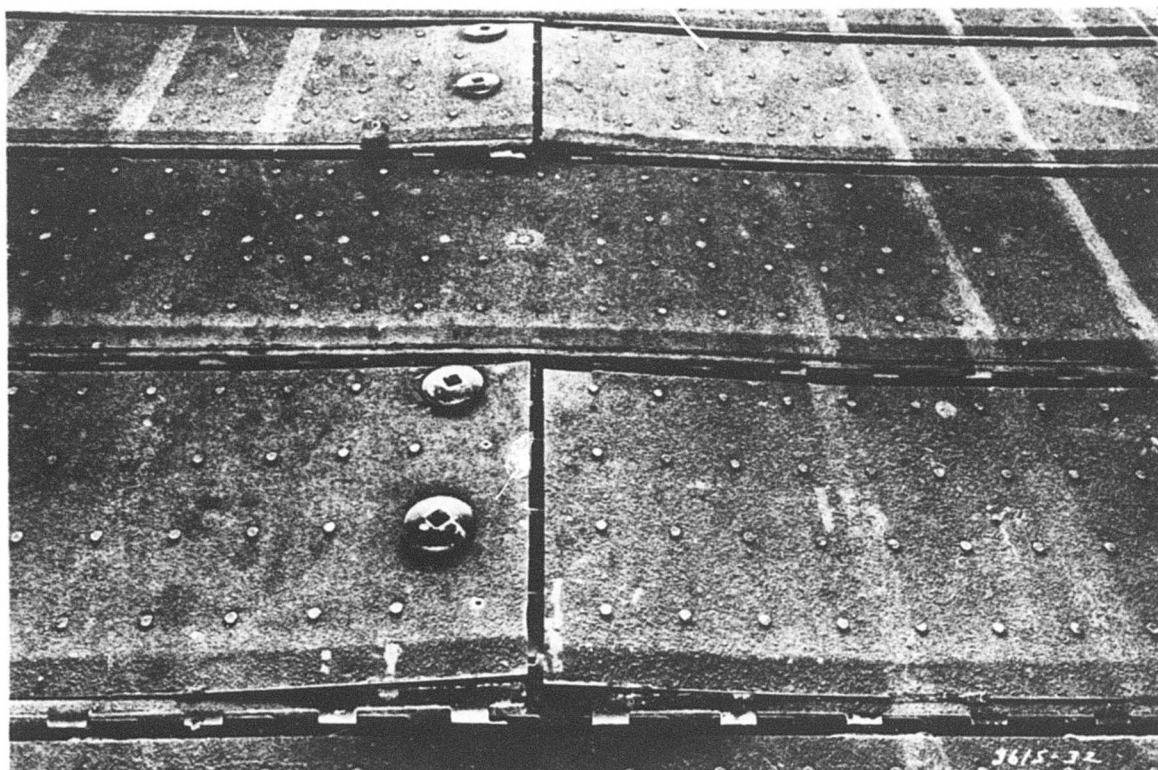
Photograph 10. Close-up of item 2 after 128 coverages

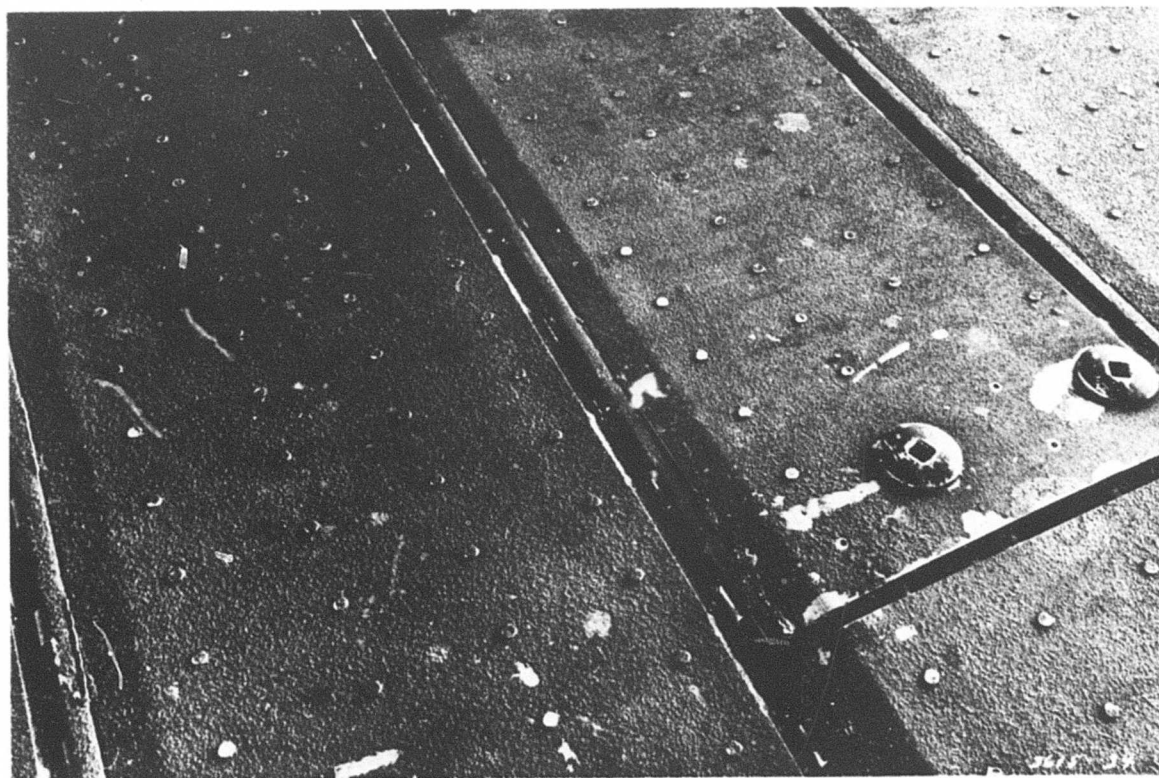
Photograph 12. Close-up of item 3 after 128 coverages

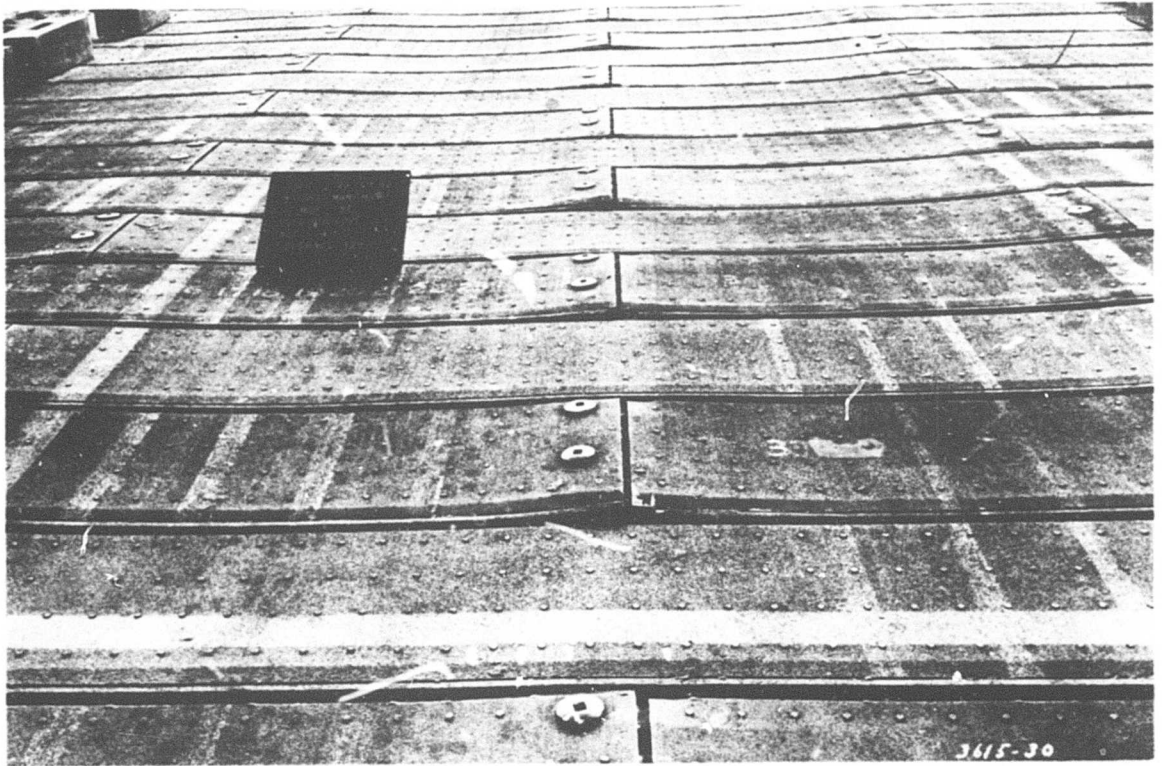
Photograph 13. Item 4 after 128 coverages
