A-7 ALOFT HARDWARE REQUIREMENTS ENVIRONMENTAL  
ANALYSIS

Naval Electronics Laboratory  
San Diego, California

| REPORT DOCUMENTATION PAGE | | READ INSTRUCTIONS<br>BEFORE COMPLETING FORM |
|---|---|---|
| 1. REPORT NUMBER<br>Technical Document (TD-418) | 2. GOVT ACCESSION NO. | 3. RECIPIENT'S CATALOG NUMBER<br>AD-A009 355 |
| 20. ABSTRACT (Continue on reverse side if necessary and identify by block number)<br><br>Environmental and operational testing of a fiber-optic interface was conducted to determine suitability of fiber-optic cables, connectors, and LED module for use aboard the A-7 aircraft. | | |

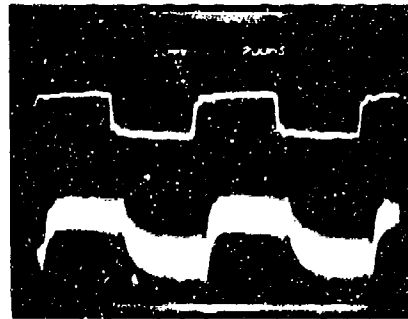
Figure D-2. System output at 85°C at sea level.

Photographs were taken of the light output of System 1 at frequencies of 100 KHz, 1 MHz, and 10 MHz. The LED module power supply was 5.0 volts. The input voltage was 0.8 volts for "0" and 2.0 volts for "1" logic levels. Inputs at 1 MHz are shown in the top trace of each figure. The output of the system is shown in the bottom trace of each figure as it was detected by a silicon avalanche photo-diode (TIXL55) operated at 180 volts.
