155MM XM198 HOWITZER MUZZLE WEAR

R. G. Hasenbein

Watervliet Arsenal

May 1975

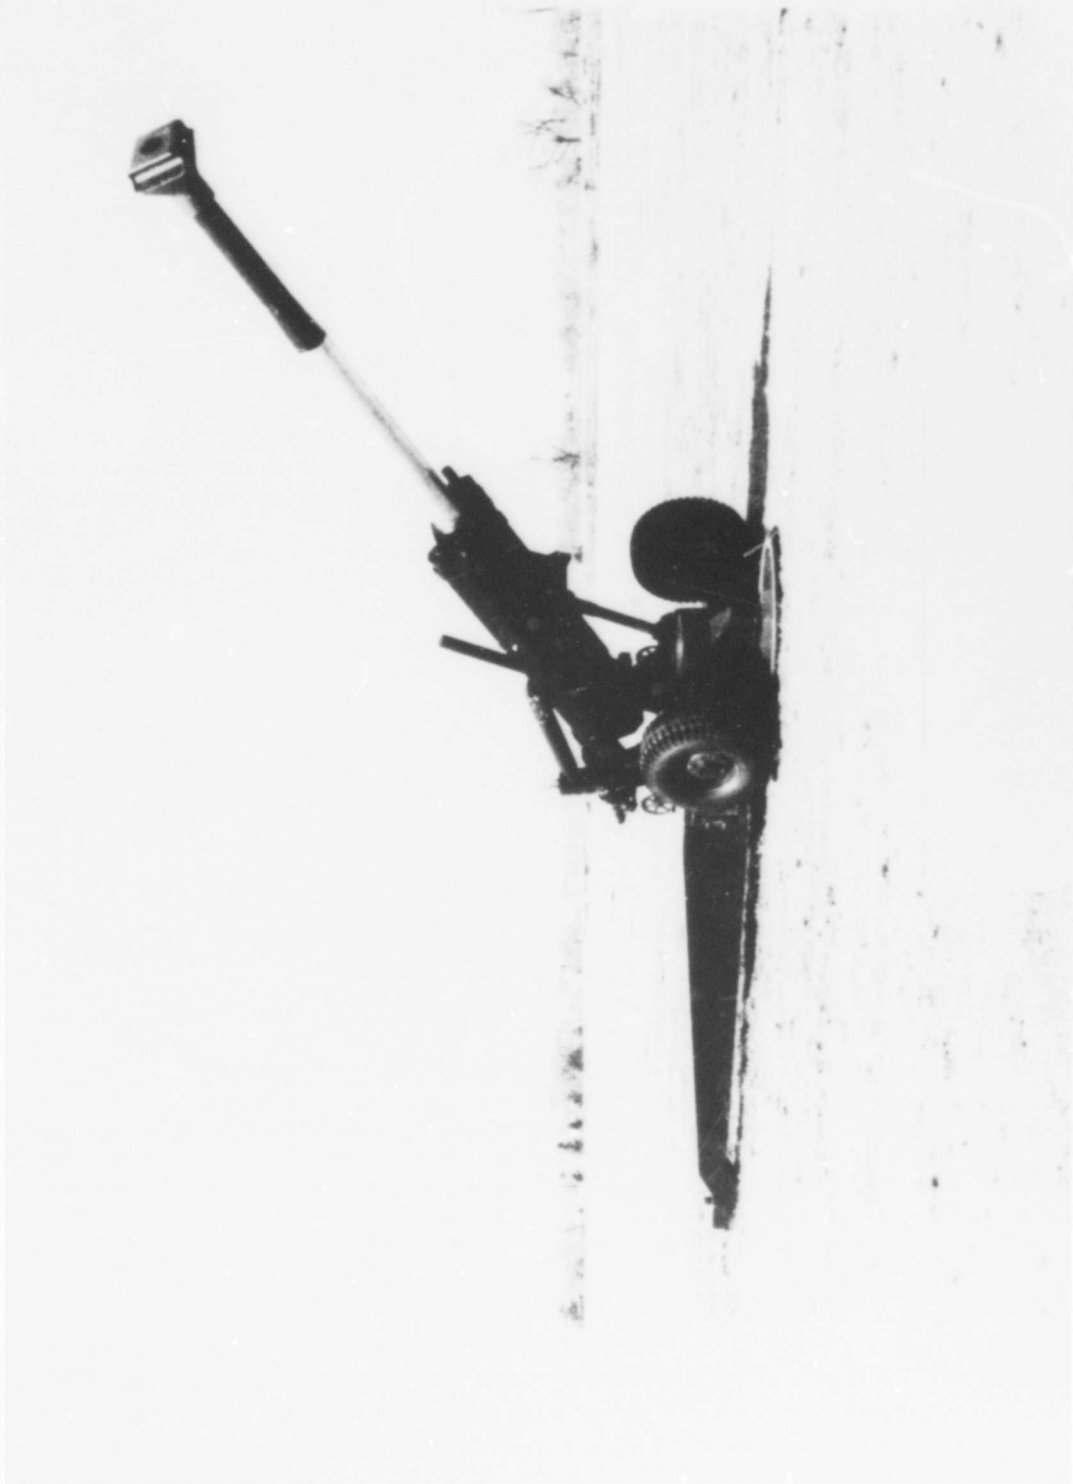
Figure 1. 155mm XM198 Howitzer

A 15,000 round Durability Test was conducted on the 155mm XM198 Howitzer system (see Fig. 1) from September 1973 to August 1974 at Camp McCoy, Wisconsin and Jefferson Proving Ground, Indiana. During the course of this test, several XM199 Cannon tubes (see Fig. 2) showed high muzzle wear and/or rates of muzzle wear.

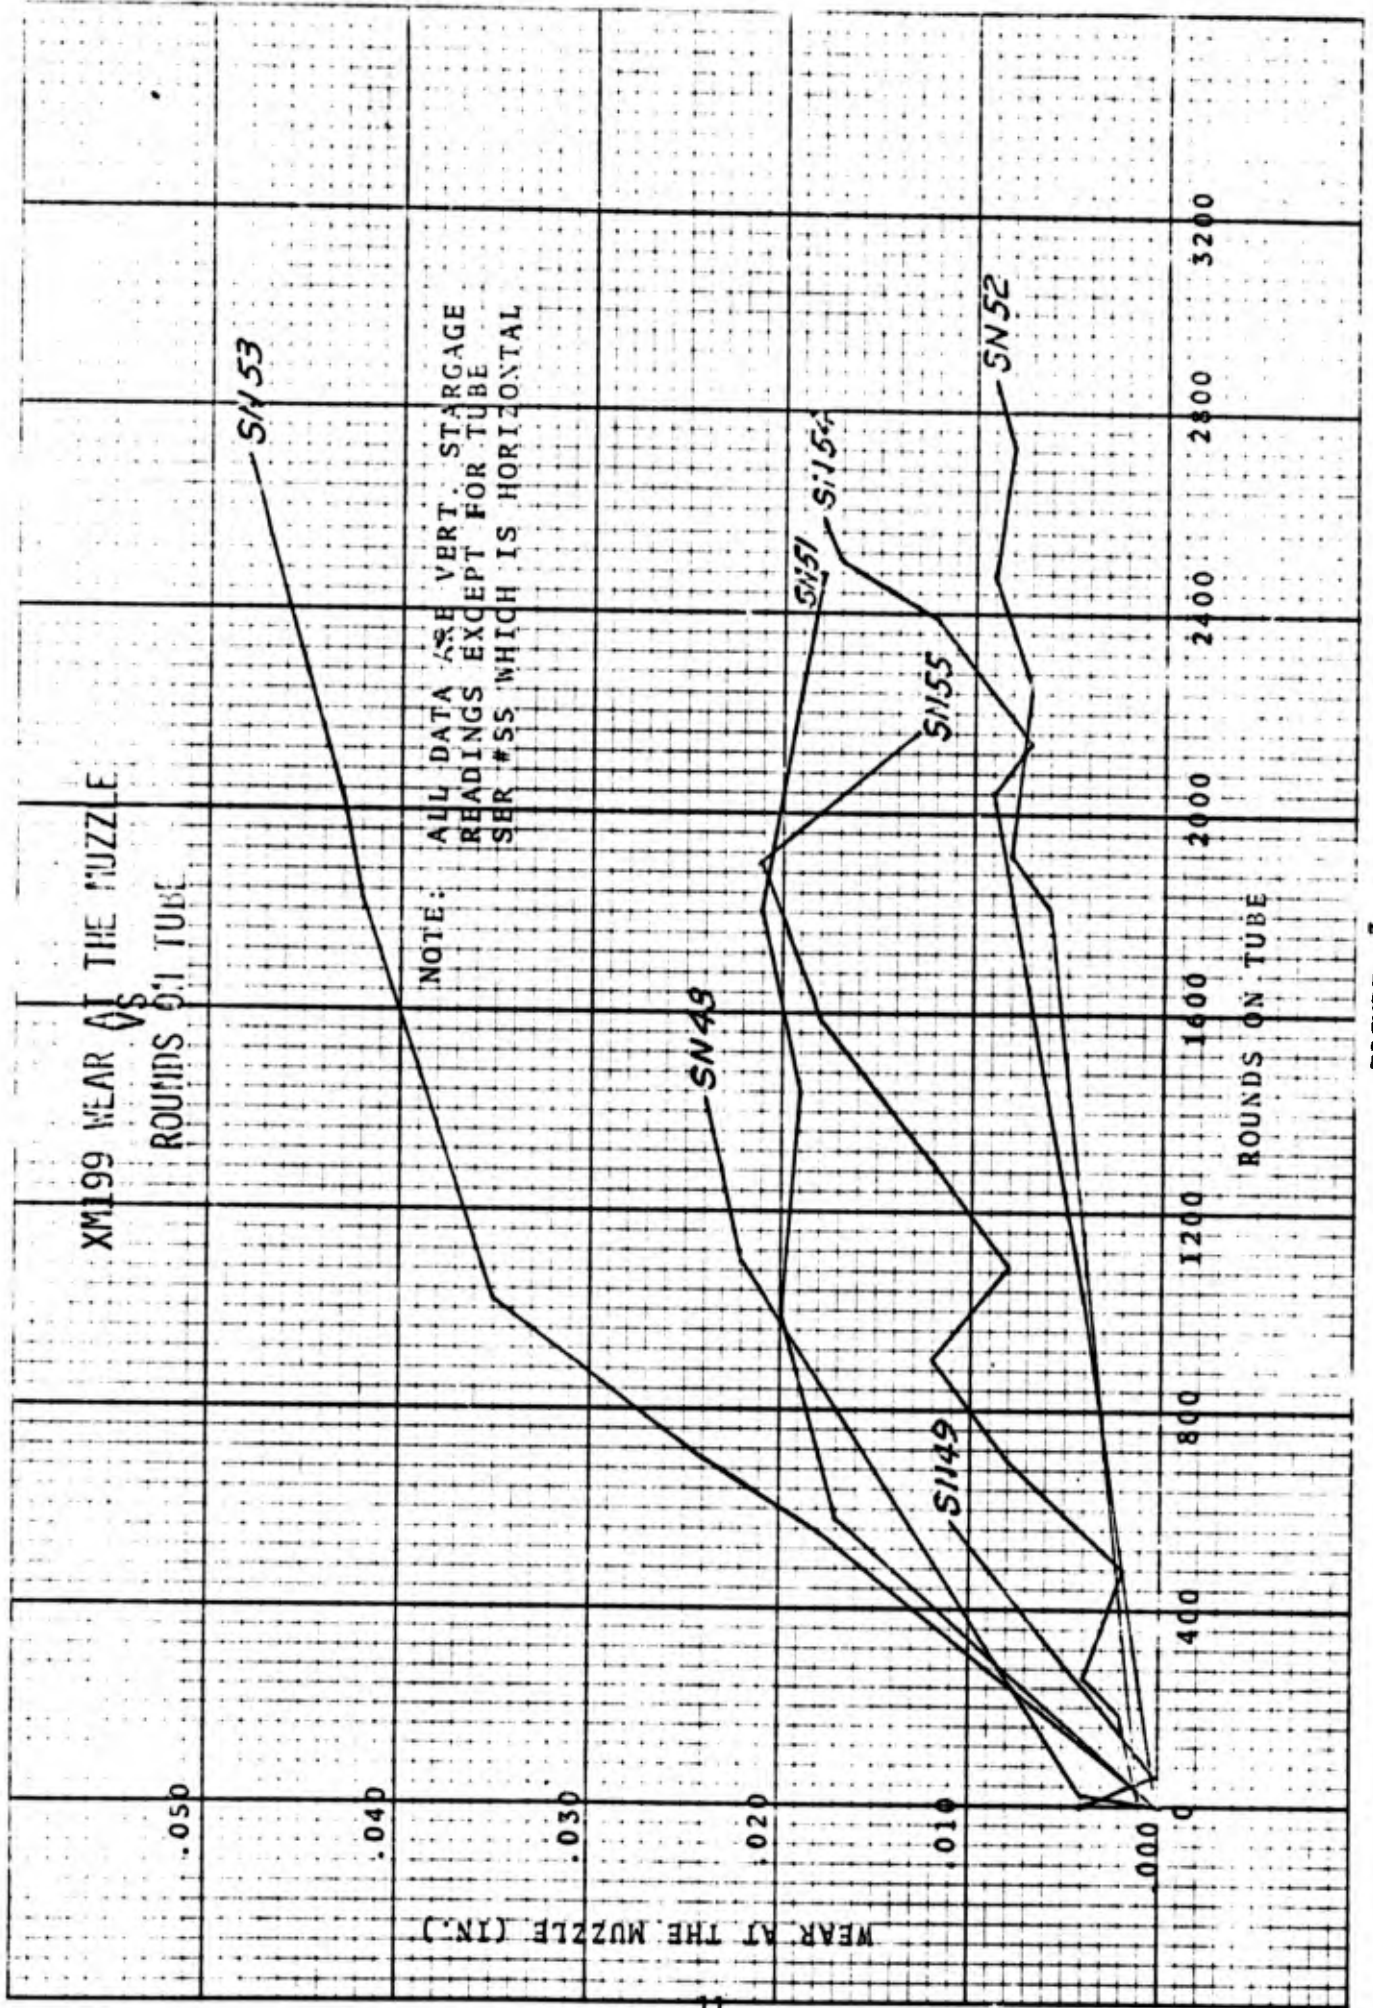
FIGURE 3

A closer look reveals that the above data (while correct) might be misleading. Table 3 shows that muzzle wear rate is not linear; rather, it varies without regard to the number of rounds on the tube. The data in Table 3 is shown graphically in Figure 3. It can be seen, for example, that S.N.51, had an extremely high wear rate at the muzzle for the first 580 rounds and then decreased drastically for the last 1,897 rounds. On the other hand, S.N.54 demonstrated a low wear rate for its first 2,146 rounds; the rate then increased considerably for the last 436 rounds. Numerous other examples of varying rates of wear can be cited.

Based on Table 3 and Figure 3, then, tubes S.N.48, 49,51 and 53 will be considered to have "high muzzle wear" because of the high rates of muzzle wear which occurred early in their lives. Tubes S.N.52 and 54 will be considered to have "low muzzle wear" since they maintained low muzzle wear rates until quite late in their lives. Tube S.N.55 apparently had a much more erratic muzzle wear pattern than the others, and a case could be made for calling it either a "high" or "low muzzle wear" tube. However, since its final value of .013 inches of wear has been confirmed twice by Jefferson Proving Grounds personnel, since it tended to show generally lower wear levels throughout its life and since several of the stargage readings were obtained while the tube was hot (thus giving

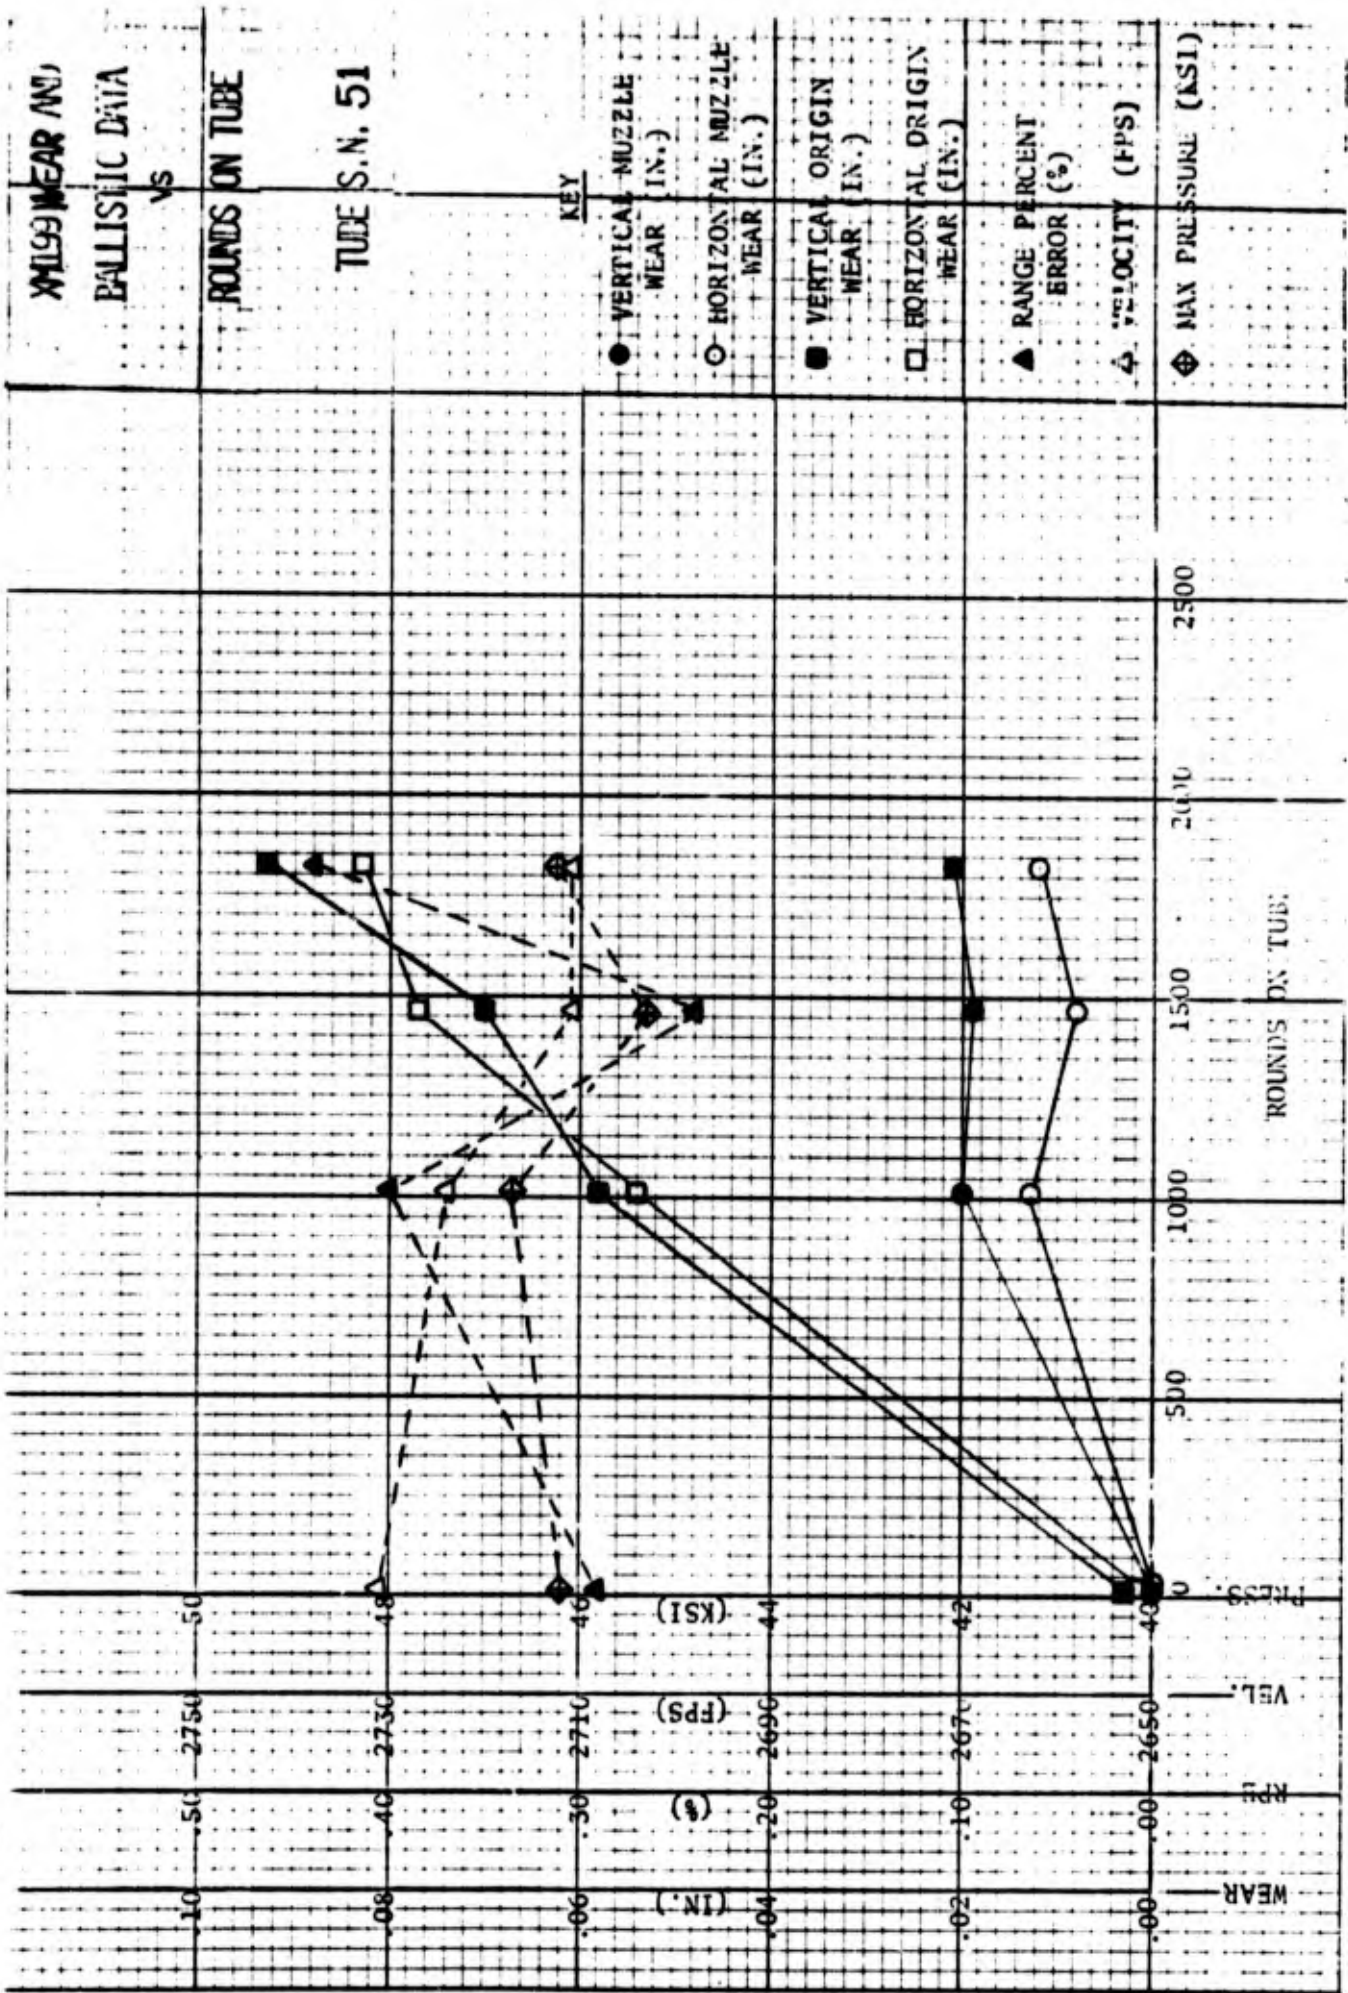
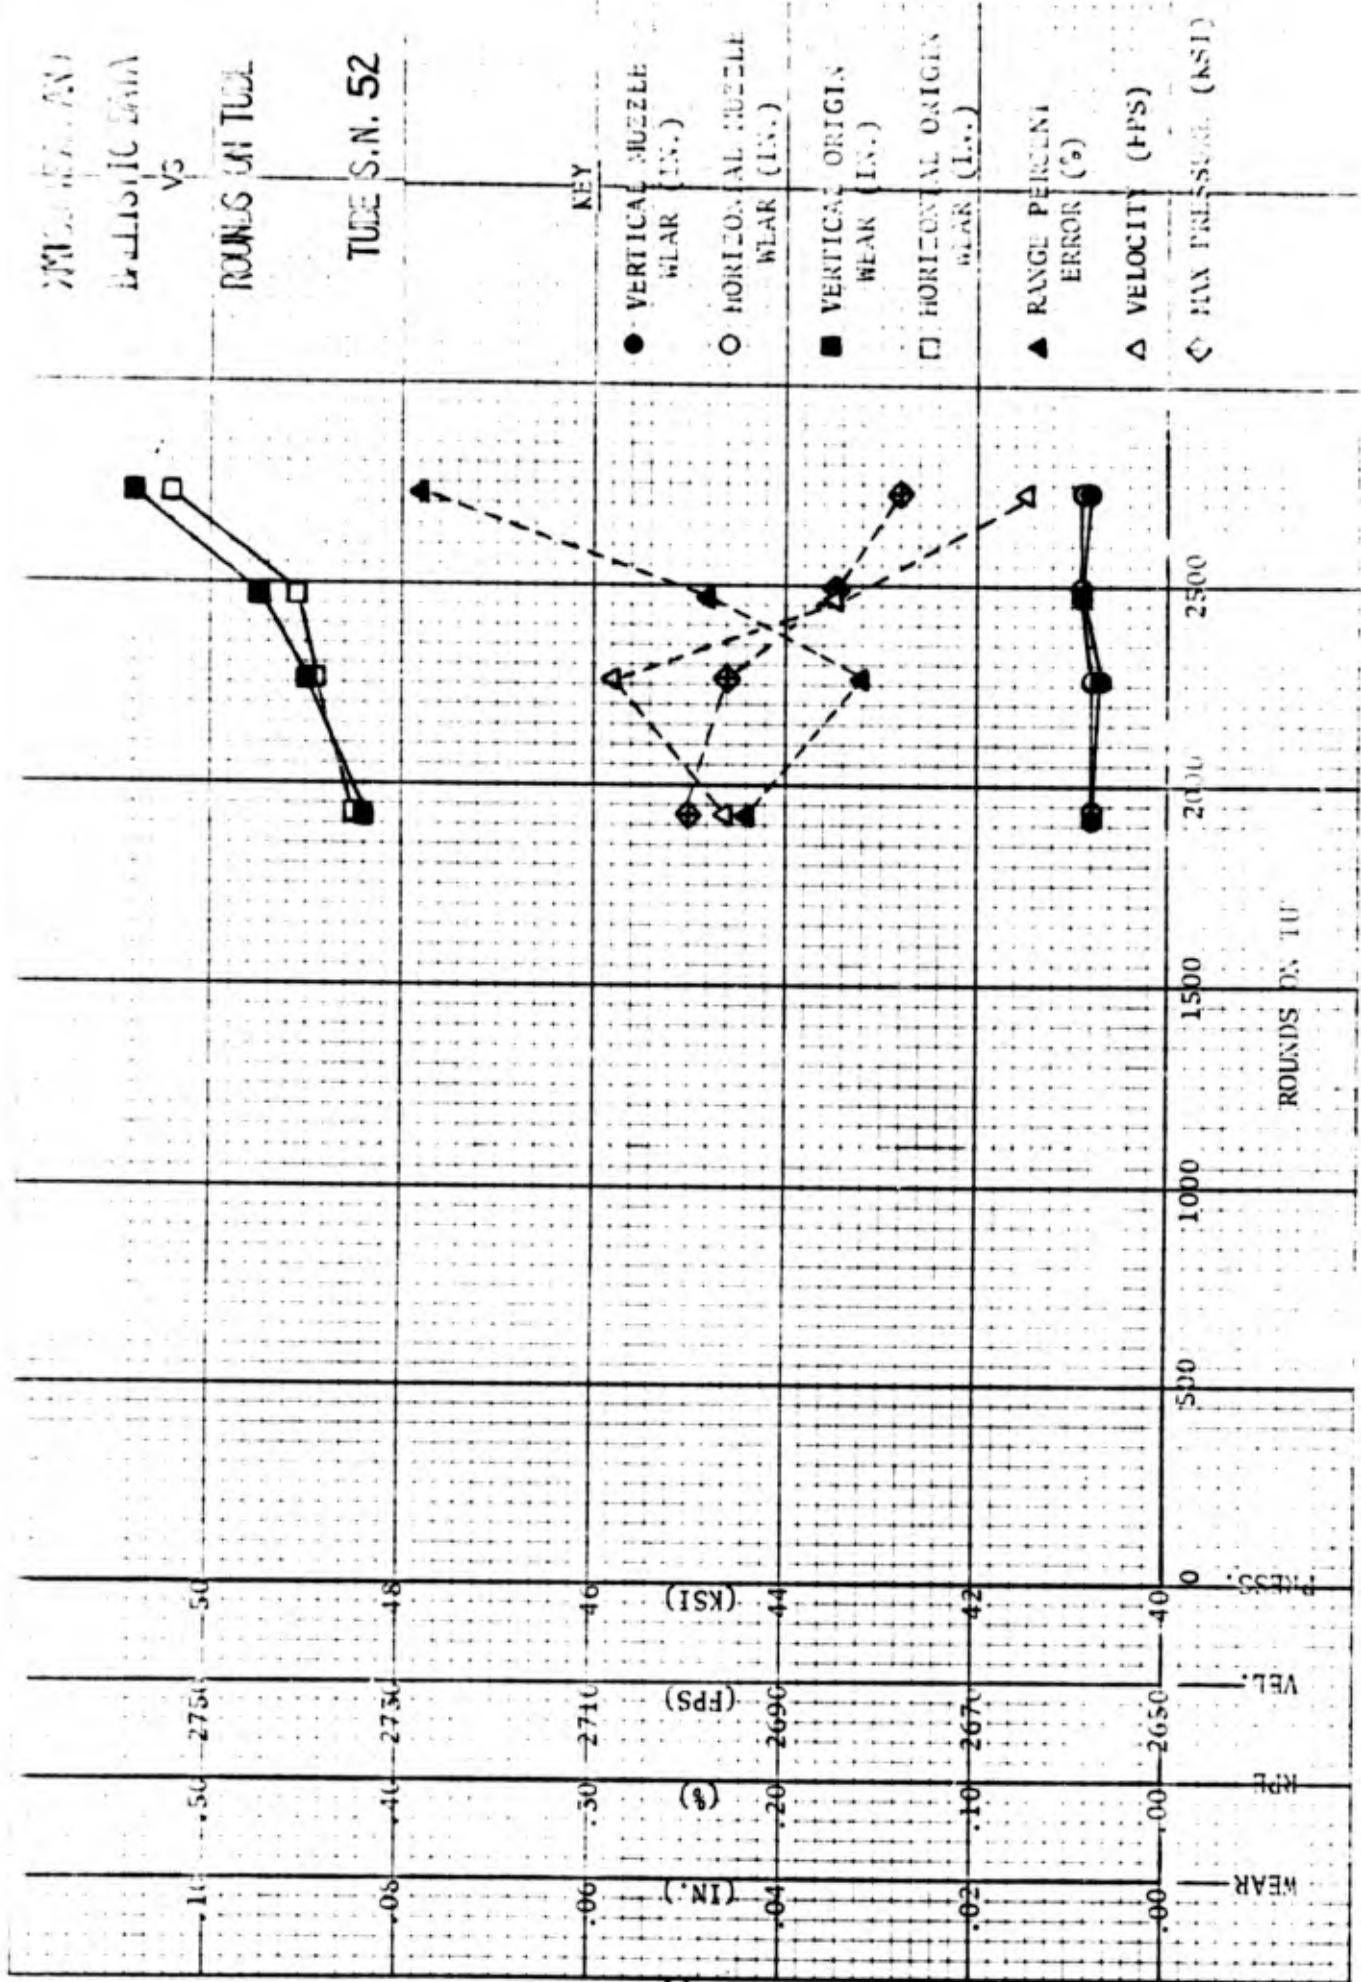
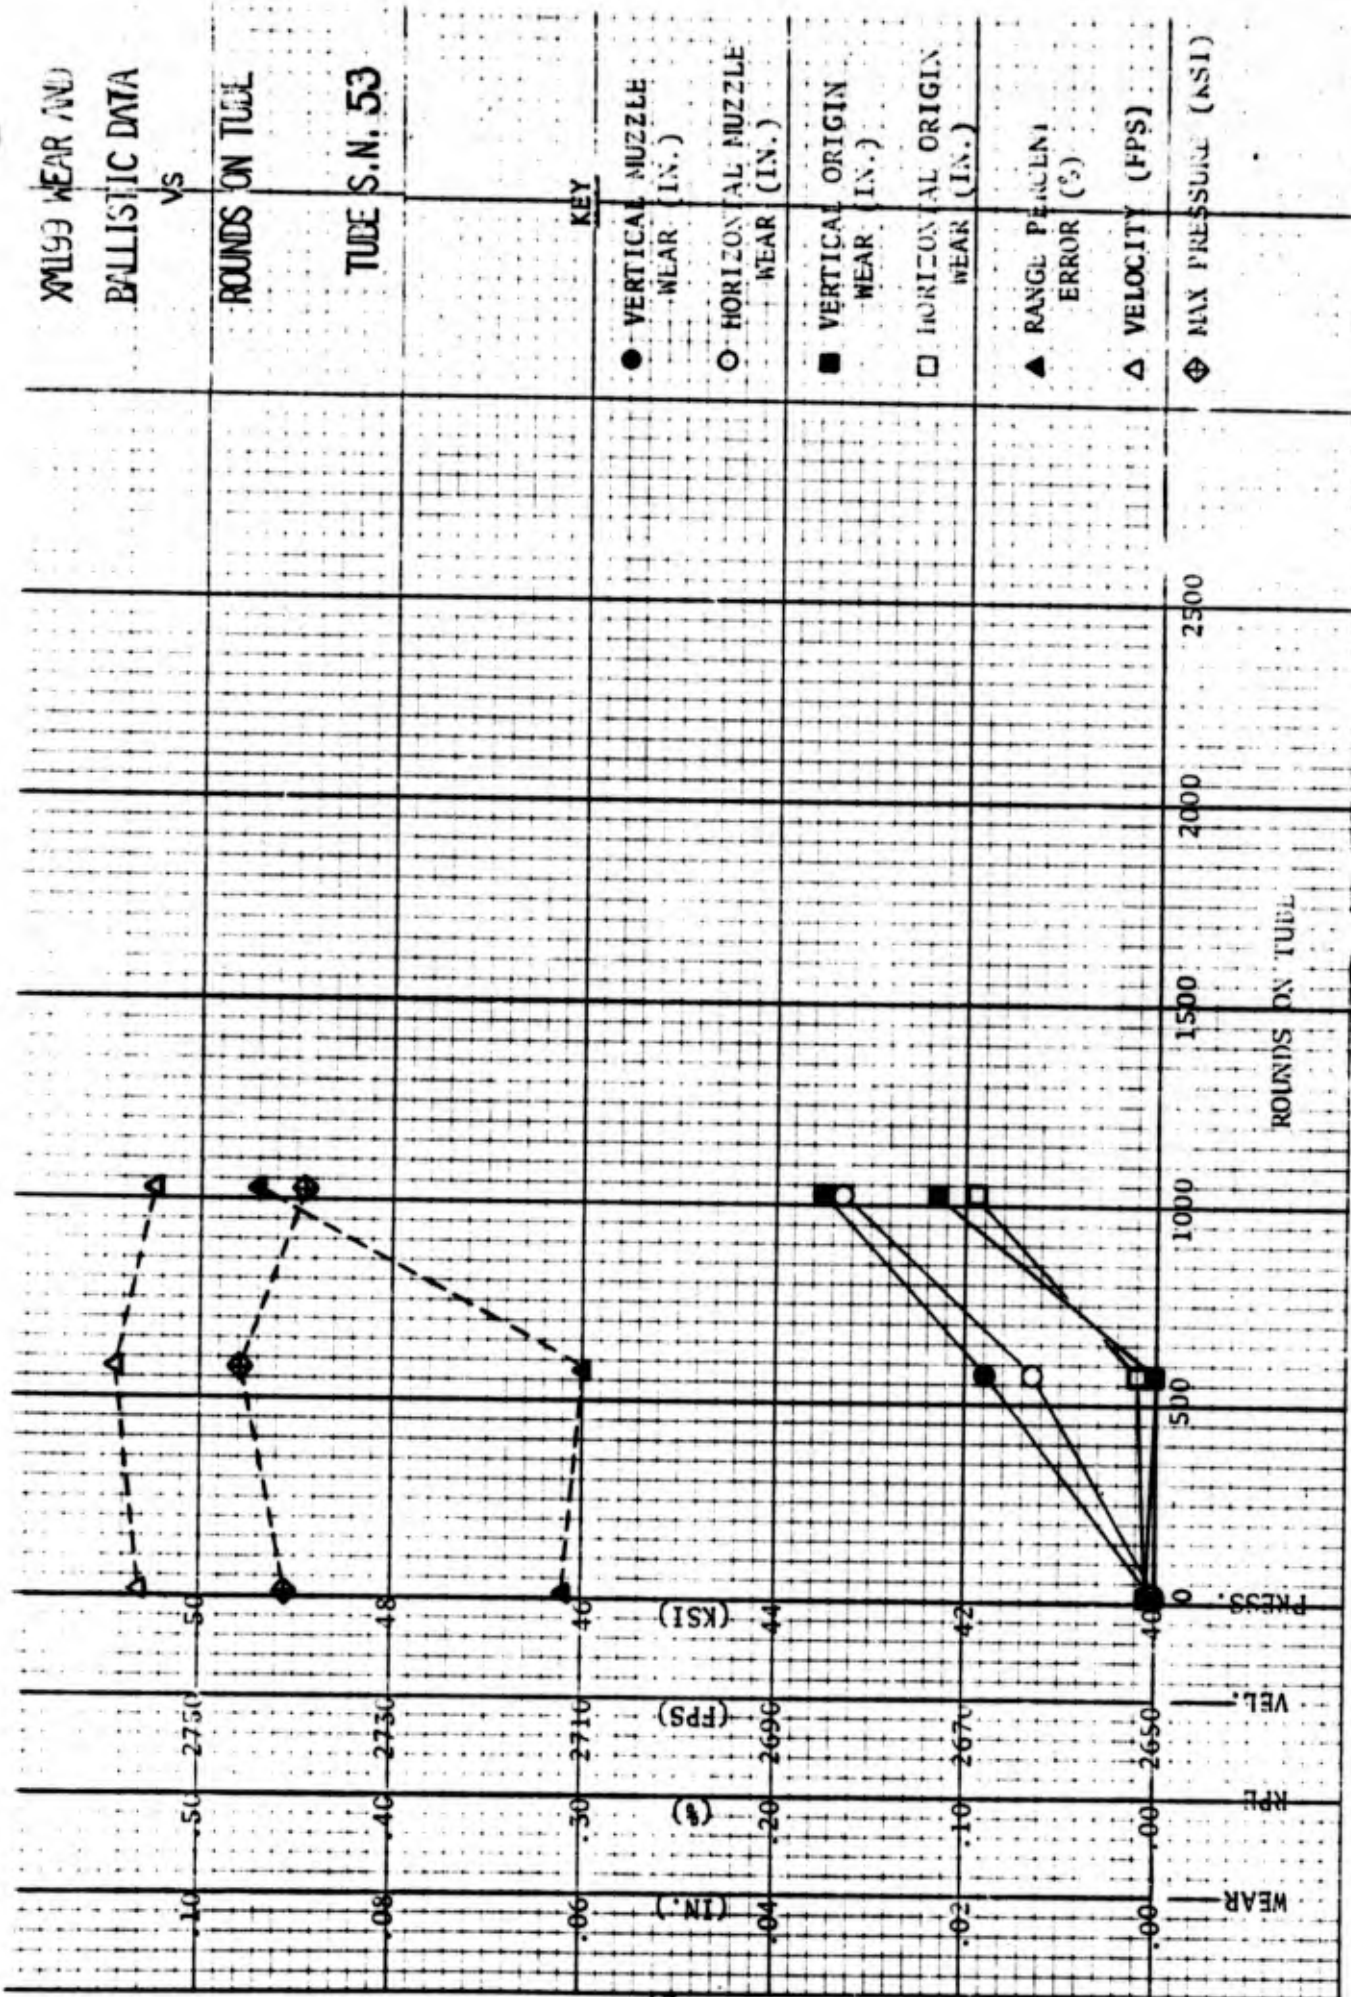
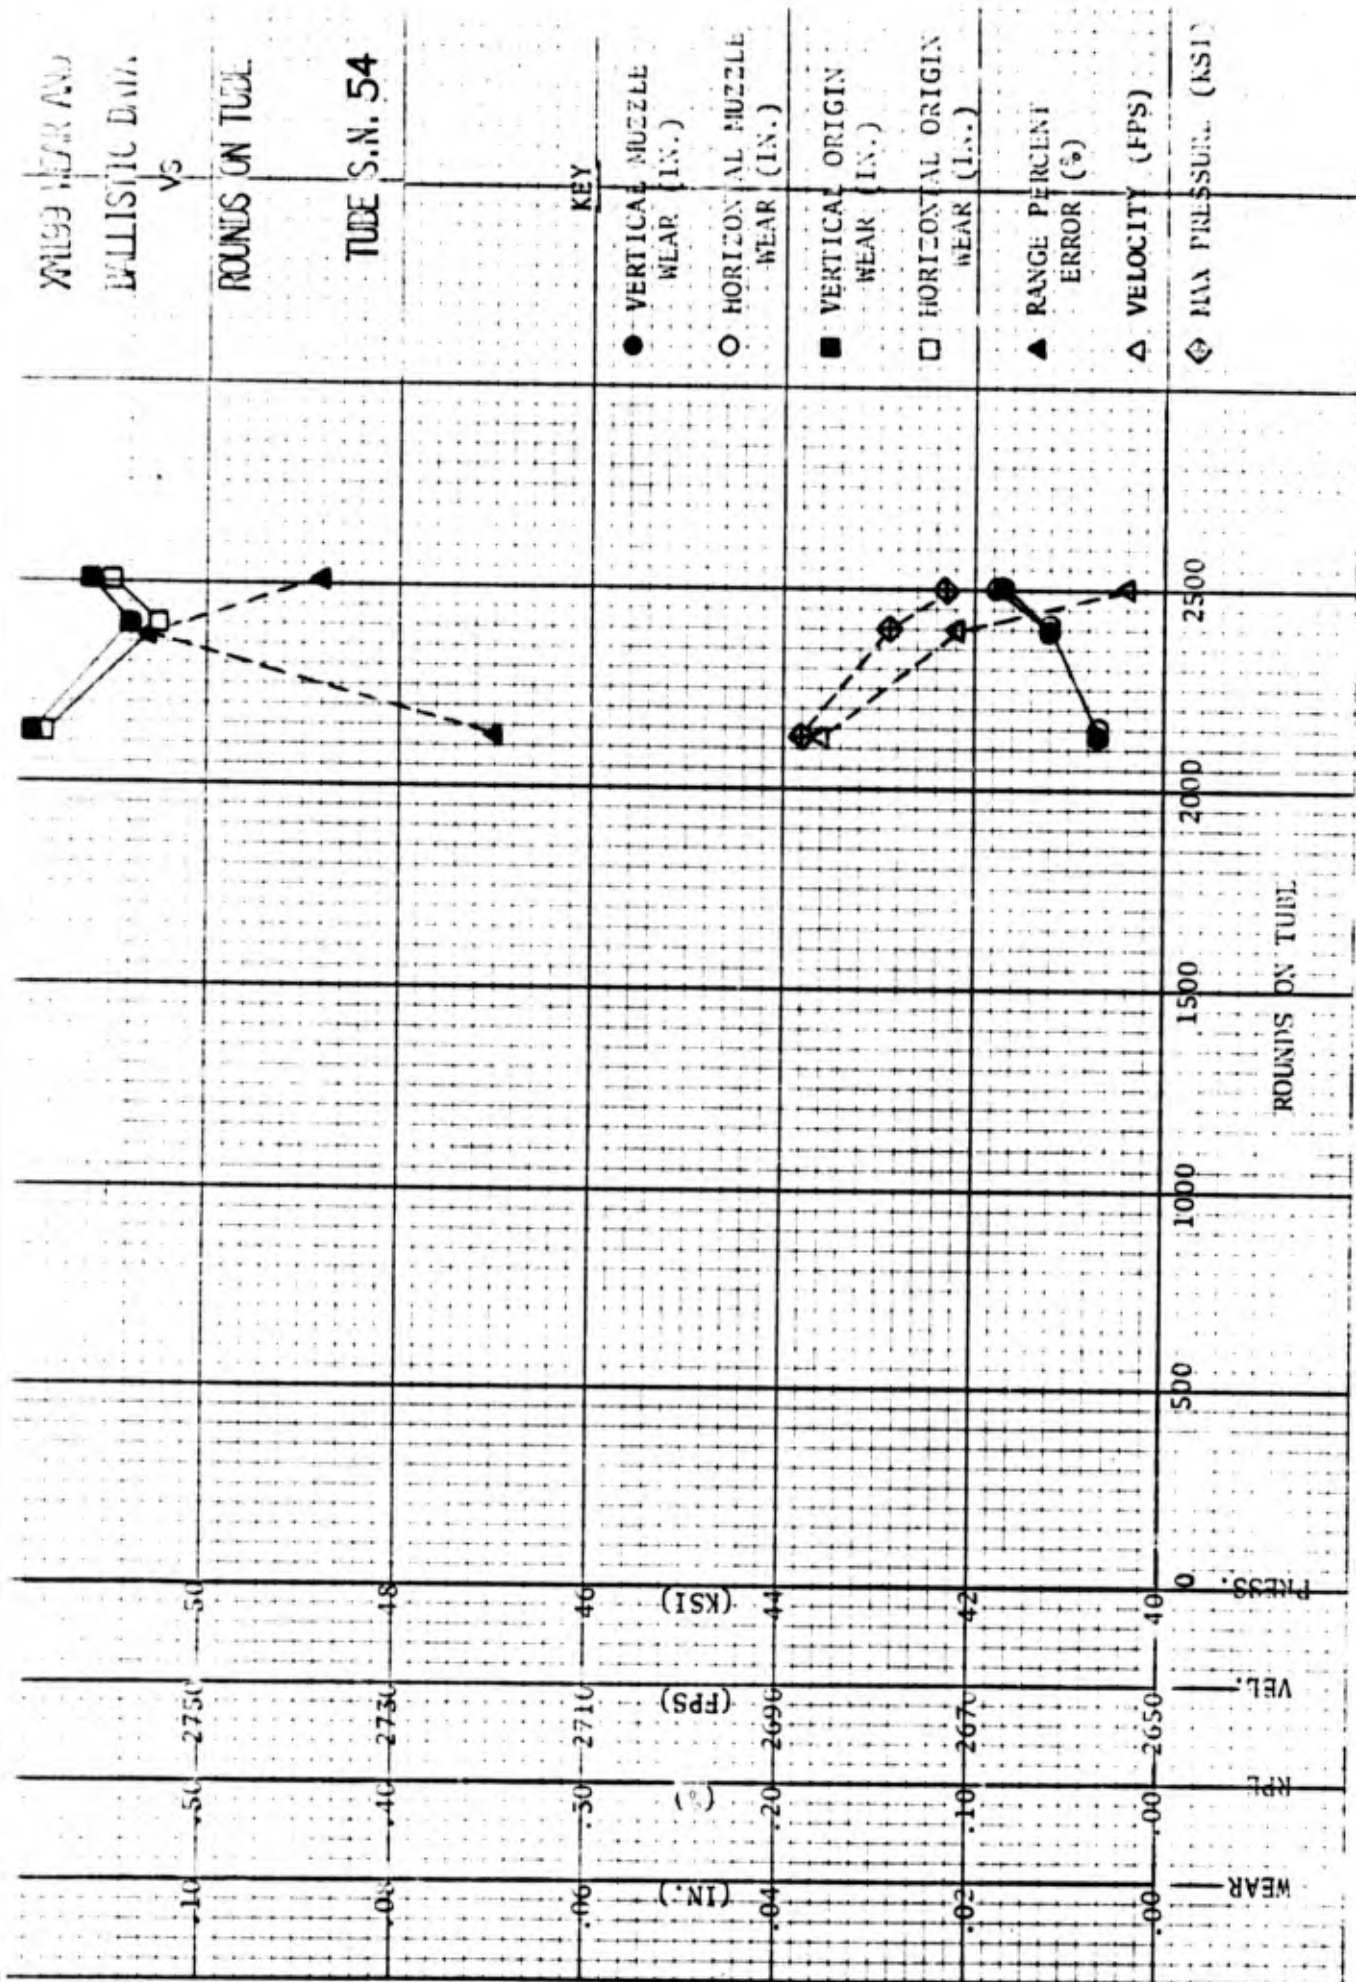
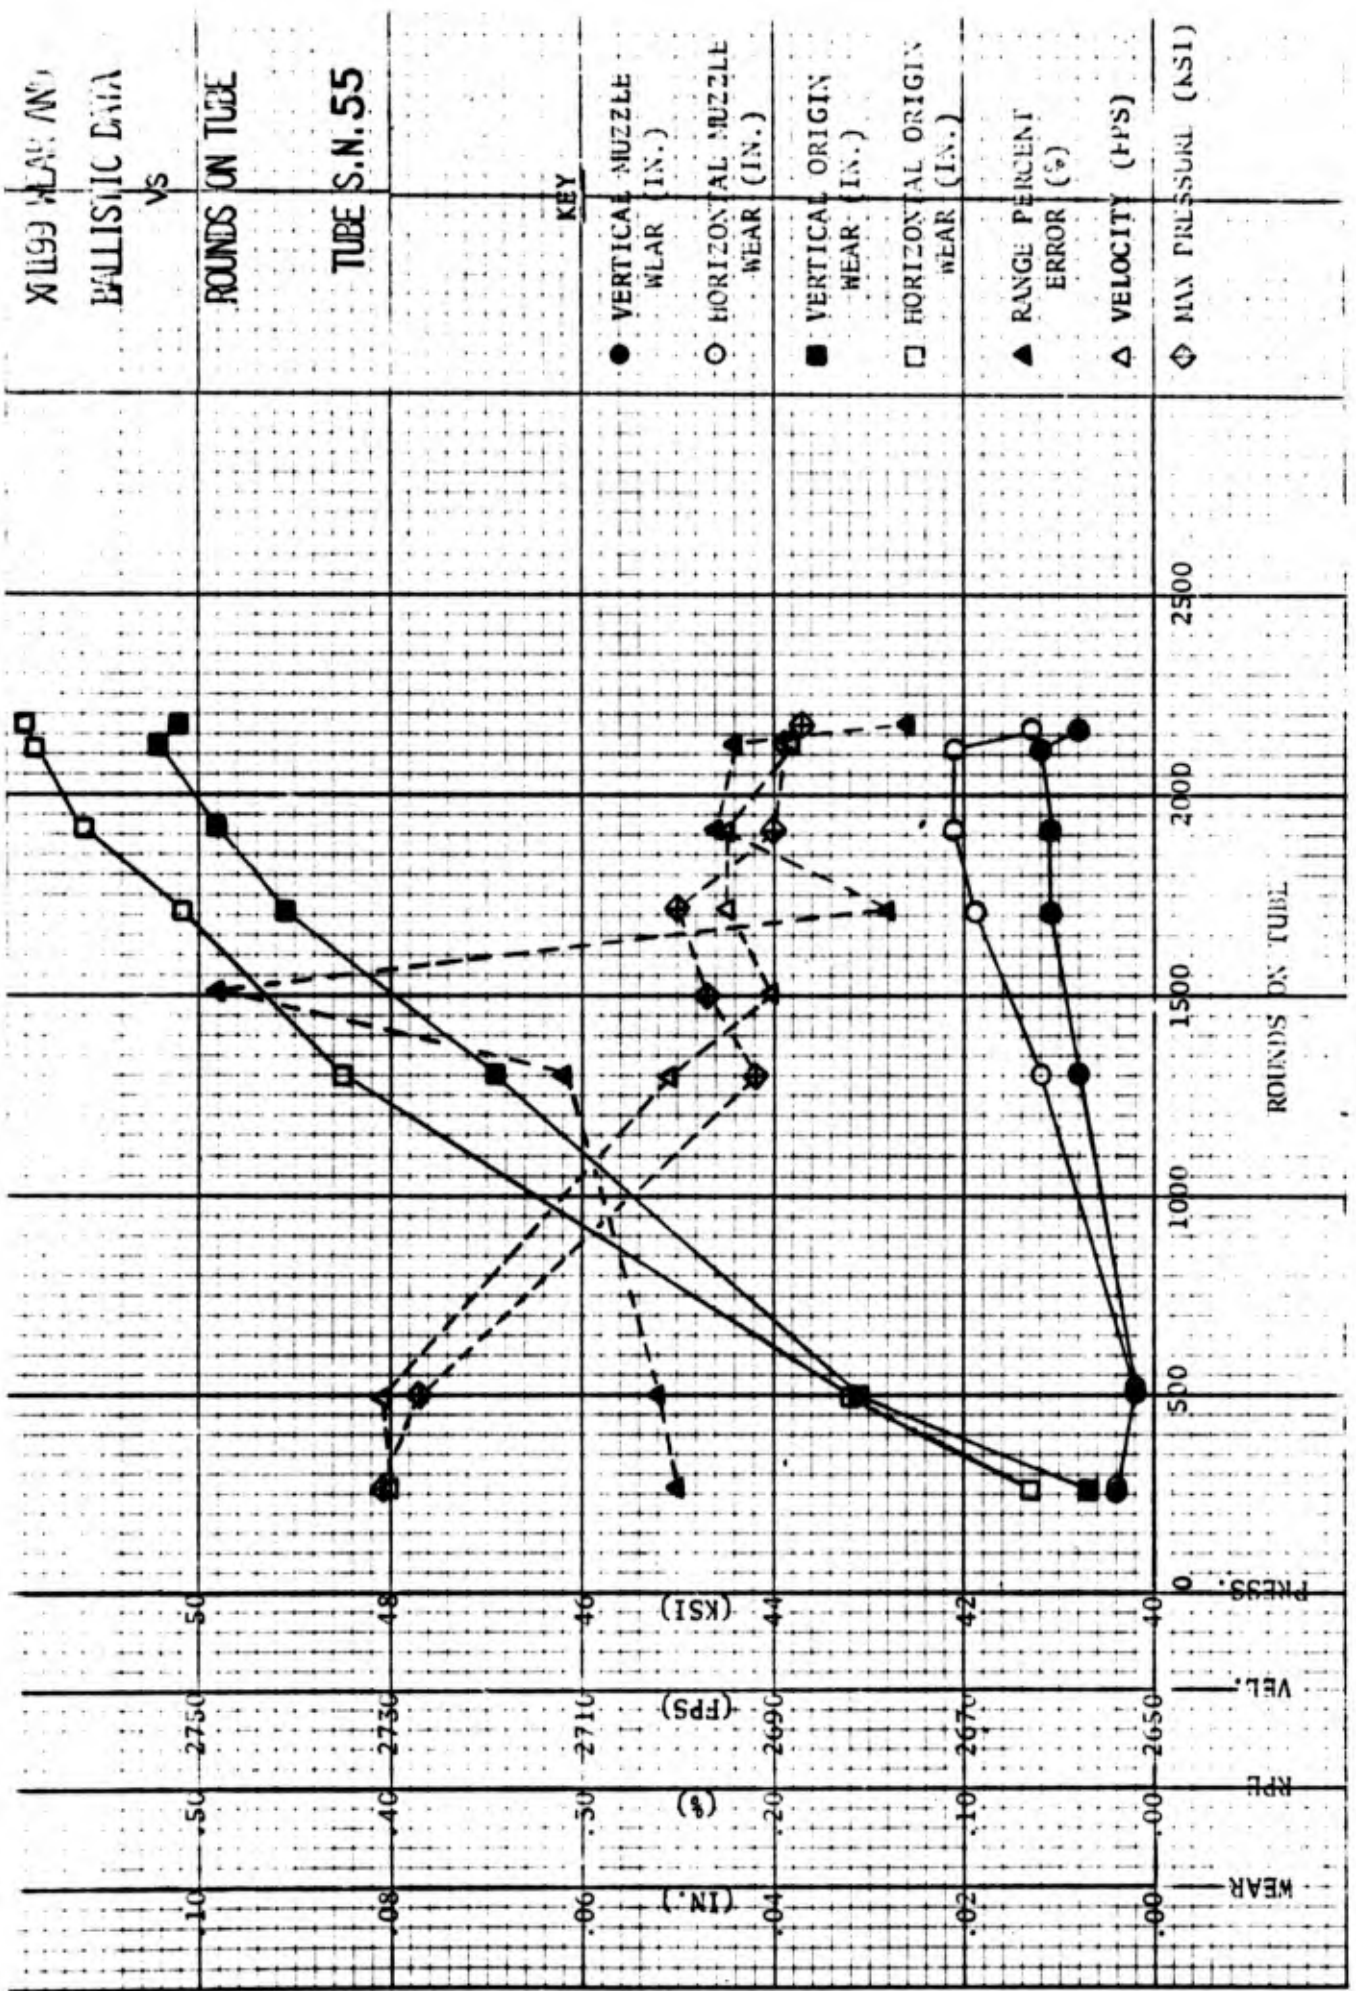
At various times during each* tube's life, ballistic data was taken. average pressure, average velocity near the muzzle, and range percent error. These parameters have been tabulated in Table 4 and plotted for each tube in Figures 4 thru 8. In figures 9 thru 11, these data are shown as a function of vertical muzzle wear in hopes of finding valid linear relationships:

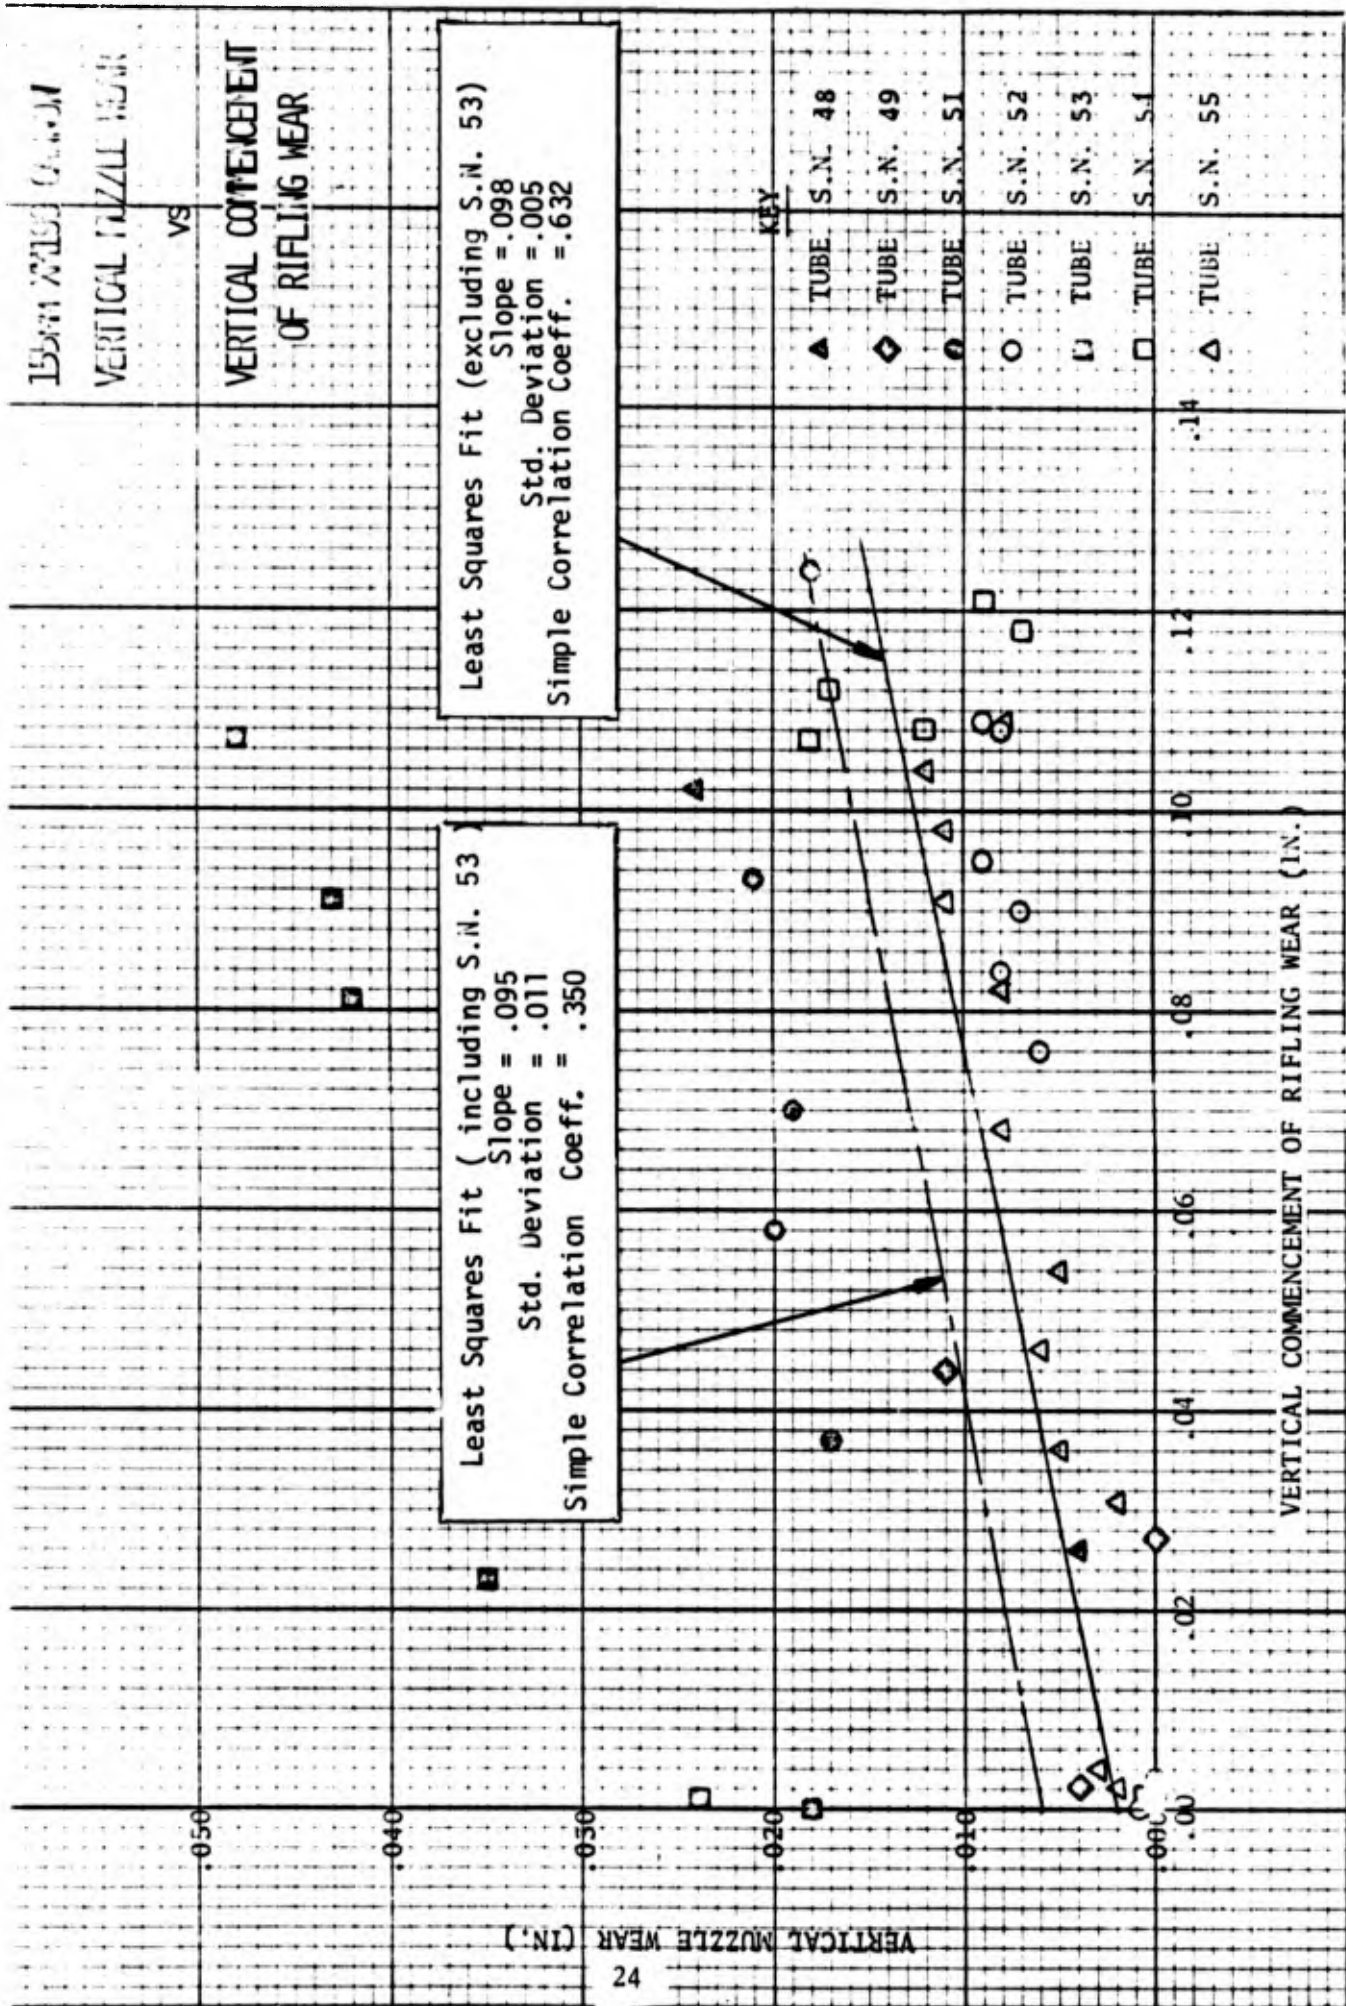
FIGURE 12

Vertical stargage data from Table 4 are plotted in Fig. 12. As stated previously, the bore of S.N.53 had been chrome plated .003 inches (nominal) per surface. Fig. 12 shows that its muzzle wear vs. commencement wear pattern differed significantly from the other six tubes. Two regressions of muzzle wear on commencement wear were performed, one including data from S.N.53 and one excluding this data. As can be seen in Fig. 12, both regressions resulted in an approximate 10 to 1 relationship between commencement wear and muzzle wear. Statistical analysis shows that the relationship including data from S.N.53 is valid with only 80 to 90% confidence; however, the regression excluding data from S.N.53 is valid with approximately 98% confidence. Likewise, only 12% of the total variation in muzzle wear can be explained by commencement wear in the first regression whereas, in the second regression, 40% of the total variation in muzzle wear can be explained by commencement wear. Thus, although

vertical wear at the muzzle is dependent in part upon wear at the commencement of rifling, other factors also appear to play a large part in determining the extent of muzzle wear.
