155MM XM198 HOWITZER MUZZLE WEAR

R. G. Hasenbein

Watervliet Arsenal

May 1975

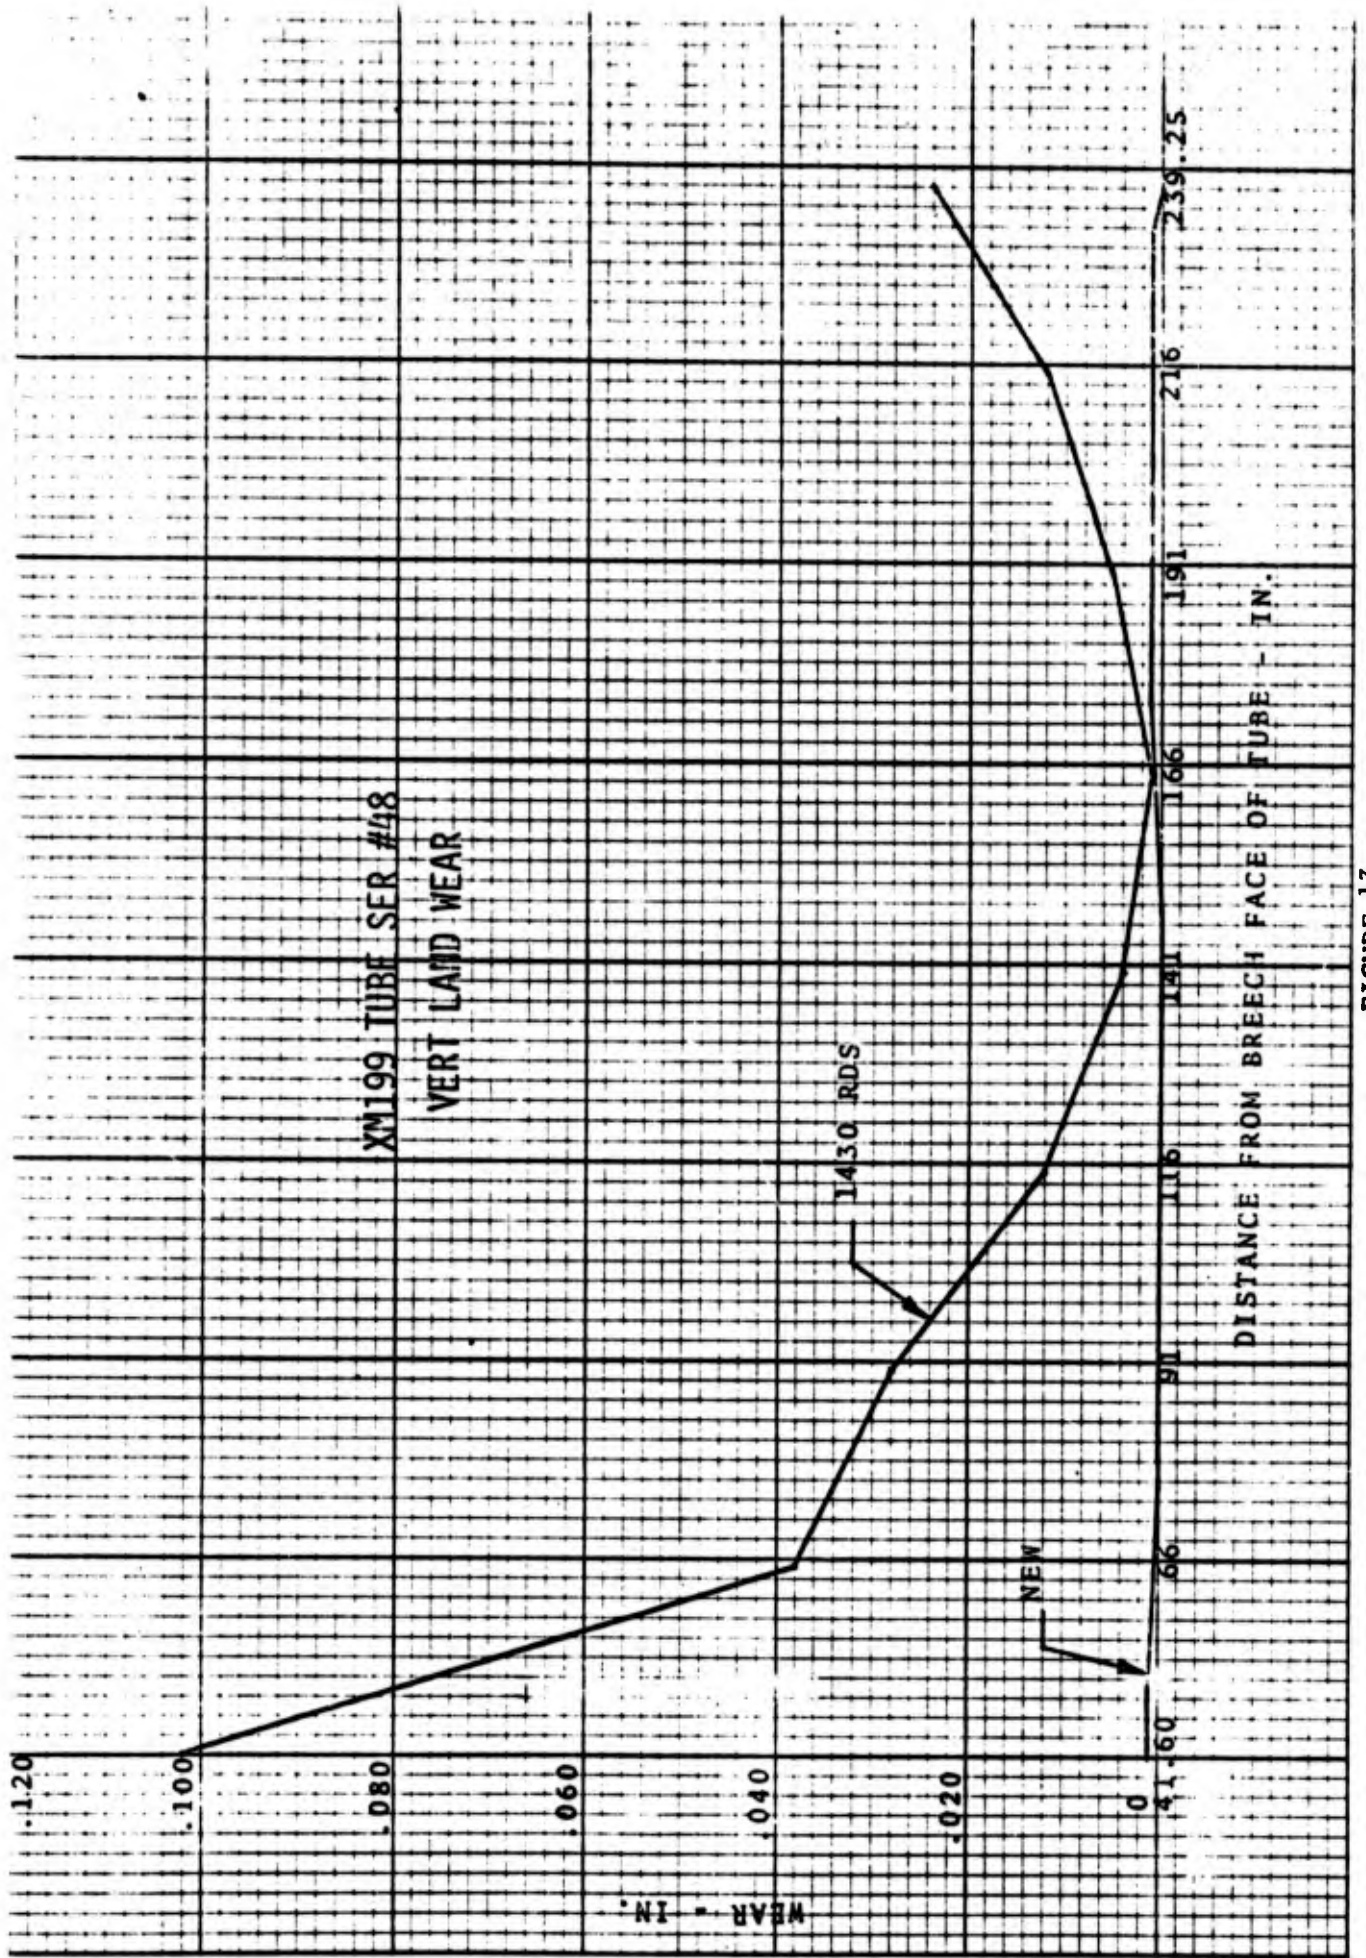
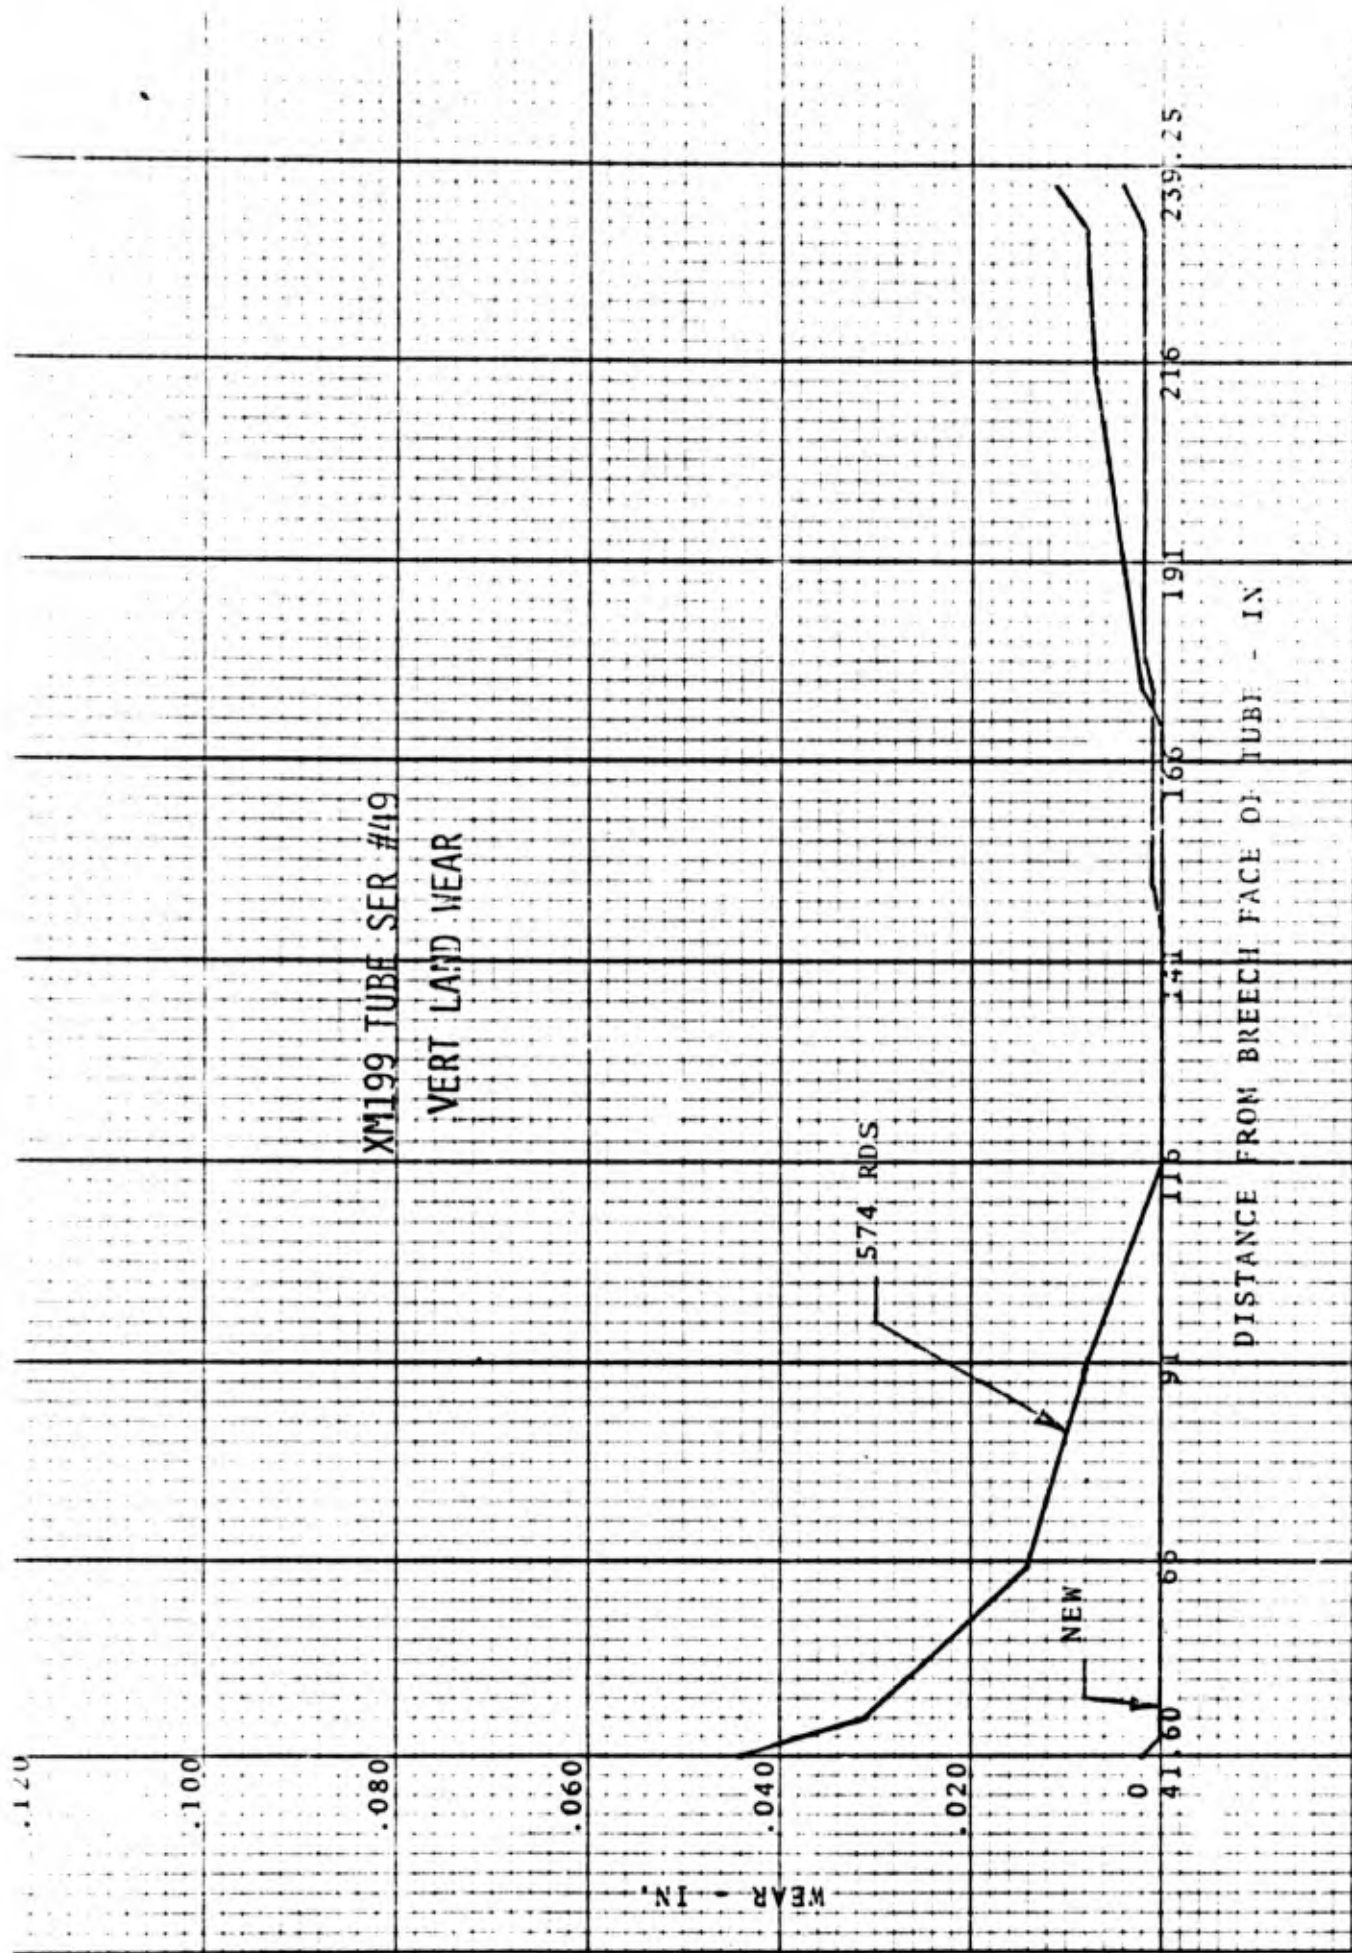
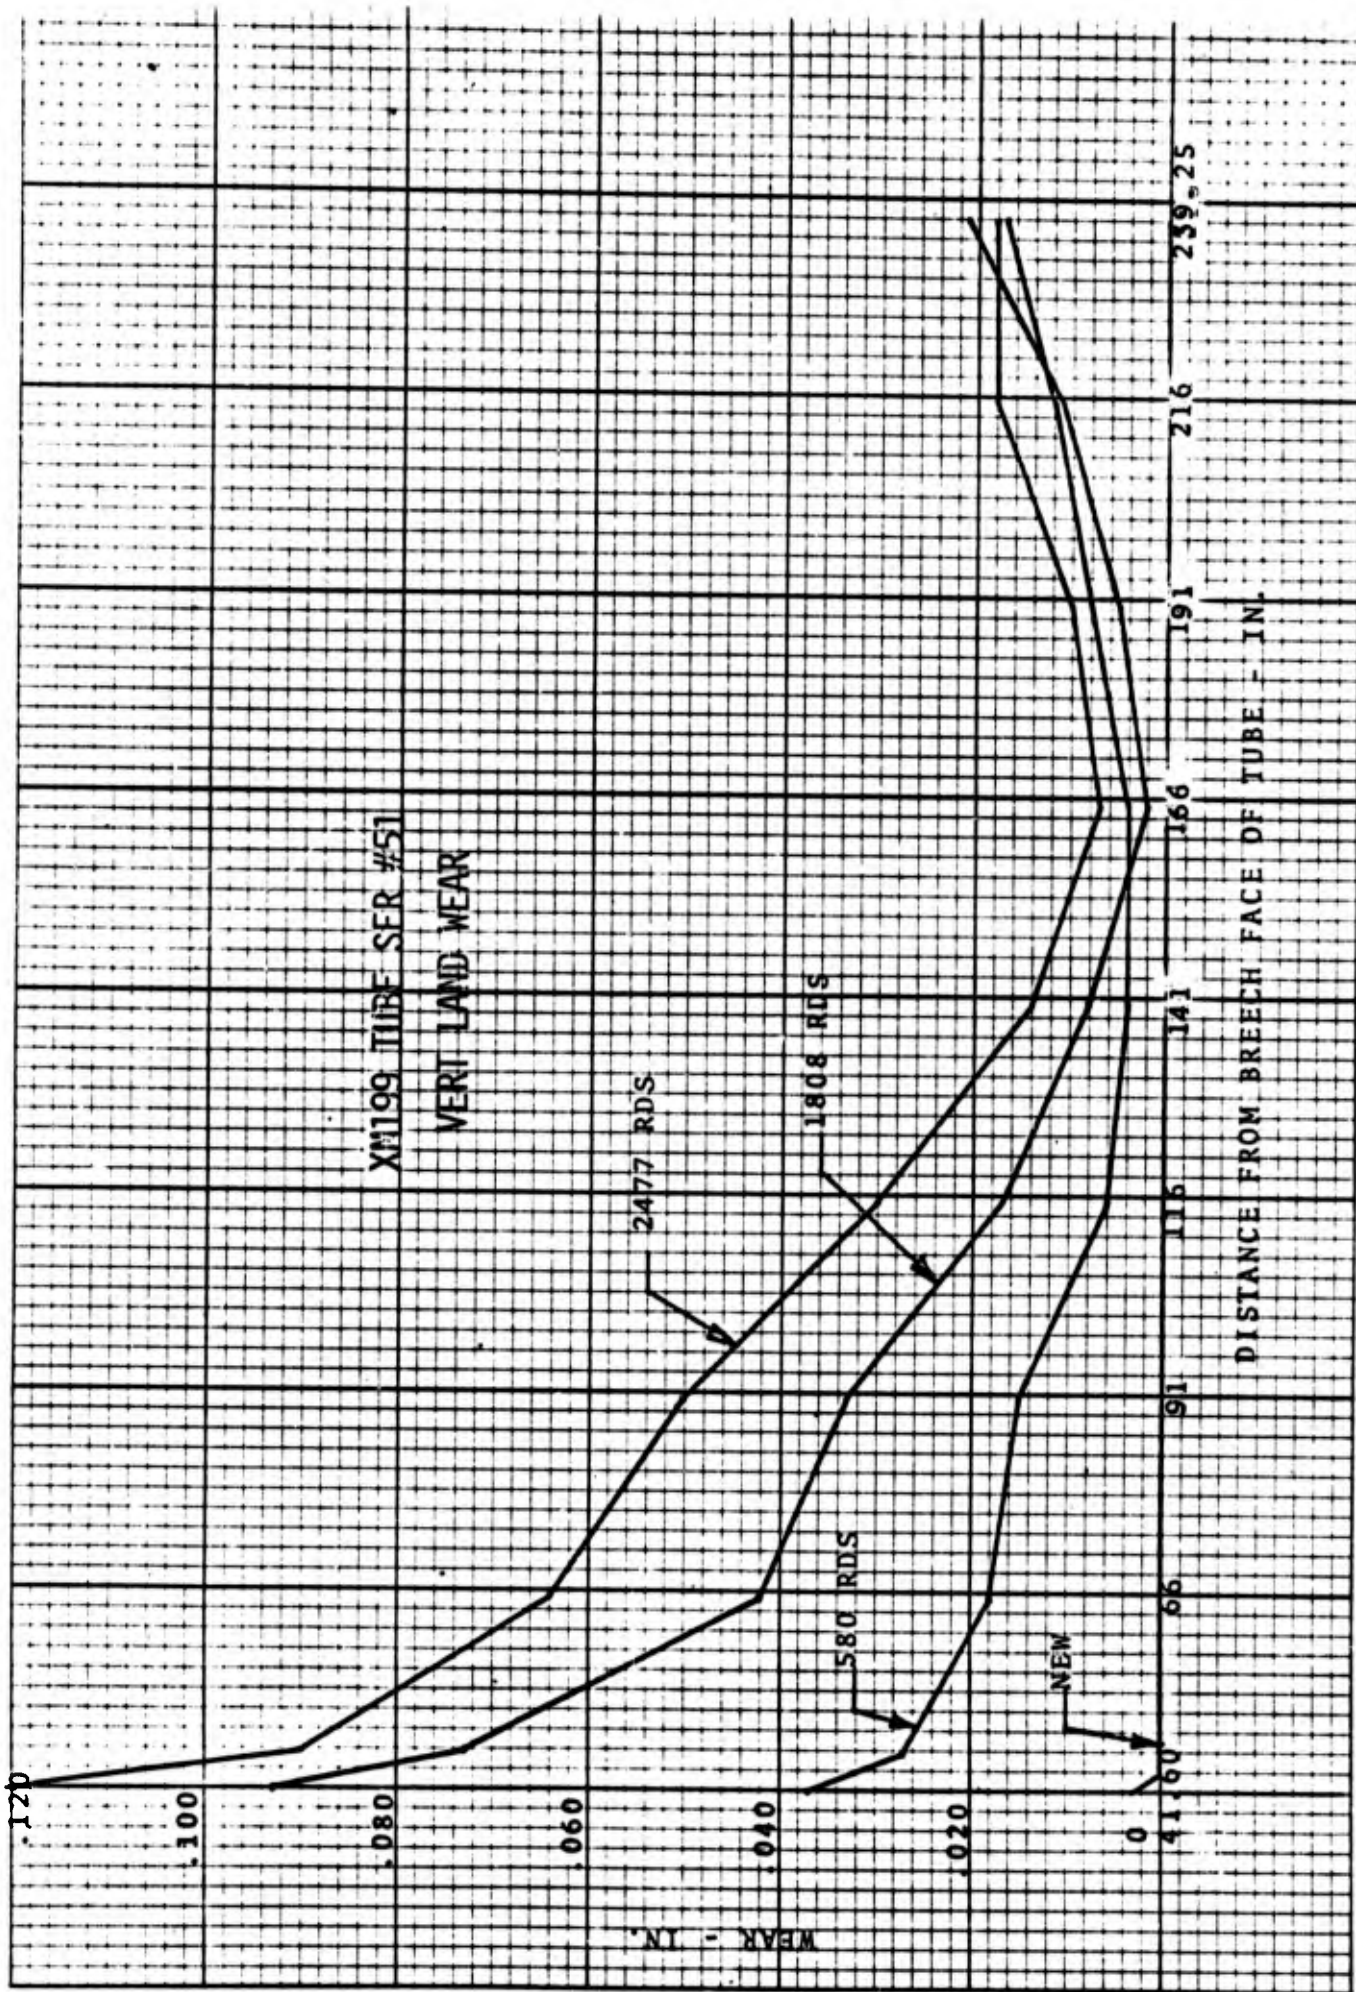
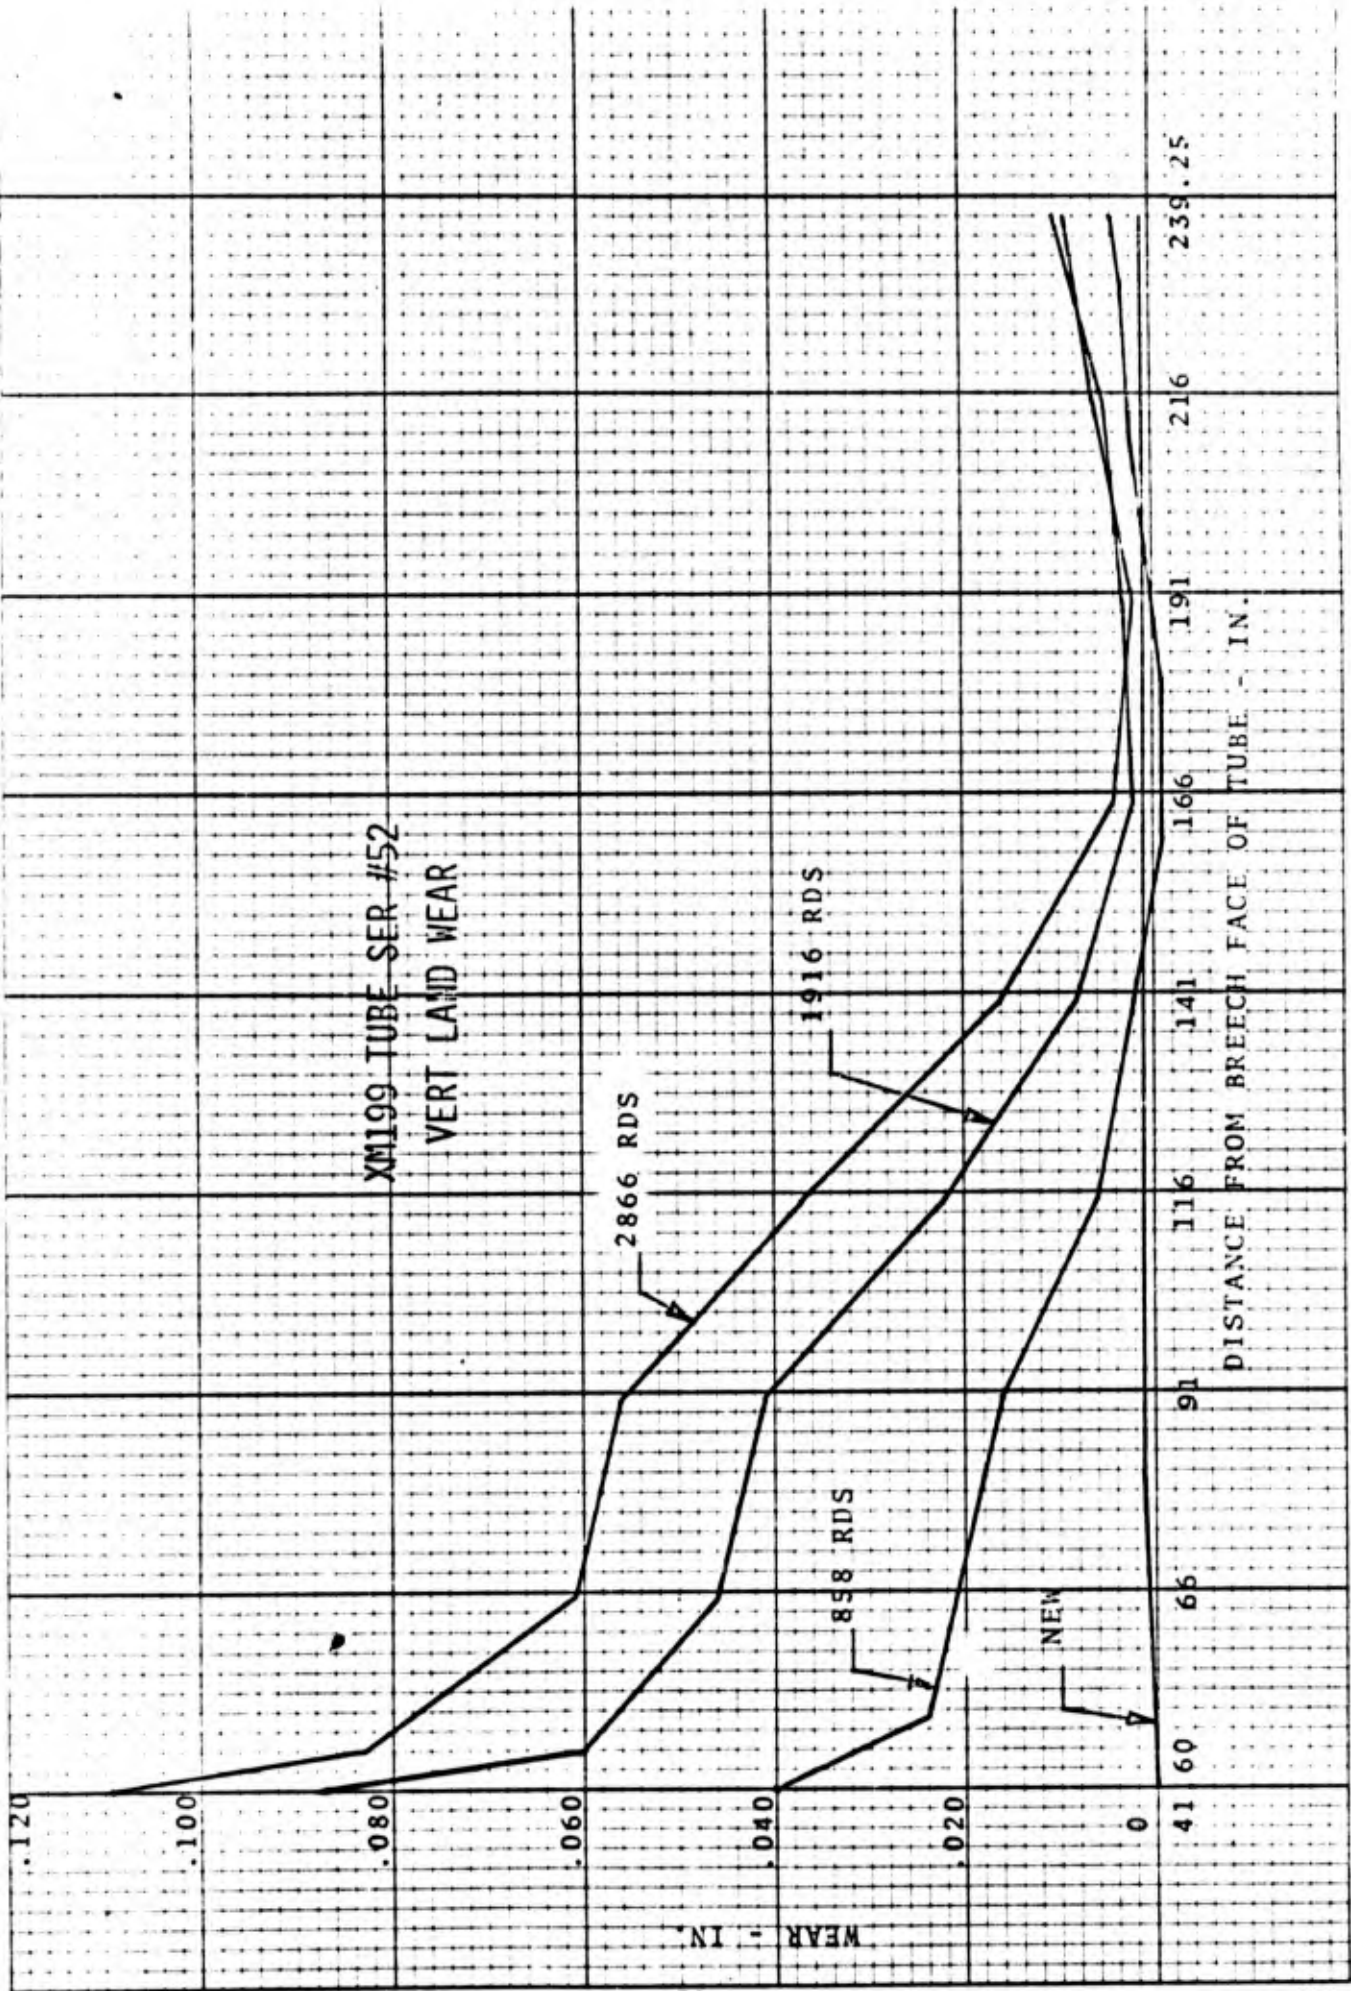
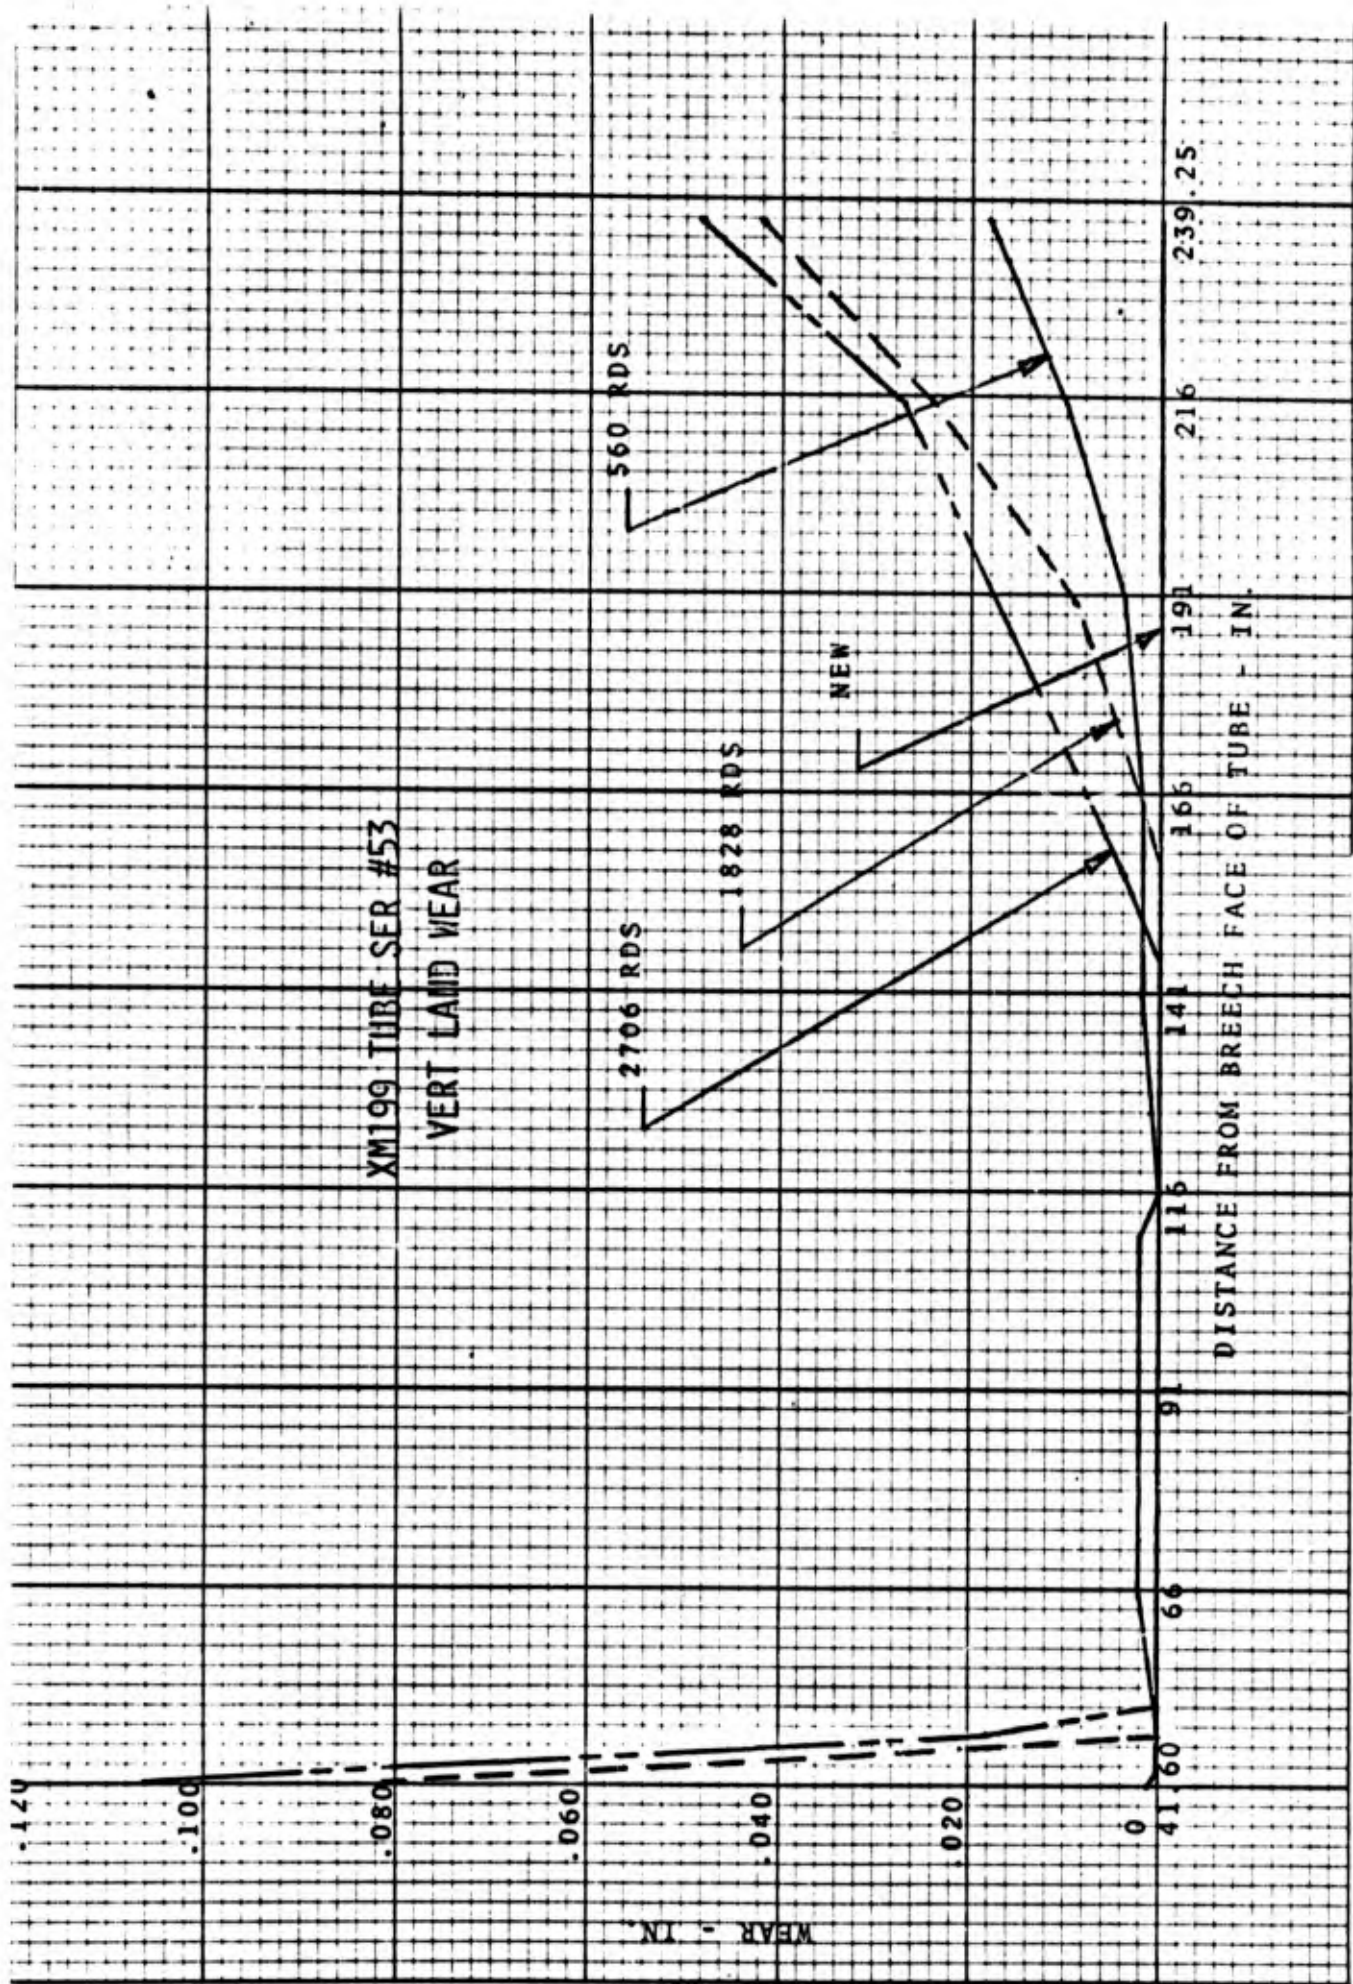
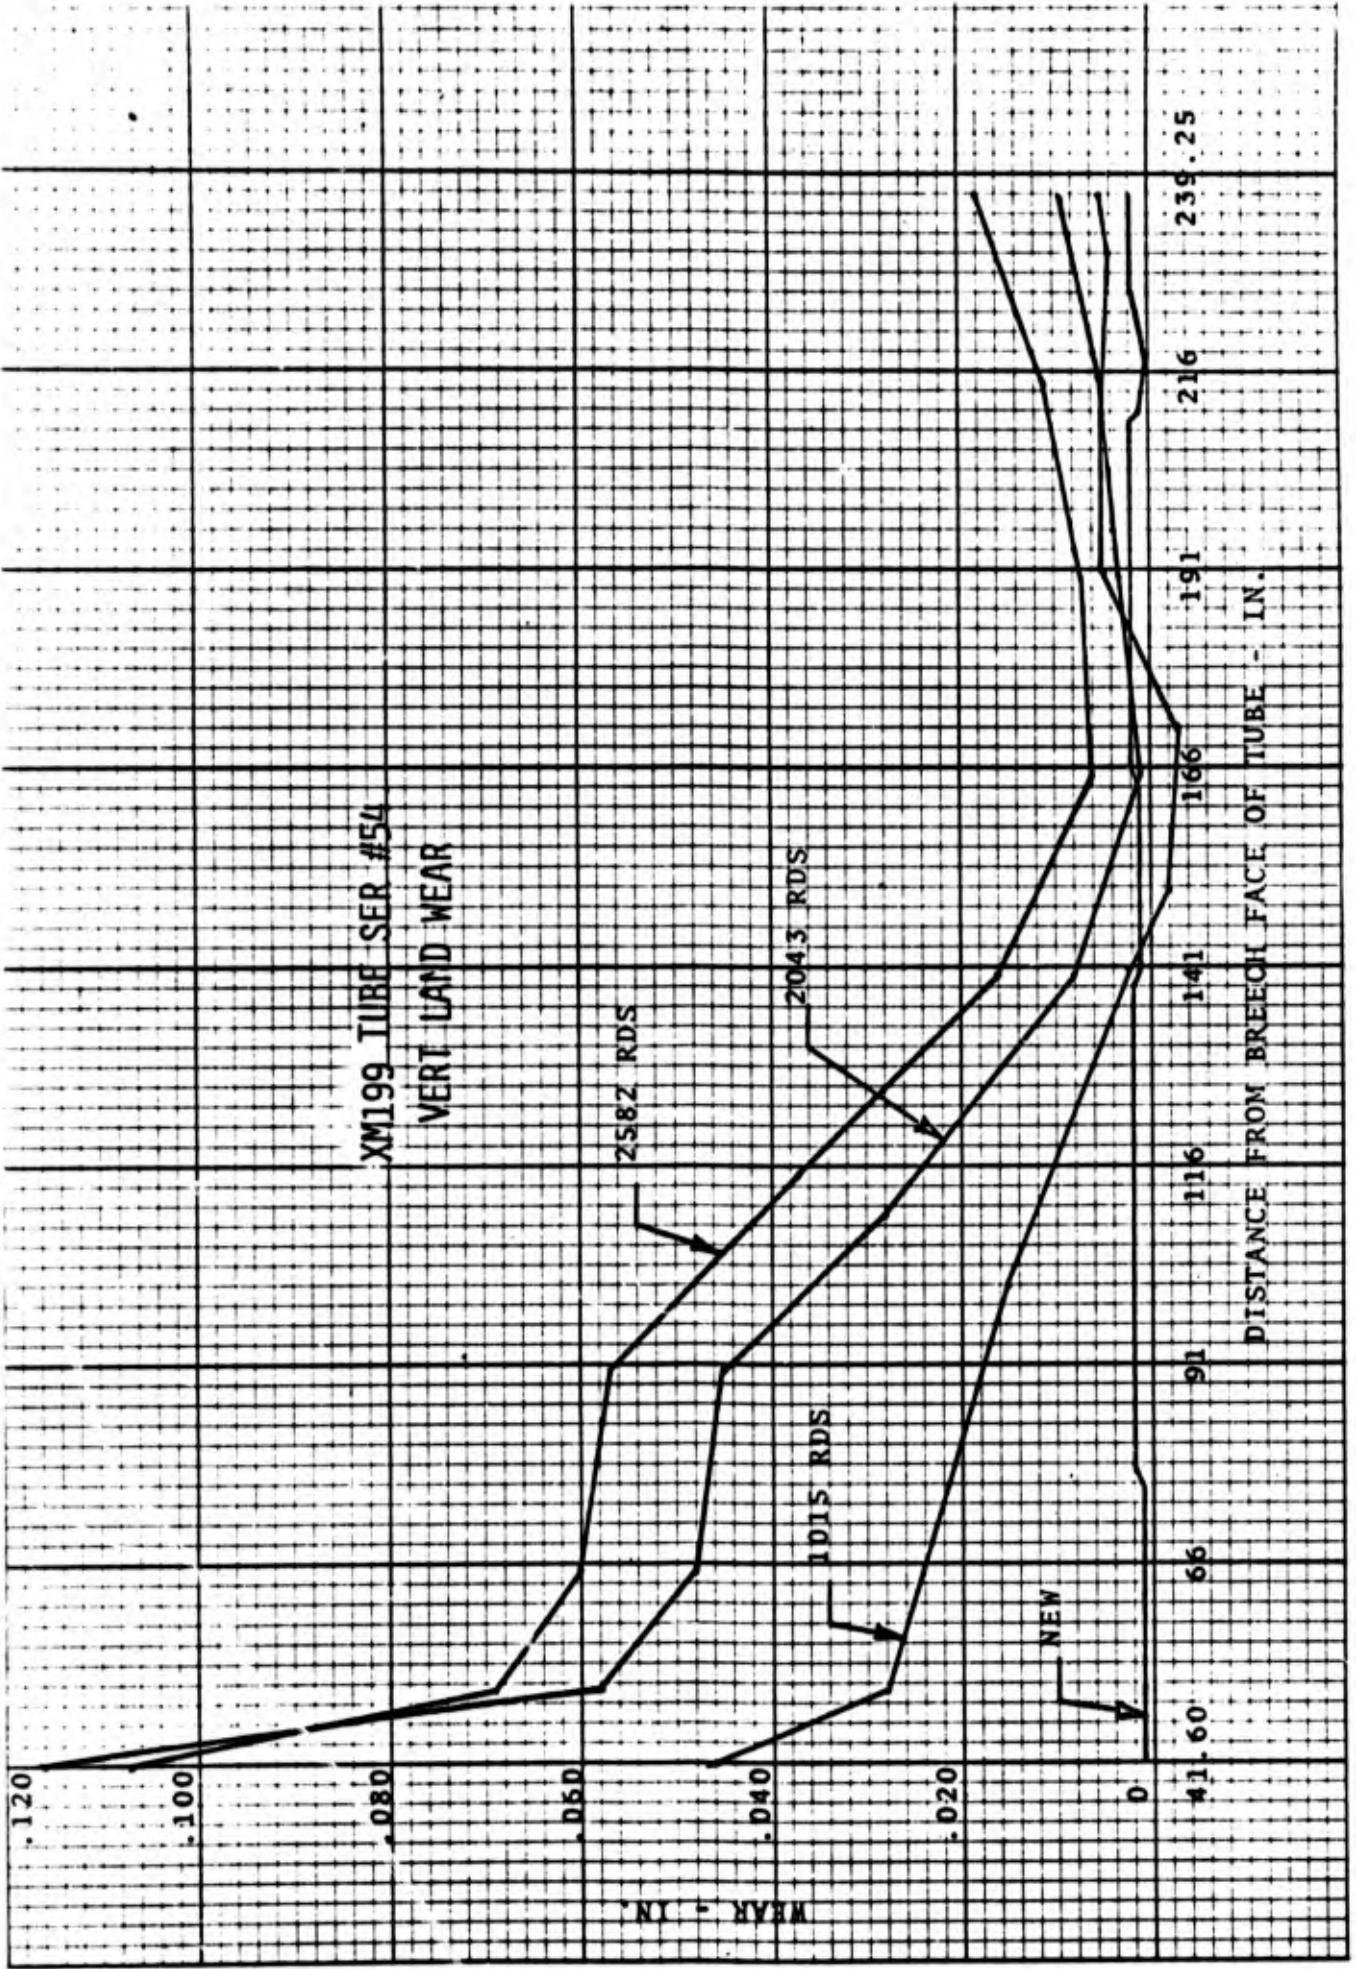
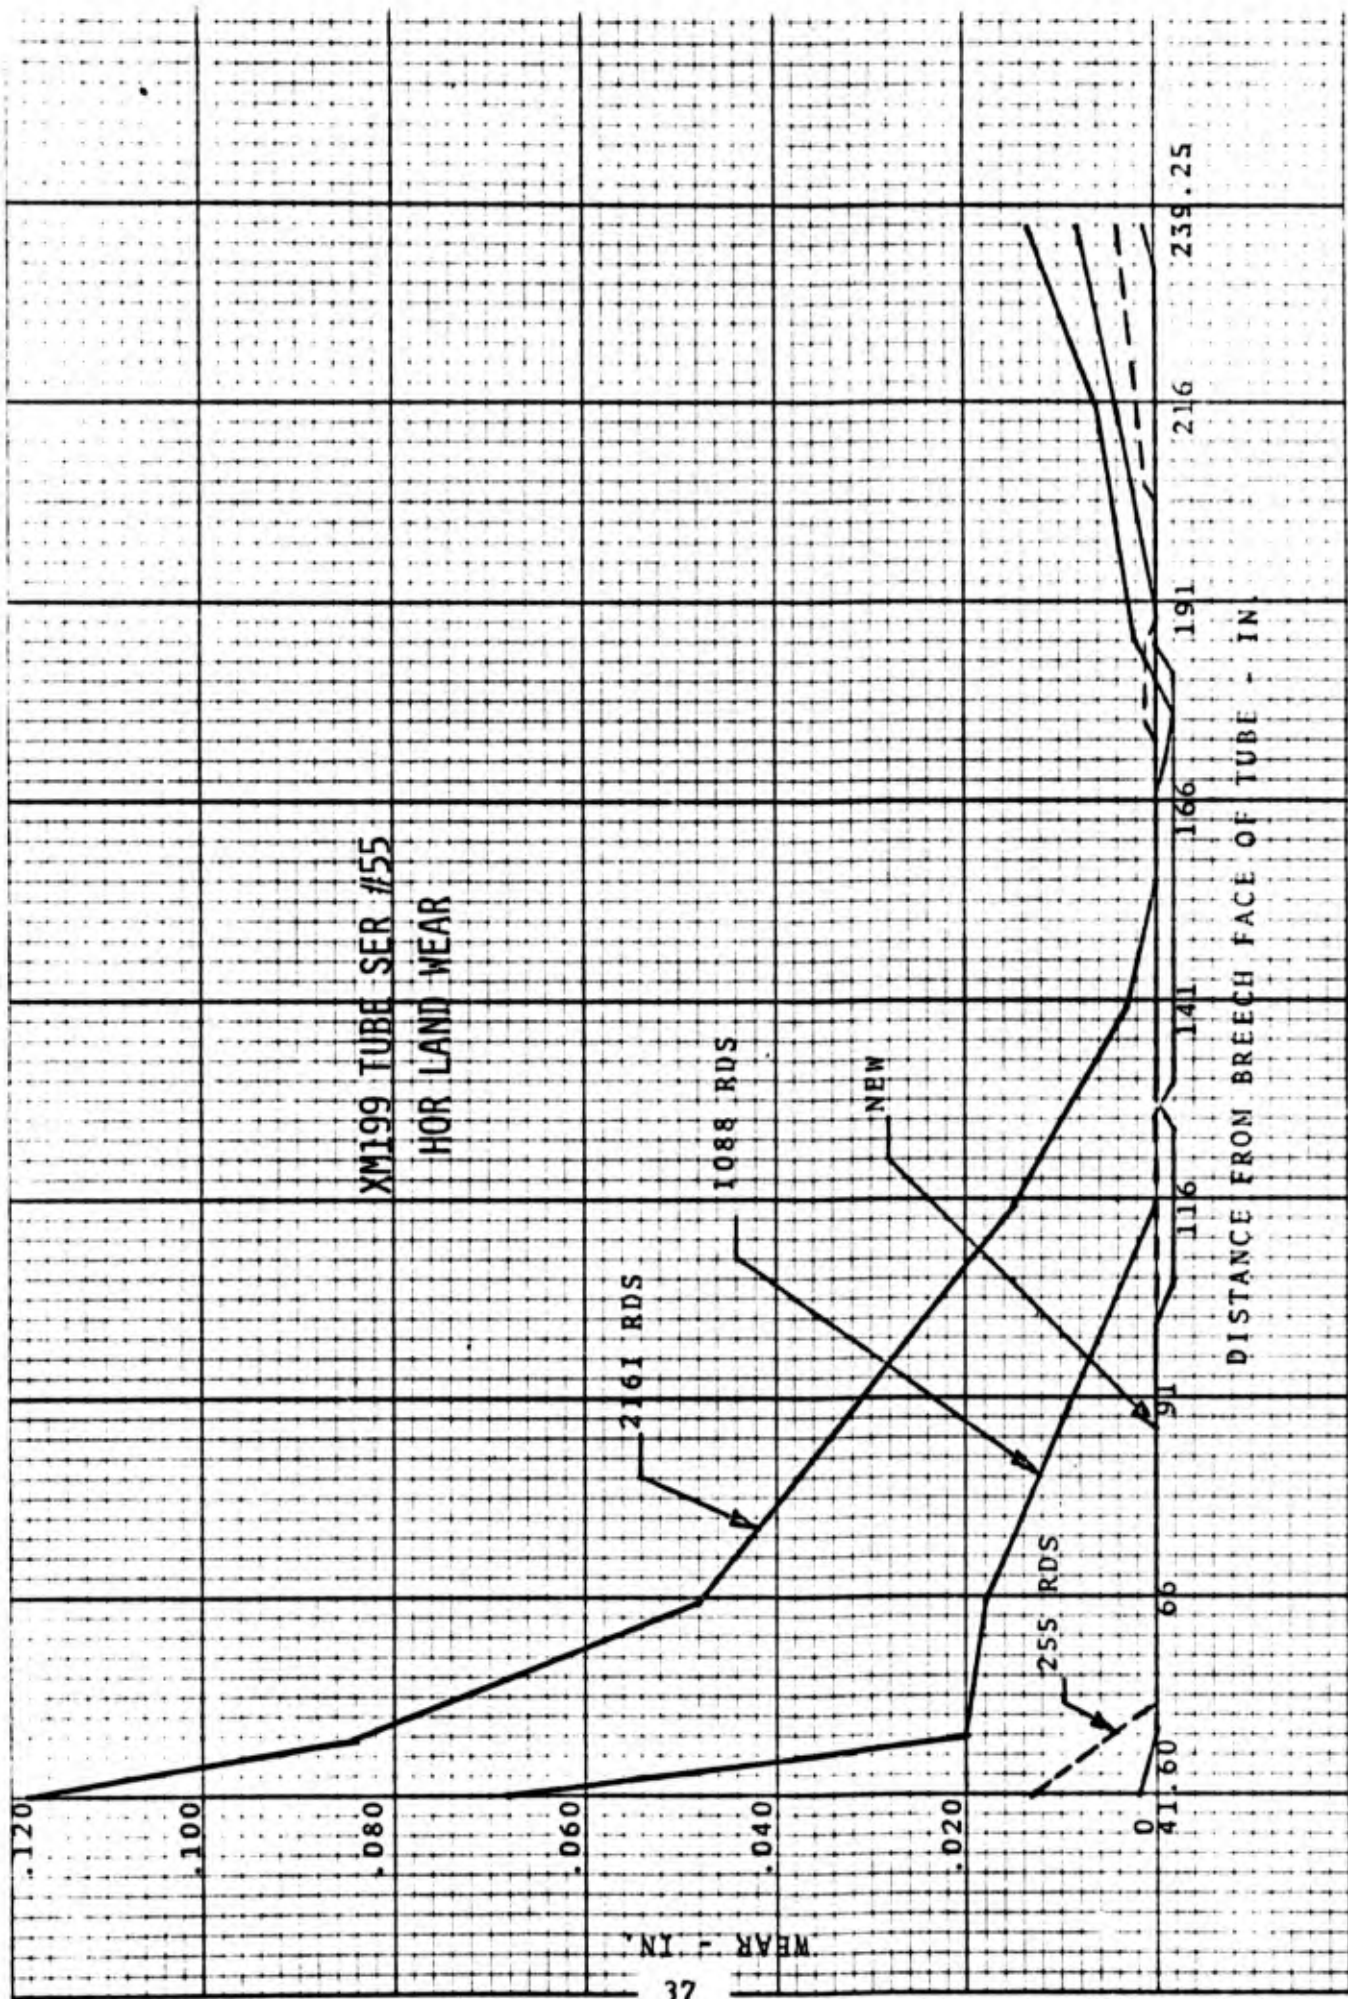
1. Axial Location. The vertical stargage readings were greater than or equal to (within .001 inches) the horizontal readings for every tube except S.N.55 (gain twist rifling). Selected axial wear data are presented in Figures 13 thru 19 for the seven tubes tested. Two types of wear are evident in these figures. The first is origin wear which is greatest in the vicinity of the origin of rifling and decreases downbore. At some axial location, wear again becomes significant and increases all the way to the muzzle. The latter wear phenomena ordinarily is confined to the lands and is termed muzzle wear. Traditionally, origin wear and muzzle wear have been treated as two distinct problems.

Table 7 shows the axial location where muzzle wear began to develop for each tube tested; the last available stargage readings were used. Muzzle wear was evident over the last 44 to 94 inches of projectile travel for the seven tubes tested. On the average, muzzle wear began approximately 175 inches from the rear face of the tube (65 inches from the muzzle) and increased all the way to the muzzle.
